# Post Wildfire Assessment

Richard Muhl  
Senior Environmental Scientist  
Central Valley Regional Water Quality Control Board  
[Richard.Muhl@waterboards.ca.gov](mailto:Richard.Muhl@waterboards.ca.gov)

# MENDOCINO COMPLEX FIRE

# MENDOCINO COMPLEX FIRE POST-FIRE ASSESSMENT

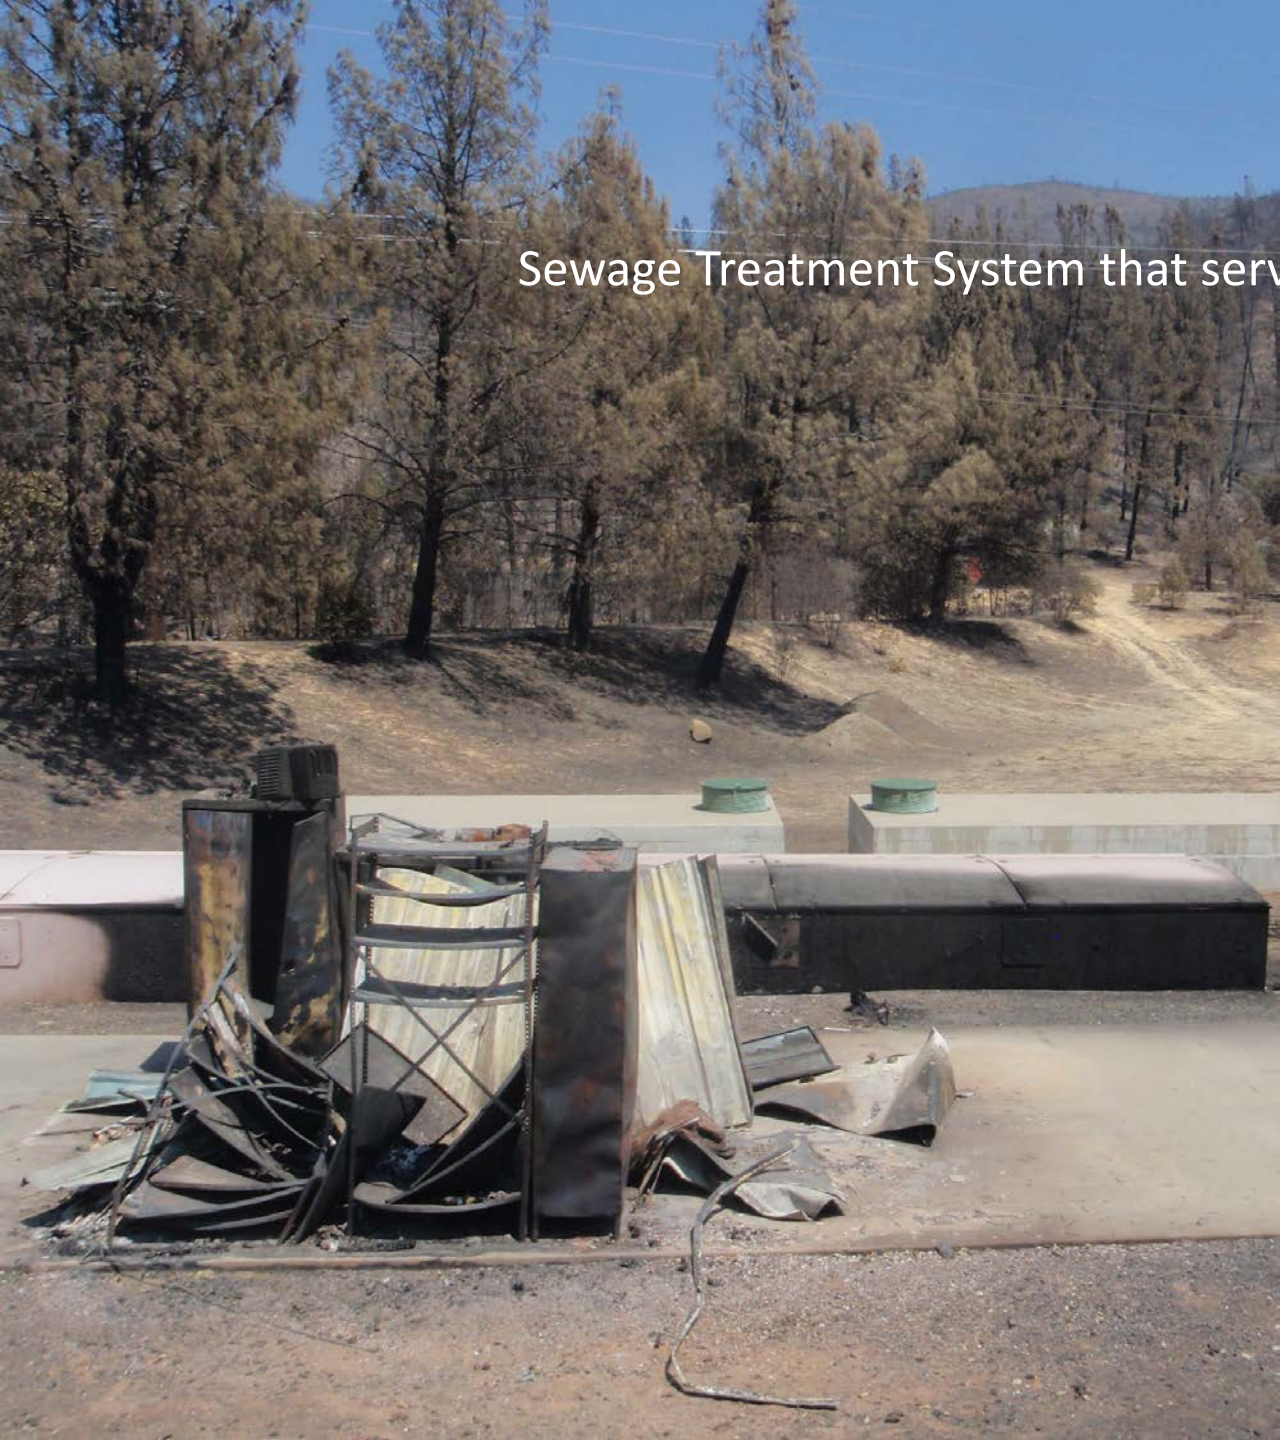
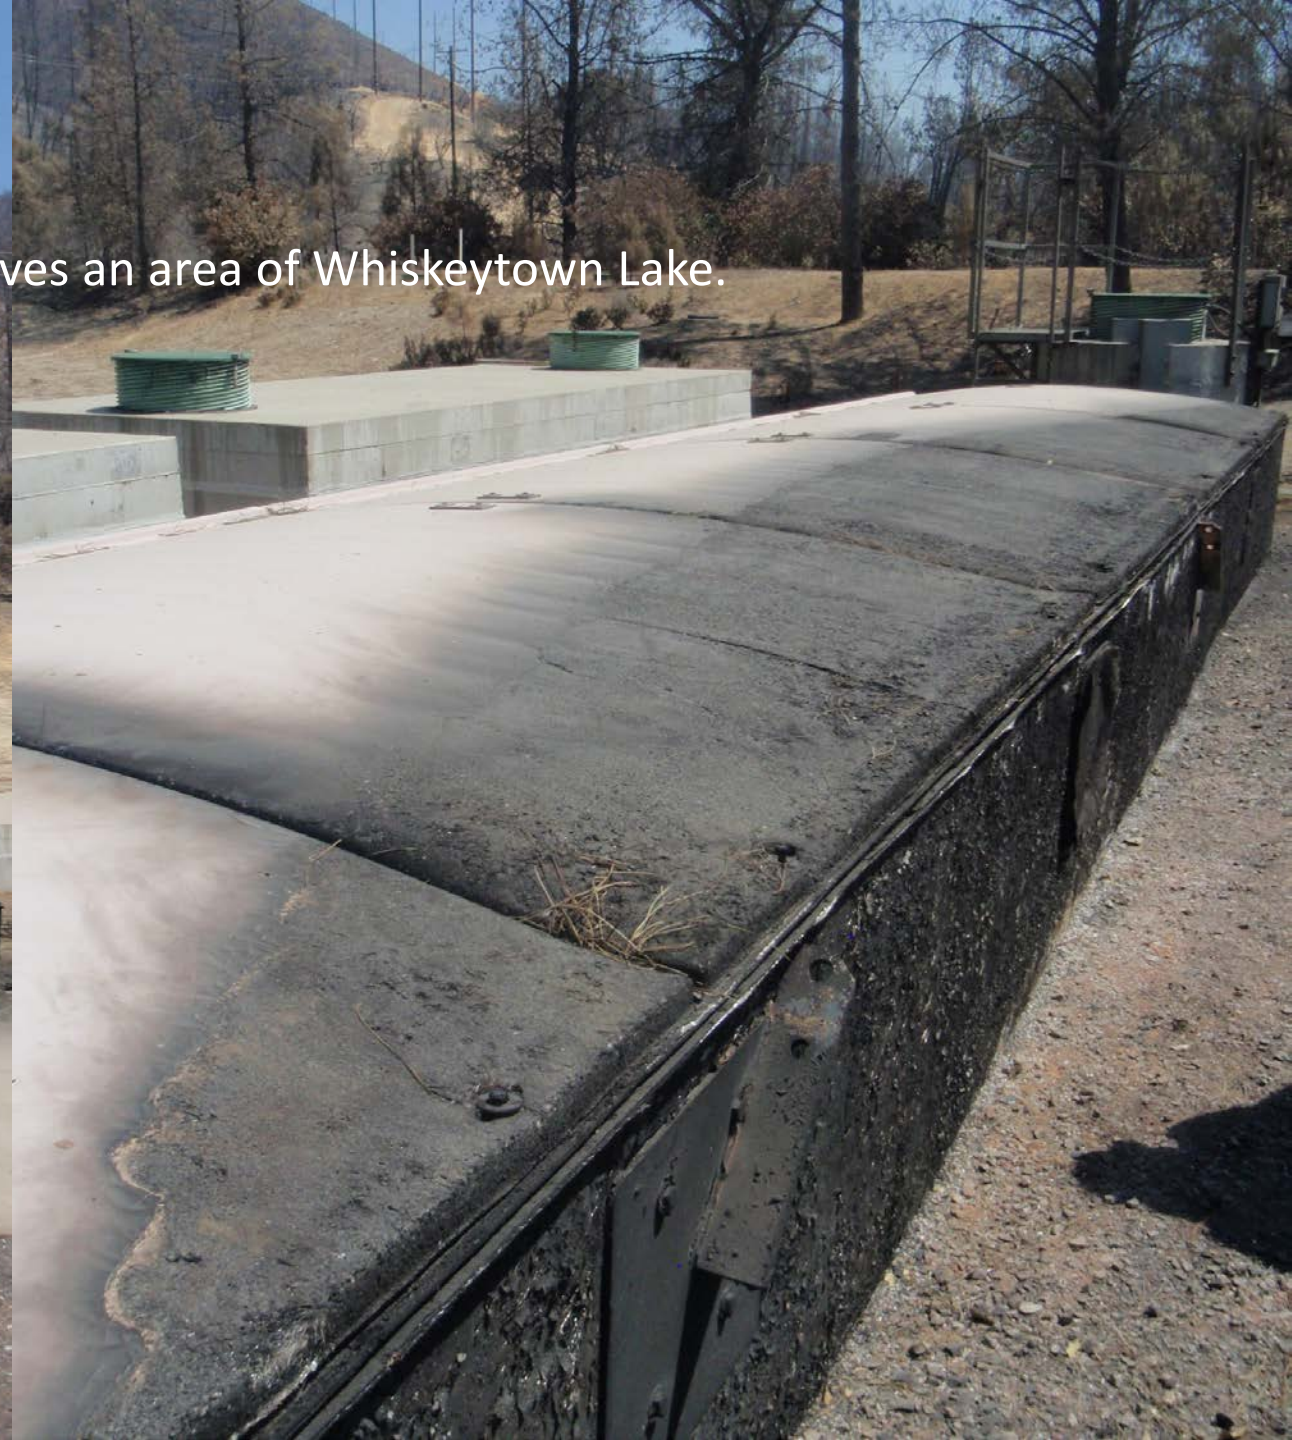
Whiskeytown NRA CG Well and Tank

Sewage Treatment System that serves an area of Whiskeytown Lake.

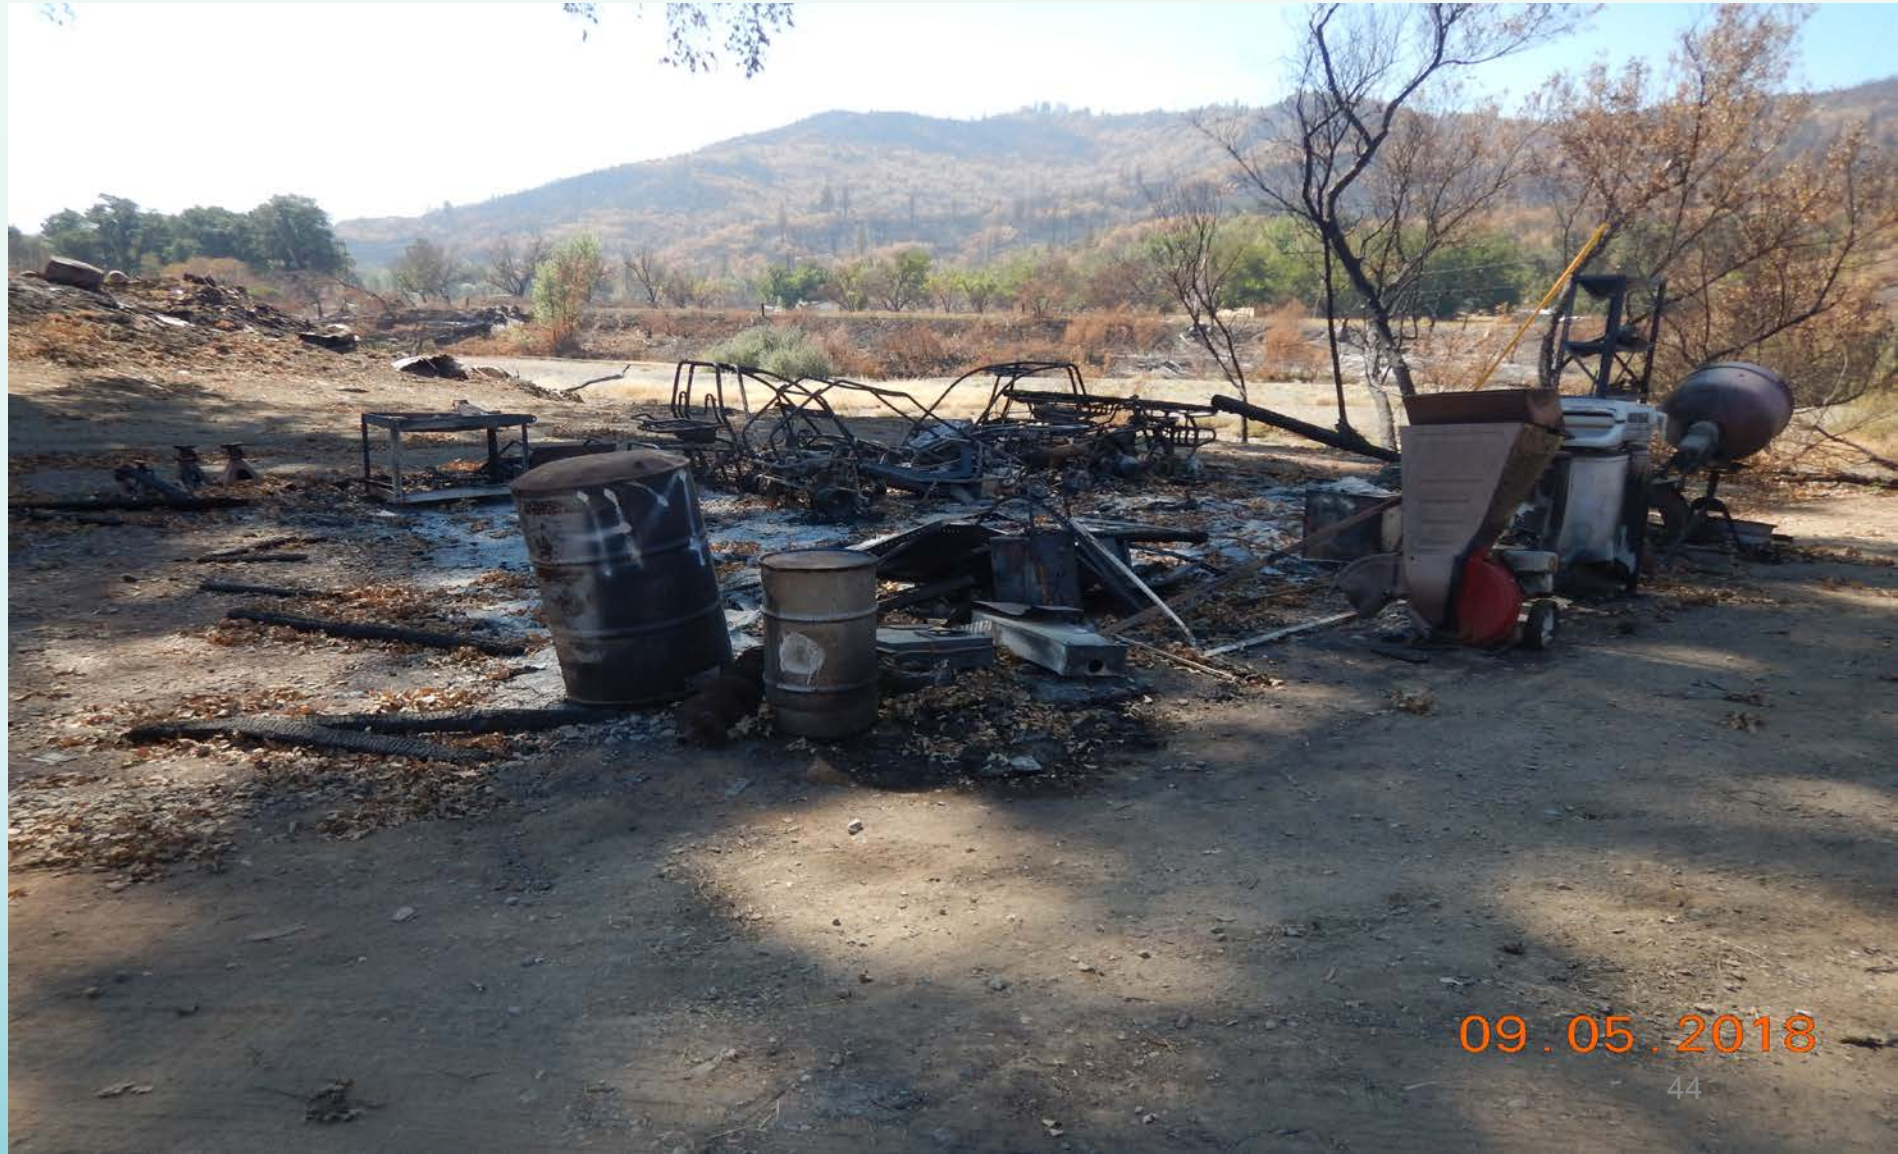
**Middle Creek/  
Structure  
Ranking A1**

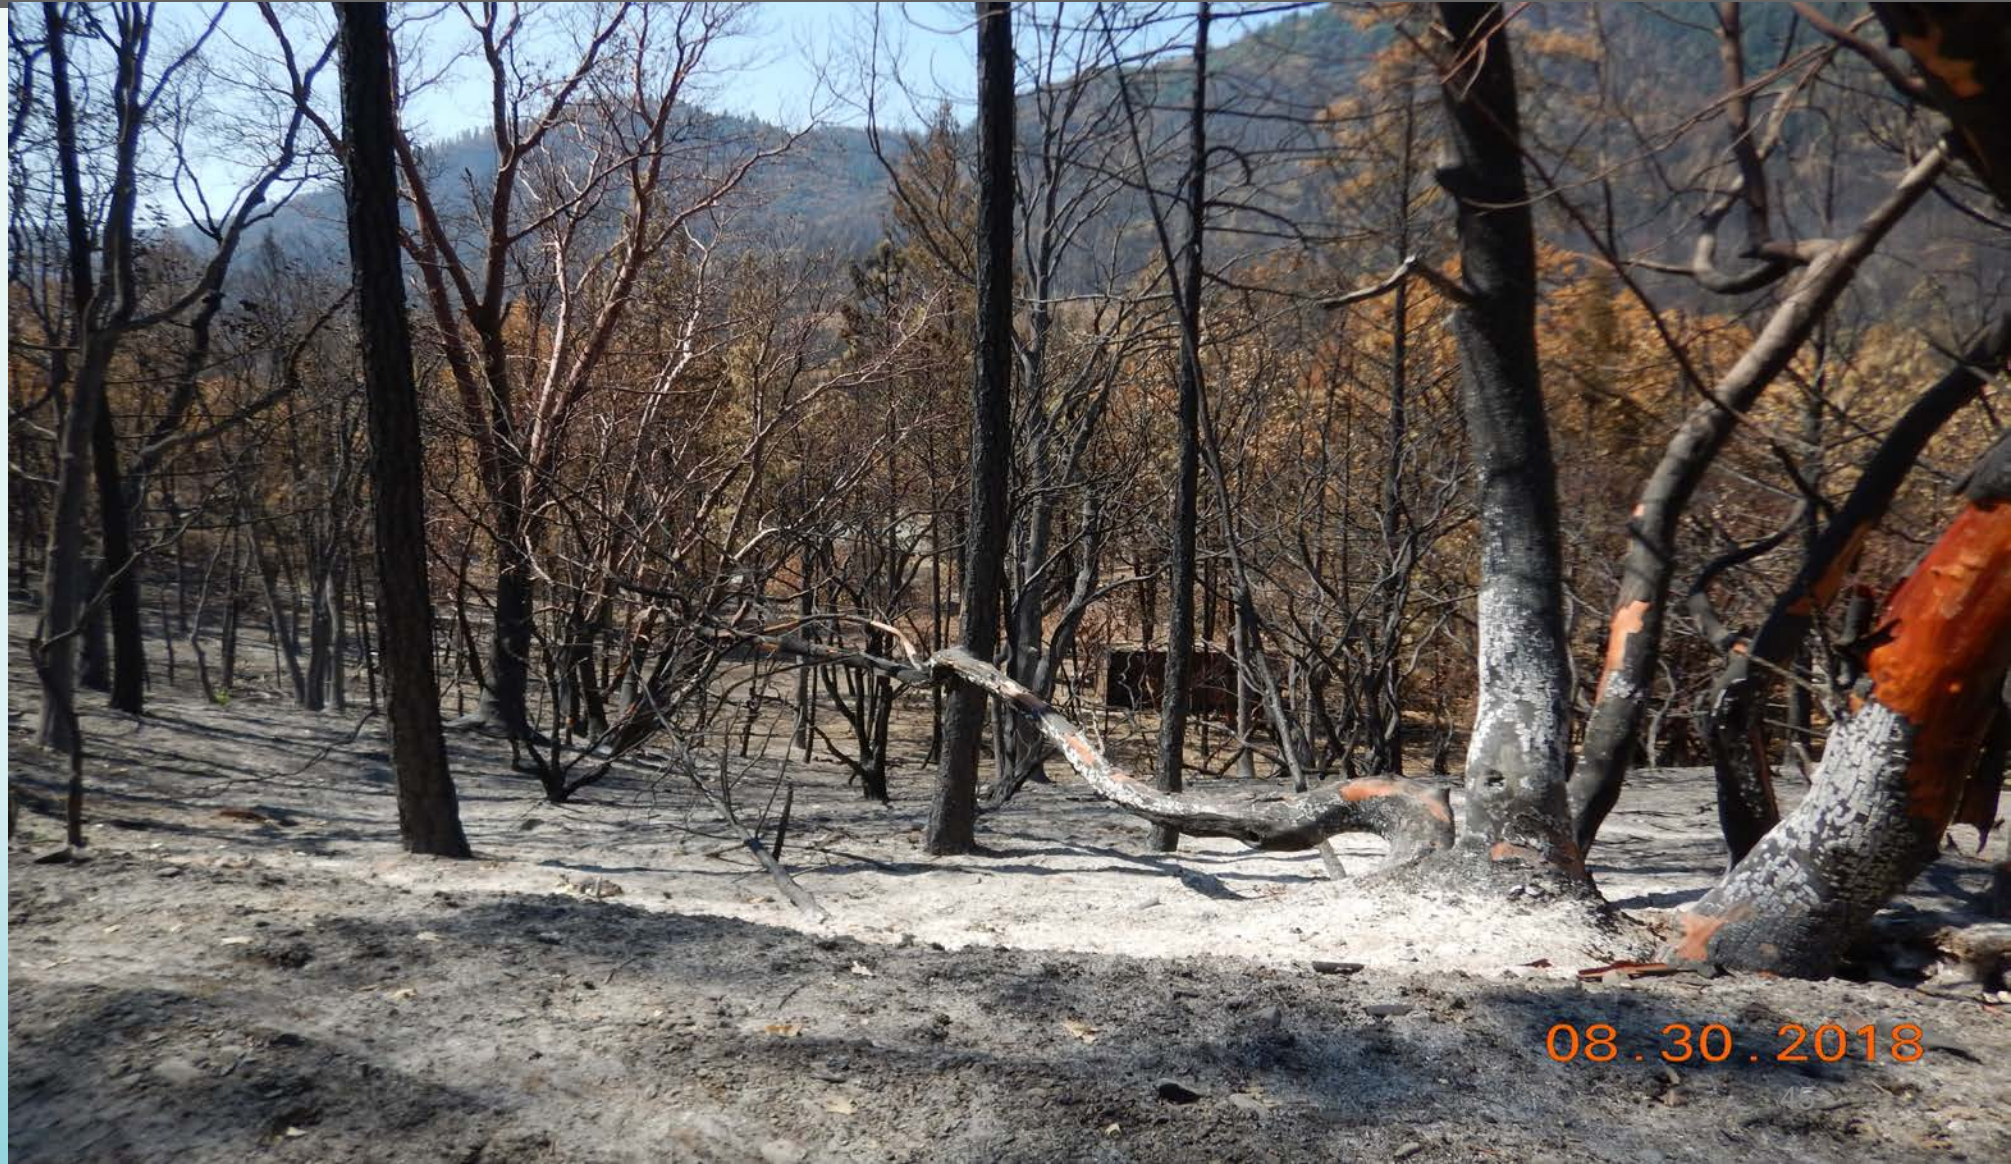
**Middle Creek/  
Slopes Ranking  
B2**

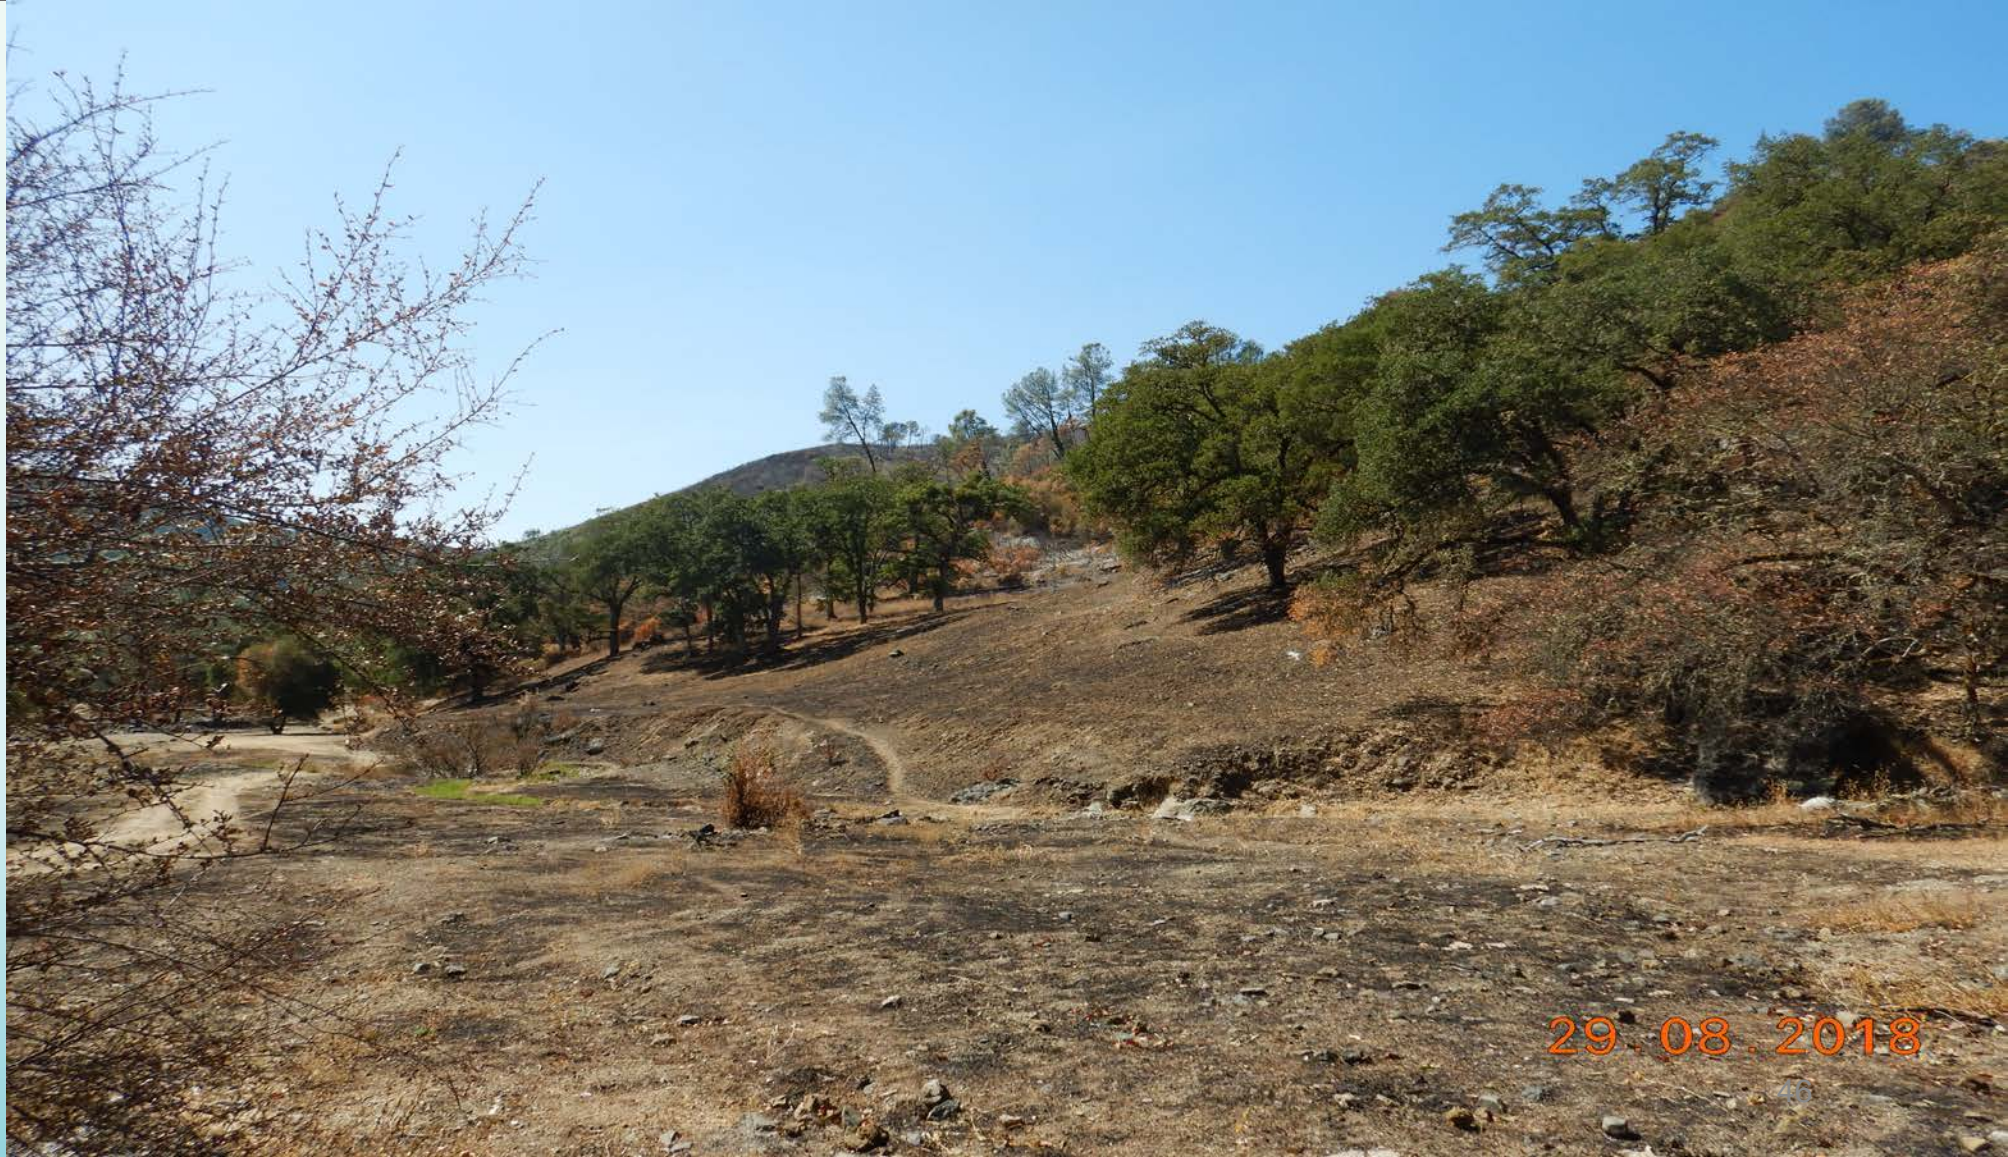
**Clover Creek/  
Slopes Ranking  
C3**

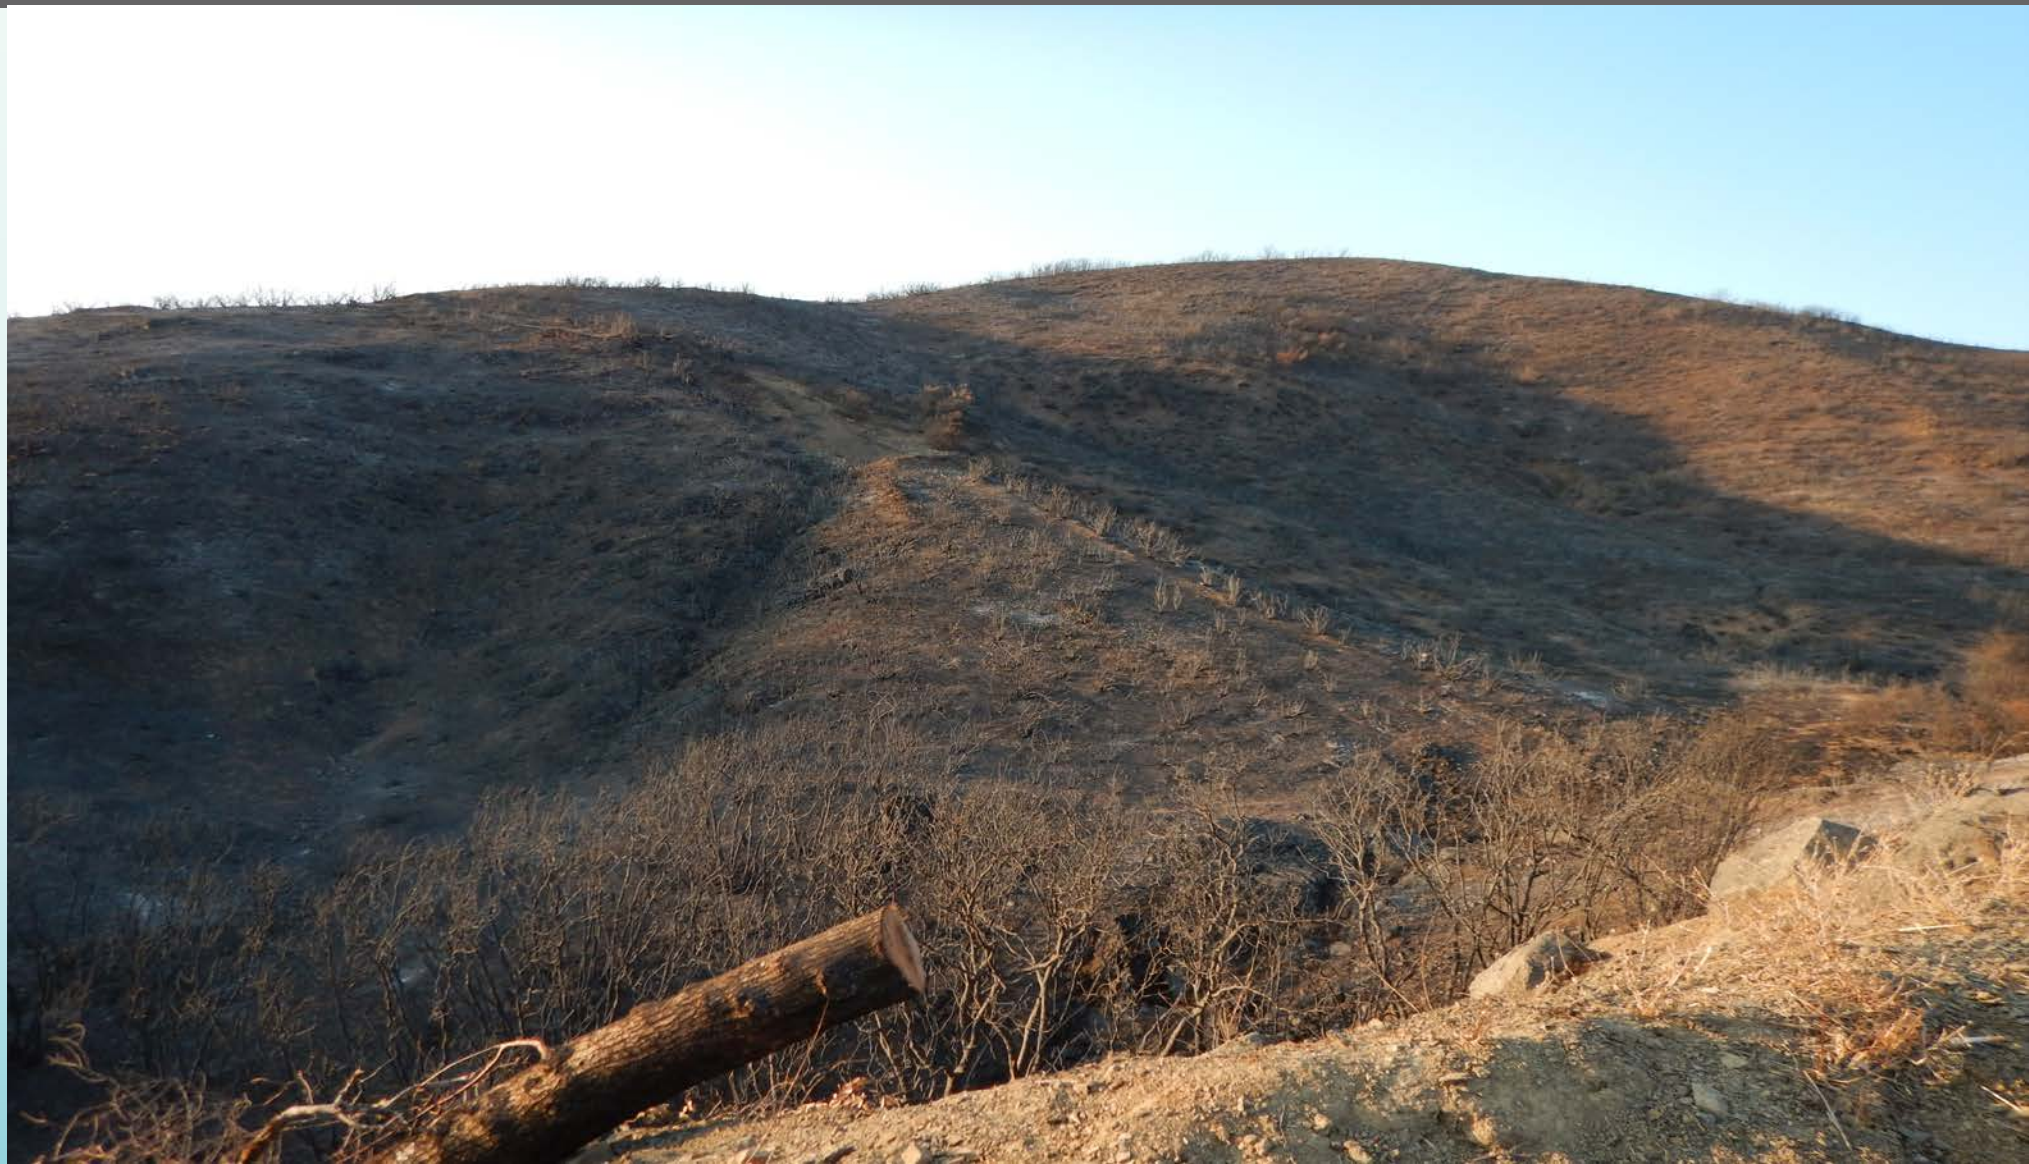
**Moderate to  
High Intensity  
burn area**

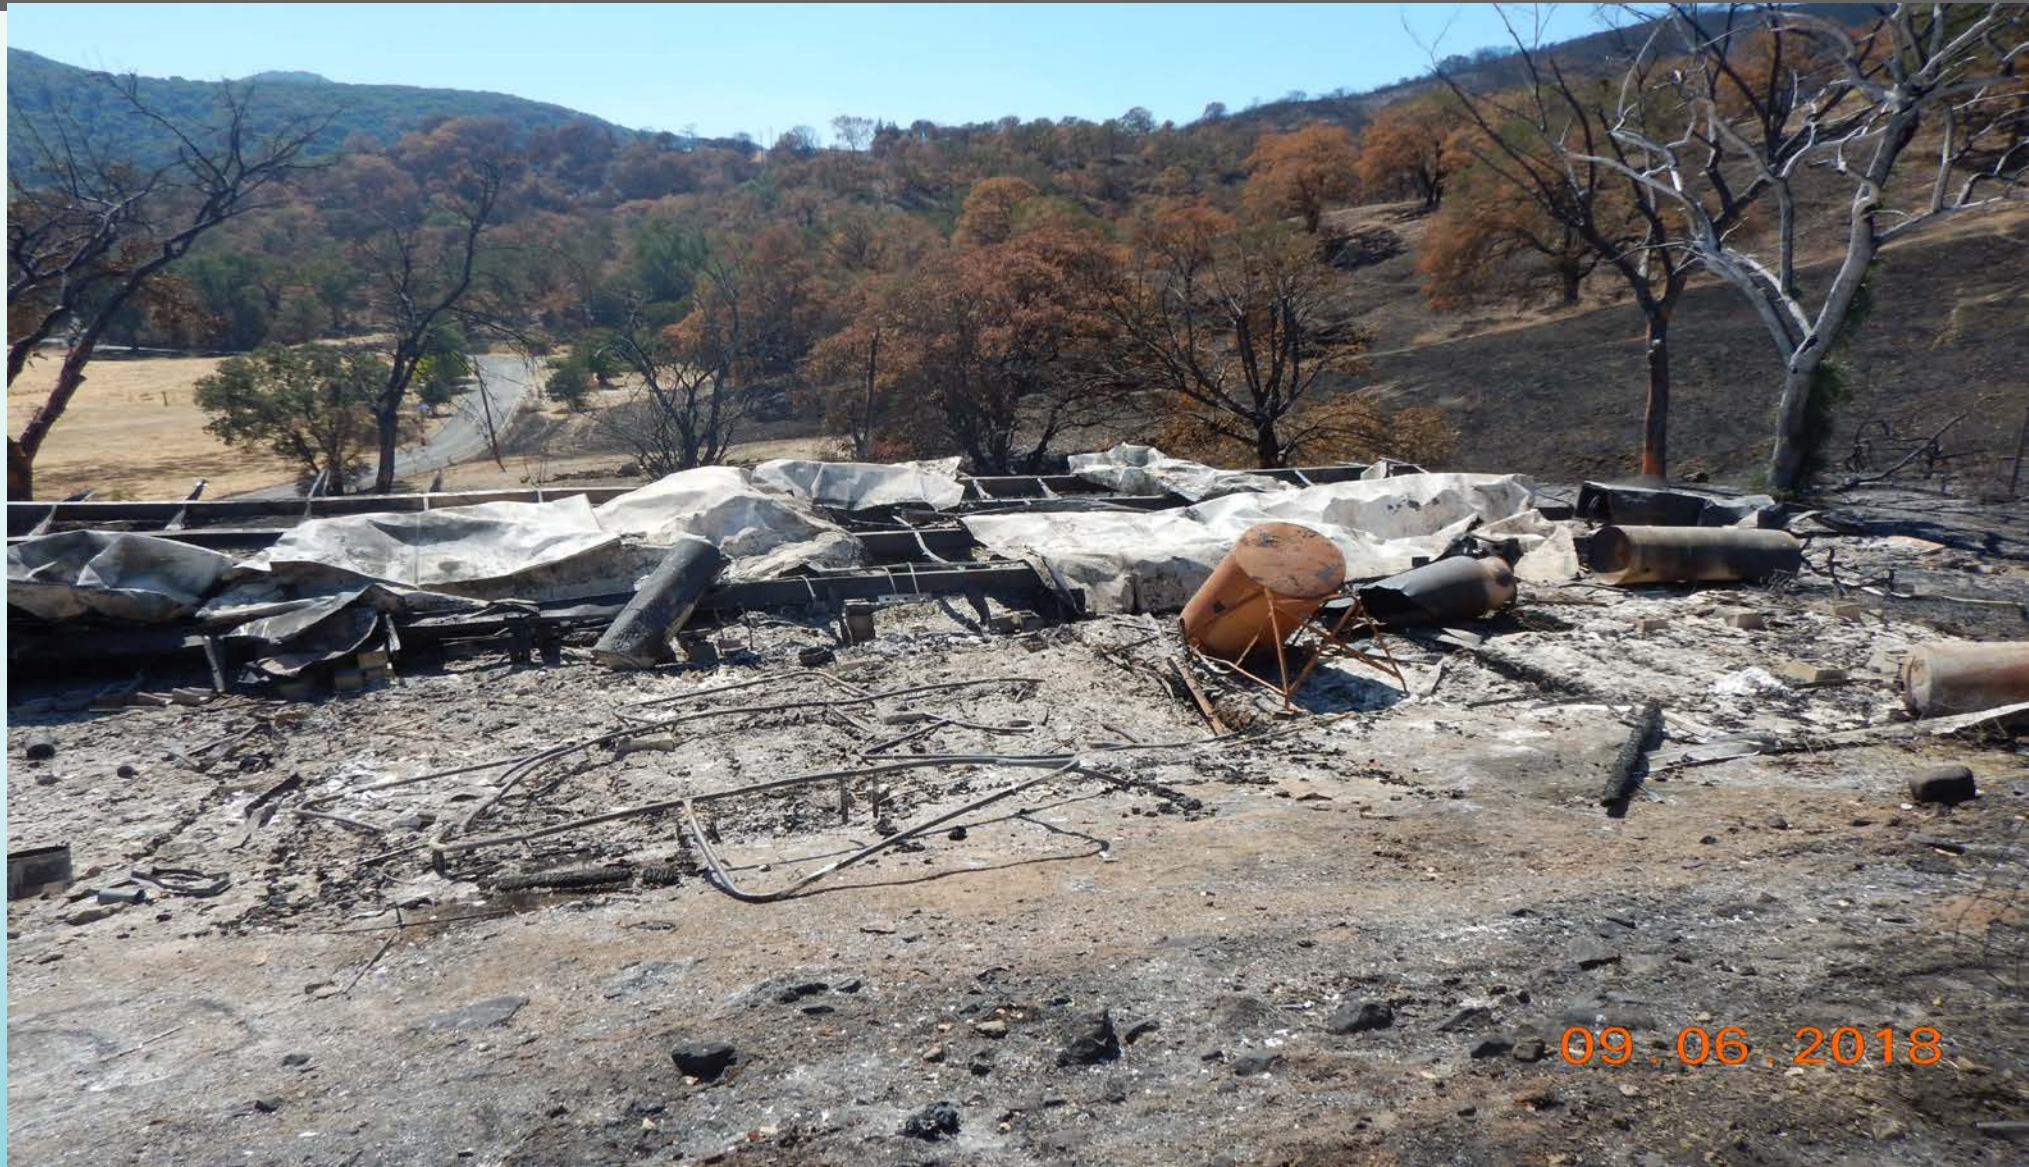
**Structure  
Destroyed In  
Fire**

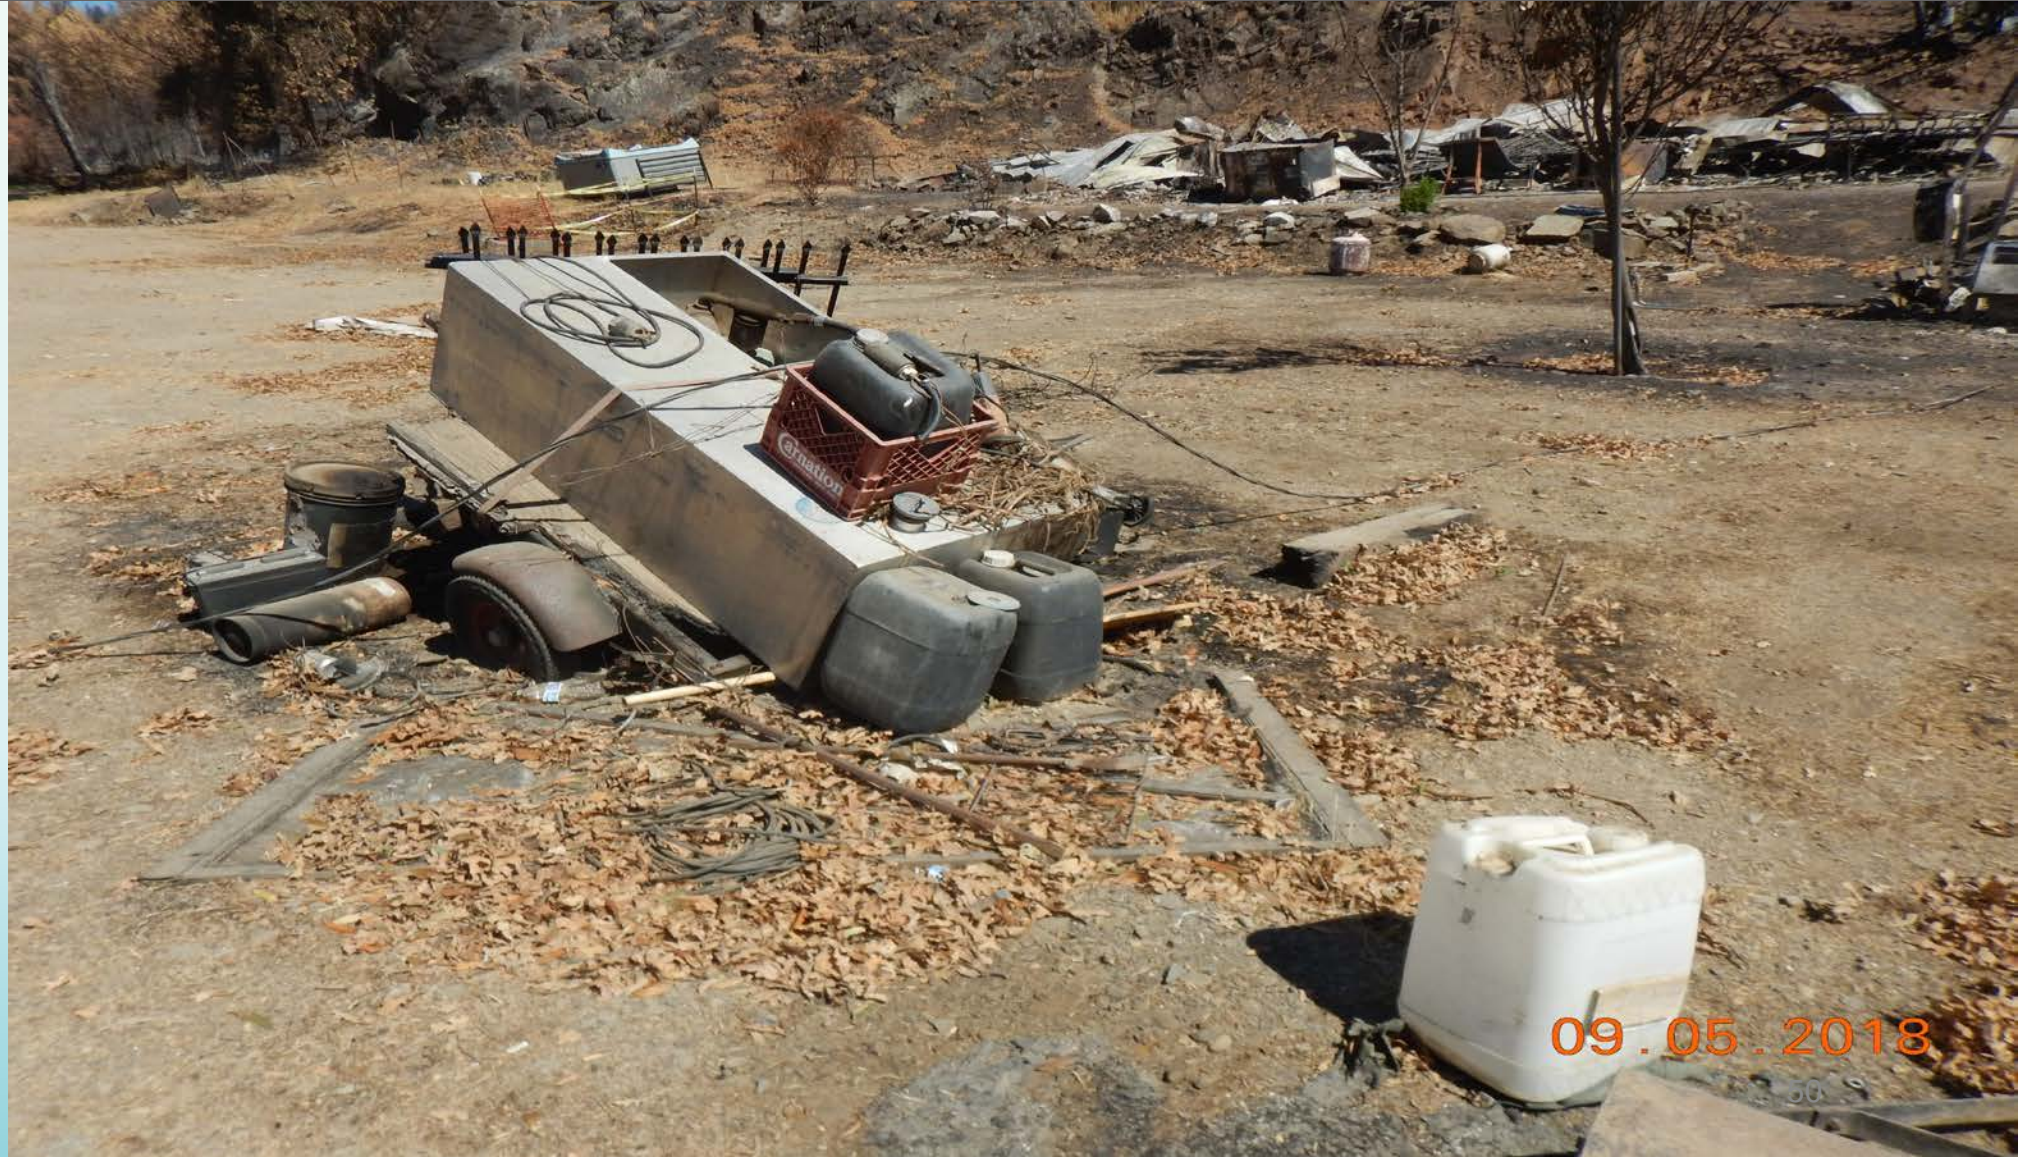
## Hazardous Waste Issues
