Re: 2014-2015 Annual Monitoring and Reporting for Pepperwood Preserve Sediment Reduction Project SRNO-2H

Pepperwood Preserve Sediment Reduction Implementation Project
Appendix B- Photo Plates 2014-2015 Annual Monitoring Report

Pepperwood Preserve Sediment Reduction Implementation Project
Appendix A- BMP Monitoring Field Sheets

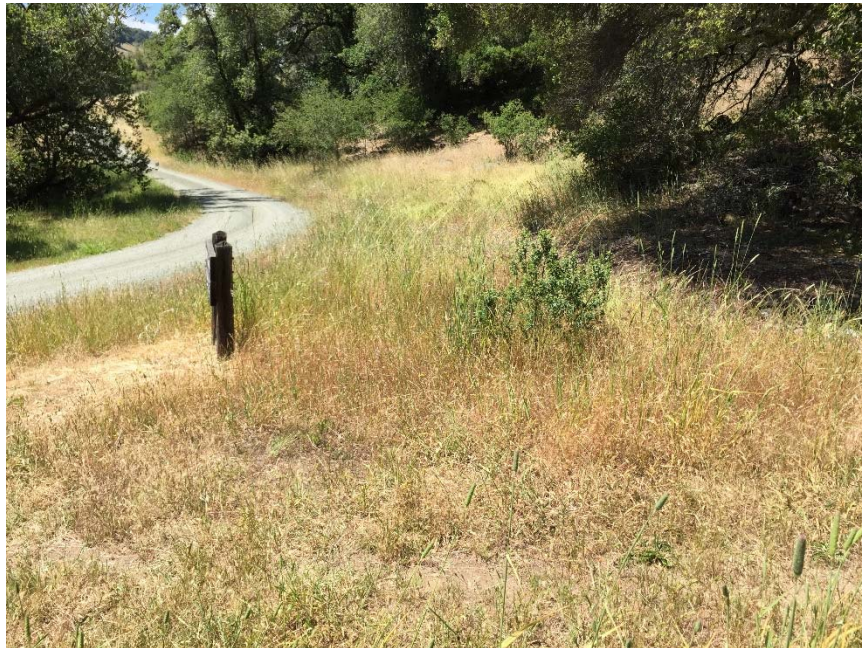
PWA Site #1 (May 2015)

<i>Distance on road (feet)</i>	<i>PWA site#</i>	<i>Road treatment</i>	<i>Site / treatment description</i>	<i>Observations (Note any deficiencies)</i>	<i>Is BMP operating properly?</i>	<i>Photo taken? (Check box)</i>
51+20	1	End CCD 3	Site 1: Diverted stream crossing. 1. Laid back vertical slopes where stream makes tight turn down to ditch. 2. Keyed in 5 yd ³ of 0.5'-2' riprap to base of bend. 3. Increased channel width and slope down to Site 2. 4. Ended clean and cut ditch.	Rock armor intact and functioning well, no sign of erosion and ditch stable	<input checked="" type="checkbox"/> Y <input type="checkbox"/> N	<input checked="" type="checkbox"/>
51+30			Roller coaster ridge trail on left.		N/A	
51+50			Locked metal gate.		N/A	
53+15		EOS	End road log at road surface drainage divide and intersection to Bechtel House on left.		N/A

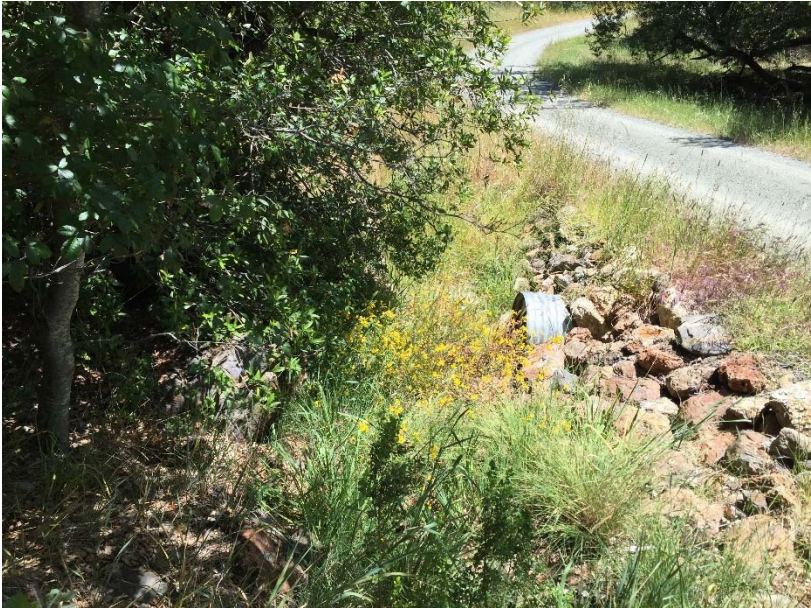
PWA Site #2 (May 2015)

50+10	2	DRC 3/ Start CCD 3	Site 2: 12" ditch relief culvert draining spring and diverted stream. 1. Replaced with a 30" x 40' long culvert. 2. Installed 25 yd ³ of 0.5'-1.5' riprap on inboard fillslope and ditch. 3. Installed 10 yd ³ of 1'-3' riprap on outboard fillslope. 4. Started clean and cut ditch for 110' to better direct flow from diverted stream crossing. 5. Re-rocked the road surface.	Culvert in good conditioning and rock armor intact at IBF and OBF. Ditch looks stable, and has revegetated well since last year.	<input checked="" type="checkbox"/> Y <input type="checkbox"/> N	<input checked="" type="checkbox"/>

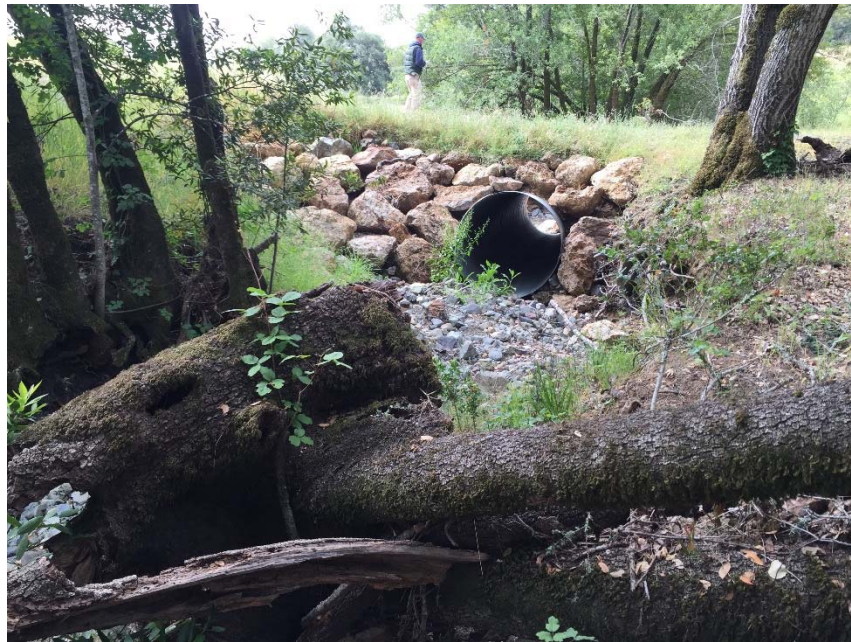
PWA Site #6 inlet (May 2015)

26+55			Intersection on right to Turtle Pond and start of road log for Goodman Road.		N/A	
		Start OSR-KD 1	1. Started road outsloping and keep ditch for 880'. 2. Re-rocked all disturbed road surfaces through outslope for average 10' road width x 0.3' depth x 880' long with 100 yd ³ of 1.5" minus road rock.	Ditch looks stable, road outslope functioning well with no rilling observed	<input checked="" type="checkbox"/> Y <input type="checkbox"/> N	
27+50		RD 2	1. Installed a type 1 rolling dip. 2. Re-rocked the road surface.	RD functioning well with no erosion	<input checked="" type="checkbox"/> Y <input type="checkbox"/> N	
29+05	6.2		Site 6.2: Existing 30" ditch relief culvert draining hillslope. 1. No treatment at site.	Site 6 itself is still in good condition and the outlet is vegetated.	NA

- All BMPs were found to be operating properly with some needing maintenance as follows:
 - Site 7.2: Landslide should be monitored for further movement. Recommendation to exclude cattle activity from site.
 - Site 6: Additional rock armor on the right bank outboard fill has been knocked out of place but no active erosion. Pacific Watershed Associates recommendation to address site is to remove all rip rap (up to 20 yd³) on right side from culvert outlet to bay tree downstream and grade hillslope to a 2:1 slope angle.
 - Site 8.1: A 3' deep by 2' wide headcut (as mentioned in Site 6.2) has developed. Recommendation to key in 0.5-1.0' rock at each of the headcuts to prevent further erosion and migration of the headcut.
 - Bechtel House Road 44+50: Recommendation to clean both inlet and outlet to reduce plugging.
 - Site 9: Recommendation to monitor gully.

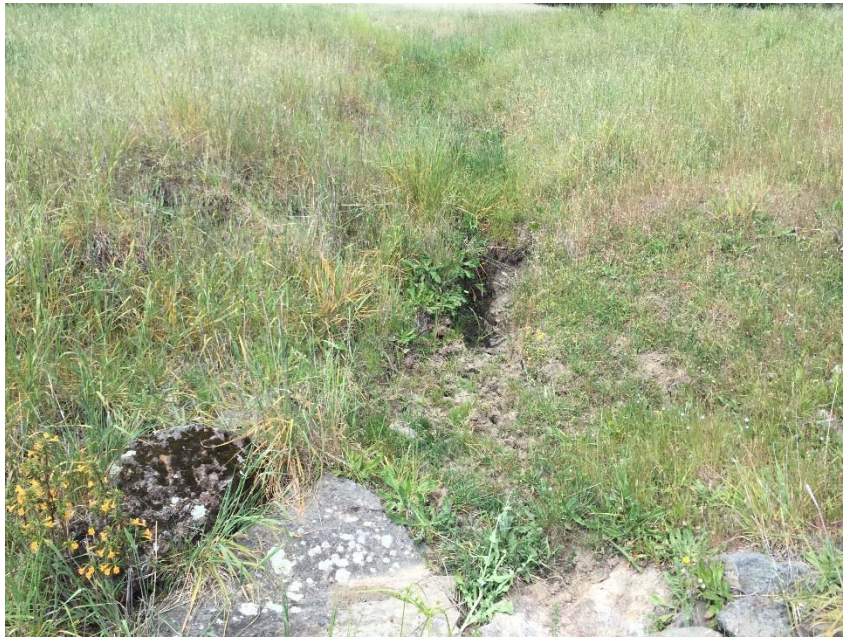
Headcut above PWA Site #6.2, below PWA Site #8.1 (May 2015)

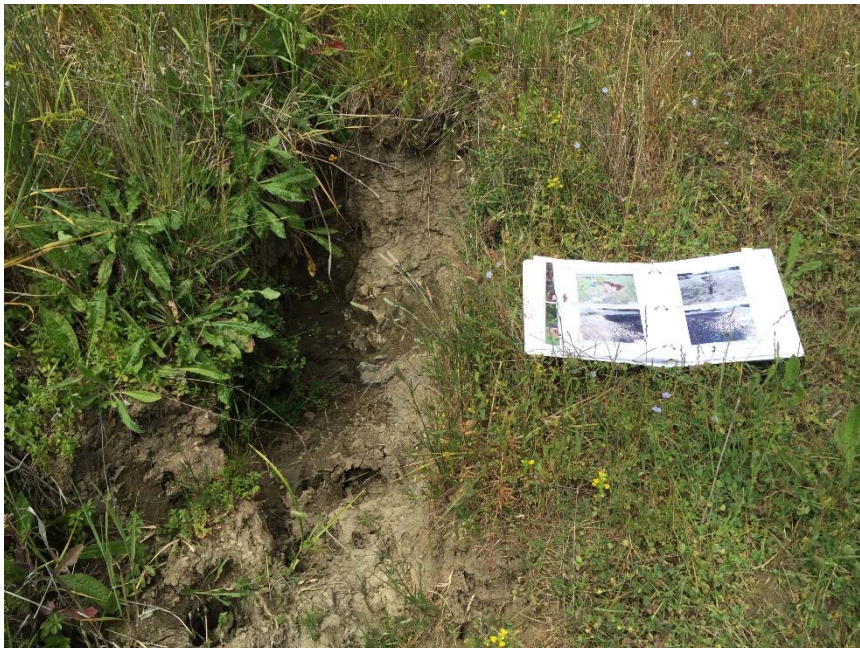
Additional view of headcut above PWA Site #6.2, below PWA Site #8.1 (May 2015)

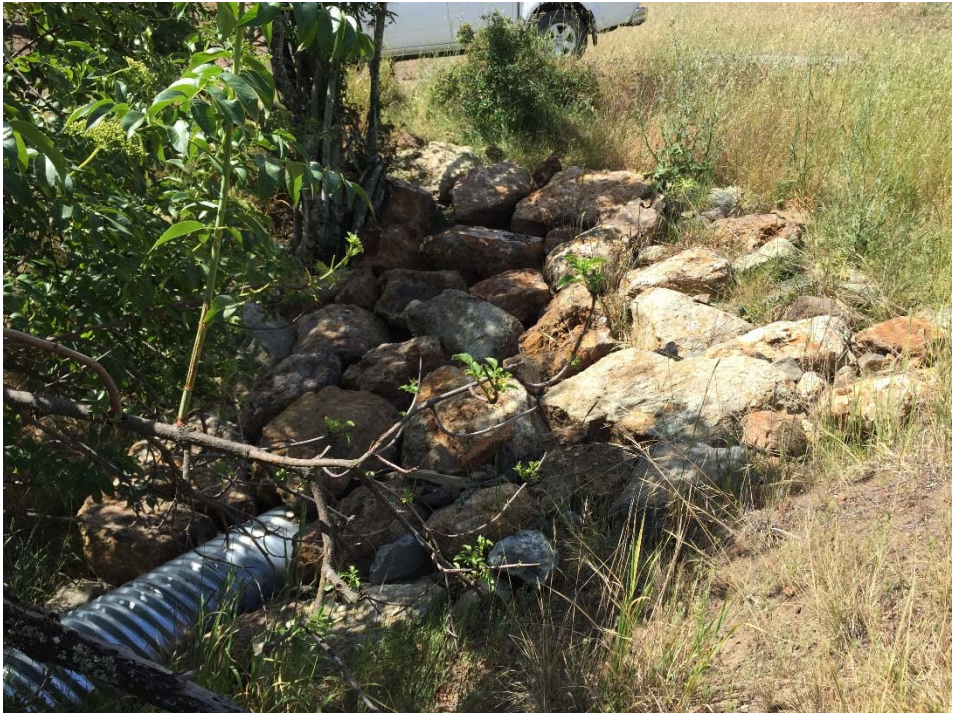
PWA Site #7 (May 2015)

<i>Distance on road (feet)</i>	<i>PWA site#</i>	<i>Road treatment</i>	<i>Site / treatment description</i>	<i>Observations (Note any deficiencies)</i>	<i>Is BMP operating properly?</i>	<i>Photo taken? (Check box)</i>
25+30	7	CD 1	Site 7: Stream crossing with 12" rusted and plugged culvert. 1. Replaced with 24" x 60' long culvert at base of fill in natural channel alignment. 2. Transitioned existing stream channel above road into new lowered inlet and added 5 yd ³ of 1'-2' rip rap at new grade change and inboard fillslope. 3. Installed 20 yd ³ of 1'-3' riprap on outboard fillslope. 4. Installed a critical dip on right hingeline to eliminate diversion potential down road. 5. Re-rocked the road surface.	24" Culvert in good condition and functioning well. Rock armor intact and functioning. Critical dip looks stable.	<input checked="" type="checkbox"/> Y <input type="checkbox"/> N	<input checked="" type="checkbox"/>

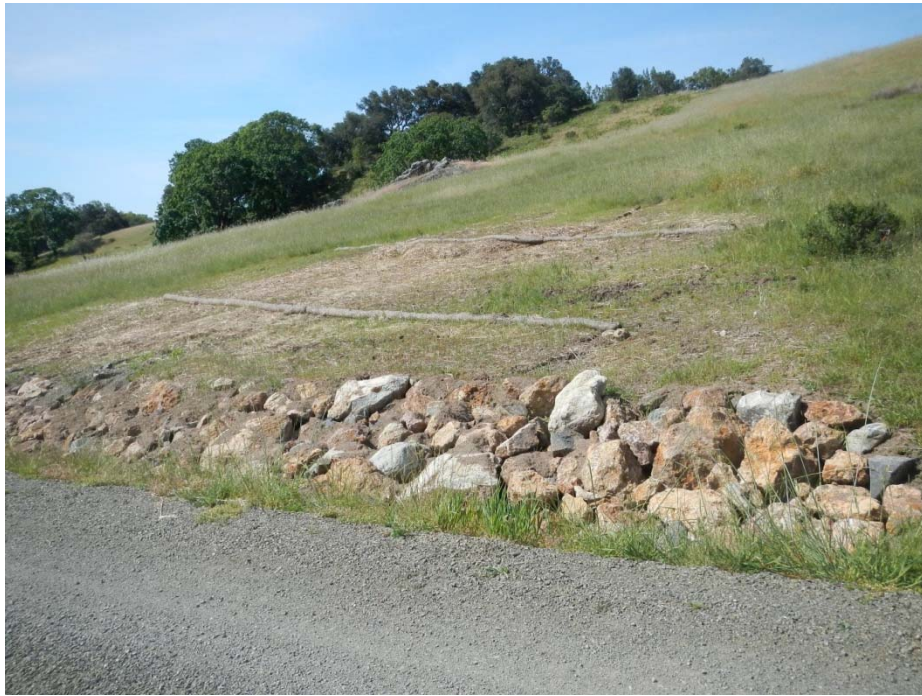
PWA Site 7.2 landslide (May 2014)

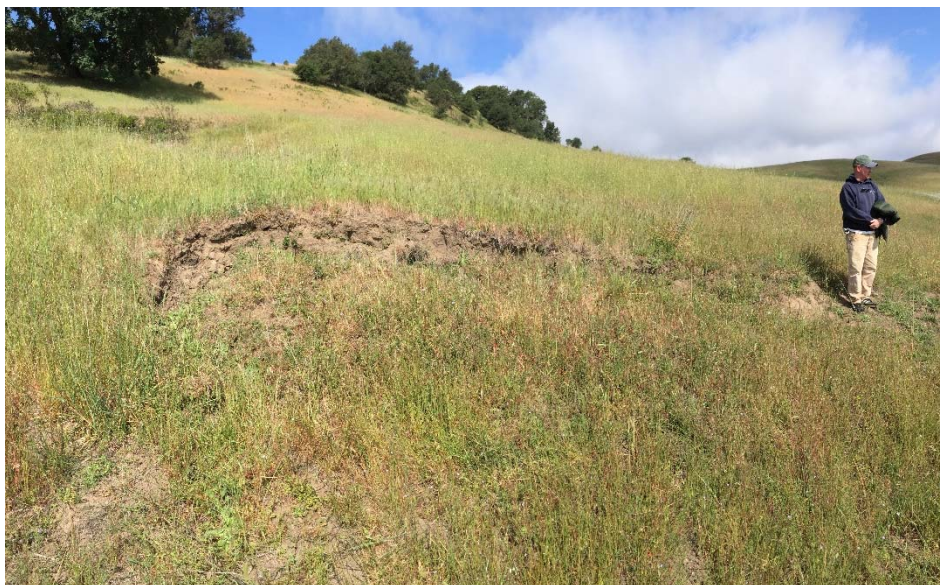
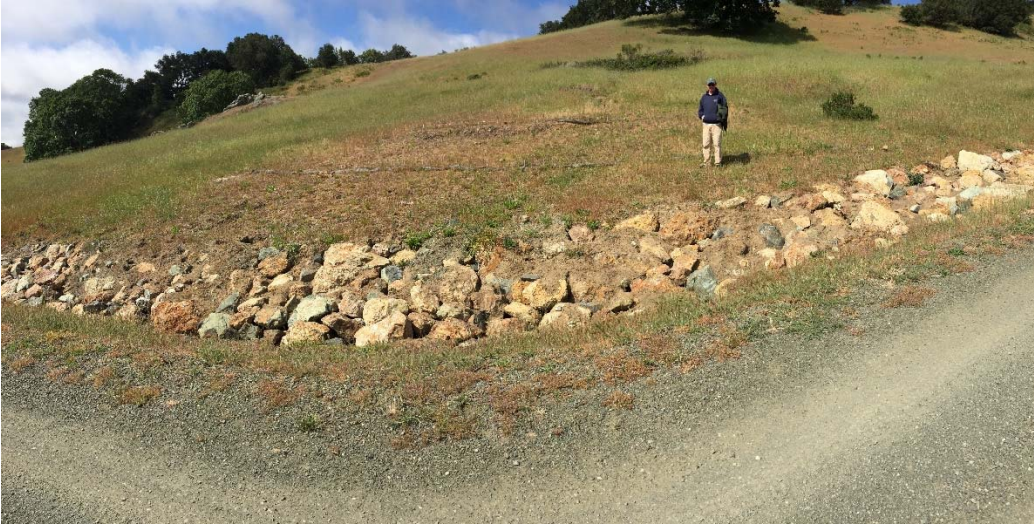
PWA Site 7.2 (May 2015)

16+20	7.2	Start RSP 1	Site 7.2: Large creeping hillslope landslide. 1. Started rock slope protection for 70' along cutbank where active slumping was occupying ditch and roadway. 2. Excavated slumping hillslope and a 70' wide x 3' deep x 10' tall trench and placed 50 yd ³ of 0.5'-3' riprap. 3. Spoils placed below road and along road surface. 3. Re-rocked the road surface.	The mobilized sediment lobe from March 2014 is more or less in the same spot as last year as is the 1 to 2ft head scarp at the top of the slump. Some finer sediments have reached the rock armor at the bottom of the slope, but are not yet affecting the drainage ditch. The majority of the mobilized material is still 20 ft from the bottom of the slope. Vegetation is slowly re-establishing, so cattle activity should be excluded from this site. Site should be monitored for further movement.	<input checked="" type="checkbox"/> Y <input type="checkbox"/> N	<input checked="" type="checkbox"/>

16+90		End RSP 1	Ended rock slope protection treatment.	The rock armor is still functioning, but should be monitored for future slumping	<input checked="" type="checkbox"/> Y <input type="checkbox"/> N

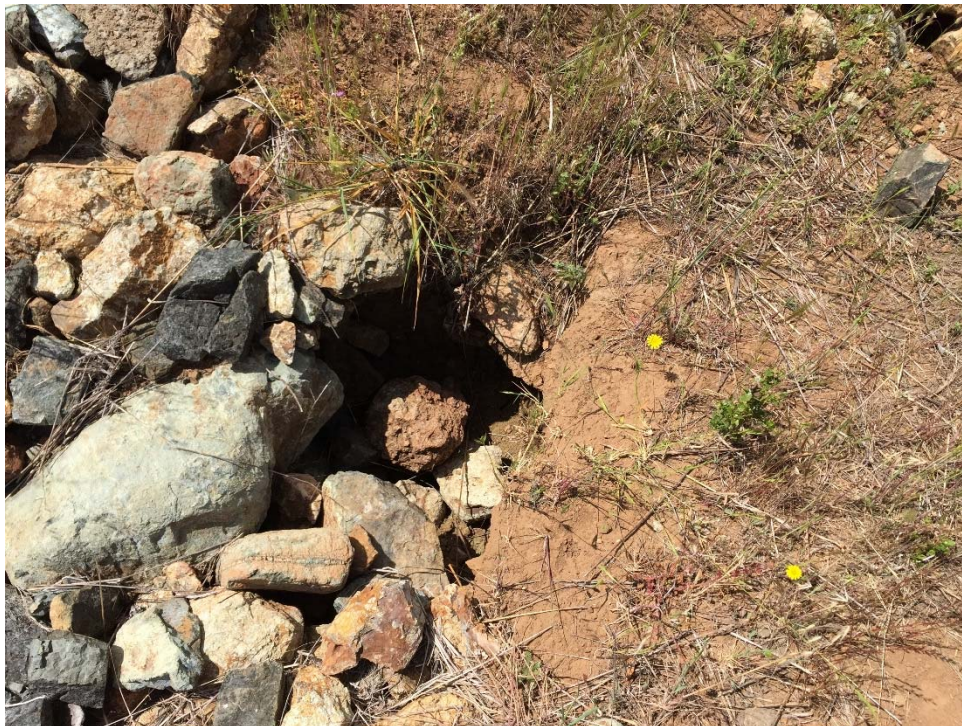
PWA Site #8.1 Grade Control Structure Headcut (May 2015)

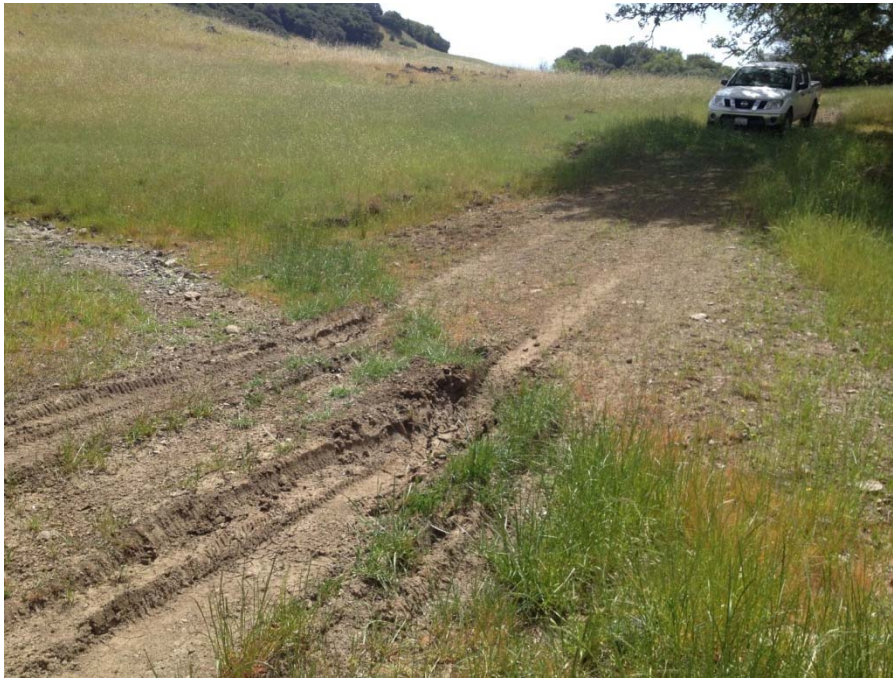
PWA Site # 33 – Tire ruts in road (May 2014)
