CENTRAL VALLEY REGIONAL WATER QUALITY CONTROL BOARD

INSPECTION REPORT

DISCHARGER: Rego Dairy # 2

INSPECTION DATE: 1 February 2012

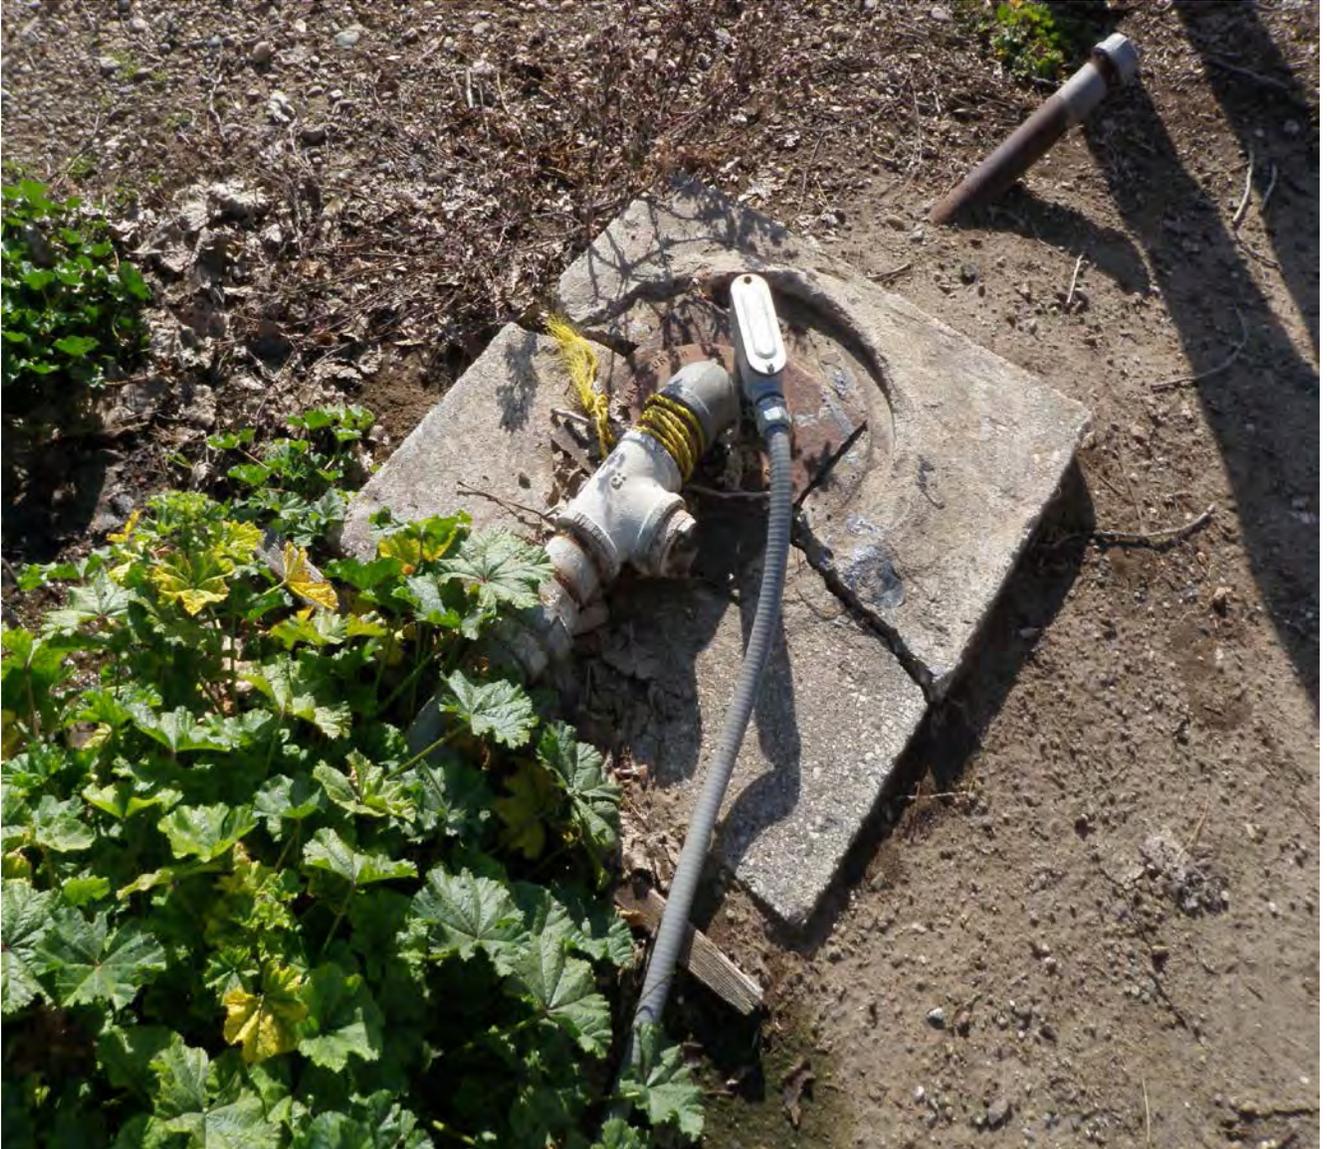
Photo 1: Domestic well north of milk barn with some weeds surrounding a cracked concrete pad.

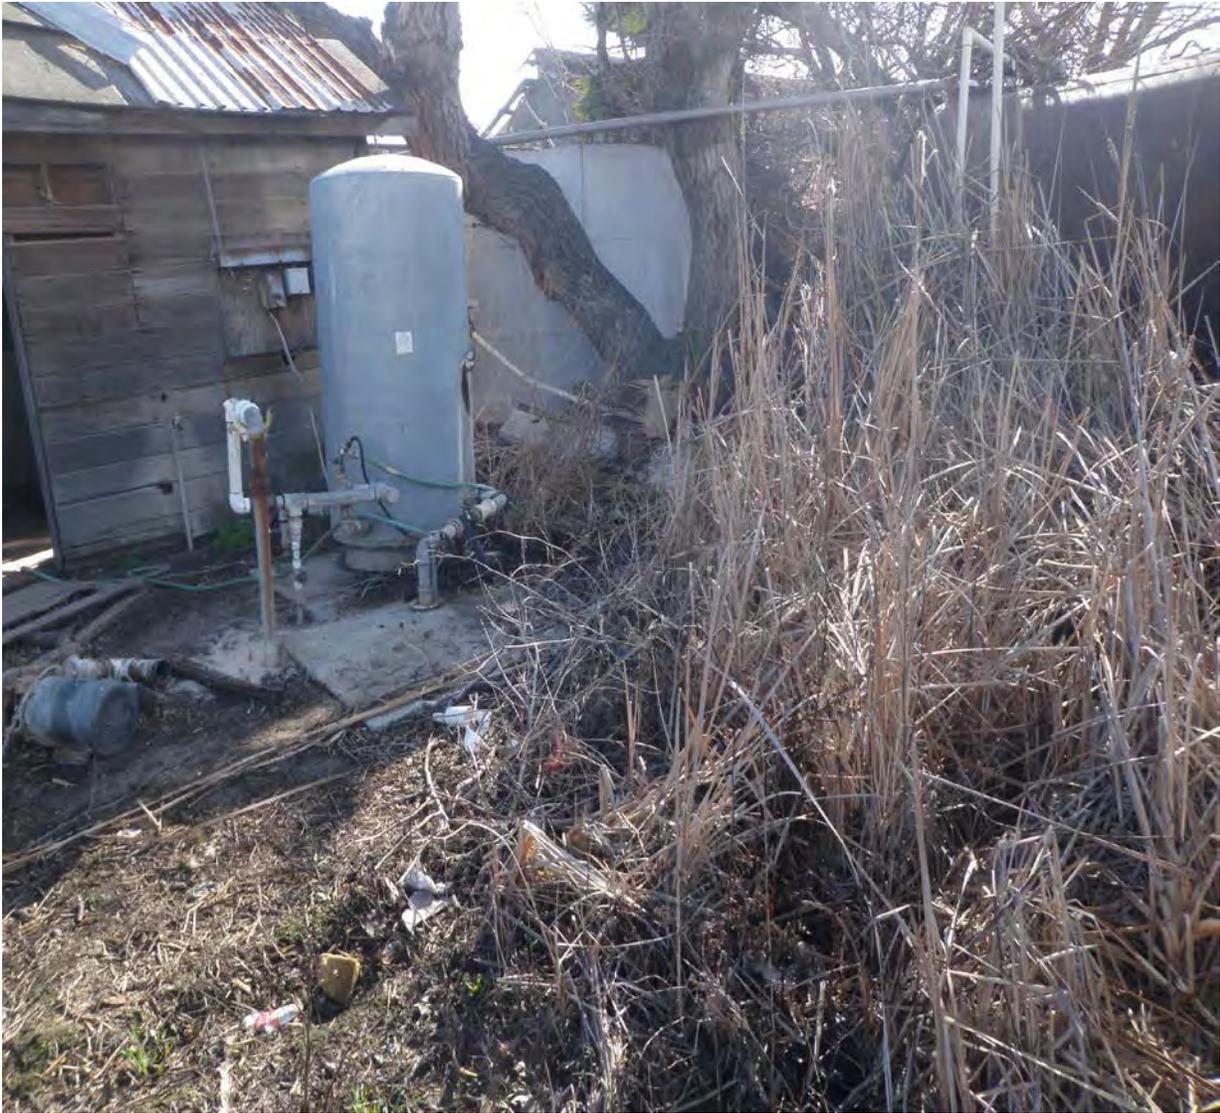
Photo 2: Domestic well near the milk barn with excessive weeds and ponding.

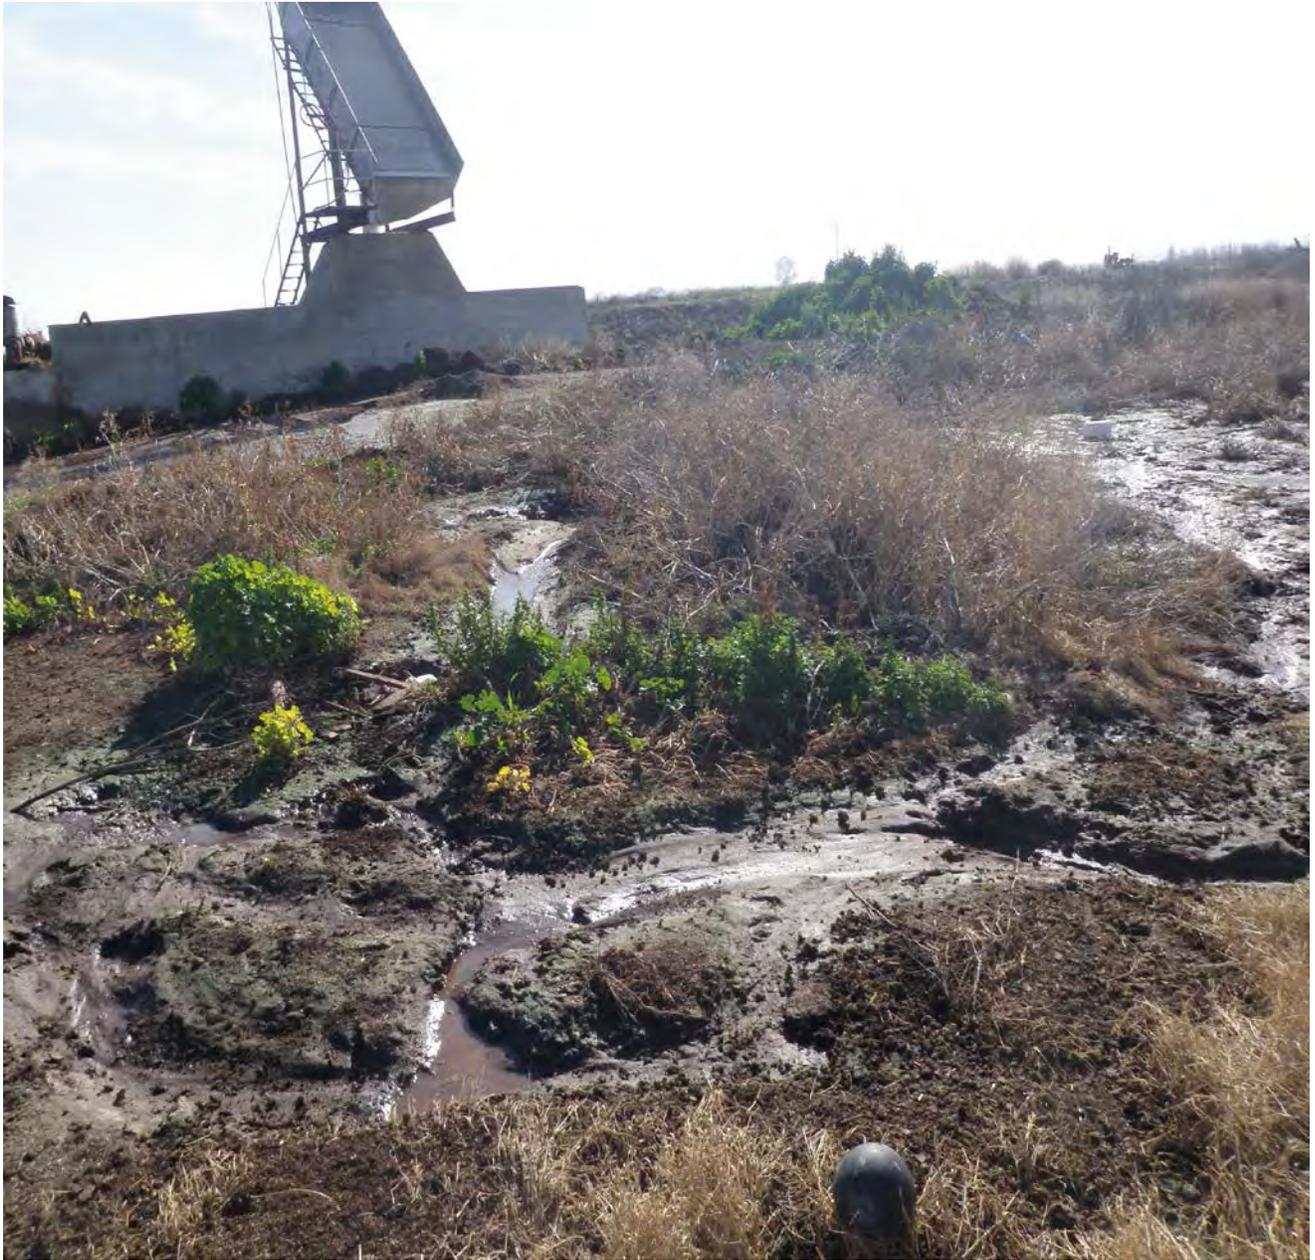
Photo 3: Photo of the mechanical separator not being used.

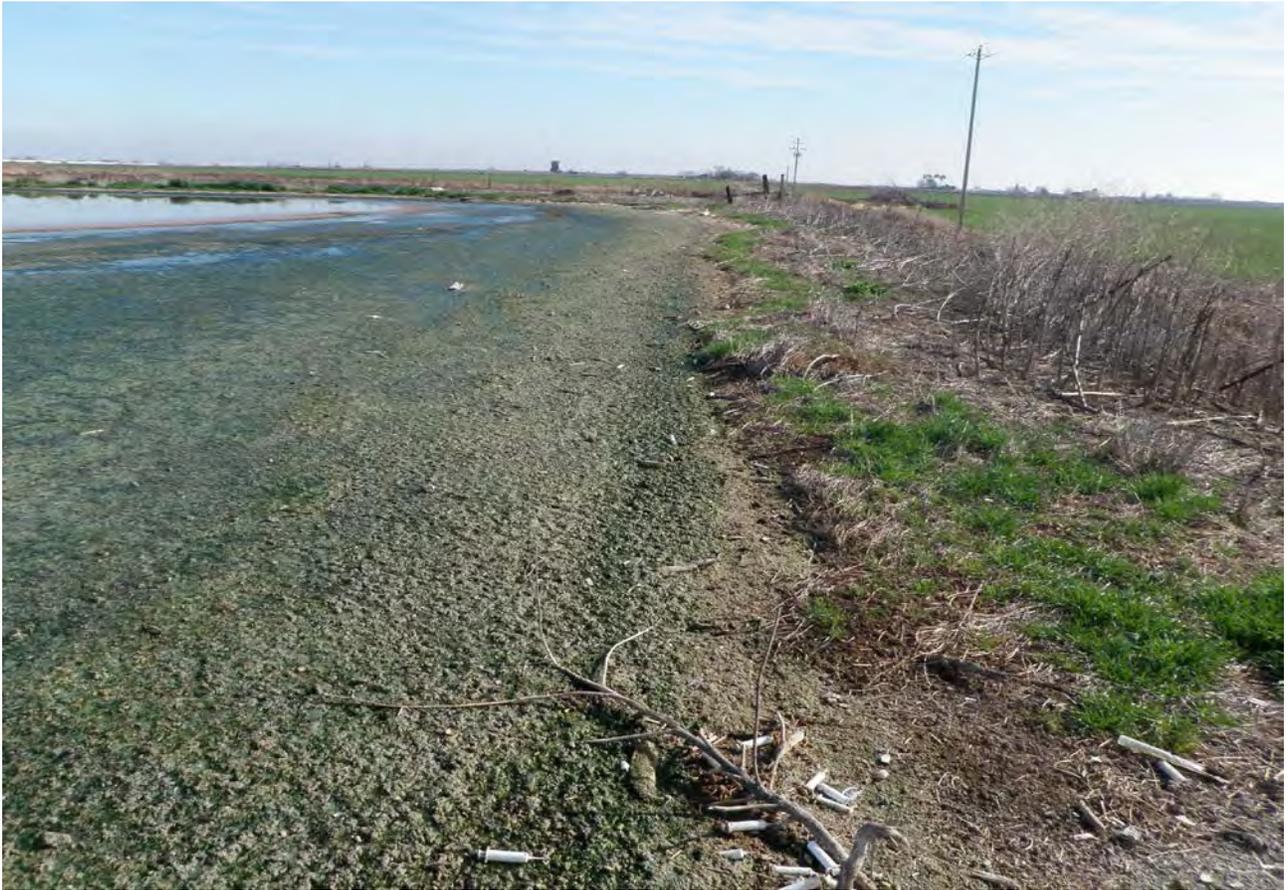
Photo 4: Photo of a near overtopping lagoon with excess weeds and rodent holes on the embankments.

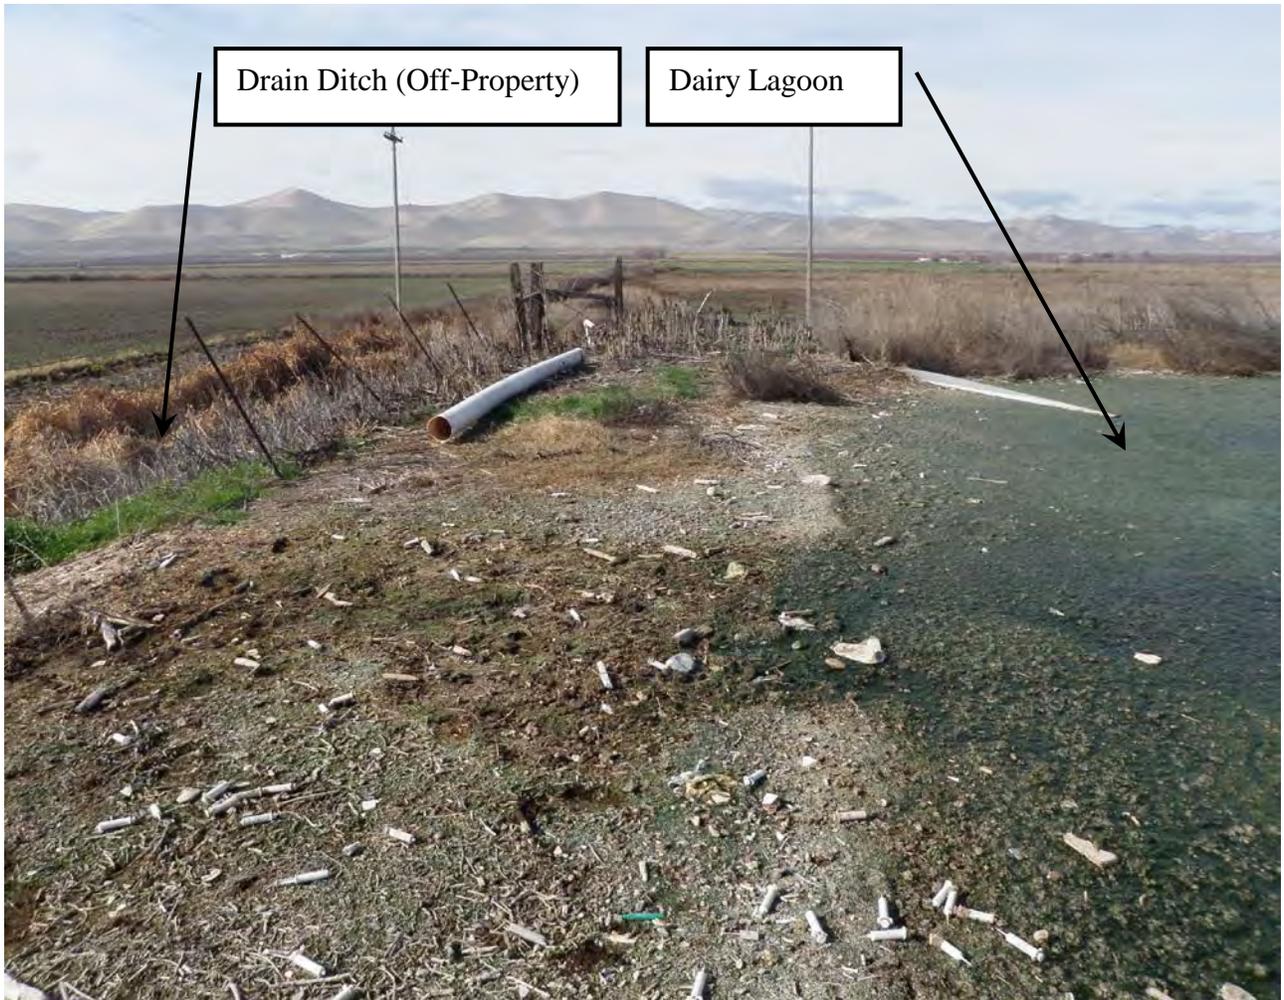
Photo 5: Photo of veterinary medical supplies strewn along the bank of the lagoon. Note the eroded discharge path from the lagoon towards the drain ditch located on the lagoon's south embankment.

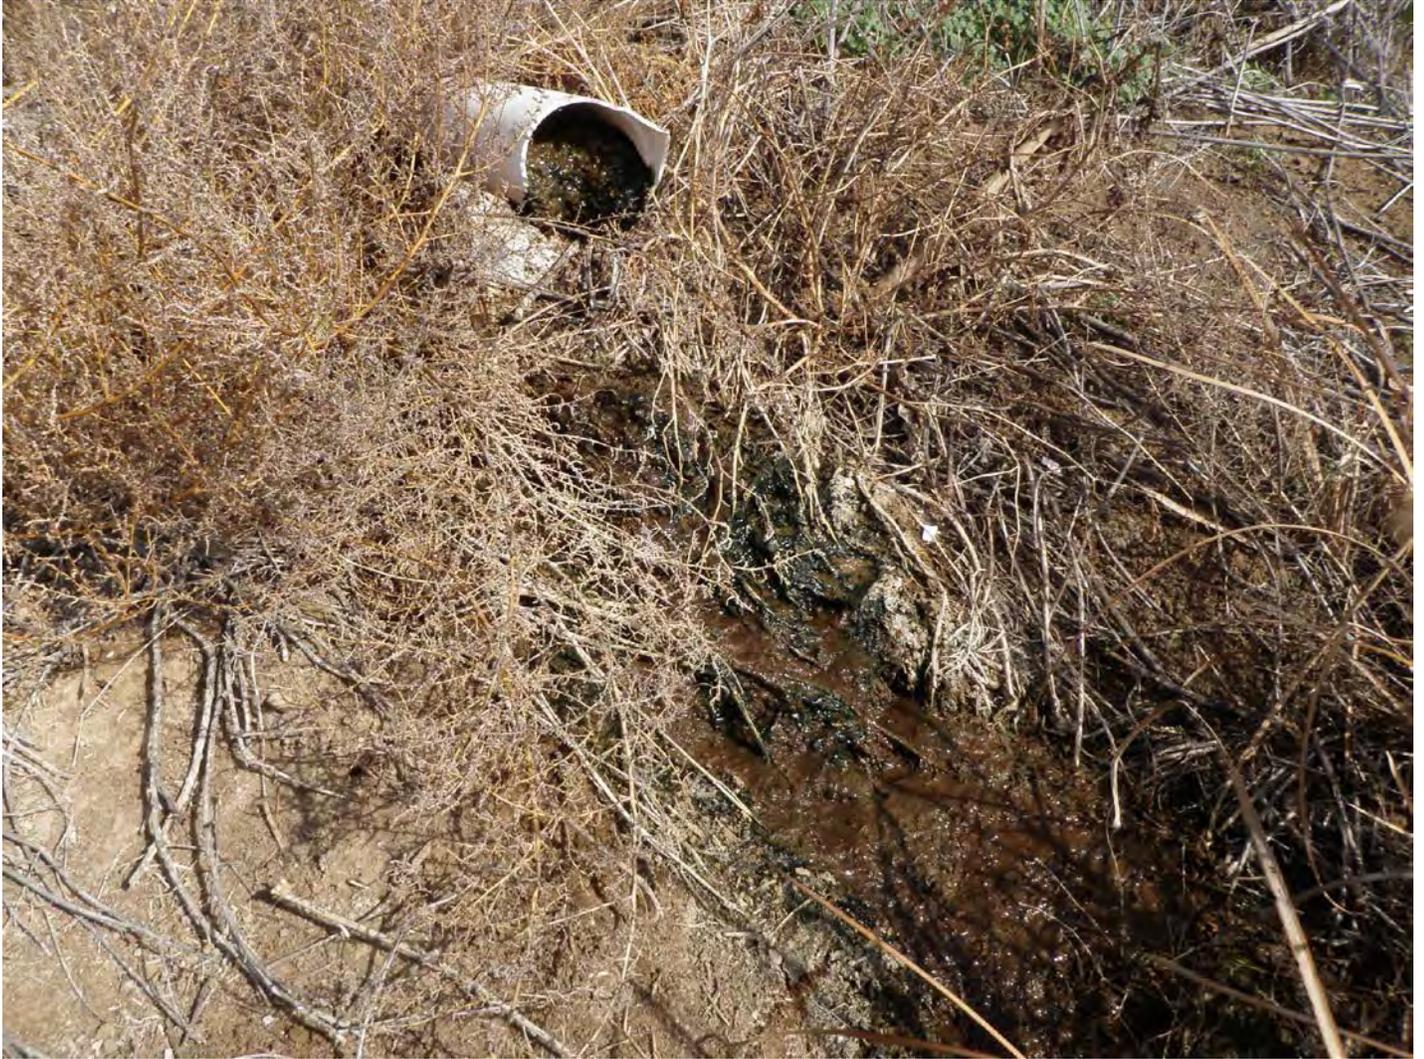
Photo 6: Photo of leaking 6-inch PVC pipe plugged with concrete on the lagoon's south embankment. The leaking pipe was discharging wastewater from the lagoon directly into the off-property drain ditch.

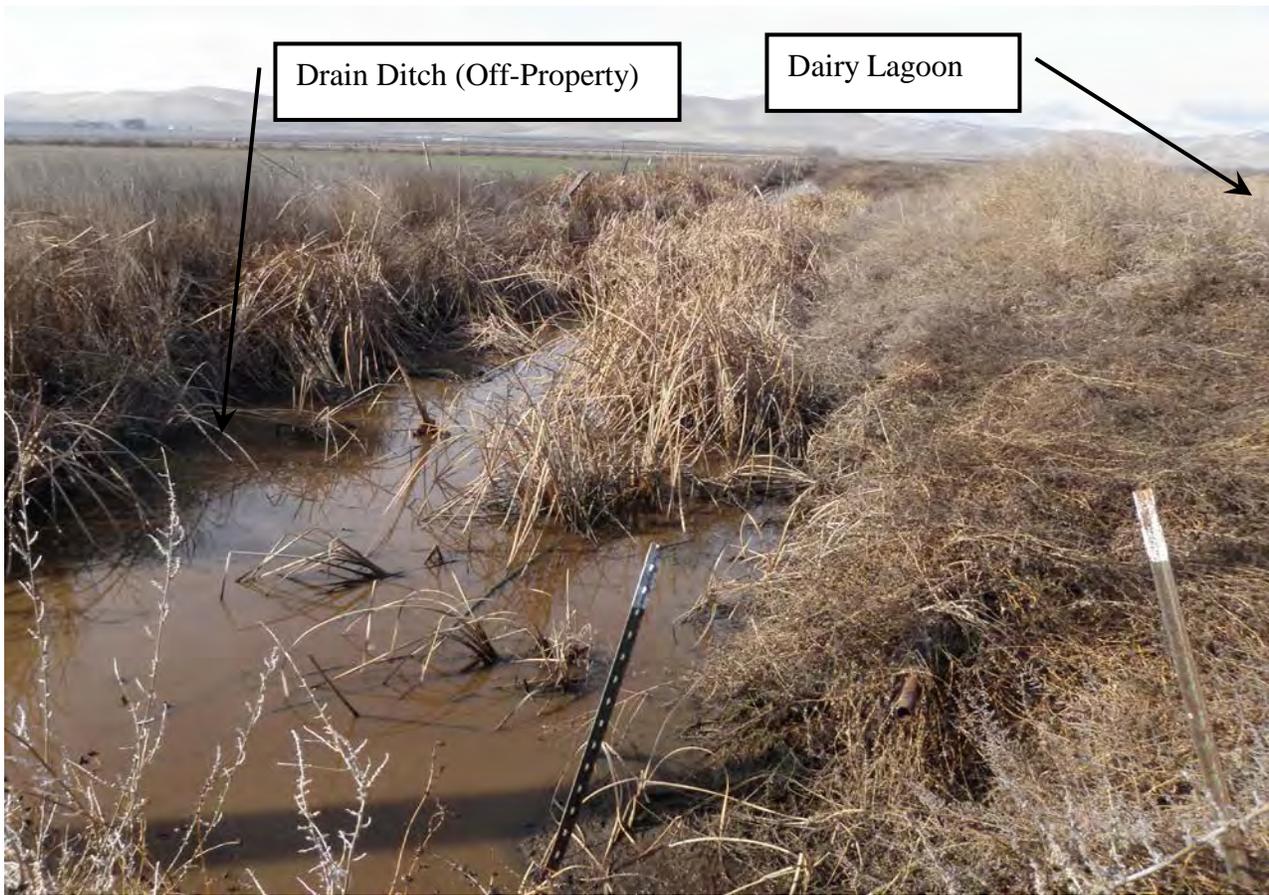
Photo 7: Photo of the drain ditch along the south production area perimeter full of manure wastewater.

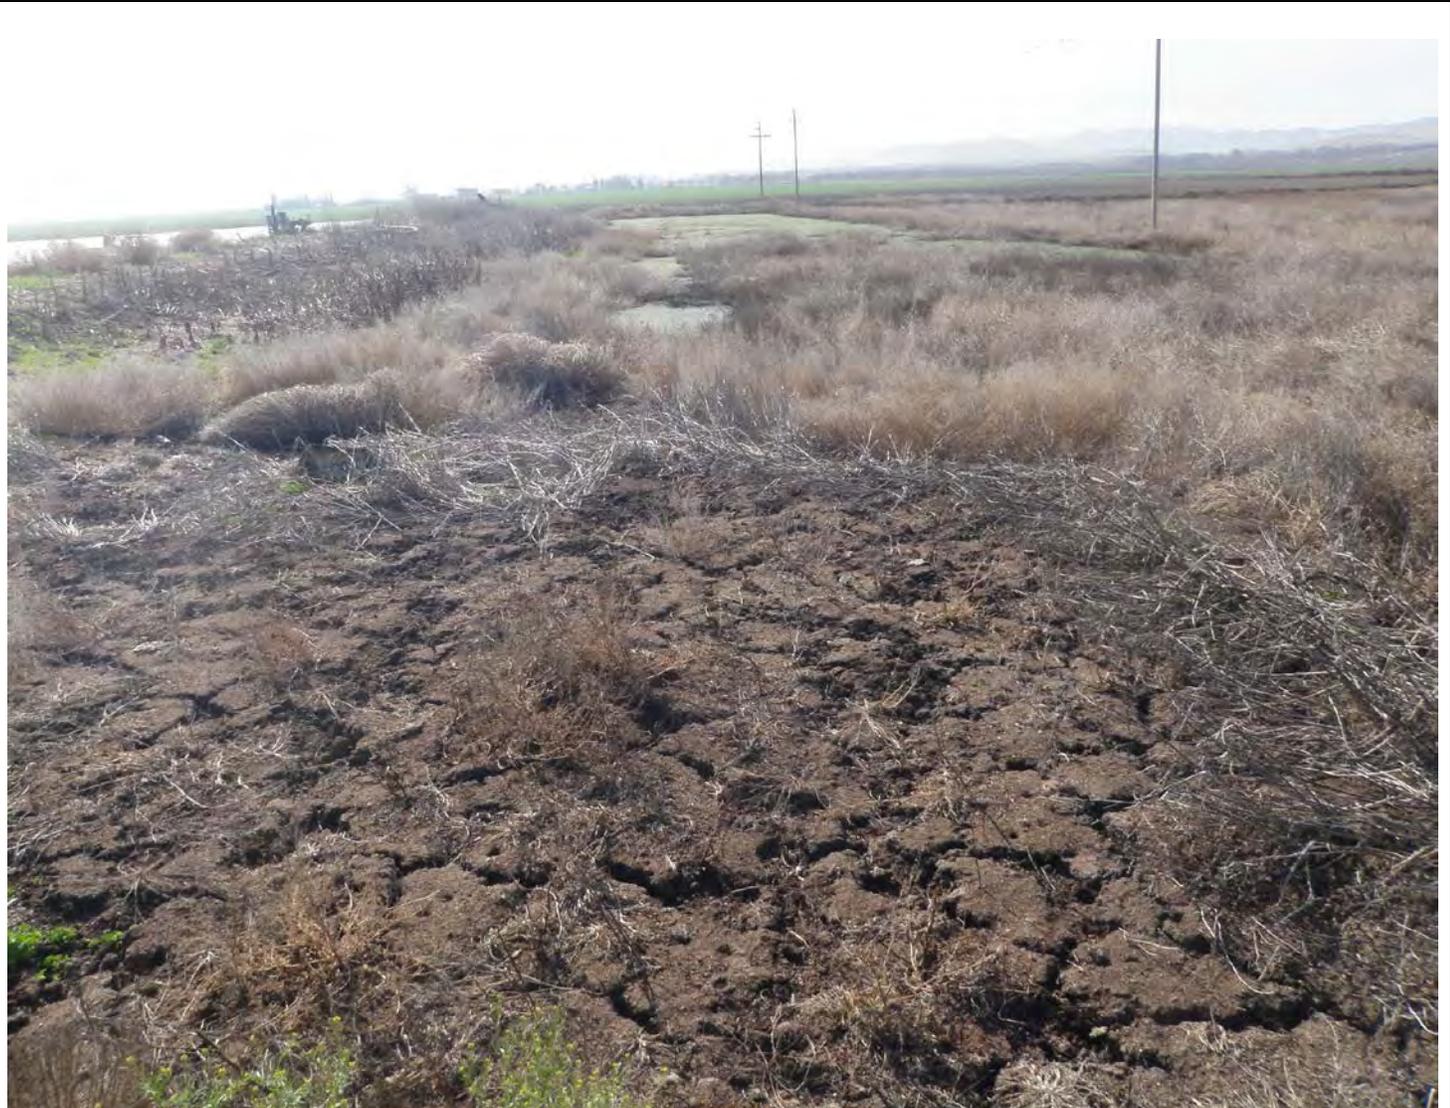
acre area that resembled a lagoon, but it was manure wastewater on bare native soil (see photo 8). Mr. Rego told staff that the manure in this area was already there when he purchased the dairy property in 2002, but staff observed evidence that the wastewater from the lagoon had been dumped onto the 1 to 2 acre area recently. As staff walked on the lagoon embankment, staff observed the southeast corner of the production area contained a large animal burial area: several deceased cows covered in manure in one pile (see photo 9) and a larger area with cow carcasses in various stages of decomposition (see photo 10). Mr. Rego was very hesitant to allow staff to continue taking photos and complete their inspection, but did allow the inspection to continue after all. As staff and Mr. Rego approached the illegal burial area (see photo 11), staff observed more than fifty cow carcasses in various states of decay buried in cow manure and full-size cow bones next to the drain ditch (see photo 12). Staff asked Mr. Rego when he started burying dead cows onsite and Mr. Rego told staff that he started in 2002 and never stopped. Mr. Rego later telephoned staff and told them that he had recently started burying dead cows, not since 2002 as he had originally stated. Staff also observed that wastewater ponding in a corral and in the burial area (see photo 13) was flowing into the drain ditch. Staff collected two samples of wastewater flowing from a corral past the carcasses buried in manure and into the drain ditch. Staff continued walking the east perimeter of the production area and observed leachate runoff from the silage pile also being directed towards the drain ditch (see photo 14). As staff continued walking north along the east perimeter staff noticed a line of weeds from the back of a home on-property to the drain ditch. A further look revealed that septic waste was flowing to the ground surface and was being directed down a swale and to the drain ditch. Staff disturbed the soil along the discharge path and observed it to be black in color and had a strong smell consistent with septic waste (see photo 15).

Photo 8: Photo of the 1 to 2 acre area west of the dairy lagoon where manure wastewater was pumped from the lagoon onto bare native soil.

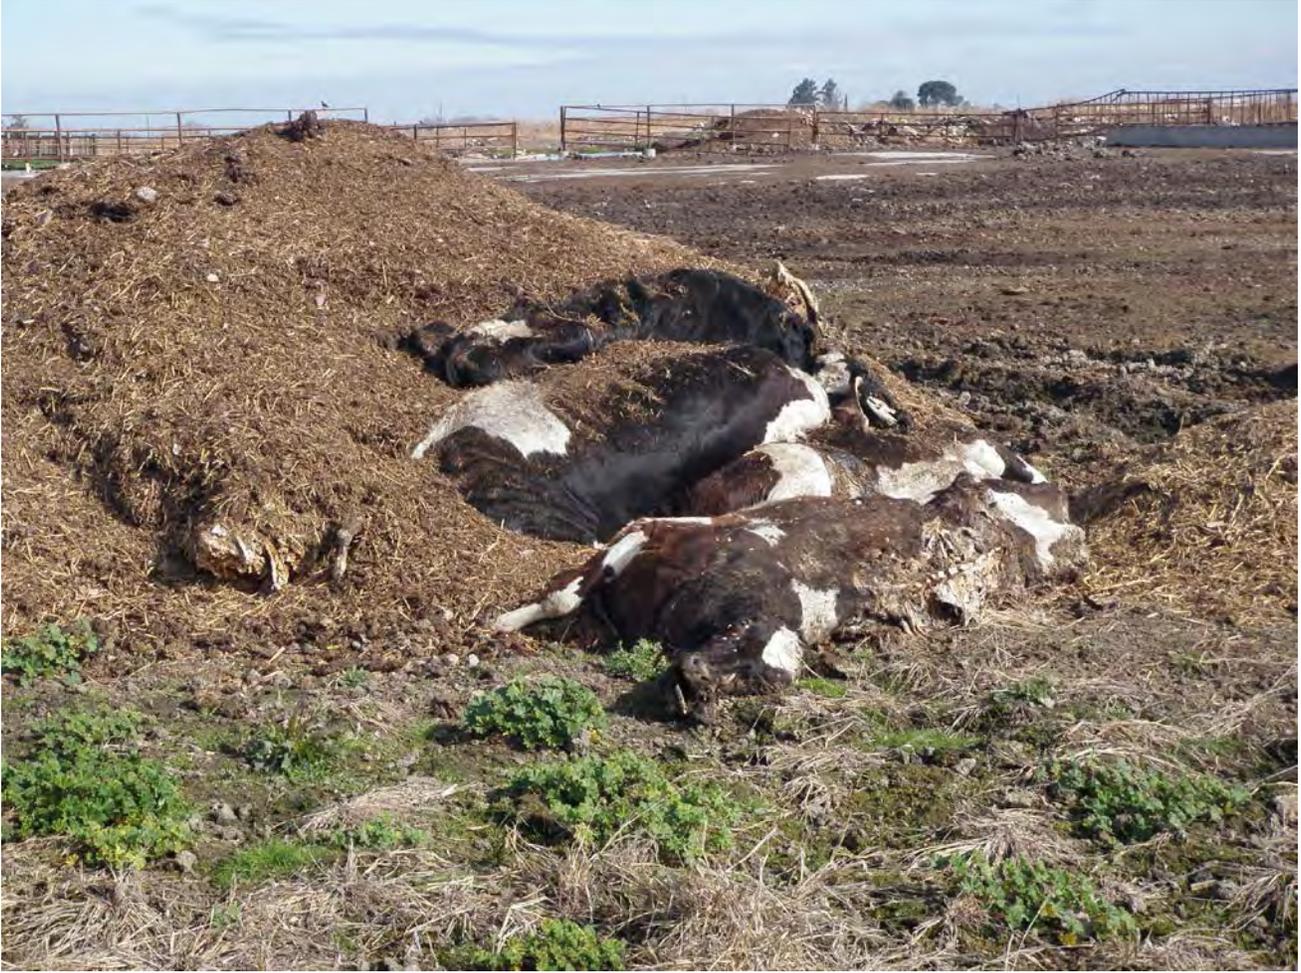
Photo 9: Photo of deceased cows covered in manure.

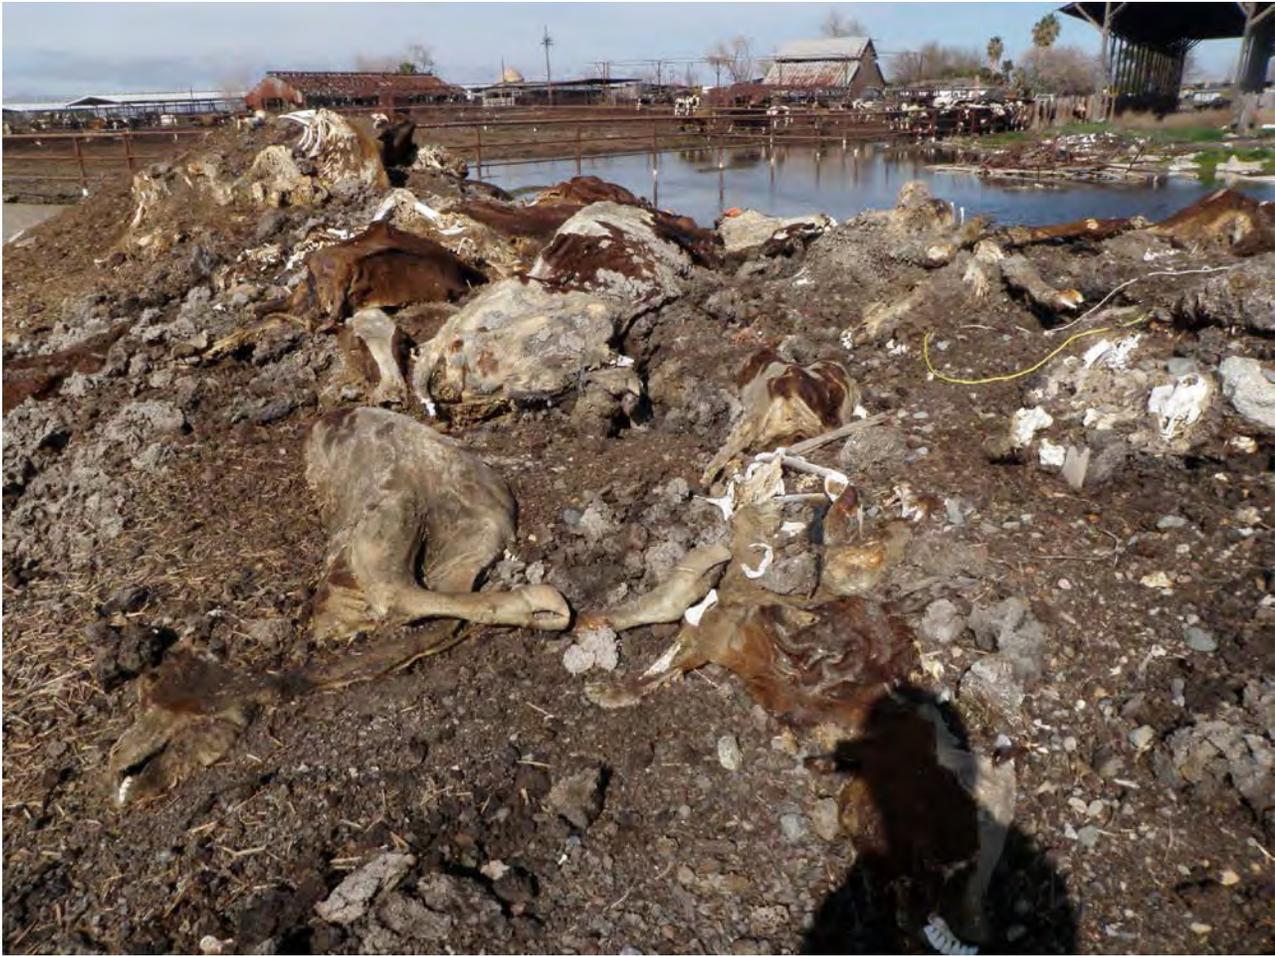
Photo 10: Photo of a large area with cow carcasses in various stages of decomposition.

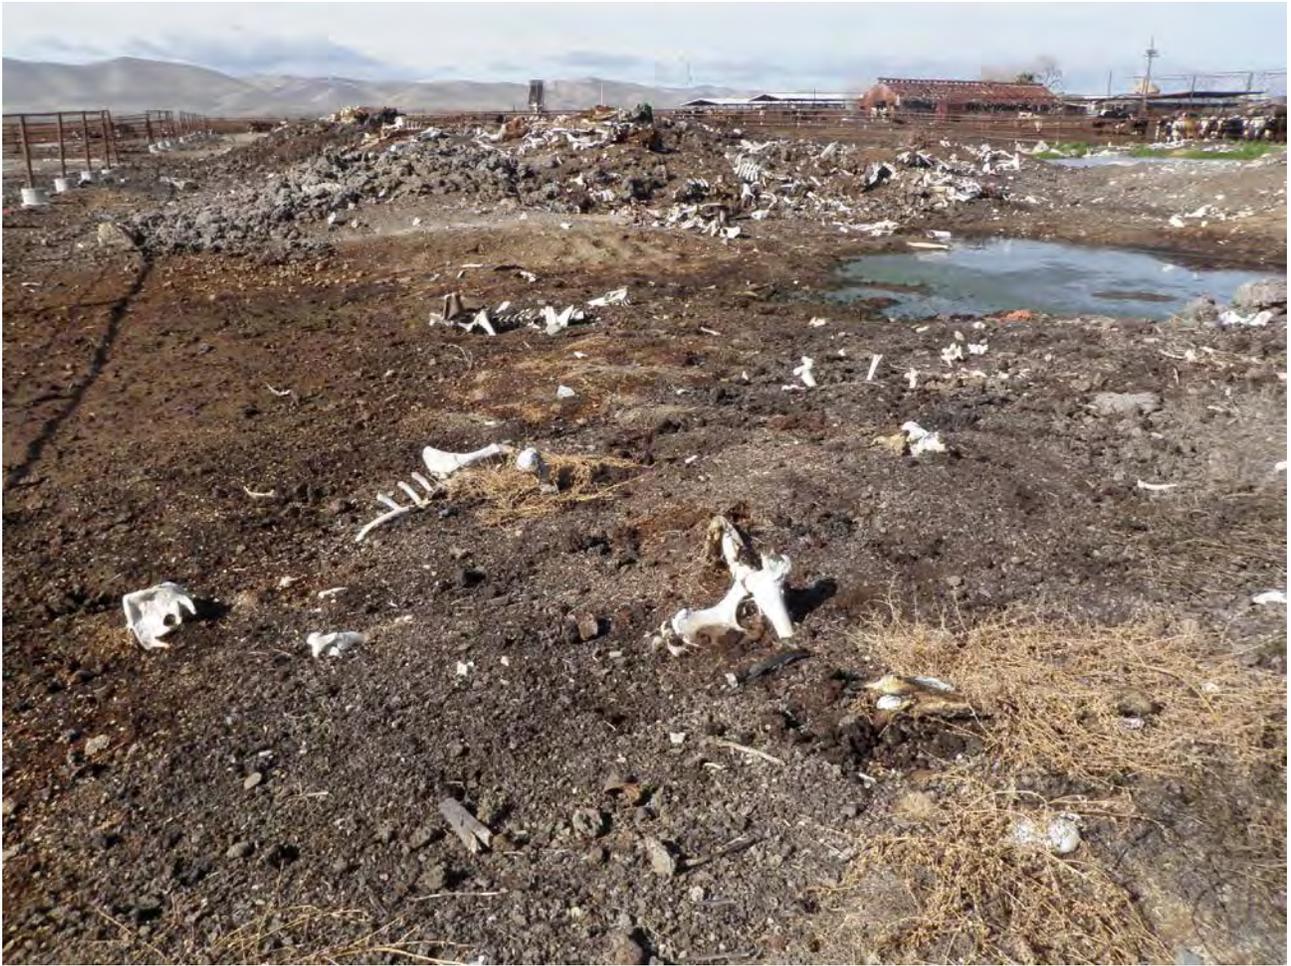
Photo 11: Photo of the illegal burial area.

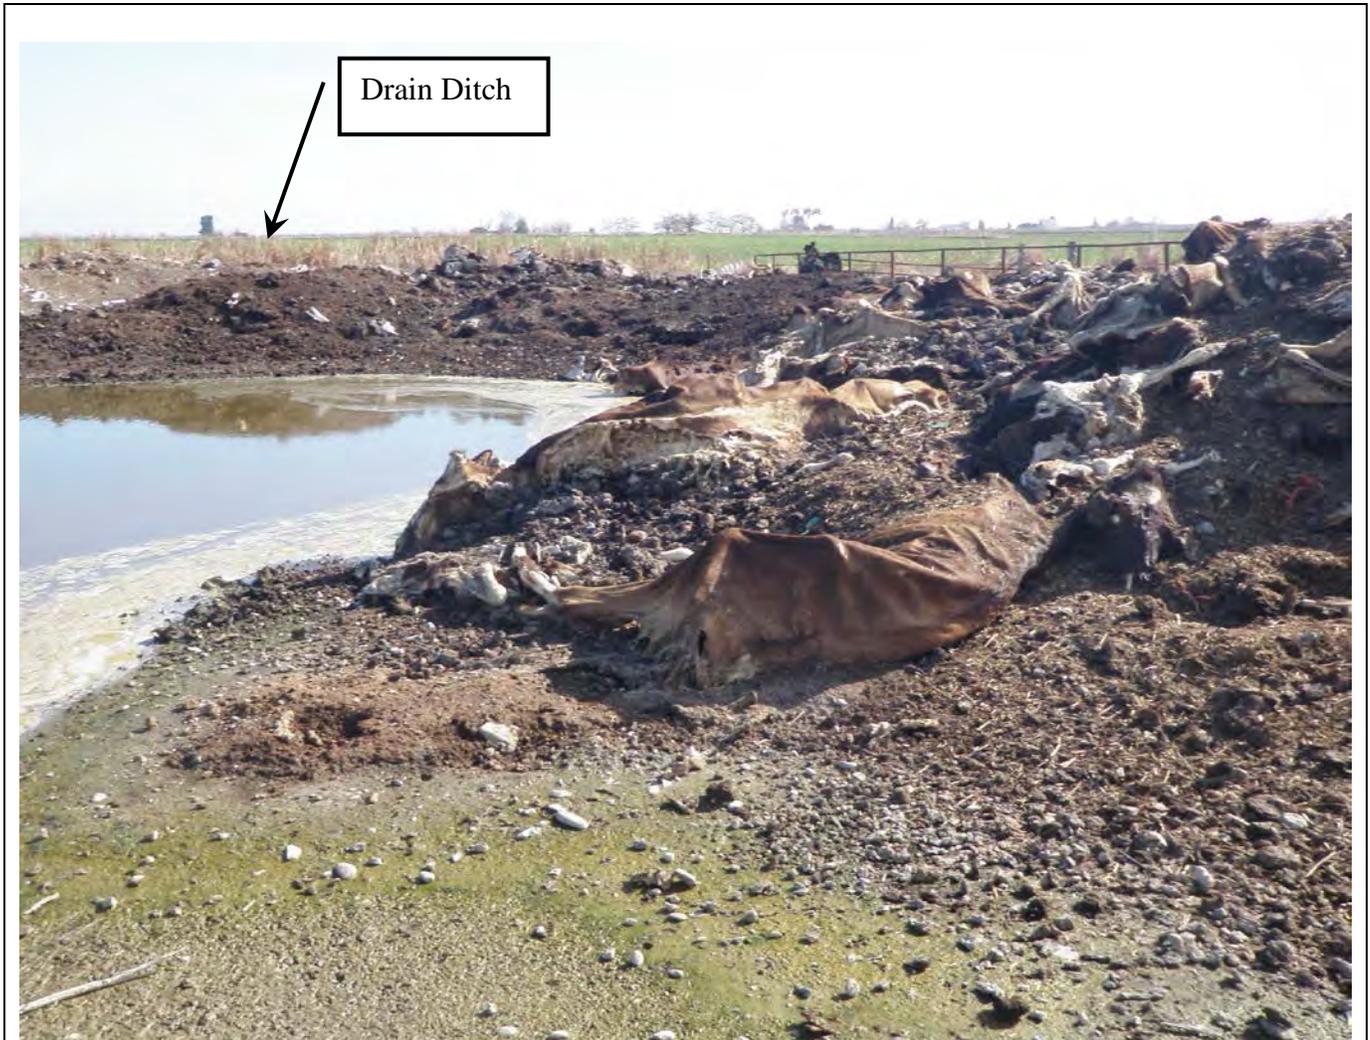
Photo 12: Photo of cow carcasses in cow manure and cow bones next to the drain ditch.

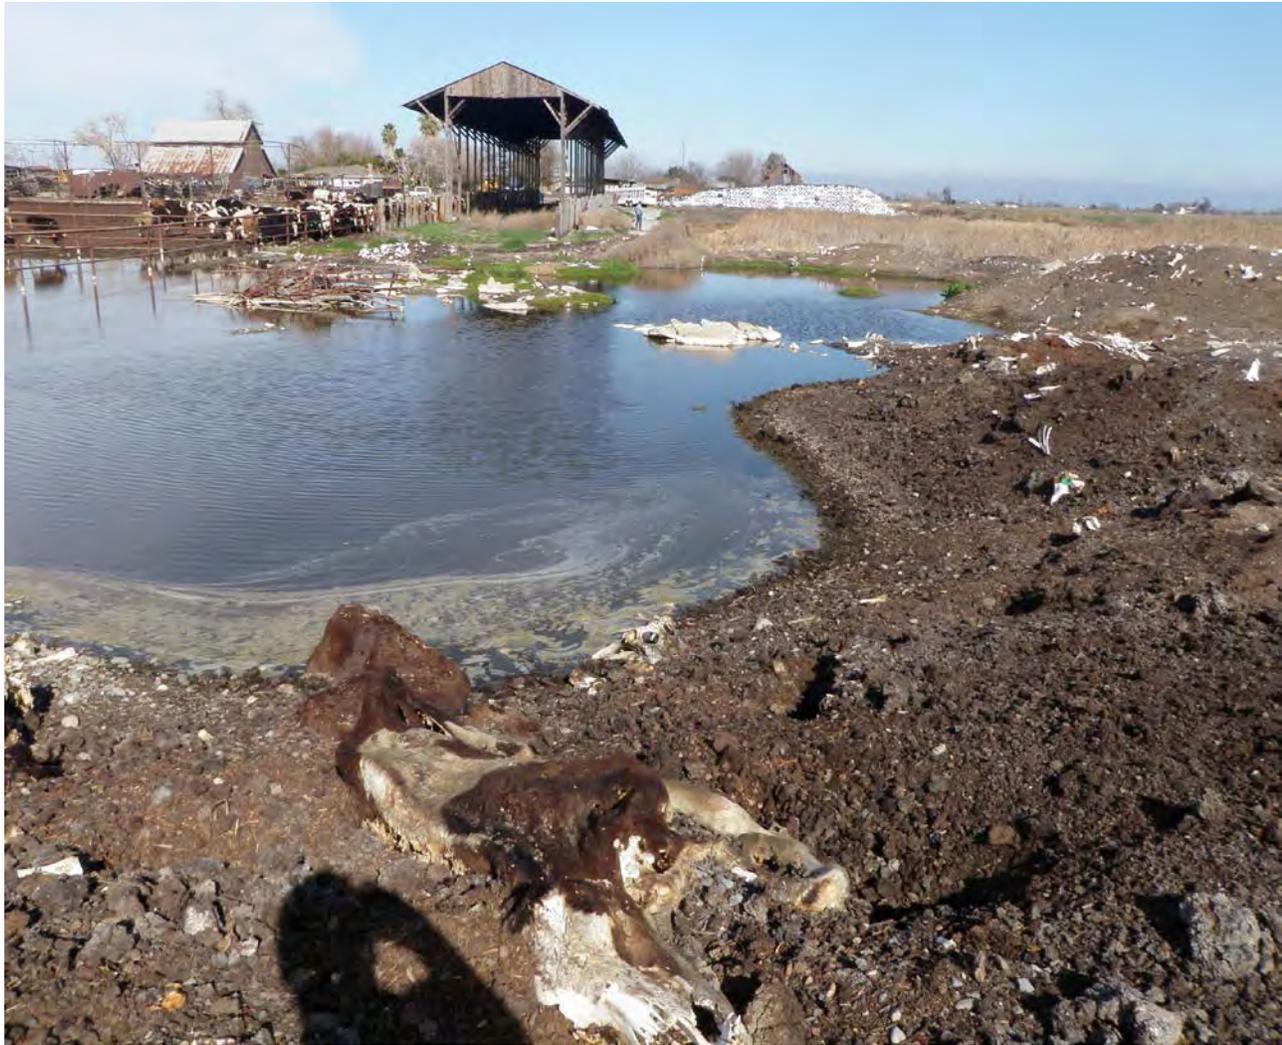
Photo 13: Photo of wastewater ponding adjacent to the burial area.

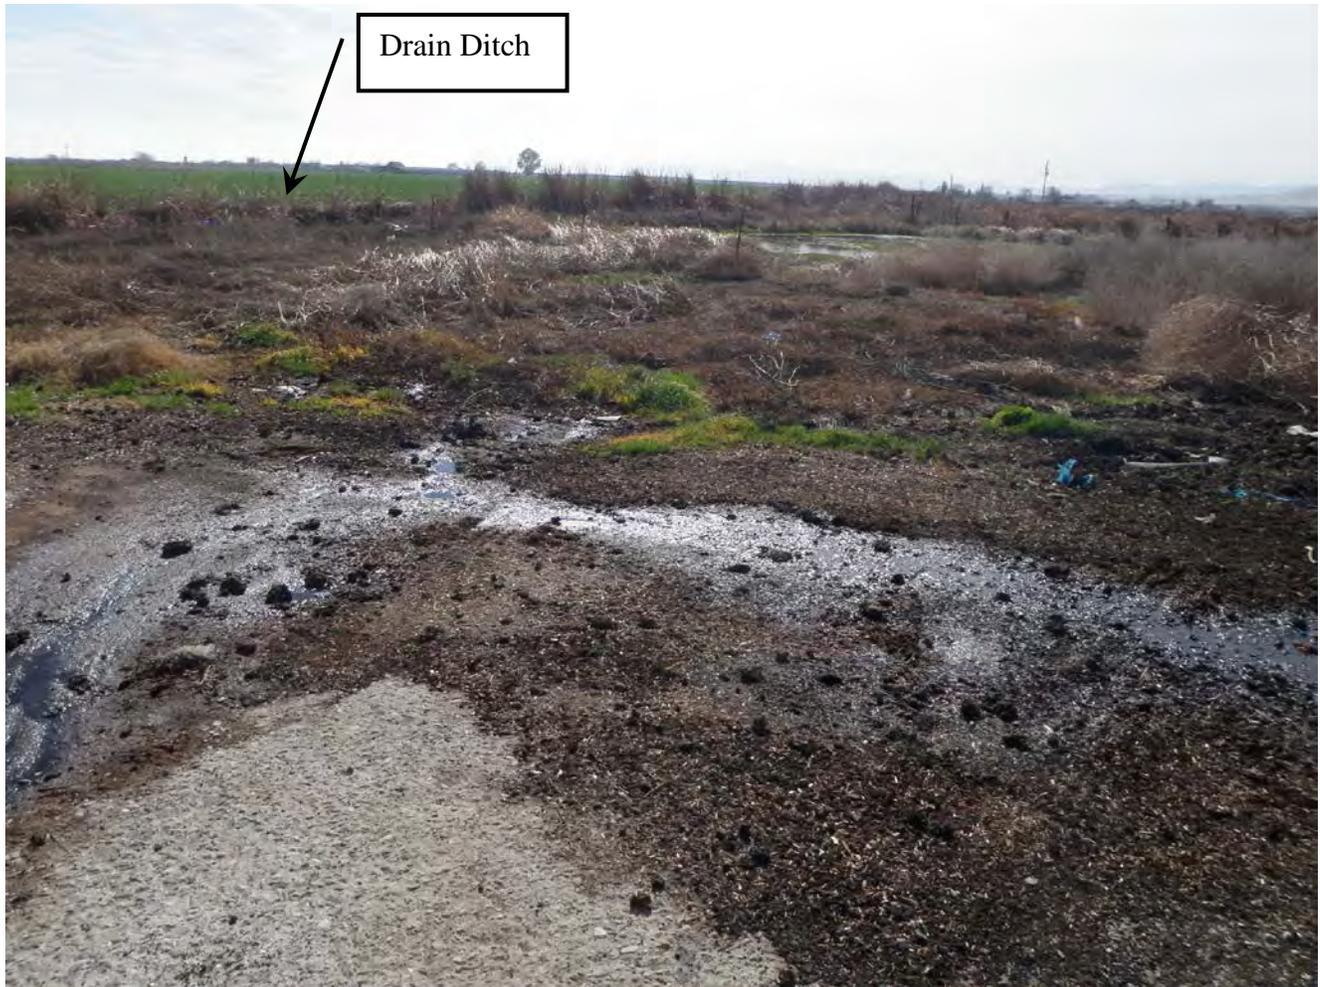
Photo 14: Photo of silage leachate being directed towards the drain ditch.

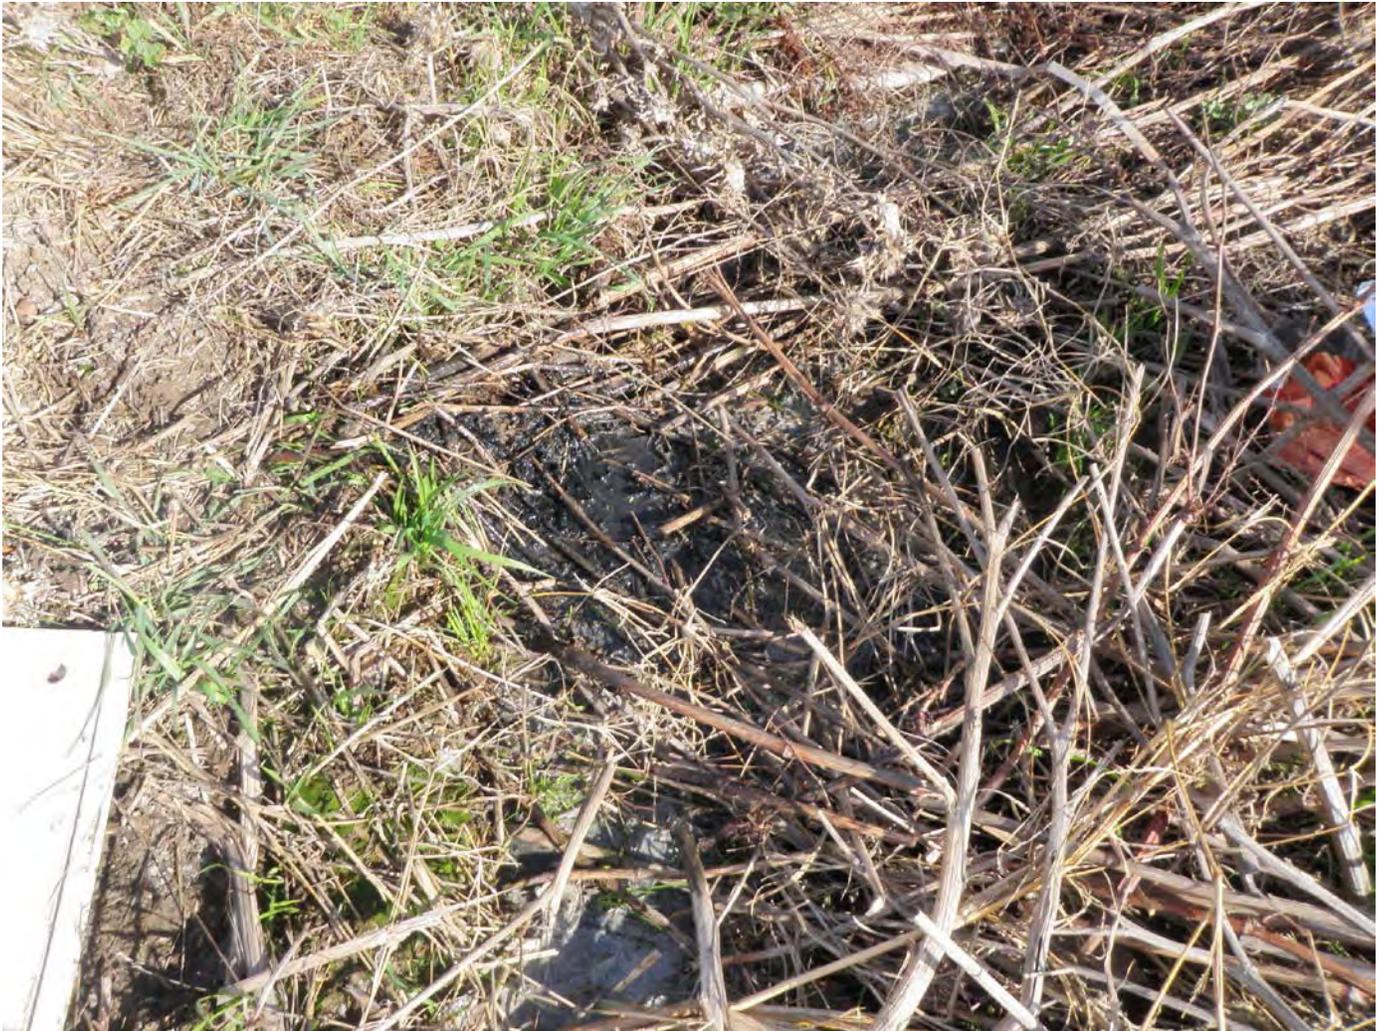
Photo 15: Photo of Septic waste being directed in a swale to the drain ditch. Note that the septic waste was black in color with a strong septic waste odor.
