FRIENDS OF THE NORTH FORK NOVEMBER 3, 2011
REBUTTAL EVIDENCE LIST

Note: All documents are from DWR Division of Safety of Dams, Sacramento, files for Wastewater Storage Dam No. 2022-0

Wastewater Storage Dam, No. 2022
Placer County

INSPECTION OF DAM AND RESERVOIR IN CERTIFIED STATUS

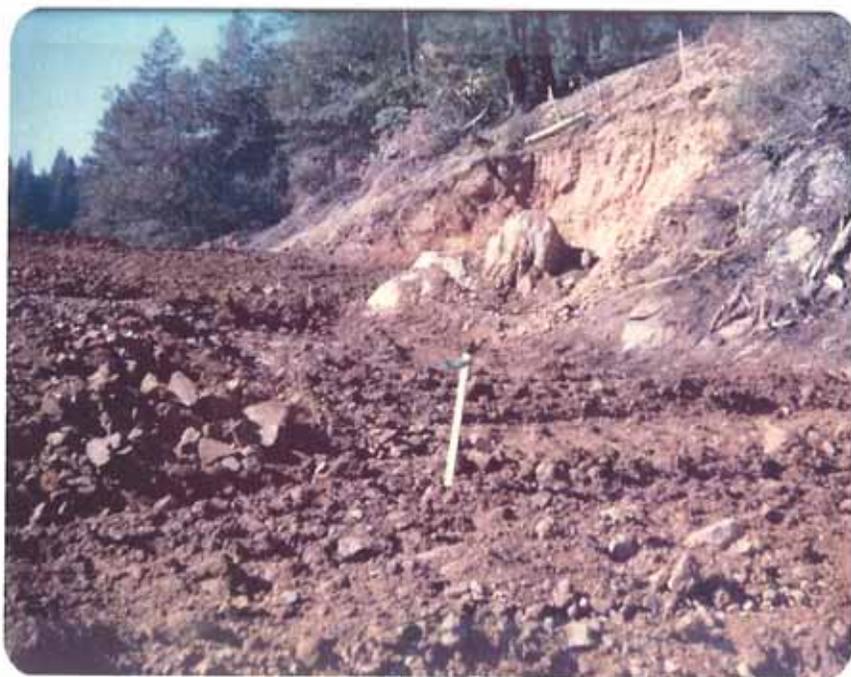
1. No inspector on the job
2. Embankment lift being placed up to 2 feet thick.
3. Two large boulders attached to right abutment were being ignored.
4. Two scrapers on short haul ($\frac{1}{2}$ mile round trip) with only one tamper working.
5. Moisture content of the borrow, however, appeared excellent for working.

Closeup of right abutment. Two large boulders in background are the ones referred to in the report. Left of the lath you can see the end of the two foot lift.

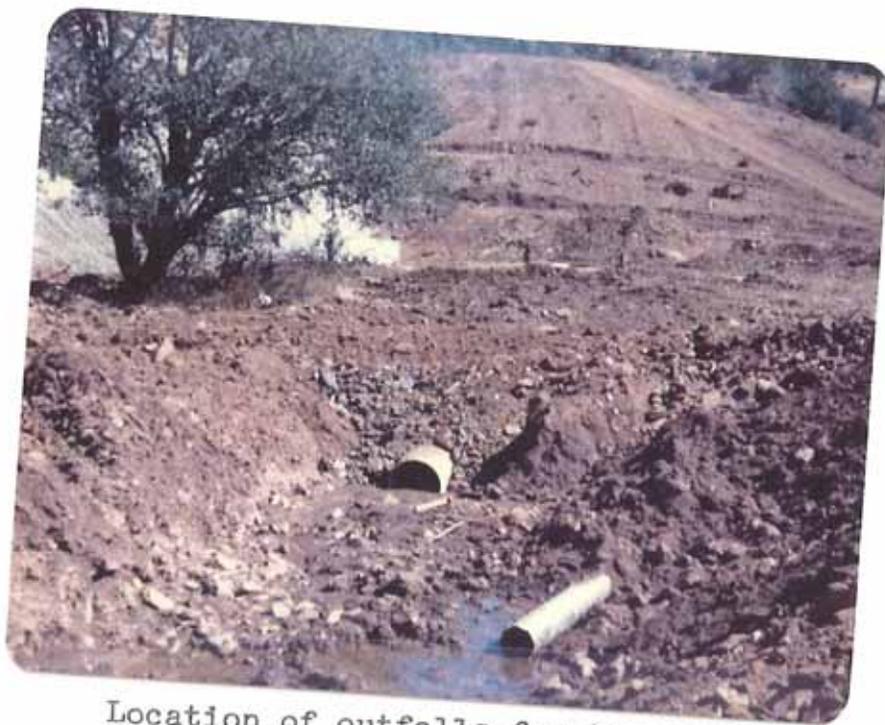
Location of outfalls for the left
8-inch drain and the outlet pipe.

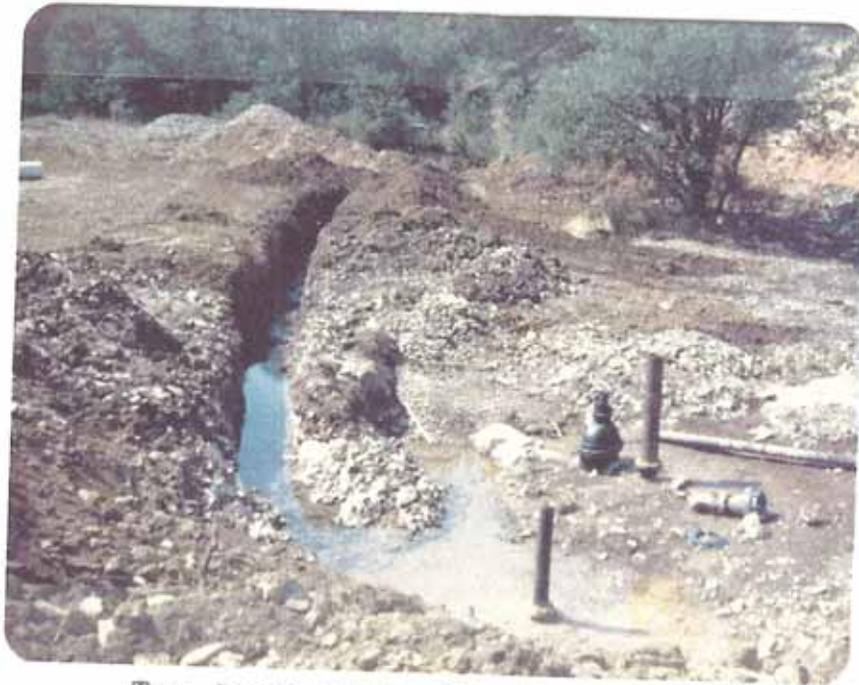
Toe drain left of outlet

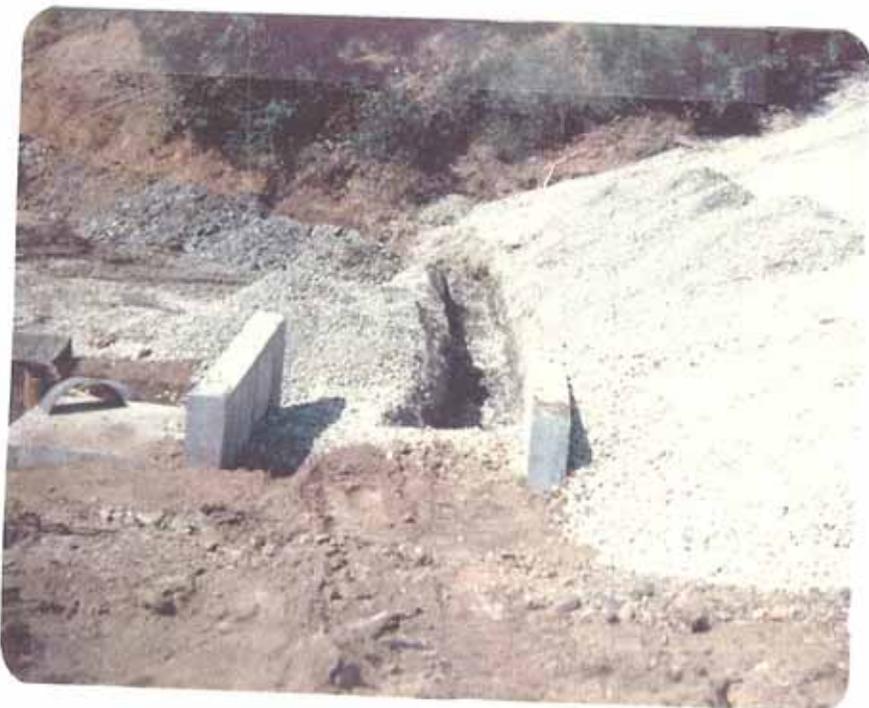
Toe drain right of outlet

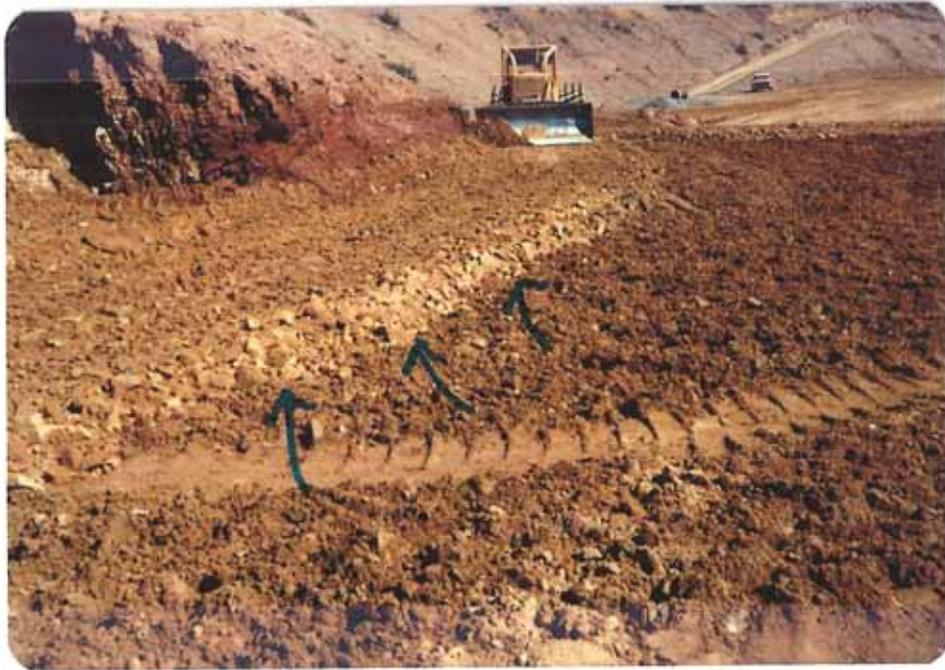
Material in the borrow pit is dry and it is not being adequately moisture conditioned before it is brought to the fill. Several loads of dry material had to be removed from the fill and the rest of the material watered and mixed before it could compacted.

Arrows point to dry fill material.

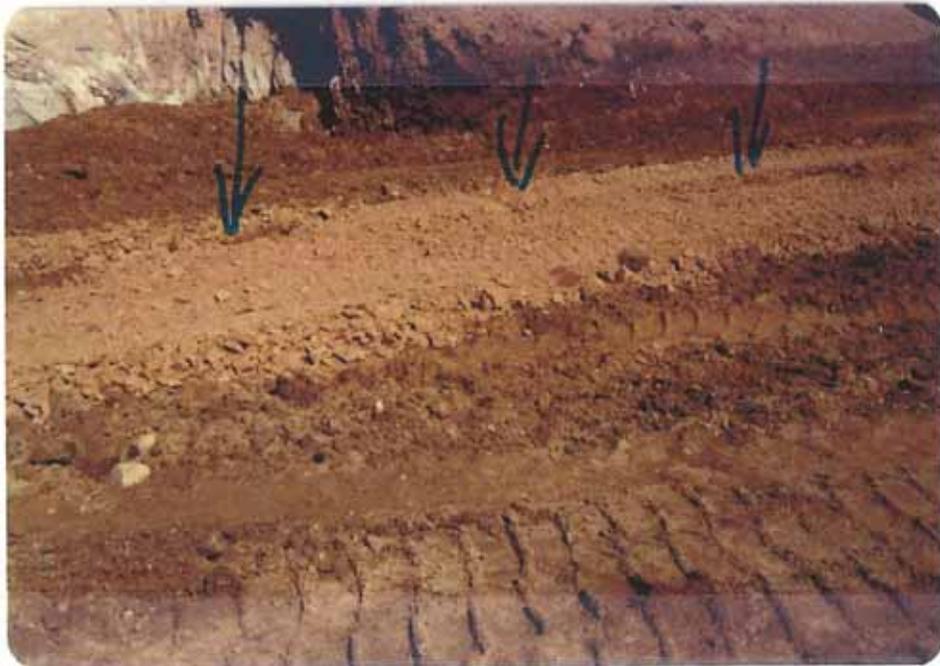
Arrow points to load of dry fill.

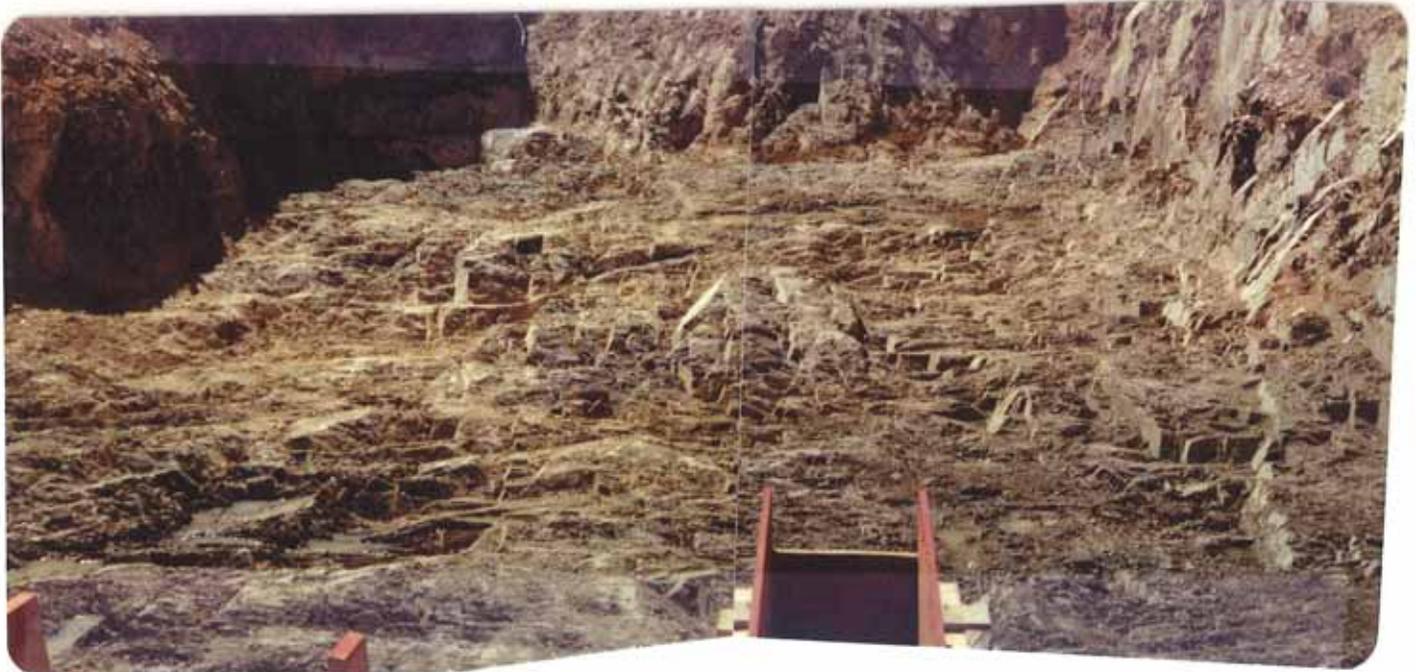
Core trench cleanup at base of right abutment.

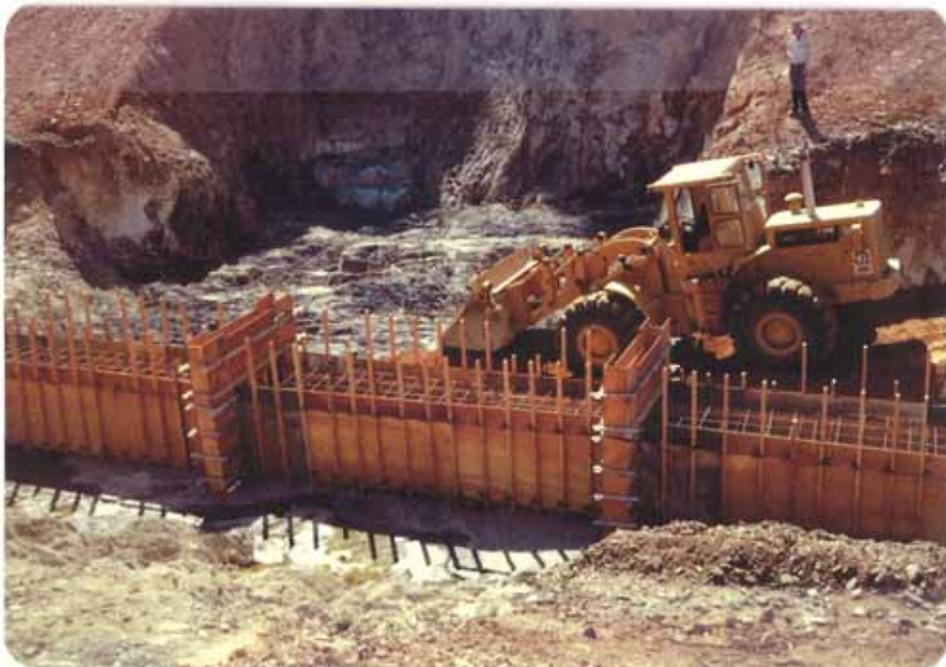
Initial fill in core trench.

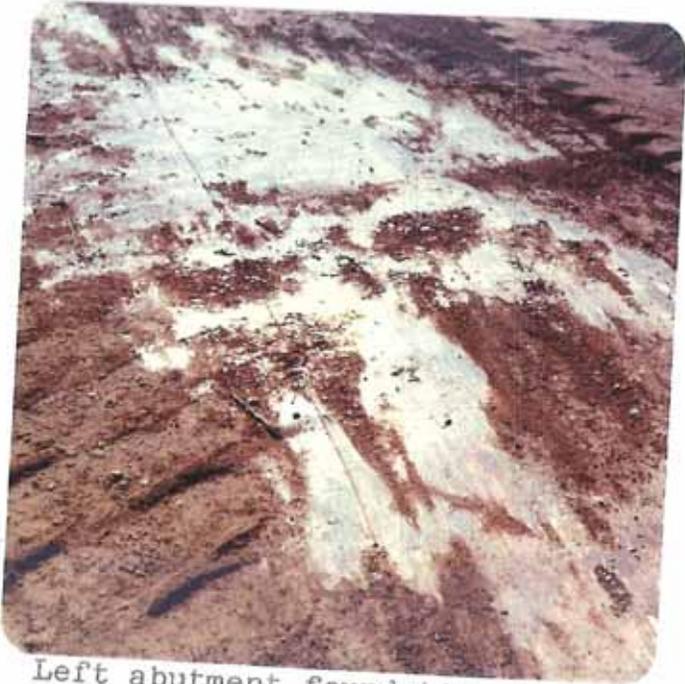
Left abutment foundation for main embankment.

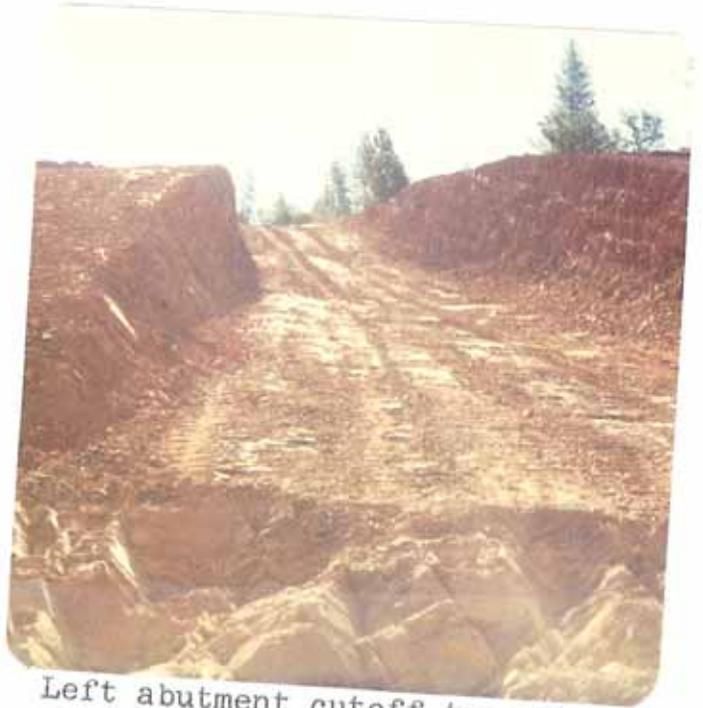
Left abutment cutoff trench from centerline.

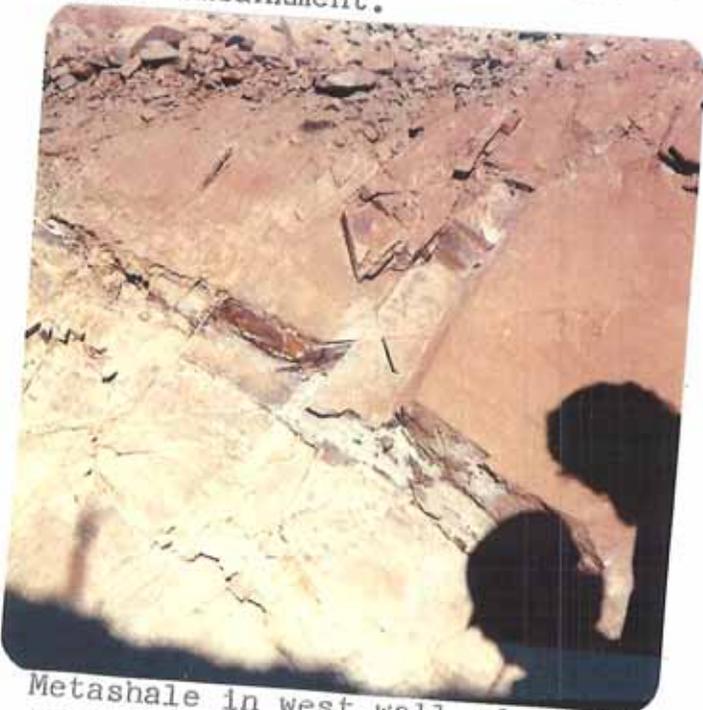
Metashale in west wall of outlet trench downstream from cutoff.

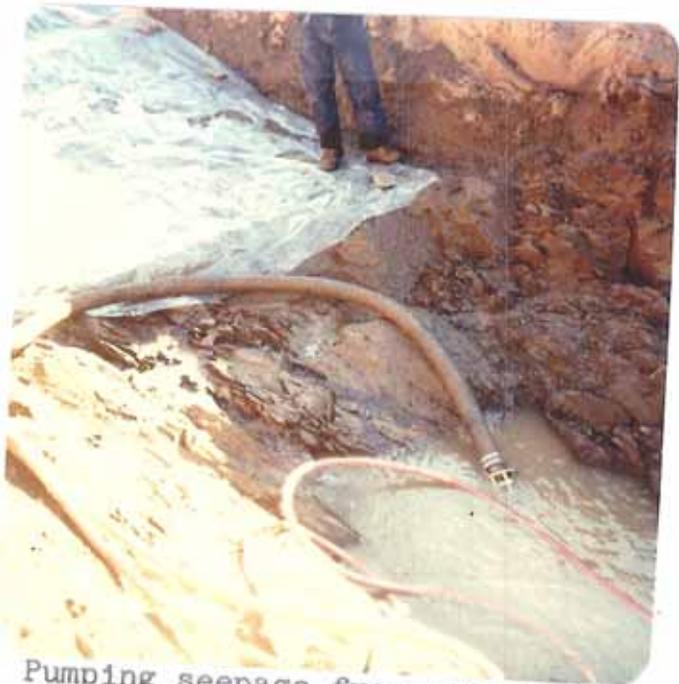
Pumping seepage from outlet trench downstream from cutoff.

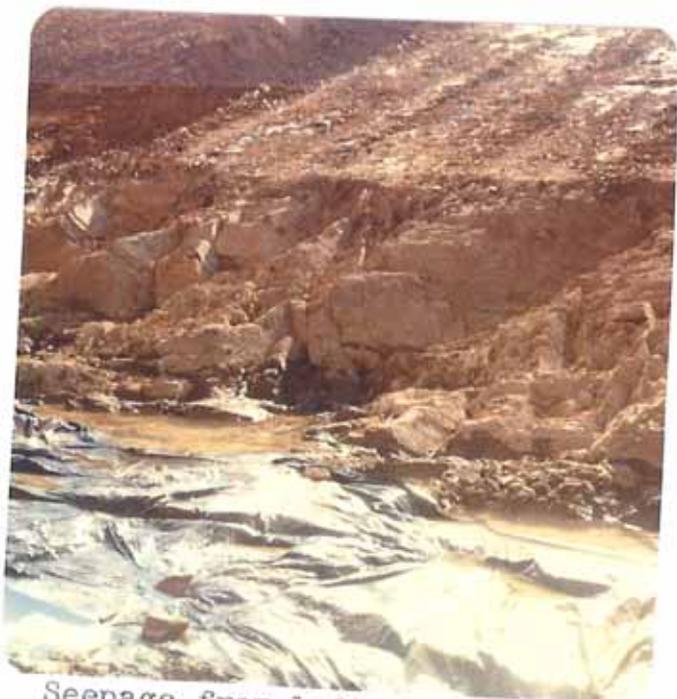
Seepage from left abutment into outlet trench at cutoff.

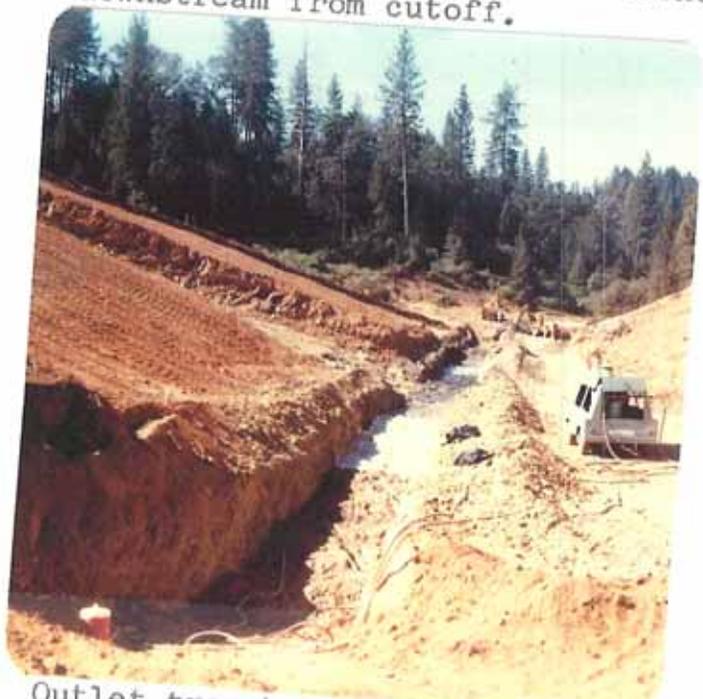
Outlet trench seen from upstream.

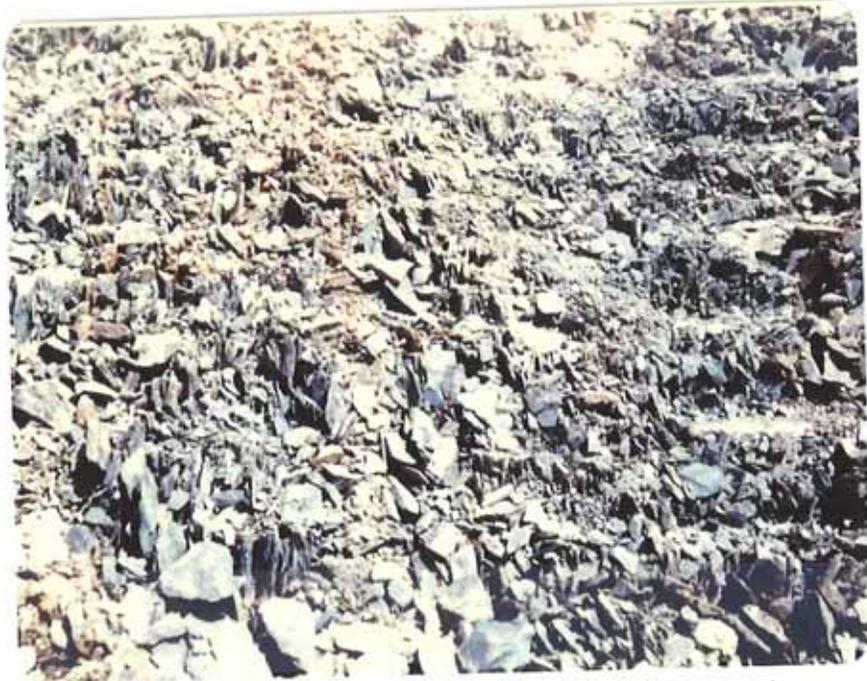
Closeup of Zone 2 foundation.

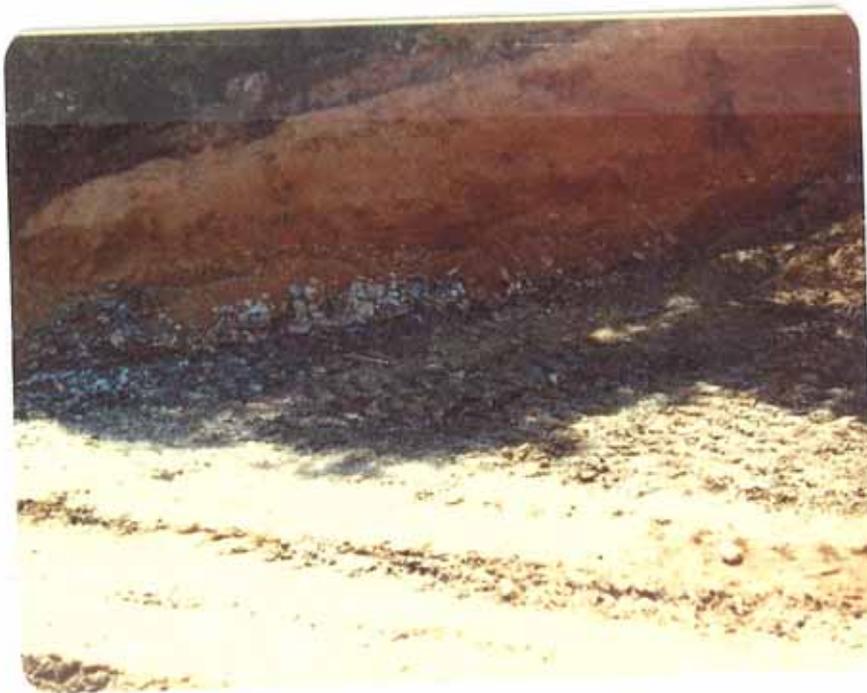
Typical Zone 2 foundation.

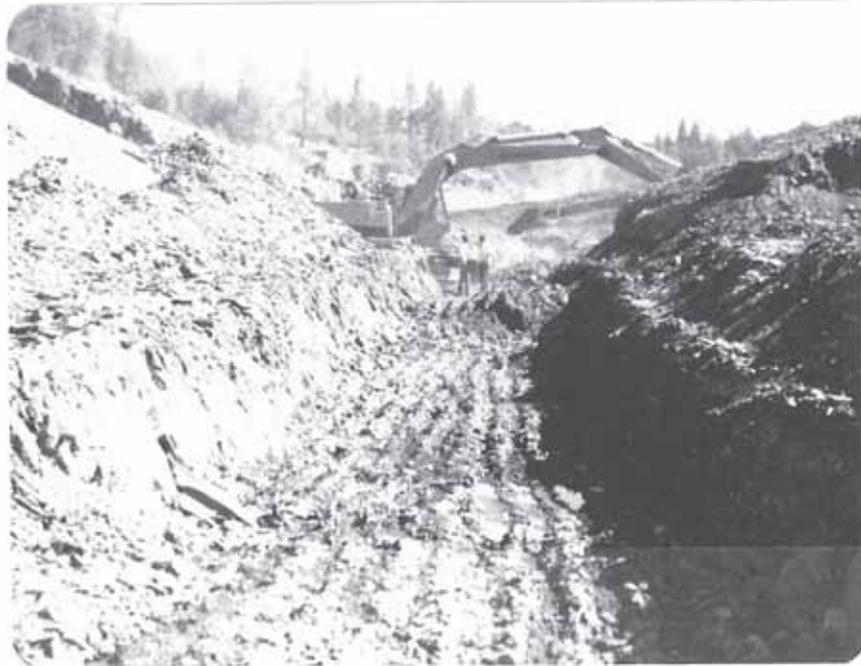
Outlet trench excavation looking upstream from below dam centerline.

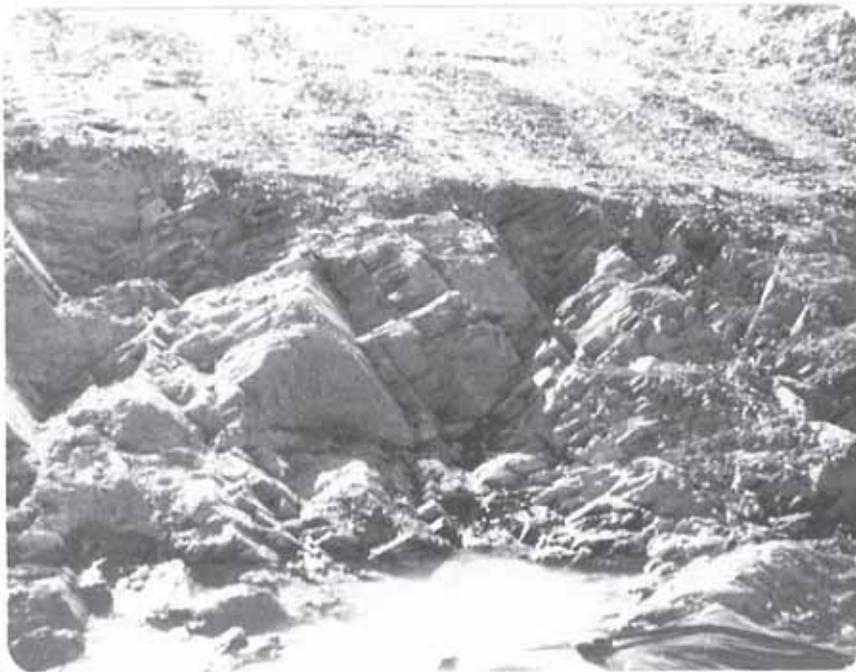
Outlet trench excavation looking up left half of cutoff trench excavation from the dam centerline. Note distinct bedding planes in the rock structure.

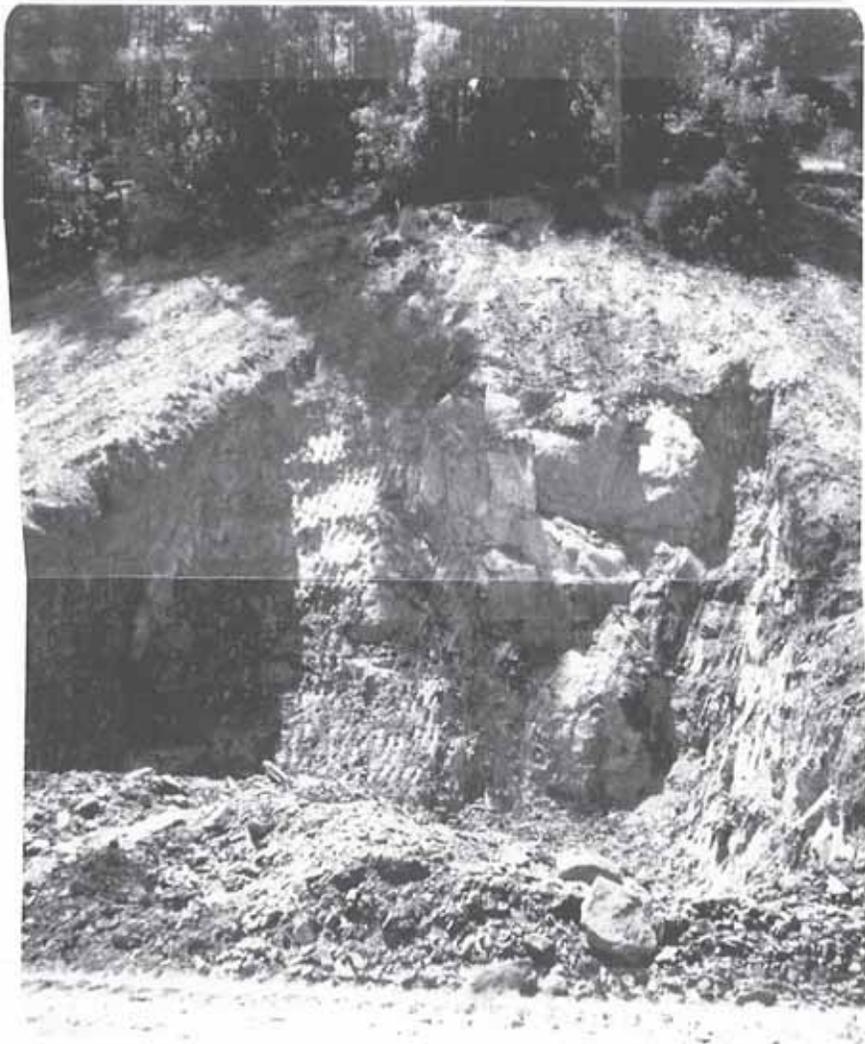
Right abutment cutoff trench.

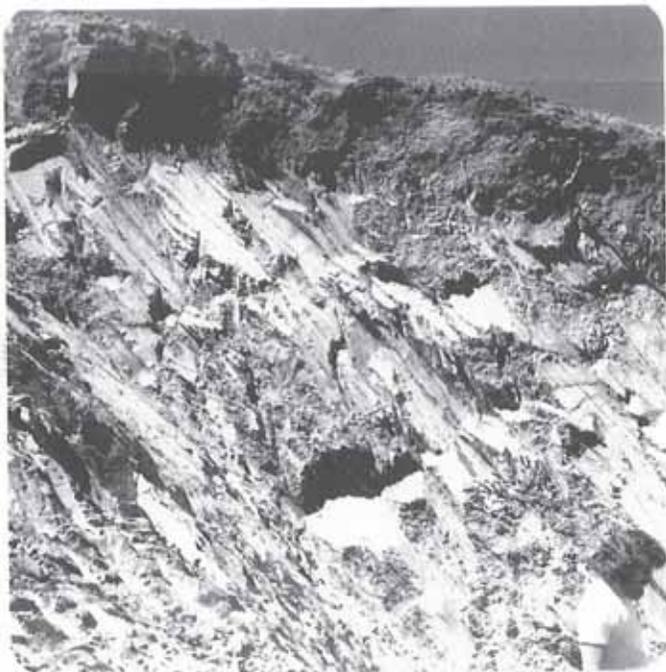
Kaolinized slate and soil cover--
upstream wall of right abutment
cutoff trench.

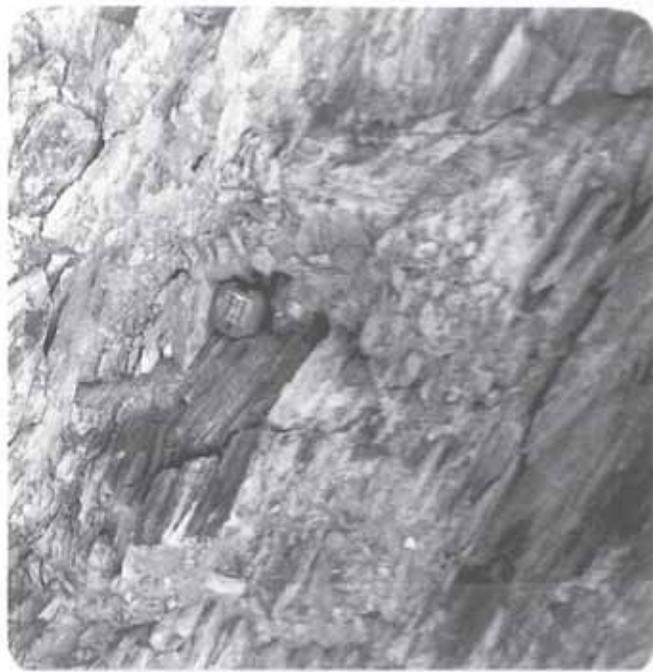
Slate (Mariposa Fm.) in downstream
wall of right abutment cutoff
trench.

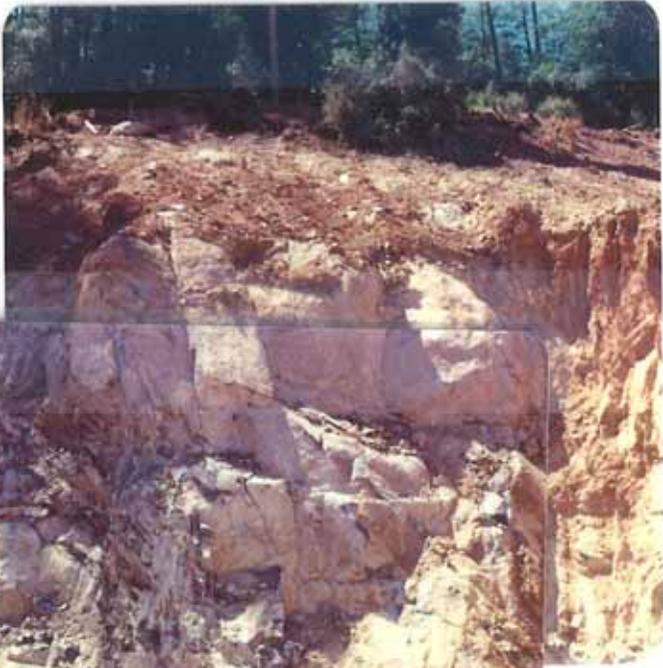
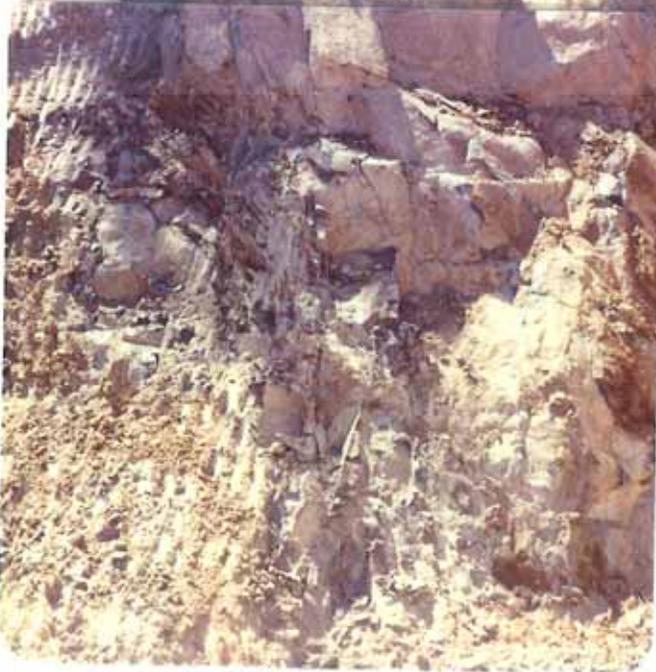
Metasandstone in upper right
abutment cutoff trench.

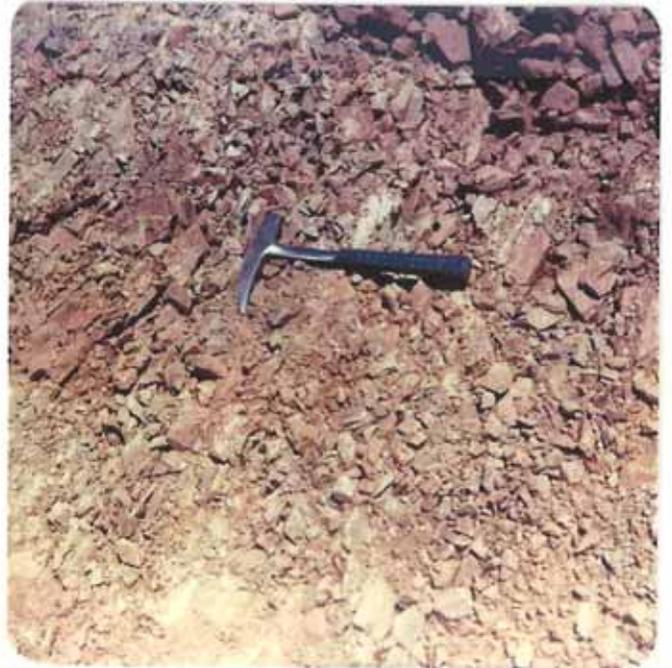
Loose slate in bottom of right
abutment cutoff trench.
