# CENTRAL VALLEY REGIONAL WATER QUALITY CONTROL BOARD

**ACL Complaint R5-2012-0515  
Attachment F  
19 July 2012 Inspection Report**

**INSPECTION DATE:** 19 July 2011  
**FACILITY:** Del Mar Farms  
**LOCATION & COUNTY:** Cropland APNs 027-018-055 and 049-014-001  
Westley, Stanislaus County  
**INSPECTED BY:** Terry Bechtel  
**ACCOMPANIED BY:** Lt. Phil McKay, Ca Dept. of Fish and Game

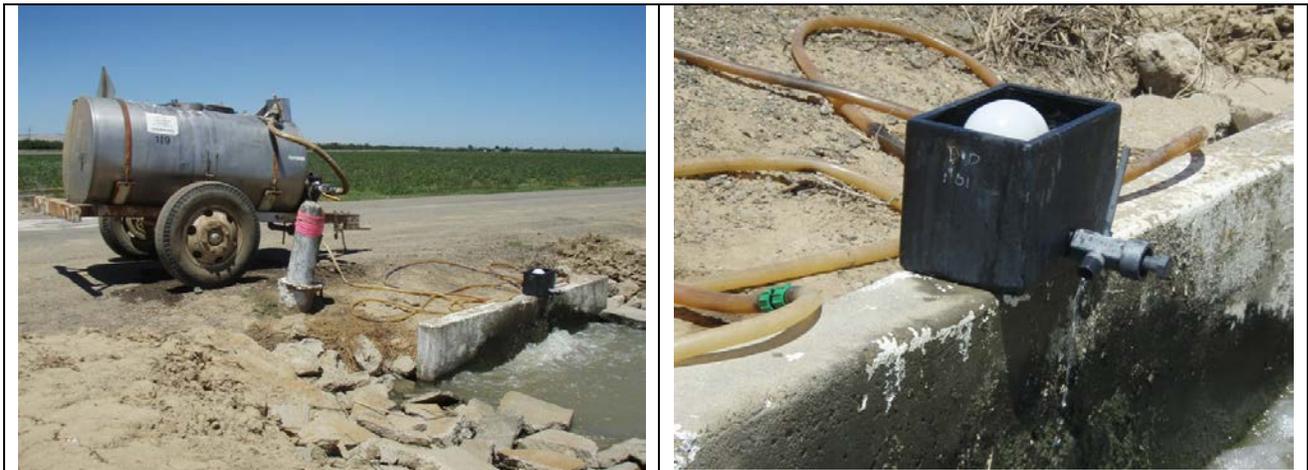
Photos taken at 12:30 - Tank next to JT Crow Road with clear liquid flowing via the metering box into the irrigation supply water. Hwy 33 is to the left of the photo and the tomato field is to the right of the photo.

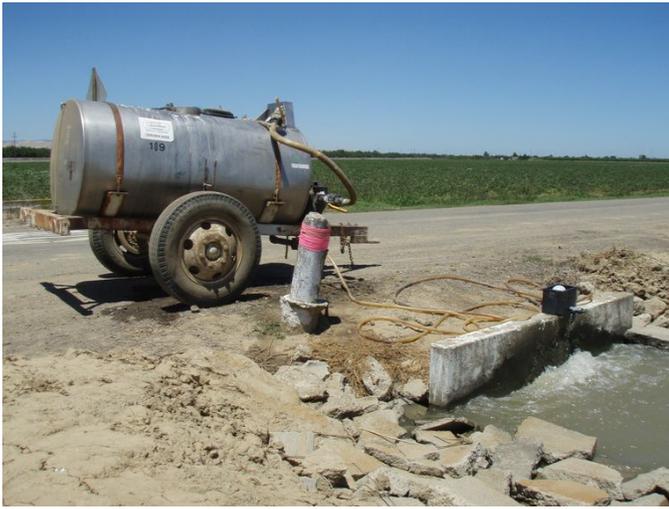
Note: When the lab samples were received, the analysis for the fertilizer tank indicated (and was later confirmed by the operator) that it was CAN-17 (calcium ammonium nitrate solution). CAN-17 is available via a number of distributors. It is derived from ammonium nitrate and calcium nitrate. The analysis is 17 % nitrogen (5.4% ammoniacal-N, 11.6% Nitrate-N) and 8.8% calcium (from calcium nitrate).

**Photo 1:** Looking at the tank with the battery box water running a clear viscous liquid into the irrigation supply water. (later identified as Calcium Ammonium Nitrate fertilizer – CAN 17).

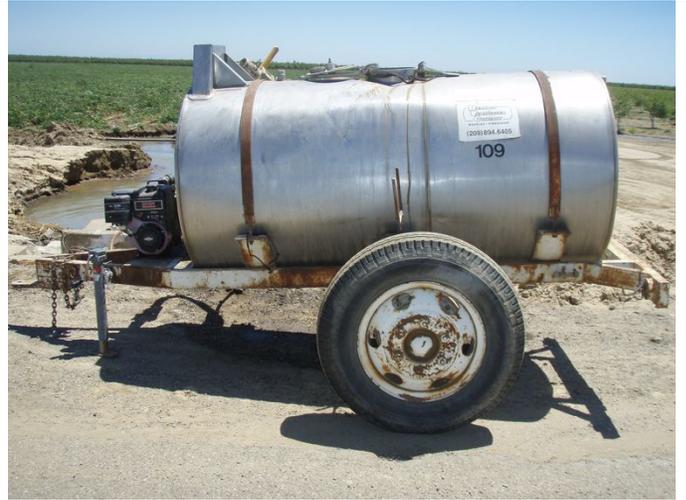
The tank did not have a tag or other labeling on it to identify what was in the tank. It did have the number "109" on the tank and a label with DeIDon Fertilizer Company, Westley – Firebaugh with the phone number (209) 894-6405. I contacted Lt. Phil McKay of the CA Dept. of Fish and Game regarding the event. I did not have the contact information for the grower/operator.

**Photo 2:** No tank tags indicating what was inside the tank were seen.

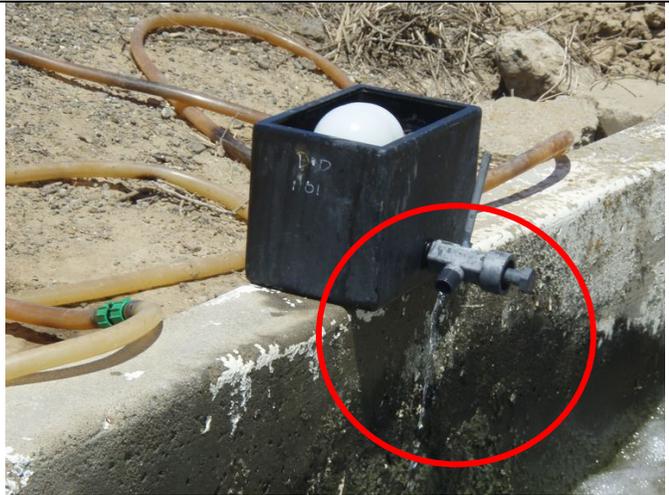
**Photo 3:** The flow from the battery box took 29 seconds to fill a 1 pint bottle.

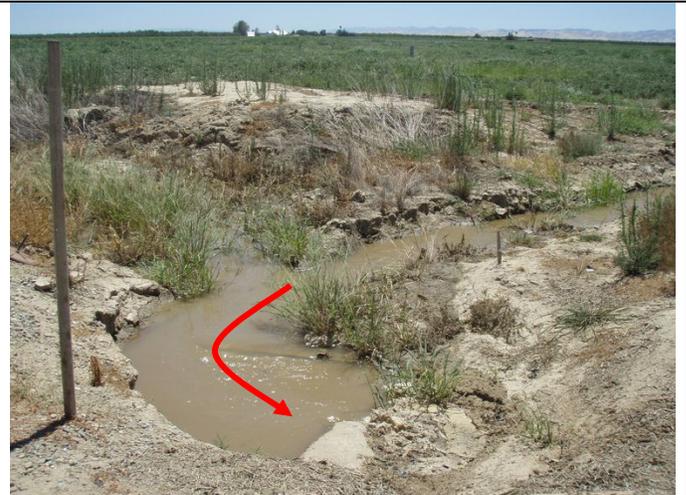
**Photo 4:** The tailwater drainage from the (with the fertilizer still being applied in the water) was flowing into the area drain into the Amaral Line underground pipe.

Flow rate from the field into the drain was approximately 4 ft wide, ½ foot deep, with a velocity of approximately 12 ft. in 7 seconds. Adjusted for float velocity coefficient of 0.66, the rate was approximately 102 ft<sup>3</sup>/min.

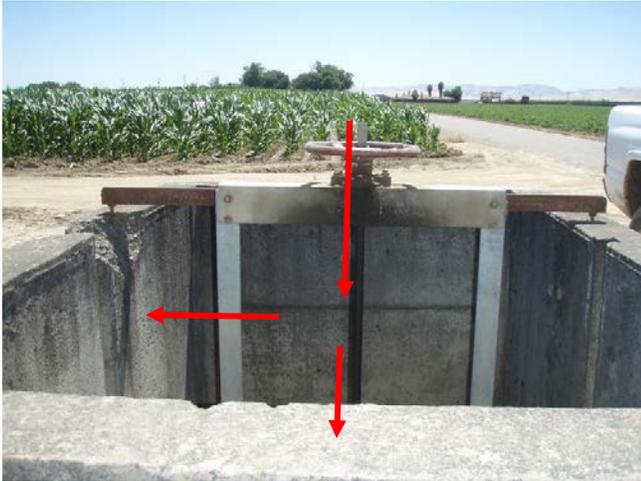
**Photo 5:** Looking west from a control box on the Amaral Line toward the tomato field (past the trees in the photo).

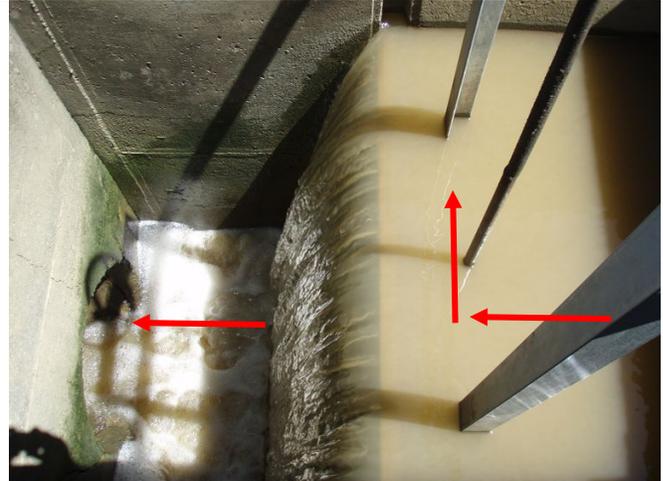
**Photo 6:** A portion of the water in the Amaral Line (including the tailwater from the field) was being used as irrigation water by other farms to irrigated an alfalfa field (toward the top of the photo). The balance continued east toward the S.J. River (left of the photo and shown in Photo 7).

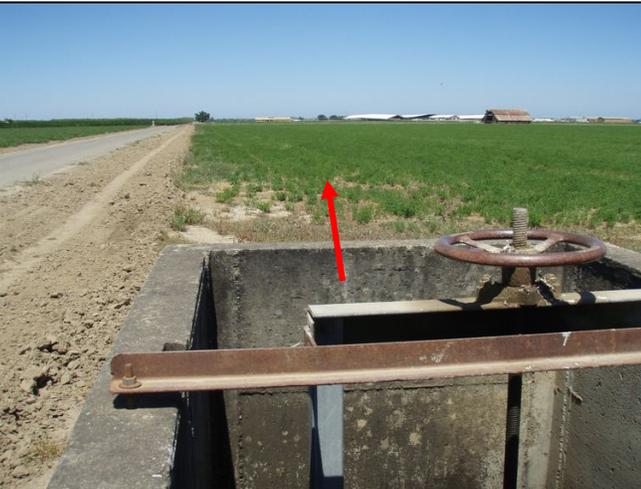
**Photo 7:** The balance was flowing east (left in the photo) to other properties and the San Joaquin River.

Note: The Amaral Line is used for both irrigation supply water (from the CCID Canal) and as a drain to the San Joaquin River.
