Photo 1. Red Ink Main Mine Portal.

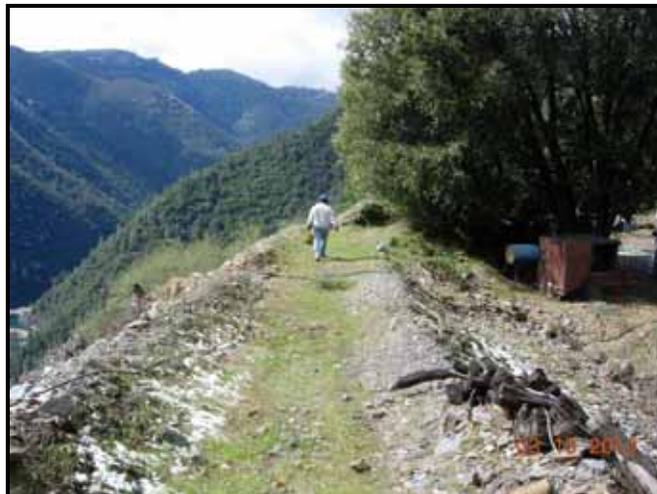
Photo 4. Looking west at the berm of waste dump #2. Middle Fork of the American River visible on left.

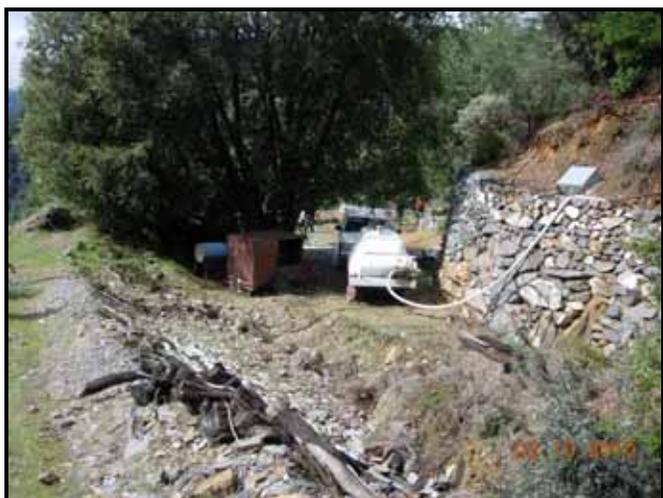
Photo 2. Portal area looking west.

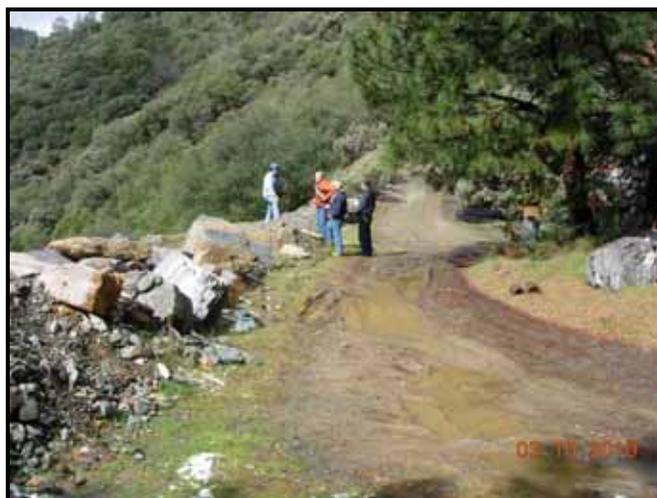
Photo 5. Portal area looking towards waste dump #1.

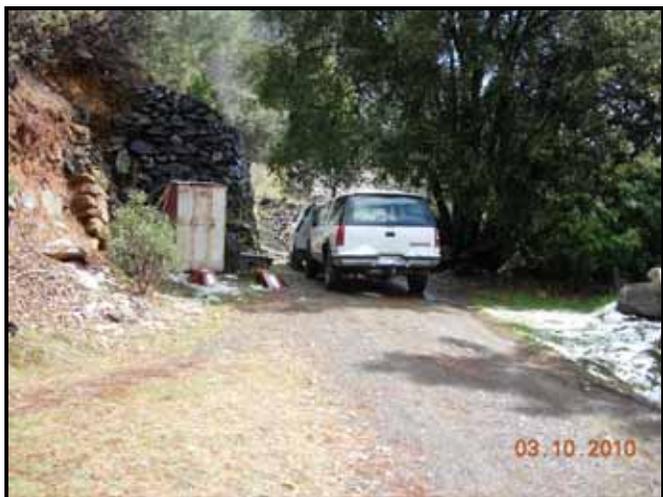
Photo 3. Portal area looking east.

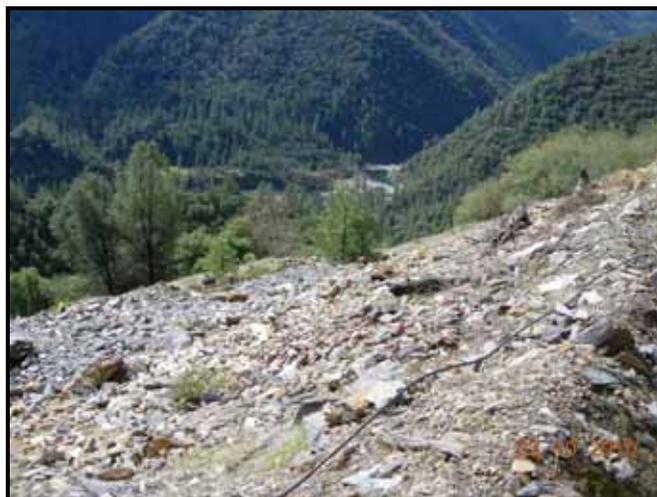
Photo 6. Waste dump #3, looking west.

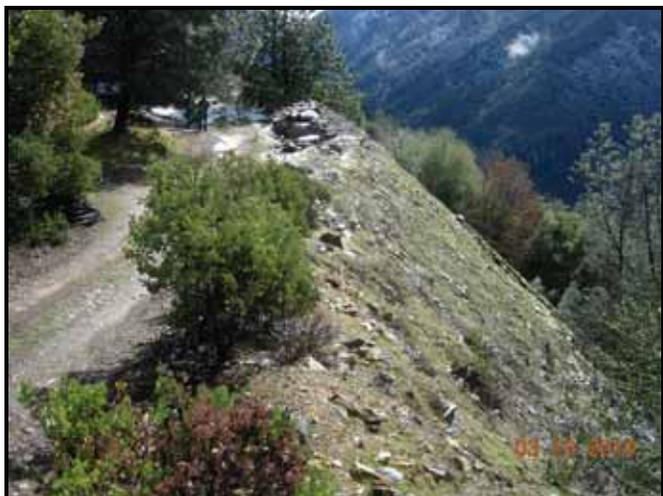
Photo 7. Looking east at waste dump #1.

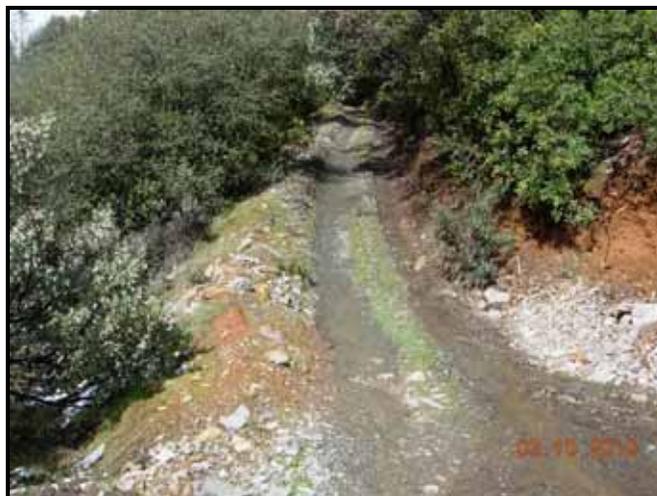
Photo 10. Looking west at the access road to waste dump #5.

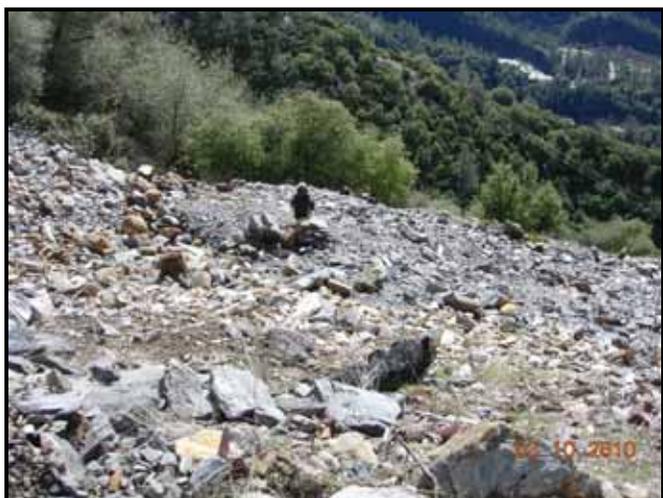
Photo 8. Looking east at waste dump #4.

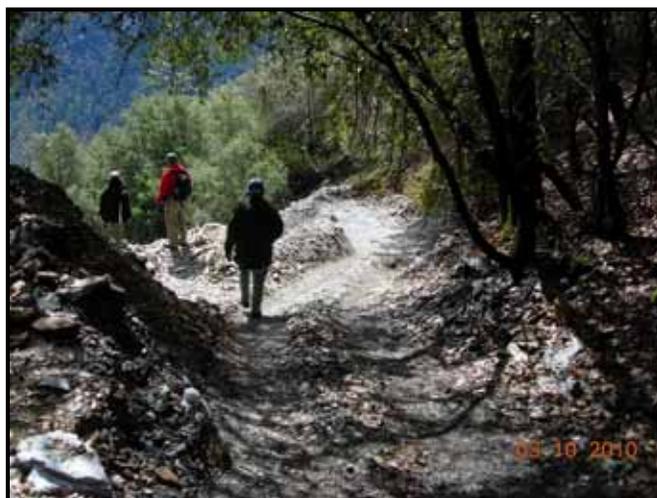
Photo 11. Waste dump #5 looking west.

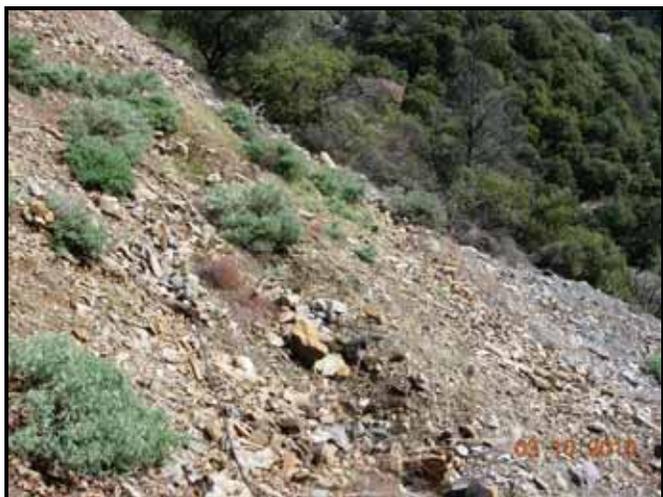
Photo 9. Looking at slump failure on waste dump #4.

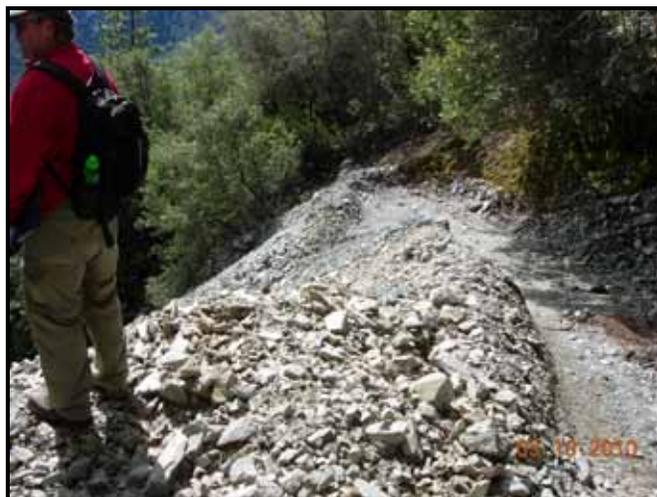
Photo 12. Waste dump #5 showing end dumped mining waste.

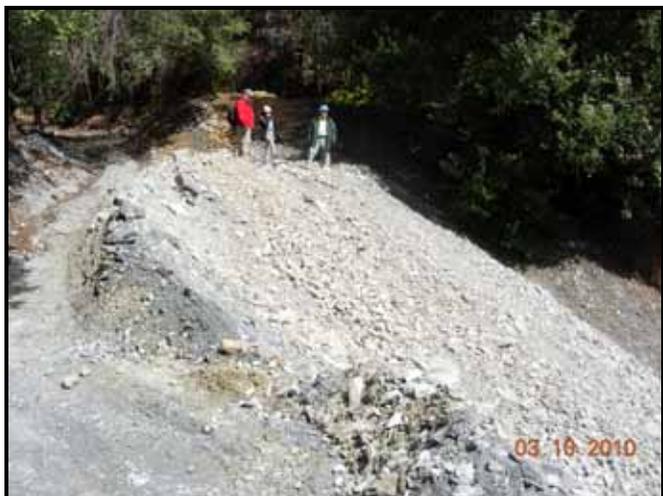
Photo 13. Waste dump #5 showing end dumped mining waste.

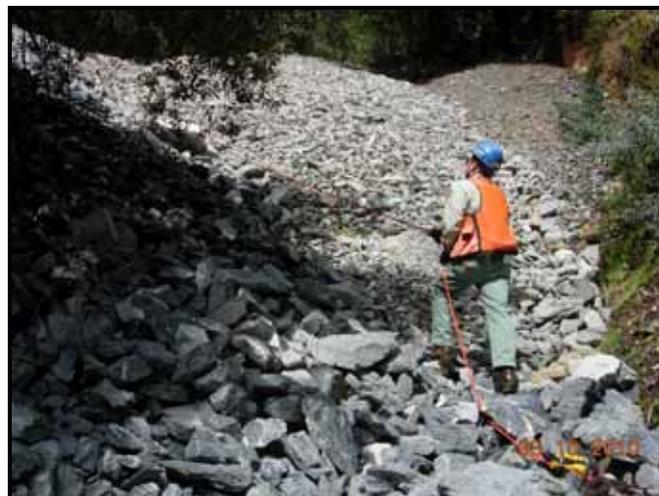
Photo 16. Showing natural segregation of end dumped materials.

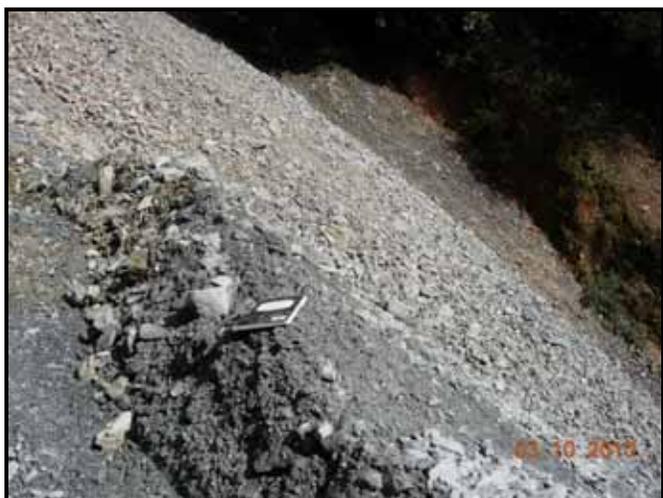
Photo 14. Showing fine grained materials in waste dump #5.

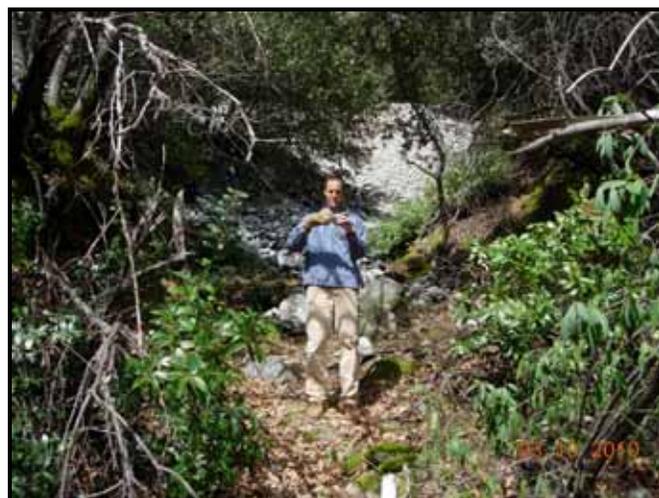
Photo 17. Looking up from the debris barrier to waste dump #5.

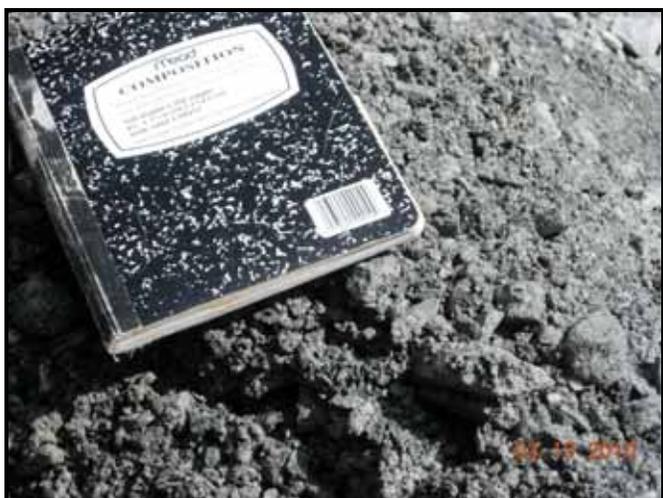
Photo 16. Close up of previous photo.

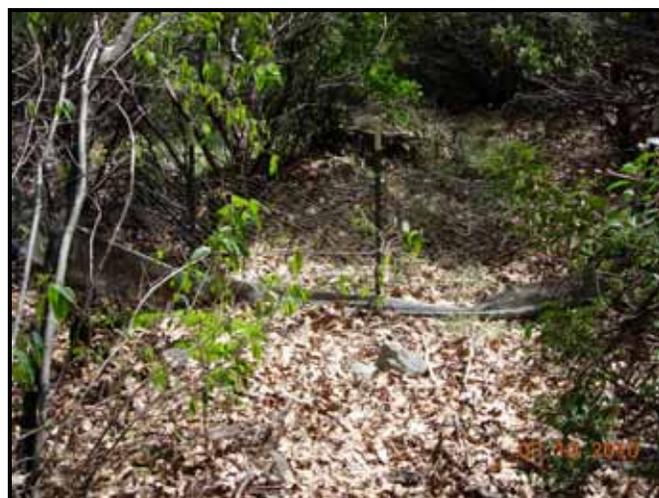
Photo 18. Near the toe of waste dump #5, looking downgradient at the debris barrier

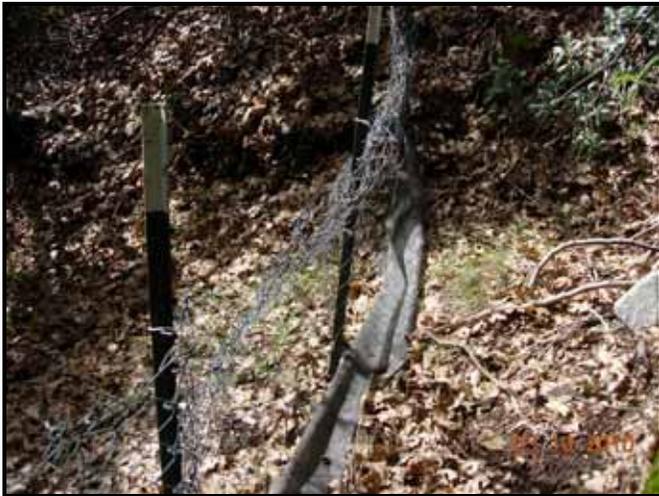
Photo 19. Debris barrier downgradient of the toe of waste dump #5

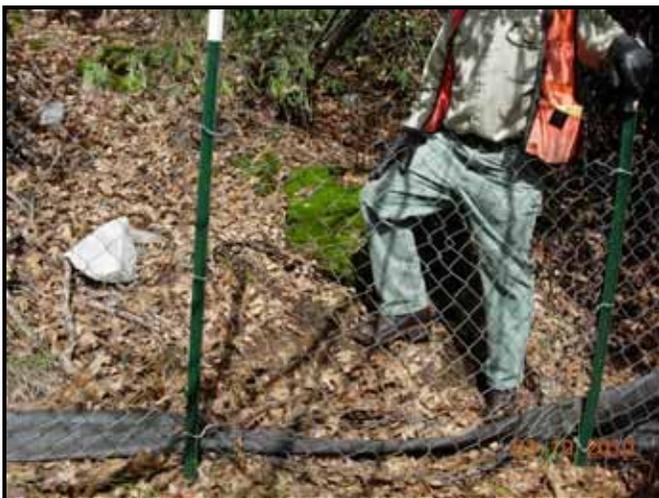
Photo 20. Close-up view of previous photo.

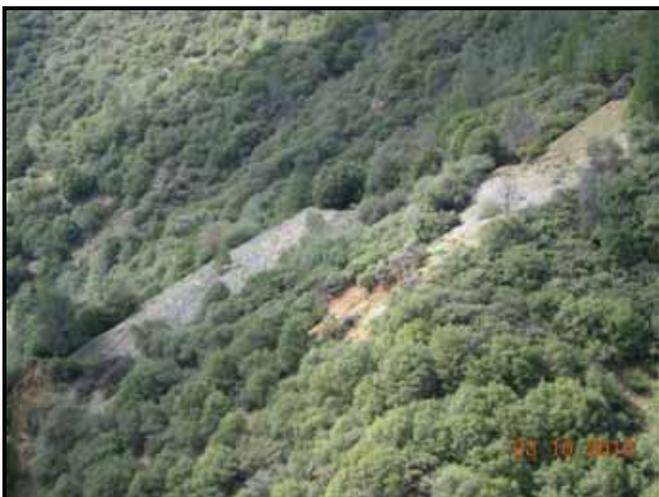
Photo 21. Photo taken from Mosquito Ridge Road overlook 1 mile east of mine site. Photo shows slope failures at the toes of waste dump #2 and #4.
