From: Mr. Jeff Fleming <jefflem@dairydesigners.com>
Sent: Tuesday, October 30, 2012 1:43 PM
To: Herbst, Charlene@Waterboards; Herbst, Charlene@Waterboards; Walsh, Sean@Waterboards; Walsh, Sean@Waterboards; Davis, Daniel@Waterboards
Cc: Avila, David; Skelton Chris
Subject: Monitor well 3, Henry Tosta Dairy
Attachments: DSC00157.JPG; DSC00020.JPG; DSC00033.JPG

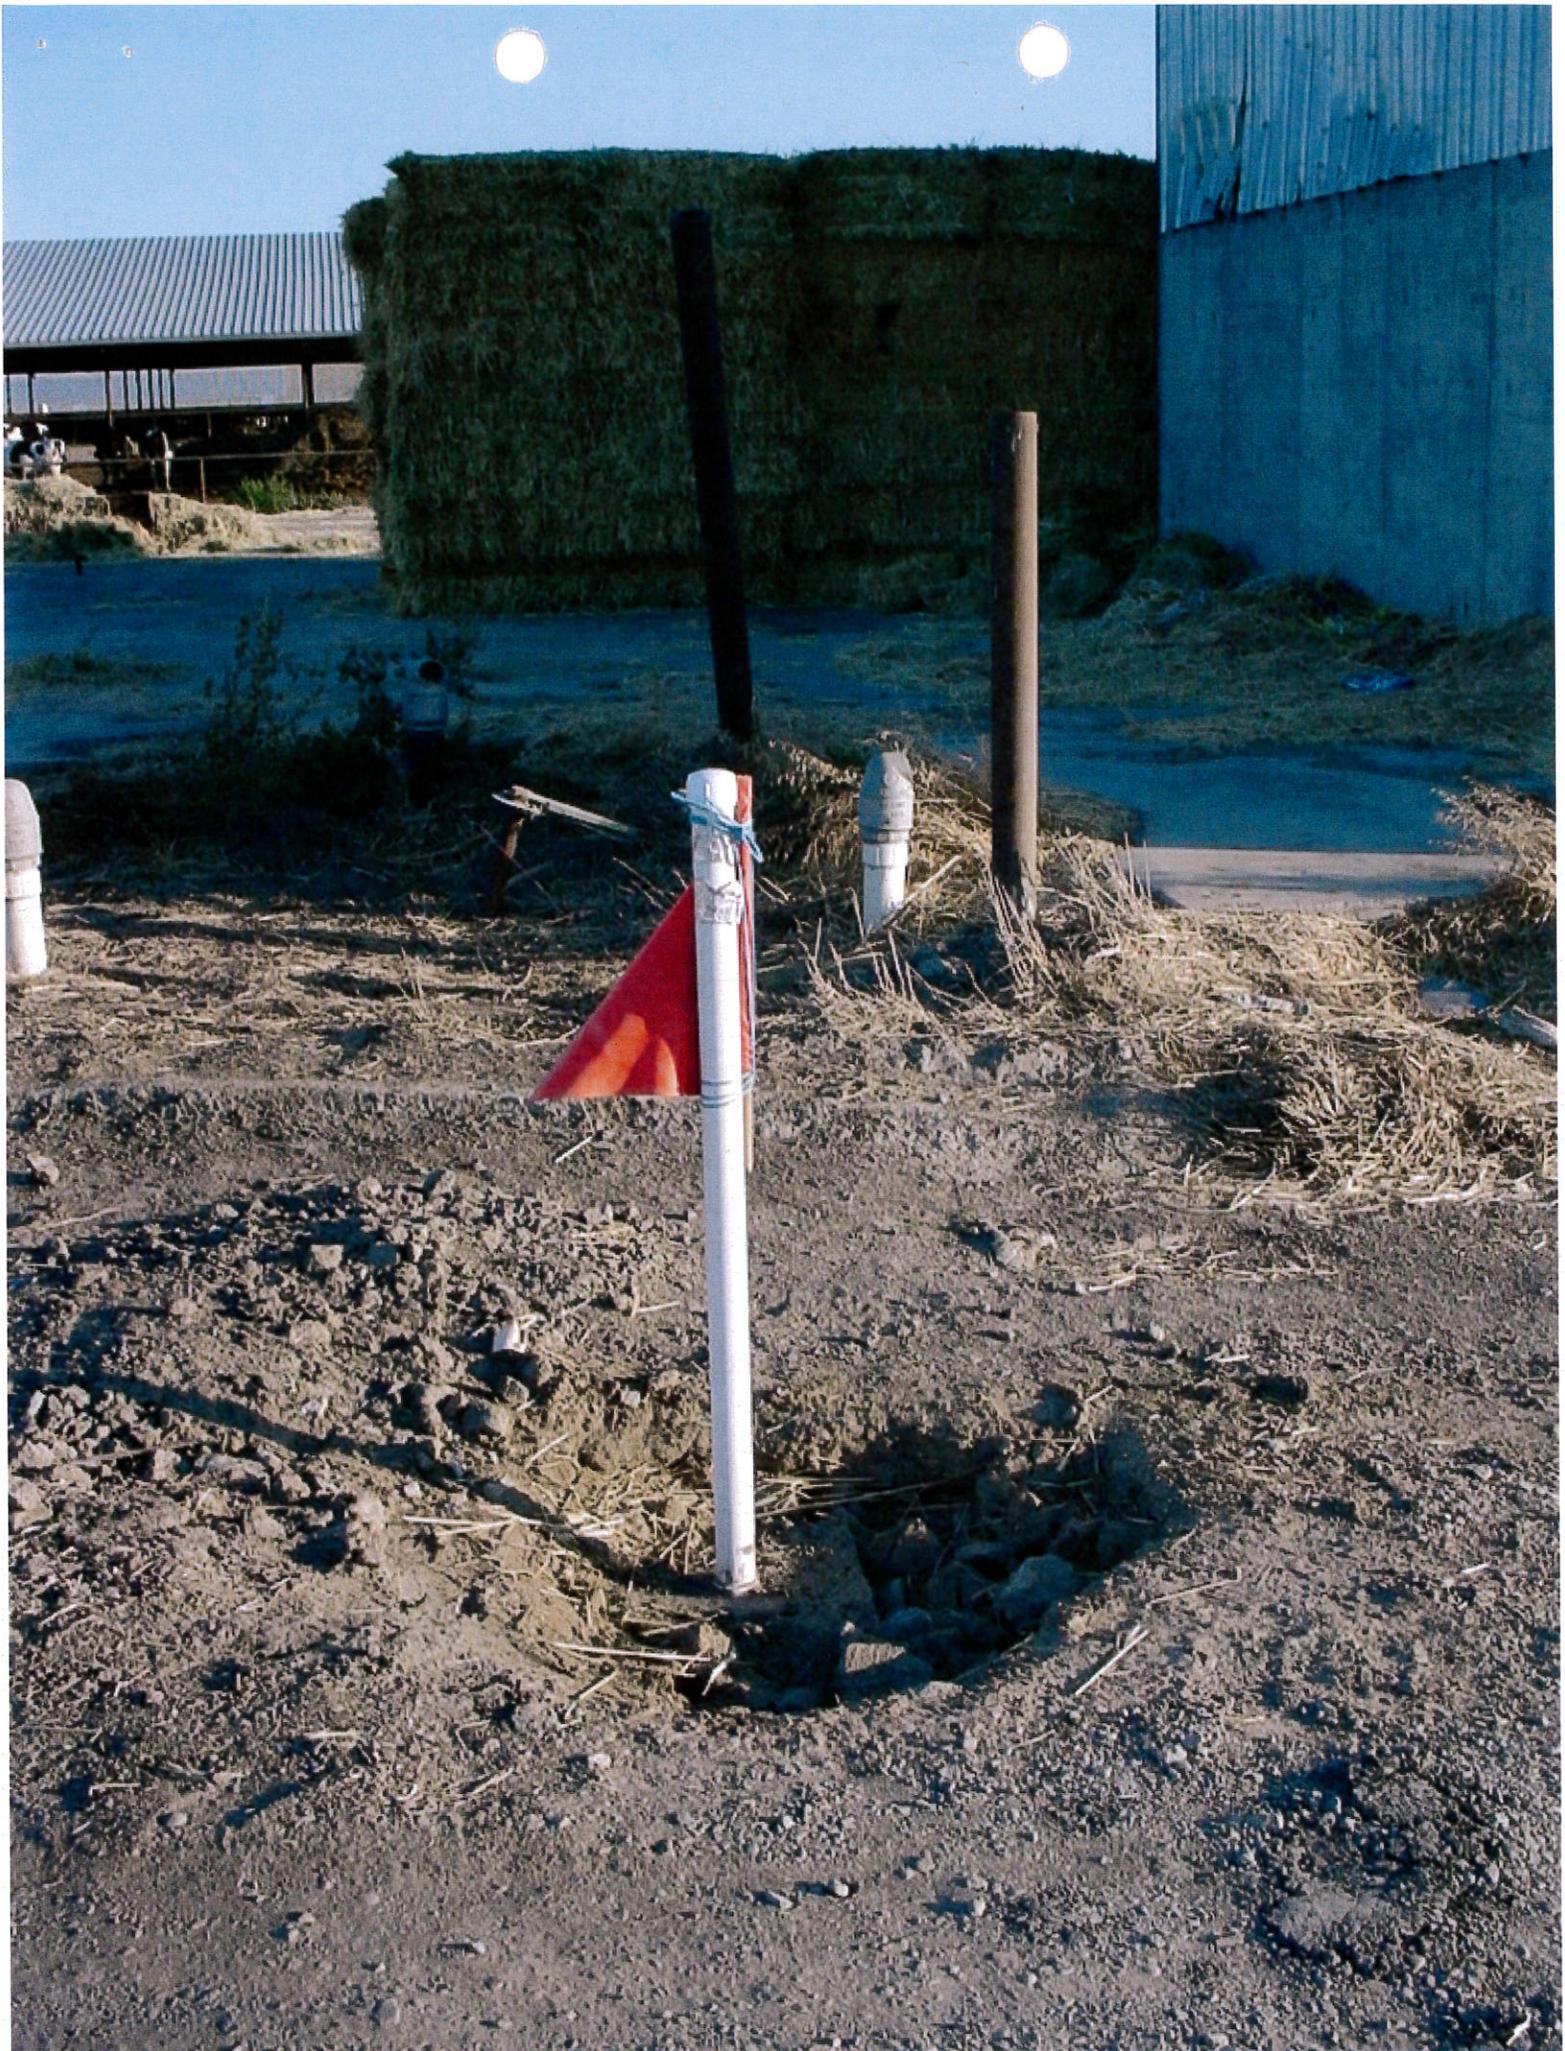
When I went to shoot well casing levels and get water samples on Oct. 9, I found that the northernmost monitor well, which we are calling #3, had been run over by a truck. Tosta dairy personnel repaired the well immediately, and it was fixed as shown in the photos when I saw it on Oct. 9. Photo DSC00157 shows it as it was "before", and DSC00020 shows it as it is now. DSC00033 shows a more overall view. The earlier photo has a higher number because the camera memory was cleared before my Oct. 9 trip. The well top is protected by a truck wheel, the well casing sticks out less than the height of the truck wheel rim, there is a PVC cap, and a big HEEAVY!! piece of half inch steel plate covers all of that. Note the piece of steel plate in the pic. I flipped the plate back over the well and shoveled some road base over it before I left. I think MW3 is now the best protected monitor well on the property, almost as well protected as it would be if a commercial manhole cover had been installed.

Note also in the picture, the piece of PVC well casing and coupling which was cut off from the well. I took this piece back to my office. It is exactly 46.0 inches long. What you see coming out of the truck wheel hub opening is a 5.0 inch long (measured inside the pipe) piece and coupling glued to the old casing. Therefore, the old well casing elevation was exactly 41.0 inches higher (3.417 feet) than the elevation I shot on Oct. 9. I allowed for this difference in my calculations.
