CENTRAL VALLEY REGIONAL WATER QUALITY CONTROL BOARD

INSPECTION REPORT

LOCATION & COUNTY: Henry Tosta Dairy
20662 San Jose Road, Tracy
San Joaquin County

INSPECTION DATE: 7 December 2012

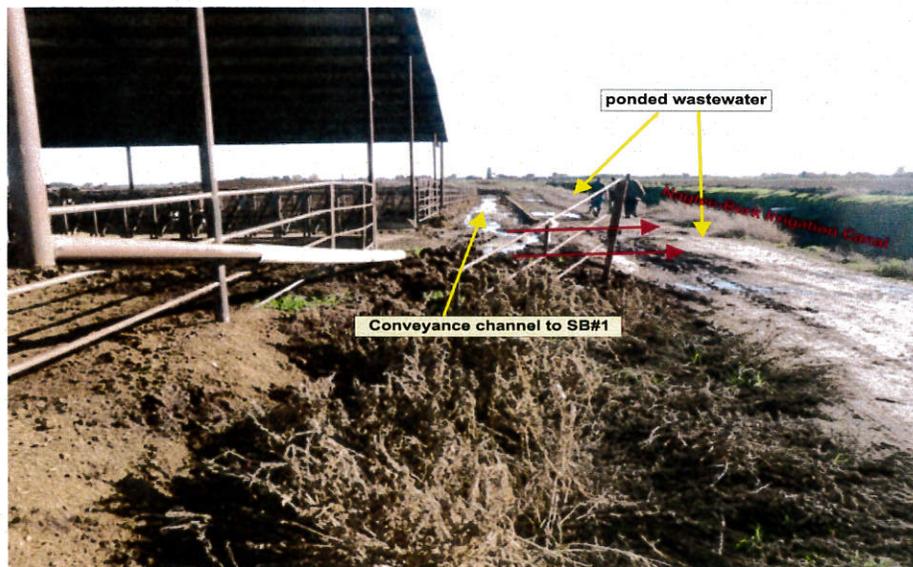
The southern perimeter of the property contains a storm water drain that routes storm water through solid manure before entering a concrete channel that is designed to convey water into Settling Basin #1 (SB1). When SB1 is at capacity it appears a portion of the water ponds in the concrete channel and has the ability to over-top and/or back-flow from the channel south off-property into the Naglee-Burk Irrigation canal; another portion flows into the corral that is adjacent to the above mentioned concrete channel. At the time of this inspection puddles of wastewater and solid manure were present on the access road south of the concrete channel and north of the Naglee-Burk canal (see Photos 1-3).

Photo 1: Looking east down the southern perimeter of the production area. The white pipe conveys storm water from the roof of the barn east down a manure-laden concrete channel to Settling Basin #1. Also water from a corral is supposed to flow east down the same channel to Settling Basin #1. Red arrows indicate how water can flow if the channel backs-up because SB1 is at capacity.

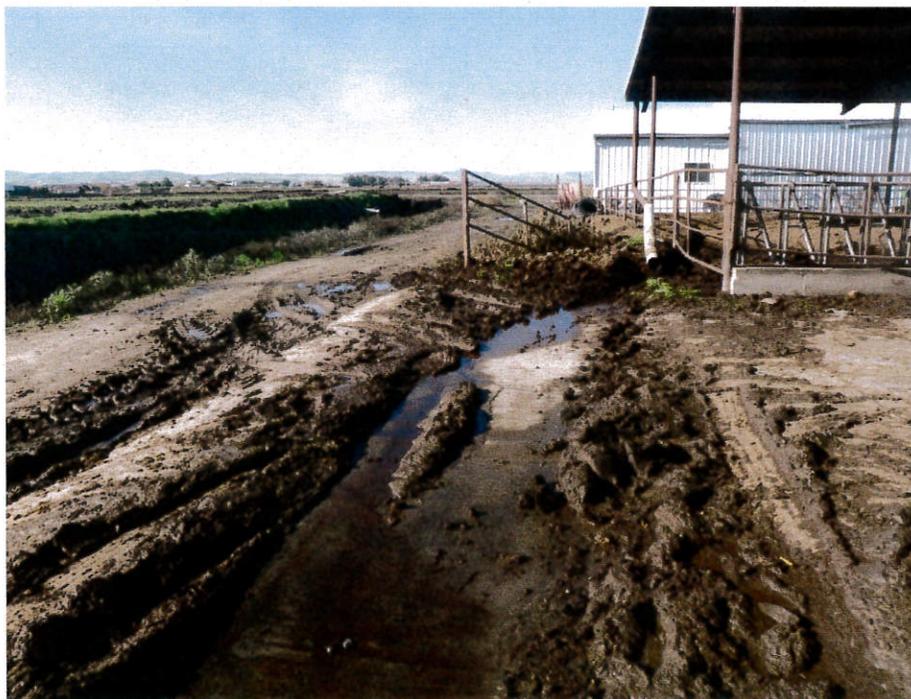
Photo 2: Same as Photo 1 but looking west. Note solid and slurry manure located both inside and outside the conveyance channel.

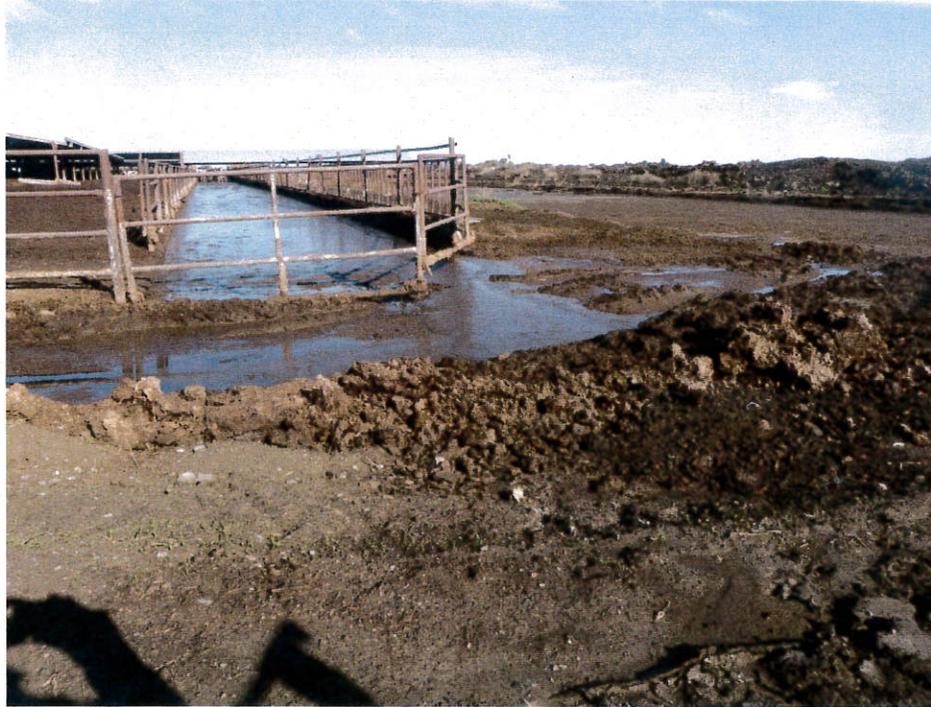
Photo 3: Looking northeast at the southwest corner of Settling Basin #1.

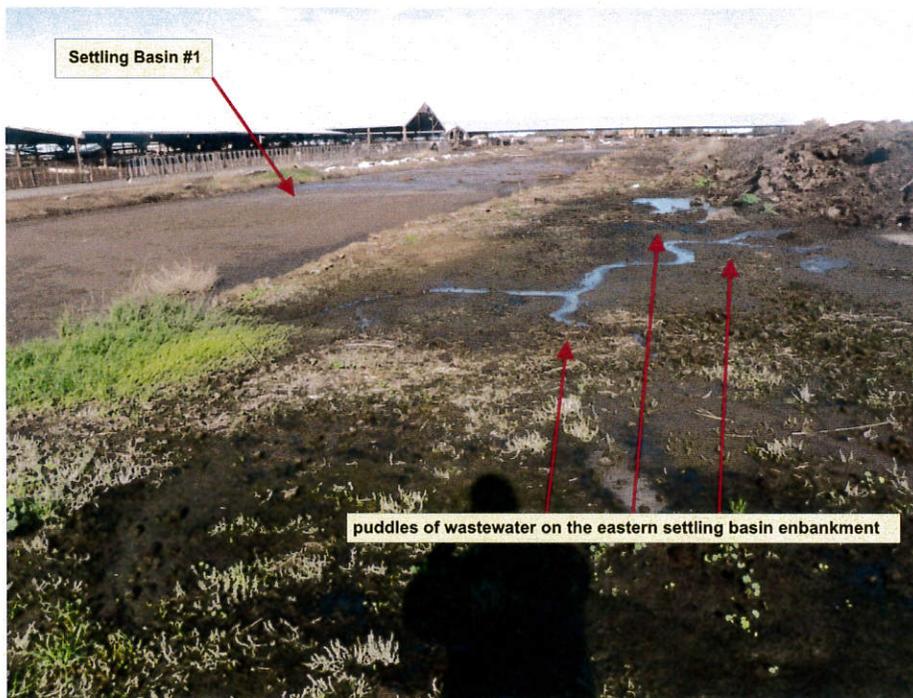
At the time of the inspection SB1 had approximately 1' of freeboard. Staff observed puddles of wastewater and wet soil on the east embankment of SB1 indicating wastewater had recently over-topped the embankment (Photo 4). It appeared to Water Board staff that a portion of the wastewater in SB1 had been transferred to the 3-4 acre slurry area (Photos 5-6). A large notch

Photo 4: Looking north at Settling Basin #1. Staff observed wet soil and puddles of wastewater on the eastern embankment of Settling Basin #1 (indicating recent over-topping).

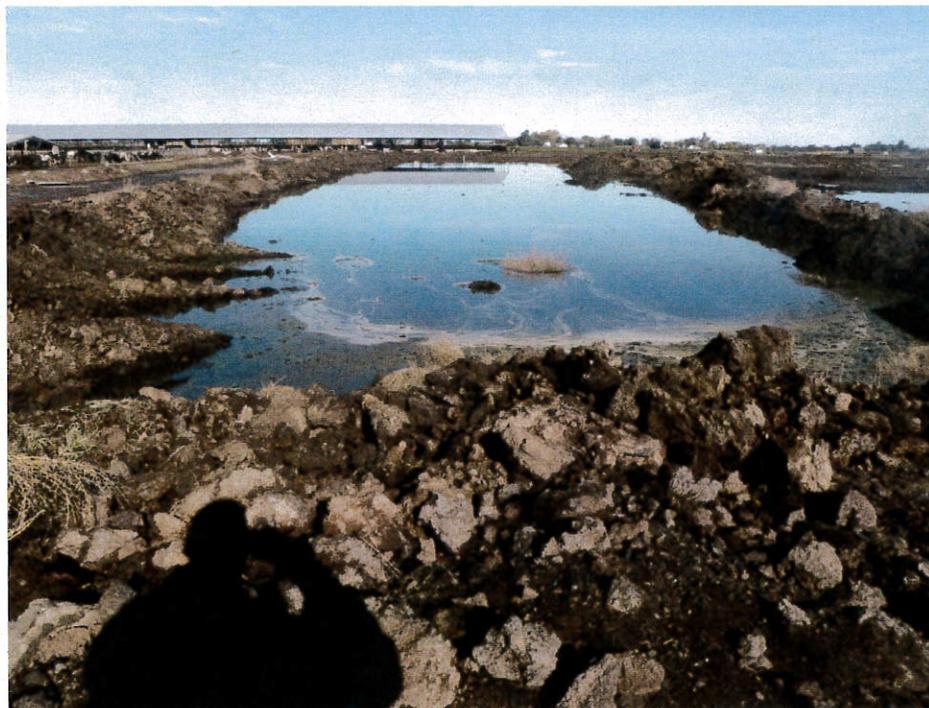
Photo 5: This is not a wastewater lagoon. Looking north at the 3-4 acre slurry area (underwater). It appears to staff that a significant amount of water was pumped from Settling Basin #1 into the 3-4 acre slurry area (now partially underwater). See Photos 6-7 for details.

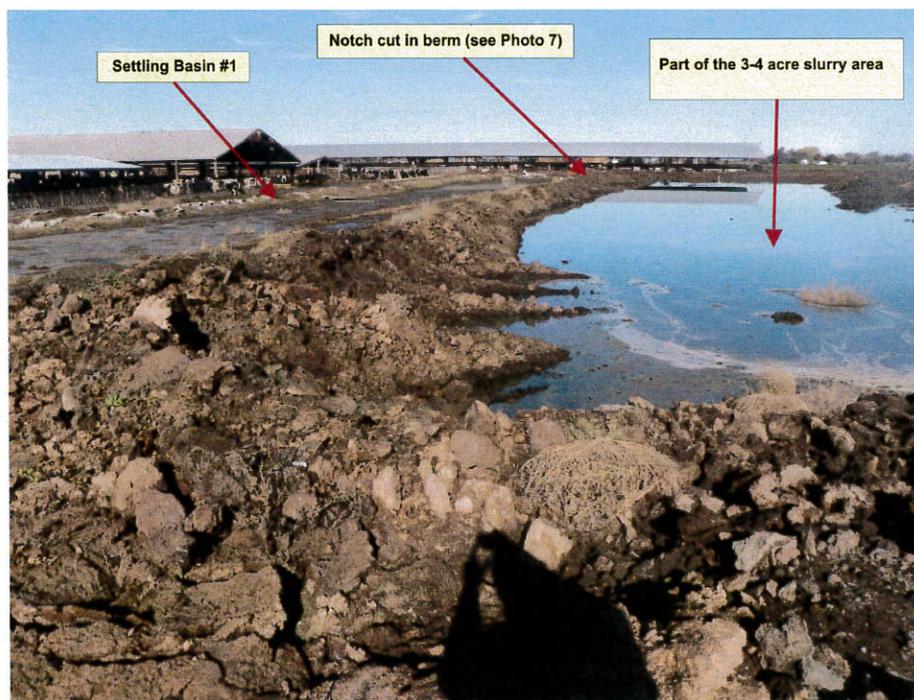
Photo 6: Looking north at Settling Basin #1 and the 3-4 acre slurry area. It appeared to staff that wastewater was moved from the settling basin to the slurry area.

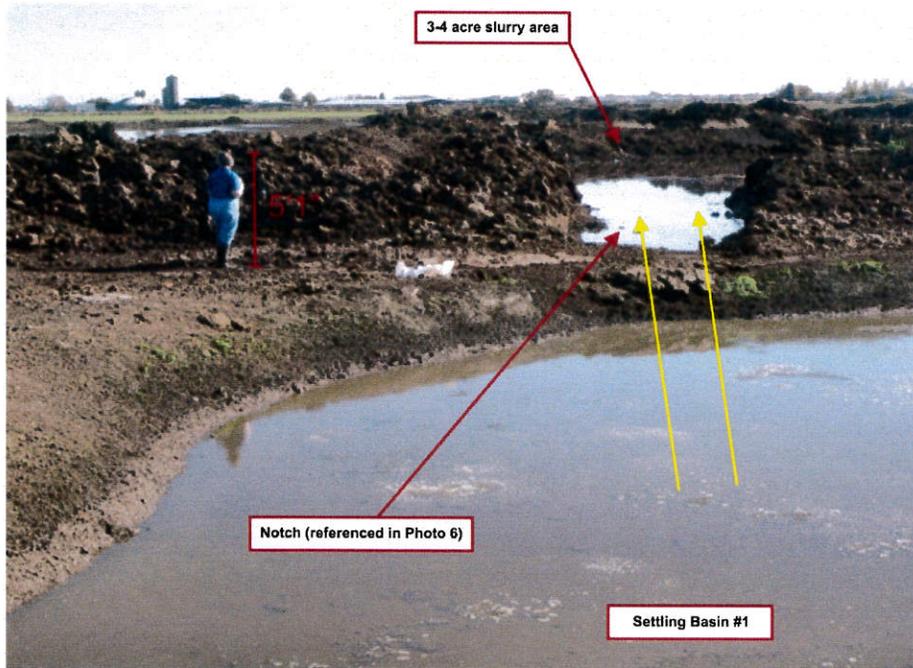
was cut into the manure berm that separates SB1 from the 3-4 acre slurry area; it appears the notch was used to facilitate the water transfer from SB1 to the 3-4 acre slurry area (Photo 7).

Photo 7: Looking east at the north-end of Settling Basin #1. It appears the large notch was cut and used to transfer water from the settling basin to the 3-4 acre slurry area (see Photo #5 and Photo #6). The yellow arrows indicate how water appears to have moved.

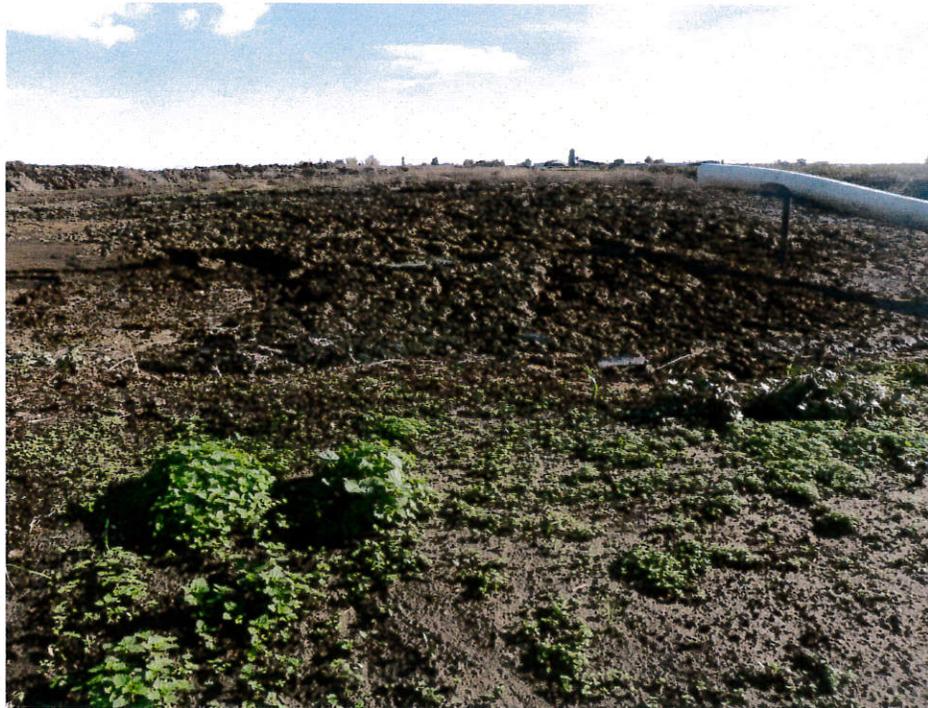
At the time of the inspection Settling Basin #2 (SB2) had less than 1' freeboard (Photo 8). The basin is designed to transfer wastewater to Wastewater Storage Lagoon #1 (L1) via an underground pipe. It appears since the west side of L1 is full of solid manure (Photo 10), or the transfer pipe is clogged, an earthen channel has been constructed at the east end of SB2/L1 by-passing the transfer pipe allowing the wastewater to flow directly to L1. At the time of the inspection, the above mentioned by-pass channel was blocked with a solid manure berm causing ponding inside the conveyance channel (Photo 9).

Photo 8: Looking east at the west-end of Settling Basin #2. Staff observed less than one foot of freeboard here.

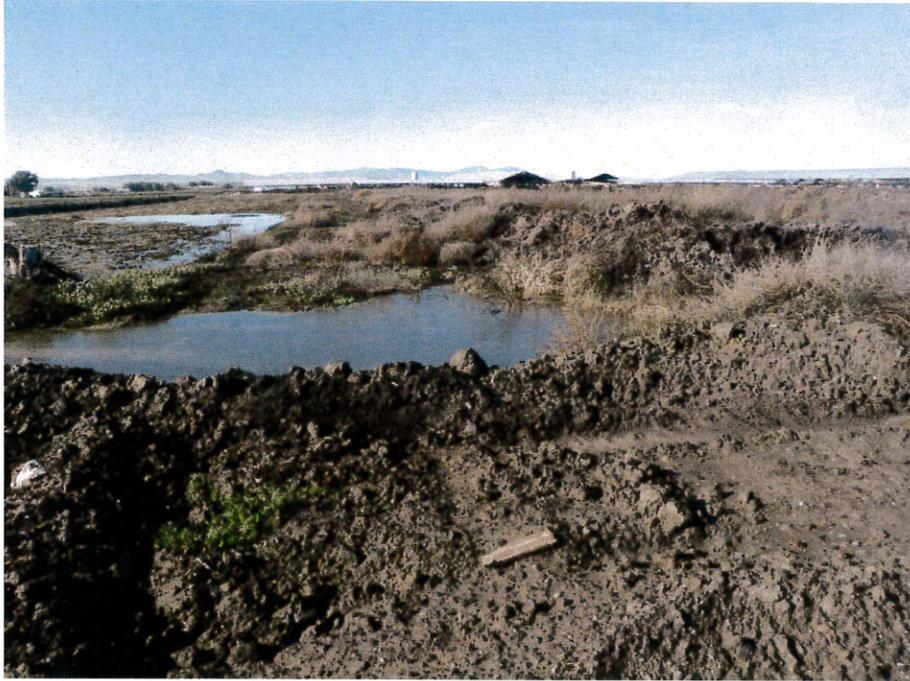
Photo 9: Looking west at the east-end of Settling Basin #2. Note fresh dirt berm in foreground of photo and ponded water in the center of the photo. Although wastewater is supposed to flow to Wastewater Lagoon #1 via gravity, the conveyance channel is blocked causing the ponding in the photo. It appears as water escapes Settling Basin #2 impromptu berms are erected attempting to control/contain the water.

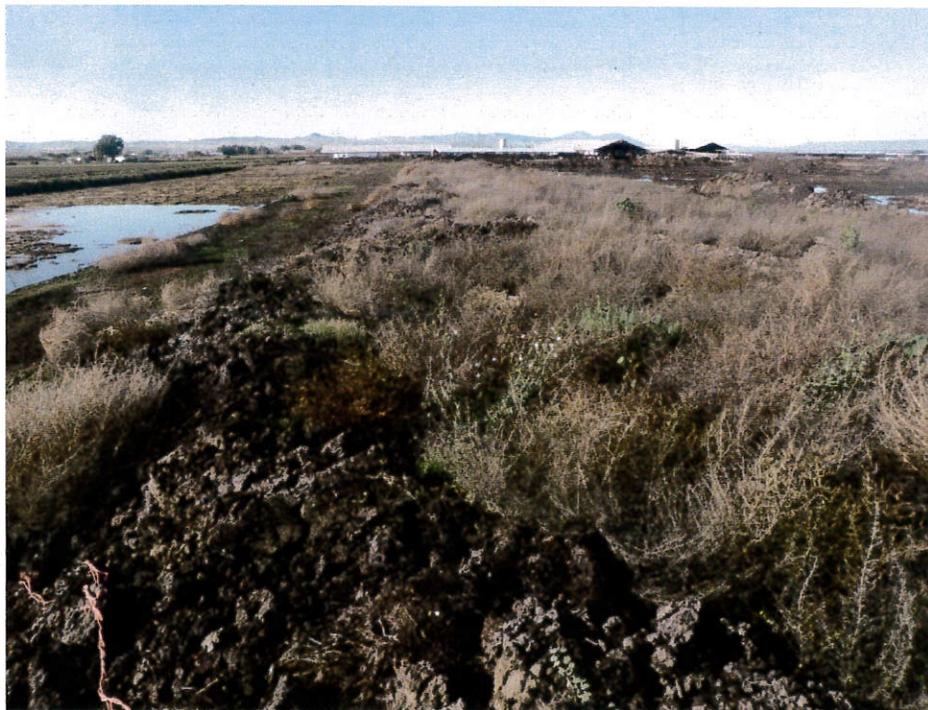
Photo 10: Looking west at Wastewater Lagoon #1 (L1). A significant amount of solid manure is contained in L1. The eastern embankment of L1 has been constructed with manure (see Photo 11).

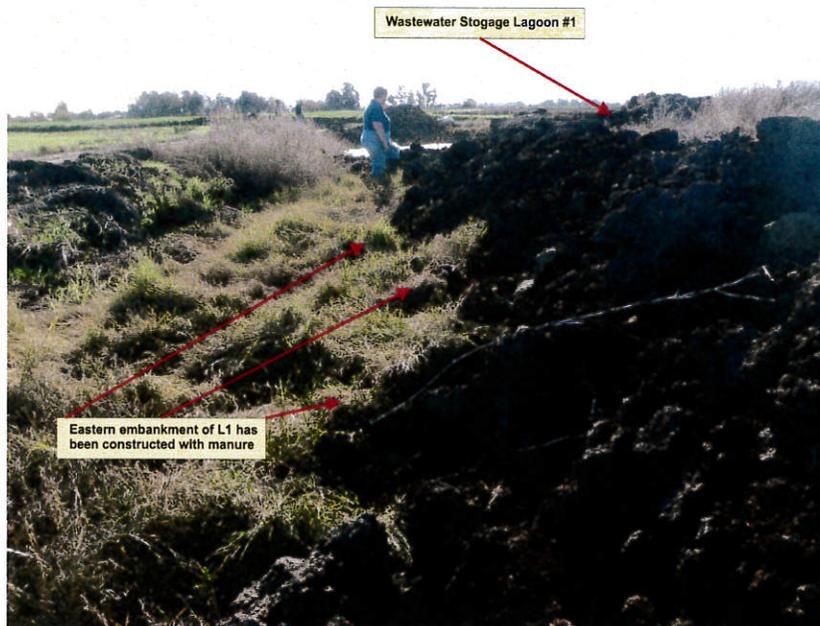
At the time of the inspection the eastern end of L1 was full of solid manure. Also the eastern embankment of L1 was constructed with solid manure (Photo 11).

Photo 11: Looking southwest at the east end of L1; the eastern embankment has been constructed with manure

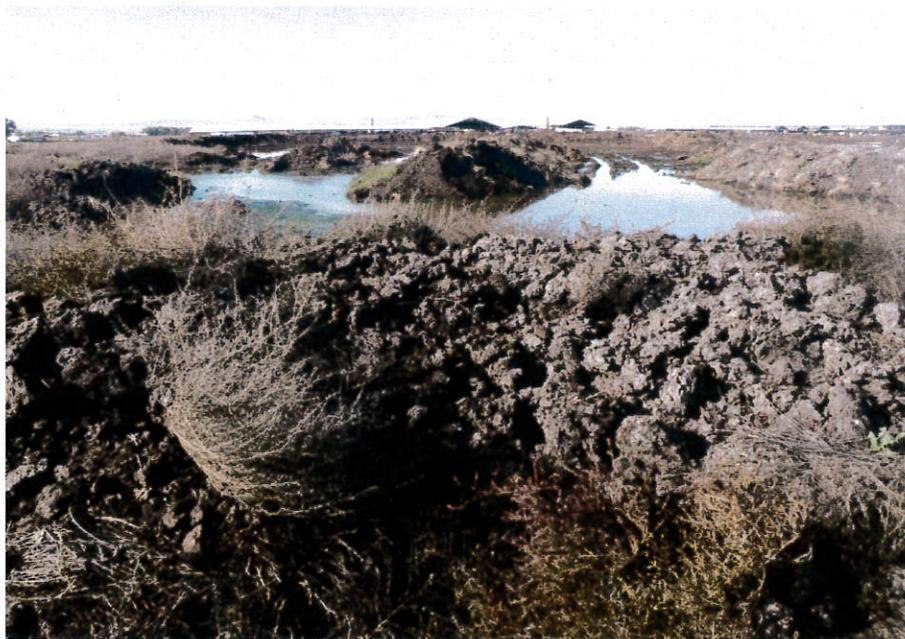
L1 contains significant amounts of windrowed solid manure and process wastewater (Photos 12-13).

Photo 12: Looking west at Wastewater Lagoon #1 (L1). Significant amounts of solid manure and wastewater remain in the lagoon. Wastewater is transferred through a notch cut in the east end of the embankment separating the lagoons – not at the location shown on the WMP map.

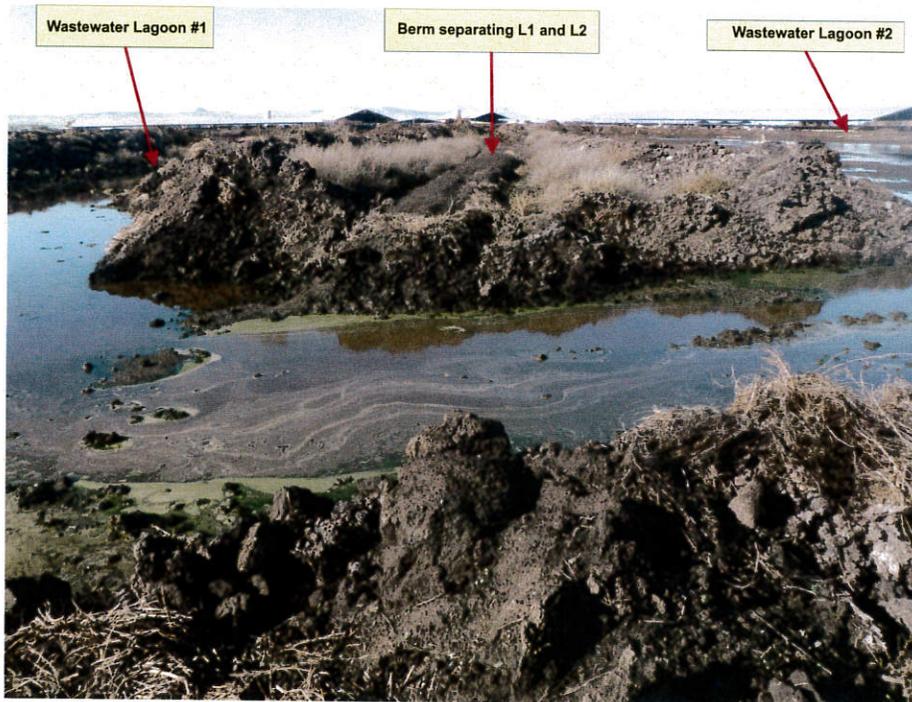
Photo 13: Looking west at Wastewater Lagoon #1 and Wastewater Lagoon #2. Significant amounts of solid manure and wastewater remain in both lagoons. Staff wanted to inspect the berm separating the lagoons for damage but it wasn't accessible at the time of the inspection.

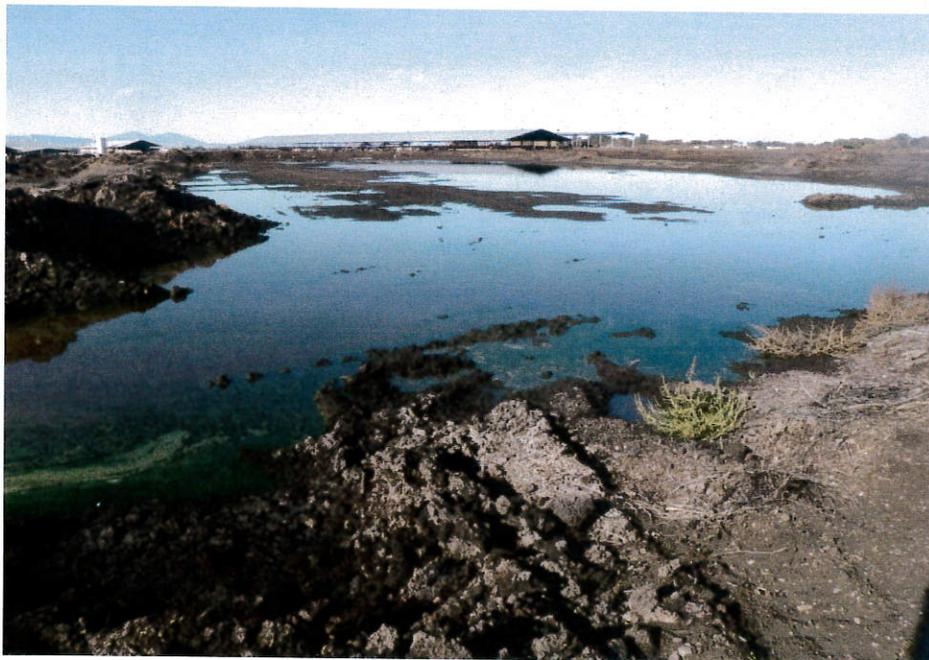
Wastewater Storage Lagoon #2 (L2) contains solid manure and process wastewater. A notch has been cut into the west berm of L2 and L4 (Photos 13-14, 16).

Photo 14: Looking west at Wastewater Lagoon #2. Wastewater and solid manure remain in the lagoon.

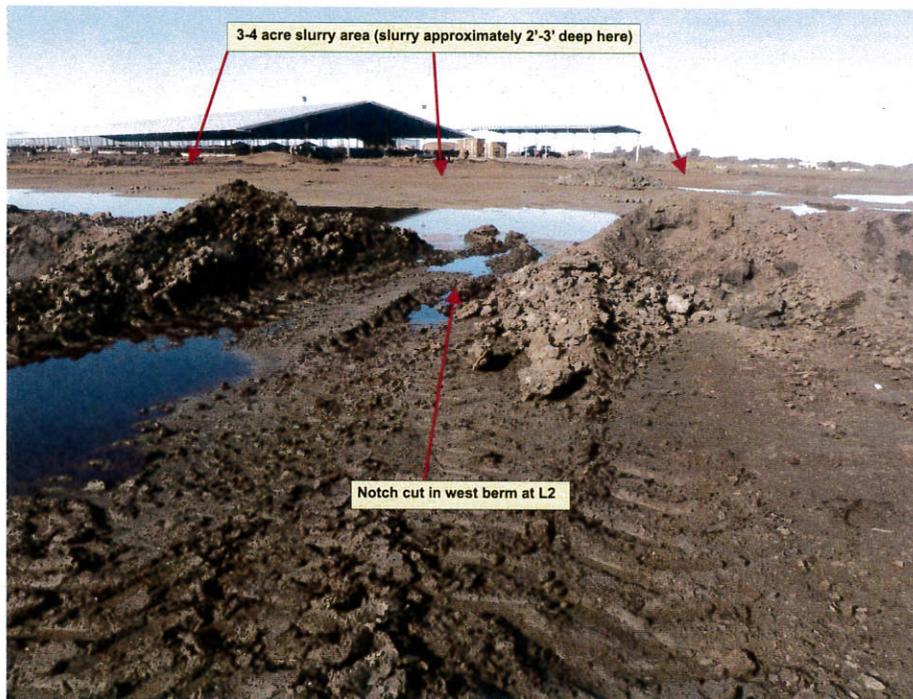
Photo 16: Looking west at the 3-4 acre slurry area that was underwater at the time of the inspection. See Photo 17 for a close-up of the same area. A similar notch was cut into the west berm of L4.

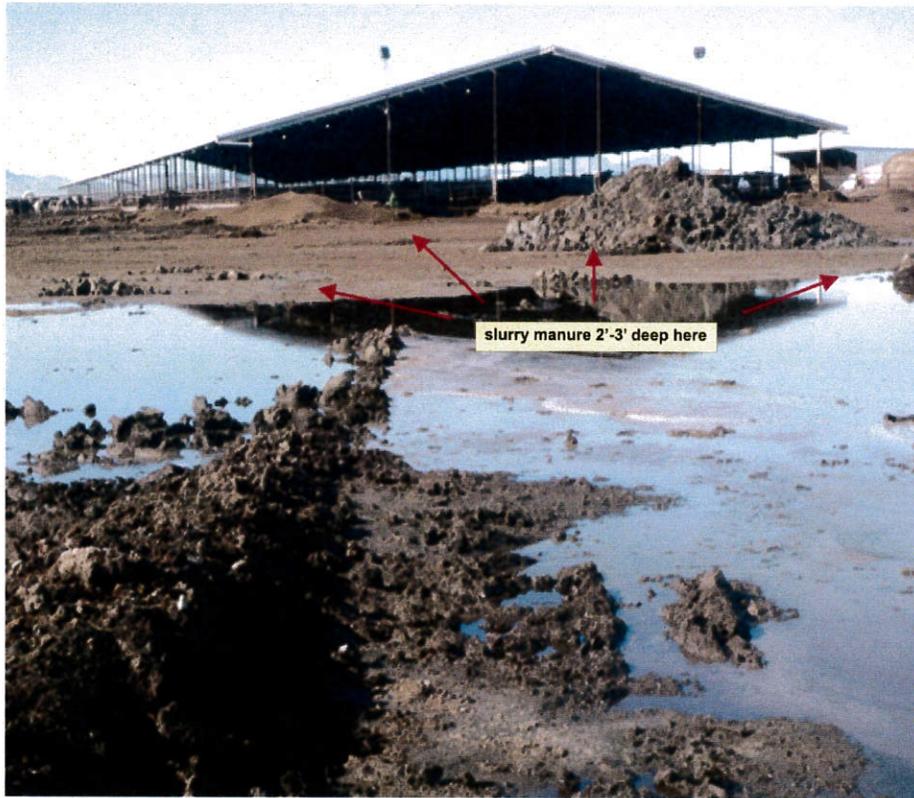
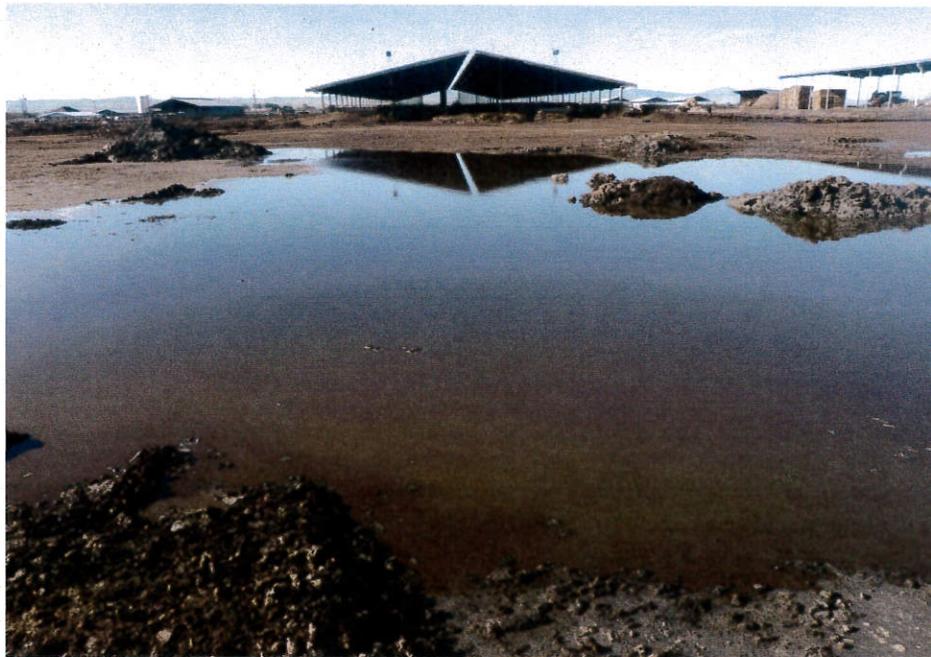
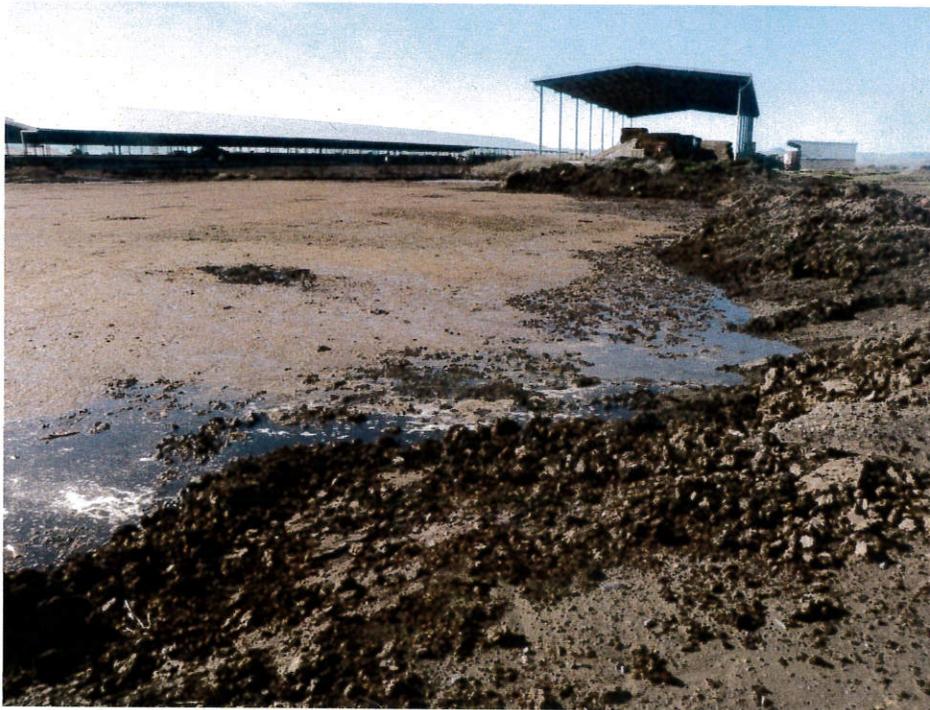
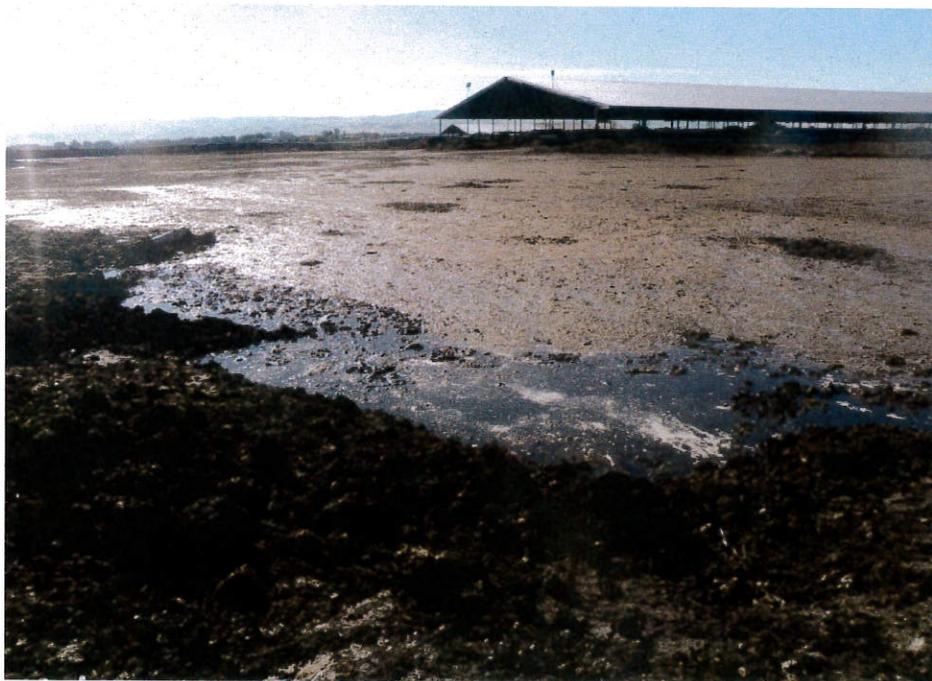
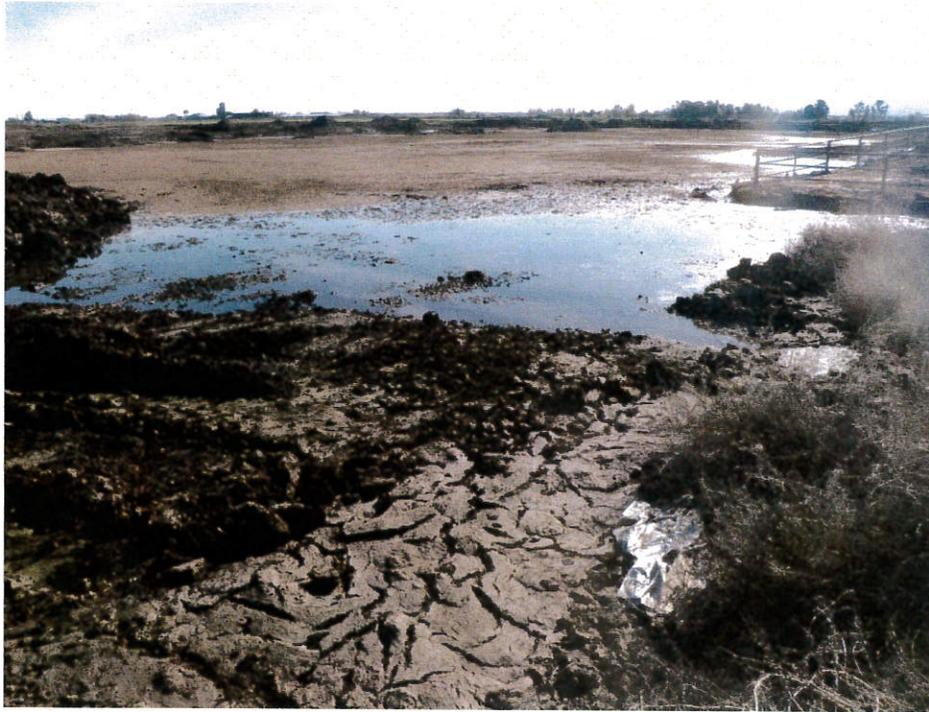
The 3-4 acre slurry area contains a significant amount of solid manure, slurry manure, and process wastewater, and is still being used to store waste (Photos 16-21). The freestall barn that contains the milking-cows is still being scraped into the slurry area; the northern corral located south of the silage pit drains directly to the slurry area (Photo 22); the silage pit ultimately drains to the slurry area (Photo 23); and it appears the milk-barn wash out ultimately drains to the slurry area. Additionally, in order to increase freeboard at SB1 it appears a significant amount of wastewater was transferred from SB1 to the 3-4 acre slurry area (Photos 5-7).

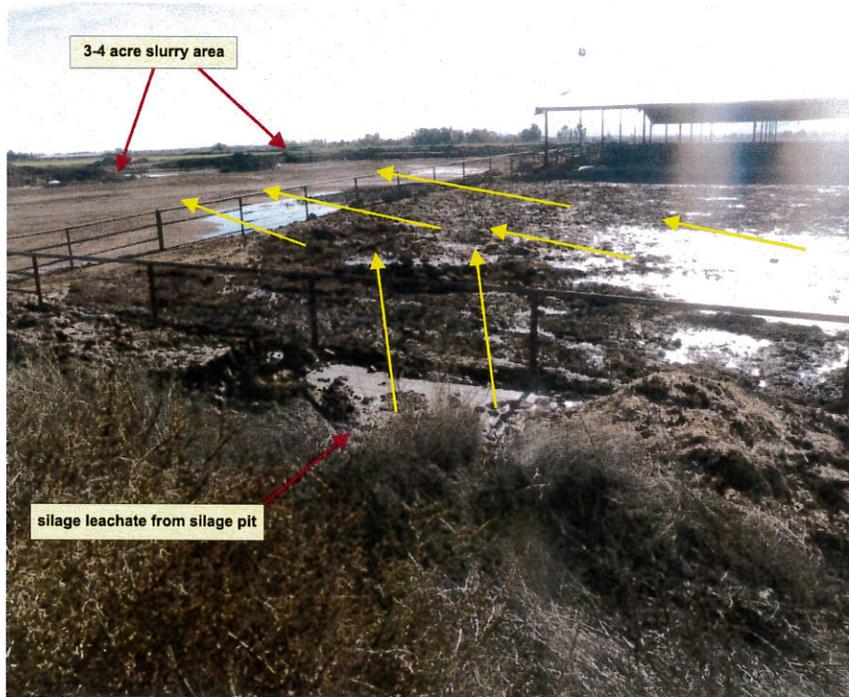
The corral south of the silage pit contains a significant amount of slurry manure and process wastewater (Photo 24) and is not contained. The corral run-off flows east discharging out of the corral and ponding in the 3-4 acre slurry area (Photo 22-23).

Photo 22: Looking southeast at the corral located on the northern perimeter of the production area; and beyond the corral the 3-4 acre slurry area. Corral run-off and leachate from the silage pit flows through the corral and into the 3-4 acre slurry area; the run-off does not flow to a basin designed to store wastewater. The yellow arrows indicate direction of flow.

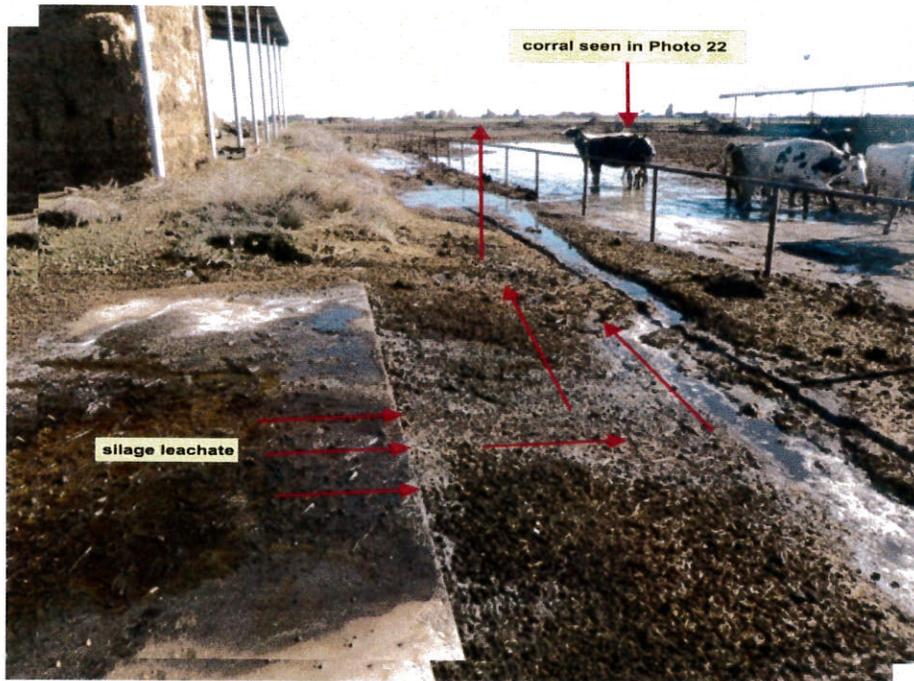
The silage is located on a concrete slab. All silage leachate flows south off the slab and into an earthen lined channel that conveys the leachate east before flowing southeast through a corral ultimately ponding in the 3-4 acre slurry area (Photos 22-23).

Photo 23: Looking east at the earthen channel that conveys silage leachate directly to the corral pictured in Photo 22; the silage leachate appears to ultimately flow directly to the 3-4 acre slurry area after discharging from the corral.

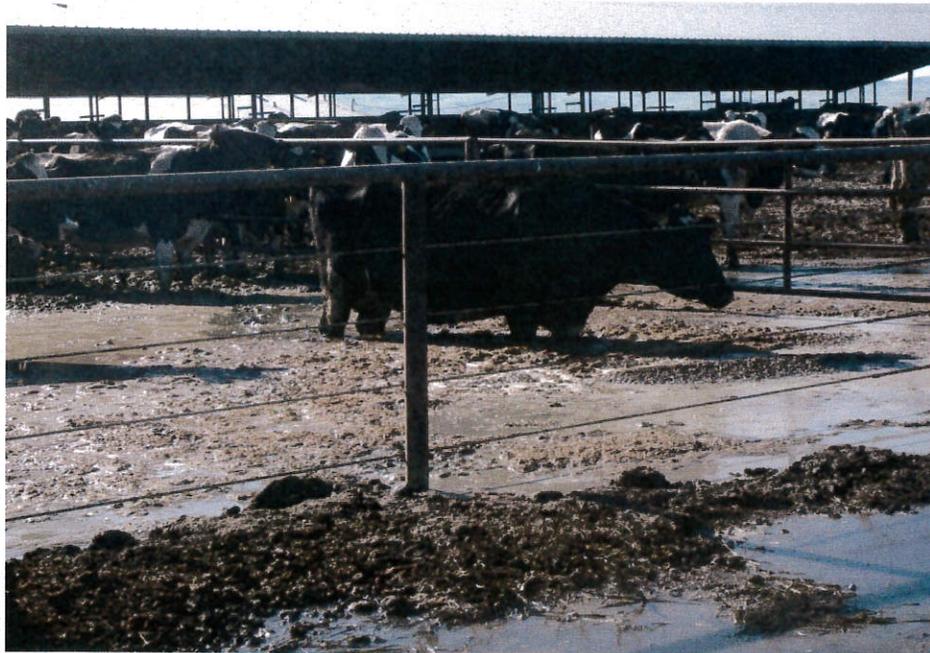
Photo 24: Same corral as seen in Photo 22 and Photo 23.

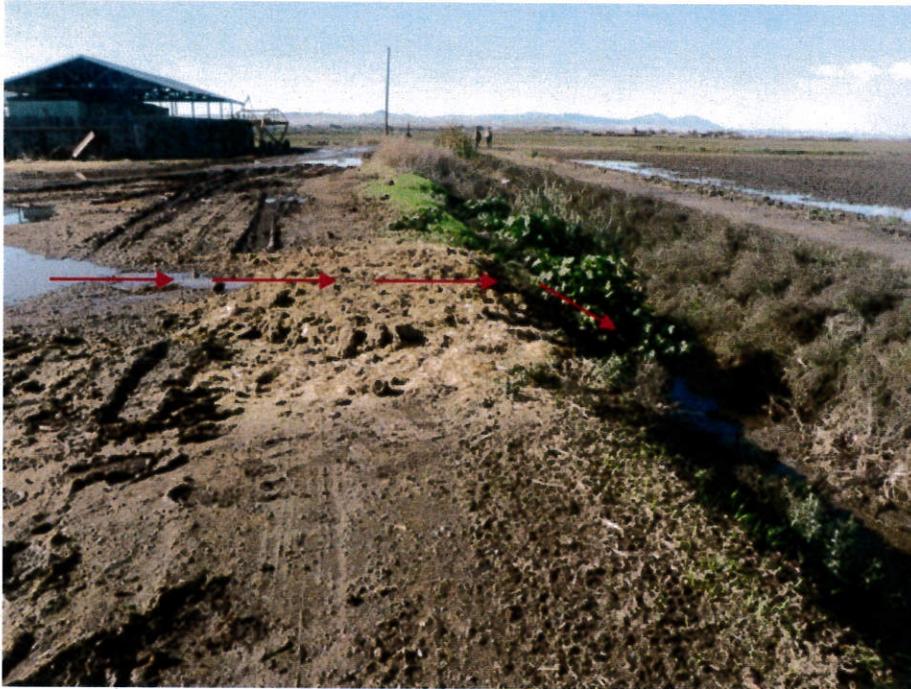
Staff observed a point of discharge immediately west of Monitoring Well #3 at the northern perimeter of the production area (Photo 25). It appears a berm was breached allowing wastewater/silage leachate to discharge north into a cropland field drain that has the ability to

convey water off-property. The breach had been patched with dirt and hay (Photo 25). The water in the ditch immediately adjacent to the breach/patch was dark brown in color (electrical conductivity = 5,985 $\mu\text{s}/\text{cm}$, pH = 7.86, and temperature = 12.5° C). Large puddles of wastewater in the immediate area further indicate the discharging waters was process wastewater from the dairy.

Photo 25: Looking west down the northern perimeter of the production area. The red arrows indicate how water flowed through the breach in the berm and into the cropland field drain.

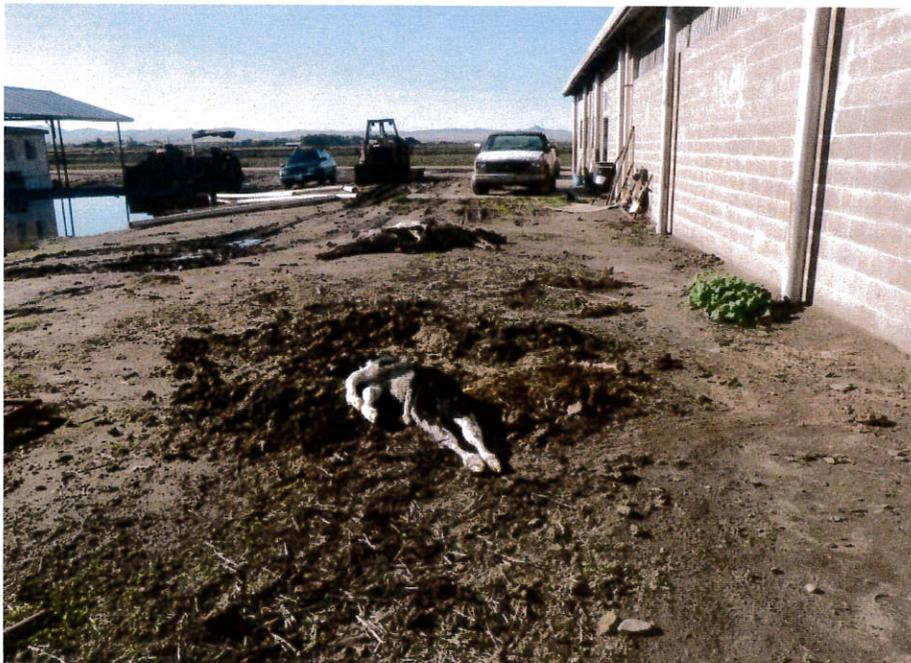
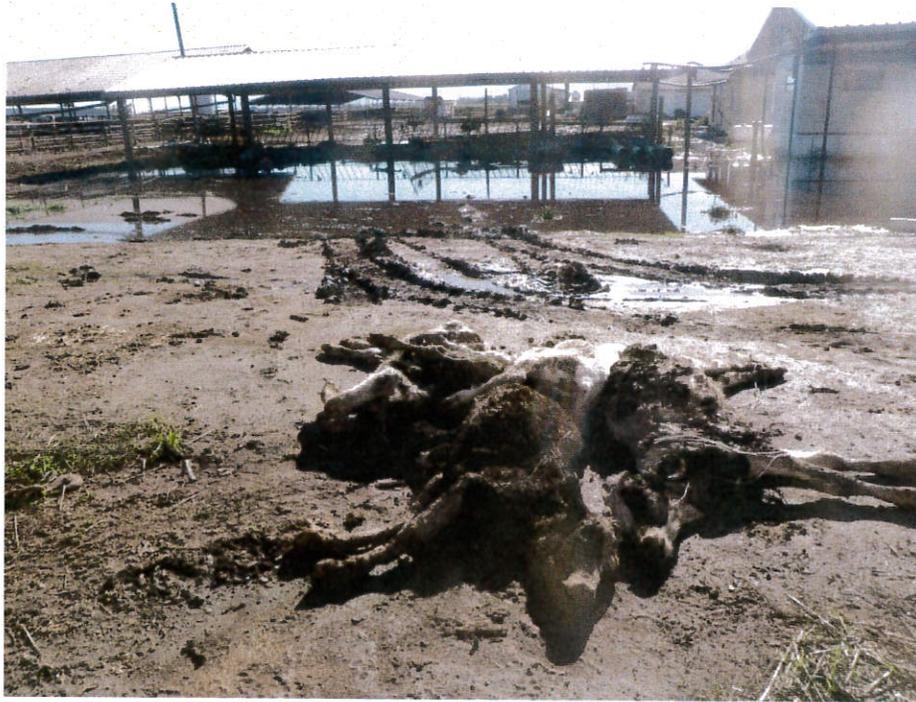
Several dead animals were observed north of the milk barn out of site from the road and placed behind several pieces of equipment. It didn't appear to staff that the dead animals were staged where a rendering company would be able to access and remove the dead animals. (Photos 26-28).

Photo 26: Dead cows adjacent to the Tosta Dairy milk barn.

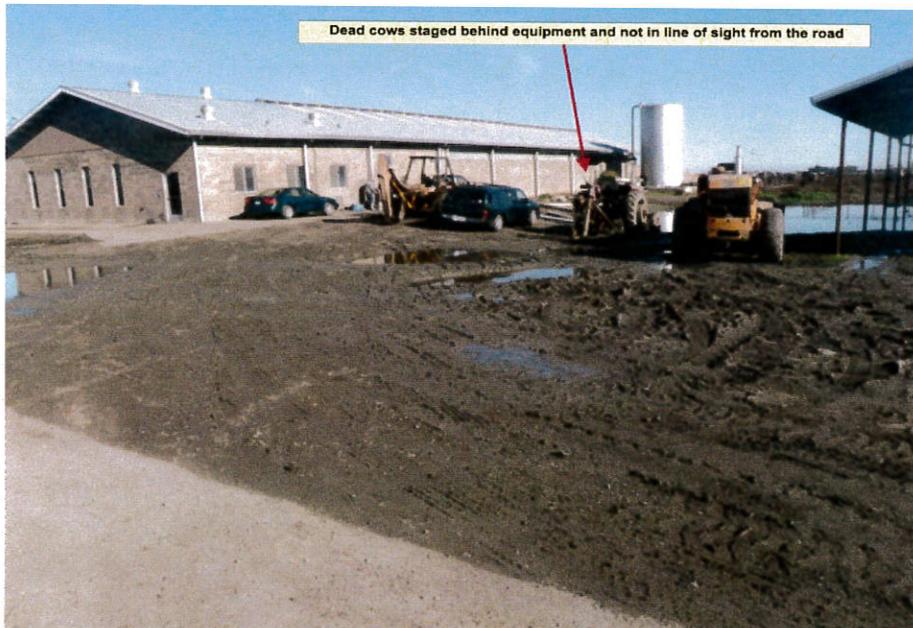
Photo 28: Looking east at the Tosta Dairy milk barn. The dead animals are staged behind the equipment and not in line of sight from the road; it appears to staff these animals are not being staged for rendering.

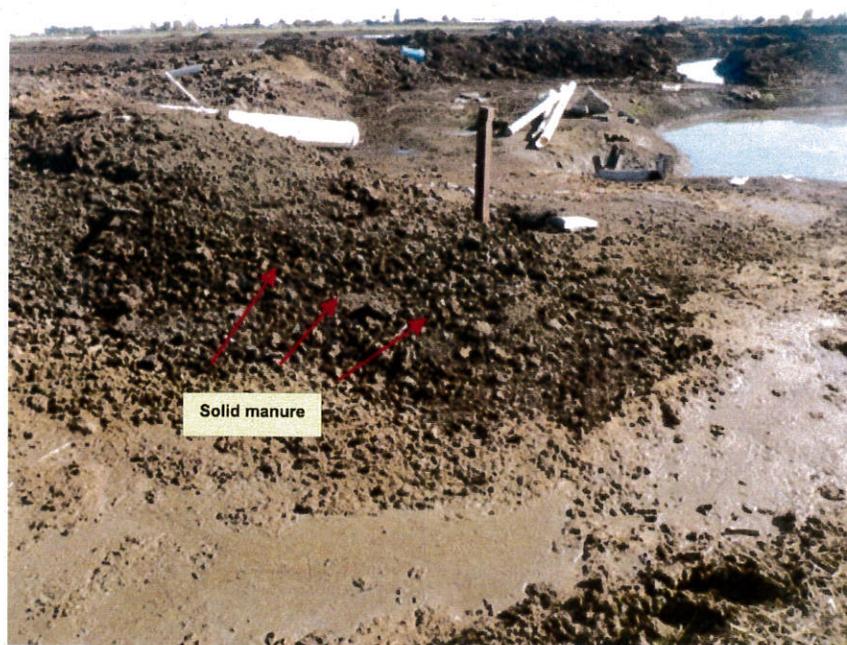
Monitoring Well #2 is located in the central portion of the production area immediately north of SB1. Significant amounts of solid manure are located on top of and surrounding the well. In previous inspections staff has observed a bobcat deposit slurry manure just northwest of the well (Photos 30-32).

Photo 30: Looking east at Monitoring Well 2; note solid manure surrounding the well. See Photo 31 for a close-up.

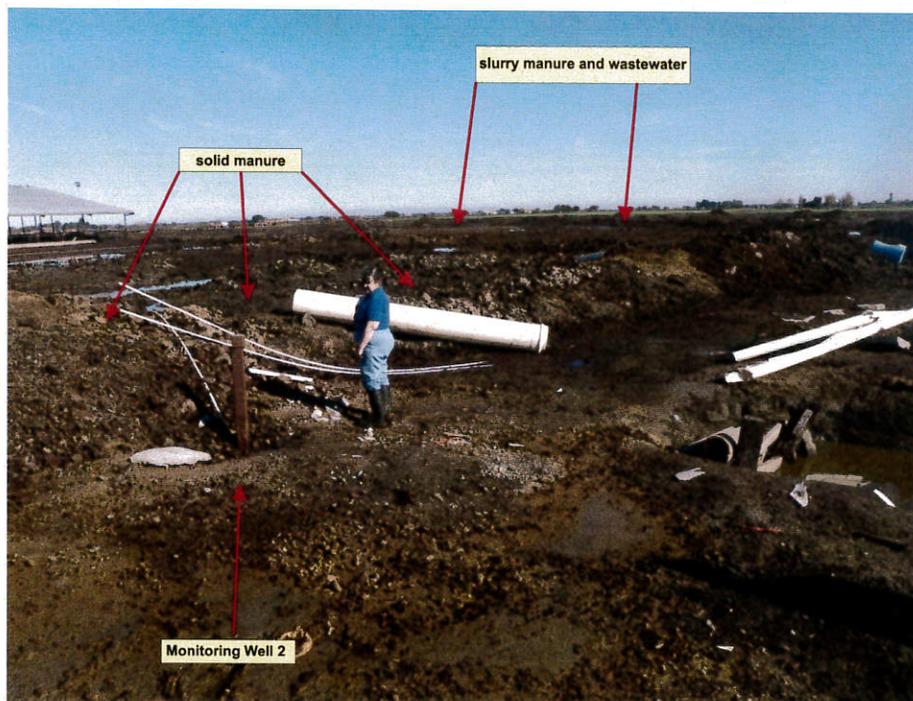
Photo 32: Looking east at Monitoring Well 2 and in the background the 3-4 acre slurry area which contains a significant amount of solid manure, slurry manure, and process wastewater.

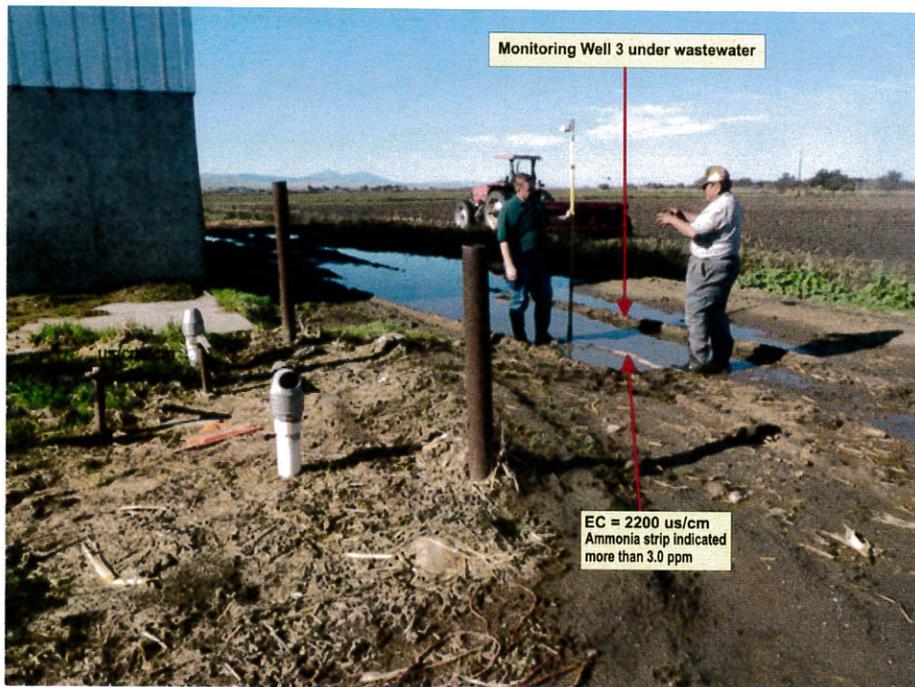
Monitoring Well #3 is located at the northern perimeter of the production area north of the silage pit. At the time of the inspection Monitoring Well #3 was under wastewater with an electrical conductivity = 2200 $\mu\text{s}/\text{cm}$; an ammonia strip indicated ammonia was more than 3.0 ppm (Photos 33-35).

Photo 33: Looking northwest at Monitoring Well #3, which at the time of the inspection was under process wastewater.

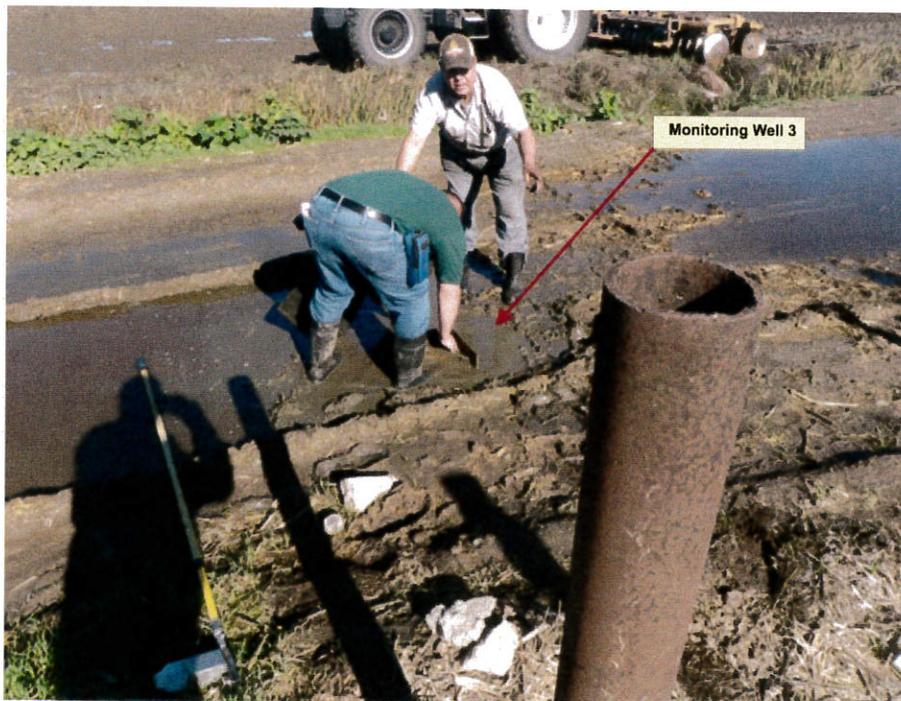
Photo 35: Looking at the slurry manure and wastewater that is covering Monitoring Well 3.
