August 4, 2010  
File No.: 77754-2

Re: Dellar Property Landfill Final Cover Reconfiguration  
Sacramento, CA

Figure 1 – Site Photographs

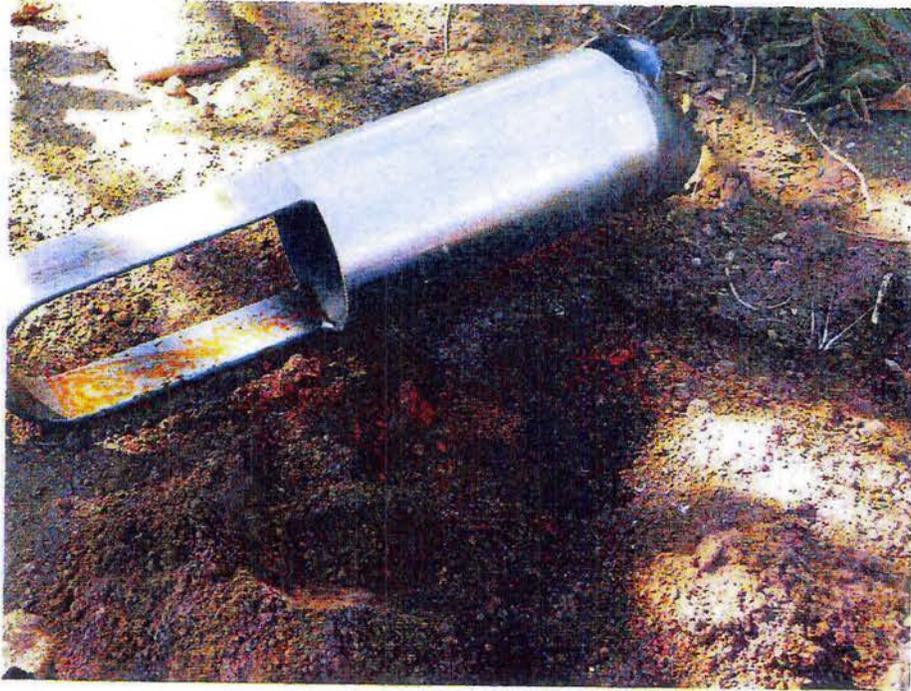
Hand auger borings advanced to a depth of 2 feet near the Elderberry plants falling within the footprint of the proposed final cover encountered debris at locations EB-4 and EB-5. Borings at the remaining locations (EB-1 through EB-3, and EB-6 through EB-9) encountered either no waste or trace amounts. The soil type encountered in the borings was primarily silty sand.

Brick and Wood Debris at EB-5 Boring

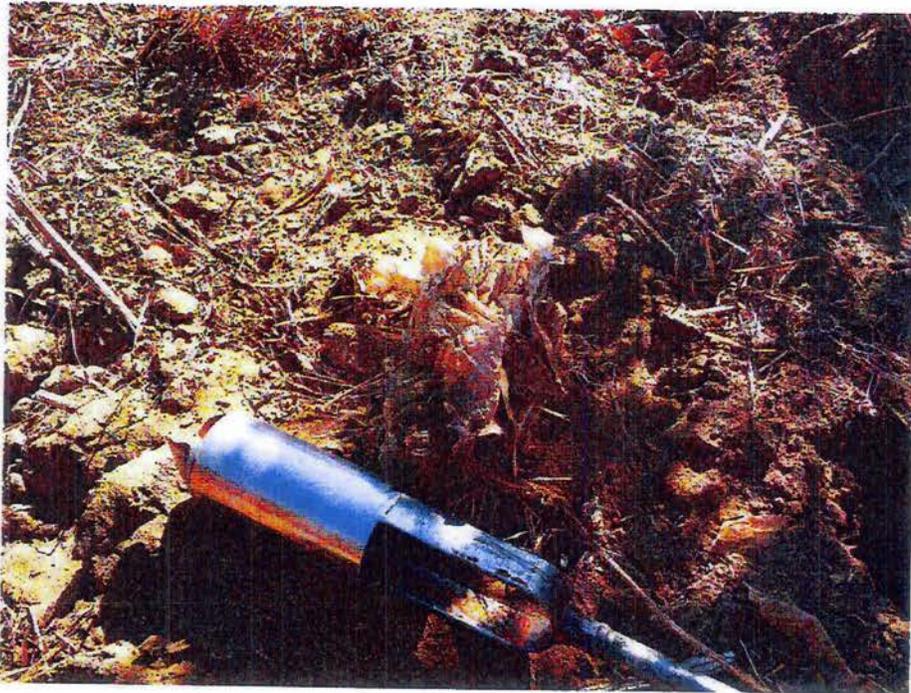
Plastic Debris at EB-7 Boring
