Central Valley Regional Water Quality Control Board

TRANSMITTAL OF SITE INSPECTION REPORT; RECOLOGY YUBA-SUTTER LANDFILL, MARYSVILLE, YUBA COUNTY

INSPECTION REPORT

FACILITY NAME: Recology Yuba-Sutter Landfill

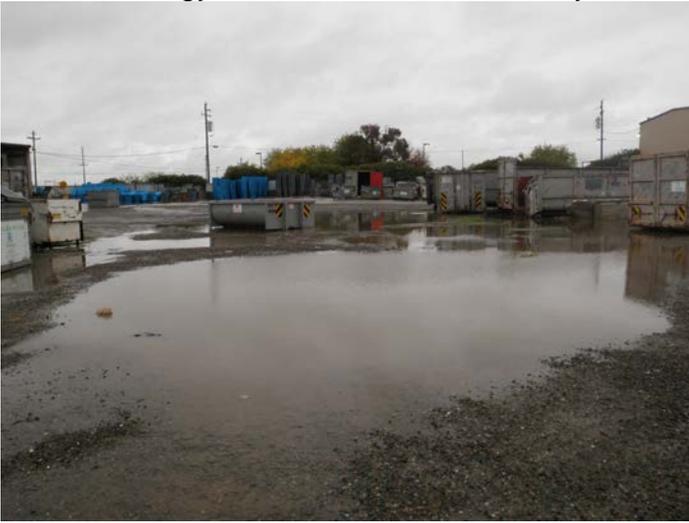
Photo# 1 shows standing water in an area west of the Integrated Waste Recovery Facility. This area is on top the final closure cover placed over the unlined LF-1 WMU. This area did not appear to be graded properly to prevent standing water. Title 27 Section 21090(b)(1)(A) requires a minimum 3% slope over a landfill closure cover to discourage standing water unless adequate alternative means of drainage can be shown per Section 21090(b)(1)(B). Figure 3 of a report submitted by Golder Associates dated 12 November 2012 (*12 Nov 2012 Golder Report*) does not show adequate drainage in this area to warrant slopes less than 3%.

9. Settling and ponding over closed landfill shall be repaired expeditiously to maintain proper drainage per Title 27 §21090(a)(4)(C) and §21090(c)(1). Photos# 1, 4, 15, 19, 23, 24-26 show ponding above the LF-1 final closure cover that has not been repaired prior to the rainy season.

Photo# 1 - Standing water in an area west of the Integrated Waste Recovery Facility (IWRF)

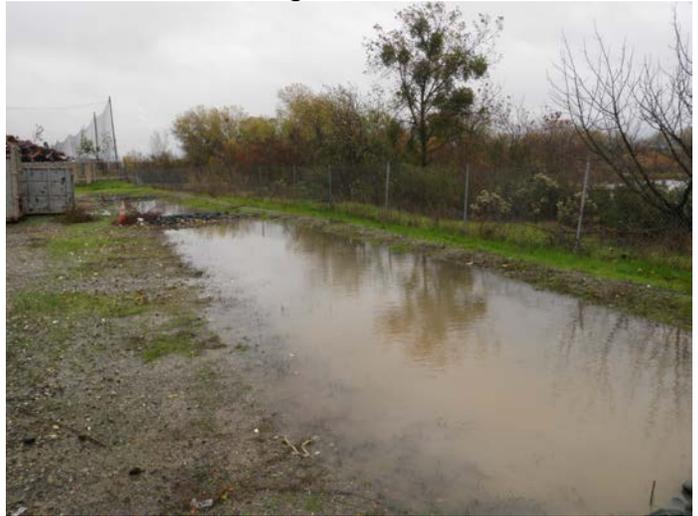
Photos# 2-3 show a storm water drainage collection ditch south of the scrap metal yard. This standing water is also on top the final closure cover over LF-1. It is unclear why Recology has placed dams in this drainage ditch, allowing storm water to collect and percolate through the closure cover into the underlying refuse.

Photo# 2 - Storm water drainage collection ditch south of the scrap metal yard

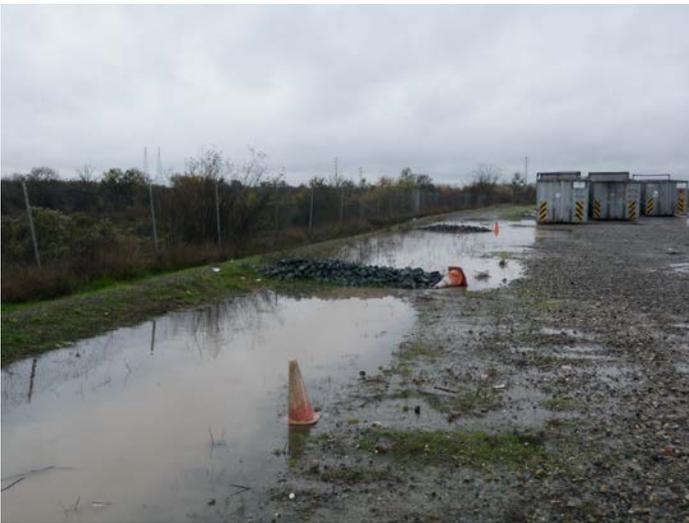
Photo# 3 - Storm water drainage collection ditch south of the scrap metal yard

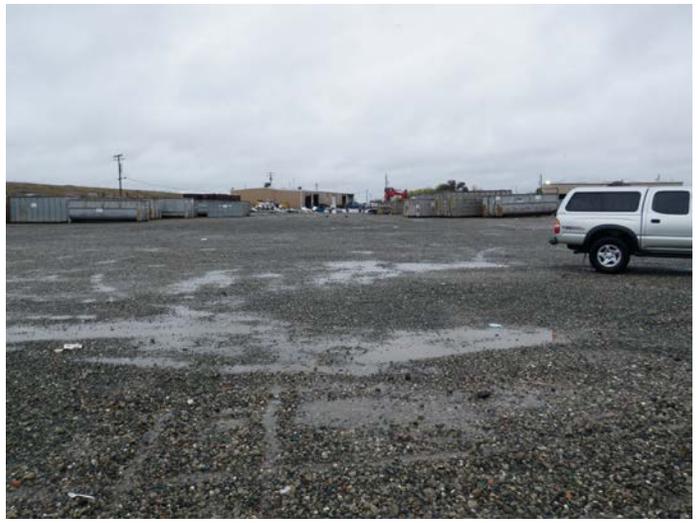
Photo# 4 shows the compacted gravel area in the metal scrap yard. Recology was asked whether the gravel material used in this area was engineered to provide a low hydraulic conductivity barrier above the final closure cover. The response was that no special materials or process was used in this area to ensure low hydraulic conductivity. This area was also noted to have slopes that appeared to be less than 3% and does not appear to have alternative means of drainage as indicated in the *12 Nov 2012 Golder Report*.

Photo# 4 - Compacted gravel area in the metal scrap yard

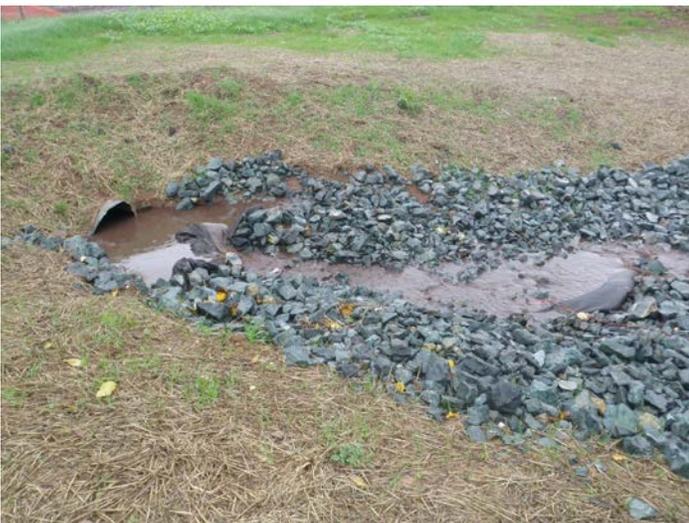
Photo# 5 shows the discharge of storm water that drains the chip and grind area identified on the SWPPP map in Attachment 3. The discharge could be characterized as a dark red/brown soup-like liquid. This discharge was sampled (See Photos# 19-21 description for details) at the entrance to the culvert shown in Photo# 5.

Photo# 5 - Discharge of storm water that drains the chip and grind area

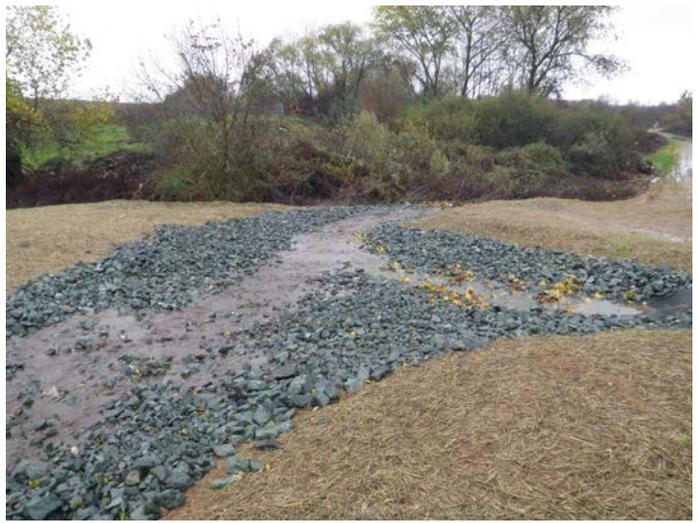
Photo# 6 shows the confluence of the discharge of storm water in Photo# 5 and Photo# 7. This confluence occurs outside of the fenced landfill area. This photo shows the stark difference in water quality between storm water coming from the chip and grind area on the left of the photo (red/brown soup-like liquid) and storm water (clear with some light brown sediment load) coming from the Material Recovery Facility shown on the right of the photo.

Photo# 6 - Confluence of the discharge of storm water in Photo# 5 and Photo# 7. This confluence occurs outside of the fenced landfill area

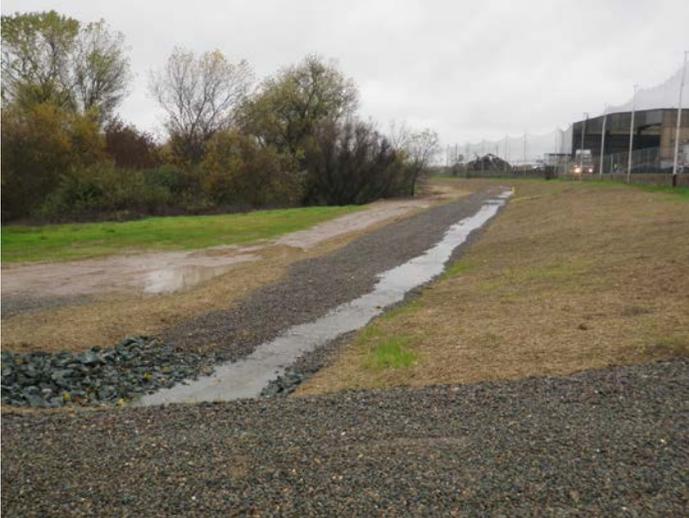
Photo# 7 is described in Photo# 6. The storm water appearance was clear with some light brown sediment load. It appeared as one would expect storm water to appear exiting an industrial facility.

Photo# 7 – Same location as Photo #6. The storm water appearance was clear with some light brown sediment load

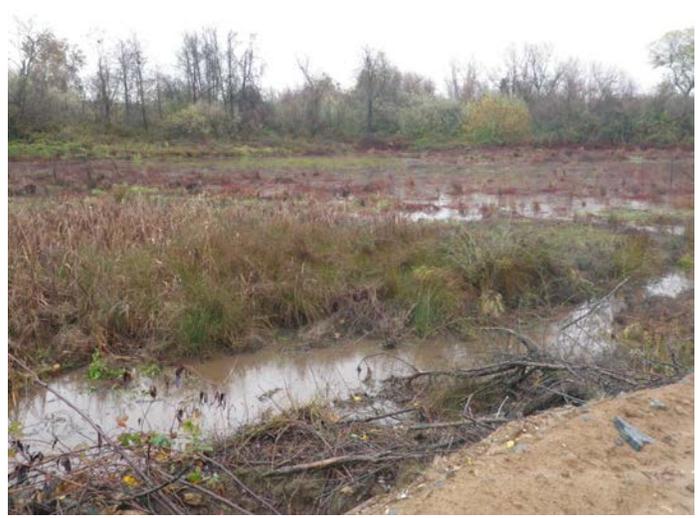
Photos# 8-9 show the storm water discharges shown in Photo# 6 discharging into the Storm Water Storage Pond (Also called Big Pond on the SWPPP map). This pond is located within the Yuba River flood plain. FEMA map 06115C0345D identifies this area within the 100-year flood zone. We observed that a huge diameter culvert that had connected the pond to the Yuba River flood plain had been recently removed. The Recology stated that the surface water hydraulic connection through the culvert was removed because of ongoing litigation with the California Sportfishing Protection Alliance (CSPA) over their NPDES industrial storm water permit.

5. Designated waste shall be placed in a minimum Class II surface impoundment per Title 27 §20210. Photos# 8-9 shows an unlined pond that accepts waste with elevated levels of pollutants from the composting facility.

Photo# 8 - Shows storm water discharges shown in Photo# 6 discharging to Storm Water Storage Pond

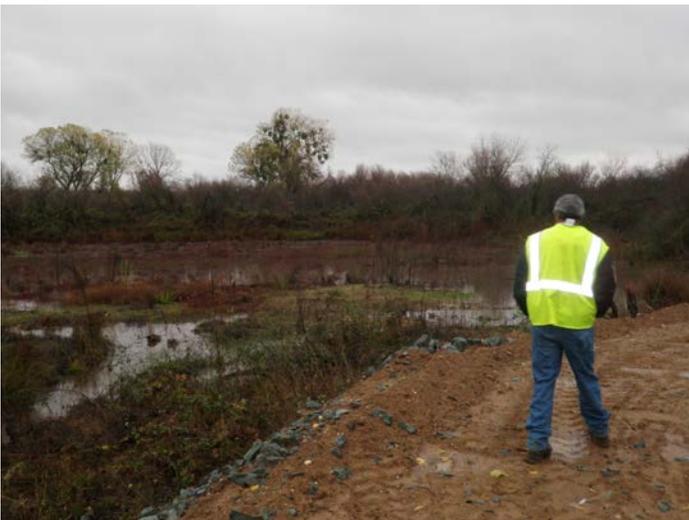
Photo# 9 - Shows storm water discharges shown in Photo# 6 discharging to Storm Water Storage Pond

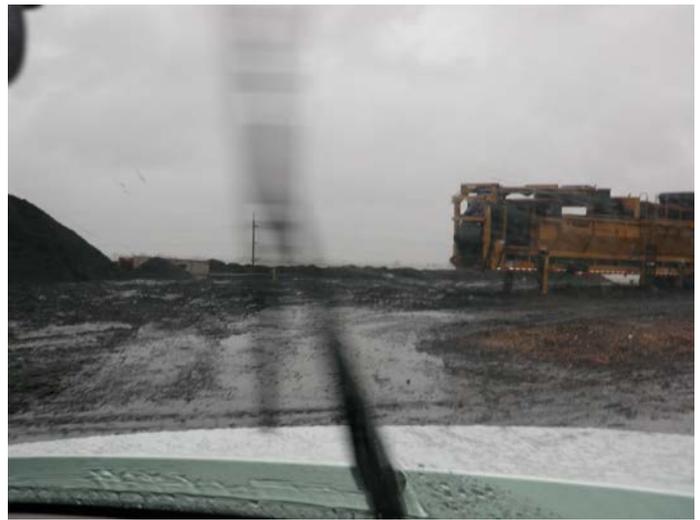
Photo# 10 shows the entrance to the chip and grind area. This is where the public can enter to drop off green waste. The entrance area had severe settling and ponding.

Photo# 10 - Entrance to the chip and grind area where the public can proceed to drop off green waste.

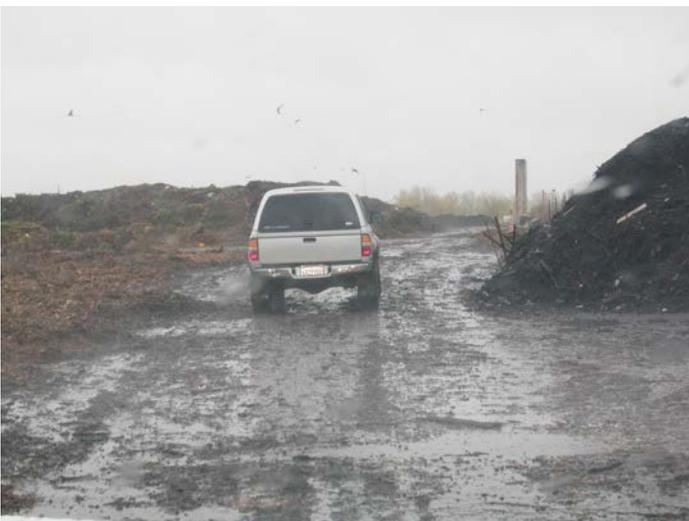
Photos# 11-14 show the active composting area. Photos 12-14 were taken from the road along the LF-2 WMU looking north-westerly down the rows of composting material. The photos show ponding. Leachate from the composting piles flows away from where the pictures were taken towards Levee Road. The leachate is then directed towards the Hog Farm Area as shown on the SWPPP map. This is where it is disposed of as shown in Figure 2b of the SWPPP map.

Photo# 11 – Road through active composting area

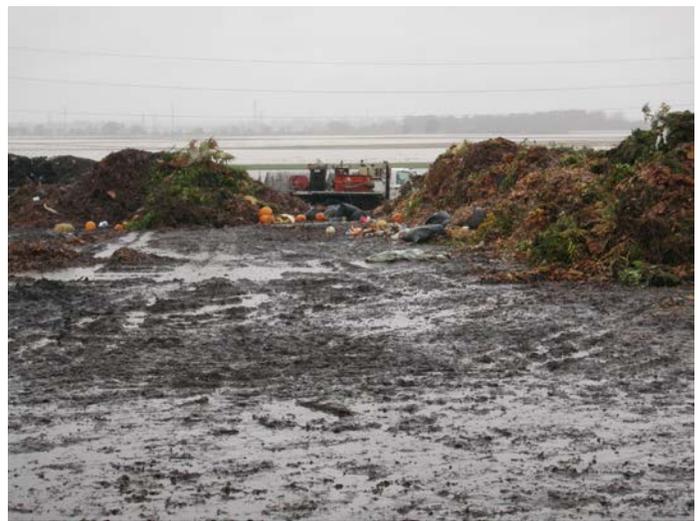
Photo# 12 - Active composting area

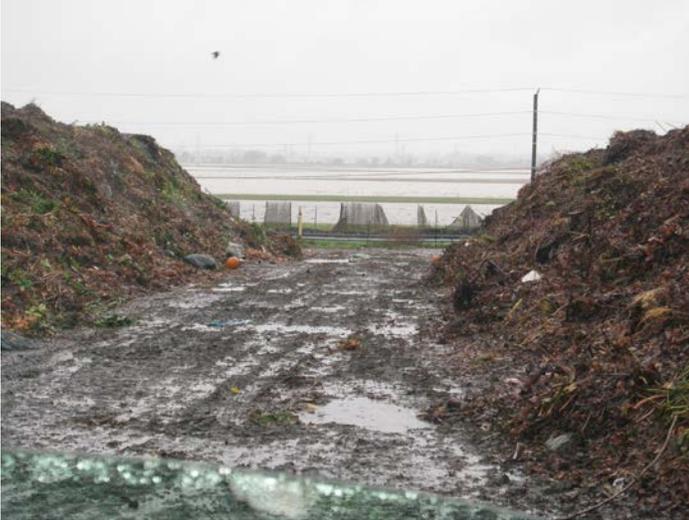
8. Addition of moisture to closure cover only for dust control or irrigation of the vegetative layer per Title 27 §21090(a)(5). Photos# 13-18 show composting piles that require the addition of moisture during non-precipitation periods to facilitate composting.

Photo# 13 - Active composting area

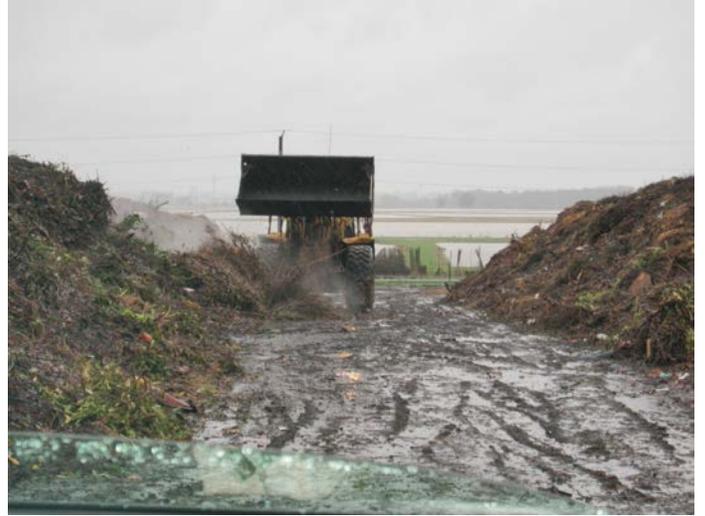
Photo# 14 - Active composting area

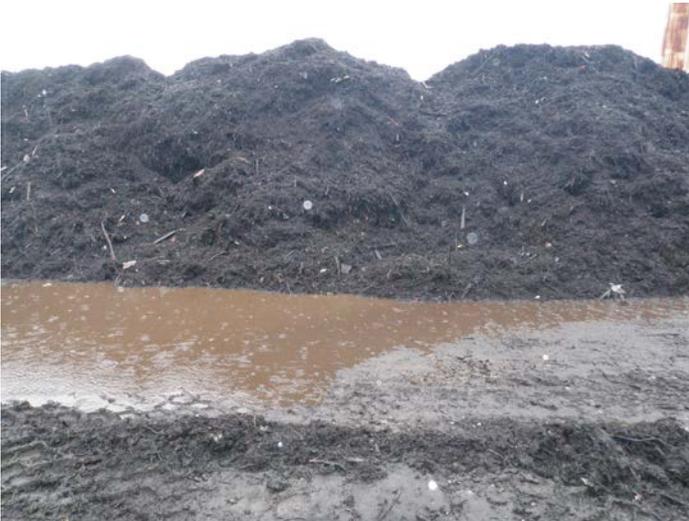
Photo# 15 shows the leachate pond at the toe of a composting pile. From this pond **Sample S-1** was taken. This photo shows the decomposed state of the compost and the visible color of the leachate. Recology also took a sample of the discharge.

Photo# 15 - Shows the leachate pond at the toe of a composting pile

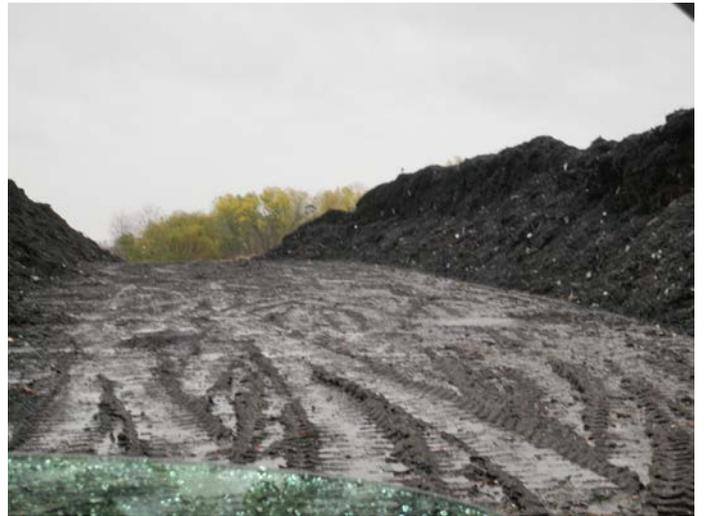
Photos# 16-18 show composting piles that appear to be finished product. The composting material was finely chopped and dark brown to black in color. Photo# 17 shows a large leachate pond at the toe of one composting pile. Photo# 18 is a close-up of the leachate to show the color and nature of the composting leachate generated at the site.

Photo# 16 - Composting piles that appear to be finished product

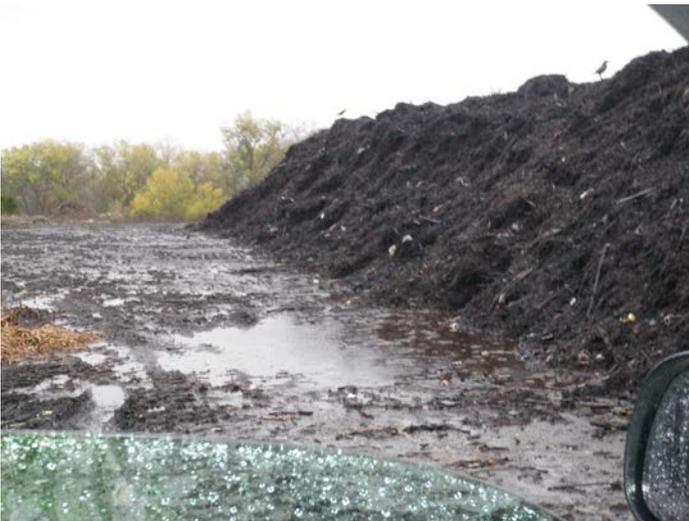
Photo# 17 - Large leachate pond at the toe of one composting pile

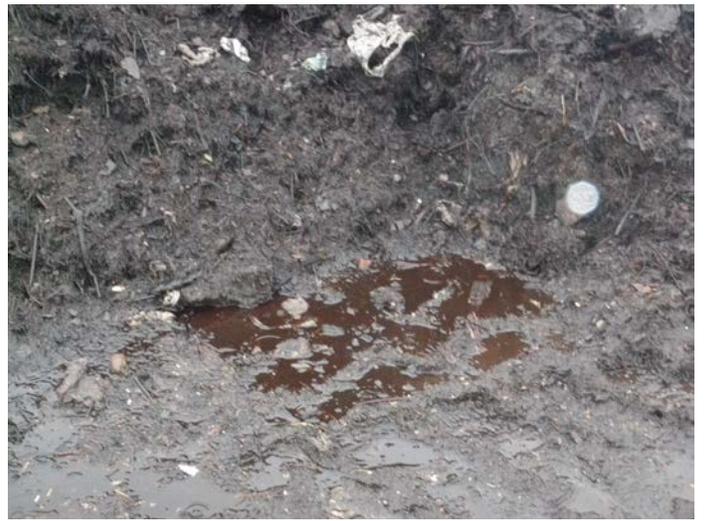
Photo# 18 - Close-up of the leachate to show the nature of the composting leachate generated at the site

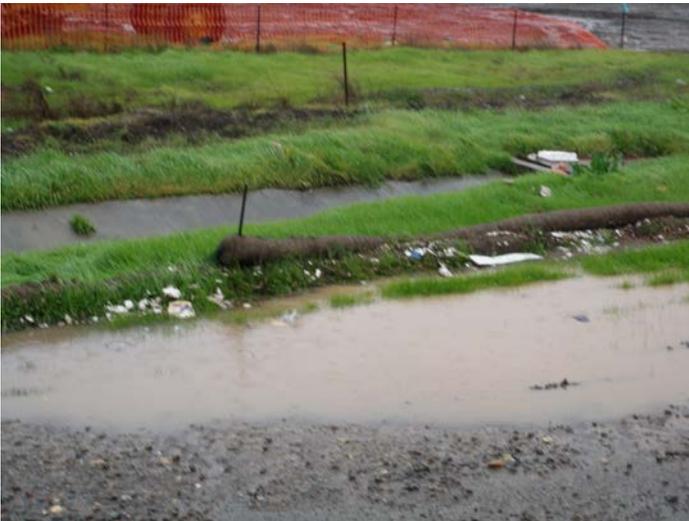
Photos# 19-21 show the vegetative swale that runs between the chip and grind area and the paved area north of the Material Recovery Facility. Photo#19 shows the quality of water coming off of the paved areas. It appeared to be typical storm water that is murky due to soil sediments (light brown in color). Photo# 20 shows the collection ditch where storm water from the paved areas passes through a vegetative filter strip and enters the collection ditch on the right of the photo. Storm water entering from the left into the ditch is drainage from the chip and grind area (dark brown in color). The photo clearly shows a visible difference in the water from the chip and grind area and the Material Recovery Facility. **Sample S-2** was taken from this collection ditch. Photo# 21 shows the vegetative swale that is supposed to filter storm water from the chip and grind area prior to entrance into the collection ditch. Discharge from the collection ditch is shown in Photo# 5. Recology also took a sample of the discharge.

Photo# 19 - Vegetative swale between chip and grind area and paved area north of Material Recovery Facility

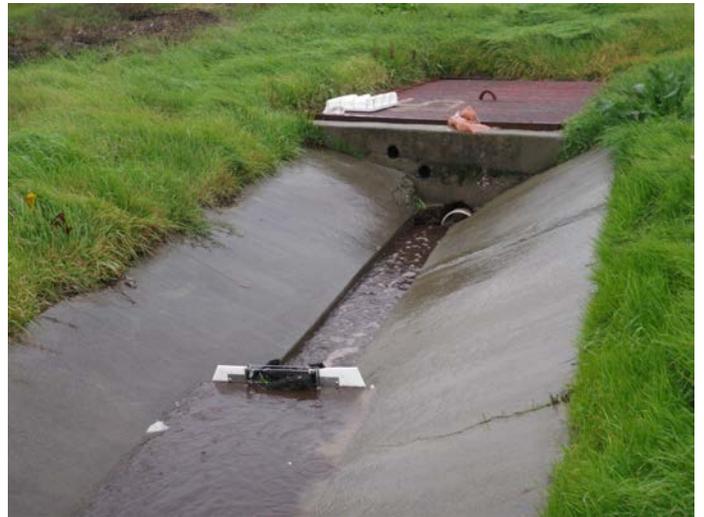
Photo# 20 - Vegetative swale between chip and grind area and paved area north of Material Recovery Facility

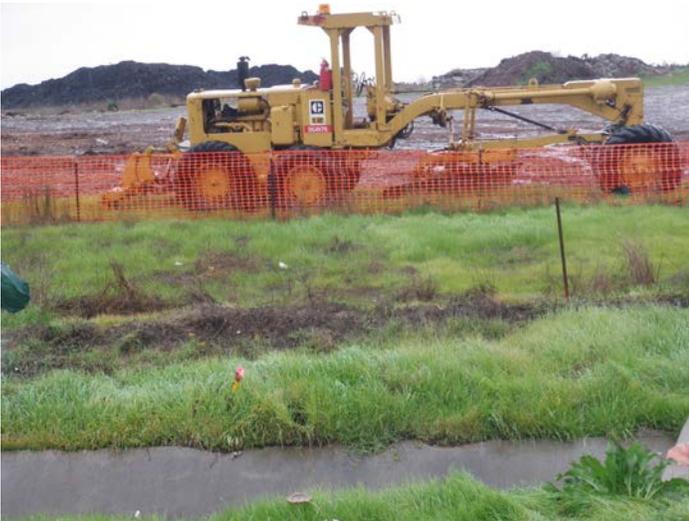
Photo# 21 - Vegetative swale that is supposed to filter storm water from the chip and grind area prior to entrance into the collection ditch

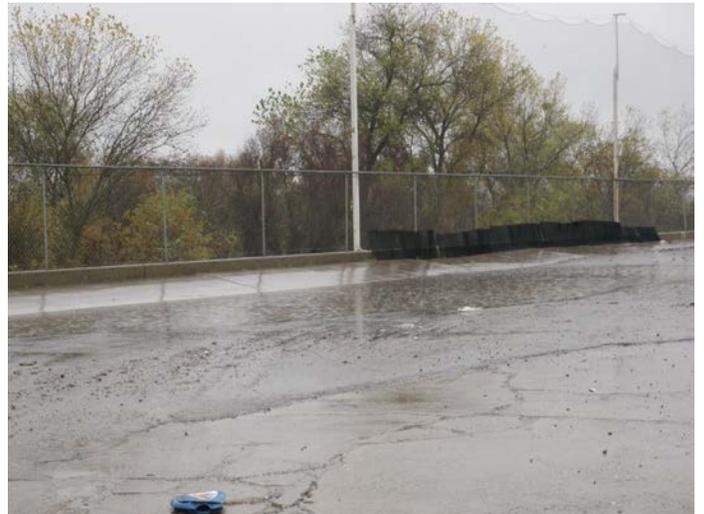
Photos# 22-25 show the ponding of water on the paved area north of the Material Recovery Facility. Photo#22 and #24 shows how the paved surface has cracked and has been repaired in some areas.

Photo# 22 - Ponding of water on the paved area north of the Material Recovery Facility

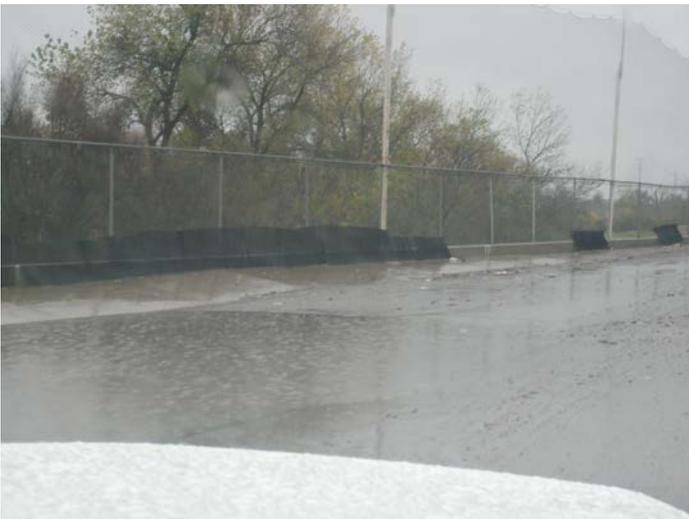
Photo# 23 - Ponding of water on the paved area north of the Material Recovery Facility.

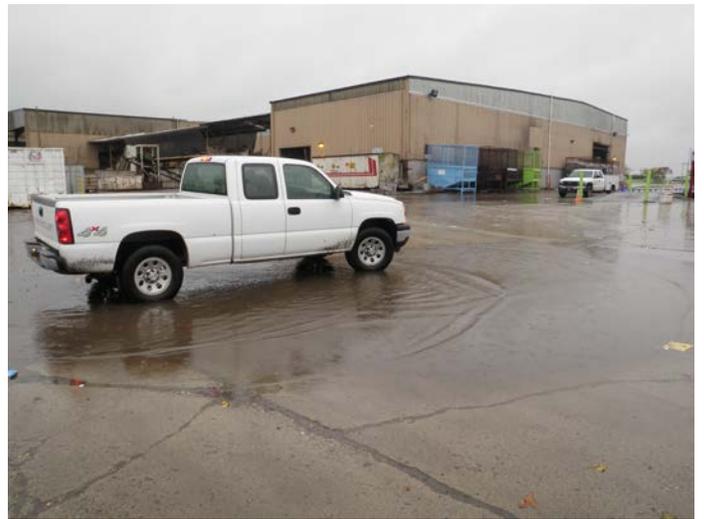
Photo# 24 - Ponding of water on the paved area north of the Material Recovery Facility.

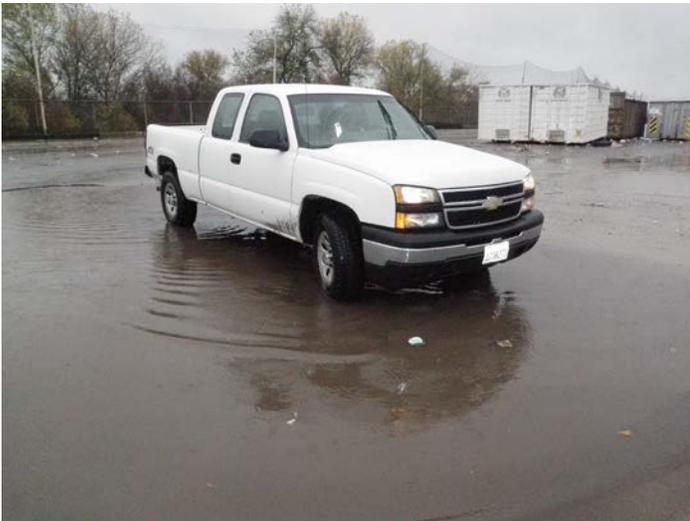
Photo# 25 – Another view of Photo# 24

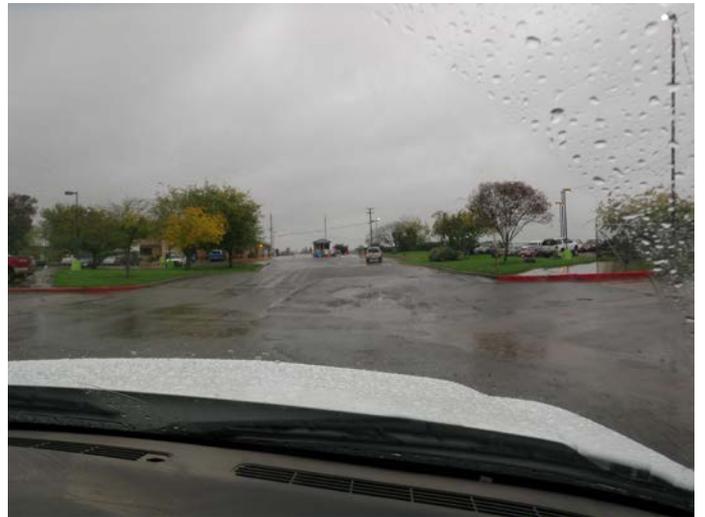
Photo# 26 shows the road leading out of the facility. The photo shows how the area over LF-1 is uneven due to settling of underlying refuse. The photo also shows mature trees growing on top of the final closure cover. It is unclear how Recology prevents the roots of the trees from penetrating the final closure cover which if not deterred provides preferred pathways for precipitation to enter the underlying refuse. Photo#26 was taken at the end of the tour. Upon completion we turned in our safety vests and exited the facility. We drove directly to ExcelChem to drop off the samples. We arrived at ExcelChem where we relinquished custody of the two samples we had taken. The chain of custody indicates that the samples were logged in at their facility at 12:37 PM. We arrived back at the Rancho Cordova office at 2:30 PM.

1. Final closure cover maximum hydraulic conductivity shall not exceed 1×10^{-6} cm/sec per Title 27 § 21090(a)(2). Photo# 26 shows mature trees growing on the closure cover. The roots of the trees provide preferred pathways for liquids to underlying refuse that defeats the purpose of a low hydraulic conductivity final cover.
2. Minimum 3% slope required over closed WMU to promote drainage per Title 27 § 21090(b)(1)(A). Photos# 1-4, 22-26 show areas where the closure cover grade is less than 3%.
3. Waste shall not continue to be placed in a closed landfill that promotes generation of landfill gas per Title 27 §21090(a)(3)(1)(a). Photos# 13-18 and #21 shows waste that generates leachate high in TOC and COD as analyzed in Attachment 4. High TOC and COD is a waste that is desirable in digesters for methane gas production.

Photo# 26 - Road leading out of the facility. The photo shows how the area over LF-1 is uneven due to settling of underlying refuse.
