RE: Compost Area Improvement Report, Feather River Organics, Yuba County, California

Project No. 1301525

**RE: COMPOST AREA IMPROVEMENT REPORT FOR THE FEATHER RIVER ORGANICS  
COMPOSTING OPERATION, RECOLOGY YUBA SUTTER FACILITY, MARYSVILLE,  
CALIFORNIA**

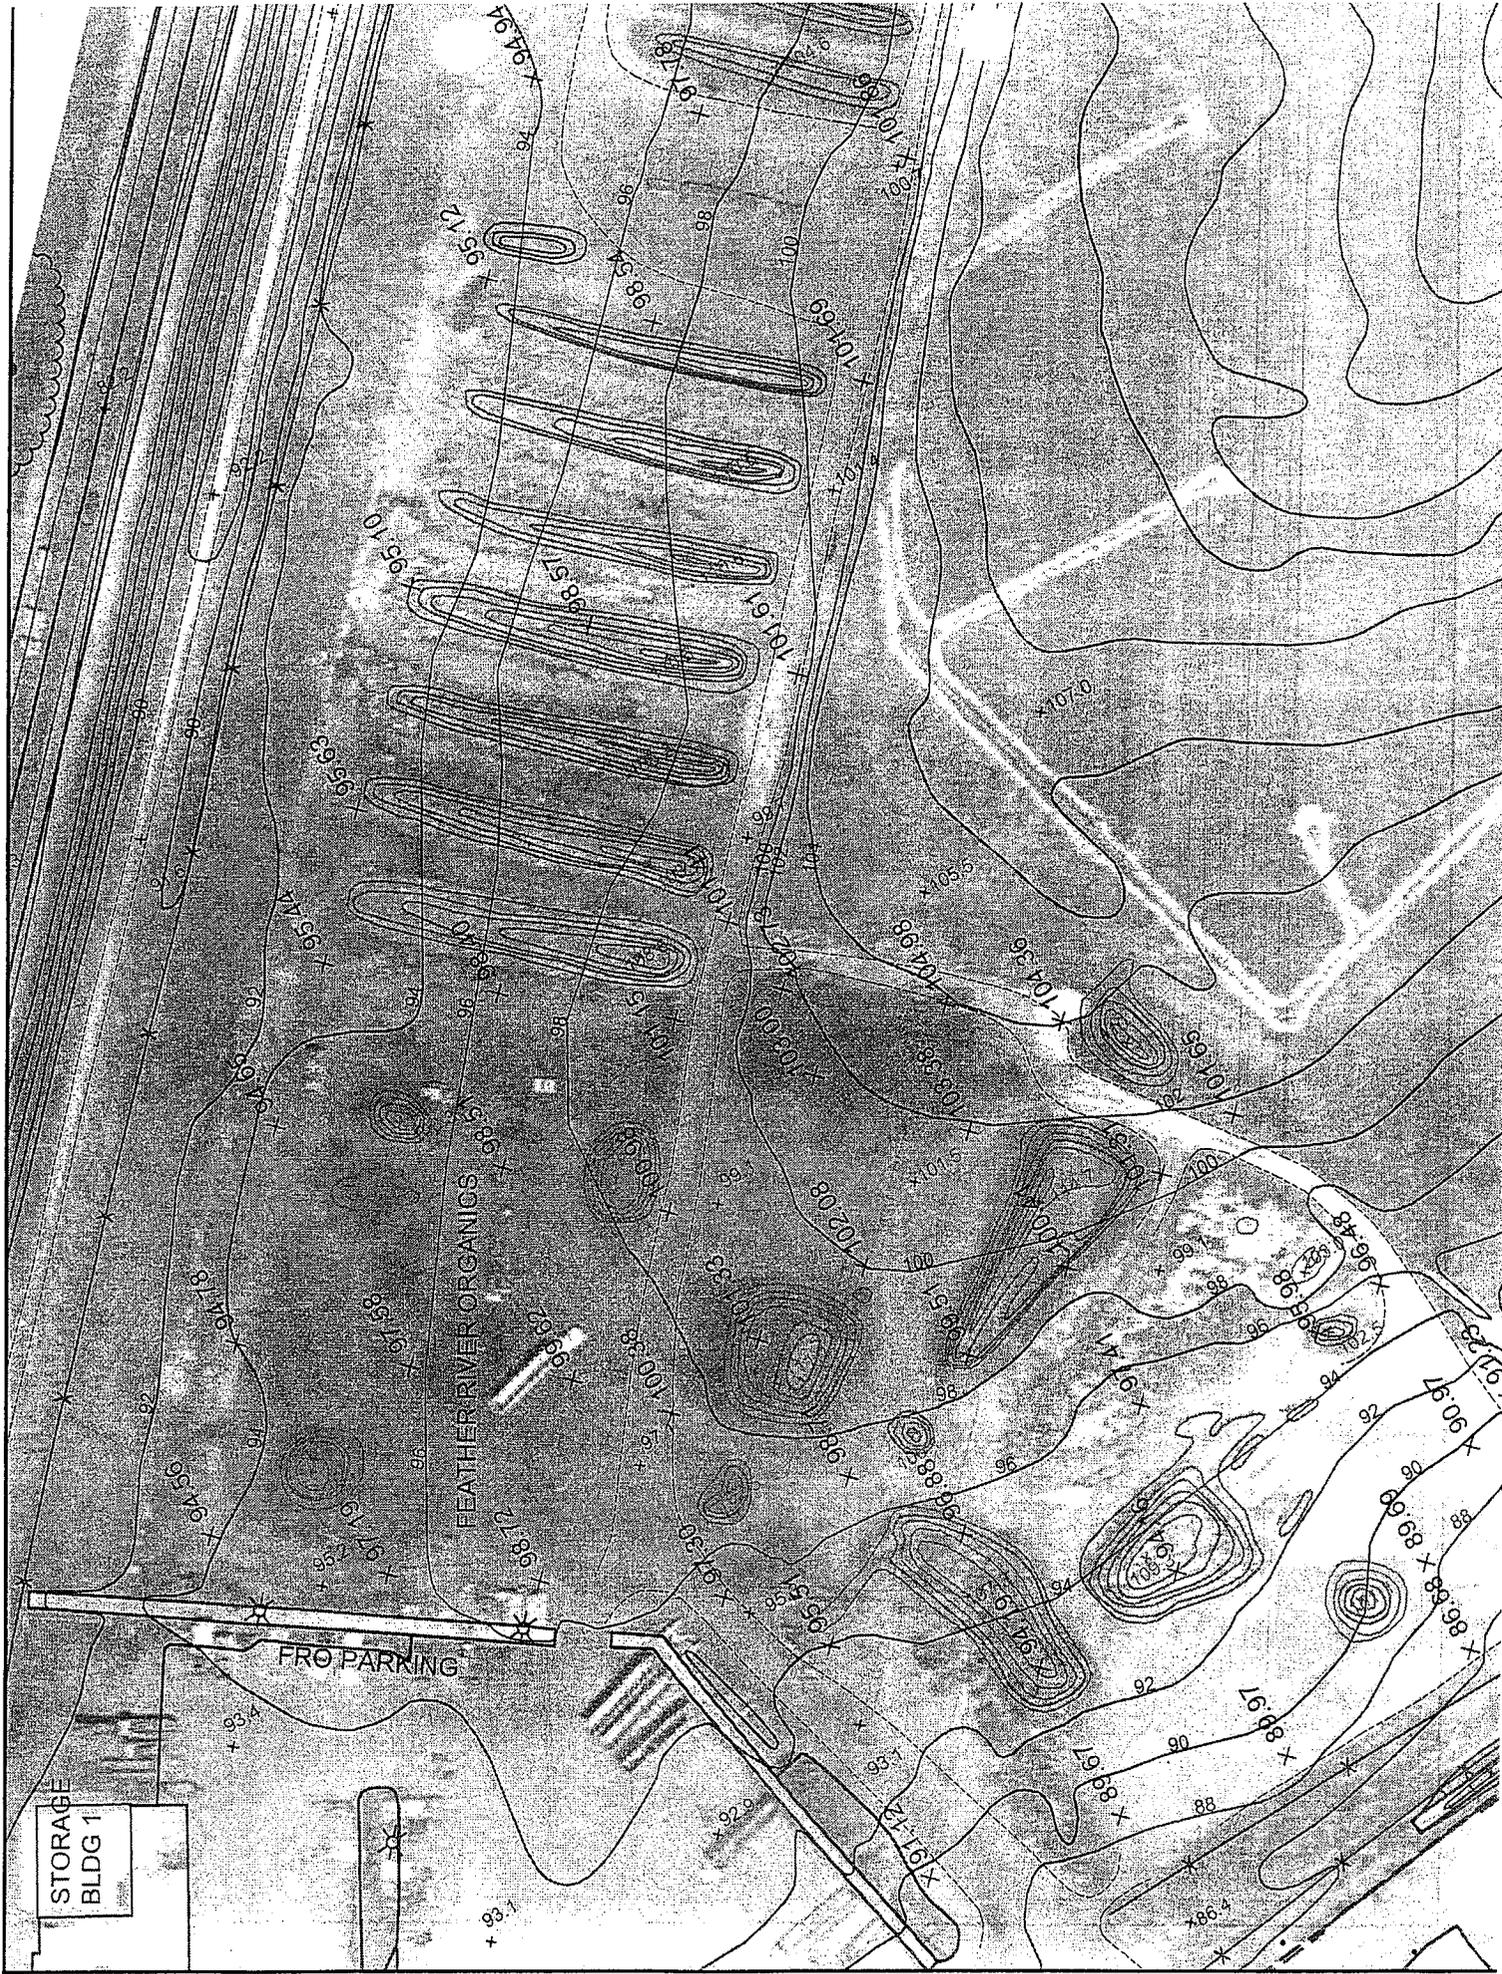
terminates near the southeast sump to limit surface water run-on. Golder also installed one (1) suction lysimeter near each storage tank group location to monitor any potential contamination within the vadose zone. Figure 3 shows the key drainage improvements and the lysimeter installation locations. Lysimeter installation logs are presented in Attachment 2 and a photograph log illustrating key drainage improvements is included in Attachment 3.

CONNECTED 4-INCH Ø PIPE TO POTW SEWER CONNECTION

4-INCH Ø DISCHARGE PIPE

CONNECTED ALL PIPES FROM C TO 18-INCH Ø HDI

NEW DRAINAGE DIVERSION BERM

INSTALLED 3 ADDITIONAL 21,000 GAL STORAGE TANKS

INSTALLED 2-HP PUMP

LYSIMETER L-8

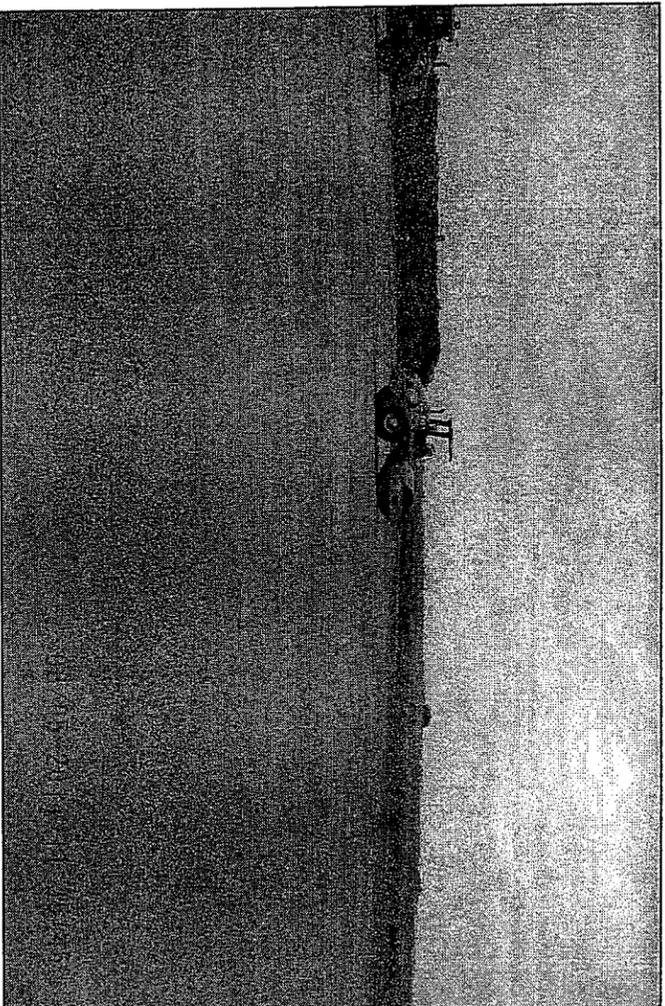
Photo 1: Operator compacting compost pad. Low-permeability aggregate.

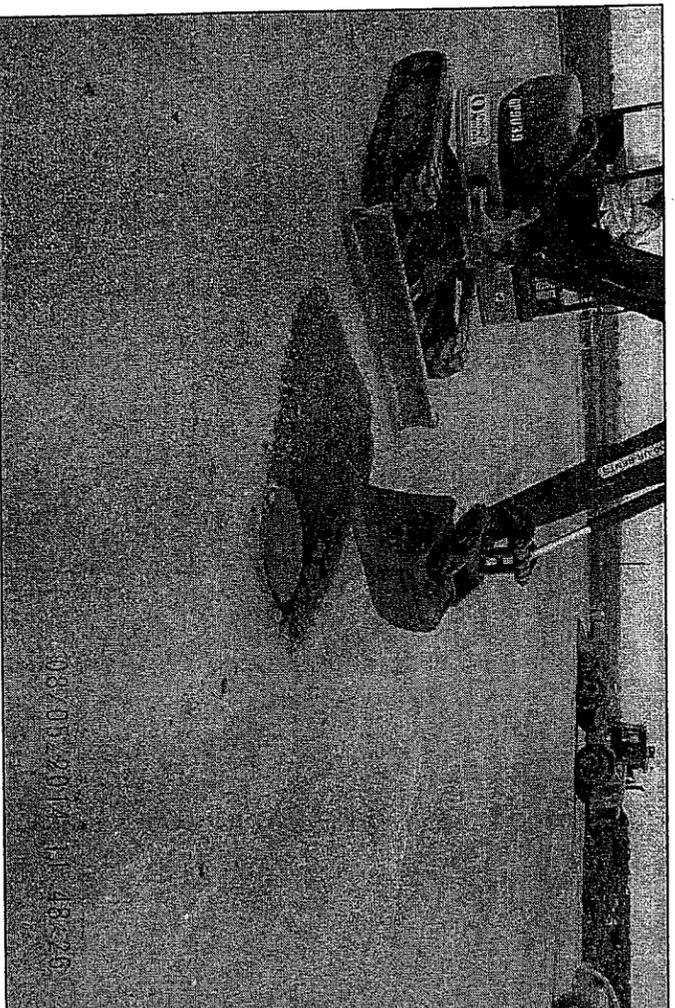
Photo 2: Operator excavating compost pad to install thickness marker.

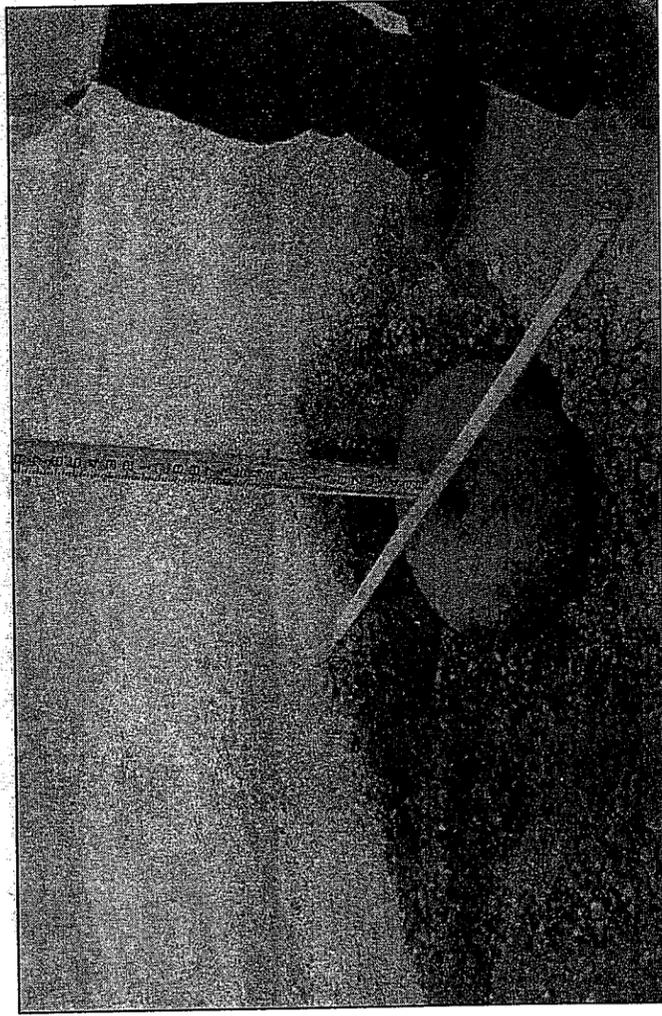
Photo 3: Laborer installs thickness marker.

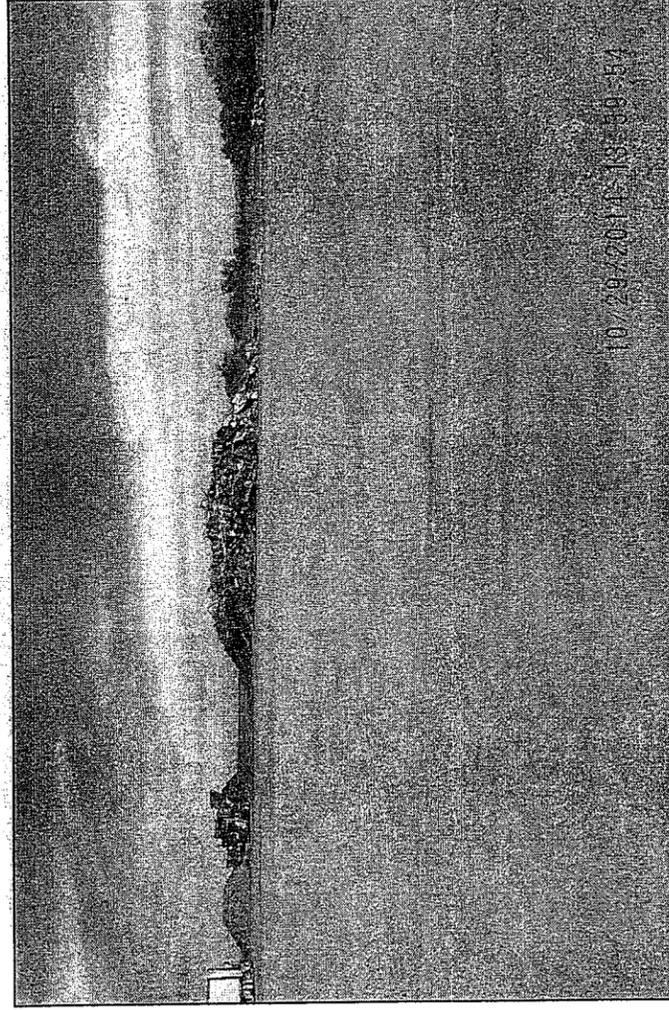
Photo 4: View of improved compost pad in the southern area of compost operations.

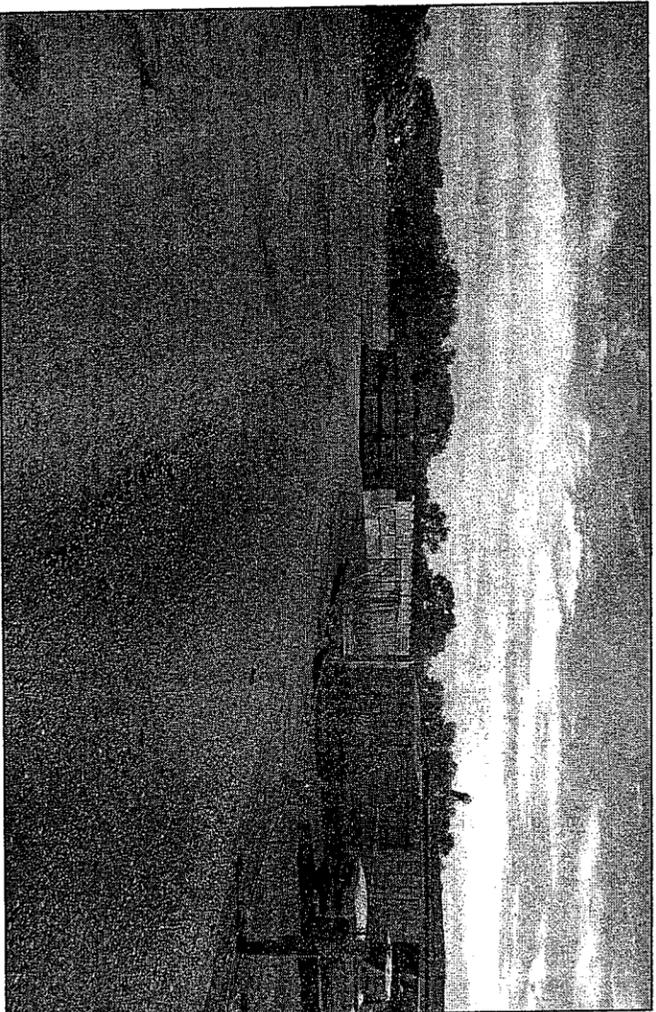
Additional improvements include the construction of a diversion berm along the entire southern boundary of the active compost area which connects to the existing diversion berm along the northwest edge and

Photo 5: Diversion berm along southern perimeter of compost operations area.

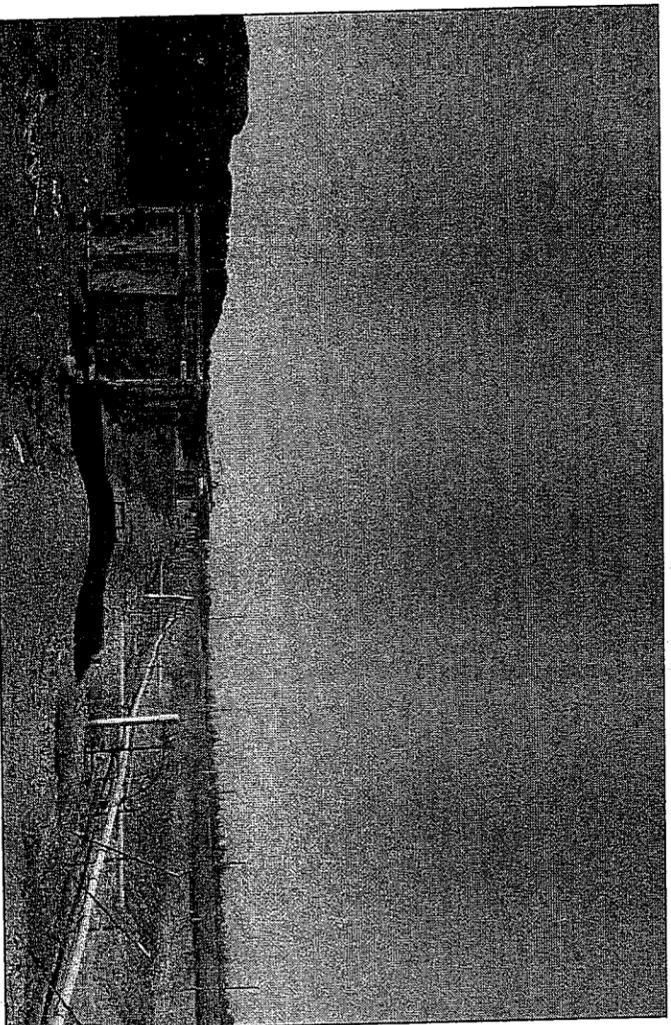
Photo 6: Diversion berm along western perimeter of compost operations area.

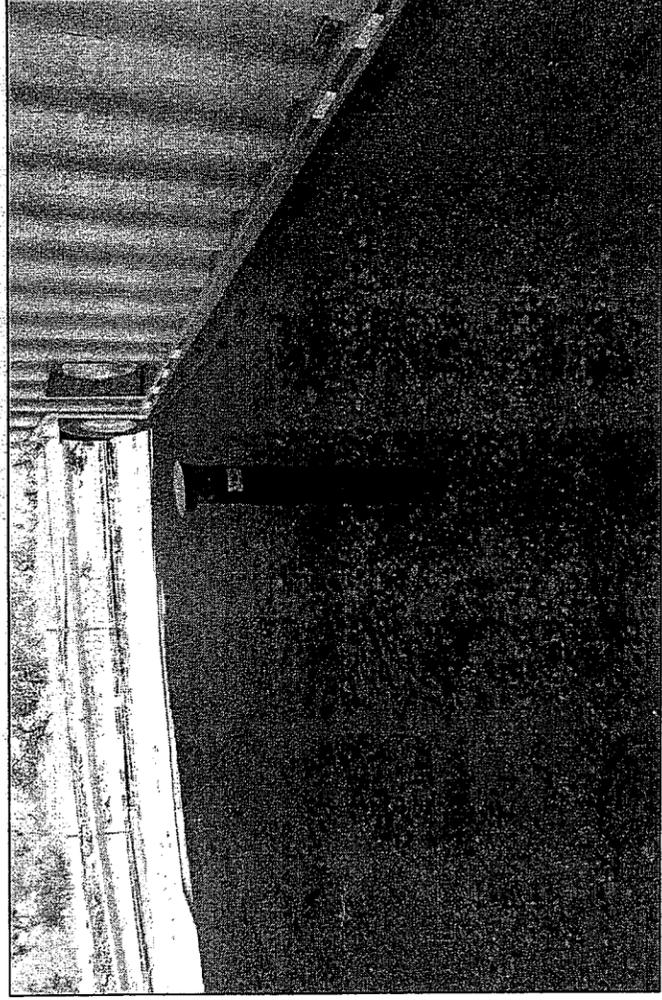
Photo 7: Typical installed Lysimeter.

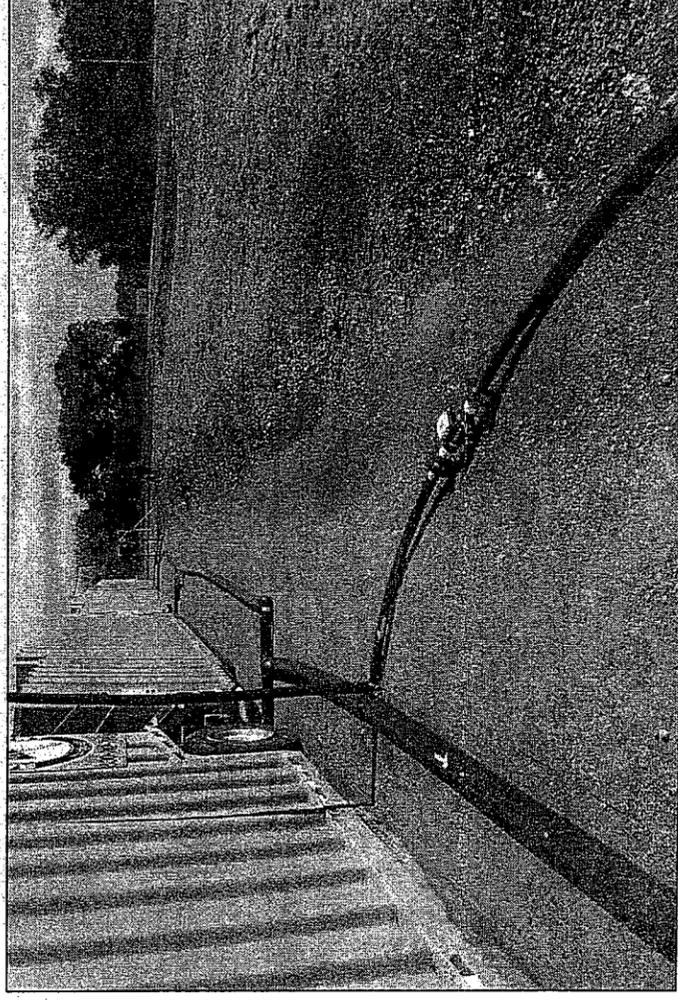
Photo 8: Typical installed flow meter.

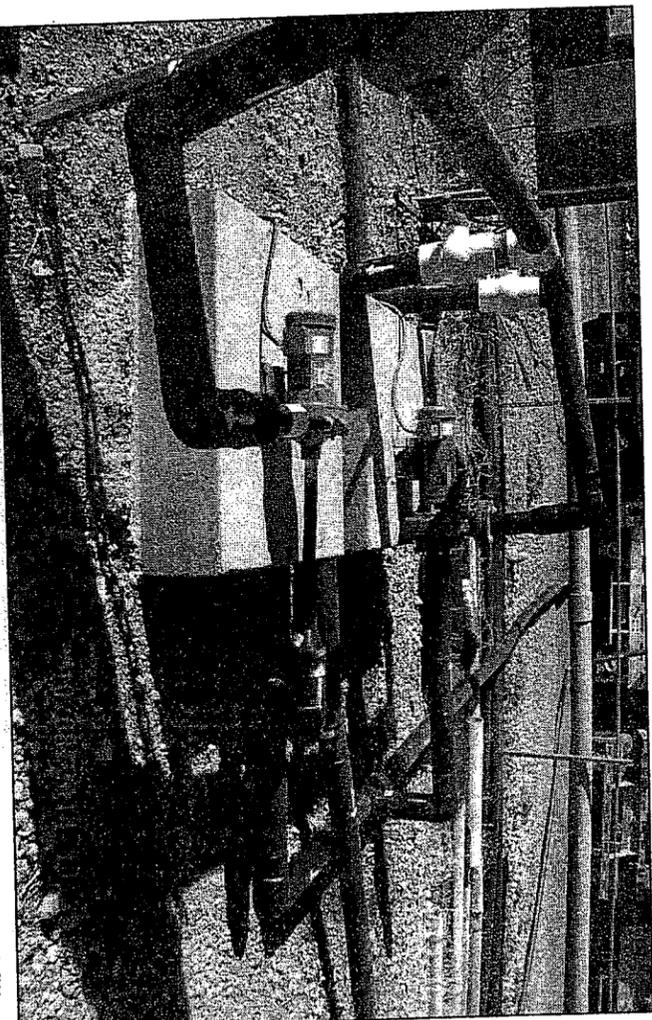
Photo 9: View of northern pumps and piping associated with POTW discharge and J-stand fill station.

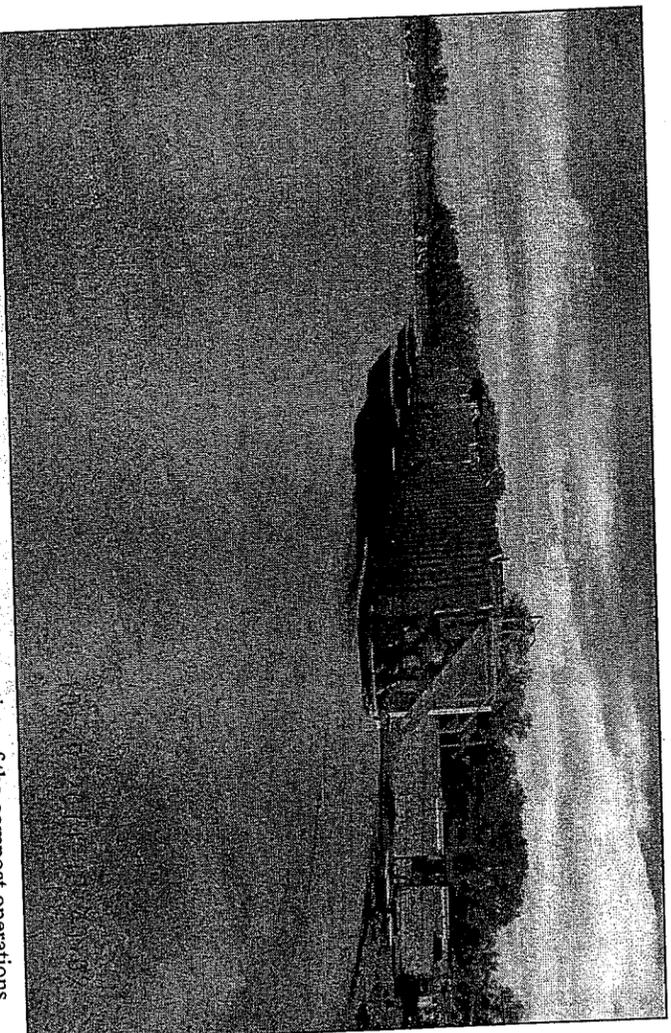
- The total number of 21,000-gallon capacity storage tanks was increased from one (1) to four (4) along the southern end of the compost pad near the Material Recovery Facility (MRF)

Photo 10: View of four Baker tanks located in the southern portion of the compost operations area.

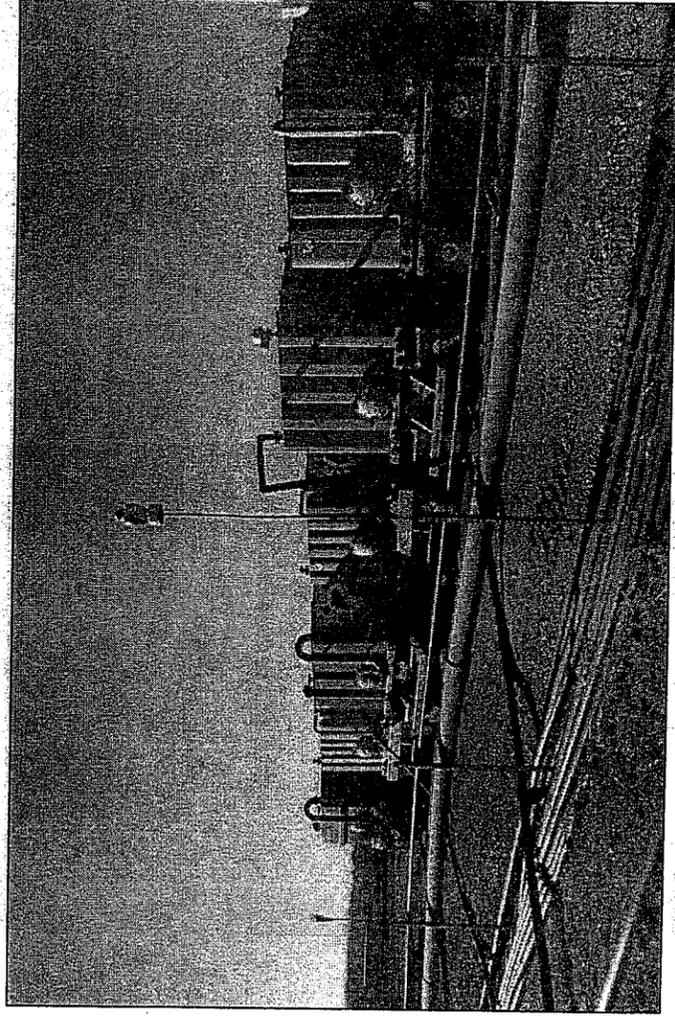
- The total number of 21,000-gallon capacity storage tanks was increased from two (2) to eight (8) at the northern end of the compost pad near the Hog Farm area

Photo 11: View of a portion of the 8 tanks located near the Hog farm.

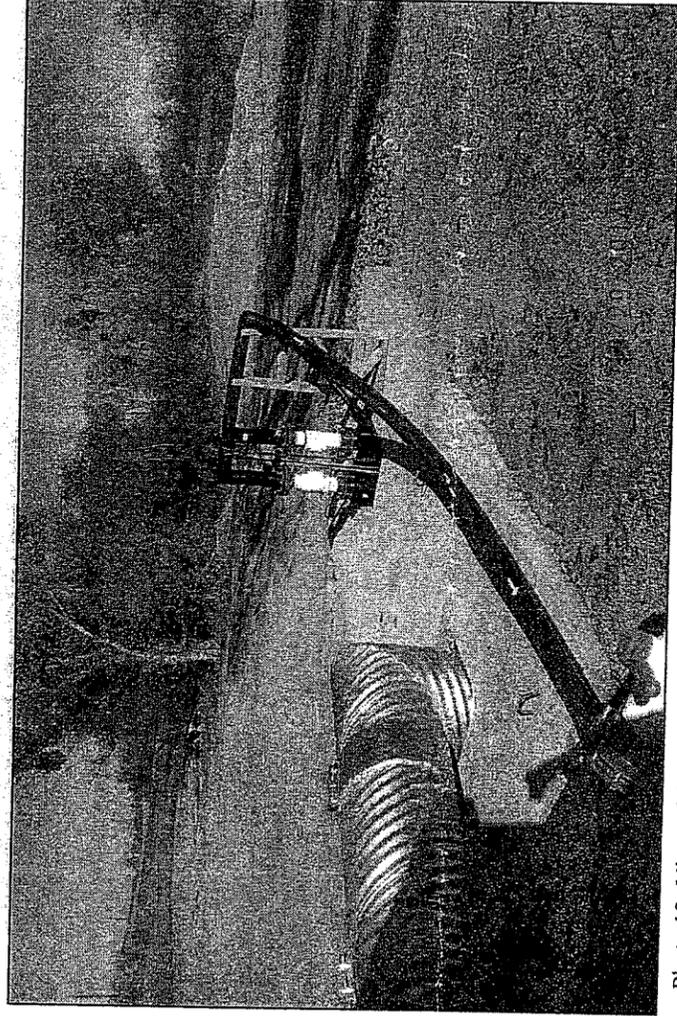
- A second vault with an approximate 5,000-gallon capacity was constructed within the Hog Farm area
- Two (2) additional 5-HP pumps were installed into the existing and new vault for a total of four (4) pumps within the Hog Farm area vaults

Photo 12: View of the second vault and associated pipes.
