## Central Valley Regional Water Quality Control Board

### ***NOTICE OF VIOLATION: WET WEATHER SITE INSPECTION REPORT, RECOLOGY YUBA SUTTER LANDFILL, YUBA COUNTY***

## INSPECTION REPORT

**INSPECTION DATE:** 3 December 2014

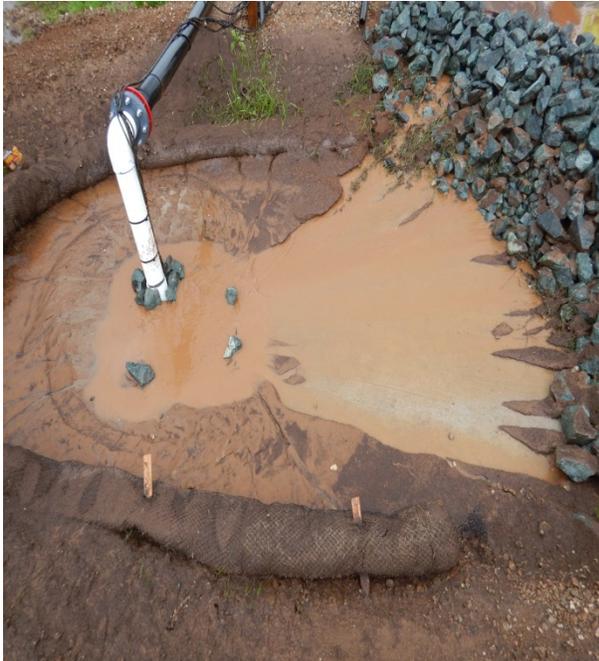
Photo 1: Compost Area southeast sump. Note extremely turbid water draining to sump. Also, sumps are dug into cover of LF-1 and earthen above concrete vault where pump is installed. Potential to allow liquid to infiltrate waste.

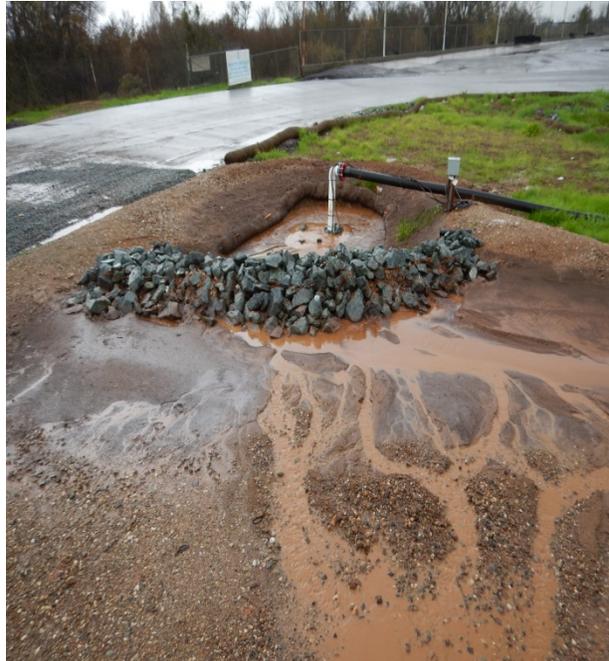
Photo 2: Looking south at the southeast sump. Note sediment transported by drainage to sump. Note water line on side walls above sump indicating water had risen during precipitation event and pump was unable to keep up with flow.

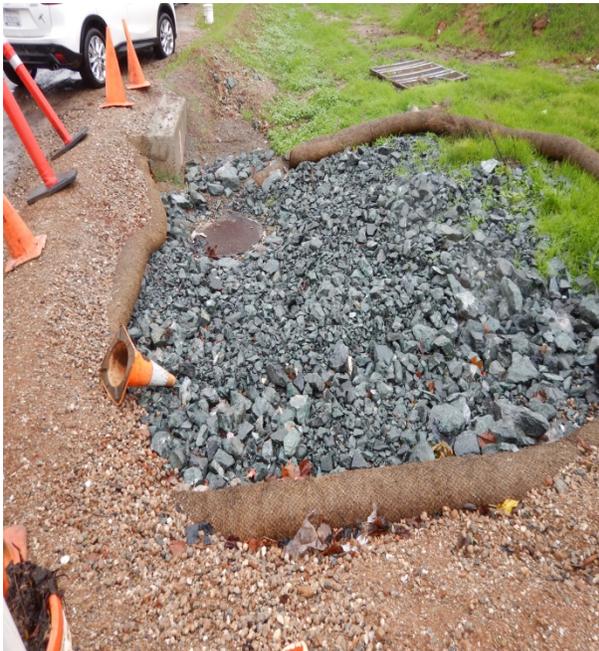
As shown in the attached Photo Log, the rainfall volume overwhelmed the leachate collection system. Staff inspected the southern sumps and storage Tanks. Rainfall on the compost area transported sediment to the sumps, which were quickly overwhelmed. Due to poor pump performance, the sumps silted up as more leachate entered the system. It is apparent in Photos 1 and 2 that leachate had risen to the top of the sidewalls of the sump, an indication the sump was too small and the pumps are undersized for the flow into the sump. During this portion of the site inspection, the rain event had stalled and the site was draining. Staff inspected the newly installed drain inlet of LF-2 (Photo 3) and the berm between LF-1 and LF-2 (Photo 4) and no areas of concern were noted with these facilities.

Photo 3: Storm water drain inlet at southwest corner of LF-2. This drain inlet was rebuilt during 2014 construction season.

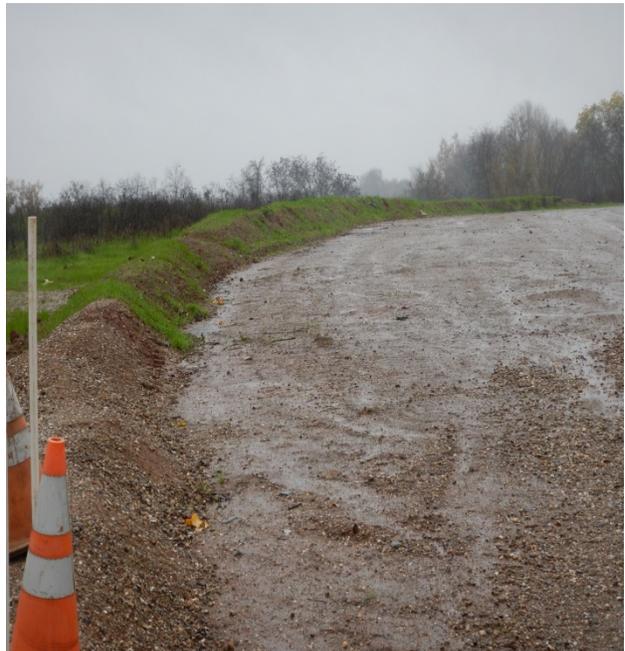
Photo 4: Southern berm of LF-2 delineating boundary of compost area (to right of photo) and LF-2.

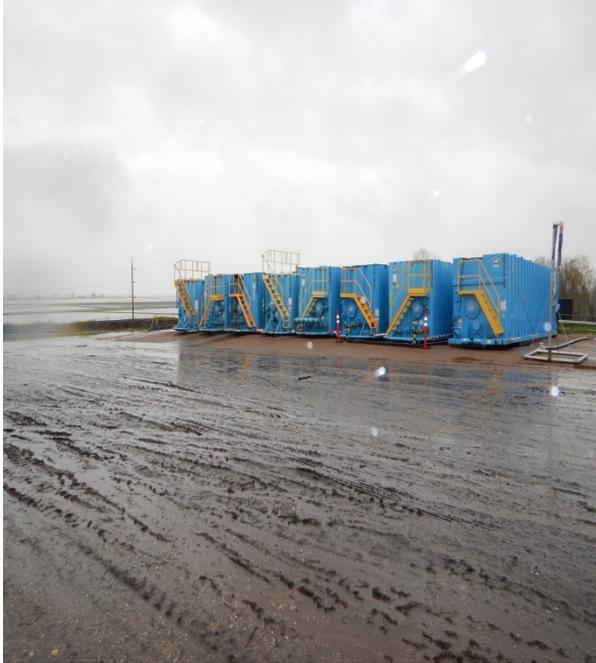
Photo 5: Bank of eight baker tanks to receive discharge from compost area. Note compost pad in foreground appears to be shedding rainfall well with no signs of erosion.

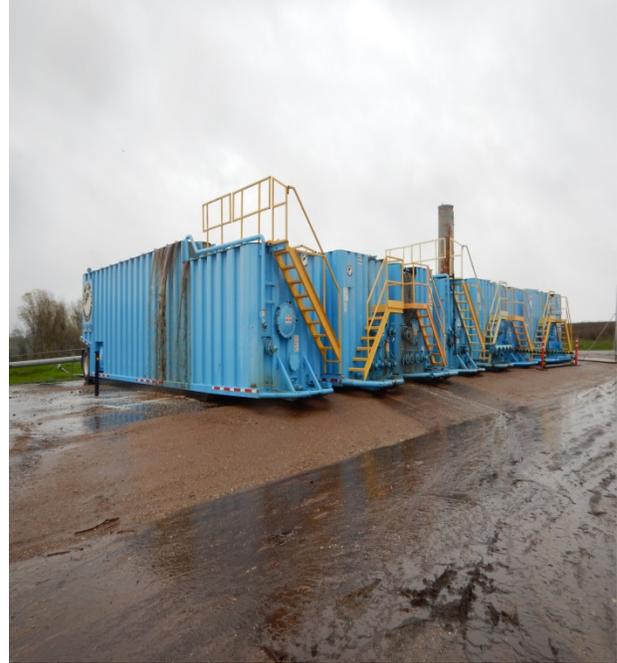
Photo 6: Looking northeast at the eight baker tanks. Note several tanks are spilling onto the compost pad area.

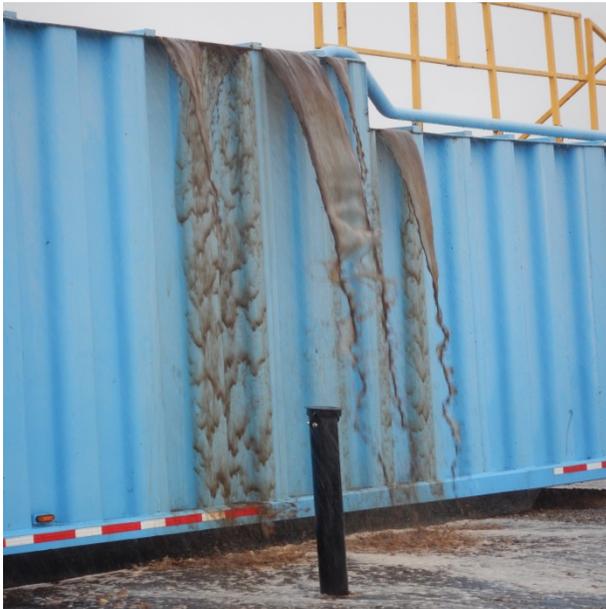
Photo 7: Baker tank overflowing.

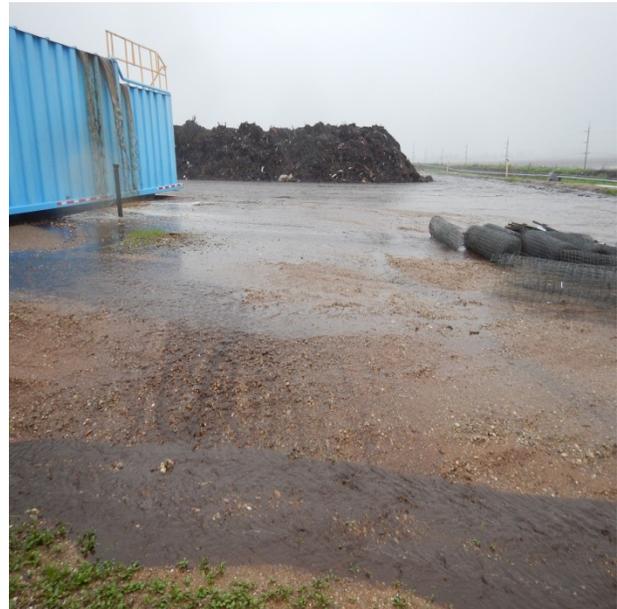
Photo 8: Baker tank overflowing as shown in Photo 7. Note volume of leachate flowing from tank system.

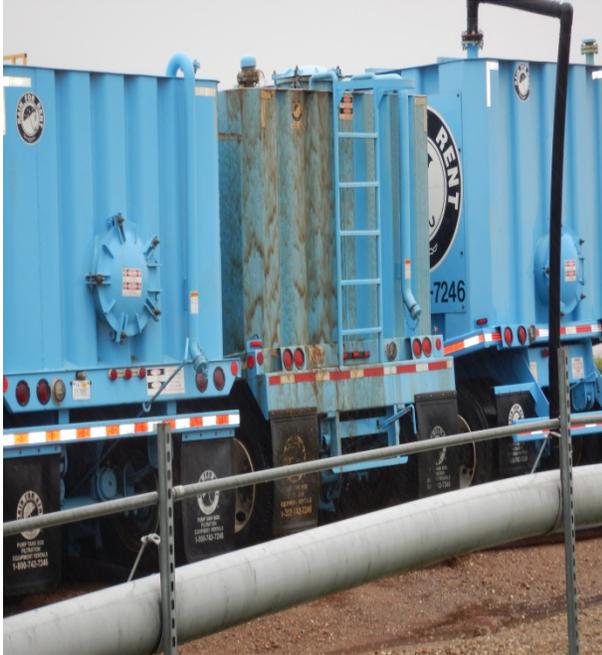
Photo 9: Baker tank overtopping.

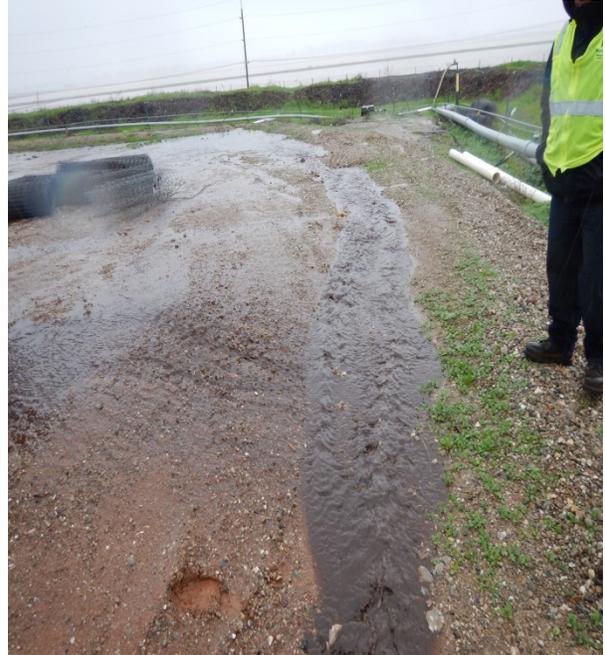
Photo 10: Spilt leachate draining to lower drain inlet. Note dark color of leachate and volume.

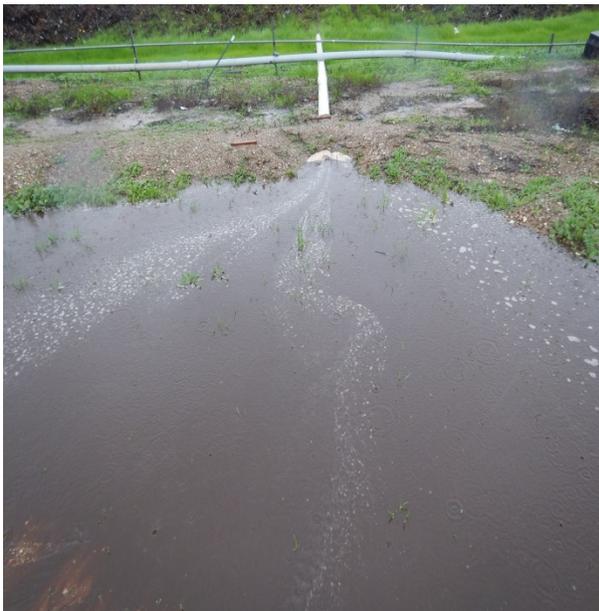
Photo 11: Ponding leachate contained by low permeable berm. Ponding of liquid on top of LF-1 is a violation of the WDRs.

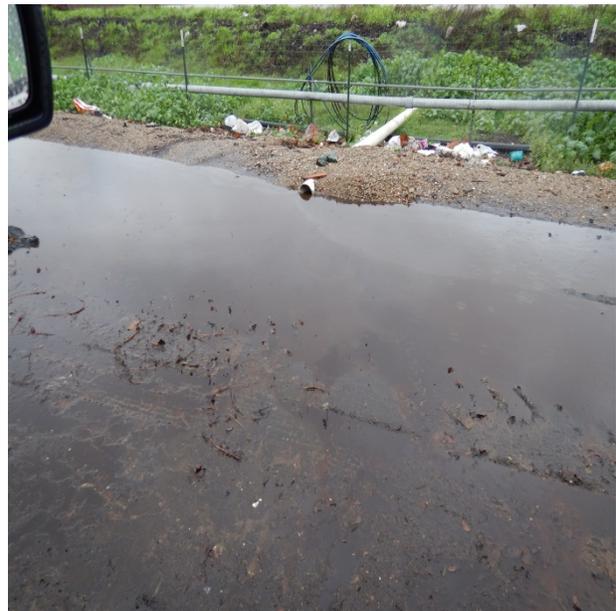
Photo 12: Ponding leachate unable to drain along the northwestern berm of the compost area. Ponding liquid on top of LF-1 is a violation of the WDRs.

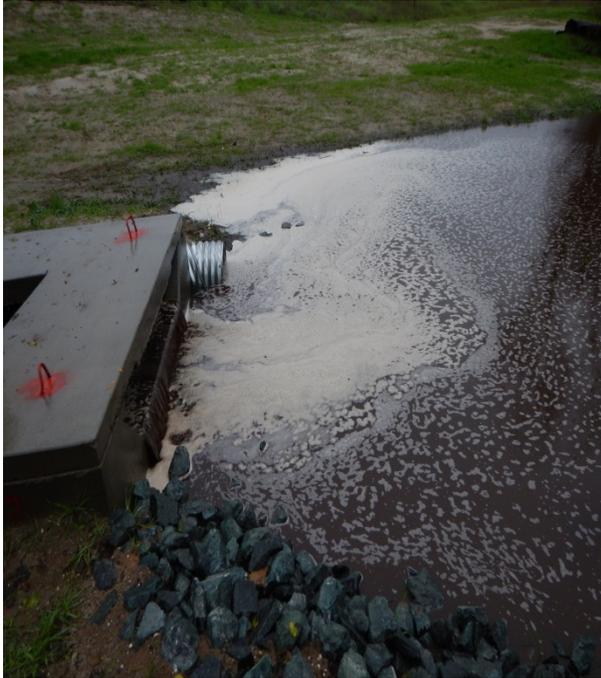
As shown in Photos 13 through 16, staff observed the two northern sumps were full and pumps were overwhelmed by the rate of run-off from the compost area. This unpermitted discharge to the Hog Farm is of an unknown quantity and a violation of the CAO and Title 27, section 20365.

Photo 13: Offsite discharge of leachate to the Hog Farm from northern compost area.

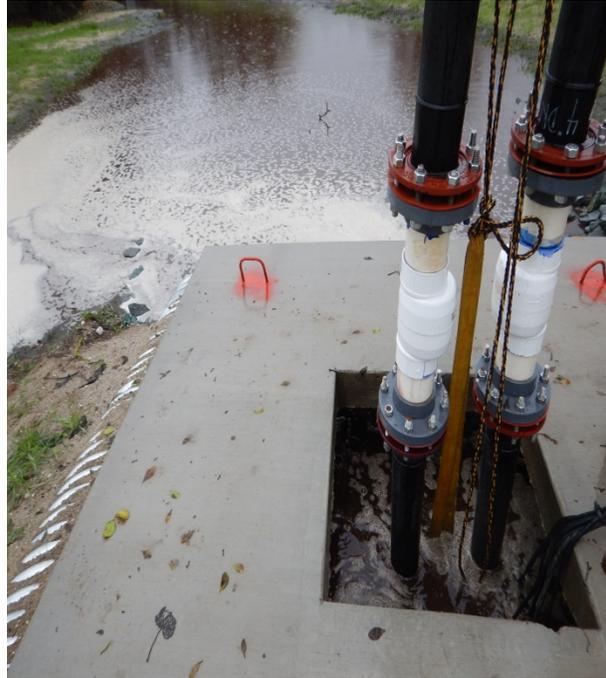
Photo 14: Looking down drainage of northern sumps. Note sump is full and pumps are overwhelmed by volume of discharge from compost area.

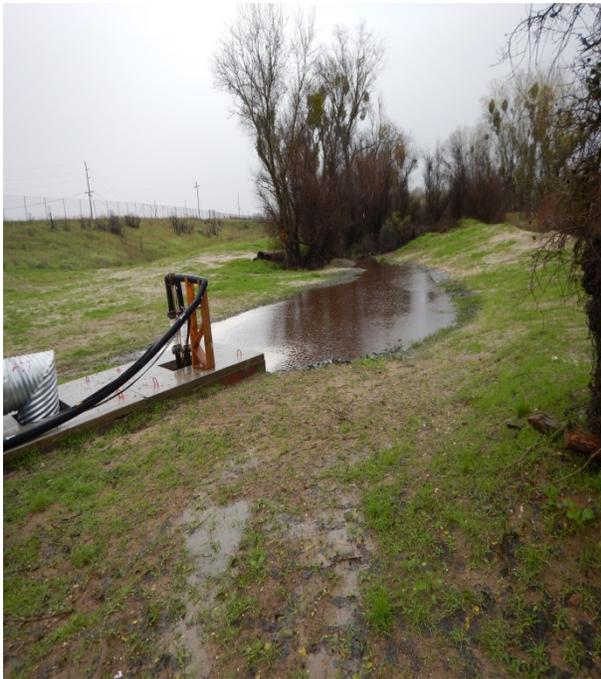
Photo 15: Looking down drainage from sumps. Note ponded leachate draining to offsite Hog Farm area.

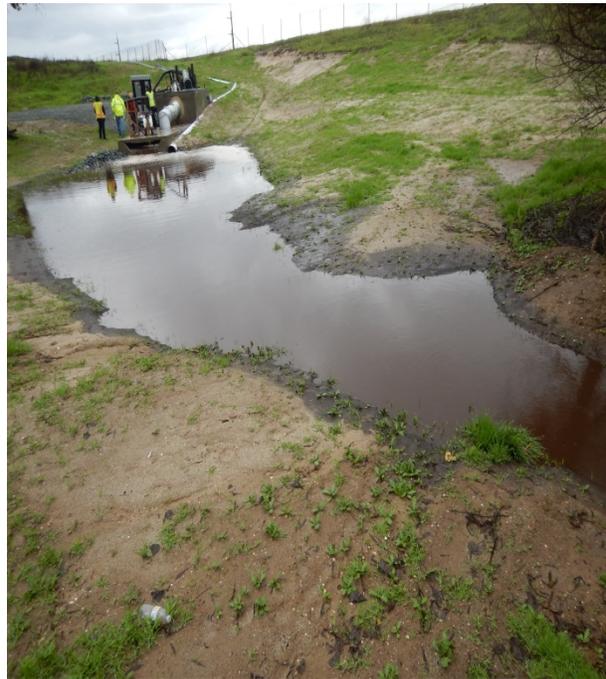
Photo 16: Looking south back toward the sump discharge.

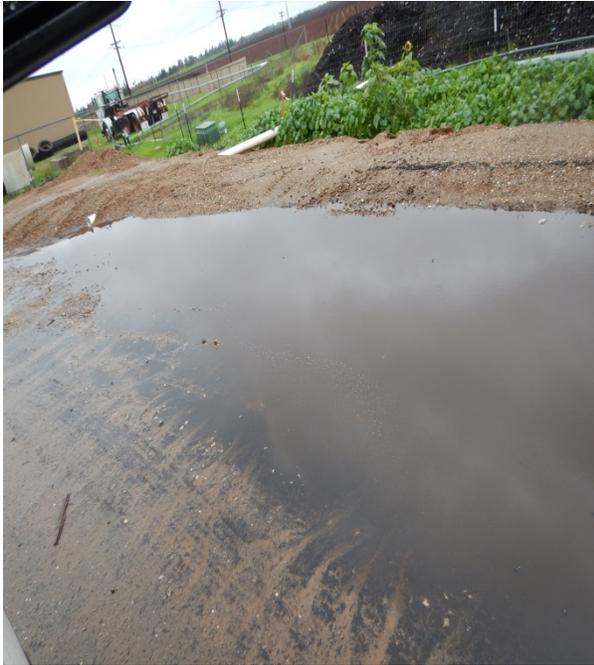
Photo 17: Looking at southwest corner of composting area where lack of drainage has allowed leachate to pond.

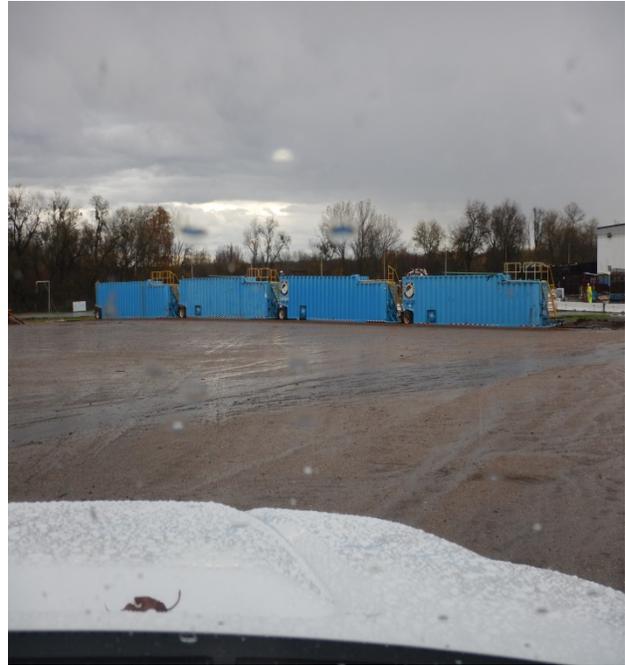
Photo 18: Looking south across green waste processing area to southern bank of Baker Tanks.

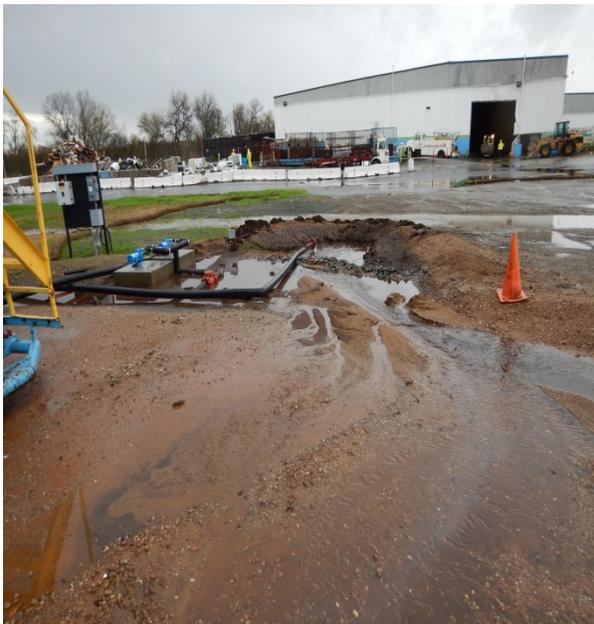
The inspection continued back to the southern Baker Tanks and sumps where areas of concern were observed. Photos 19 through 21 show the southwest sump being overwhelmed by the drainage from the processing area and that pumping from the sump was retarded by sediment transported during the rain event. Photos 22 through 24 show overflowing southern bank of Baker Tanks at capacity during this site inspection.

Photo 19: Looking south at the southwestern sump of the compost area. Note significant volume of liquid draining to sump. Also, quality of leachate is different than of quality of leachate shown in the northern part of compost area.

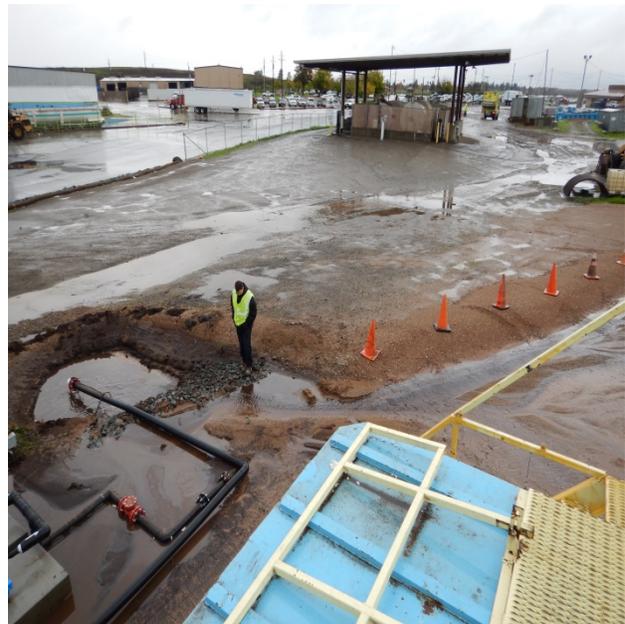
Photo 20: Overhead view of drainage to southern sump.

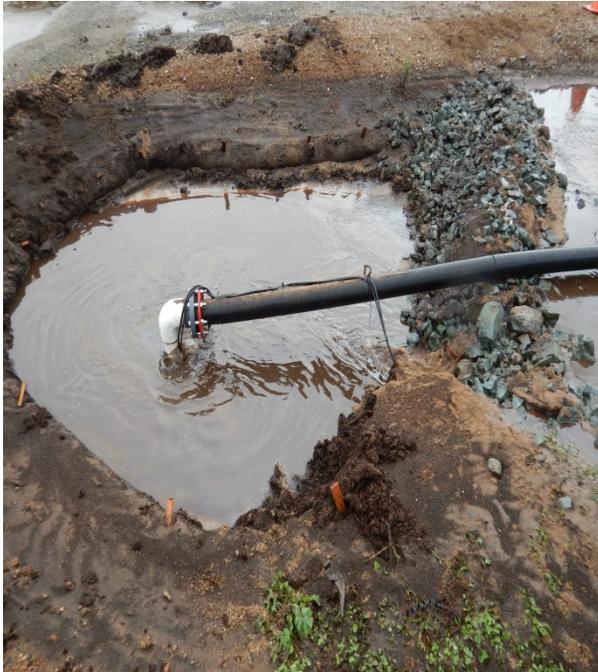
Photo 21: Cavitating pump due to clogging of southwestern sump. Note sidewalls of sump lined with compost debris and other fine material.

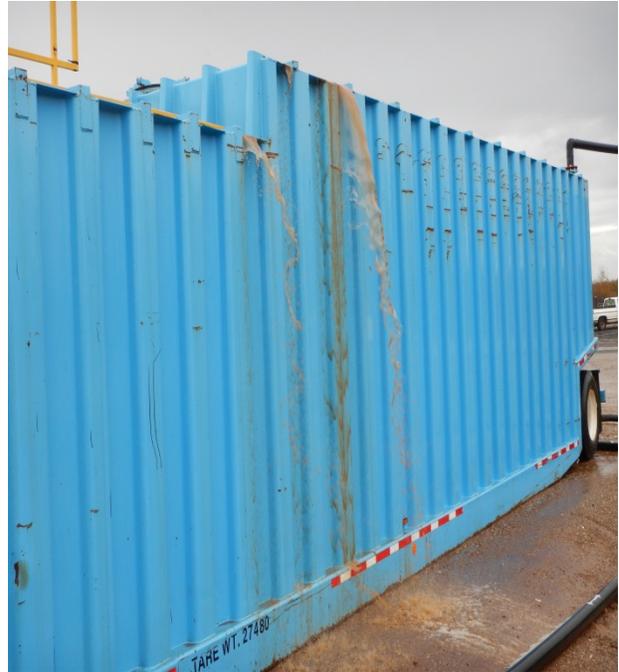
Photo 22: Overflowing Baker Tank.

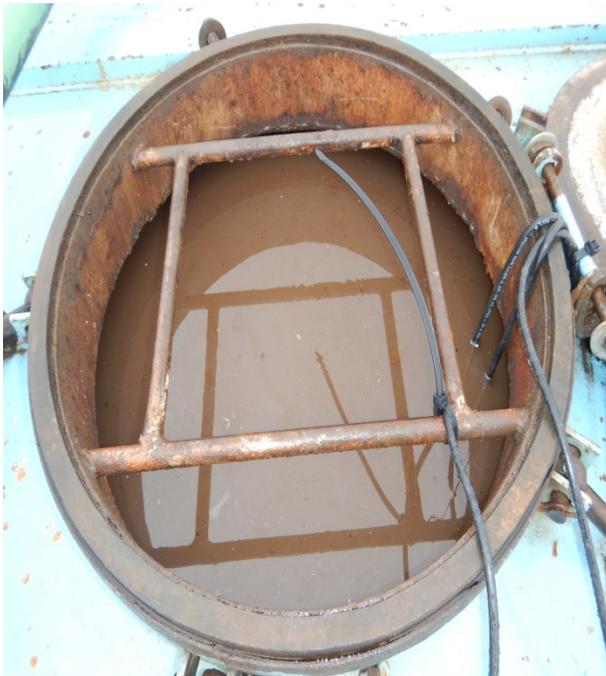
Photo 23: Baker Tank full.

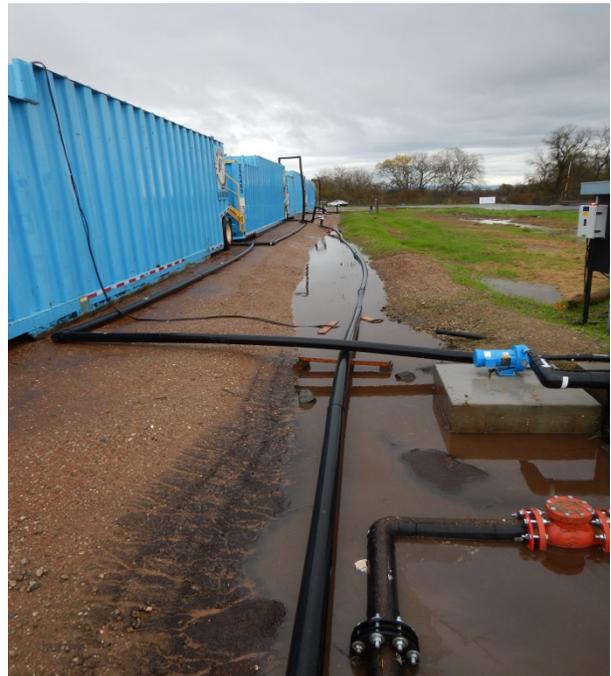
Photo 24: Looking east-southeast at bank of Baker Tanks. Note outside (right of center) perimeter berm and position of pipes and tanks. Overflow is being contained within compost area.
