CLEANUP AND ABATEMENT ORDER NO. R5-2015-0701

**Attachment B – 19 November 2014 Baker Ridge Inspection Report**

## INSPECTION REPORT

**PHYSICAL PROPERTY ADDRESS:** Baker Ridge Road, Igo, CA 96047

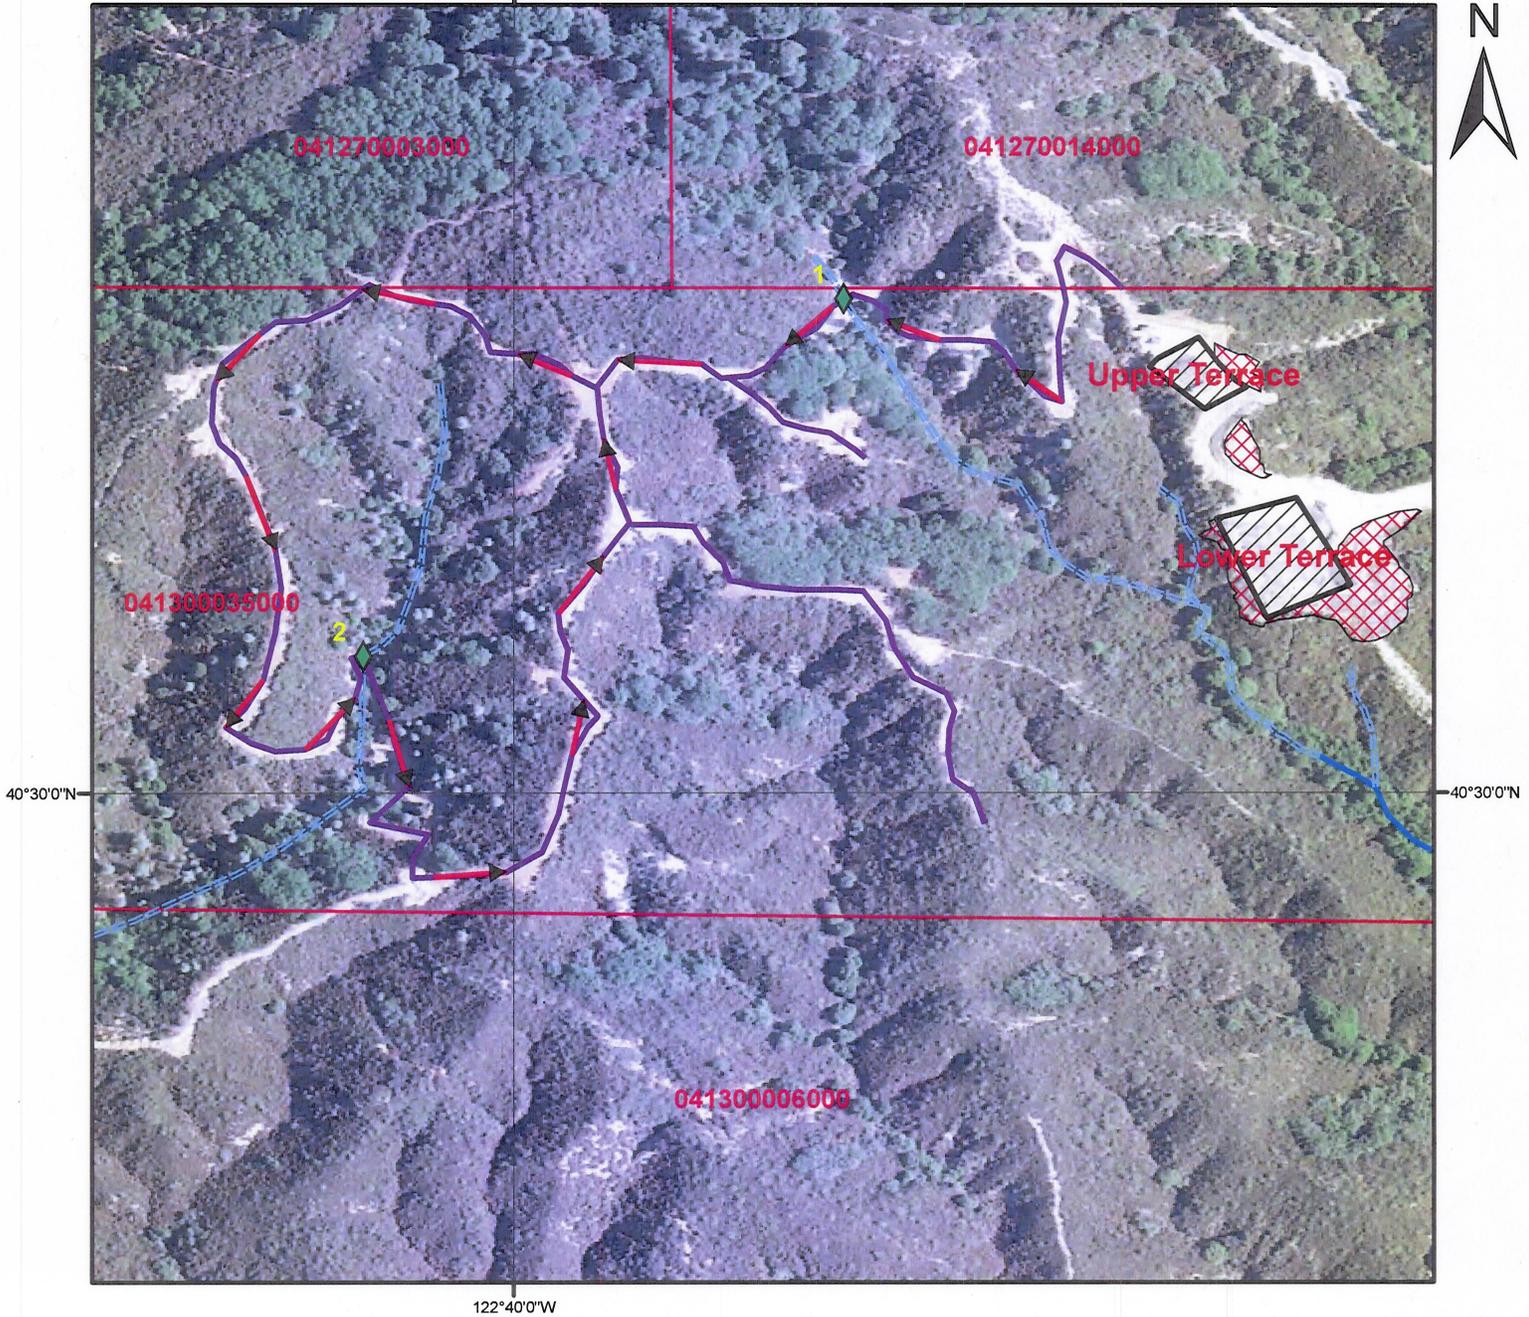
**Appendix A – Figure 1**

Staff identified two watercourse crossings (Refer to Figure 1) on the New Road. Both were constructed by pushing/grading native soil material into a watercourse and riparian zones, to form a surface over which vehicles could pass.

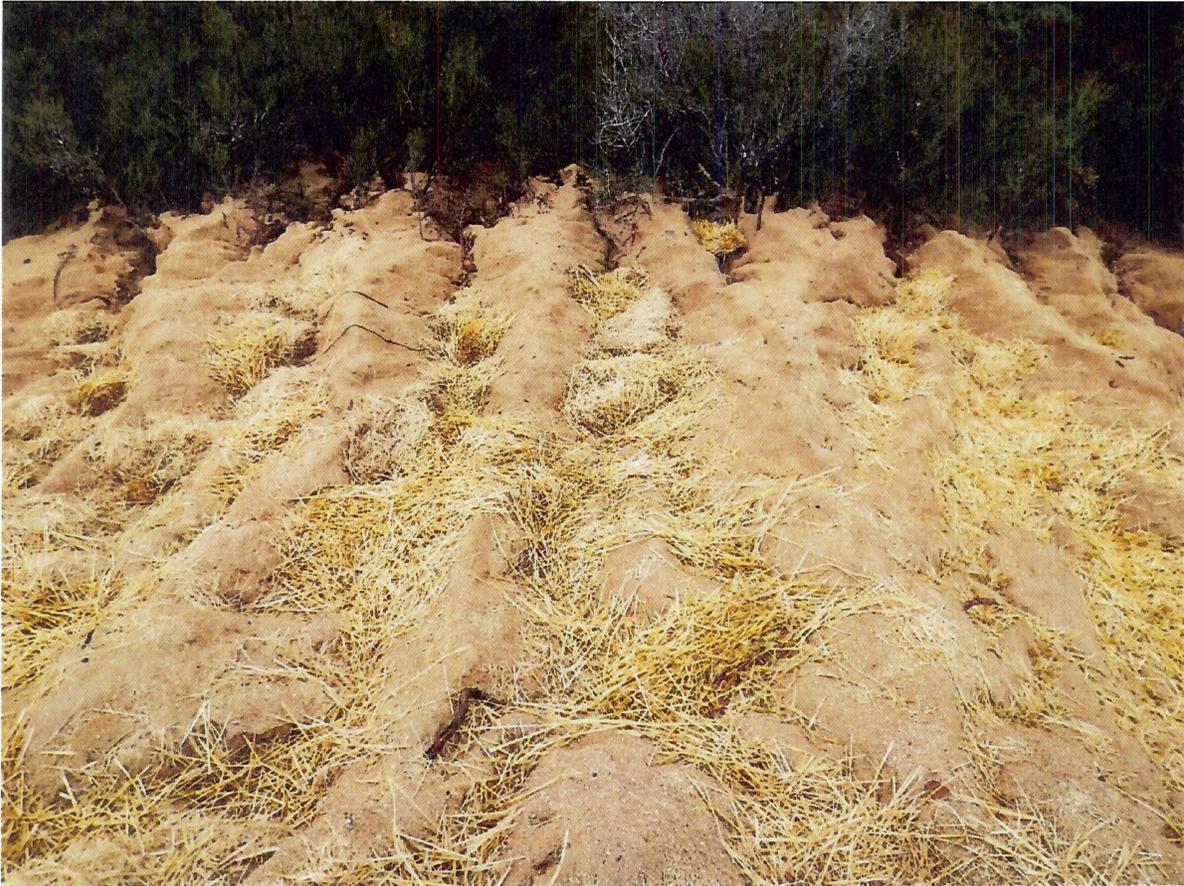
It was evident due to rain and runoff before and during this inspection that the seed and straw mulch, while effective on the flatter areas of the terraces and the road, was insufficient to fully protect and prevent erosion on the steep (greater than 50% grade as measured during 28 October 2014 inspection) south and west fill/side slopes of the lower terrace. On these steep fill/side slopes the seeds and straw mulch had been mobilized downslope and into rills by wind and rain, leaving the majority of the erodible fill/side slope surfaces exposed and vulnerable to further erosion (Photograph #1). Mr. Axner stated that he would like to "pull back" those fill/side slopes to make them less steep then install erosion control blankets to protect the slopes.

Photograph #1. West fill/side slope of lower terrace with straw mulch ineffectively protecting fill material from erosion.

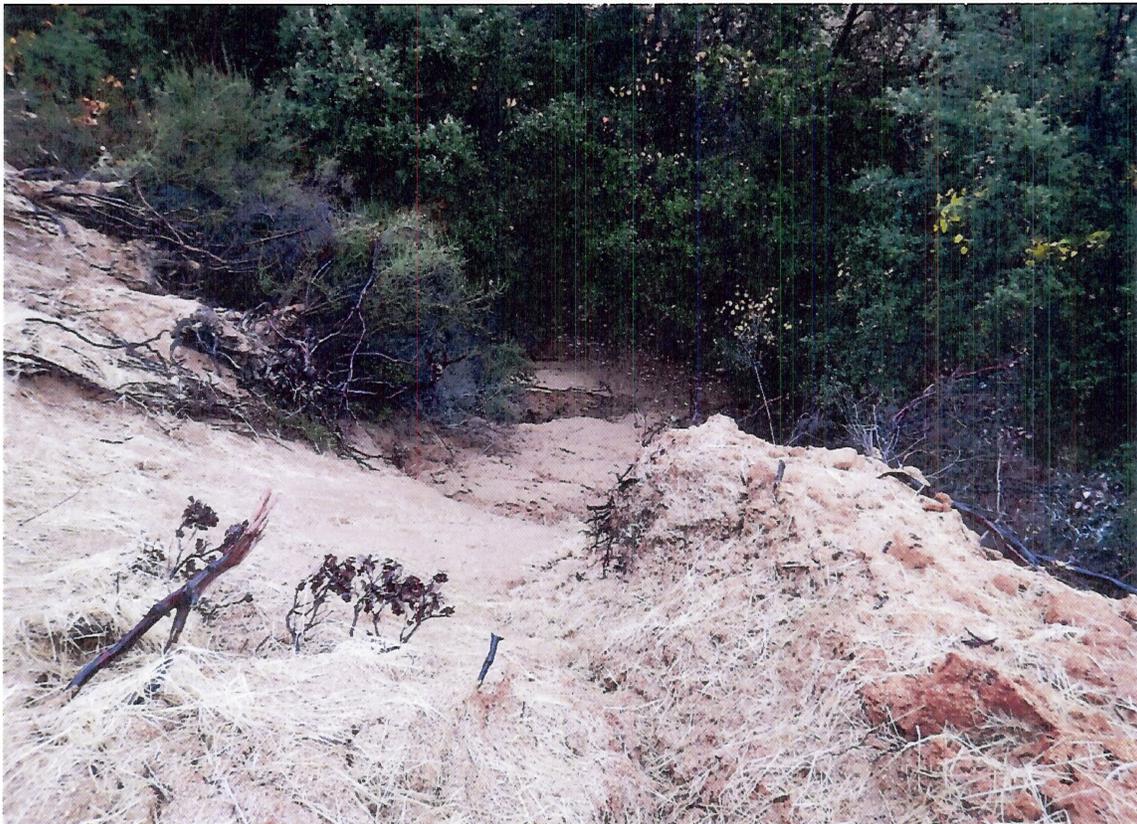
Photograph #2. Area where road and fill material from the New Road has discharged to an un-named tributary of North Fork Cottonwood Creek.

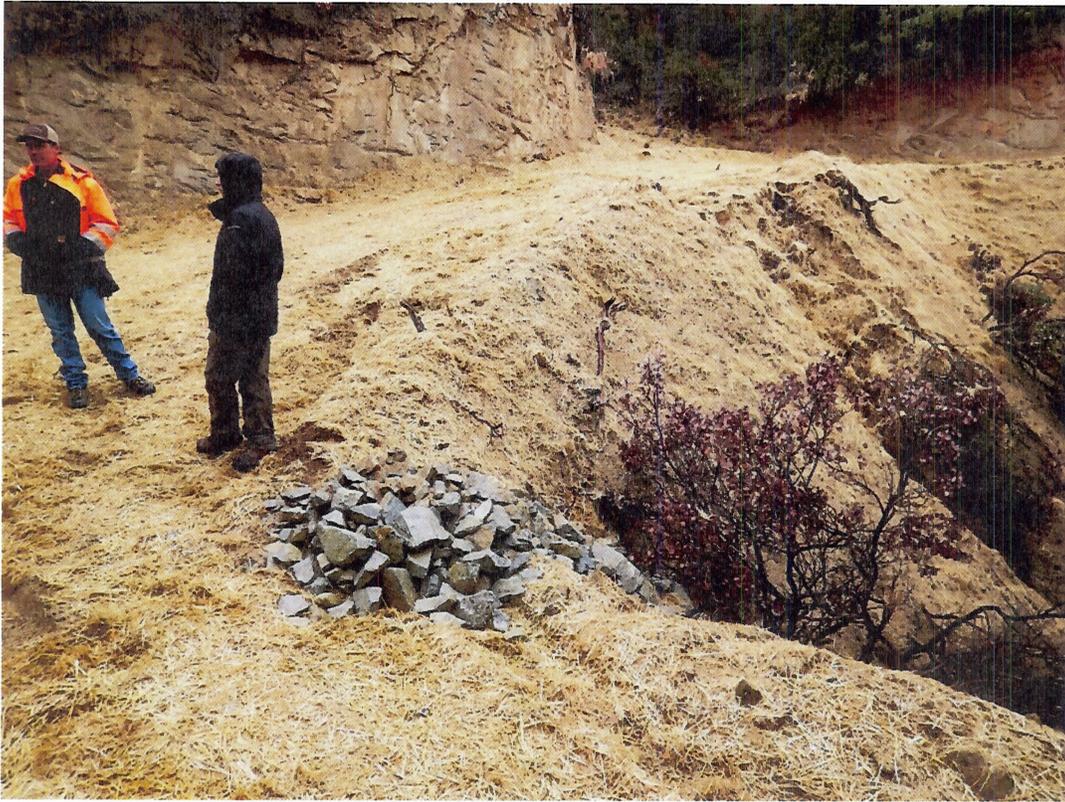
#### *Crossing 1, Photograph #3*

At Way Point 1, Eddie Axner Construction had placed riprap in a deep erosional scar that was created by flow from the watercourse passing over the crossing then exiting the road surface to the downstream side. This riprap could prevent the current erosional scar from growing, but will not prevent flow of the watercourse from continuing to erode this un-armored watercourse

crossing and discharging fill/road material to the watercourse. Mr. Axner agreed that a significant amount of fill and road material had already discharged to the watercourse, and that additional measures were needed to stabilize this watercourse crossing and prevent it from discharging more fill/road material to the watercourse. The crossing was conservatively measured during the 28 October 2014 inspection as being approximately 32 feet long, over 20 feet wide, with an average thickness of over 12 feet on the downstream side, 0 feet on the upstream side, and was constructed by placing more than 3,840 cubic feet (as calculated from measurements) of native rock and soil in the watercourse and adjacent riparian areas at this location. No permits were obtained for the construction of this watercourse crossing.

Photograph #3. Way Point 1 - Riprap in deep erosional scar on downstream side of watercourse crossing.

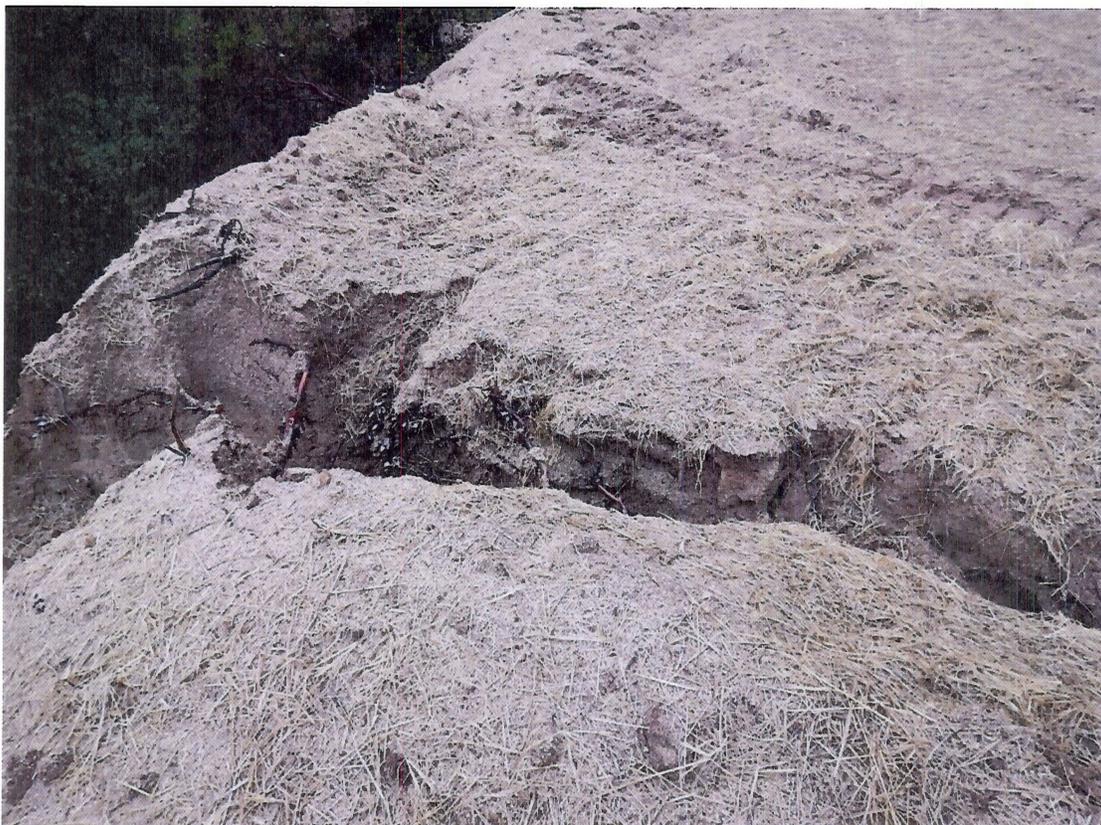
Photograph #4. Stormwater discharge location on New Road approximately 100 yards south of Way Point 2.

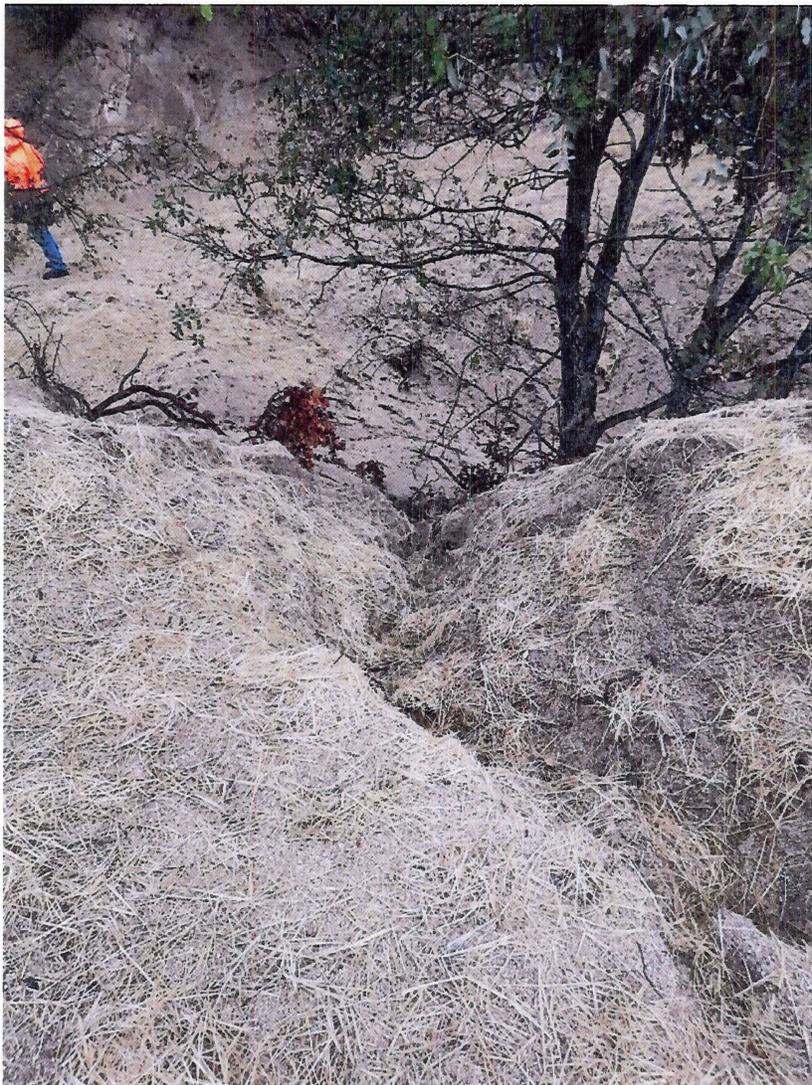
#### Crossing 2, Photograph #5

At Way Point 2, staff estimated more than 75 feet of stream channel had been filled using more than 4,680 cubic feet (as calculated from measurements) of native earthen materials to construct the watercourse crossing. The crossing was conservatively measured by CDFW staff during their 7 November 2014 inspection as being approximately 78 feet long, over 12 feet wide, with an average thickness of over 10 feet on the downstream side, 0 feet on the upstream side. There is no culvert or armoring at this crossing, meaning that flow from the watercourse passes over the road surface composed of native soil that is highly erosive and largely un-compacted decomposed granite fill and then down the fill/side slope to the channel below. Mr. Axner and Mr. Bond agreed that a significant amount of fill and road material had already discharged to the watercourse from this crossing, and that significant erosion control measures were needed to stabilize this watercourse crossing and prevent it from discharging more fill/road material. It is the consensus of Staff that, due to the topography and the erodibility of soils at this location, a watercourse crossing should never have been constructed at this location. Again, no permits were obtained nor plans submitted for the construction at this crossing.

Photograph #5. Way Point 2 – Fill and road material from New Road/watercourse crossing within watercourse on downstream side of watercourse crossing.

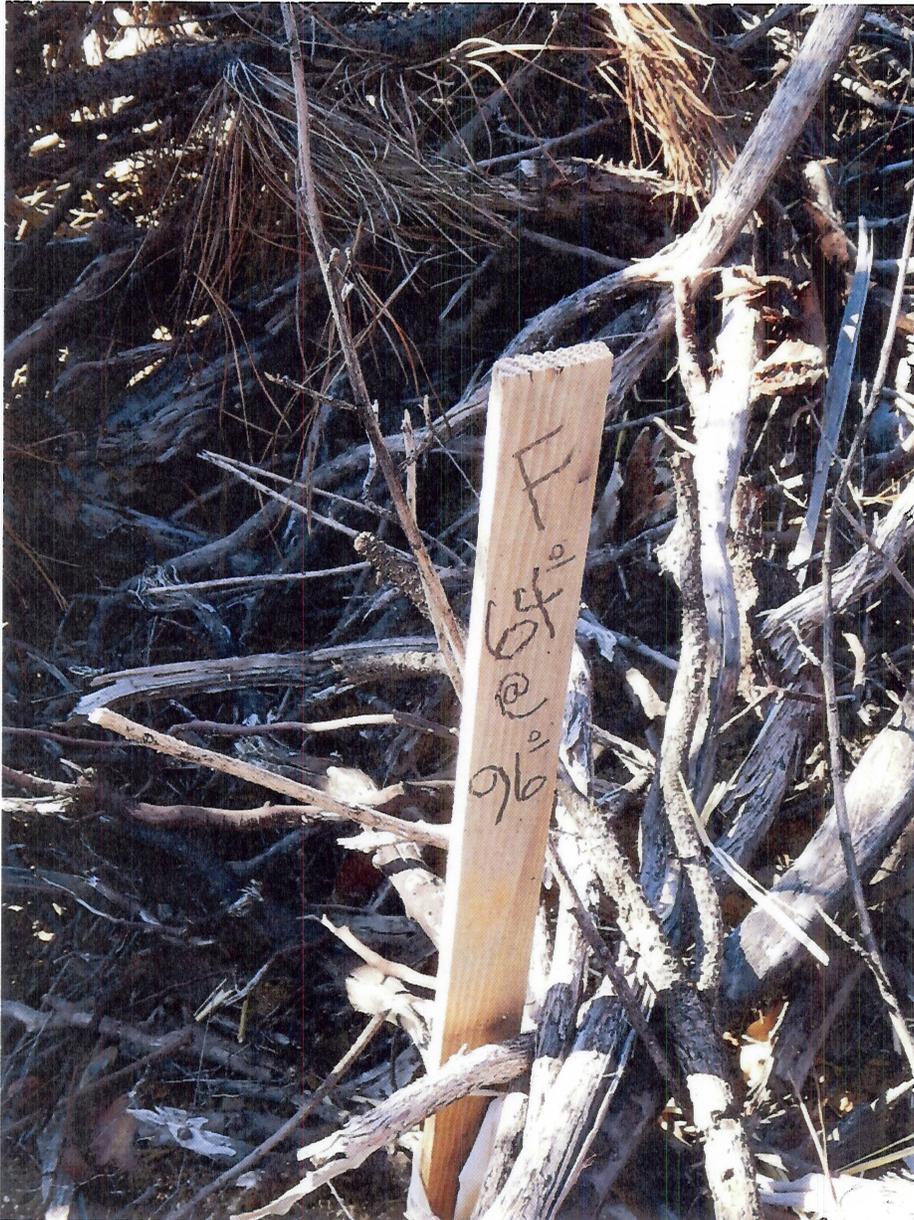
Photograph #6. Eddie Axner Construction grading stake documented during the 28 October 2014 inspection.
