21 June 2016 Inspection Report

CENTRAL VALLEY REGIONAL WATER QUALITY CONTROL BOARD

INSPECTION REPORT

FACILITY: Joseph Magdic Jr.:
Madera County APN 045-122-007(40 acres)

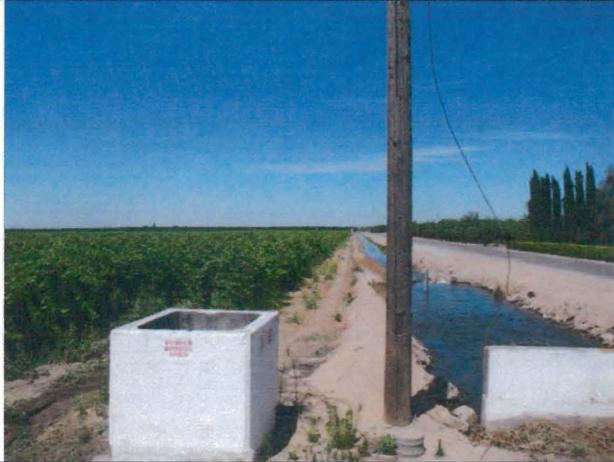
Photo 1(photo 2616): Photo taken facing West from northeast corner of Madera County Assessor's parcel number 045-122-007. Parcel is a vineyard, and is lower than adjacent supply canal by about 1ft.

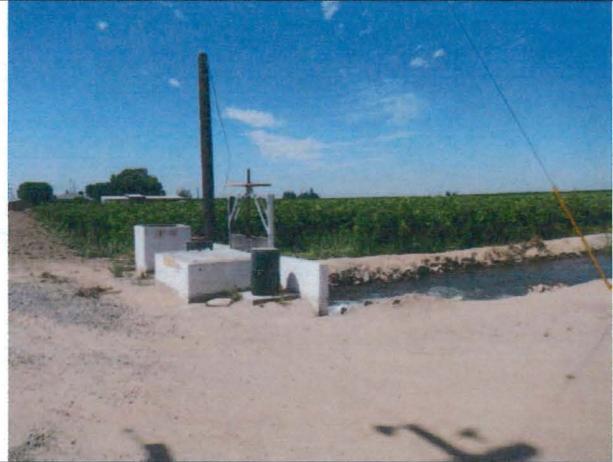
Photo 2(photo 2617): Photo taken from same location as photo 1. Photo shows supply canal and vineyard.

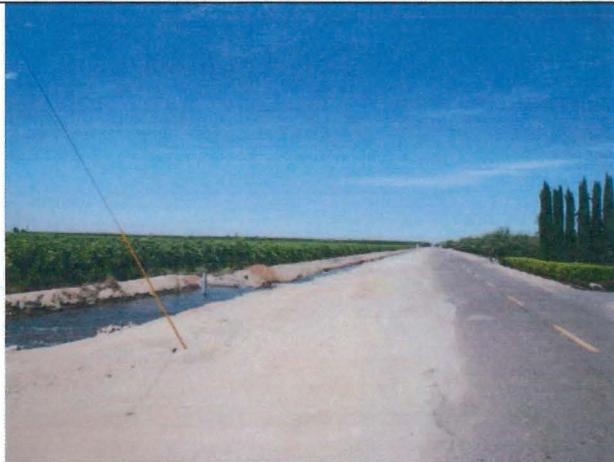
Photo 3 (photo 2618): Photo taken facing West from same location as photo 1. Shows another view of vineyard and supply canal. There are no roadside drainage ditches in this area of the County.

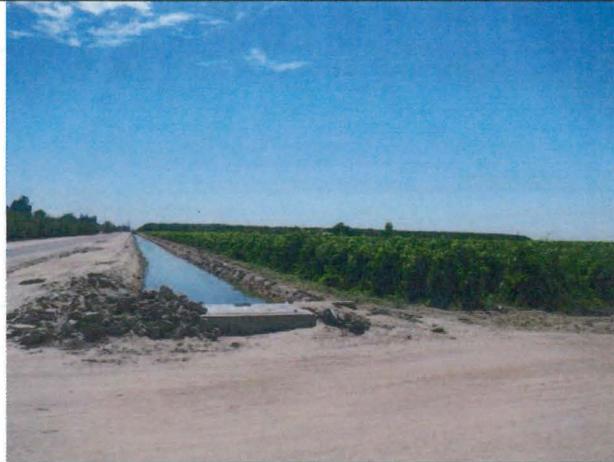
Photo 5 (photo 2620): Photo taken from same location as photo 4. Photo shows parcel is lower than supply canal.
