16 September 2015 Inspection Report

Irrigated Lands Regulatory Program Inspection Report

Owner(s):	Gilbert & Enedina Marroquin	Coalition:	KBWQA	County:	Tulare
Parcel Number:	119-110-012	Acres:	39.6	I.D. #	P1

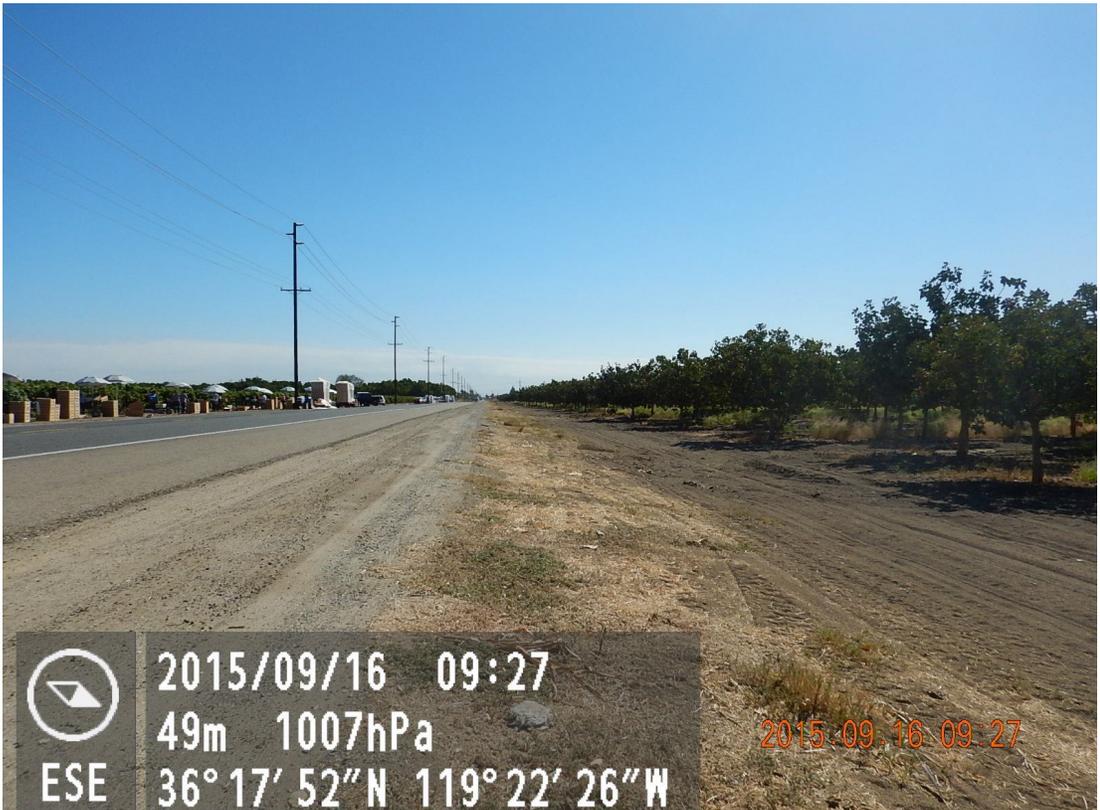
Inspection Photo:

Date Inspected:	9/16/2015
Inspected By:	PAB/RKW
Type of Inspection:	Field
Results:	Commercially Irrigated Agriculture
Crop type:	Pistachios
Irrigation Method:	Drip
Other/Notes:	Parcel is generally lower than the road. Canal that runs along east and south side of parcel has elevated bank 2-3 feet above field level. No drainage pipes or other features that would facilitate discharge into canal. No signs of discharge.

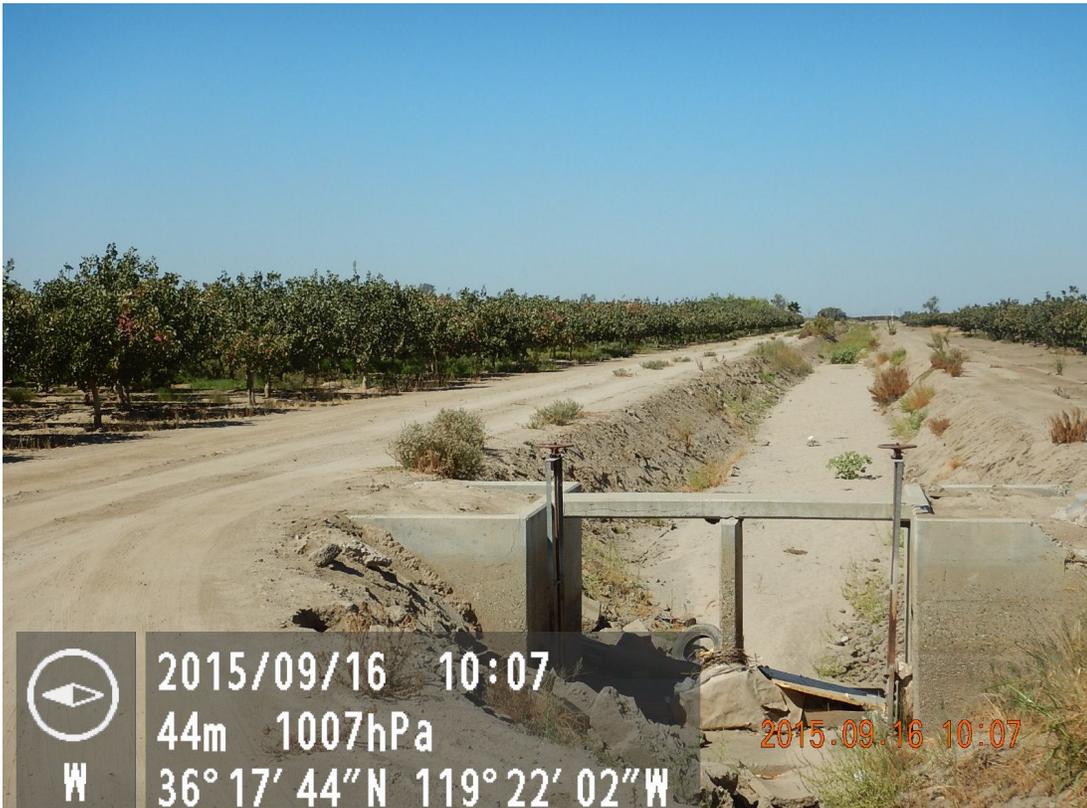
Inspection Photo:

Date Inspected:	9/16/2015
Inspected By:	PAB/RKW
Type of Inspection:	Field
Results:	Commercially Irrigated Agriculture
Crop type:	Pistachios
Irrigation Method:	Drip
Other/Notes:	Parcel appears to be lower than road that runs along the eastern edge of the property. Canal that runs along northern edge of parcel has an elevated bank of 2-3 feet. No visible drainage pipes or features that would facilitate discharge into canal. No visible signs of discharge.
