ATTACHMENT B - INSPECTION PICTURES

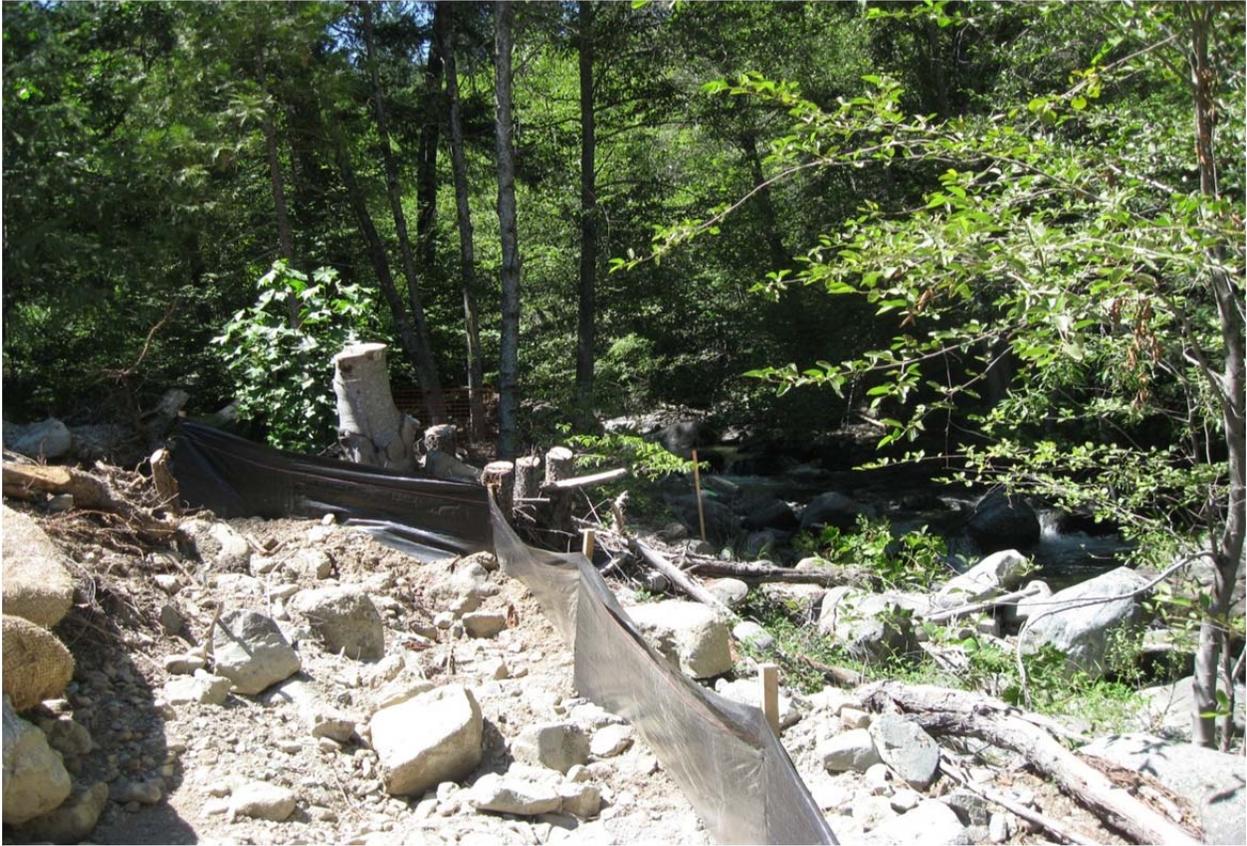
Picture above (08/03/11) shows silt fence overloaded and undercut with sediment discharge beyond the fence. Improperly installed and unmaintained silt fence was observed several times.

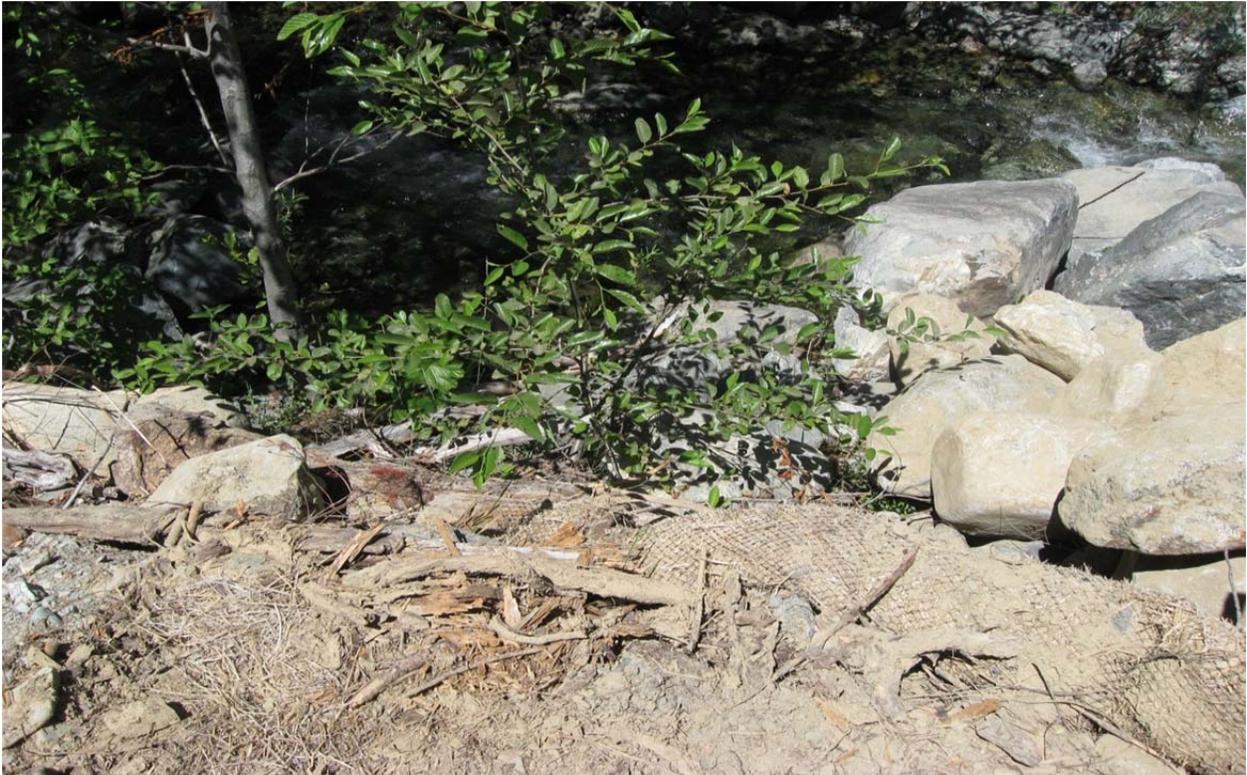
Picture above (08/03/11) shows inadequate perimeter controls, with straw wattle being damaged and improperly installed.

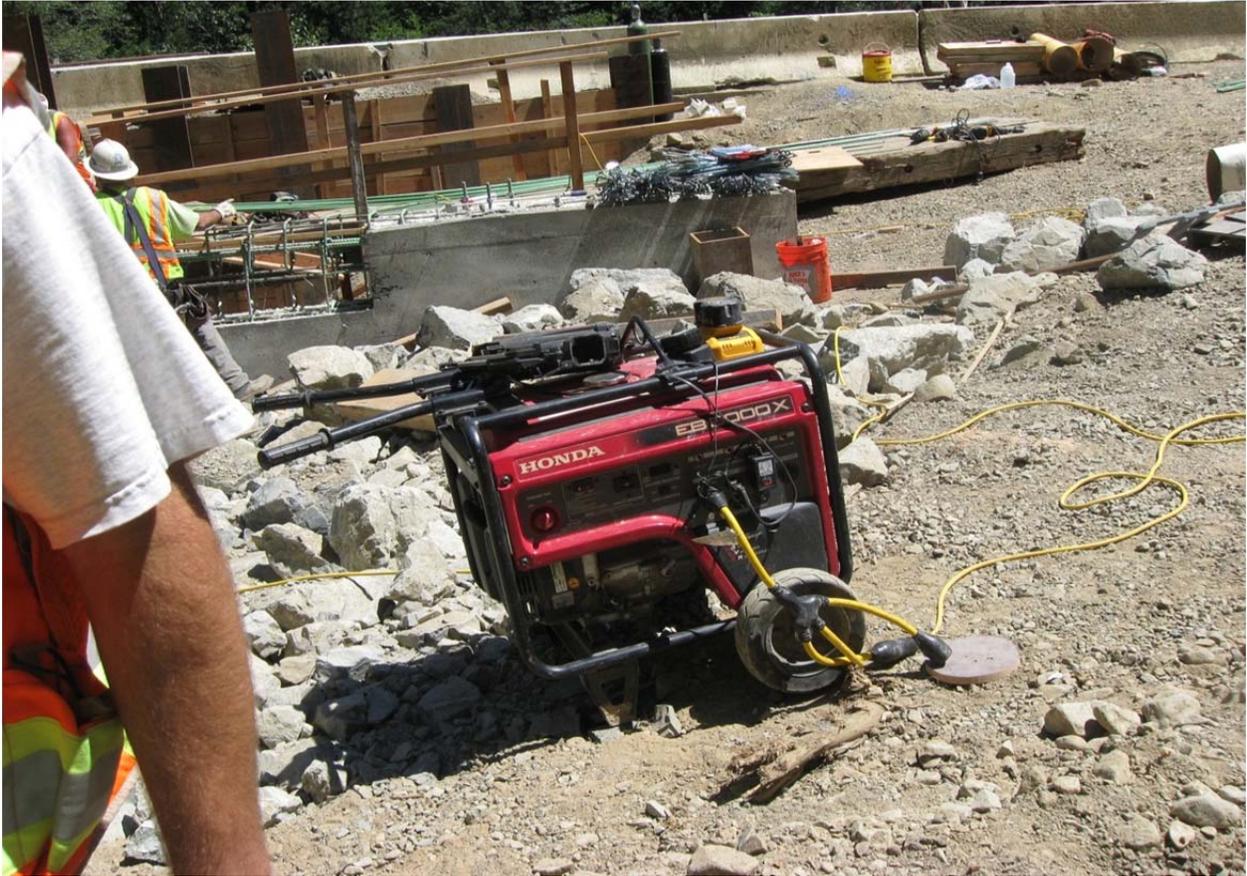
Picture above (08/03/11) shows generator without secondary containment within 50 feet from the creek.

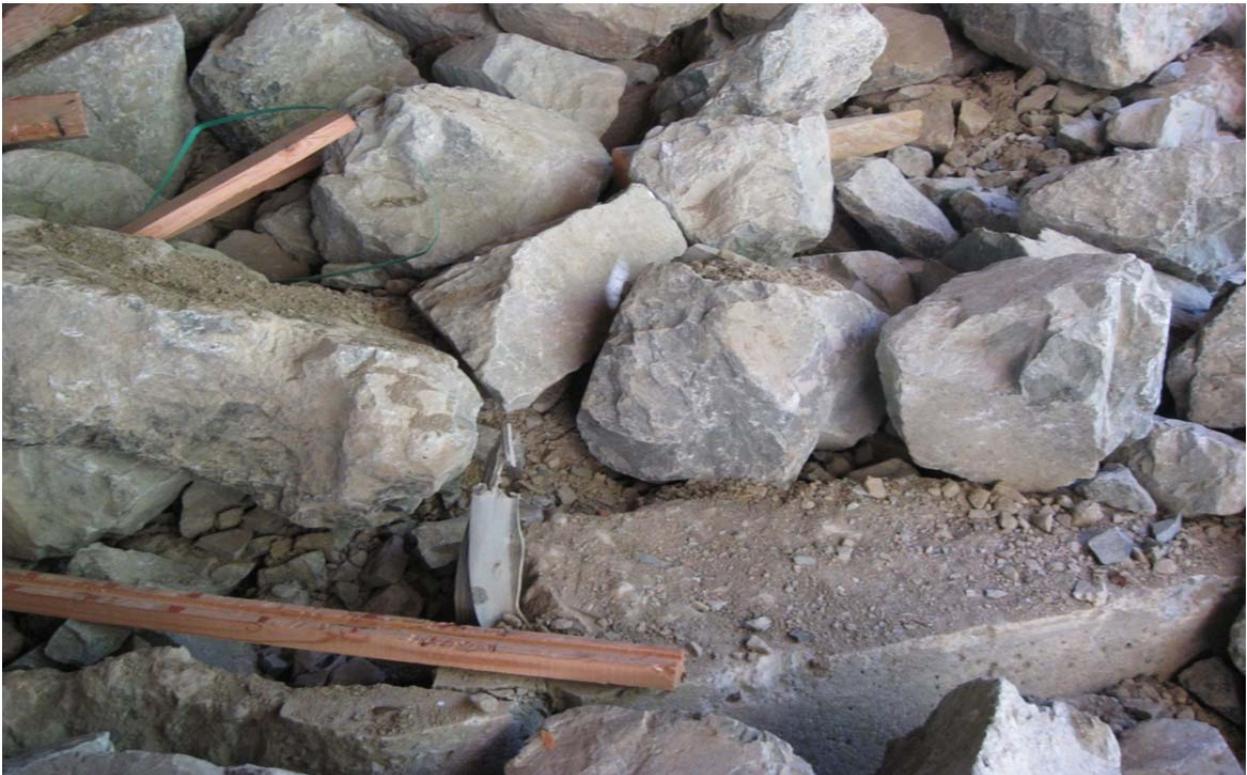
Picture above (08/03/11) shows rock with fines, loose sediment, concrete chunks, plastic, slash, and other construction debris. This image illustrates the lack of effort to provide clean fill material.

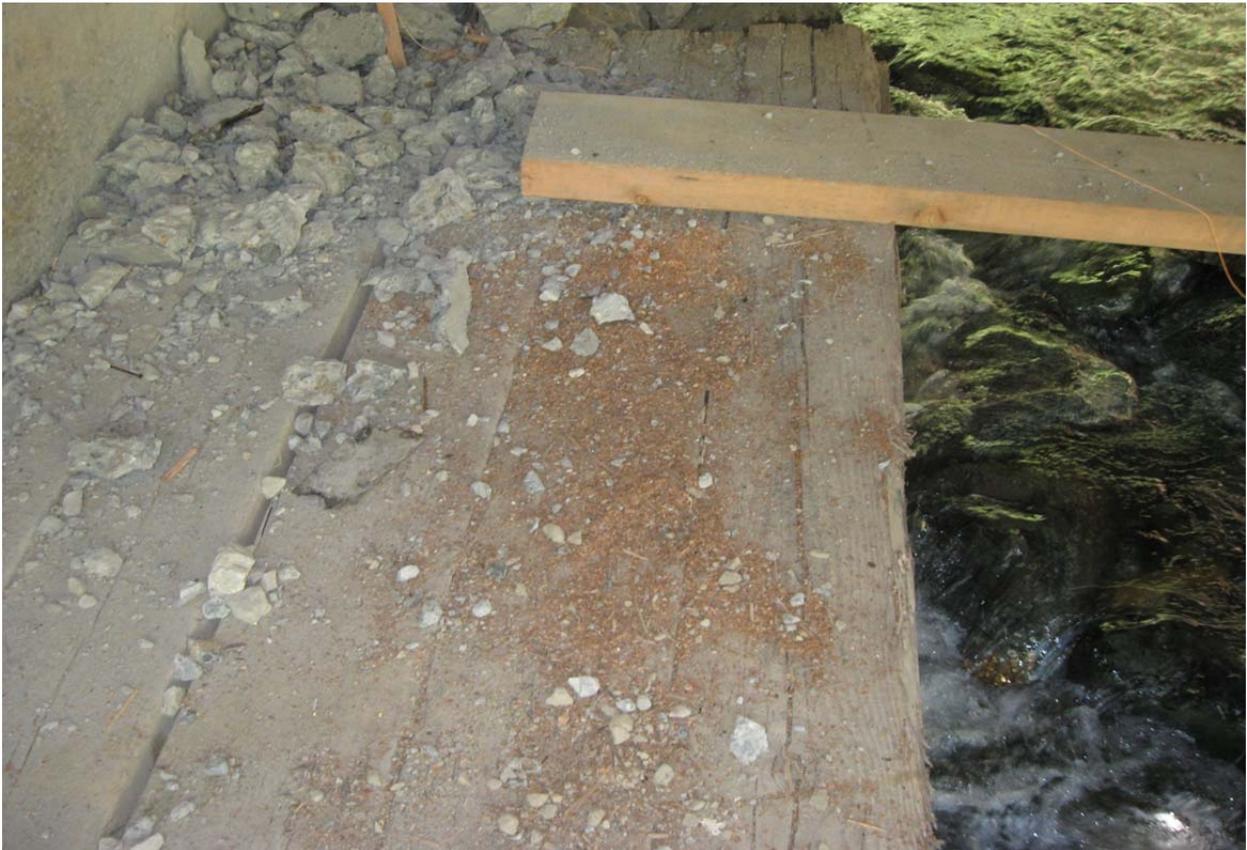
Picture above (08/03/11) shows insufficient containment of debris associated with construction.

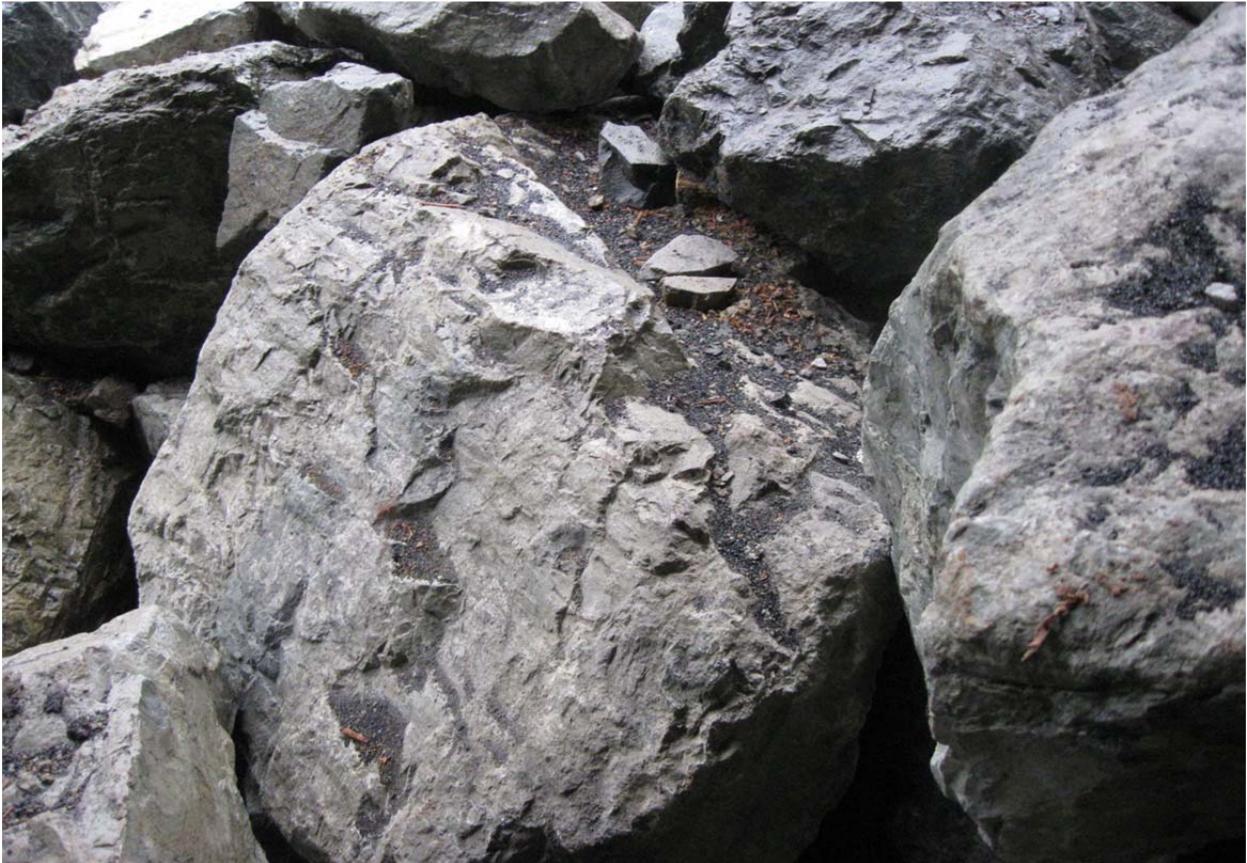
Picture above (12/29/11) shows sandblast material and welding slag that covered the rock slope protection and was found throughout the creek.

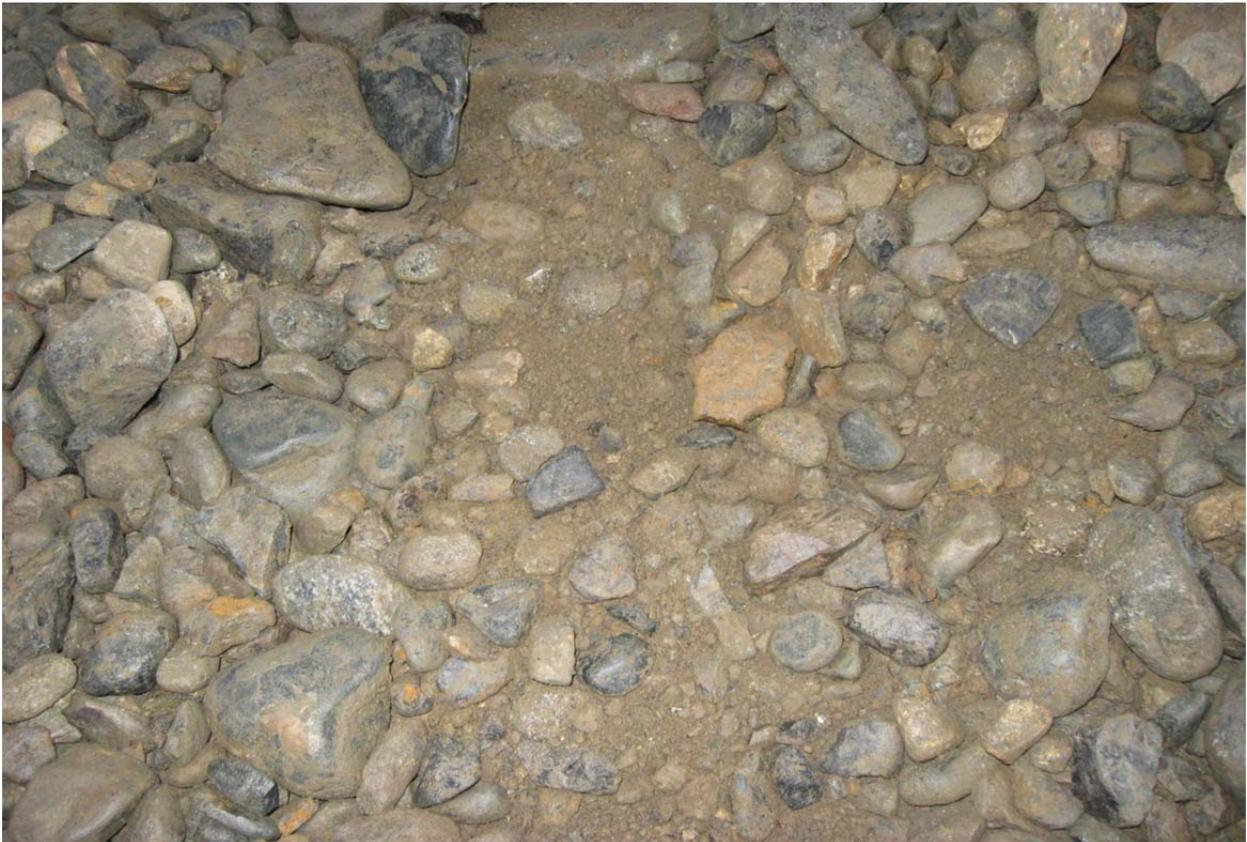
Picture above (12/29/11) shows an example of sediment discharged throughout the gravel bar at the Trinity River Bridge.

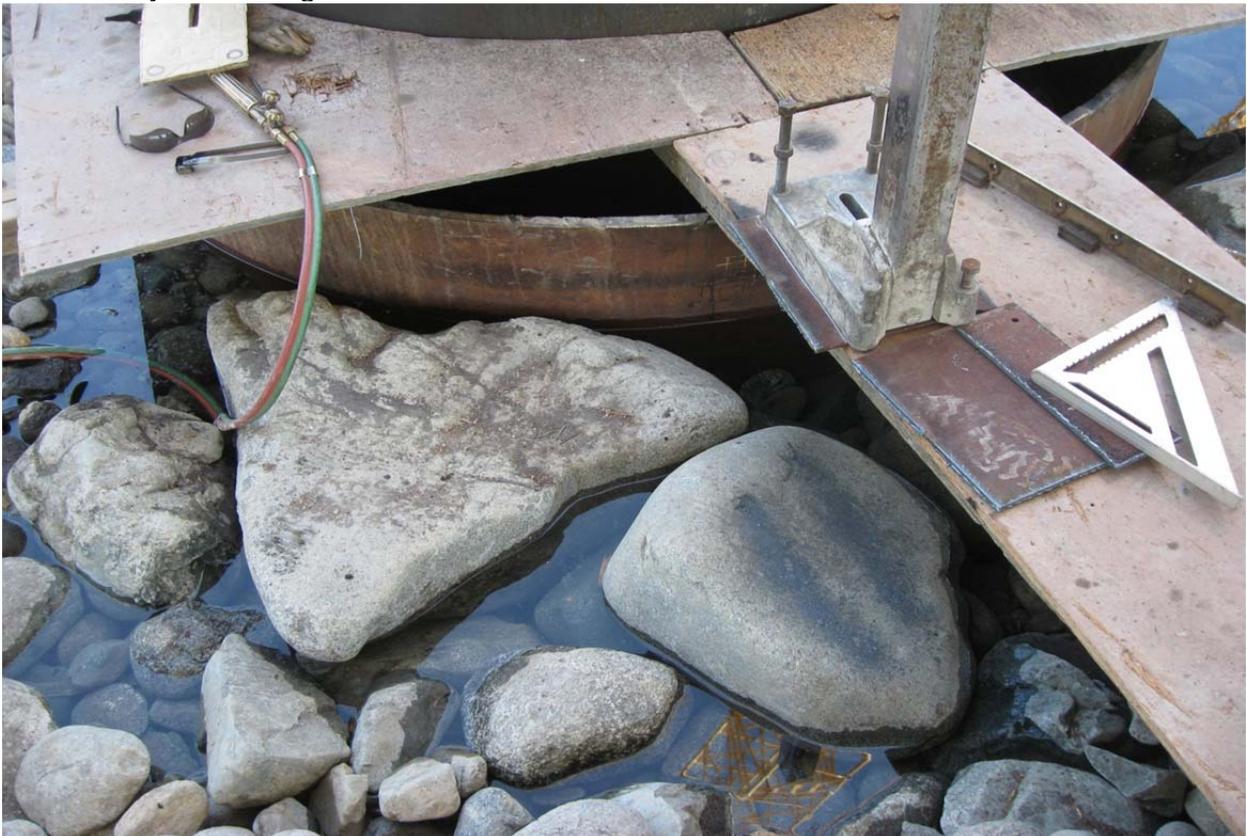
Picture above (08/03/11) shows slag and evidence of welding directly on the gravel bar at the Trinity River Location.

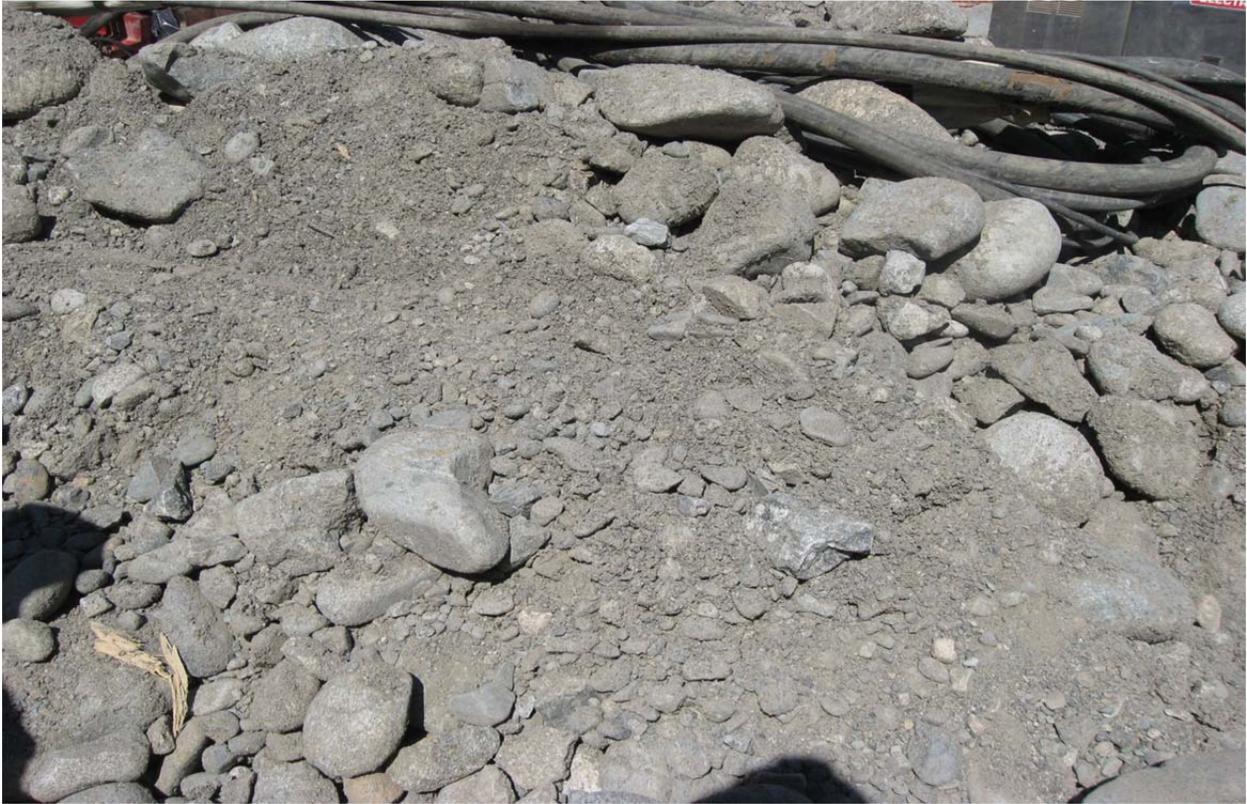
Picture above (08/03/11) shows example of drill spoils deposited directly on the gravel bar and hydraulic hoses and equipment without sufficient containment.

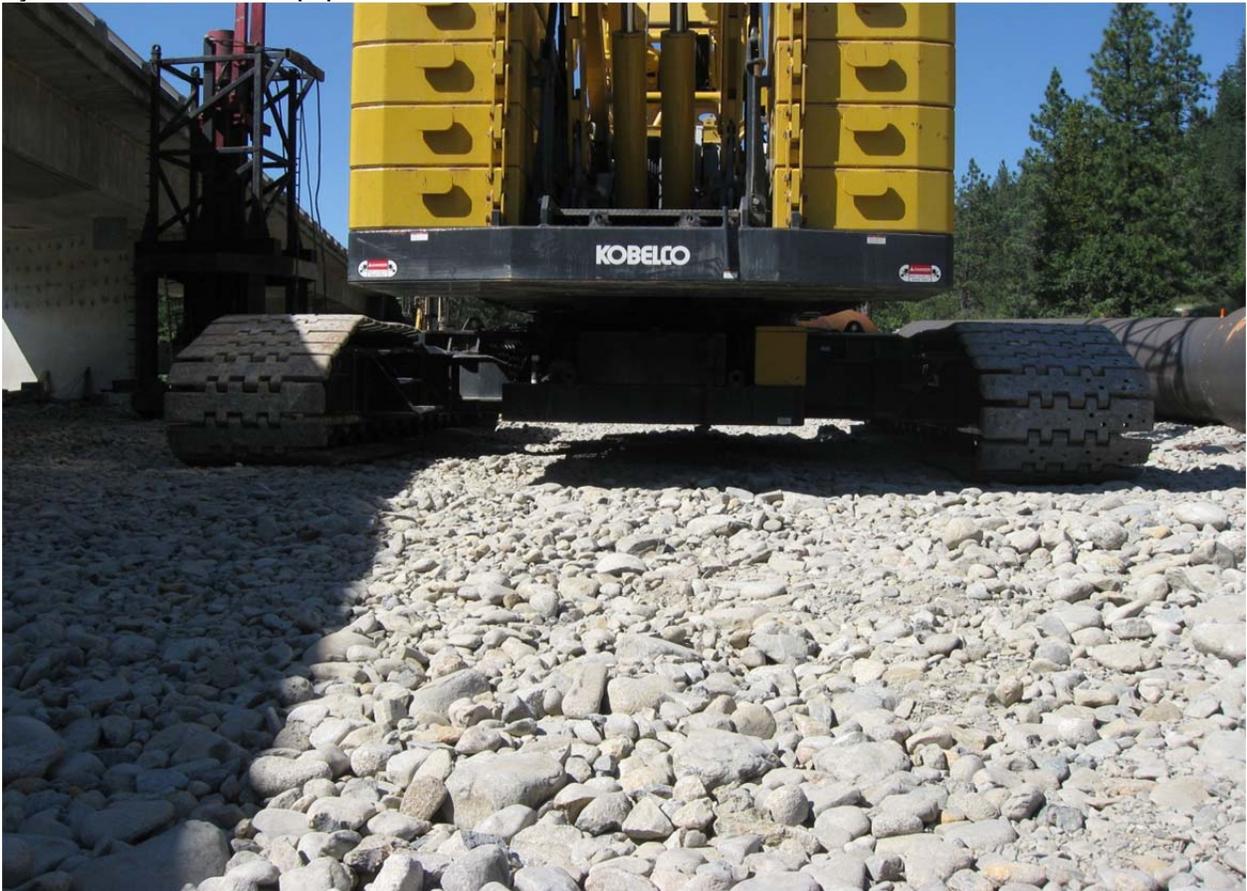
Picture above (08/03/11) shows idle/cold equipment on the gravel bar without drip pan or containment. Oil and grease was observed at several locations on the bar.

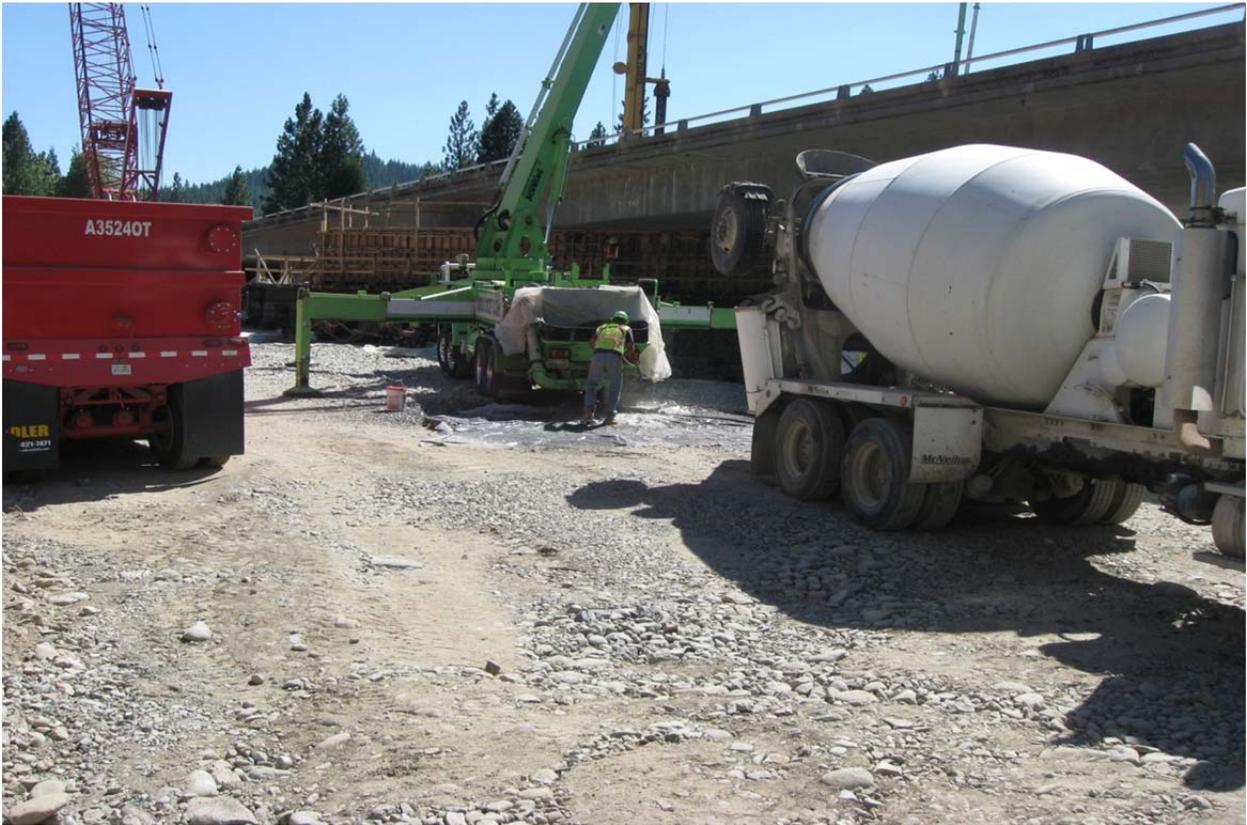
The picture above (08/16/12) shows the contractor washing off the wet concrete onto the gravel bar.

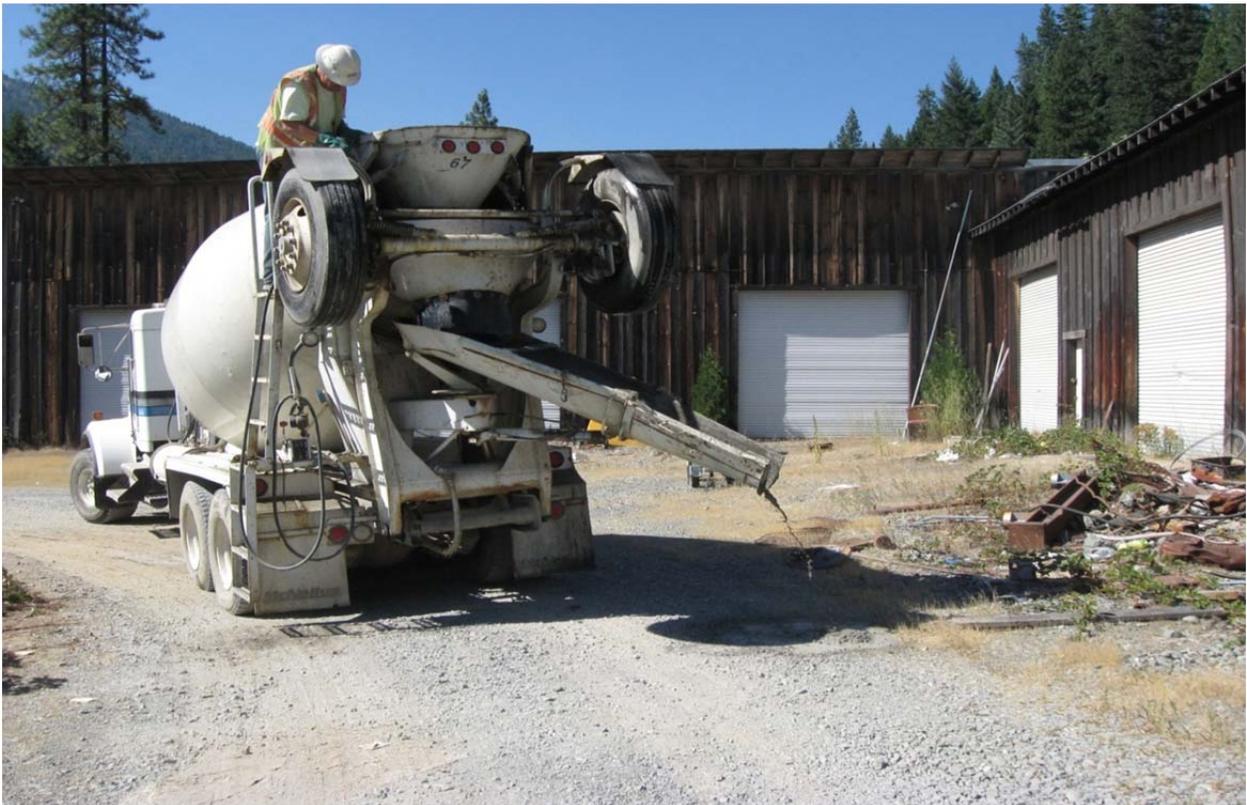
The picture above (08/16/12) shows a concrete truck being washed out on the ground next to the concrete washout and batch plant.

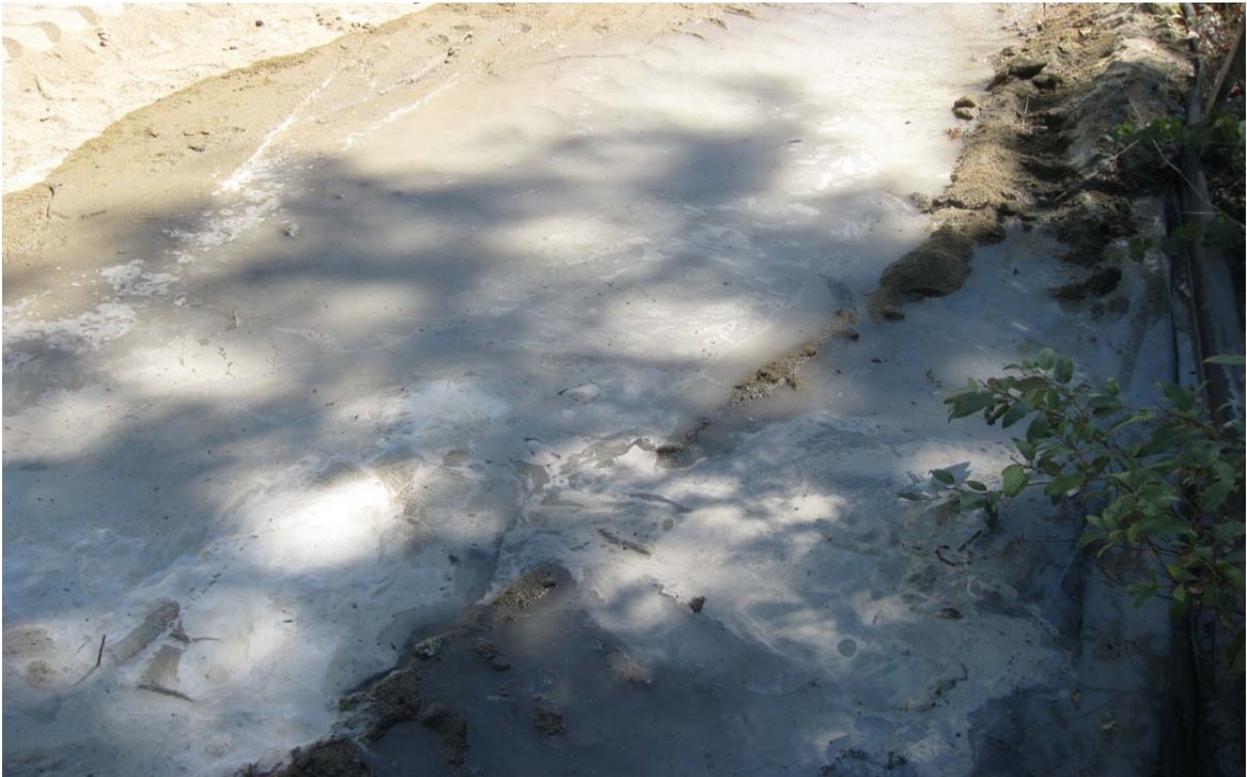
The picture above (08/16/12) shows a pool of concrete contact water that is rinsed off the batch plant. pH was measured at 10.82, see picture below.

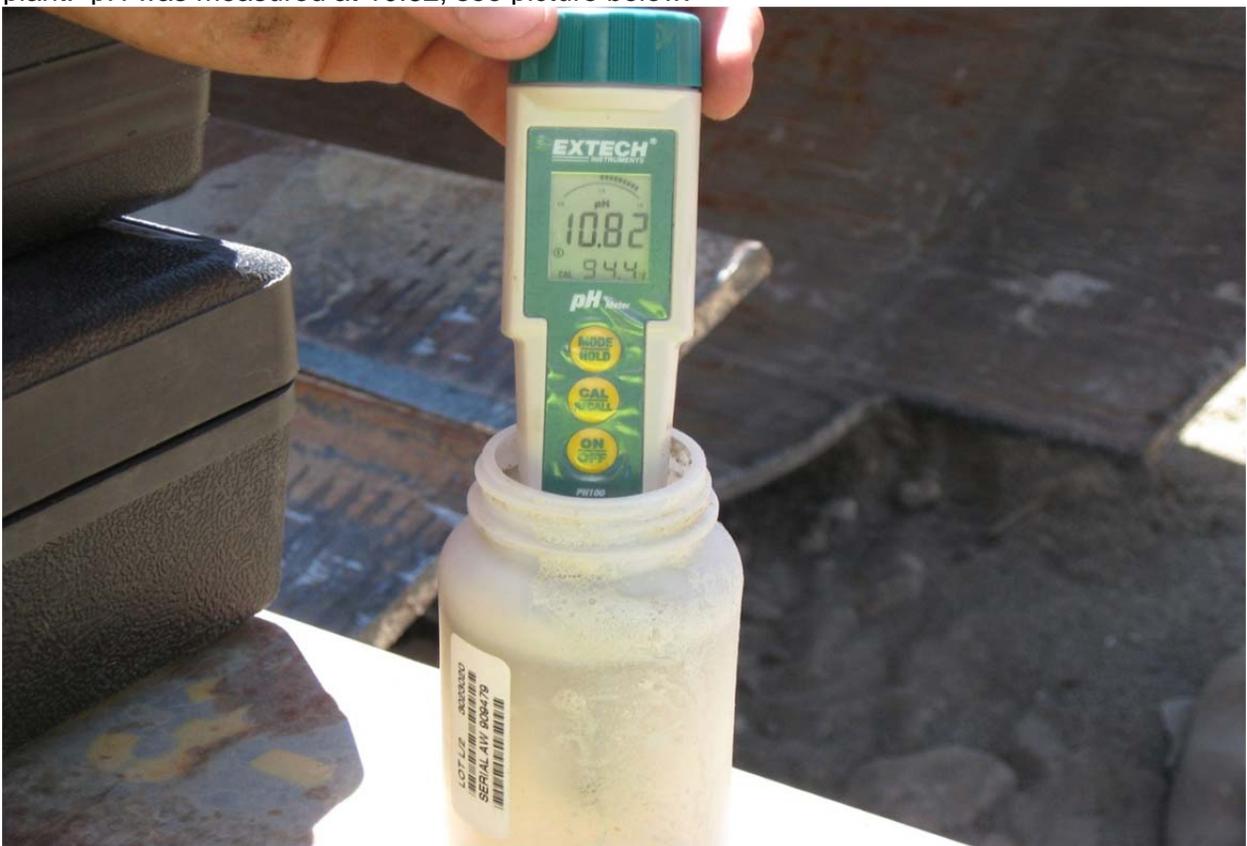
Meter was calibrated prior to use at the request of Regional Water Board inspector.

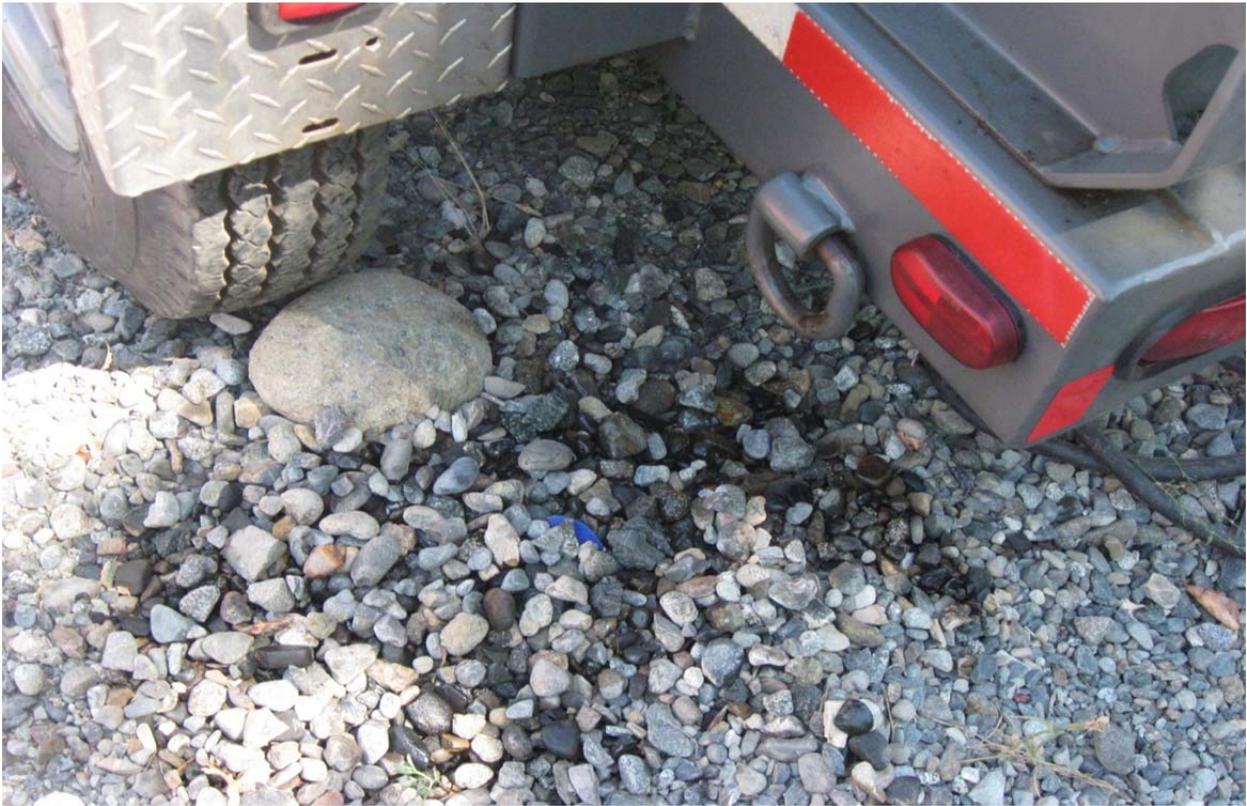
The picture above (08/16/12) shows a diesel spill that was not reported or cleaned up until directed to during the inspection.

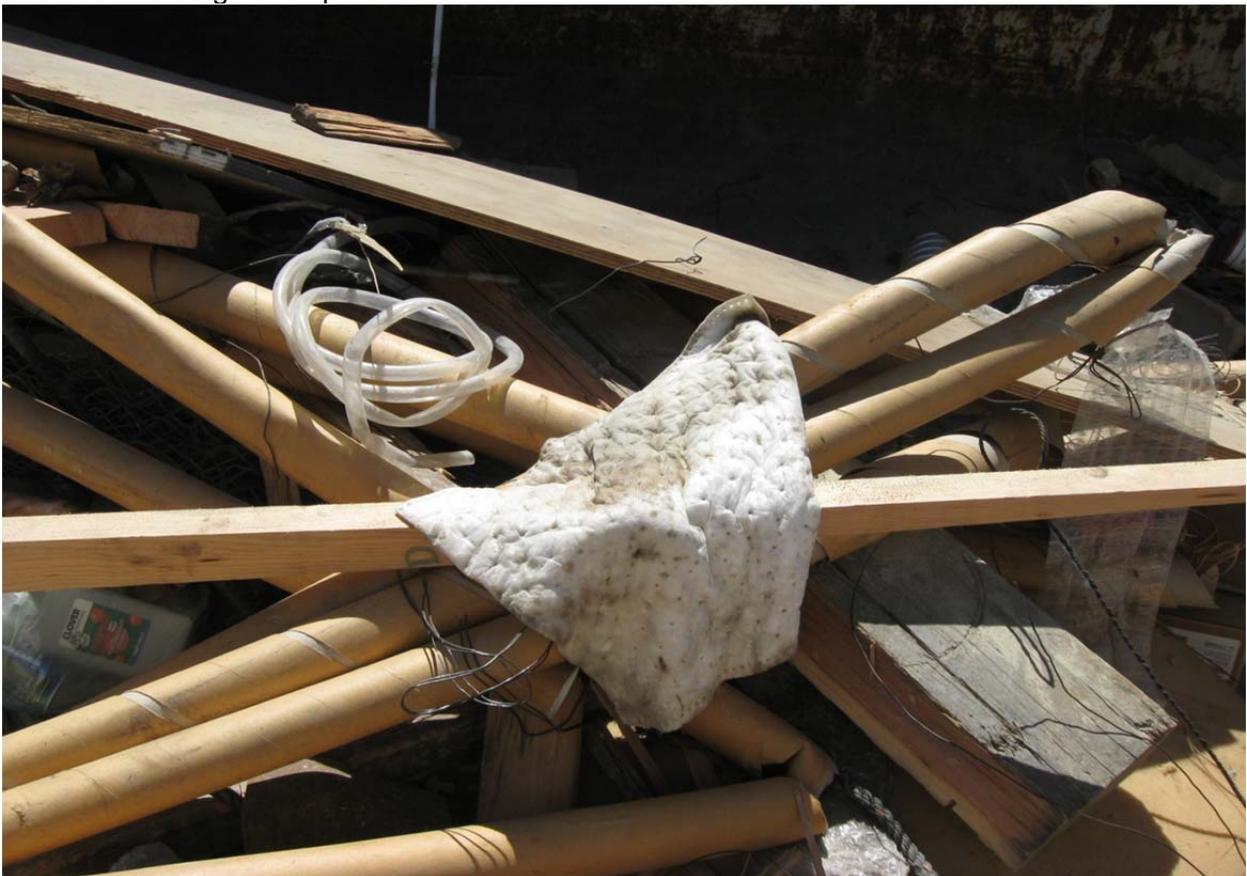
The picture above (08/16/12) shows an example of an oily adsorbent towel that was disposed in the non-hazardous waste dumpster.

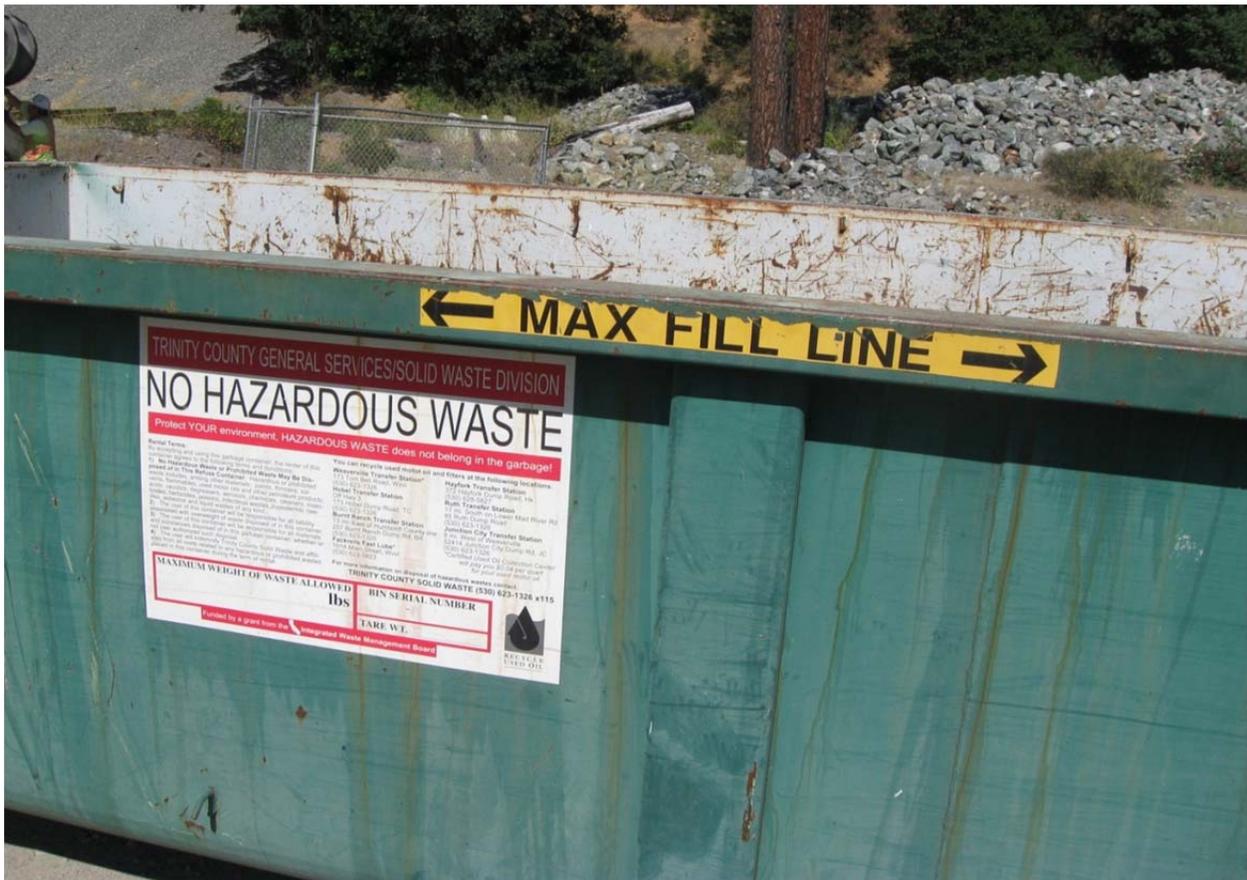
The picture above (08/16/12) shows the dumpster where oil rags and adsorbents were disposed.

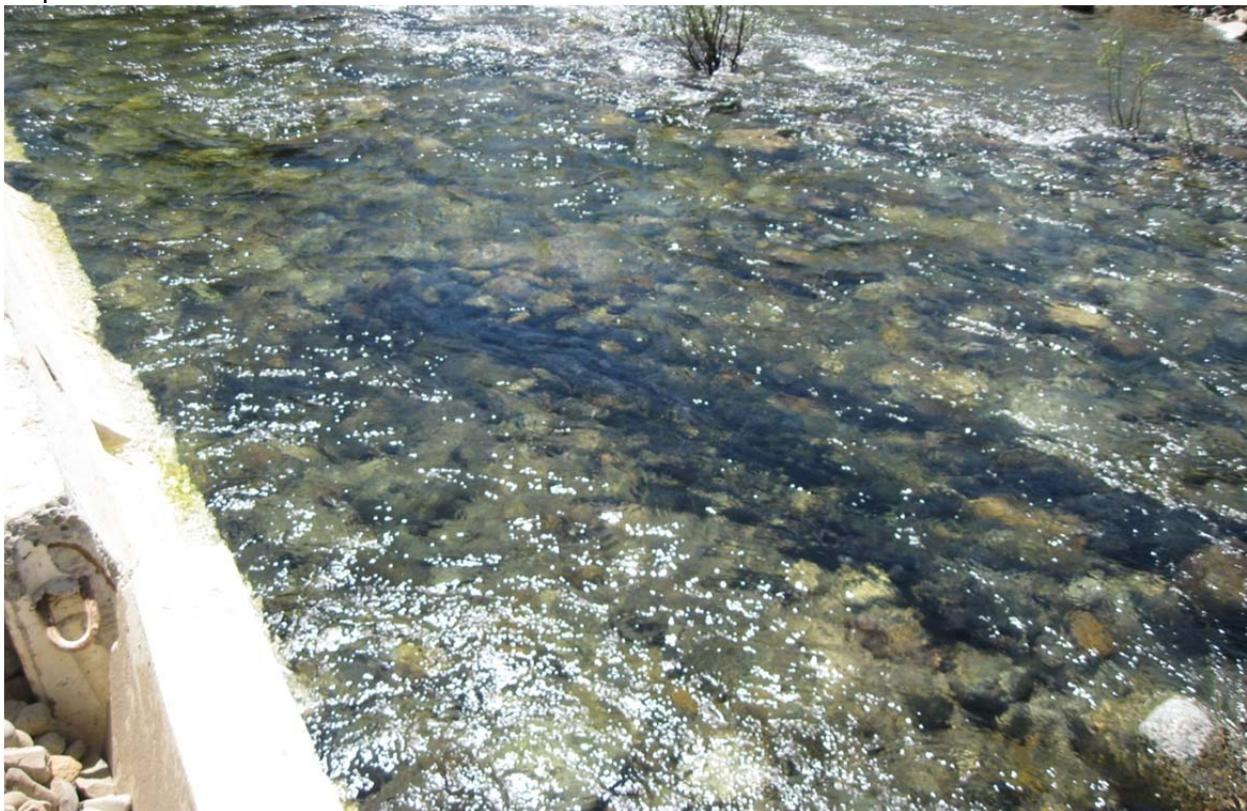
The picture above (08/16/12) shows plastic in the river from the previous year's diversion.

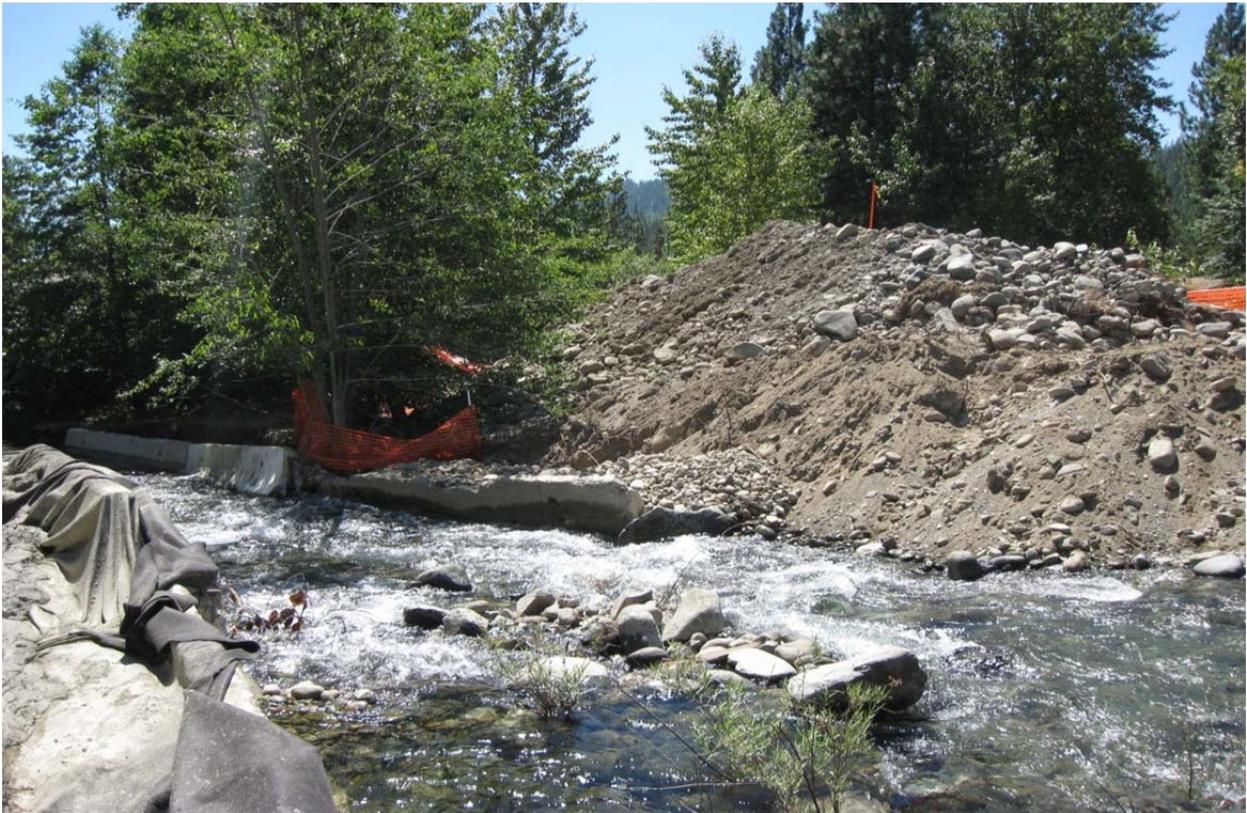
The picture above (08/16/12) shows the inadequate installation of the clear water diversion downstream of the project work area. Also, a stockpile of loose soil is adjacent of the river with little to no BMPs and appears to have contributed sediment to the stream.

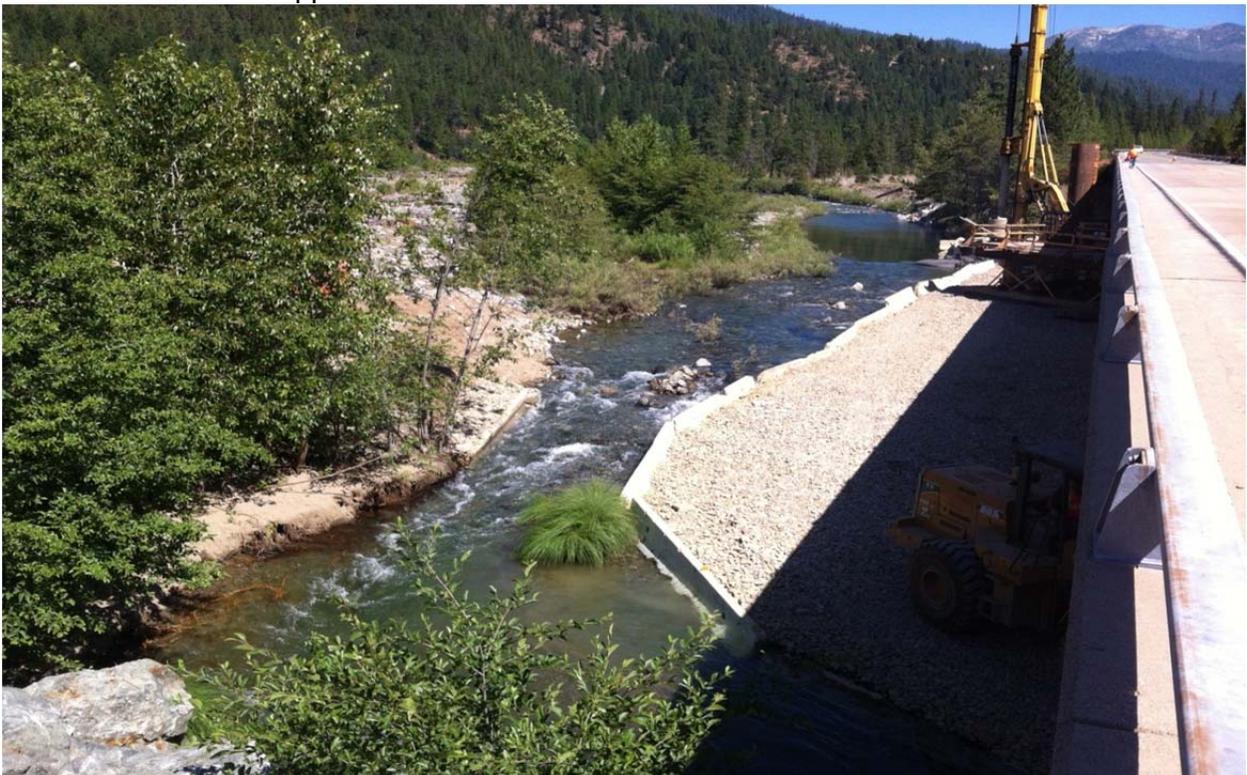
The picture above was provided by Caltrans on (08/03/11) notifying the Regional Board of Turbid discharges and issues with the diversion.
