North Coast Regional Water Quality Control Board

Subject: *Notice of Violation* for the Sonoma County Department of Transportation and Public Works, Central Solid Waste Disposal Site, 500 Mecham Road, Petaluma, CA

File(s): SCDPW Central Solid Waste Disposal Site, 500 Mecham Road, Petaluma CA, Sonoma County WDID#'s 1B801490SON and 1B99011RSON

Photograph Attachment

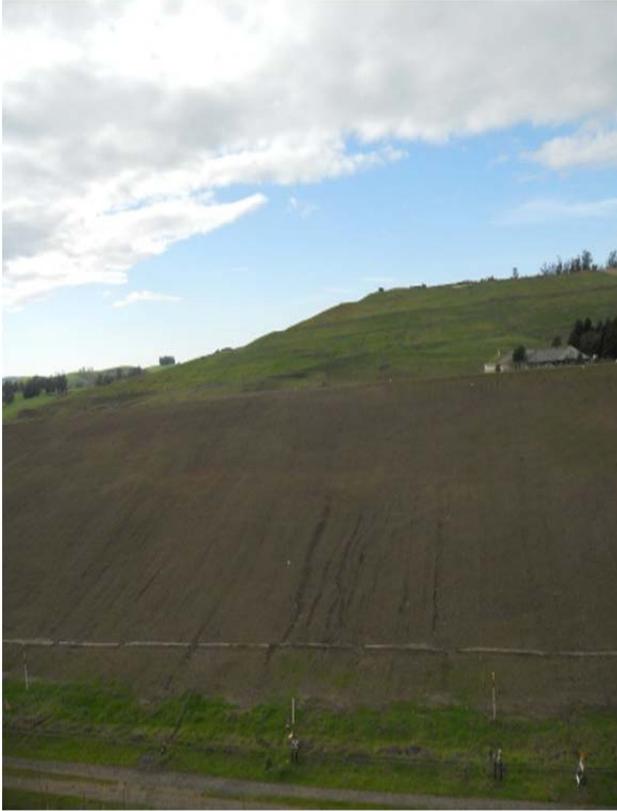
Active landfilling had concluded on the East Canyon Expansion Area (Landfill 2) several months prior and the daily cell/active face was moved to Landfill 1. All of Landfill 2 thus requires appropriate intermediate cover and erosion control measures to be deployed. The top deck and eastern side slopes of Landfill 2 had been graded but lacked adequate vegetative cover. Sparse erosion control materials were in place resulting in exposed and bare soils. Although the top deck and dome are graded to promote positive drainage, the slope length off of the eastern portion is long, and it lacks benching. Hydro-seeding efforts, reportedly completed in early October 2012, did not result in a successful cover crop. Staff did not observe residual seed remaining within the cover soil. No mulch had been applied to the top deck and the dome had experienced consecutive erosion rills throughout the length of the unit's eastern face.

Landfill 2
Rilling off top deck, sparse erosion control measures deployed. Inadequate vegetative cover on long slope run.

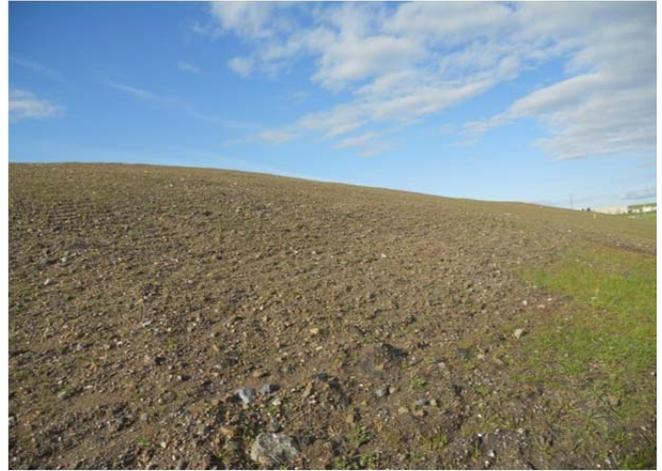
Landfill 2-Decking looking north
Inadequate vegetative cover and exposed soil.

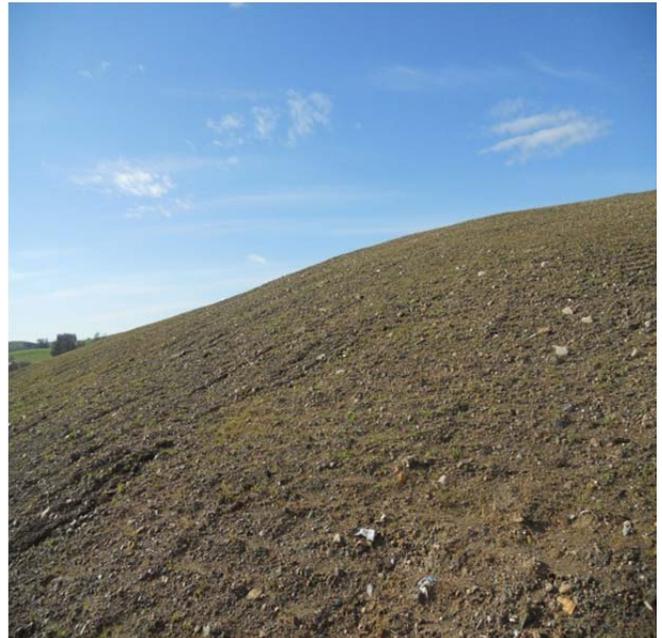
Landfill 2-Decking looking south
Inadequate vegetative cover and rilling.

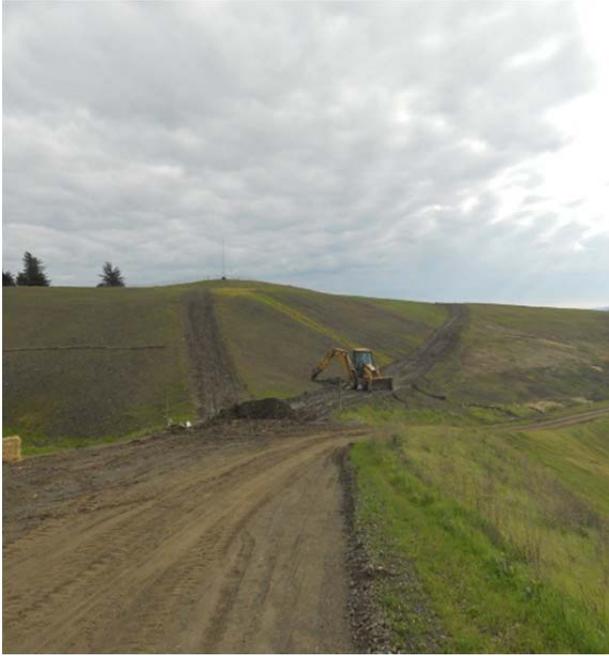
Vehicles and equipment had accessed the haul road/access ramp to the top deck (likely in response to the heavy rain and damage) leaving exposed mud and tire ruts along the road incline. The ramp had not been winterized or rocked, inside ditch lines had eroded with recent rains and the drainage culvert was inadequately constructed in that site drainage had been directed across the waste fill prism daylighting onto the waste slope (i.e. shot-gun culvert). Significant saturation resulted. Sediment and mud discharges were evident within the lower perimeter bench drainage ditch. Lower Sedimentation Pond 6, which receives runoff from this area, appeared turbid.

Landfill 2
Access ramps are not winterized.

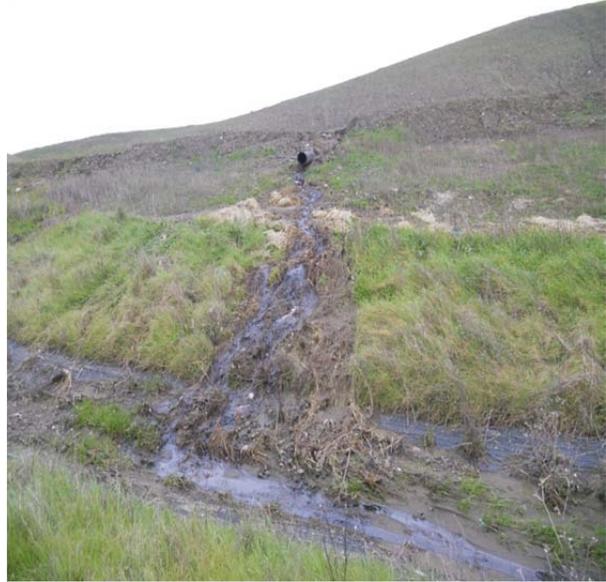
Landfill 2
Deck access ramp drainage culvert with discharge across waste prism. Requires removal and redesign of access road drainage system.

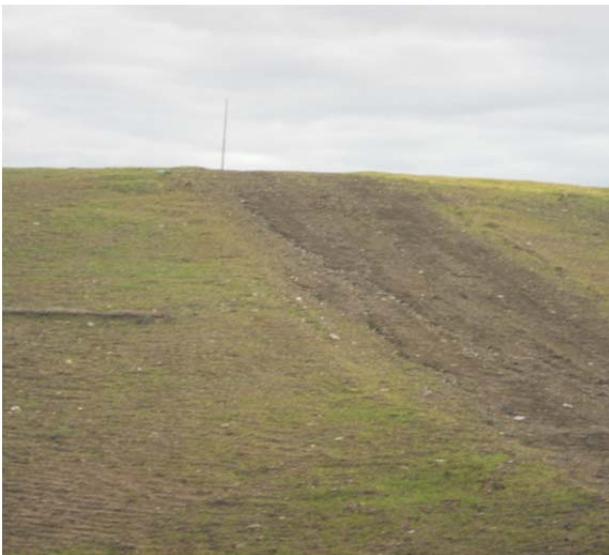
Landfill 2
Haul road is not winterized, stabilized or properly abandoned.

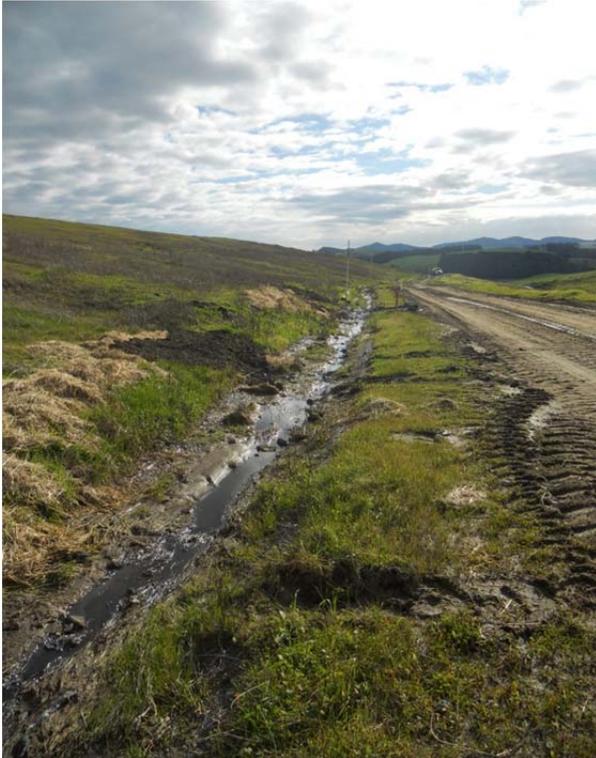
The length of the western facing slopes appears highly saturated. Staff observed many individual leachate seeps at varying elevations within the slope above the perimeter road surface drainage, a drainage way which discharges to sedimentation pond #6. Seeps are present throughout the slopes and they continue around the front toe area perimeter ditch line. Staff did not observe ponding or areas of standing water on the top deck. As of Friday afternoon, December 28, appreciable rains had ceased for the ~36 hours prior. However, the perimeter road surface drainages had measureable flow discharging from the side slopes, which was being intercepted within the surface drainage features. By December 29, flows had lessened, but still continued.

Landfill 2
Surface drainage and perimeter seeps on west facing slopes. Consistent flow.

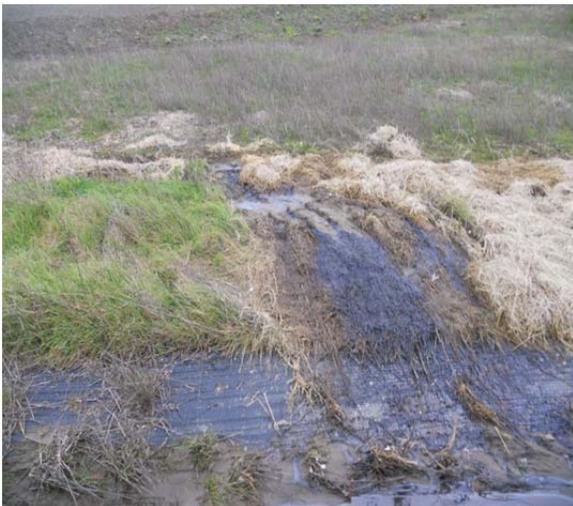
Landfill 2
Saturated slope conditions with seepage.

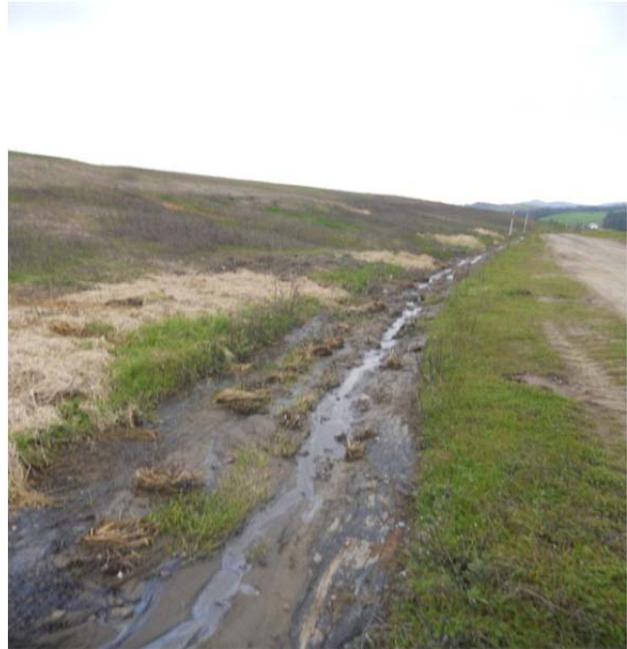
Landfill 2
Surface drainage and perimeter seeps on west facing slopes. Flow in drainage.

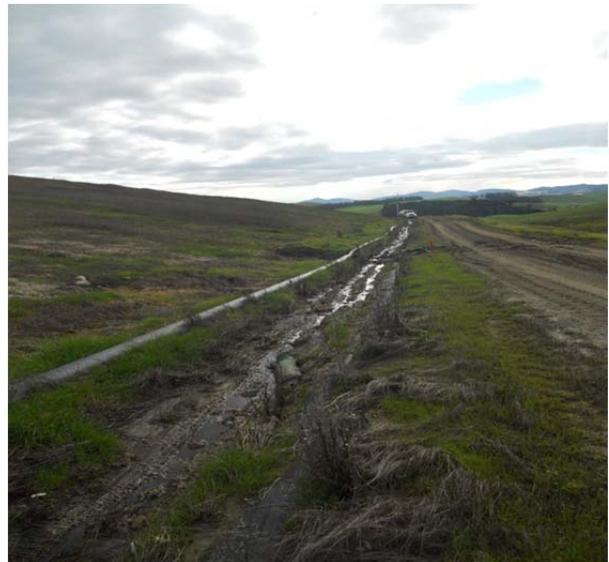
Landfill 2
Seep discharges, lessened flow. Collection at bench end via pumper truck.

In response, the site operator installed a temporary collection station by plugging the bench down drain HDPE riser and pumping the surface ditch discharge into a pumper truck via portable power source. The site operators indicated the pumper truck would remain until the seep flows cease.

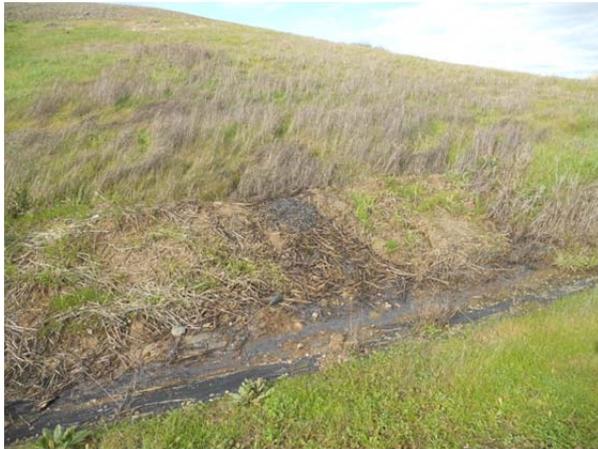
Landfill 2
Toe area perimeter seeps.

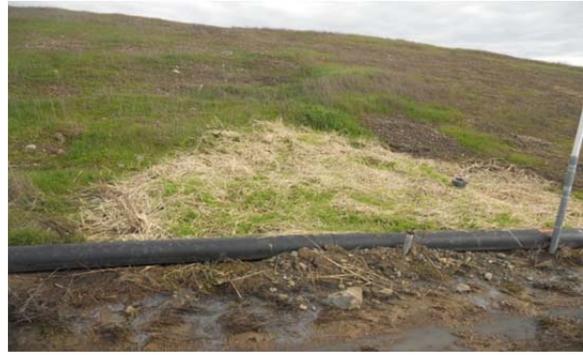
Landfill 2
Perimeter seep discharge through previous repair.

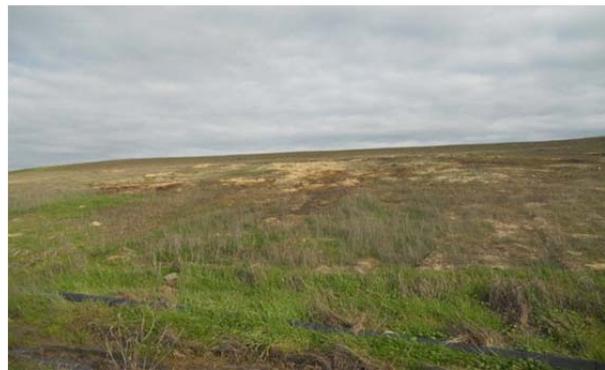
Landfill 2
Midslope leachate seeps. Inadequate intermediate cover.

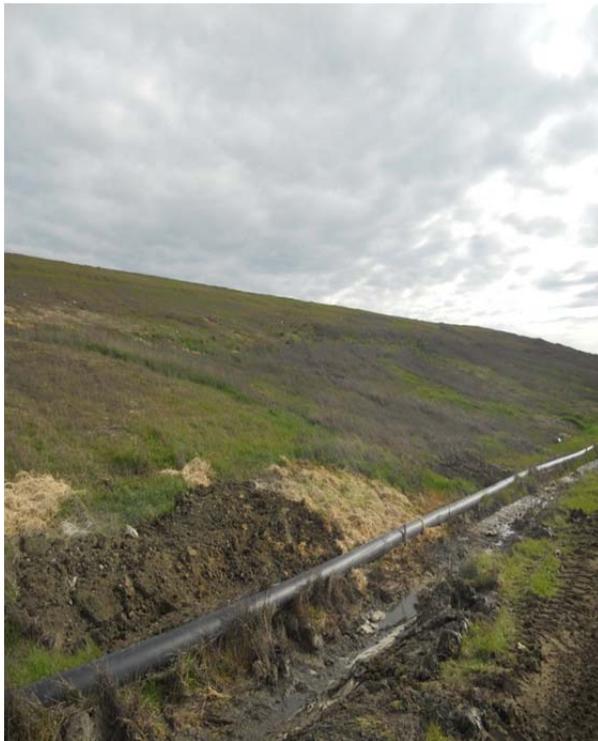
Landfill 2
Inadequate temporary seep repair.

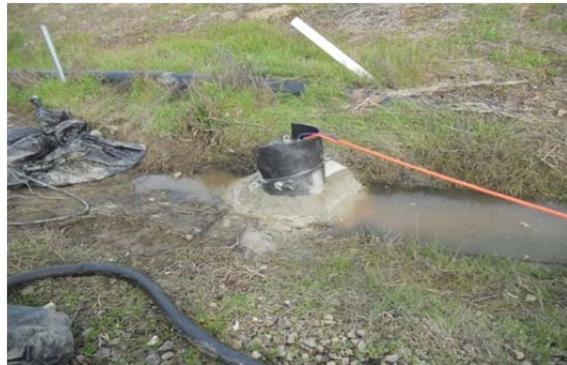
Landfill 2
Temporary plug and pump station installed to collect leachate seeps in perimeter road drainage ditch.

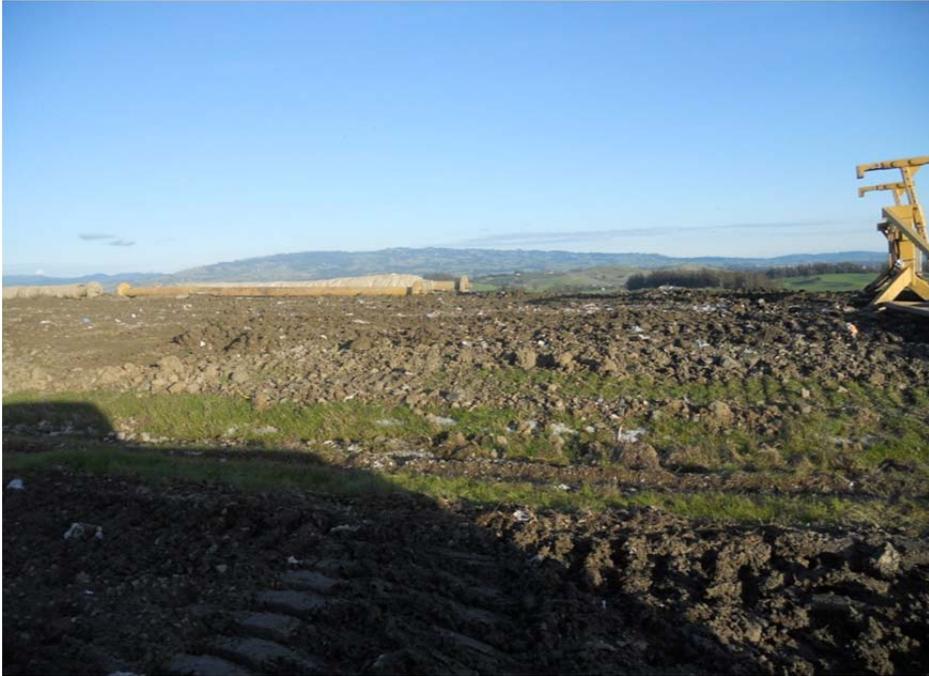
The active face has been located to the south end/front of the Landfill 1 top deck. The operator is planning to construct a new lift here, intending to raise the height an additional ~25 feet. Daily cover is being applied with tarps. Considerable residual wastes are being tracked through the scraper path, which is left exposed, muddy and not tarped. Active face operations are wet. Staff did not observe any active face leachate collection or engineering controls which is a requirement under the facility's operating Order.

Landfill 1
Scraper path with residual wastes.
No active face runoff engineering controls in place.

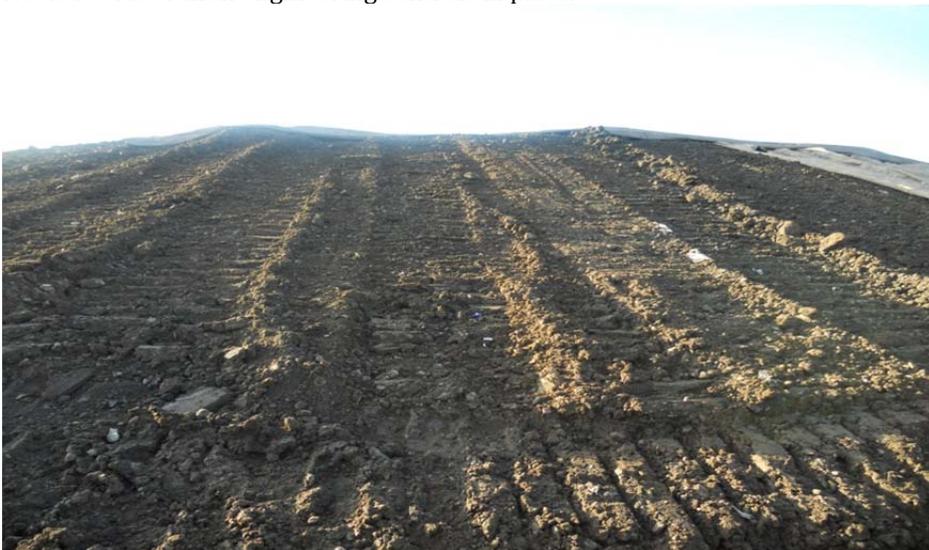
Landfill 1.
New Cell –Outward facing slopes
Intermediate cover will require adequate compaction and erosion control.

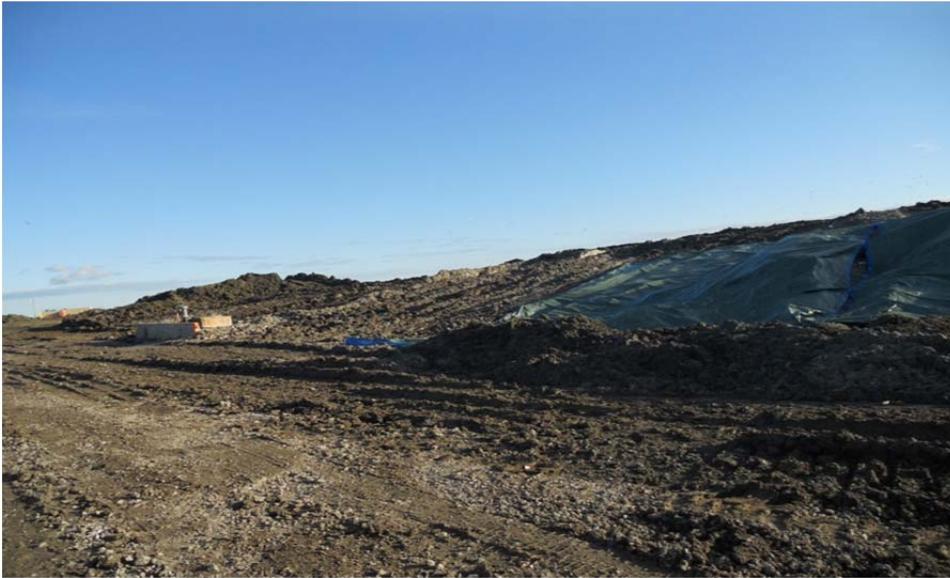
Landfill 1

New import materials have been end dumped in various locations along the haul road top deck alongside the winter soil stockpile. Import materials consist of mixed wastes, predominantly whitish (possibly styrofoam?) material with minimal soil content. The materials are reportedly being generated by screenings from a recycling operation. Mixed waste material is a *waste* and should not be left exposed to rain. It has not been approved for wet weather daily cover operations, and it is not acceptable for use as intermediate cover. The large quantity of mixed waste materials requires a stockpile management plan demonstrating adequate containment during wet weather and a proposal for any use as approved Alternative Daily Cover during dry weather only.

The winter soil stockpile which had been compacted and hydroseeded is now opened up and completely exposed. A scraper path has been constructed through the center of the pile. Staff observed one perimeter stretch of wattles on the south side of the stockpile. Staff did not observe cover or adequate engineering controls in place on Friday, December 28th, 2012. All active winter operations must be minimized and adequate erosion control measures must be deployed.

Winter stockpile is wide open.

Mixed wastes to be used for daily cover require adequate containment.

6. Screen all import daily cover material. Any unsuitable winter operation daily cover is to be adequately contained and set aside for periods of dry weather. Provide for a protected stockpile area for mixed wastes. Note that import daily cell cover material comprised of mixed waste such as that observed by staff during the December 28 and 29 inspections, is unsuitable daily cover during rain events.

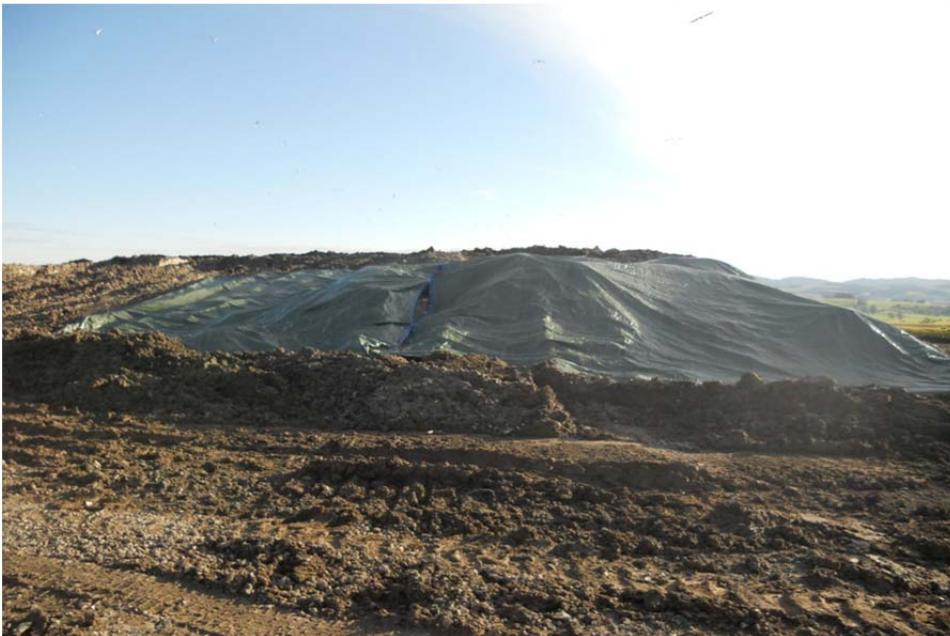
Landfill 1

Inadequate erosion control measures at the winter stockpile areas. All active winter operational areas are required to be minimized and contained.

3. Winterize and minimize all open stockpiles.
4. Develop and submit an updated as-built drawing of the storm water piping and drainage conveyances.
5. Develop and submit a winter operation cell sequencing plan that provides for collection and control of all active face runoff. Within the cell sequencing plan, provide a construction detail demonstrating active face runoff collection capabilities. Winterize all active area outside slopes and provide intermediate cover and mulch for prevention of outward leachate seeps.
