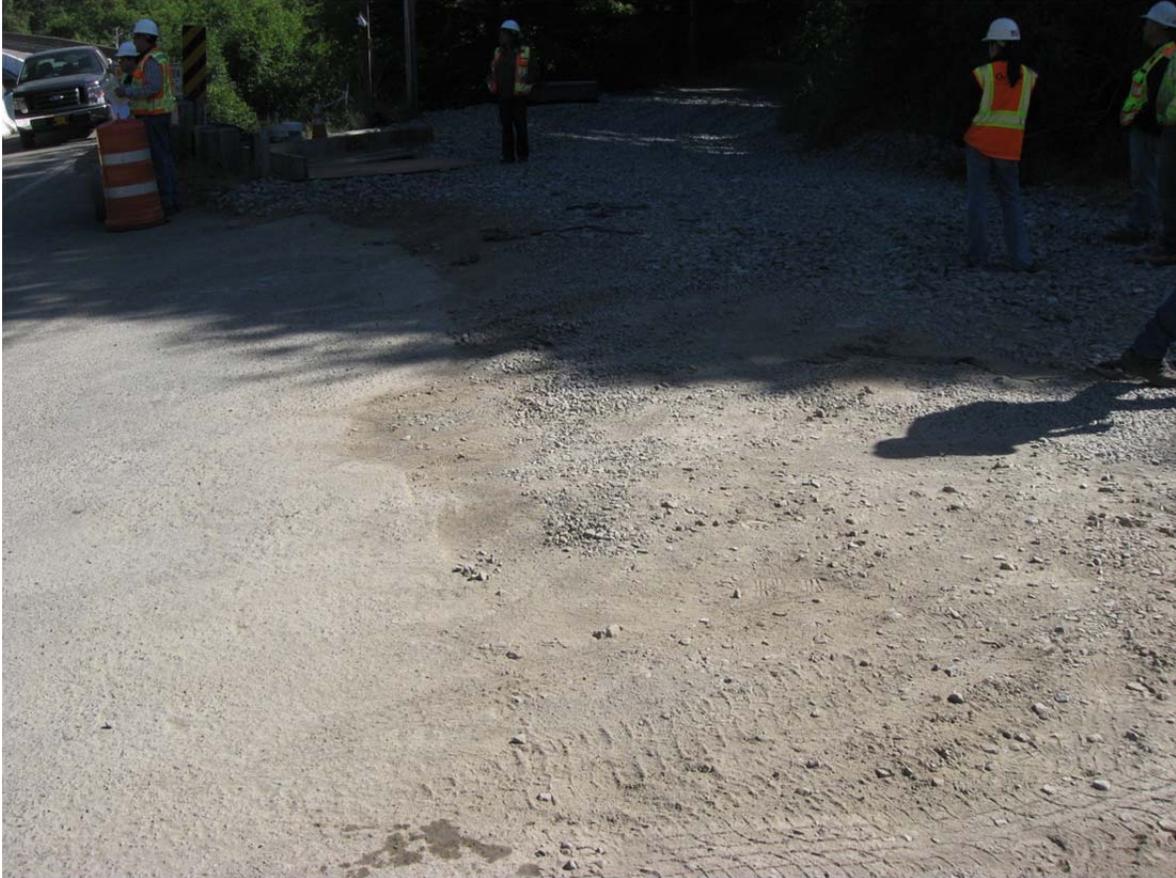
Image 1, 06/19/12 - Above shows the construction site entrance BMP as inadequate to prevent tracking onto the highway.

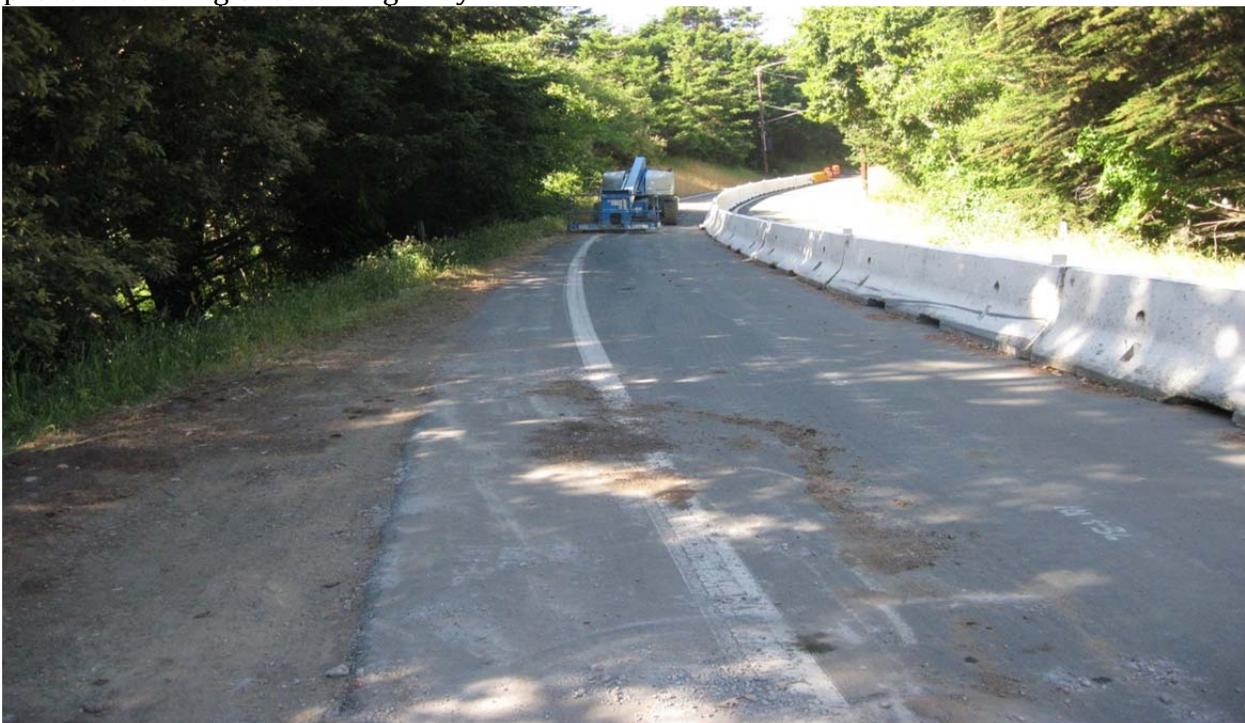
Image 2, 06/19/ 12 - Above shows sediment, gravel and concrete dust and debris tracked and spilled onto the highway.

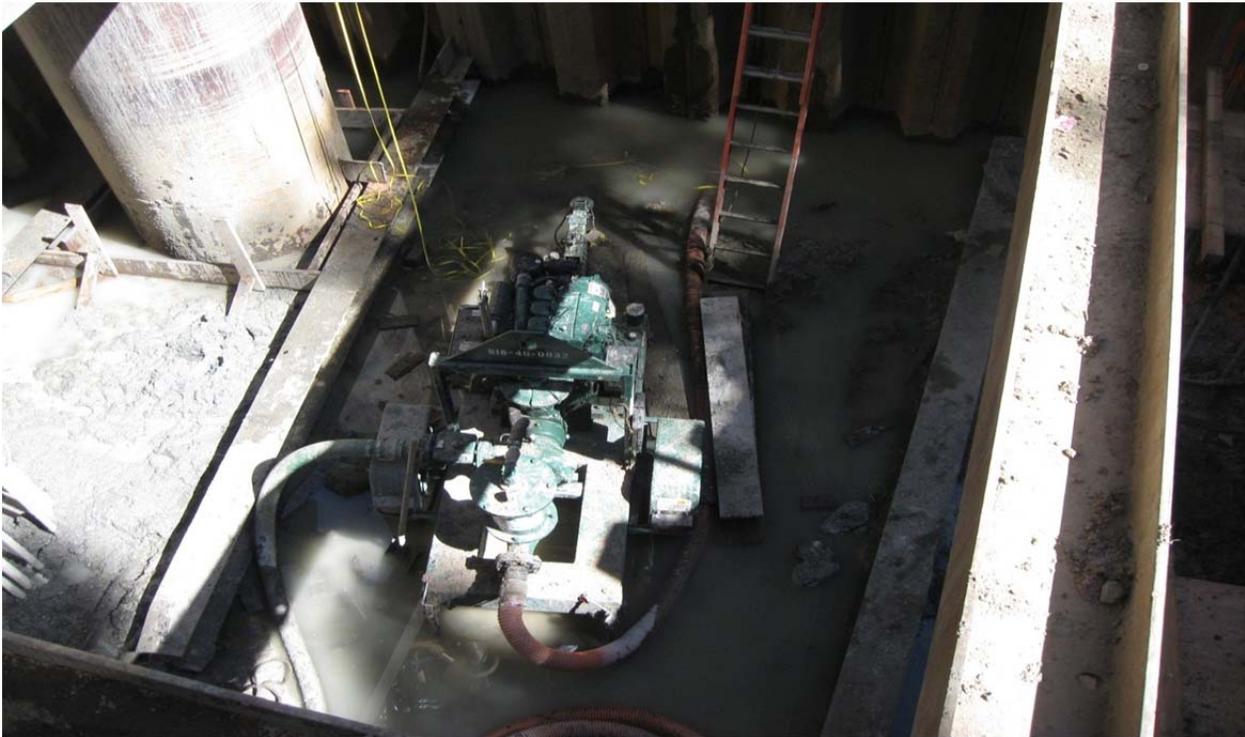
Image 3, 06/19/12- Above shows dewatering pump within the coffer dam without containment.

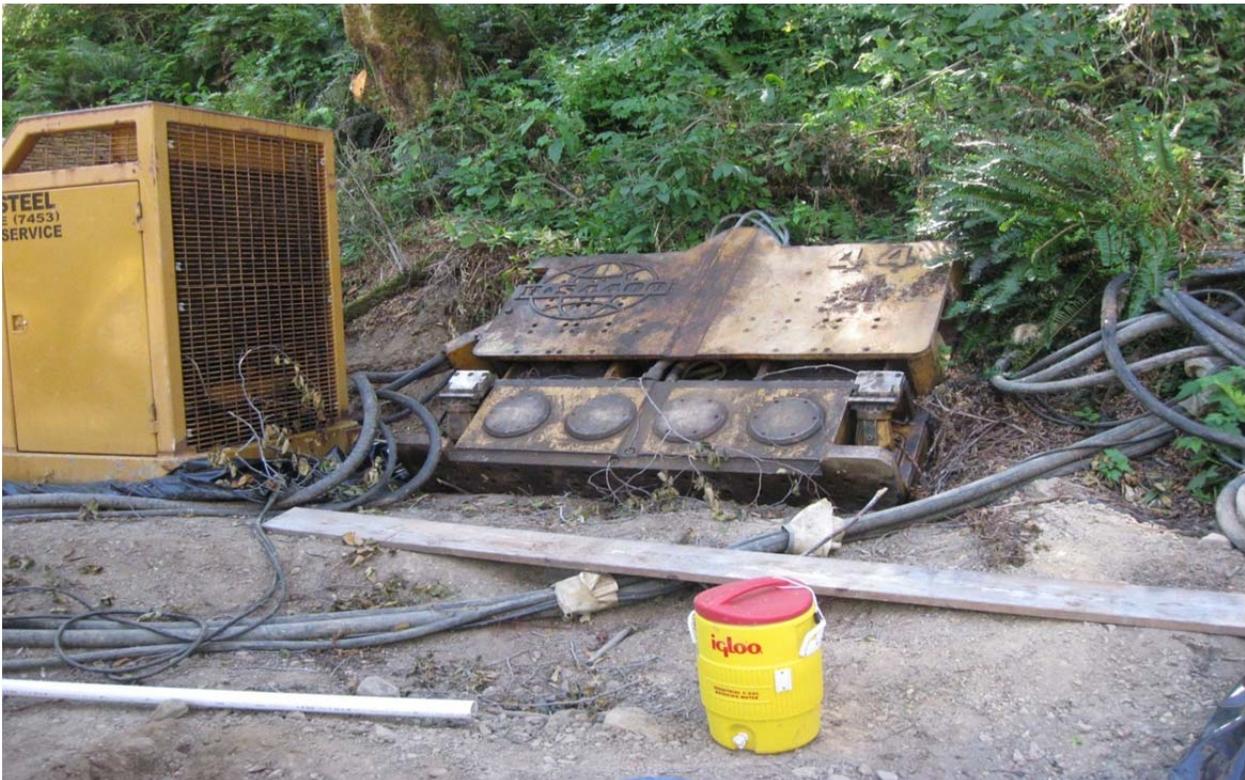
Image 4, 06/19. 12 - Above, shows generator, and equipment with inadequate containment BMPs.

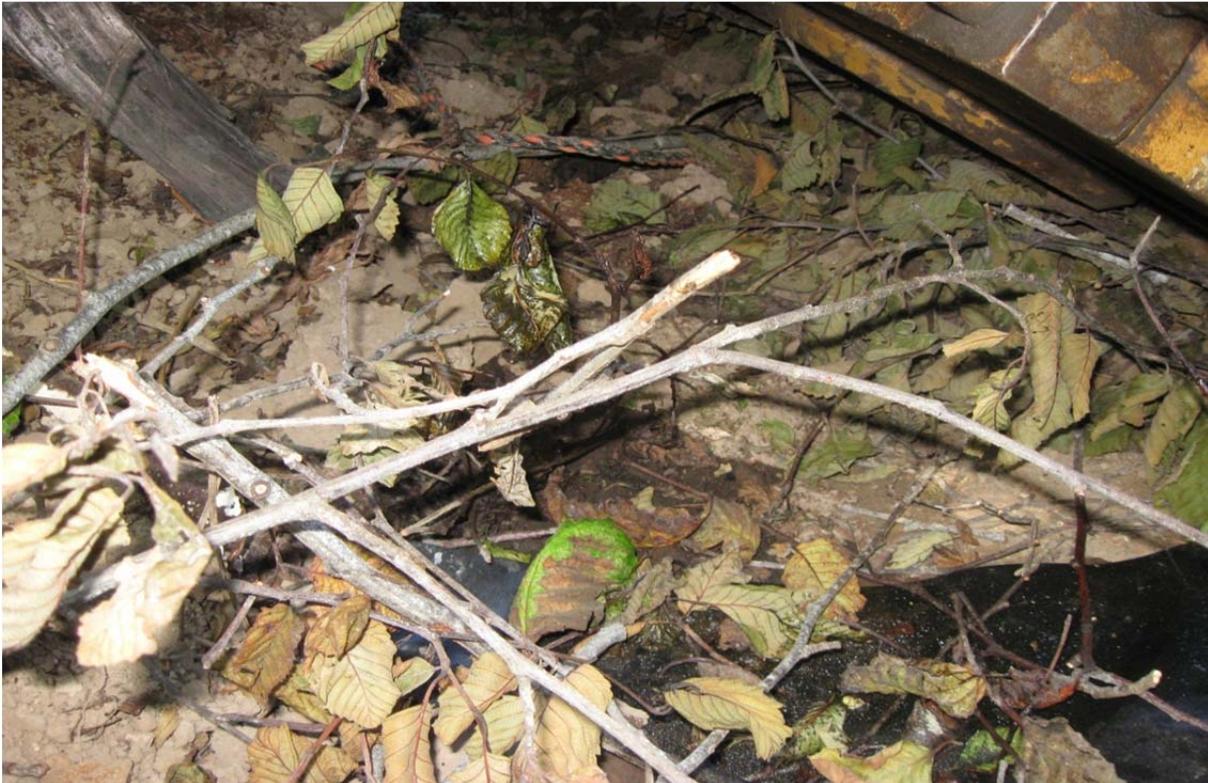
Image 5, 06/19/12 - Above shows fuel and fluid leaking onto the ground adjacent to the equipment.

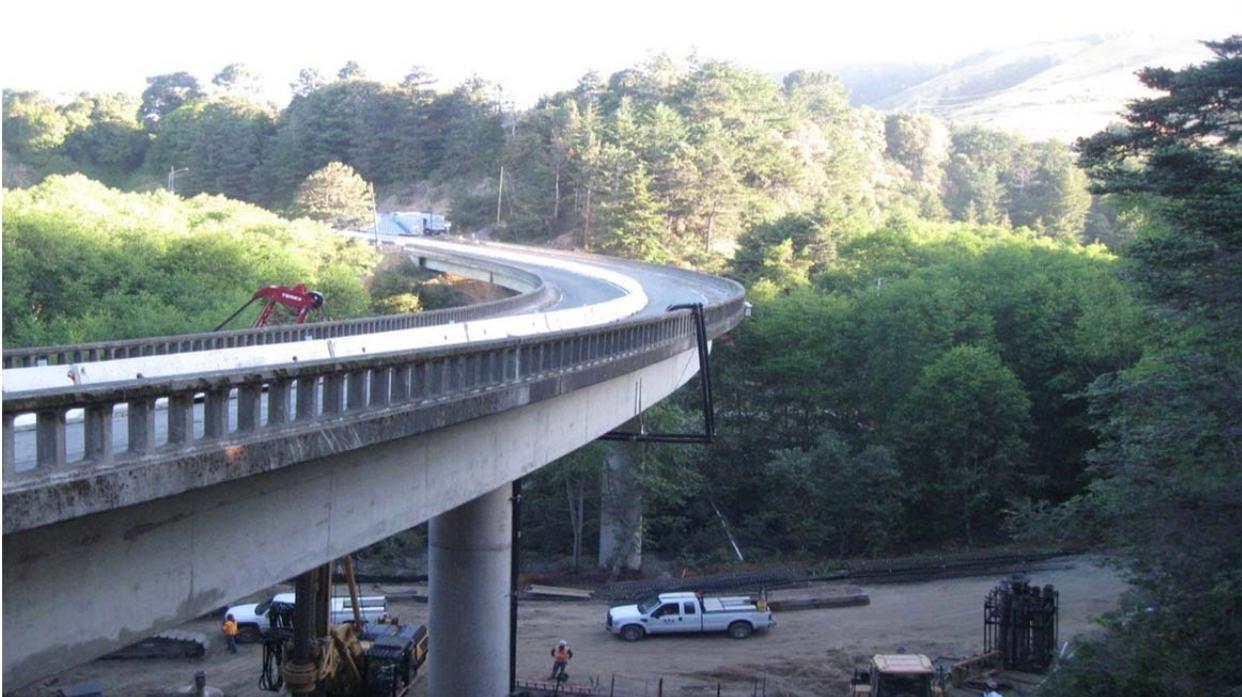
Image 6, 06/19/12 - Above shows the black pipe off bridge and baker tank which contains drilling slurry. These potential pollutants, potential exposure, and pathways were not identified in the Storm Water Pollution Prevention Plan (SWPPP) or dewatering plan.

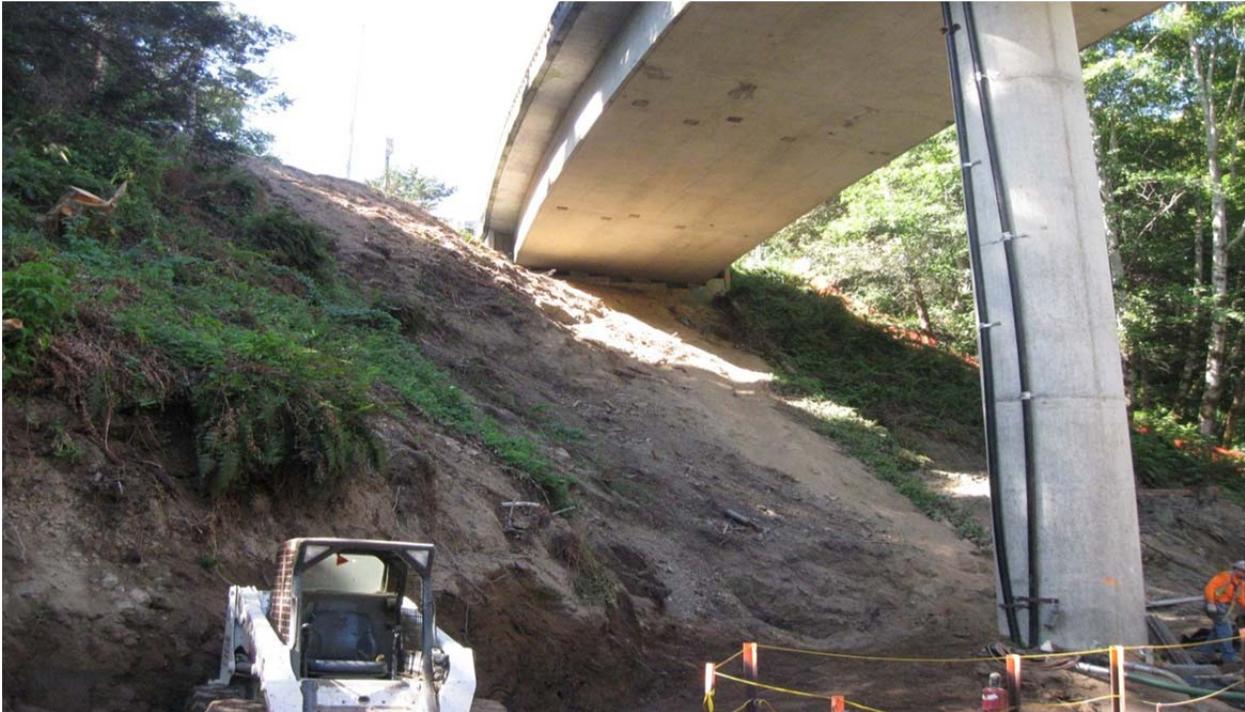
Image 7, 06/19/12 - Above, is the southern bridge abutment DSA slope >50% with no sediment or erosion control.

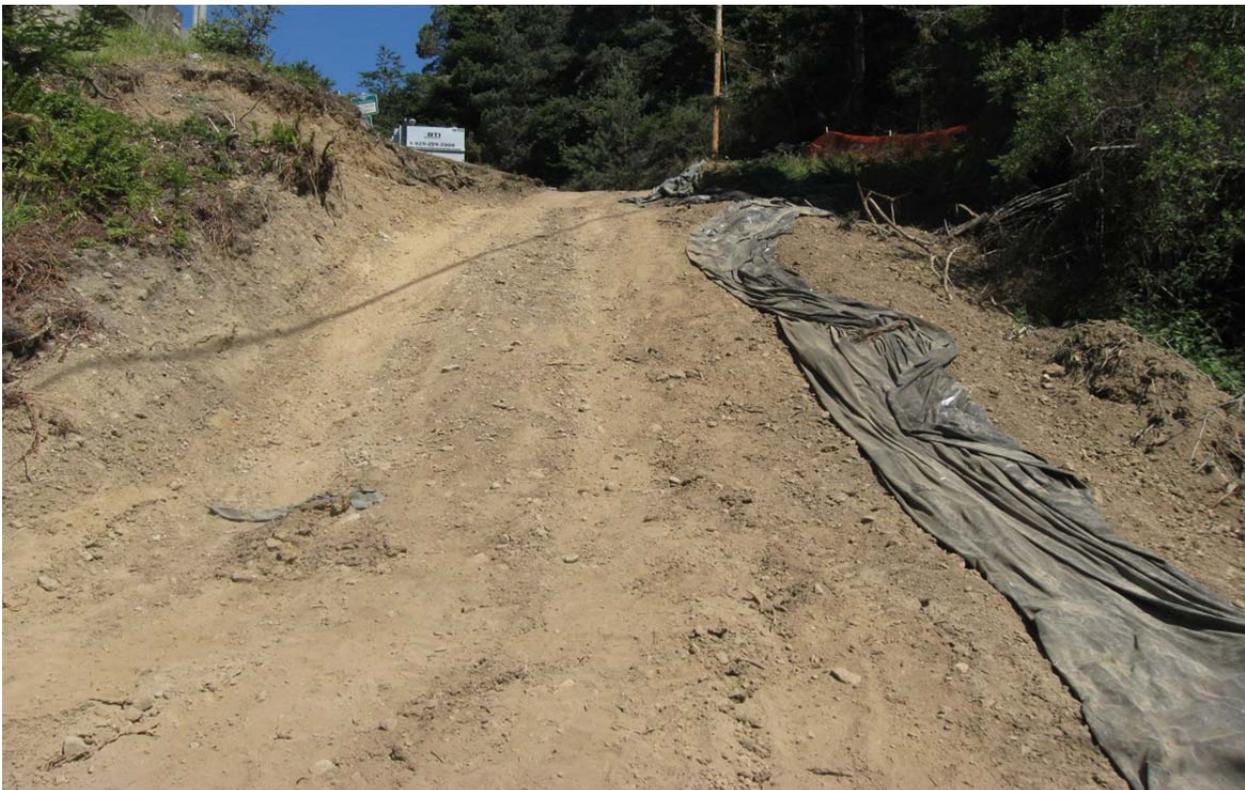
Image 8, 06/19/12 - Above shows access road with inadequate and ineffective erosion and sediment controls.

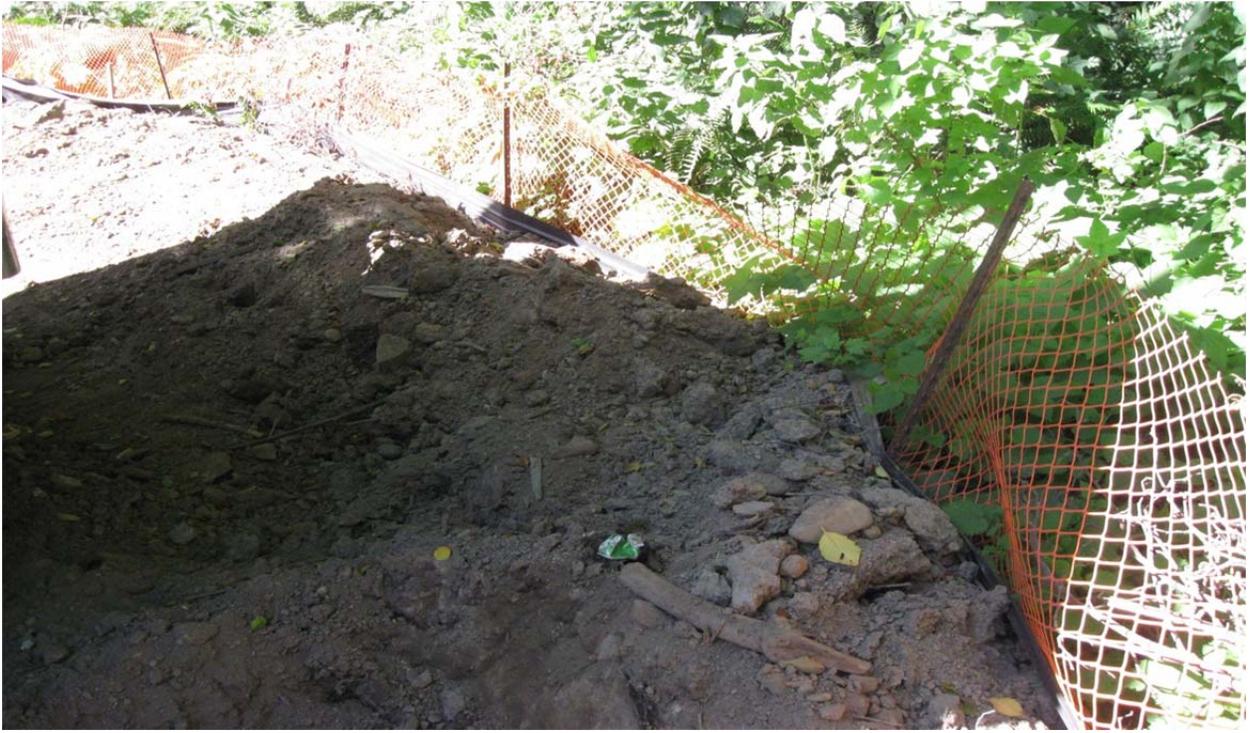
Image 9, 06/19/12 - Above shows silt fence overloaded and breached with sediment.

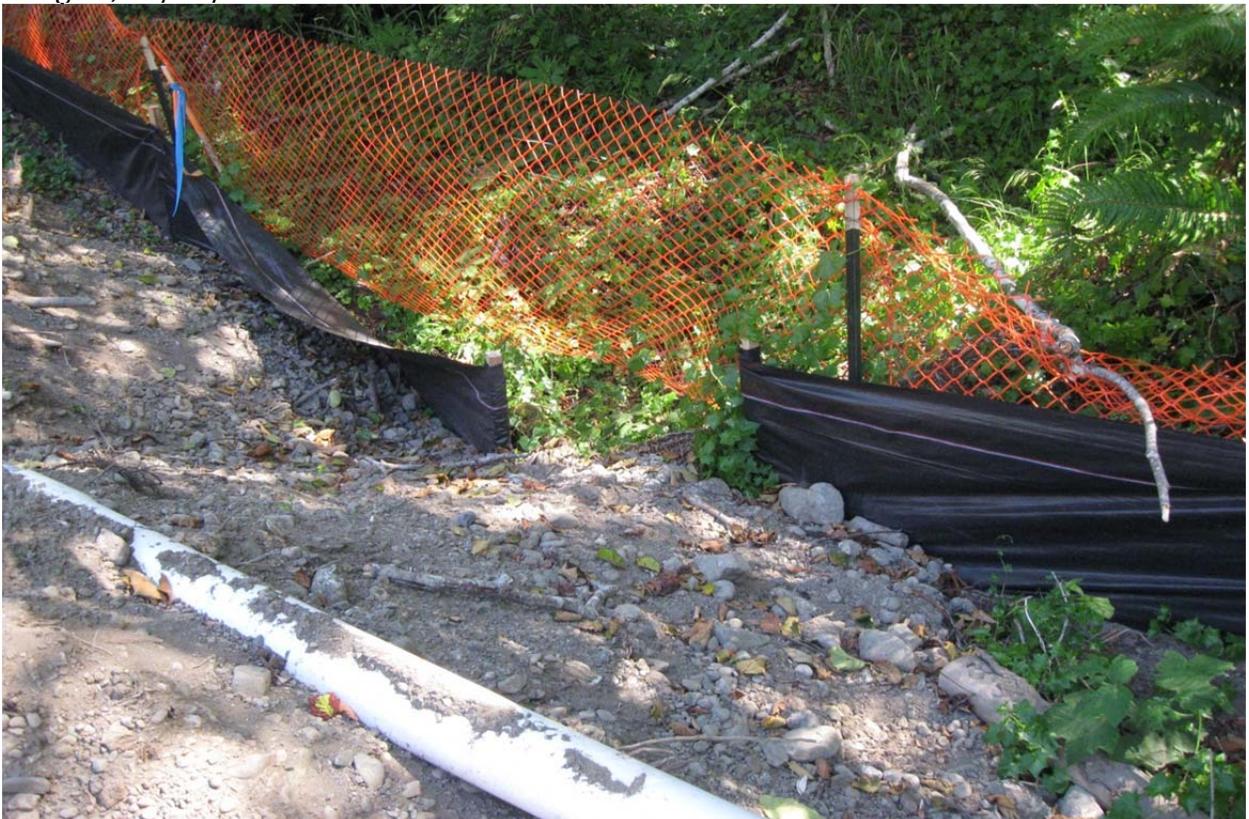
Image 10, 06/19/12 - Above shows gap in silts fence, a common theme for the site.

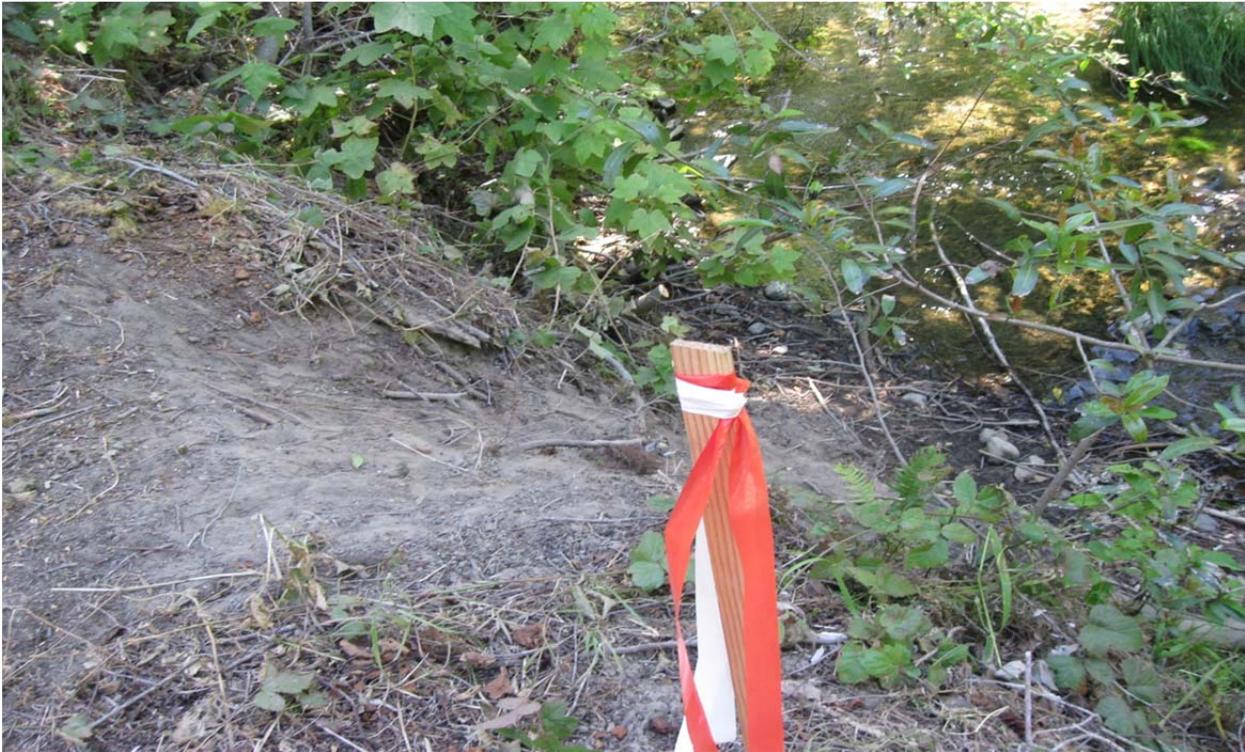
Image 11, 06/19/12 - Above shows low spot next to creek without erosion or sediment controls.

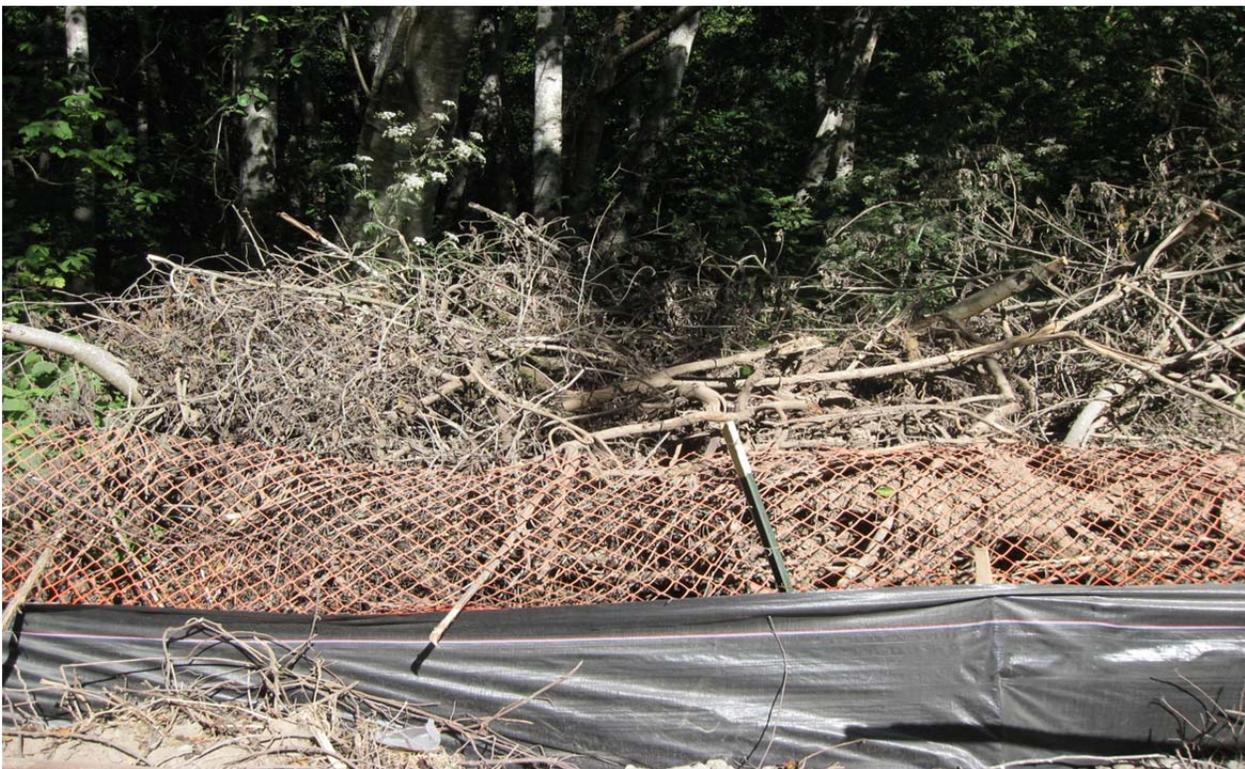
Image 12, 06/19/12 - Above shows silt and slash, created from the grading of the access road, deposited over the silts fence and environmentally sensitive area (ESA) fence.
