## **Plowright Property Watercourse Restoration and Monitoring Plan**

**April 29, 2011**

A Cleanup and Abatement Order (CAO) #R1-2011-0014 was issued by the California Regional Water Quality Control Board on January 18, 2011 for watercourse discharges at property owned by Patricia Plowright located at 3500 Little Mill Creek Road, near Booneville, California. The CAO and various agency reports detail conditions of Little Mill Creek resulting from grading and bulldozing activities on the property. The grading and bulldozing activities were determined to have resulted in a discharge and threatened discharge of sediment to waters of the Navarro River Watershed.

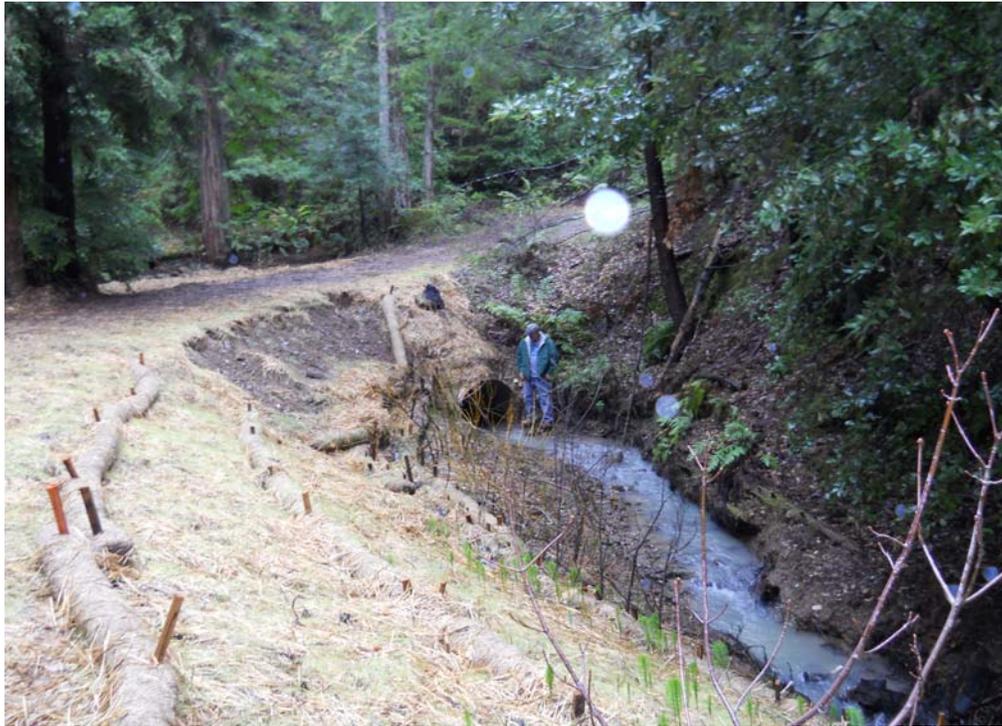
This site is at an existing 48" culvert crossing of Little Mill Creek, a Class I watercourse at this point. Previous agency inspection reports indicate that this is the location where a Caterpillar tractor had been stuck in the watercourse. As of the date of the site inspection conducted in association with the preparation of this plan (3/8/11) the tractor had been removed and several remediation actions had been conducted. Perched material below the culvert outlet had been pulled back and the exposed soils were mulched with straw. Straw wattles had also been placed parallel to the slope at the outlet of the pipe and willow sprigs had been planted adjacent to the stream. In addition, horse tail and grasses were sprouting helping to stabilize the site. It appears

**Photo 1** shows the outlet of the 48" culvert crossing of Mill Creek and the restoration activities that have already taken place. The slumping fill at the outlet shall be pulled back and rock armored. (See Site #1 description above)

- Perched fill at the pipe outlet shall be sloped back and the exposed soil shall be rock armored for 15' on either side of the pipe from the road surface to the culvert outlet. (See Photo #1 below.)
- Approximately 1-2 yards of loose sediment located on the west bank of the creek at the pipe outlet shall be removed by hand while protecting the planted willow. (See Photo #2 below.)
- The road surface shall be rocked for 50' on both sides of the pipe to prevent sediment runoff.
- A small amount of sediment perched above the pipe inlet shall be pulled back and stabilized. (See Photo #3 below.)
- The fill piled to the west of the pipe inlet shall be spread along the hillside below the driveway. This material shall be compacted and seeded and mulched to prevent runoff to the watercourse. (See Photo #4 below.)

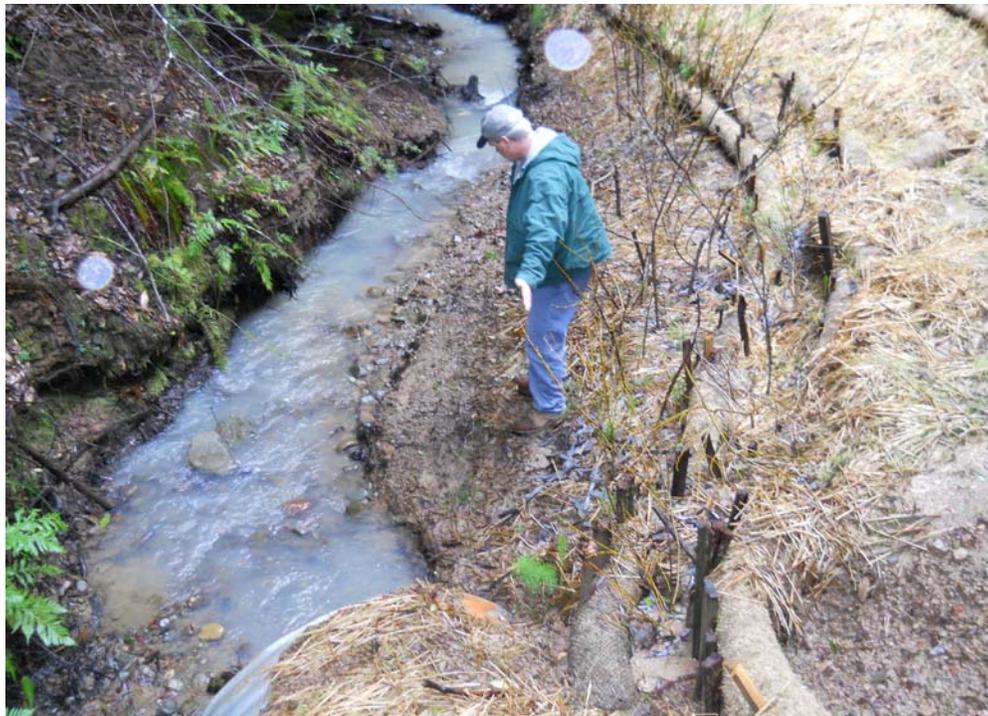
**Photo 2** shows the 1-2 yards of loose sediment on the west bank of the stream at the pipe outlet to be removed by hand. The photo also shows the willow plantings in place. (See Site #1 description above)

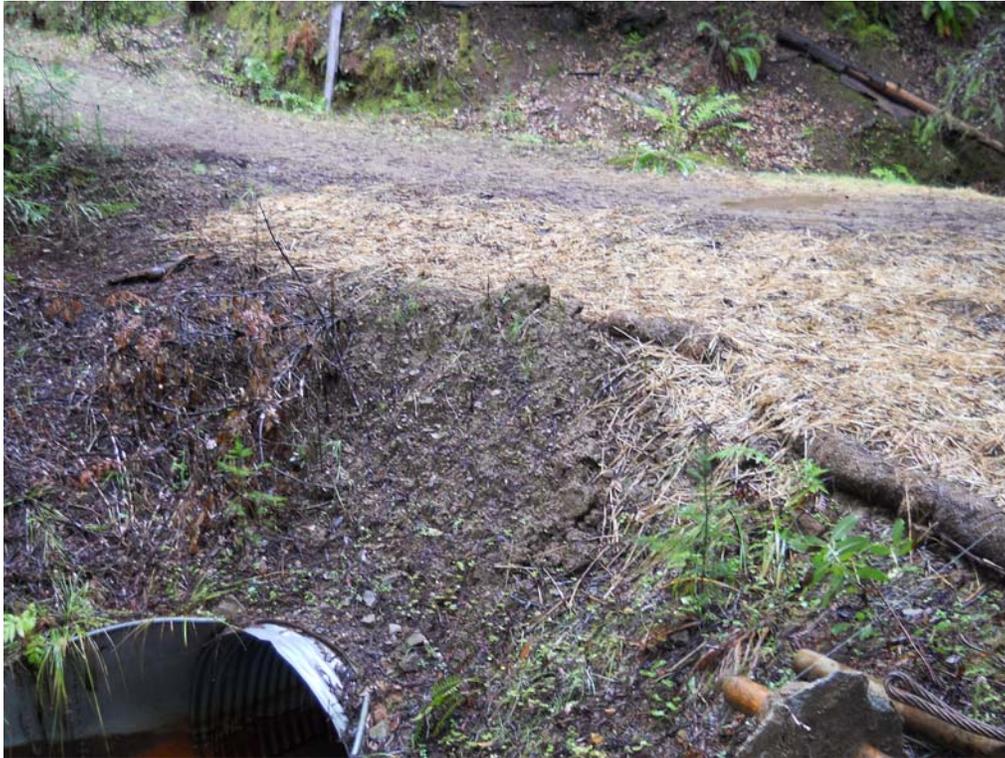
**Photo 3** shows the small amount of sediment perched above the pipe inlet to be pulled at Site #1. (See Site #1 description above)

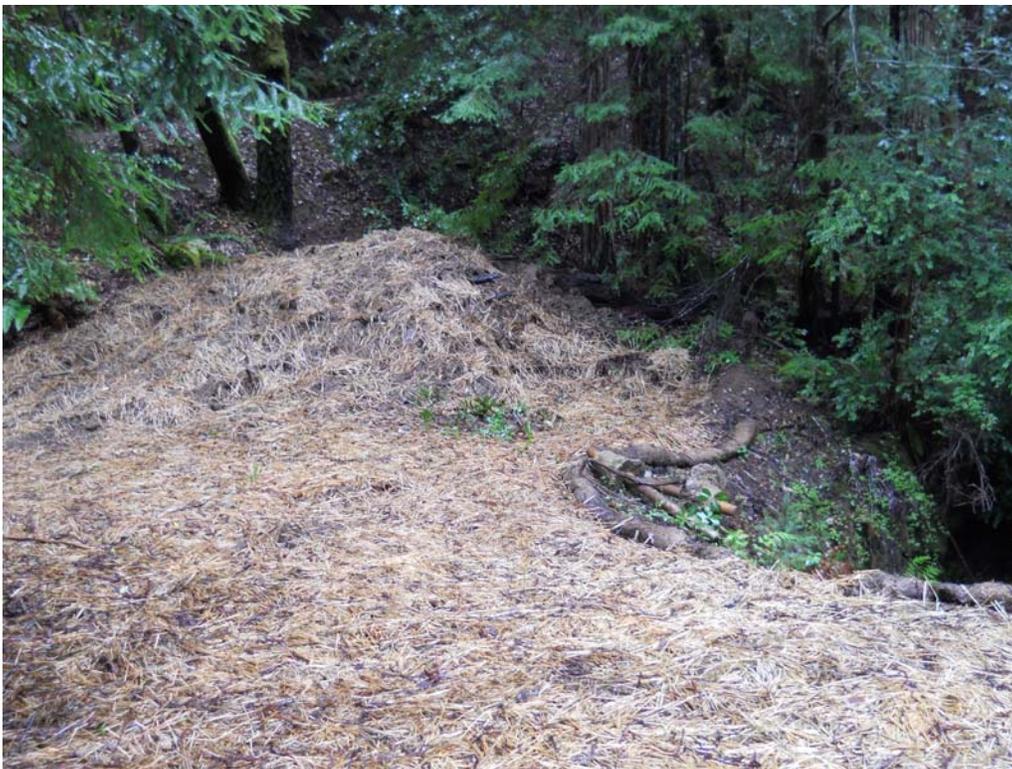
**Photo 4** shows the fill piled to the west of the pipe inlet at Site #1. This material shall be spread along the hillside, then shall be compacted and seeded. (See Site #1 description above)

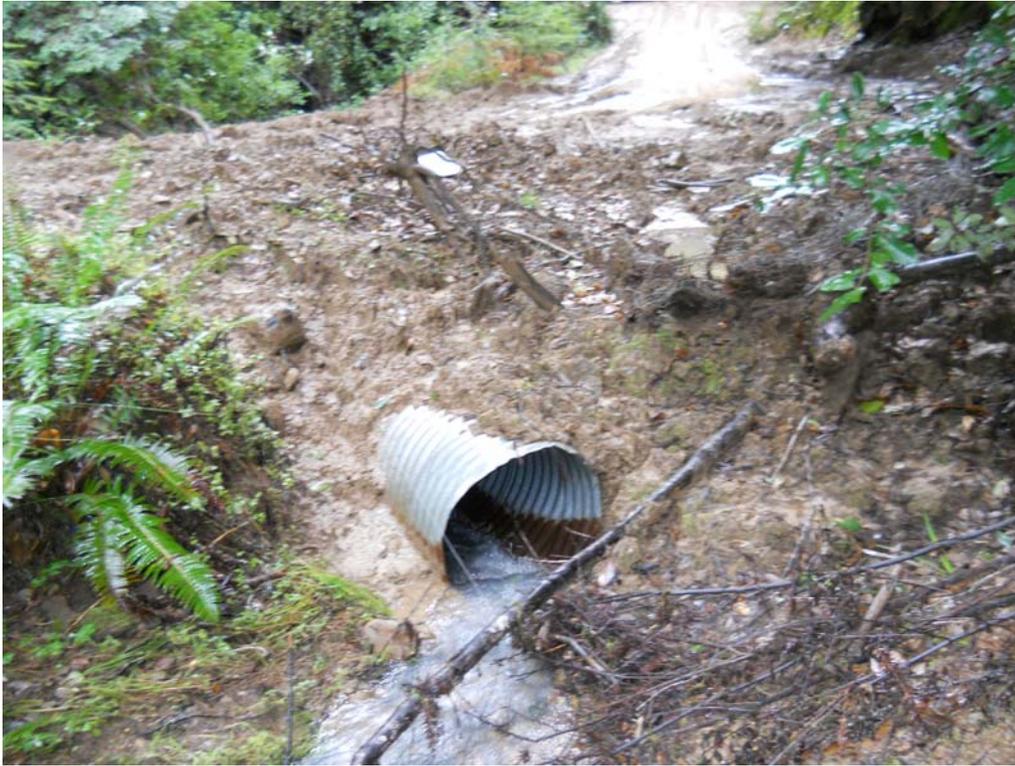
An existing pipe on Little Mill Creek, which is a Class II at this location, is undersized, rusted out and shotgunned. (See Photos 5-7 below.) The existing pipe shall be removed and replaced with a 54" pipe. The new pipe shall be installed to grade and have rock rip rap installed at both the inlet and outlet to protect fill and act as an energy dissipater. There is stored sediment currently located at the pipe inlet causing the stream to be diverted to the northeast into the road fill. This sediment shall be removed during the installation of the new pipe and the pipe shall be placed in line with the stream.

**Photo 5** shows the inlet of the undersized culvert at Site #3.

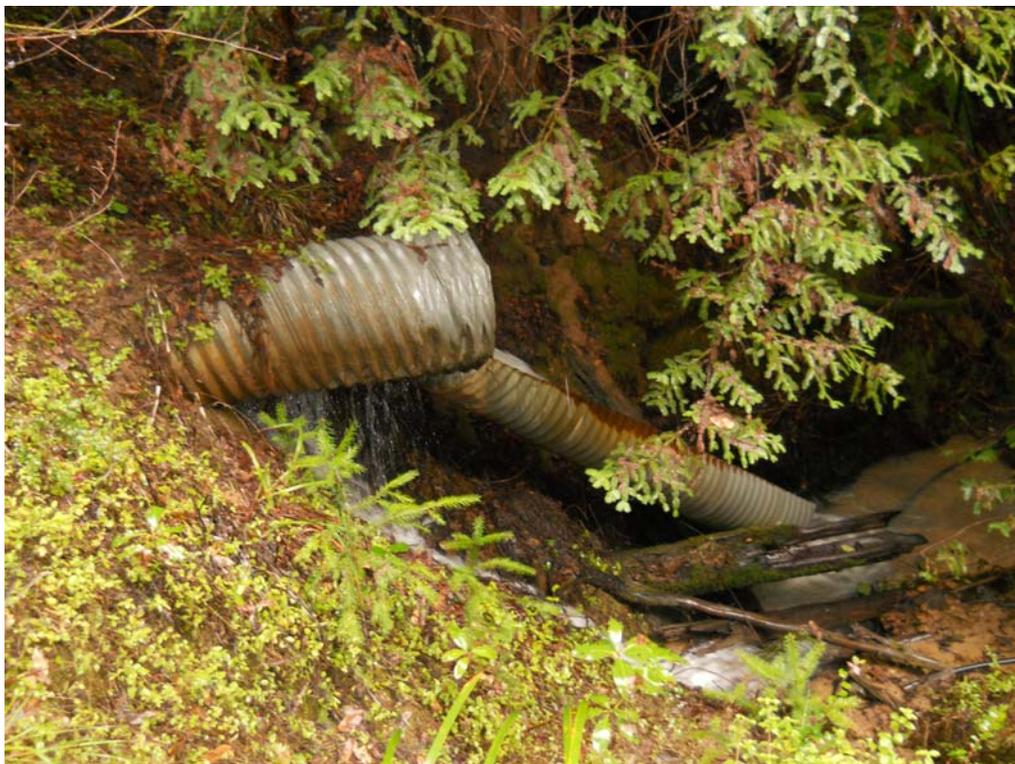
**Photo 6** shows the outlet of the undersized culvert at Site #3.

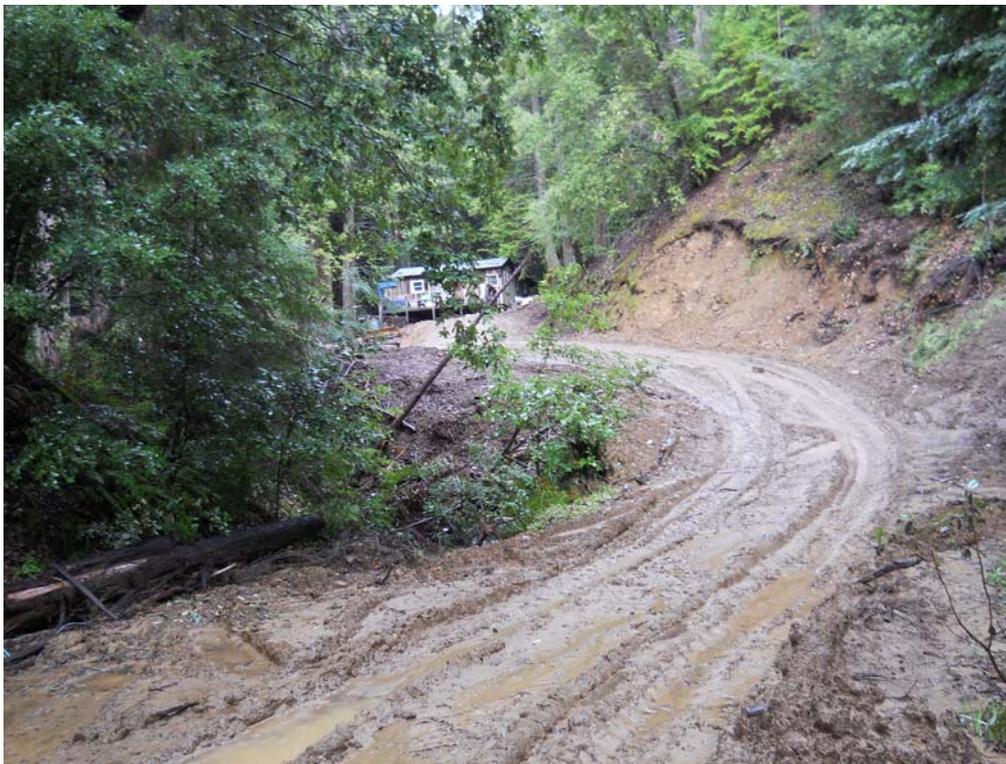
There is a significant amount of loose soil located on the road surface and adjacent to the road at this location. This soil shall be removed and placed in a stable location away from the watercourse (see site #7 for potential storage location). The road surface shall then be rocked for

**Photo 7** shows the road above the undersized culvert at Site #3. The undersized pipe shall be removed and replaced with a properly installed 54" pipe. The loose soil on the road above the pipe shall be removed and the road surface shall be rocked. (See Site #3 description above)

100' to the south of the crossing and 50' to the north. The road shall also be outsloped and/or dipped to ensure drainage does not collect on the road above the crossing.

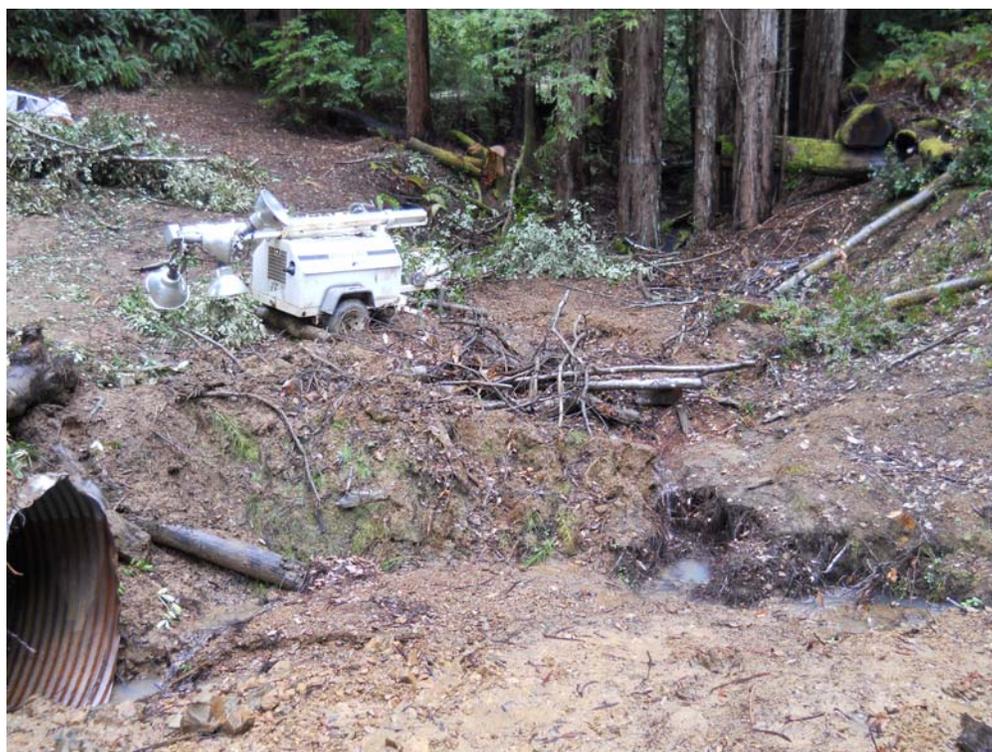
At this location a short, improperly installed 50" diameter pipe is in place. (See Photos 8-10 below.) The pipe is located at the confluence of two watercourses and perched eroding fill material is present at both the inlet and outlet of the pipe. A significant amount of fill material has also been deposited in the western fork of the watercourse and is currently diverting the flow of this watercourse. The existing pipe shall be removed and all perched fill and residential debris shall be removed from the channel. The side slopes of the watercourse shall be pulled back to no greater than a 2:1 slope and shall be stabilized. The removed fill material shall be spread on the parking area and compacted or placed in a stable location away from the watercourse (see site #7 for potential storage location). The western fork of the watercourse shall be returned to its original channel configuration and grade. Should the landowner desire a crossing at this location, a properly aligned 54" pipe with 45 degree elbow on the outlet or a rocked ford crossing shall be installed.

**Photo 8** shows the inlet of the 50" culvert and diverted watercourse at Site #5.

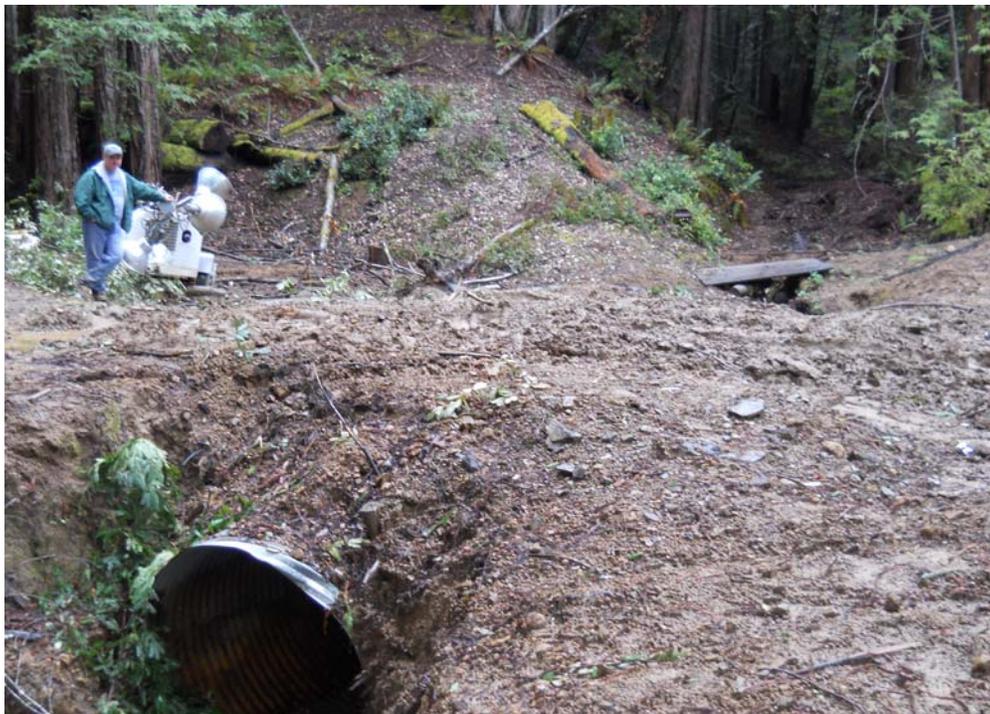
**Photo 9** shows the outlet of the 50" culvert at Site #5.

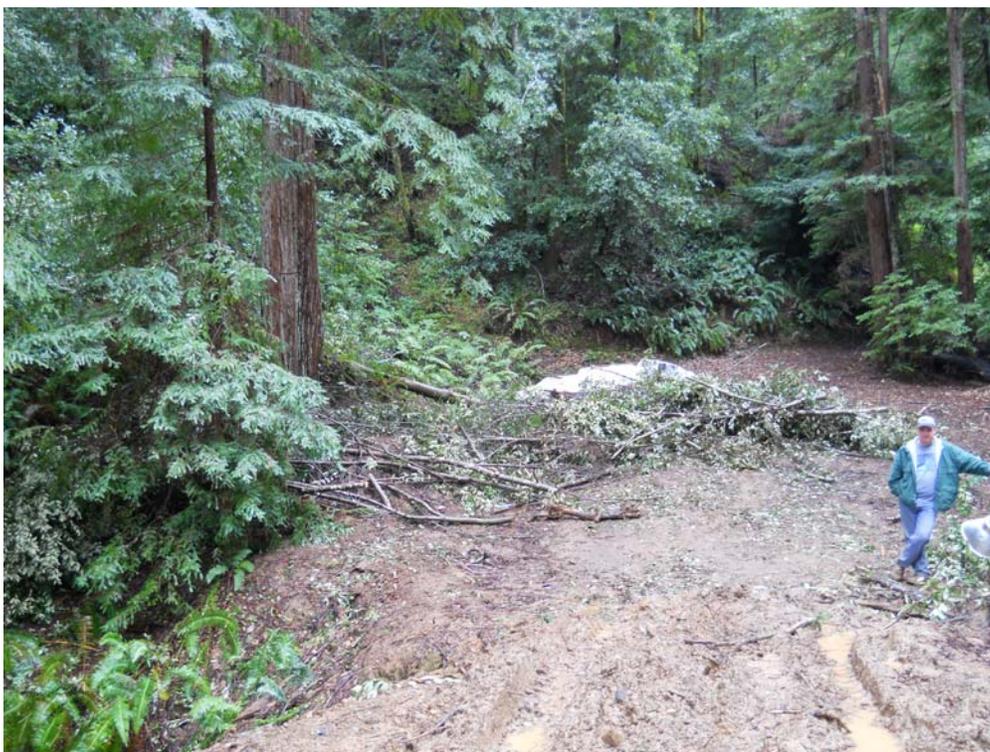
**Photo 10** shows the road above the 50" culvert at Site #5. The short, improperly installed pipe shall be removed. The fill material and residential debris to be removed from the western fork can be seen in Photo 8. The Class III watercourse referenced in the Site #6 description above shall be directed down an inside ditch to be created along the left hand side of the road shown in Photo 10. The 6" redwood referenced can be seen on the left of Photo 10. (See Site #5 & #6 description above)

At this location a small Class III drainage is being diverted by the existing truck road. An inside ditch shall be installed to capture drainage from this watercourse and shall direct the water to the Class II below, near an existing 6" redwood tree. (See Photo 10 below.) All perched fill material shall be removed from where the inside ditch will direct water into the Class II watercourse and the outlet of the ditch shall be stabilized with rock rip rap.

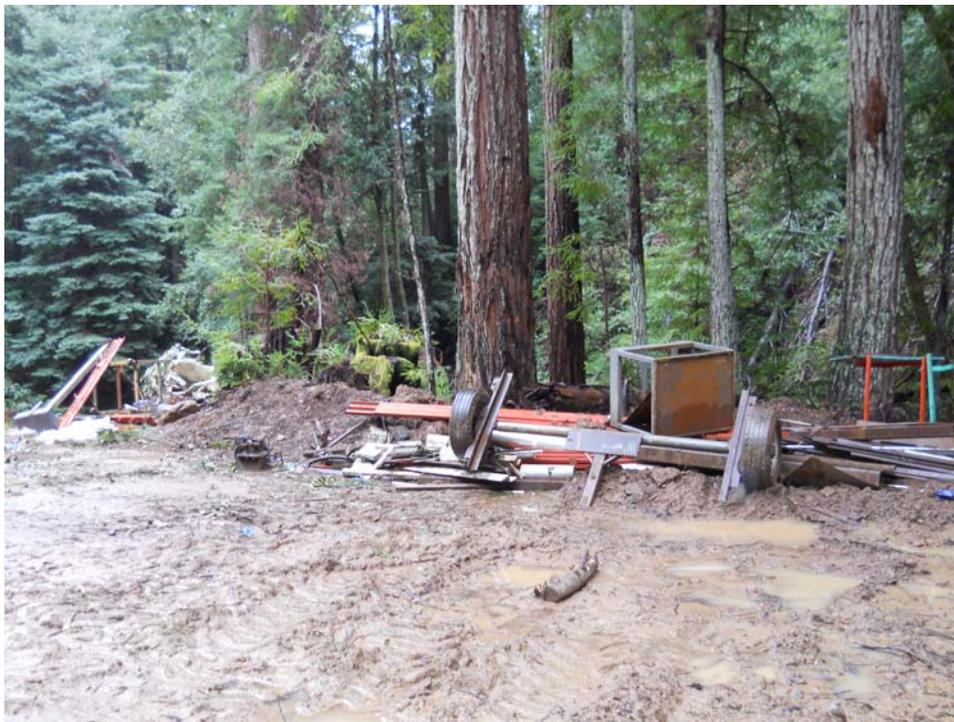
Between sites #3 and #5 there has been loose fill material pushed up adjacent to the watercourse from grading activities on a parking area below the house. In addition, a significant amount of vegetation has been cut and placed into the watercourse at this location. With the exception of the larger 20"+ diameter logs spanning the creek or logs imbedded in the creek that are acting to meter sediment or are creating habitat, the vegetative matter shall be removed from the stream channel and shall be chipped and spread on the recently graded parking area.

**Photo 11** shows the parking area with perched fill, residential debris and vegetation at Site #4. The perched fill, debris and vegetation shall be removed. Vegetation planting shall occur on exposed soils in this area. (See Site #4 description above.)

The perched fill material adjacent to the watercourse shall be pulled back to no greater than 2:1 slope and the fill material shall be spread on the parking area and compacted or placed in a stable location away from the watercourse (see site #7 for potential storage location). Where the fill material is pulled back and the stream banks are exposed, native plant species such as Tan Oak, Redwood, Douglas fir, huckleberry or sword fern shall be planted to stabilize the soil and provide future shade and nutrients for the watercourse. Where possible, new plantings shall be obtained from on site sources. There shall be a minimum of one planting for every 10 square feet of exposed soil. All exposed soil between plantings shall be mulched.

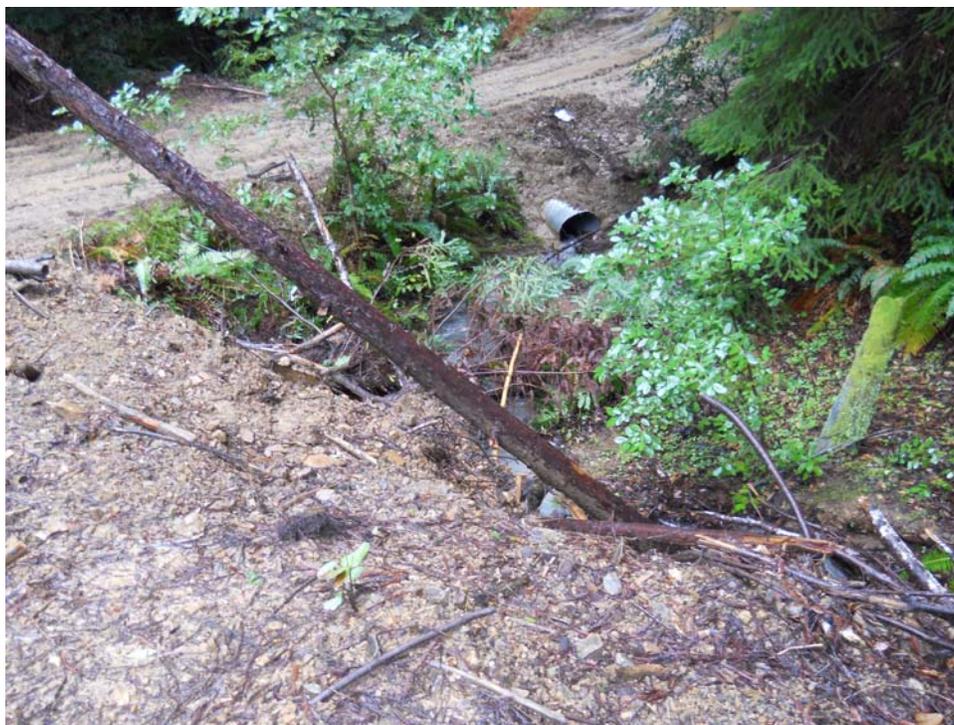
**Photo 12** shows the parking area with perched fill, residential debris and vegetation at Site #4. The perched fill, debris and vegetation shall be removed. Vegetation planting shall occur on exposed soils in this area. (See Site #4 description above.)
