North Coast Regional Water Quality Control Board

Subject: Notice of Violation of Order No. R1-2013-0005, General Waste Discharge Requirements for Discharges for Timber Operations on Non-Industrial Timber Management Plans (NTMP) in the North Coast Region

File: Non-Industrial Timber Management Plan 1-95NTMP-003 MEN,
"Surprise Valley"

August 12, 2015 Site inspection

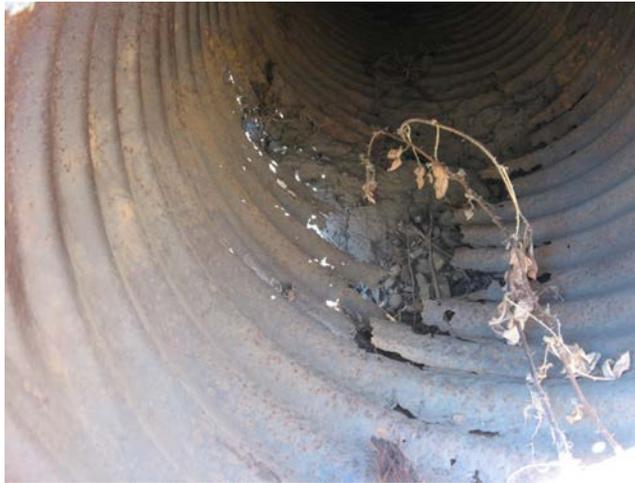
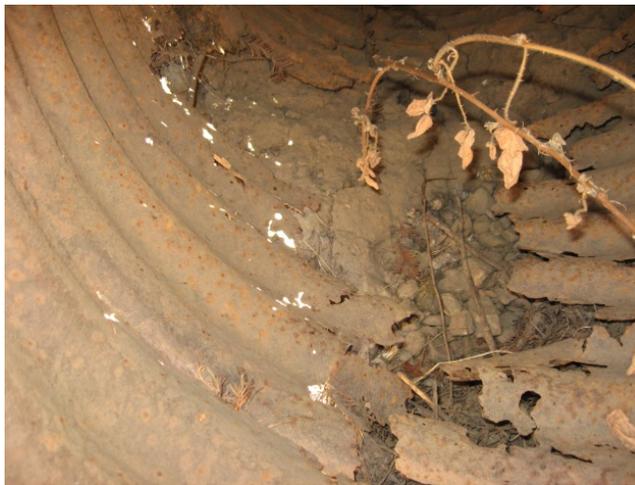
On August 12, 2015, Regional Water Board staff Ryan Bey inspected NTO #11 accompanied by RPF, Randy Jacobszoon. During the inspection, Regional Water Board staff inspected a culverted road crossing on a Class II watercourse that was not identified on NTO maps. The bottom and sides of the existing culvert were rusted through and there were large holes throughout the culvert (Figures 1 and 2). Water flowing out of the holes in the culvert may saturate underlying and surrounding fill material, increasing the potential for failure of the crossing and associated fill during large storm events. In its current condition, the culvert is no longer functioning as designed and must be replaced.

“The 24 inch culvert west of the pond in the north area of the property is rusted through on the underside and should be replaced”

The rusted culvert Regional Water Board staff observed during the NTO #11 inspection is also west of the pond in the north area of the property (Map 1). Mr. Curtis’s November 12, 2013 report also indicates that the RPF was currently evaluating culverts and developing a replacement schedule based on a prior conversation. It does not appear that that evaluation took place.

Figures 1 and 2: rust and extensive holes in bottom of culvert

At the end of the inspection, RPF Randy Jacobszoon agreed to replace the rusted culvert. The RPF must submit a written description of the existing site conditions to the Regional Water Board by October 15, 2015, with proposed corrective action plan to prevent or minimize sediment discharge. The plan must include any design, installation and material specifications, and shall address the following:

- The length, diameter and material of the new culvert, sufficient to ensure that it will accommodate the estimated 100-year flood flow, including debris and sediment loads;
- Specifics about the removal of the existing culvert and installation of the new culvert;
- Specific prescriptions to hydrologically disconnect the road approaches to the crossing, including road surface materials and incorporation and location of rolling dip(s) or other drainage structures as warranted.

All corrective actions for the rusted culvert must be fully implemented by no later than October 15, 2016. All corrective actions for the ditch relief culvert must be fully implemented by no later than October 15, 2015. Confirmation of completion of each corrective action must be provided to Regional Water Board staff no more than 30 days following completion.

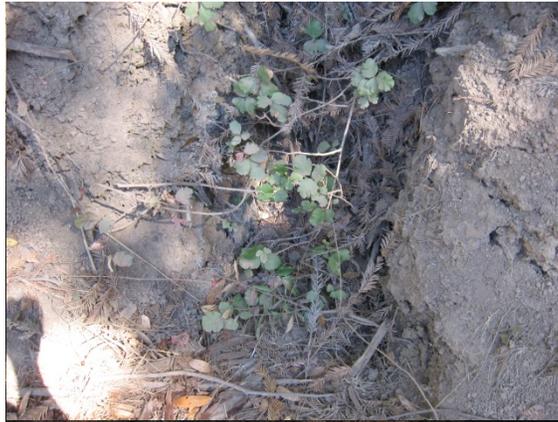
During the August 12, 2015 inspection, Regional Water Board staff also observed a ditch relief culvert (DRC) that had become filled and covered with sediment and organic material to the extent that the inlet and outlet were difficult to locate (Figures 3 and 4). During a precipitation event, water would be unable to pass through the blocked inlet and would instead be diverted down the road, potentially delivering sediment into nearby watercourses. This would violate applicable water quality requirements outlined in the Basin Plan. As the DRC is currently no longer functioning as designed, it must be flushed clean, or replaced. The NTO does not include this DRC, violating section A(5)(a) of the NTMP GWDR.

Figures 3 and 4: Ditch relief culvert inlet and outlet filled with sediment and organic materials

As discussed and agreed to during the inspection, the RPF must inventory all watercourse crossings and remaining ditch relief culverts within the NTO area, and compile a description of the current conditions at each site and proposed corrective action with time schedule for implementation. A copy of this document, with map(s), must be submitted to the Regional Water Board by no later than October 15, 2015.

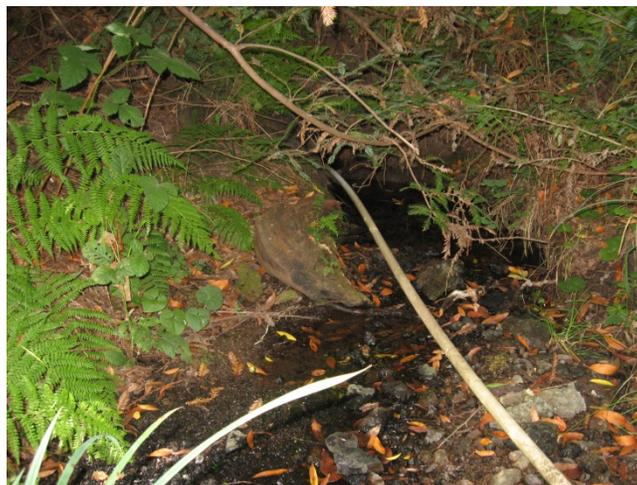
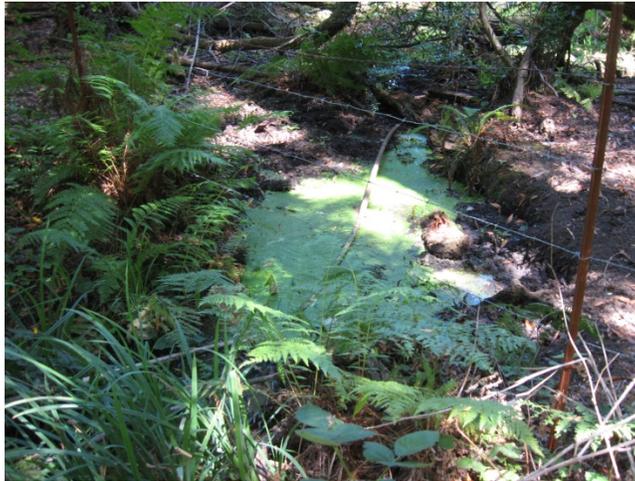
During the inspection, at the southern section of the NTO, Regional Water Board staff observed a spring to the north of the domestic well. The NTO and NTO maps do not include this feature. The spring extends to the northeast and southwest of the road. Water flows from the southwest, through a culvert, to the northeast (Figures 5 and 6). The water then dissipates into a field occupied by cattle. The existing crossing does not need replacing. Water Board staff and the RPF agreed that this spring and associated flow path should be provided Class II watercourse protection. Currently, the NTO does not identify this watercourse, and therefore does not provide for appropriate watercourse protection. Trees in this area had been felled as part of the NTO, but at the time of the inspection, had not been hauled away (Figure 7). Failure to disclose this site and to provide appropriate protection to the beneficial uses of water associated with the spring violates both the Basin Plan and sections A (5)(a) and (b) of the NTMP GWDR. You must add the watercourse to the NTO maps, and provide for appropriate protection to ensure that the beneficial uses of water are protected.

Figures 5 and 6: unidentified spring with no corresponding protection

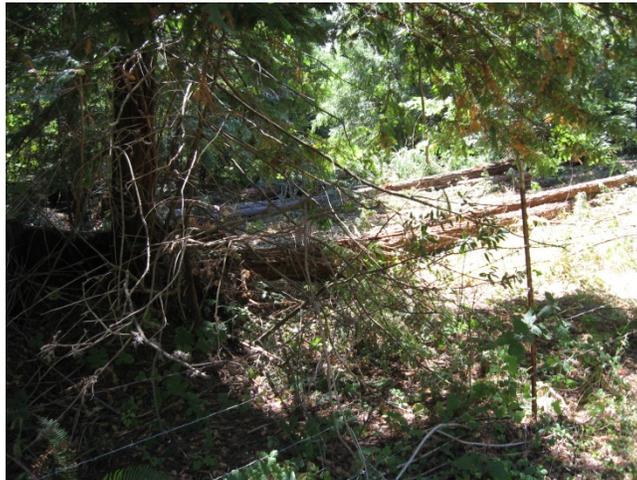
Figure 7: trees felled under NTO waiting hauling lie adjacent to unidentified spring
