Descriptions of Proposed Project and Enhanced Compliance Action As Part of Settlement of North Coast Regional Board ACL, Prepared By Russian River County Sanitation District Staff, December 2015

Russian River County Sanitation District Natural Hazard Reliability Assessment

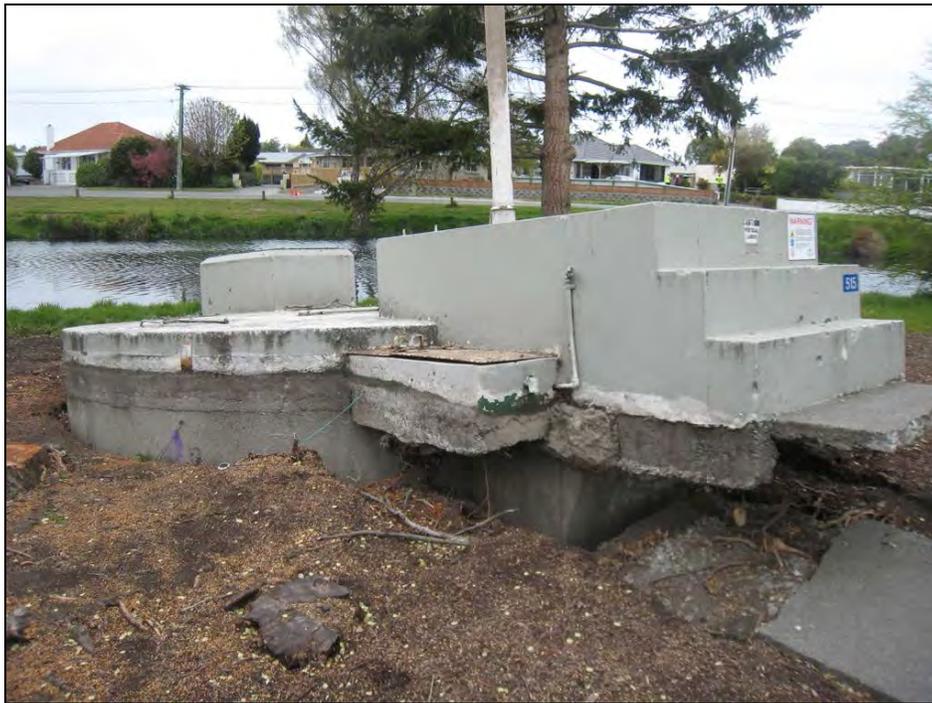
Figure A-4. Floated and Tilted Wastewater Life Station 26, Porritt Park, Avonside

Two of CCC's wastewater dry well lift stations (Figures A-4, A-5) next to the Avon River were subjected to liquefaction and lateral spreads, and they floated and tilted. While the equipment within the lift stations may not have been damaged, the sewers leading to and from the lift stations were broken, and CCC bypassed these lift stations using portable pumps and flex hose.

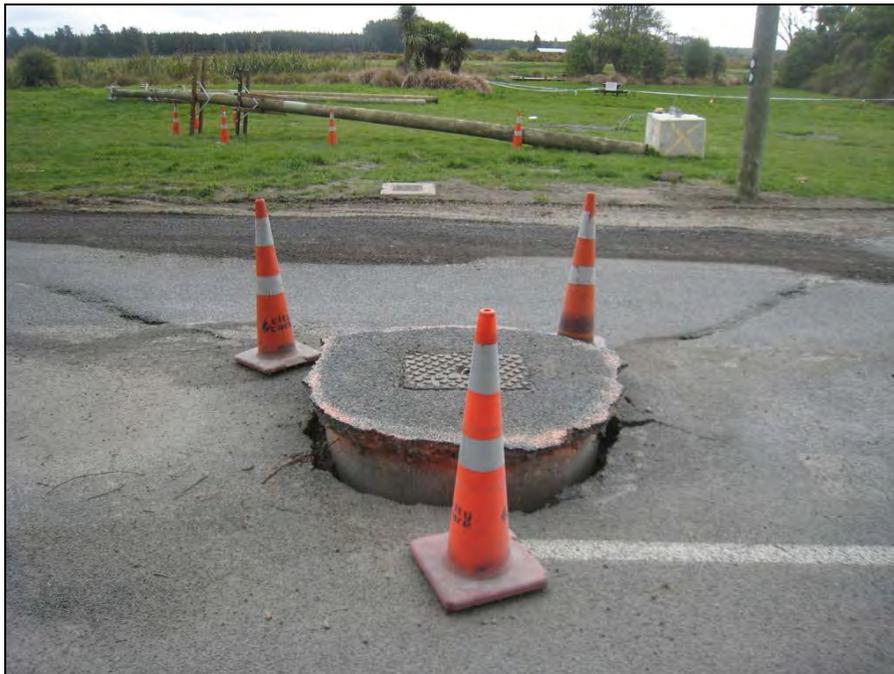
Figure A-6. Floated Sewer Manhole, Brooklands (one of fifteen)

Damage to sanitary sewers (Figures A-6 and A-7) in many places led to direct discharge of untreated sewage into local rivers, leading to contamination warnings. Damage to the sewers has also resulted in substantial inflows of silts, leading to clogging of sewers, as well as infiltration of ground water.

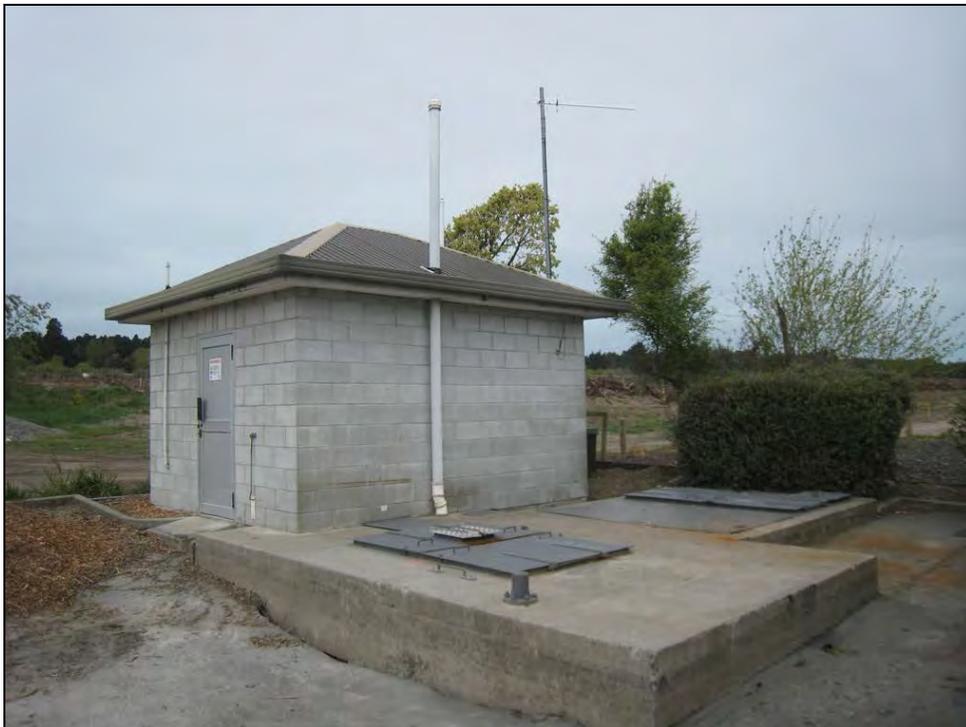
Figure A-8. Settlement due to Liquefaction, Lift Station in Brooklands

Figure A-8 shows a lift station in the Brooklands area. It appears that there was as much as 6 to 10 inches of settlement around the concrete wet well.

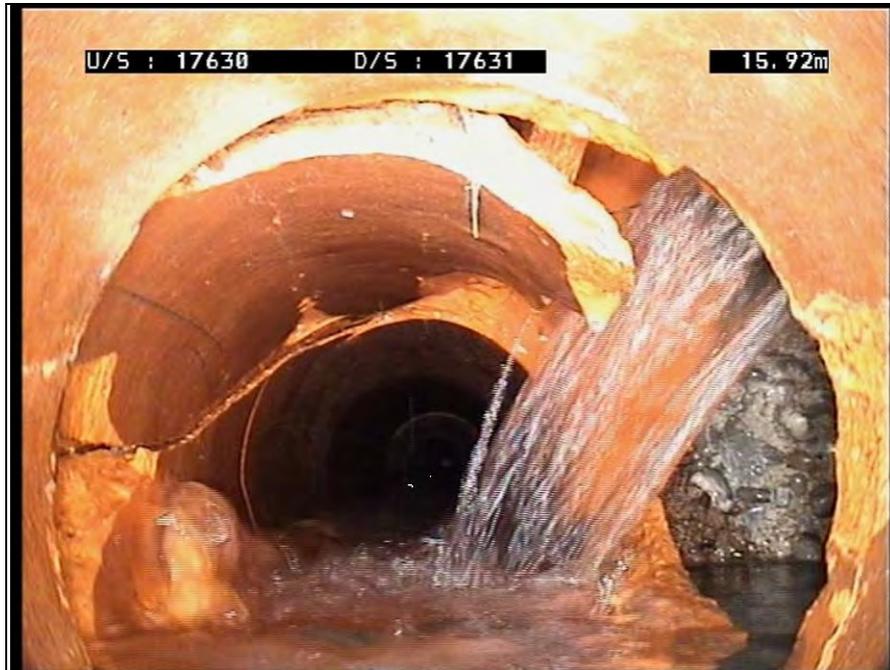
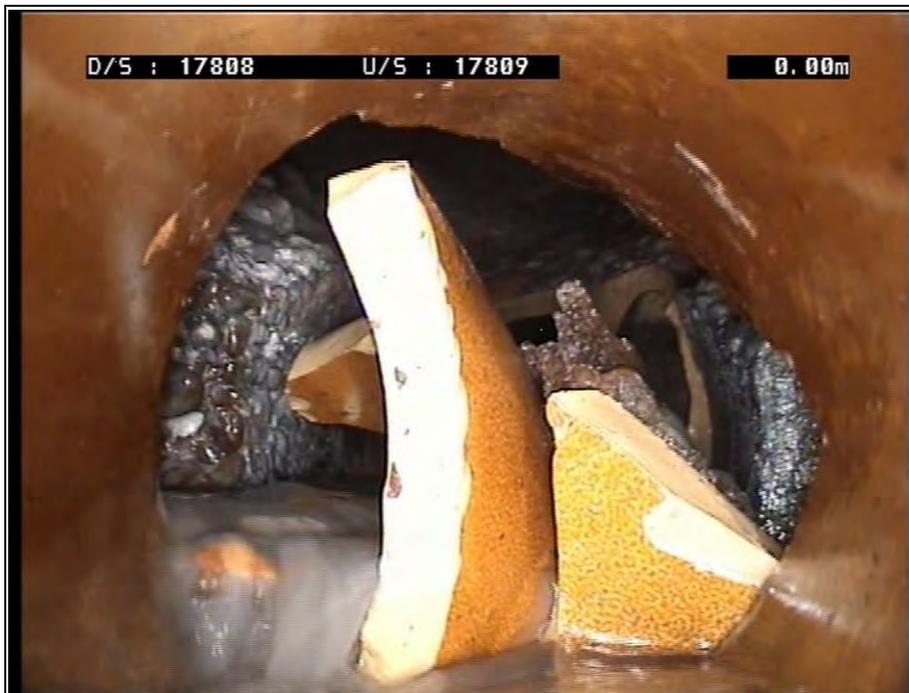
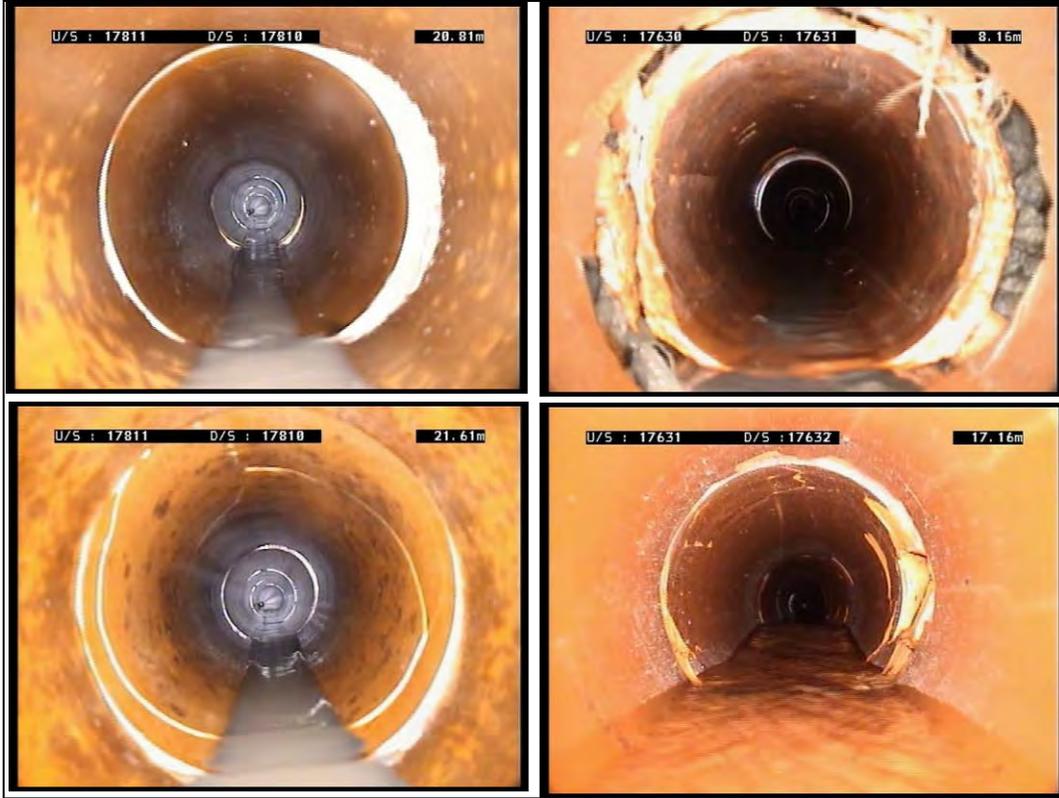
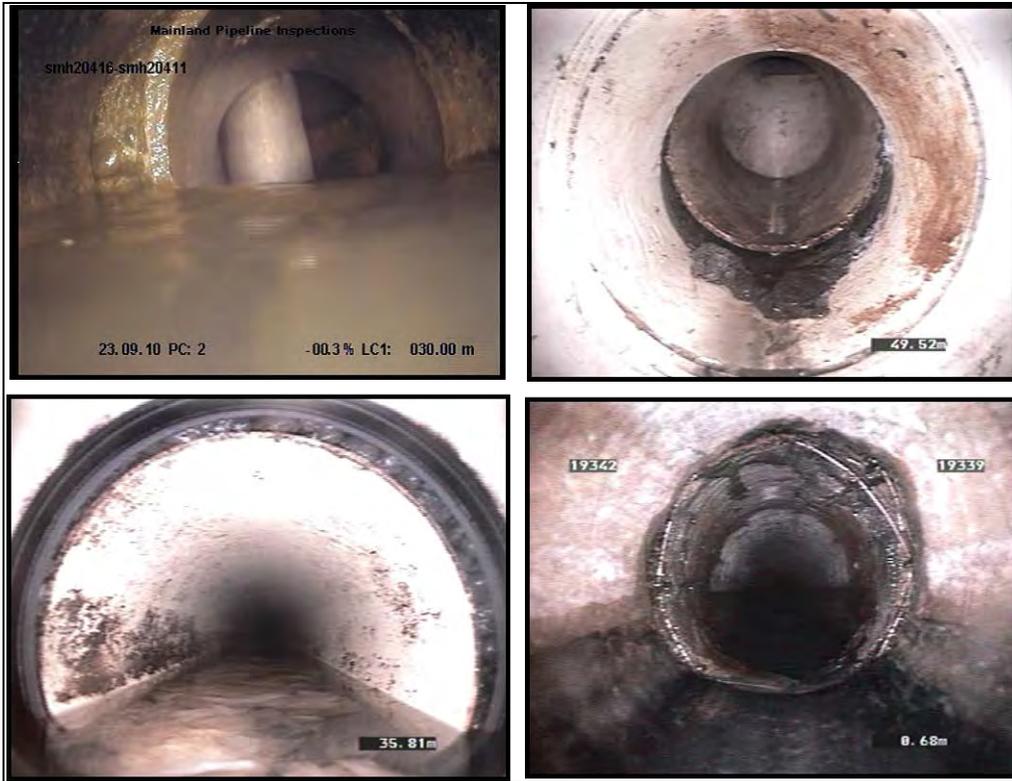
Figures A-9 to A-12 show typical images from CCTVs as to the type of damage within sewer pipes. The damage to brittle pipe is obvious. High volume infiltration of ground water, taking with it silts and sands of the streets, was problematic in the September 4 2010 earthquake, and an absolutely critical problem in the February 22 2011 earthquake.

Figure A-9. CCTV picture of Broken Sewer, WDC

Figure A-10. CCTV picture of Broken Sewer, WDC

Figure A-11. CCTV picture of Broken Sewers, WDC

Figure A-12. CCTV picture of Broken Sewers, WDC

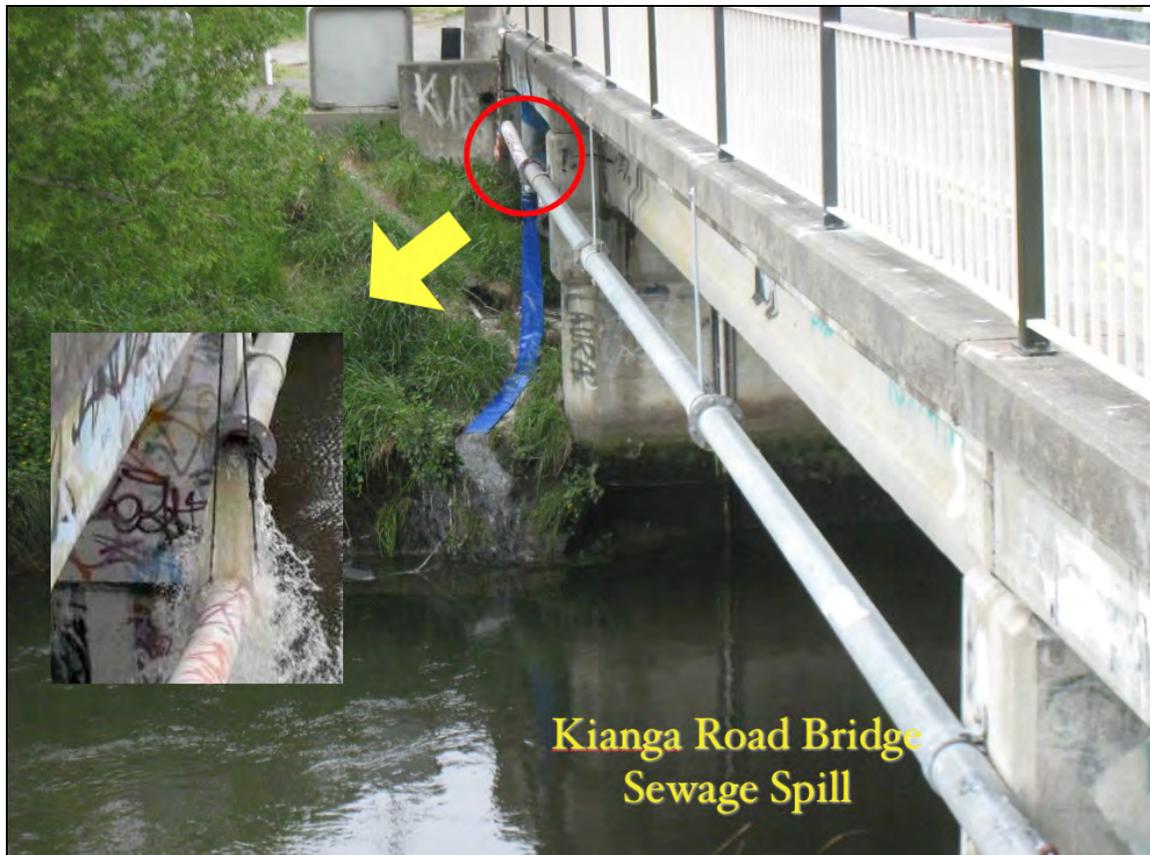
Figure A-14. Broken Sewer Pipe

Figure A-14 shows a broken sewer pipe that was hung on the side of a bridge. The blue "flex hose" was added to the broken pipe to direct sewer discharges directly into the creek. According to the design of this bridge, the bridge was originally built in the 1960s; it suffered no damage (except for settlement of the roadway of a couple of inches at each abutment). At the time it was originally built, it had no attached pipes. The broken sewer pipe is attached to the bridge at several points using both gravity-only as well as lateral supports; nominally, it would "be acceptable" per the IBC 2012 code. However, the pipe was too rigidly supported, and settlement of one abutment (far side in this photo) led to failure of the pipe.

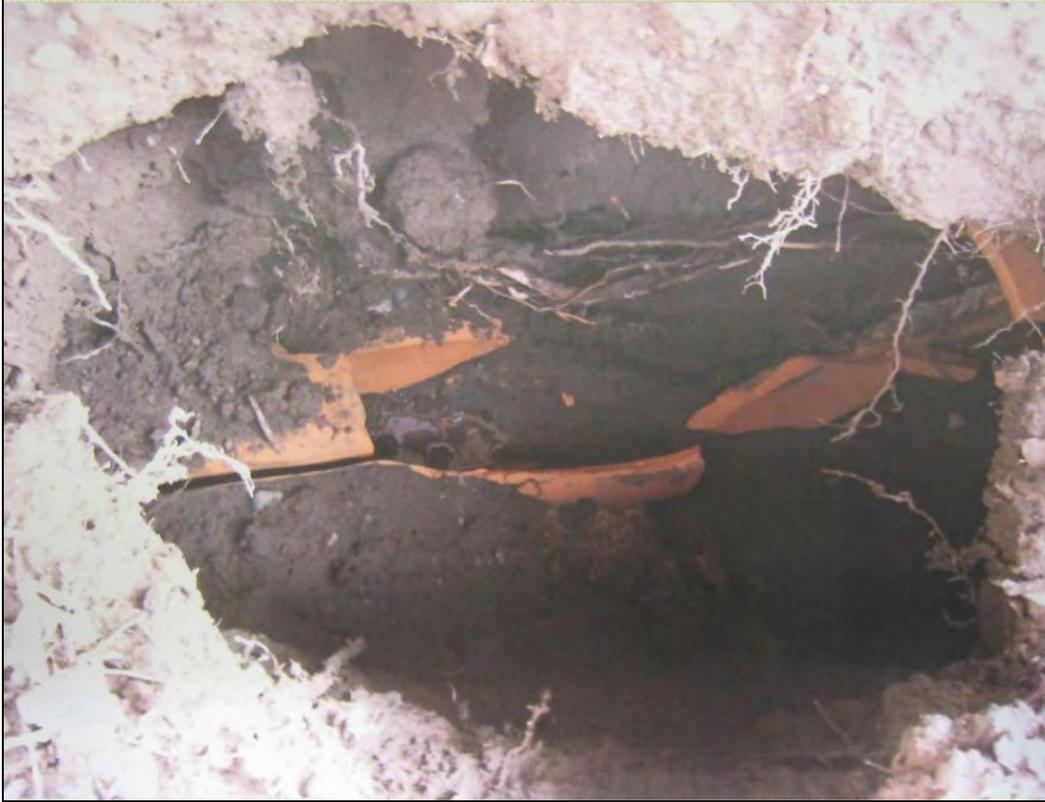
Figure A-17. Repair of Vitrified Clay Sewer Pipe

both a time consuming and expensive effort. Figure A-16 shows a crew working on repair of a deep sewer. Figure A-17 shows a damaged vitrified clay pipe waiting to be repaired.

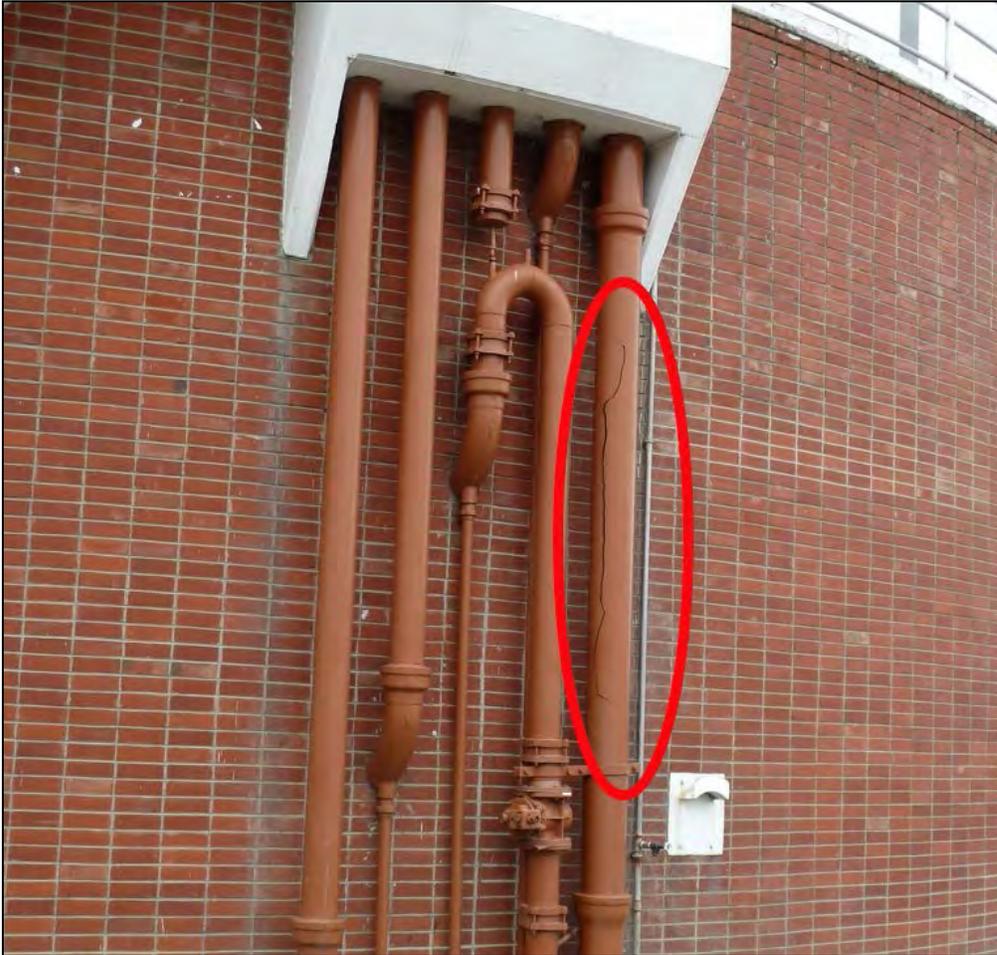
Figure A-43. Cracked Pipe to Digester, Bromley WWTP

Figure A-43 shows a cracked pipe leading to one of the digesters. There was no leak, as the pipe has an internal liner (and the digester was out of service).

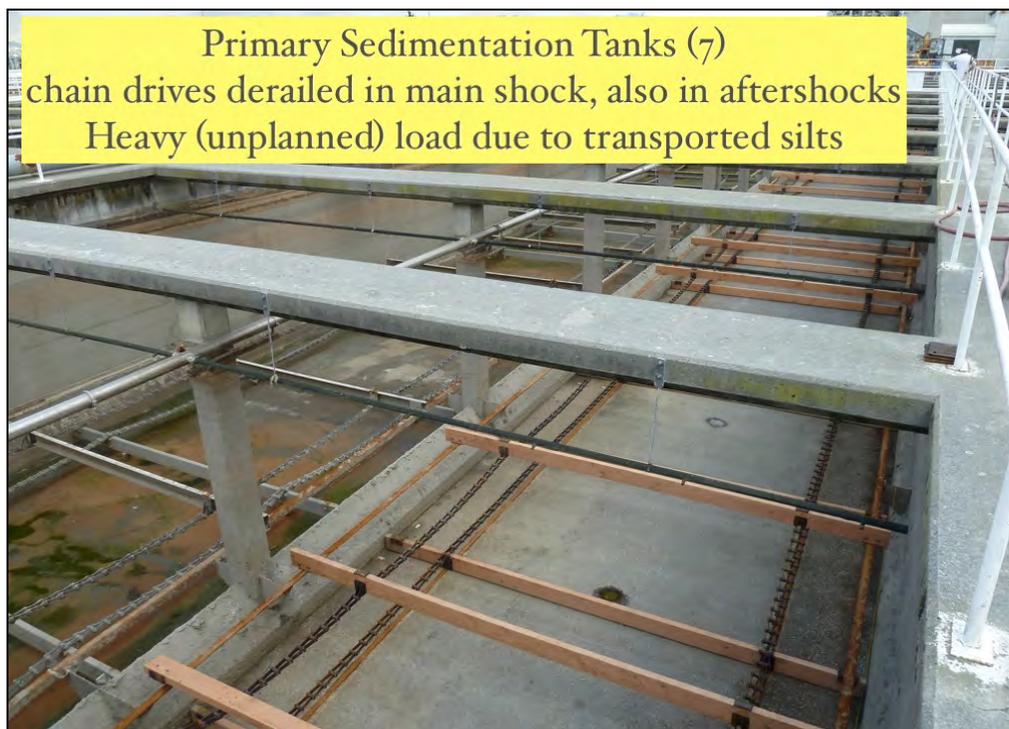
Figure A-45. Scrapers, Bromley WWTP

Figure A-45 shows damage to the scrapers in the primary sedimentation tanks. The tank on the right has wood scrapers, reflecting that the original metal channels have buckled and failed. This photo was taken in April 2011, while repairs were being made to these basins.

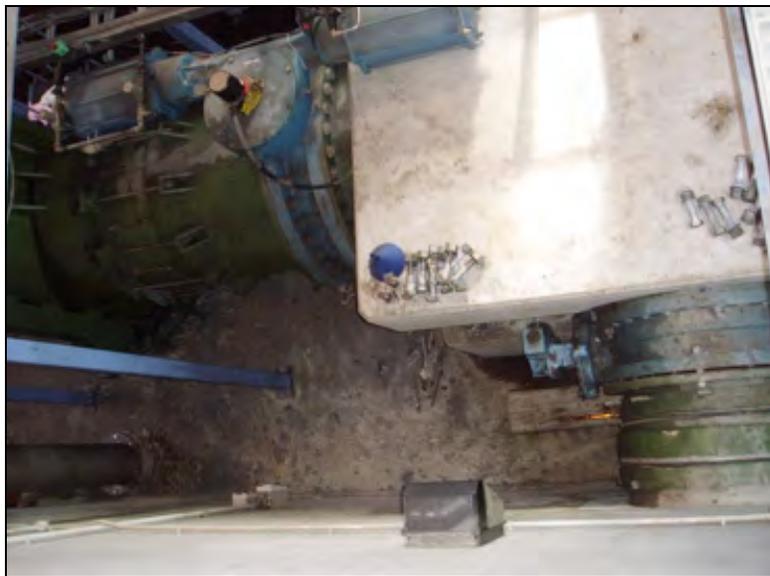
Figure A-48. Pumping Station B leak at mechanical coupling, Bromley WWTP

The Bromley WWTP has two pumping stations called Pumping Station A and Pumping Station B. There was no damage reported to pumping Station A. Pumping Station B had damage to a mechanical coupling shown in Figure A-48 that allowed sewage to leak and fill up the station. The cause of damage to the coupling was not known as of April 2011, but was suspected to be from small differential movements, as observed by the author of this report when he visited the plant in April 2011.

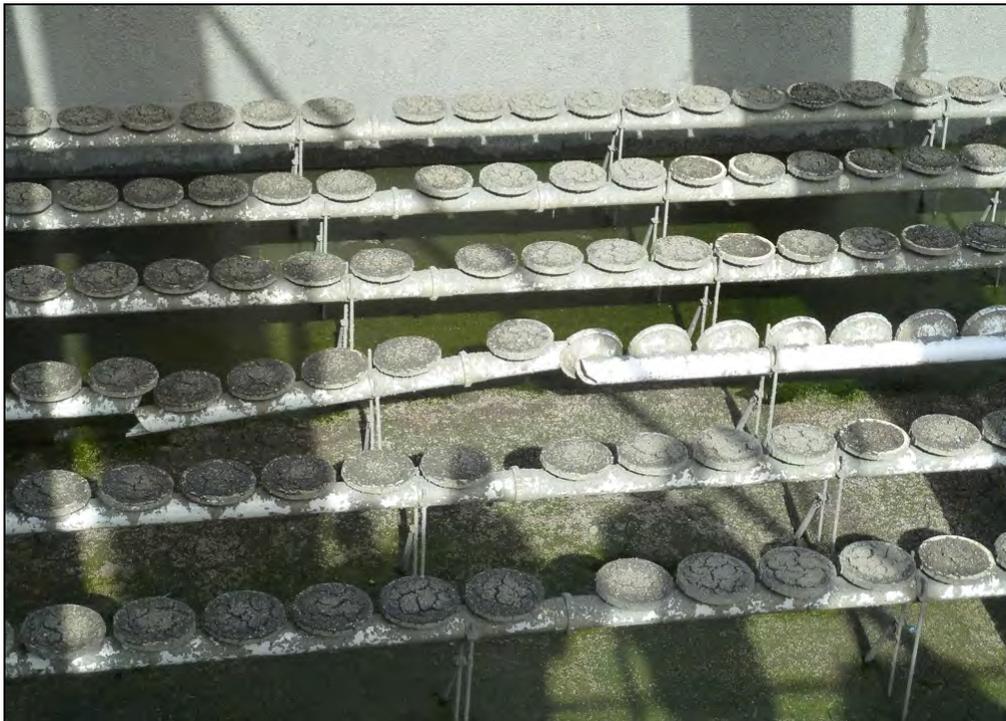
Figure A-49. Broken PVC Pipe in Aeration Tank, Bromley WWTP

Figure A-49 shows damaged 6" PVC pipe in the aeration contact tank. This type of damaged PVC pipe was seen at several other places in this tank.

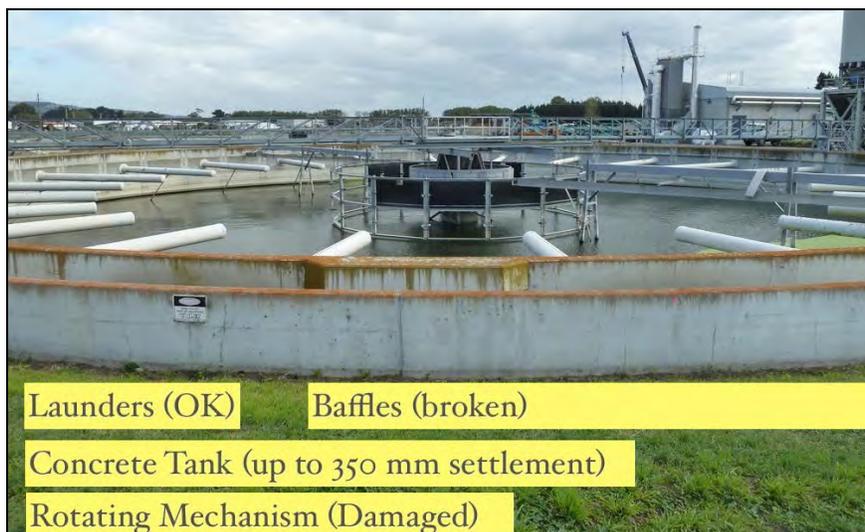
Figure A-50. Broken Secondary Clarifier, Bromley WWTP

Figure A-50 shows one of the four secondary clarifiers. Three of four clarifiers were heavily damaged, due to a combination of liquefaction and sloshing forces on the sludge mechanisms. CCC believes that some of the clarifier floors have experienced up heaving. Dewatering is necessary prior to emptying the tanks for inspections, thus significantly delaying ability to determine needed repairs/replacements. These will likely have to be rebuilt entirely.

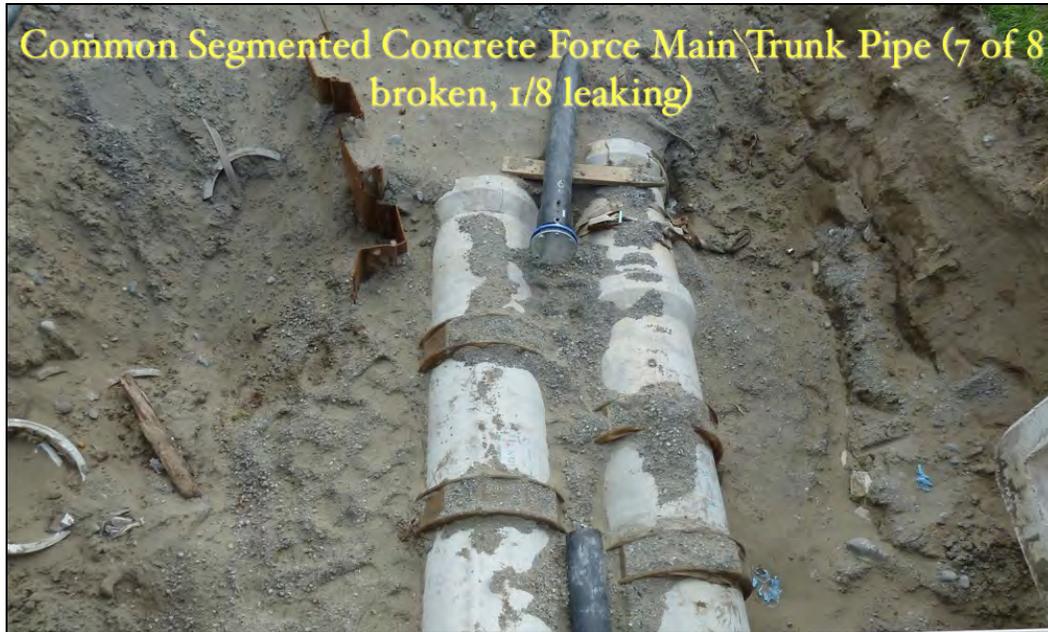
Figure A-51 shows external clamps placed on leaking reinforced concrete pipes (3-foot diameter) at the WWTP.
