**Complaint Inspection Report
Daniel Franklin Property
1-00NTMP-019 MEN/LAK
Lake and Mendocino Counties
WDID No. 1B13159CNME**

Date: April 30, 2014

Subject: May 3, and May 24, 2013 inspections

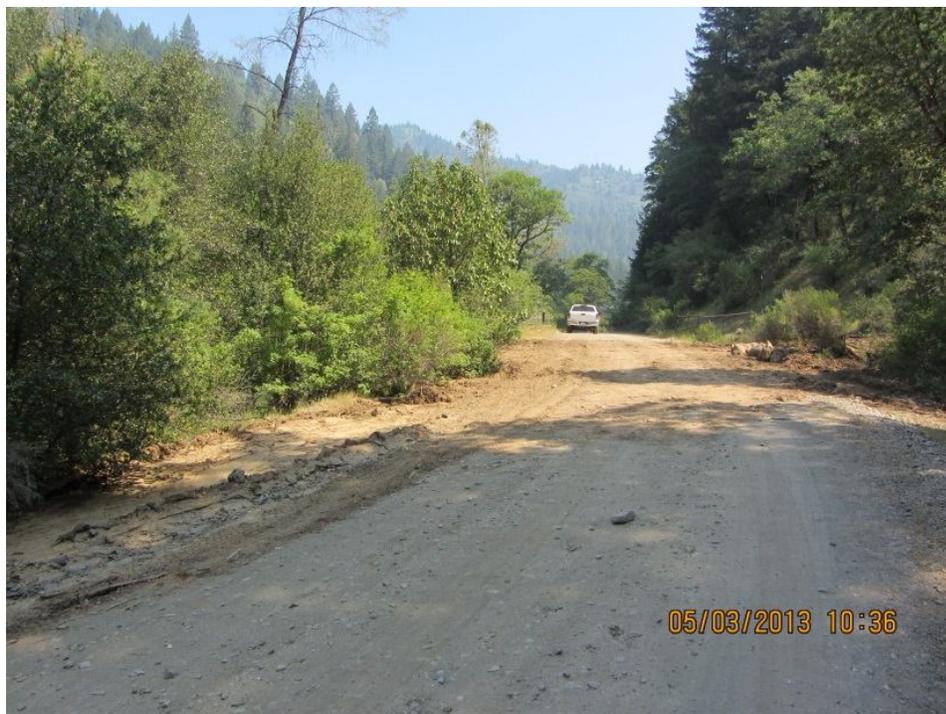
Image 1, May 3, 2013 M8 Road with soil and mud deposits from bladder failure discharge.

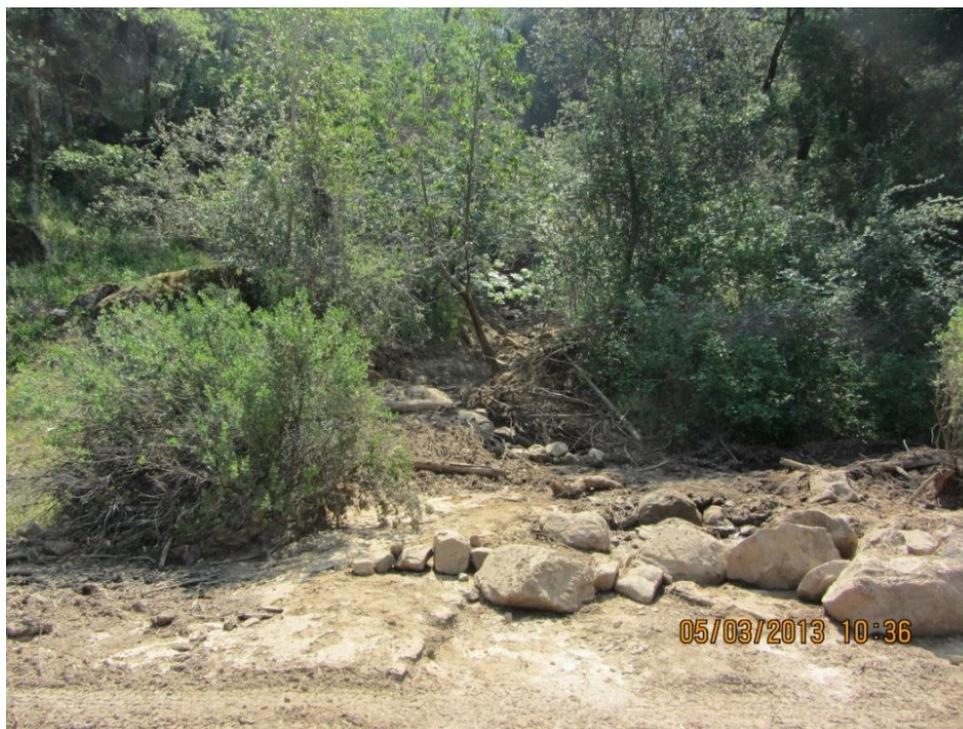
Image 2, May 3, 2013, stream crossing on M8 Road, looking upstream. This is the stream that carried the release from the failed bladder down to the road (note the large boulders deposited by the high flows at the road edge).

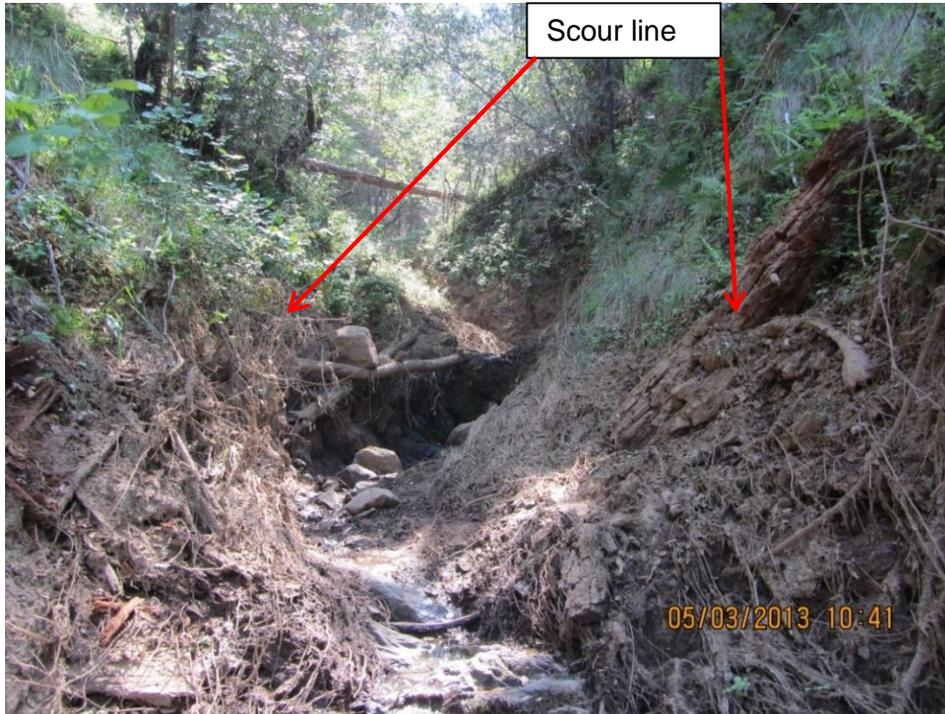
Image 3, May 3, 2013, this is taken upstream from the M8 Road crossing. Note the scour line: this shows the depth of flow during the discharge from the bladder failure. This is likely a perennial stream

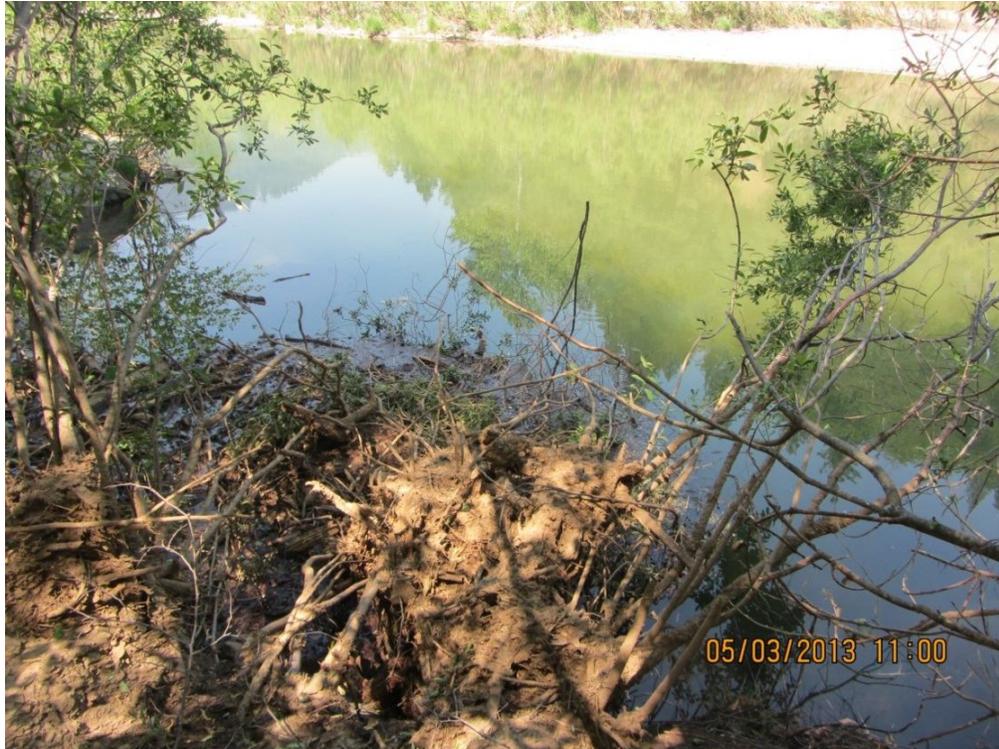
Image 4, May 3, 2013, this image depicts the confluence of the primary stream with the Middle Main Eel River (note the flood debris captured on the willow in the foreground).

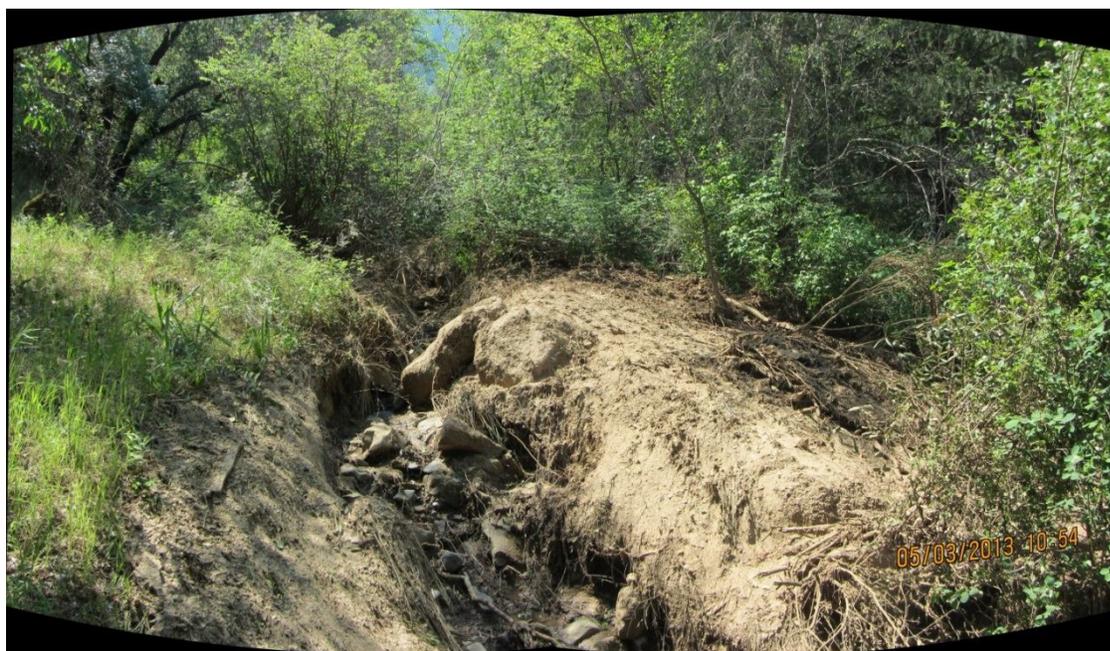
Image 5, May 3, 2013, over bank flows in the primary stream below the crossing on the M8 Road

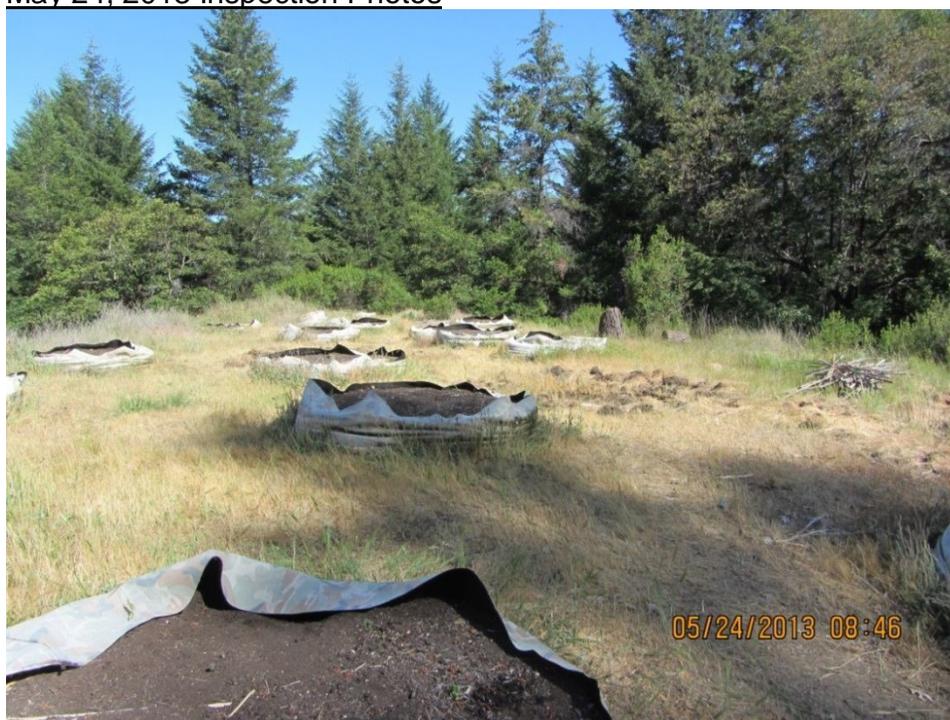
Image 6, May 24, 2013, the clearing with planting holes, reportedly one of the destinations for water stored in the bladder prior to its failure. The location is identified as "point of use" on the inspection map.

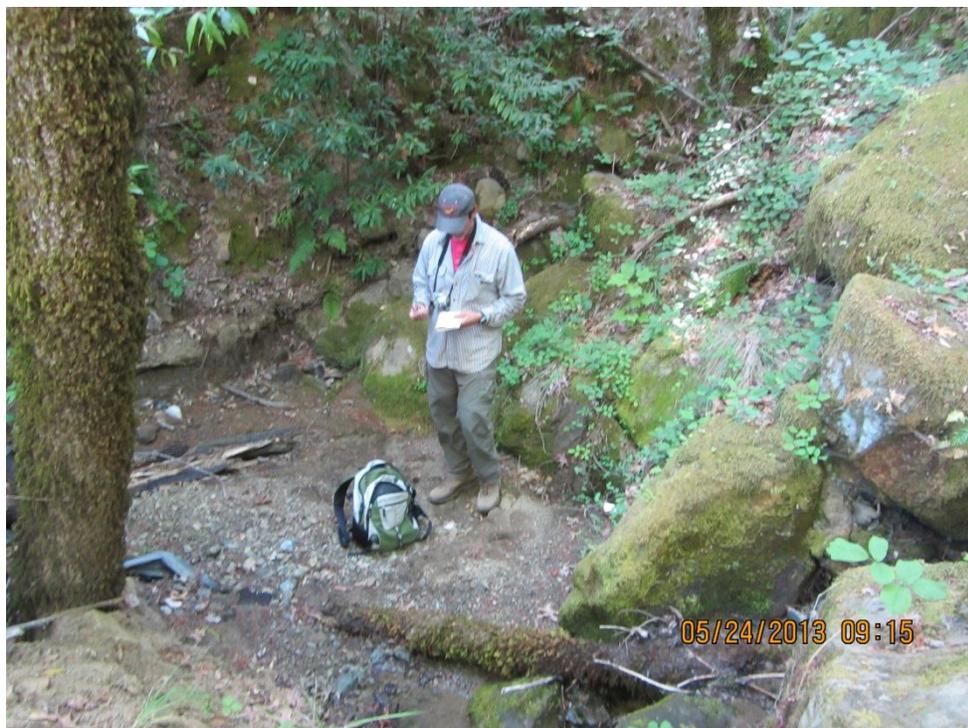
We asked Mr. Franklin where water came from to fill the tanks and he said uphill from a spring. At our request, Mr. Franklin and his partner took us to the spring, which I have identified as Point of diversion 1 (POD #1³) on the map included with this report. The "spring" feature consisted of a pool partially dug out and dammed with stones and black plastic in a Class II stream. The diversion location was dry at the time of inspection.

Image 7, May 24, 2013, point of diversion; source of water used to fill the bladder and adjacent water tanks. (N 39°21'56.8" W 123°03'47.1")

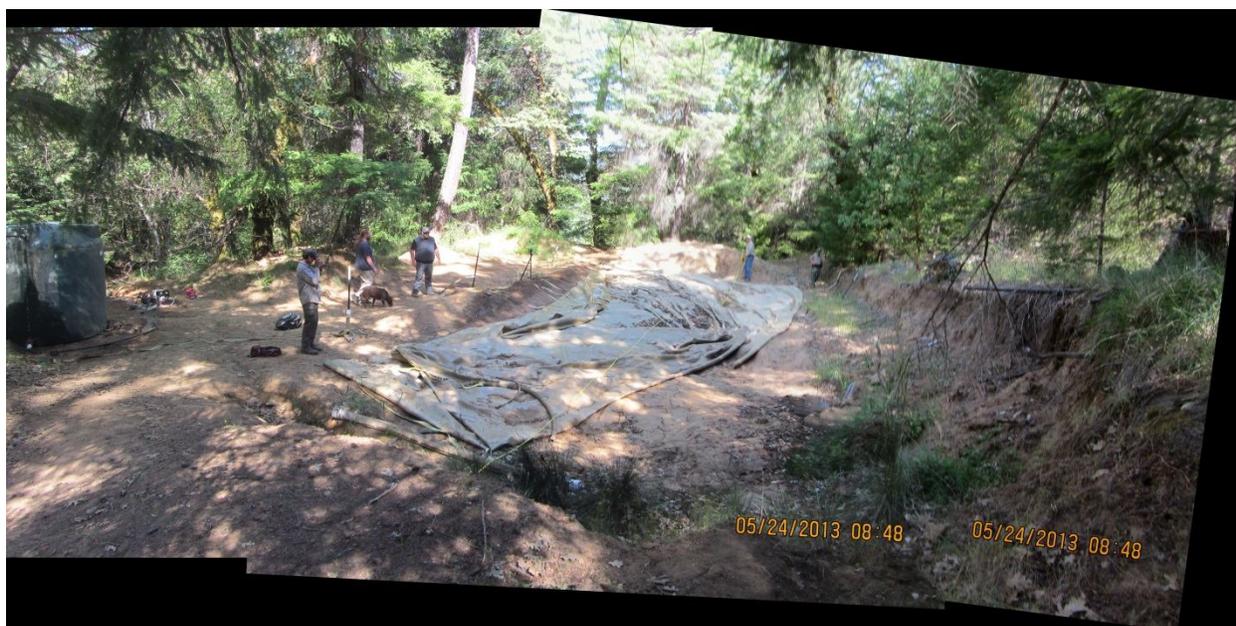
I inspected the bladder, and could see that it had burst along a seam, likely instantly releasing its entire contents into the adjacent Class II stream. I observed that the flow path caused by the bladder failure was about 30 feet wide. I walked around the bladder and found a label indicating that it is a military surplus item intended to store fuels for military use. The label indicates that the bladder capacity is a maximum of 50,000 gallons, with a maximum tank height of 4' 9." The label also states "CAUTION," "DO NOT OVERFILL," "Overfilling Will Result In Permanent Damage And Failure Of The Tank." The label also indicates that the bladder is not recommended for long term use for gasoline storage. Mr. Franklin estimated that the bladder might have contained as much as 80,000 gallons of water when it failed. Mr. Franklin stated the adjacent two (2) 2500 gallon tanks are gravity fed from the source above (POD #1), and water is then transferred to the bladder. POD #2 is also used to fill the bladder later in the year when POD #1 goes dry.

We measured the bladder and found its dimensions to be approximately 25' X 70,' as compared to the 25' X 60' discussed earlier. Considering that the bladder may have held 80,000 gallons when it failed, would explain the apparently stretched out or expanded length of the bladder from specifications when we measured it. The pad the bladder was located on was 70' X 104'. We also observed two (2) 2500 gallon water tanks next to the water bladder. Mr. Franklin indicated that the water flowed from the tanks into the bladder. From the bladder, water was either pumped back into the tanks or into the adjacent cleared area, where we observed holes filled with potting soils that looked as though they had been used for growing plants. I did not observe any plants during the inspection.

Image 8, May 24, 2013, failed water bladder (N 39°22'05.6" W 123°03'52.9")

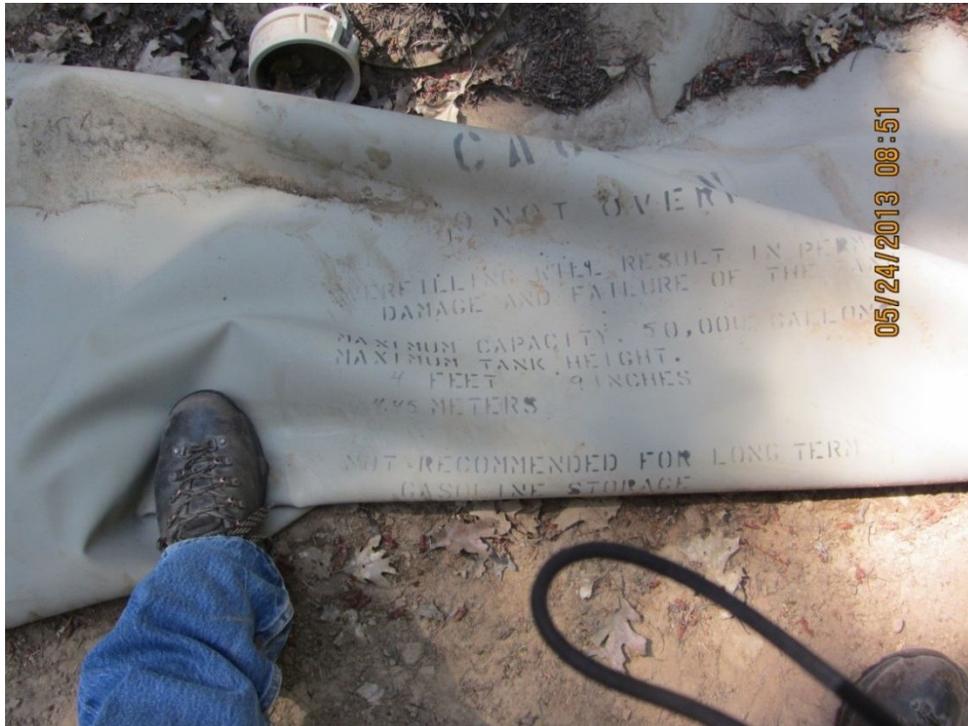
Image 9, May 24, 2013, water bladder label, which indicates it has a maximum capacity of 50,000 gallons. The bladder is designed for use with fuels, and not recommended for long term use.

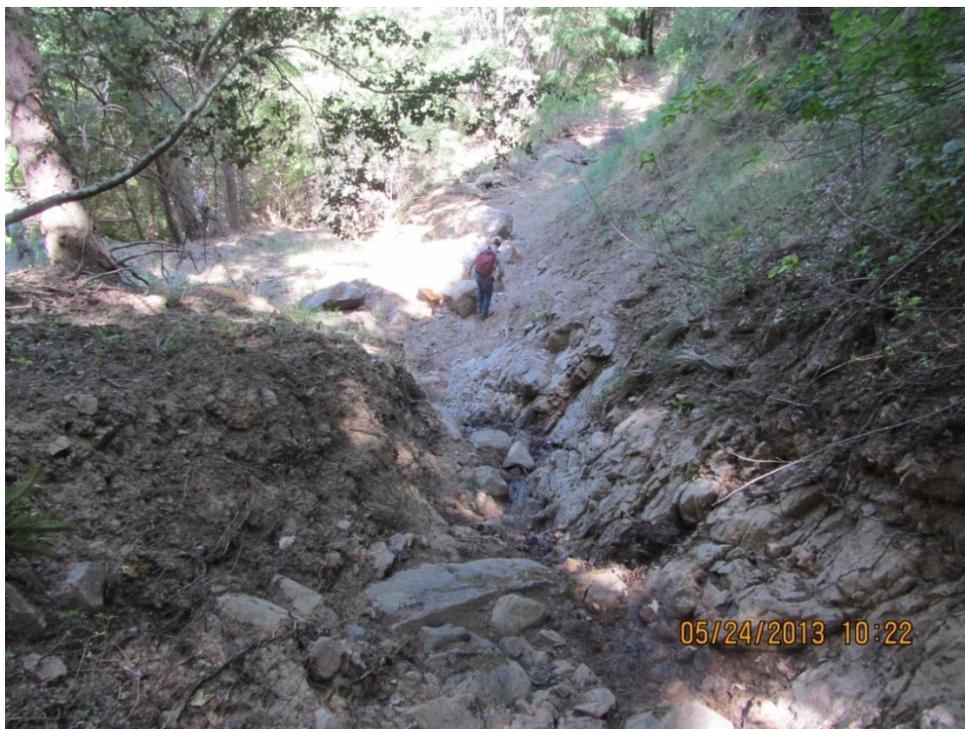
Image 10, May 24, 2013, affected watercourse, looking downstream. The channel is scoured to the bedrock and large boulders carried in the flood are sitting on the road below. The road is on the subject property.

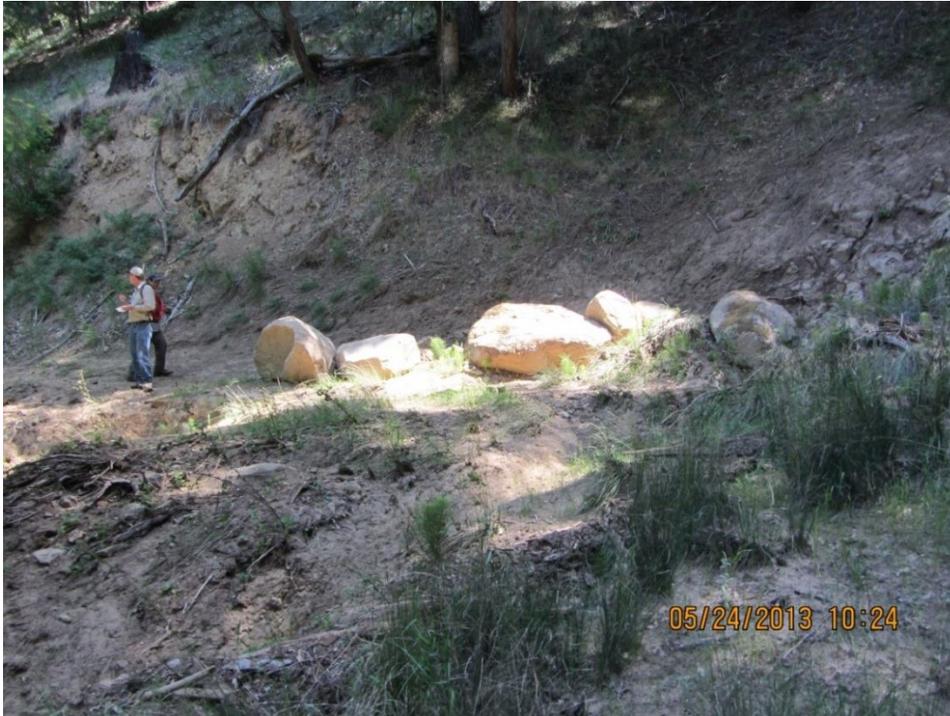
Image 11, May 24, 2013, the road shown in the previous photo at the watercourse crossing. Note the boulders deposited by the flood on the road bench and the extensive flood debris field.

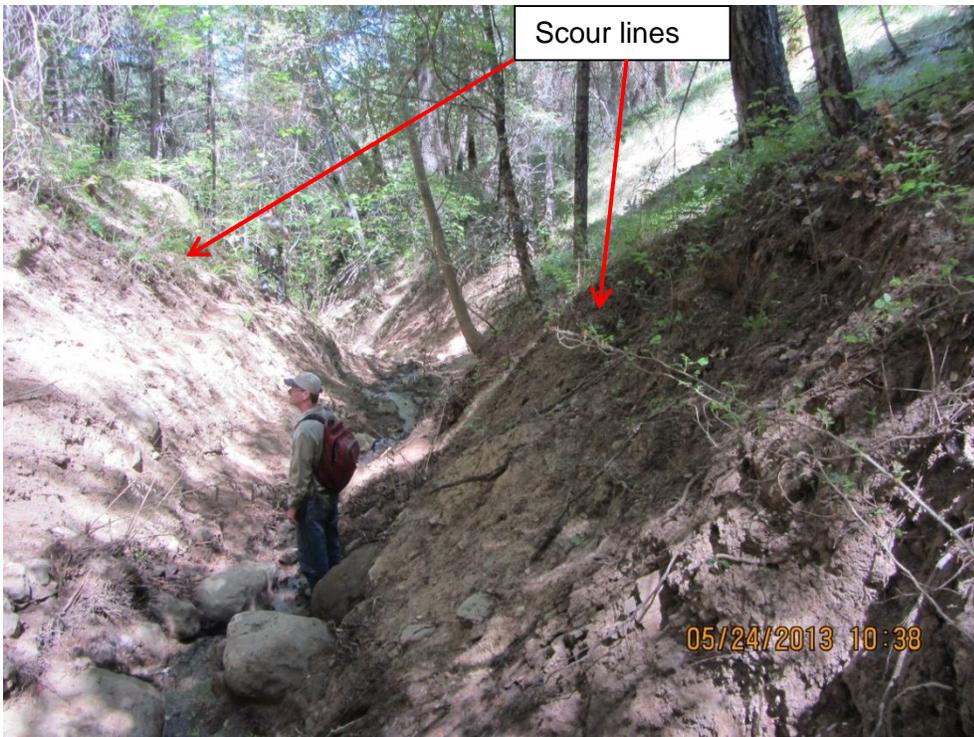
Image 12, May 24, 2013, in the affected watercourse, looking downstream; note the complete removal of all stream side vegetation and the depth of the instream channel scour.

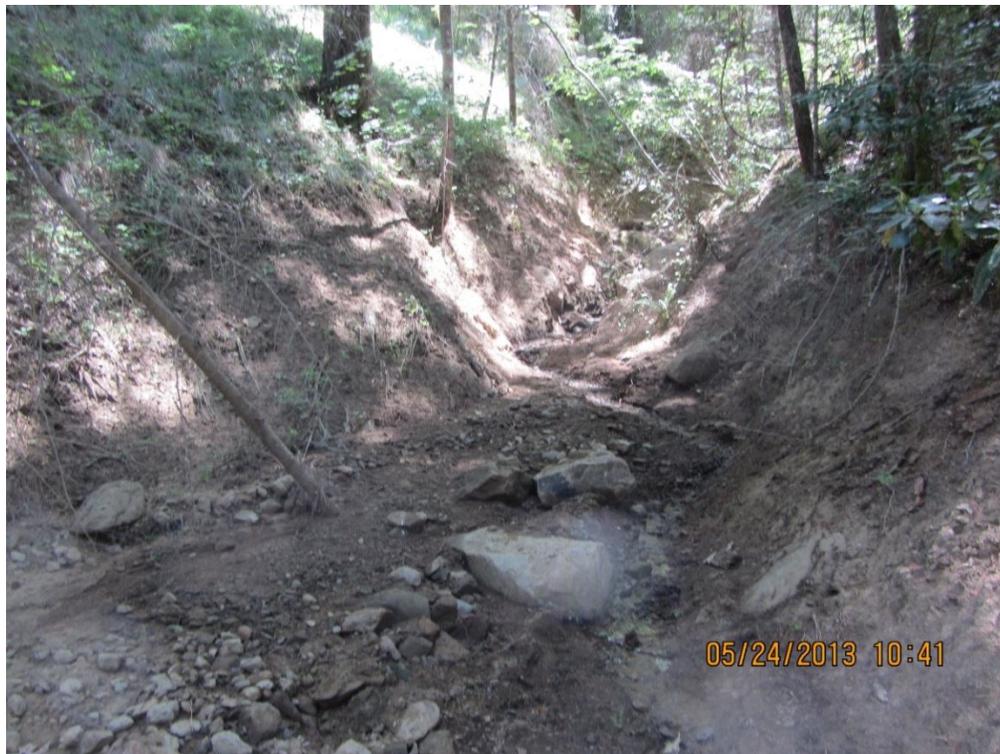
Image 13, May 24, 2013, affected watercourse channel looking upstream; instream erosion and flood deposits

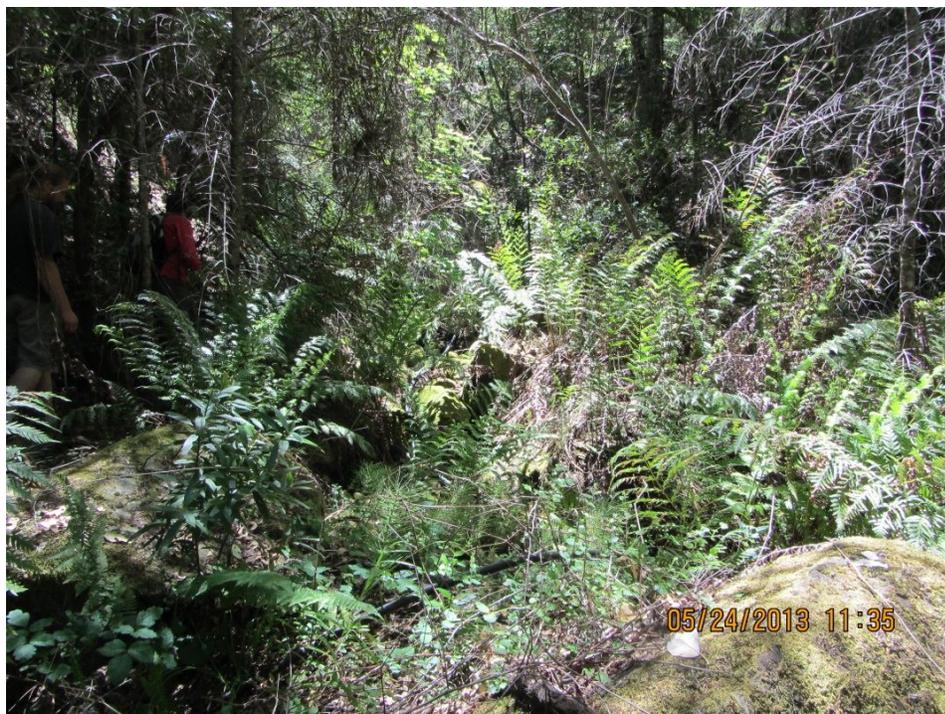
Image 14, May 24, 2013, adjacent unaffected "reference" stream. Note the stream side vegetation is well developed. In this section of stream the flow appears perennial based upon flow, the aquatic life present, and vegetation component.

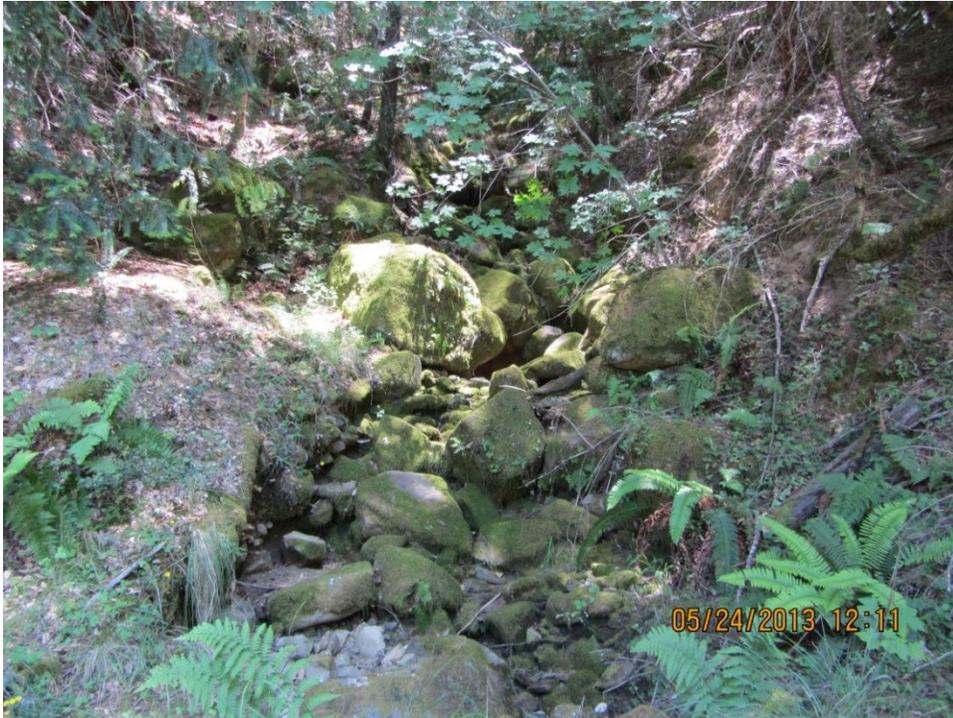
Image 15, May 24, 2013, the reference stream downstream from image 13. The stream appears to flow underground and then re-surface farther down the slope. Note that here there is moss on the stream substrate and no apparent high flow scour line.
