Field Inspection Report

Name and Location of Facility Inspected McDonough Property Humboldt County APN 211-374-014-000 510 Brown Road Myers Flat, CA	Inspection Date May 17, 2016	Inspection Time 08:40
---	--	---------------------------------

Prepared By: Erin Mustain, P.E. on June 2, 2016

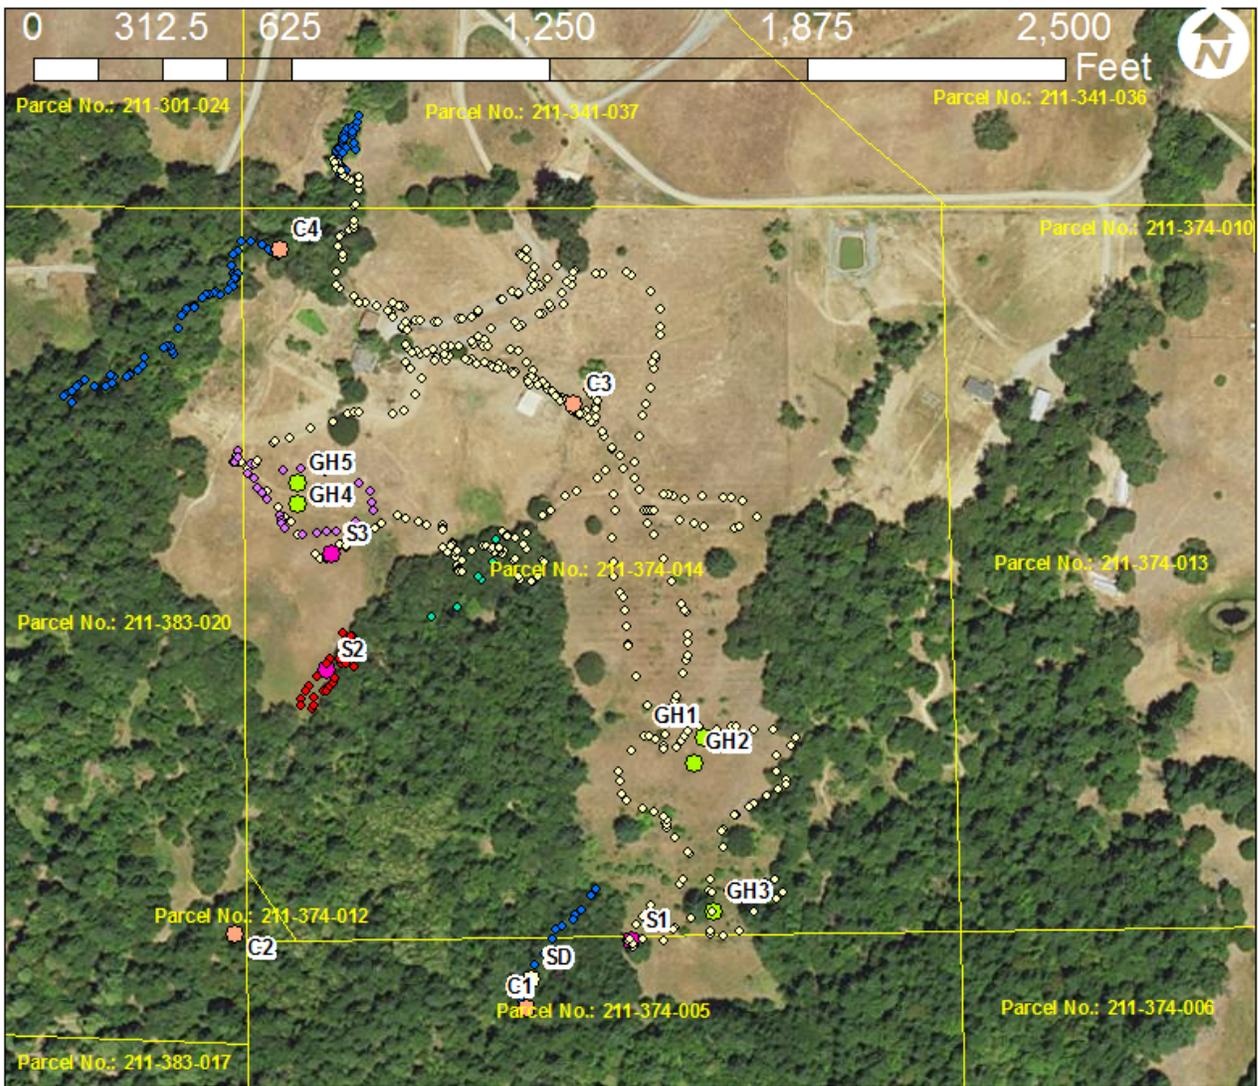
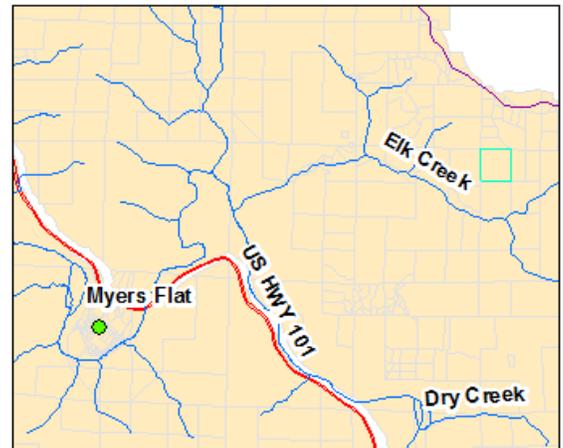
Figure 1 – Site Diagram
 Image Source: United State Department of Agriculture, 2014 NAIP Imagery

The subject parcel is located at 510 Brown Road in Myers Flat. Elk Creek is located approximately 0.3 miles southwest of the parcel. The parcel is approximately square-shaped and encompasses approximately 40 acres. The parcel boundaries presented in Figure 1 are based on available Humboldt County's Parcel Layer 2012 GIS data. These parcel boundary locations are approximate and are not intended to be relied upon for any future site development or project design use. The actual parcel boundary may actually be located up to several hundred feet west and up to approximately two hundred feet south of the location shown. The parcel is roughly 65 percent vegetated with trees, 20 percent is a wet meadow, and the remaining 15 percent has clearings for the cannabis cultivation areas, roads, and residence. Private roads run throughout the property. The parcel generally slopes towards Elk Creek. Site terrain slopes upward from the southwest to the northeast at elevations ranging from 640 feet above sea level in the southwestern corner of the parcel to 960 feet above sea level in the northeastern corner.

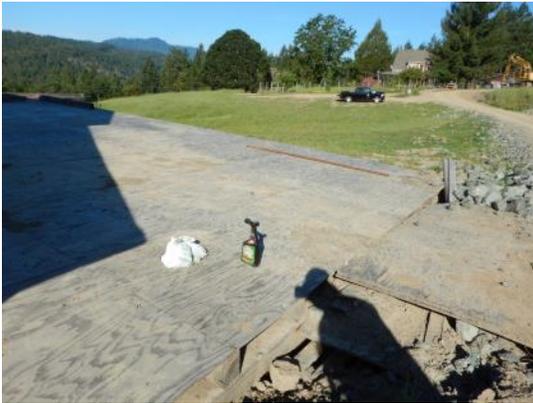
Photo 1

At approximately 8:40 a.m., Water Board staff began the inspection, looking for any conditions or features causing or threatening to impact water quality. This report focuses on water quality issues. We began the inspection in the northern portion of the parcel and walked east along one of the roads. We came across a large wooden shed (located just to the west of inspection point C3) and I observed a bottle of Triazicide Insect Killer (Photo 1). I picked up the bottle and confirmed there was liquid inside it. The active ingredient in Triazicide is gamma-cyhalothrin, a pyrethroid. Pyrethroids present a serious threat to water quality and are illegal for use on cannabis. As insecticides, they target aquatic invertebrates, which serve as a food source for larger aquatic organisms. They are also toxic to fish. Pyrethroids are the synthetic versions of pyrethrins and are often very persistent in the environment. While outside of the Water Boards' purview, it must be noted that the use of Trazicide on cannabis has not been evaluated for safety or human health effects.

This photo is unchanged (aside from being compressed to 150 pixels per inch) and the bottle, near C2, is where staff found it. Zooming in allows the viewer to read the label on the bottle.

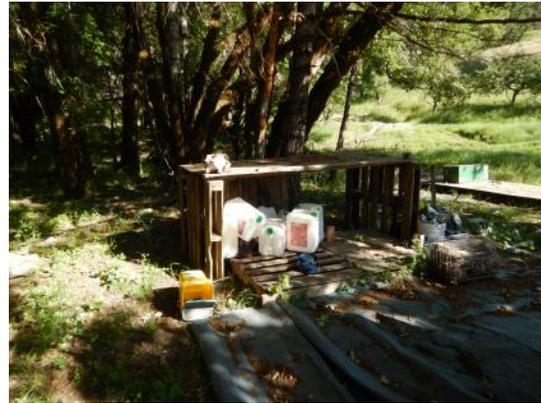
Photo 2

This photo shows empty fertilizer containers by GH3.

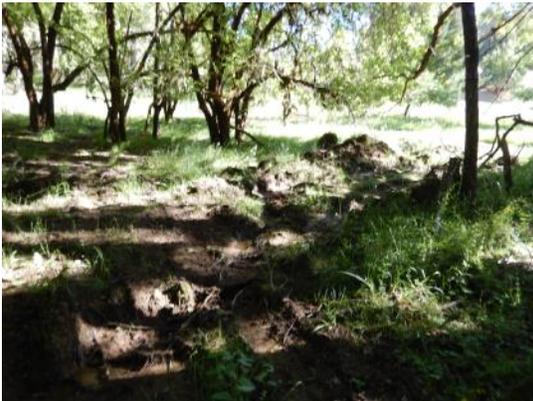
Photo 3

I observed a disturbed area with waterlogged soil (Photo 3) and the watercourse appeared to flow southwesterly from there. We walked along the watercourse and came to a pool, identified as SD on Figure 1 (Photo 4), with approximately 12 inches of sediment deposition. The sediment appeared to be predominantly (80% - 90%) sand. In another pool, with an approximately 1.5 foot diameter, I noted 1 inch of sediment deposition. Where the watercourse met the property line, I observed a culvert, which is denoted C1 on Figure 1. The culvert was an 18-inch corrugated metal pipe and appeared to be old. However, there were signs of more recent grading on the road. Staff traveled west along this road, following the property line and came to a stream crossing, roughly 2 feet wide, with no culvert (Photo 5). This is denoted C2 on Figure 1.

This photo was taken facing northeast and upstream, where the stream seemed to originate. Note the meadow in the background.

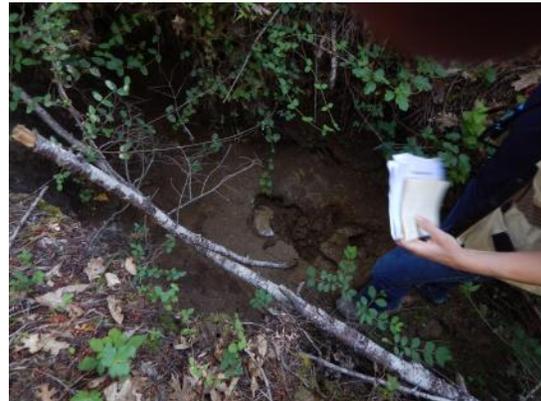
Photo 4

Pool within the watercourse. Staff dug into the sediment to determine the depth of deposition.

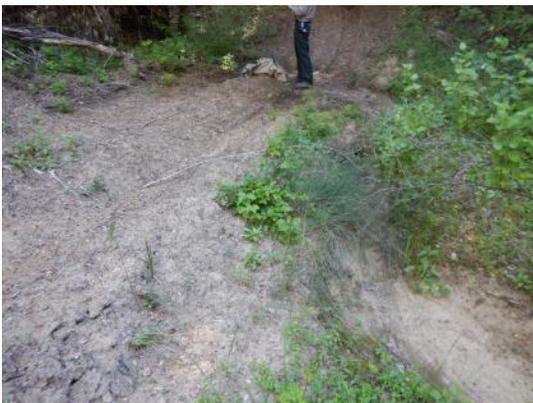
Photo 5 (White)

This photo shows a road cutting through a watercourse with no crossing and was taken facing east.

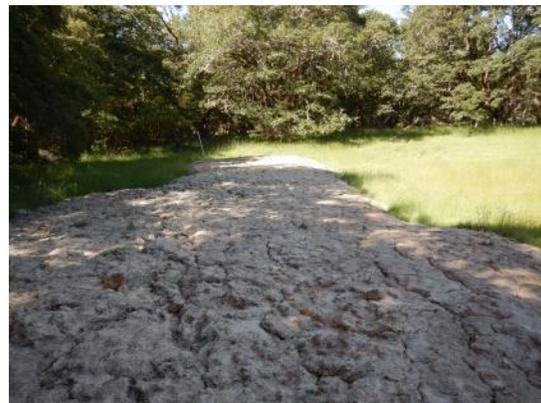
Photo 6

North of C1, we came to a meadow with muddy vehicle tracks cut through the wet, vegetated surface. Farther north, staff came across a large pile of spoils lying in the meadow. Its centroid is denoted as S2 on Figure 1 (Photo 6). The spoils were deposited when a manmade reservoir (Photo 7) that was upslope failed. I walked the perimeter of the spoils, which was roughly 0.1 acre. As I walked the perimeter of the pile, I collected a GPS track using a Garmin Rino 655t GPS unit. This is denoted as "Perimeter of spoils from reservoir" on Figure 1 and marked by a series of red dots. We continued north and upslope, to continue evaluating the meadow. Scott Bauer, a biologist from CDFW, noted that there was mint, sedge, and *Juncus* throughout the area. He pointed to each and I photographed these plants. Returning to the office, I asked a biologist with the State Water Board, Stephance Ponce look at the photos and identify the species so I could attempt to identify their wetland status. She determined that the mint is likely the obligate *Mentha pulegium*; the sedge is likely *Carex nudata* or naked sedge, also an obligate; and she confirmed my suspicion that the

This photo was taken at roughly the centroid of the spoils pile (S2) facing south.

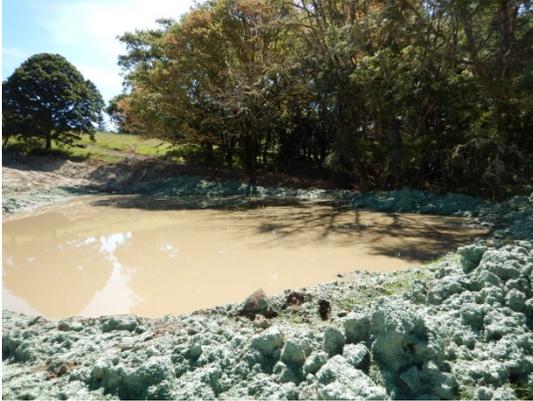
Photo 7

Northeast of S2, I observed an existing on-stream reservoir (Photo 7) that had been excavated, with the spoils push up at its sides to form the berm. Staff observed that there was no outlet or spillway. Staff also observed that the berm had been hydroseeded with hydrostraw. Hydrostraw consists of heat and mechanically treated wheat straw and moisture and has a greenish hue. This mixture of hydroseed and soil is consistent with the spoils located at S2, evidence that S2 was deposited after a previously construction in this same location failed.

State Water Board Division of Water Rights staff estimated the total capacity (top of the dam, since there was no spillway) of the reservoir to be 422,000 gallons of water. To dig out the reservoir and to reconstruct what had failed, a large volume of soil would have been excavated from the stream channel and surrounding meadow. The water in the reservoir was turbid, as evidenced from the tan color (Photo 7). Staff believes that similar stagnant, stratified, muddy water, with low dissolved oxygen and above ambient temperature discharged downstream and into the wetland when the reservoir failed.

This photo shows the reconstructed onstream reservoir and was taken facing northeast.

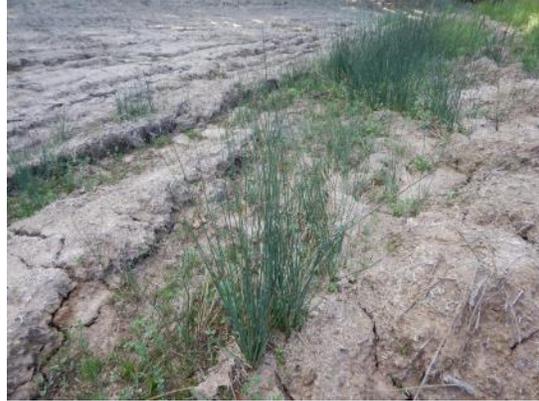
Juncus is *Juncus patens* or California grey rush, which is a facultative wetland plant. Photo 8 shows the Juncus embedded in the spoils.

This photo was taken while facing southeast and shows the Juncus that was caught in the spoils from the failed reservoir.

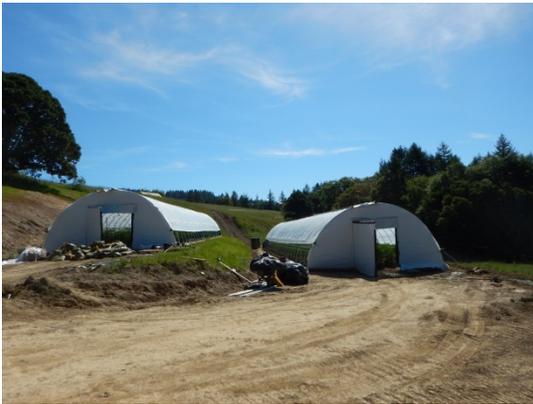
Photo 9

Additional excavation and grading has occurred in the wetland in order to construct an earthen pad for two greenhouses, denoted GH4 and GH5 on Figure 1 (Photo 9). The entire graded area was 0.5 acres. Around the perimeter of the clearing, I observed sidecast spoils consisting of sandy gravel. I observed water pooling outside of the entrance of greenhouse GH4, indicative of over-irrigation. Farther downslope and south of the spoils, I saw a pile of potting soil and what appeared to be a burn pile with remnants of partially burned wooden planks. This is denoted as S3. In this same area, I observed a well that was installed in the wetland/meadow.

This photo shows the graded area with inspection points GH4 and GH5. The photo was taken on the west side of the greenhouses facing northeast.

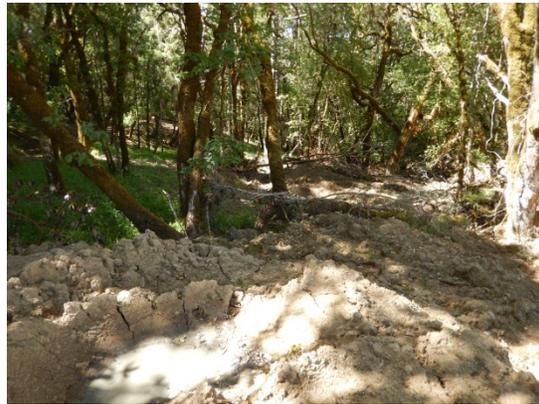
Photo 10

Immediately to the east of the reservoir, I observed a severely altered portion of the watercourse, which is denoted as "Watercourse fill" on Figure 1, the length of which is approximate 208 ft. I observed vehicle tracks consistent with the use of heavy equipment within the watercourse itself. In some locations there were pools of brown water, in others there were piles of soil. Photos 10 and 11 show portions of the impacted watercourse and fill that had been placed directly in the watercourse. To quantify the area of impact, staff took waypoints, measurements, and photographs along the "Watercourse fill" path. Table 1 shows measurements at each waypoint and the averages of these measurements to determine the discharge volume.

Table 1. – Lower fill from reservoir, denoted Watercourse fill in Figure 1 (Photos 10 and 11)

This photo shows more of the earthen fill burying the watercourse and is facing downstream and southeast.

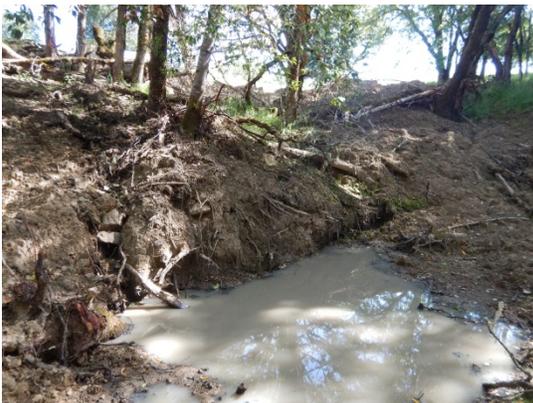
Photo 11 (White)

This photo shows the impacted stream channel and was taken facing northeast.

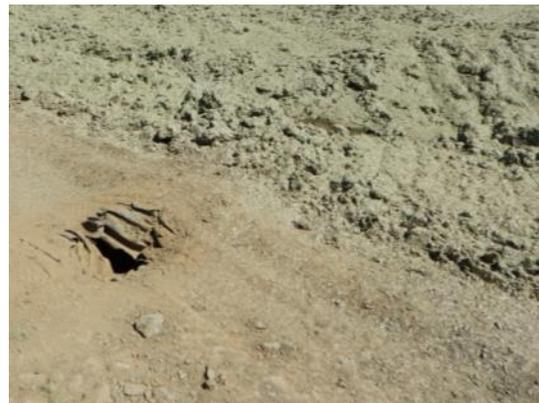
Photo 12

Staff walked back to the wooden shed to evaluate what appeared to be a stream crossing there. The culvert is denoted as C3 on Figure 1 and was made of corrugated black plastic pipe, and near the middle of the road, the surface of the road had eroded away, exposing a hole in the pipe (Photo 12). There was no water present at the time of the inspection. Below the culvert, there was grading. Photo 13 shows the grading and what appears to be a widening of the channel south of the culvert.

This photo shows the exposed and torn culvert in the road and the road's northern side slopes consisting of sidecast spoils.

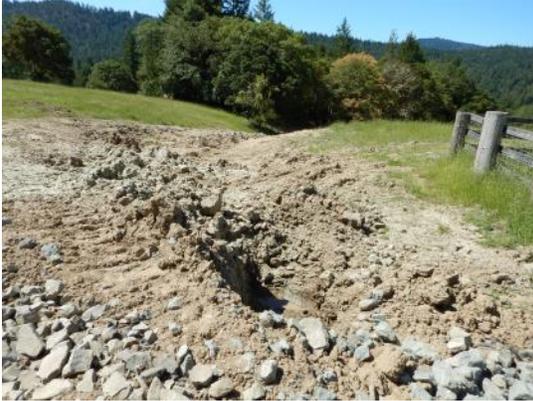
Photo 13 (White)

This photo was taken facing south, downstream of the culvert shown in Photo 11. It shows evidence of heavy equipment operation and grading in the watercourse.

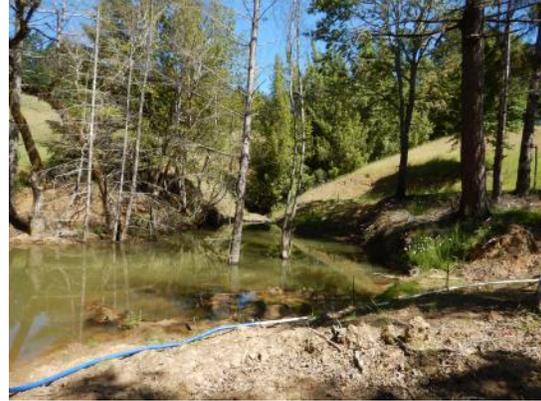
Photo 14

Staff then went to investigate another reservoir in the northwest part of the property. Staff noted that there were waterlogged trees in the reservoir (indicating that the reservoir was probably constructed without a design/plan) and its banks were steep (70 to 80% slopes) and unvegetated (Photo 14). I first walked upstream, tracking it using the Garmin; this is noted in blue on Figure 1 (Photo 15). I saw water striders, mayflies, and a beetle in the class II watercourse. The watercourse was flowing, had low hanging vegetation, significant vegetative coverage and shade, good cobble in its streambed, and still had organic topsoil on its banks.

This photo was taken facing northwest and shows the on-stream reservoir. The stream is located between the two trees in the center of the photo.

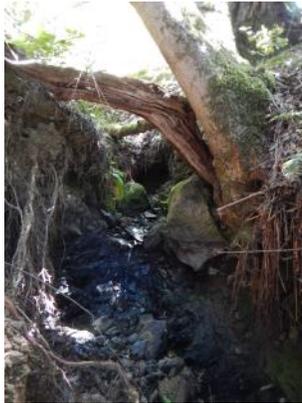
Photo 15

This photo was taken upstream of the reservoir, facing north and upstream.

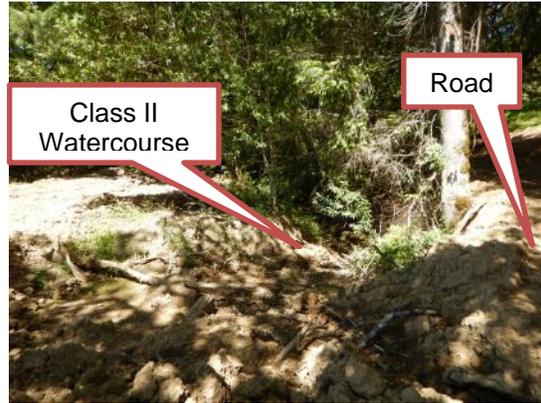
Photo 16

Staff investigated a path that cut across the watercourse, downstream of the reservoir, without a culvert (Photo 16). The crossing measured approximately 36 feet long, 12 feet wide, and was 2 feet deep; 864 cubic feet of fill. This is denoted as C4 in Figure 1.

This photo shows C4 (bottom right) and was taken facing southwest downstream of the reservoir.

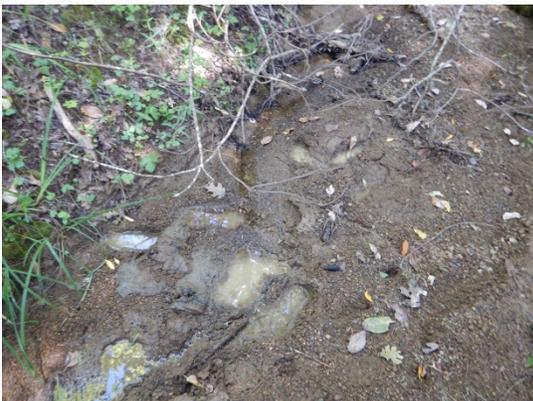
Photo 17

I then walked downstream all the way to the western property line. I observed sediment deposition throughout the length of the watercourse and took several photographs as evidence (Photos 17 and 18). The channel was approximately 3 feet wide in general, wider in some places, and the sediment deposition was at least 1.5 inches throughout; this is a very conservative estimate as in many places the cobble was completely buried and pools were filled with sediment.

This photo shows the sediment filling up the watercourse. The top right corner is downstream and southwest.

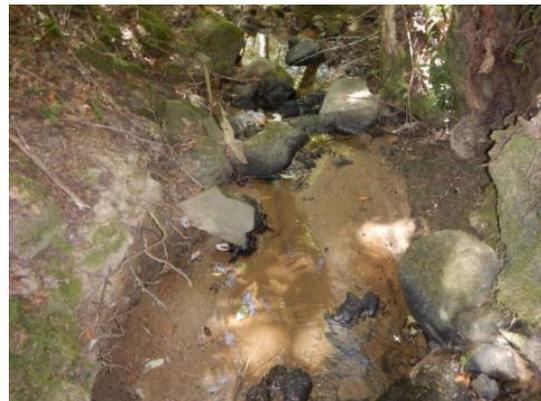
Photo 18

This photo was taken facing southwest and downstream and shows more turbid, sediment-choked water.
