State Water Resources Control Board – Office of Enforcement Inspection Report

Inspection Date & Time:	02/01/2016 11:47am –3:11 pm	Inspected By:	<i>State Water Resources Control Board, Office of Enforcement:</i> Dylan Seidner Sr. Environmental Scientist & Bryan Elder Water Resource Control Engineer see Additional Attendees , below
SMARTS WDID:	1 23CN602948	Report By:	Dylan Seidner
Owner/Operator:	Sierra Northern Railway, 341 Industrial Way, Woodland, CA 95776 Mendocino Railway – Skunk Train, Foot of Laurel St., Fort Bragg		
Site Type:	Railway construction - tunnel cave-in repair		
Site Name:	Skunk Train, Tunnel 1 West Portal		
Site Address:	Approximately 39°26'49.55"N, 123°45'46.10"W (Pudding Creek bridge)		
Site Contact:	Robert Pinoli, Vice President, Skunk Train rjp@mcn.org ; 707.964.6371		
Site Staff Present for Inspection:	Robert Pinoli, Vice President, Skunk Train Kennan Beard III, President and CEO, Sierra Northern Railway kbeard@sierrarailroad.com ; 530.666.9646 ext. 101 Teri Jo Barber, Storm Water Consultant, Ridge to River Environmental Services teriijo@ridgetoriver.com ; 707.357.0857 Josh Bumpus, Manager, Maintenance of Way, Sierra Northern Railway jbumpus@sierrarailroad.

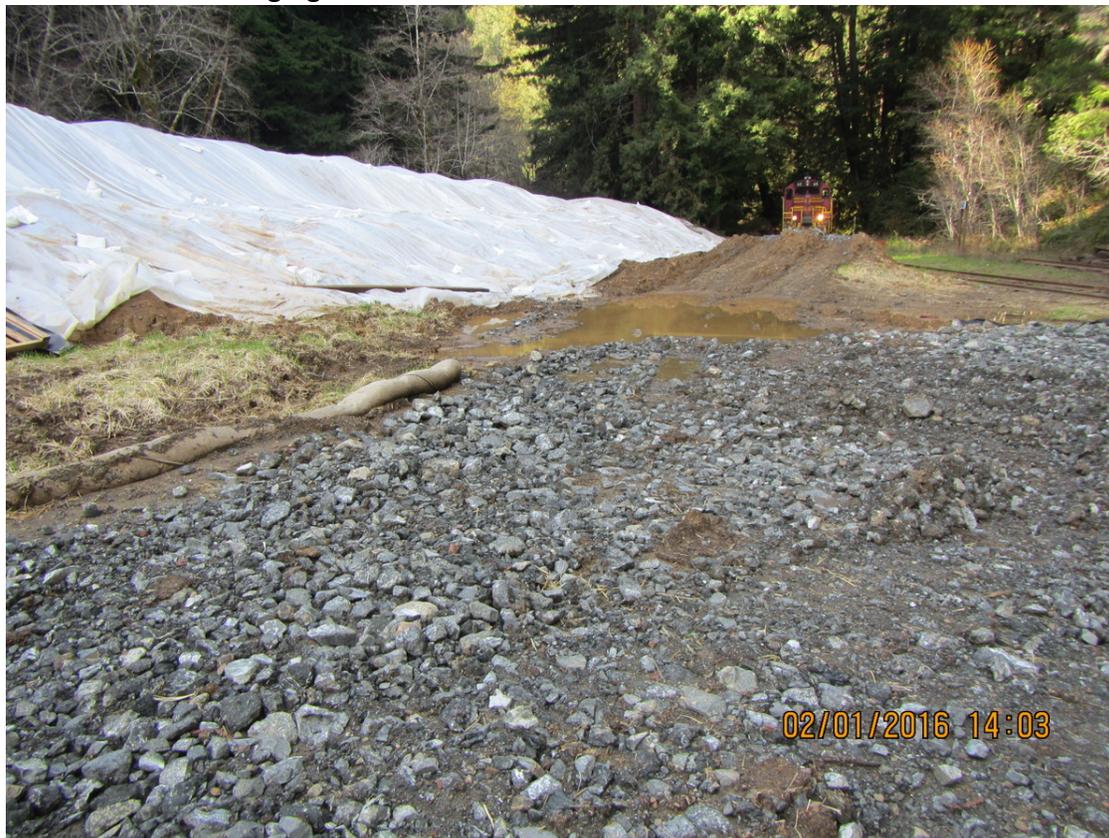
Photo 1 – Train stationed at the rail line adjacent to the North Spoils area. North Spoils stockpile is on the left, covered with plastic sheeting held in place with sandbags, and partially bordered by a fiber roll. Rocked area in the foreground is used for staging construction equipment.

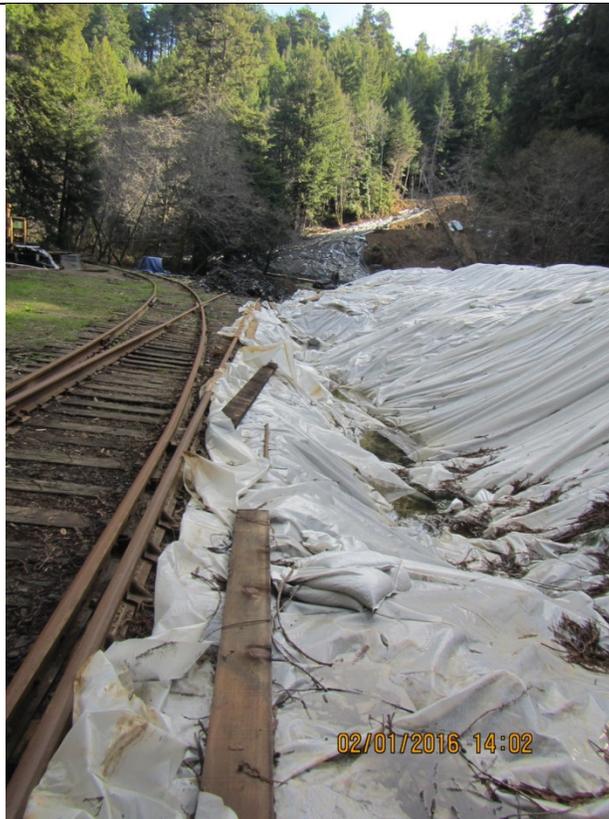
Photo 2 – View looking from the North Spoils toward Pudding Creek, the Sediment Traps and Collapse Area. Plastic sheeting is held in place on the stockpile with sandbags and lumber.

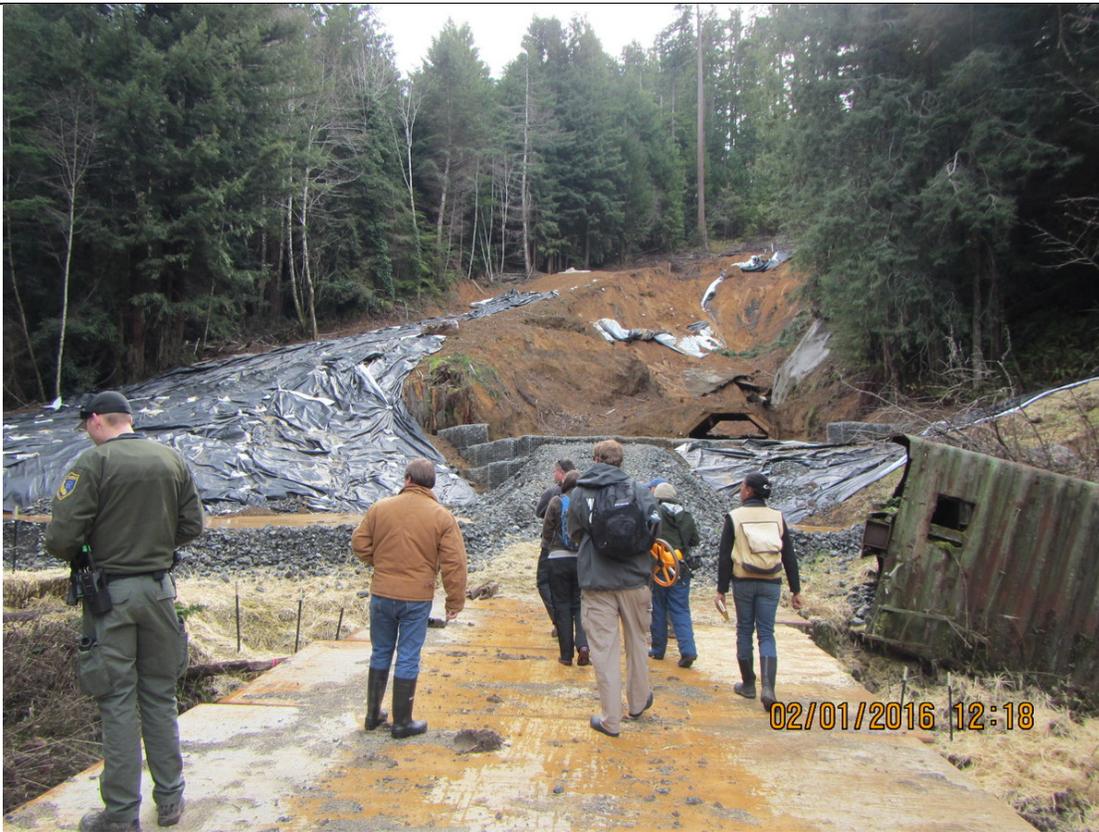
Photo 3 – Rail bridge over Pudding Creek, looking toward the Collapse Area and Sediment Traps.

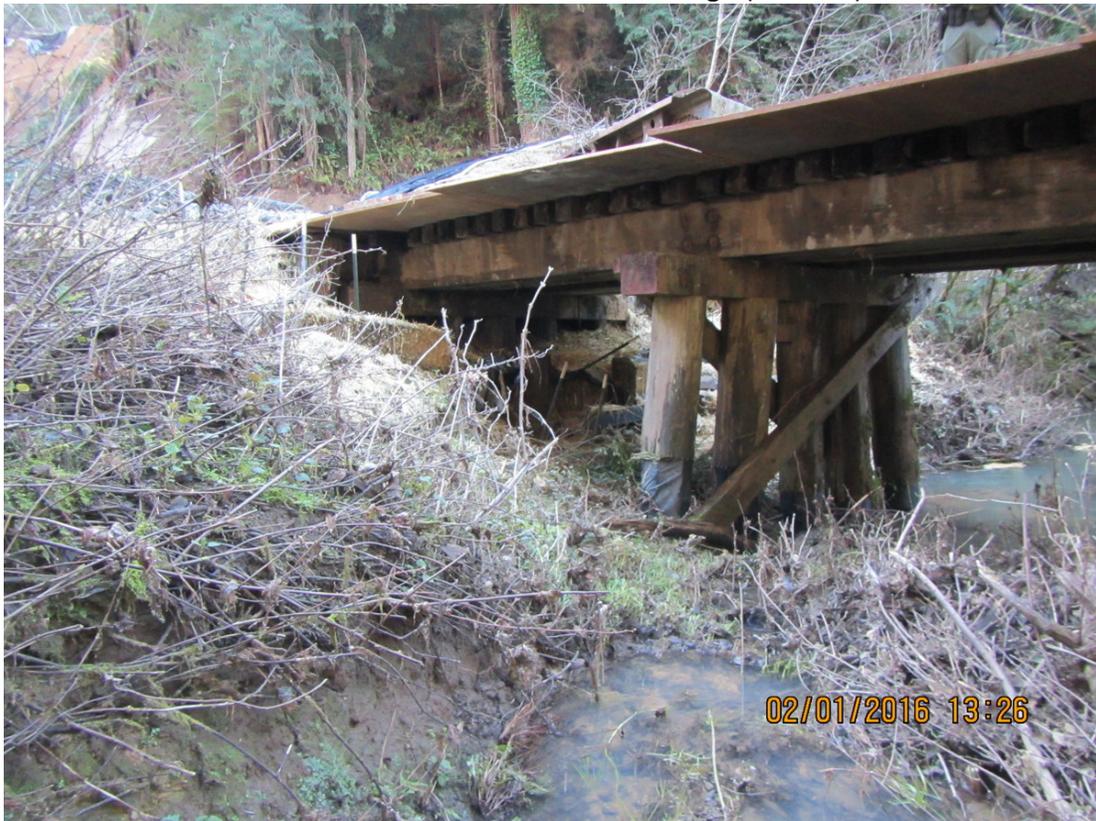
On the south side of the Pudding Creek rail bridge, straw was applied to soils on both sides of bridge. Application of straw continued down the banks and partially into Pudding Creek (Photo 4). Straw bales are staked into the south bank on both sides of and underneath the bridge (Photo 5).

Photo 4 – South bank of Pudding Creek at the rail bridge.

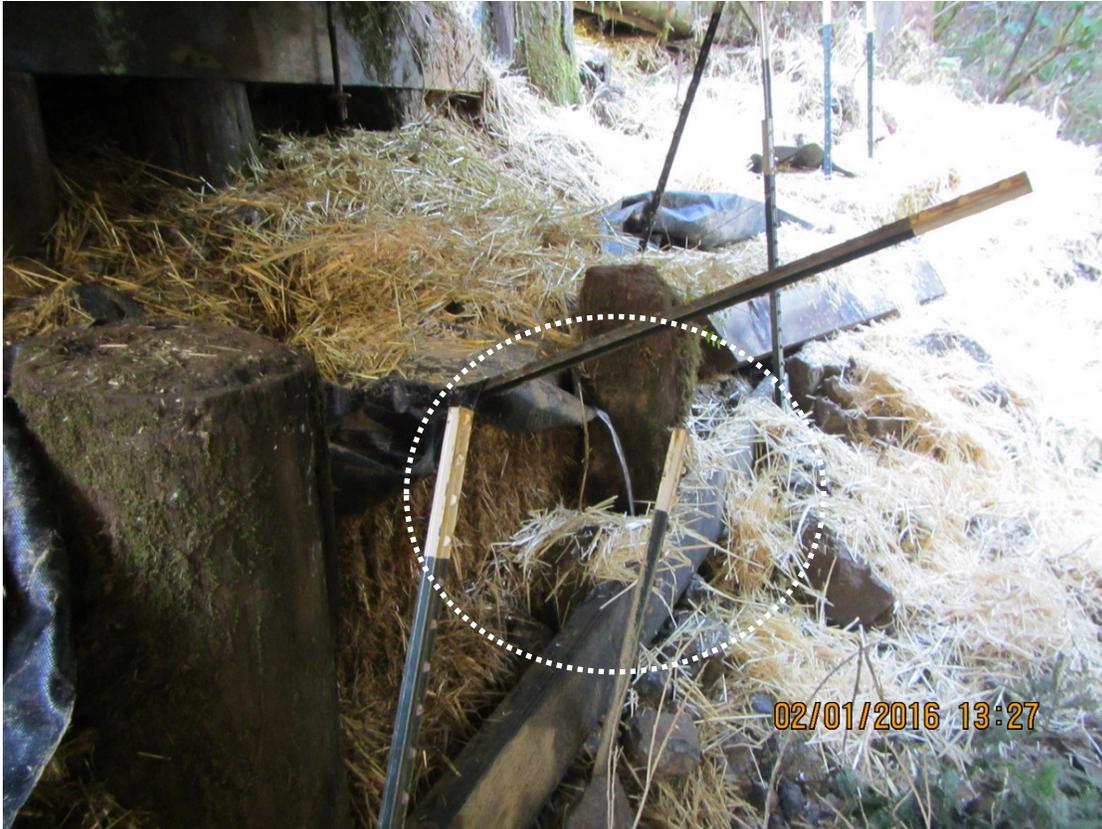
Closer inspection of the straw application and bales underneath the bridge showed a point of discharge, seen in Photo 5. Ms. Barber said that this discharge is the result of sediment traps dewatering and flowing over soil surface between the traps and Pudding Creek.

Photo 5 – Discharge point identified underneath the rail bridge on the south bank of Pudding Creek. Ms. Barber indicated that the source of this discharge is likely sediment trap dewatering.

A discharge from the overland flow produced by dewatering of the sediment traps into Pudding Creek is shown in Photo 5, underneath the rail bridge on the south bank of Pudding Creek.

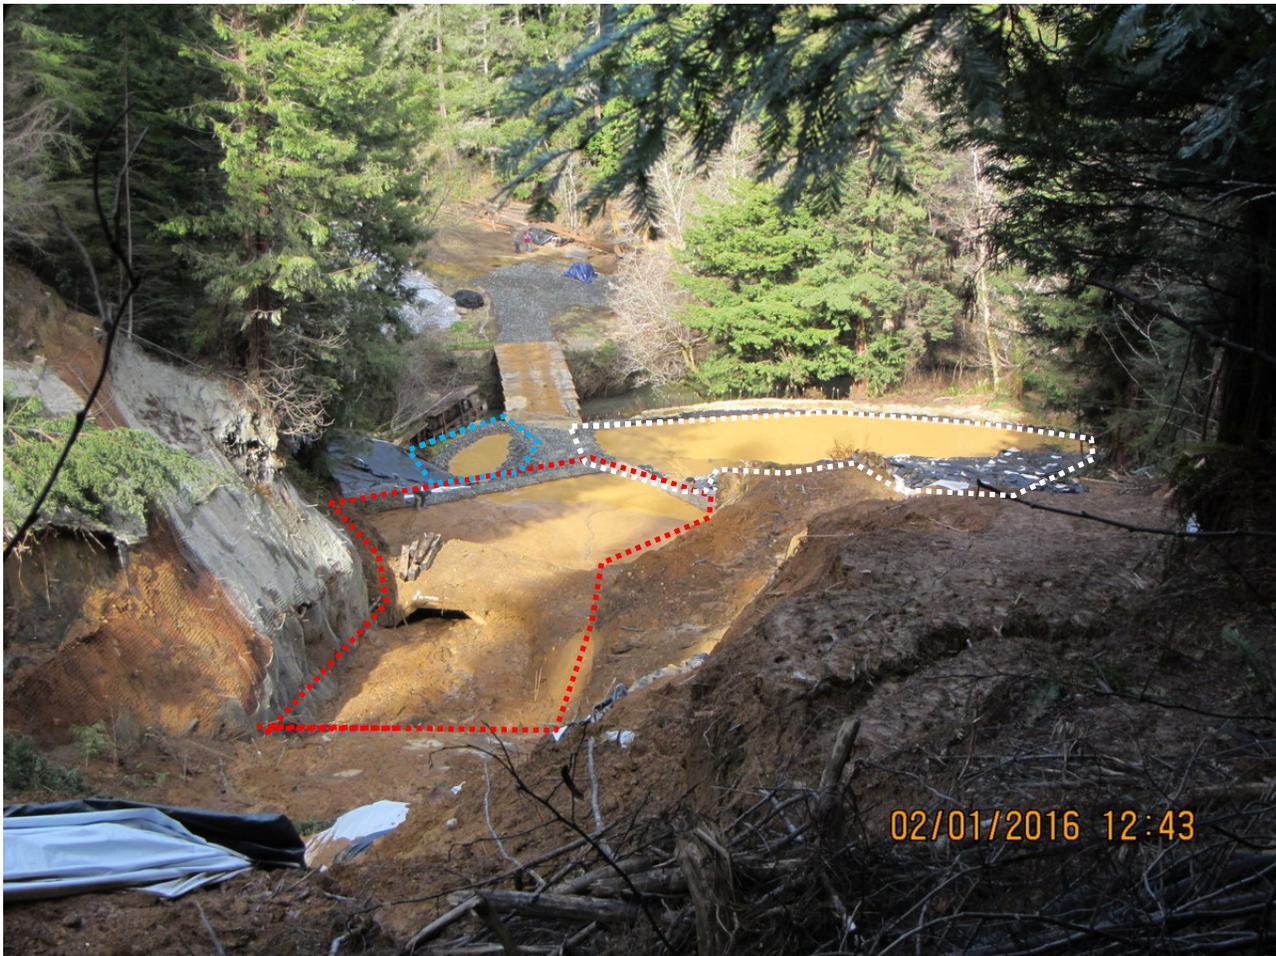
The 3 sediment traps did not have formal designations in the erosion control plan. For the purpose of this report they will be referred to as the Portal Trap, West Trap and East Trap. Outlines of the traps are seen in Photo 6.

- **Portal Sediment Trap --136,000 gallons**
Encompassing the collapsed tunnel, outlined red in Photo 6, seen in Photo 7
*Difficult to gauge as the pond extends an unknown distance into the tunnel
- **East Sediment Trap -- 32,000 gallons**
Outlined in white in Photo 6, seen in Photos 11-12
- **West Sediment Trap -- 3,000 gallons**
Outlined in blue in Photo 6, seen in Photo 9

Photo 6 - View of the 3 sediment traps as seen from the top of the Collapse Area slope looking north toward Pudding Creek. Outlined in red is the Portal Trap, consisting of the collapsed tunnel space, slopes of the collapse area and stacked gabions. Outlined in blue is the West Trap, smallest, composed of filter fabric liner and crushed rock. Outlined in white is the East Trap, also composed of filter fabric and crushed rock. Pudding Creek and the rail bridge are visible above the lower two sediment traps.

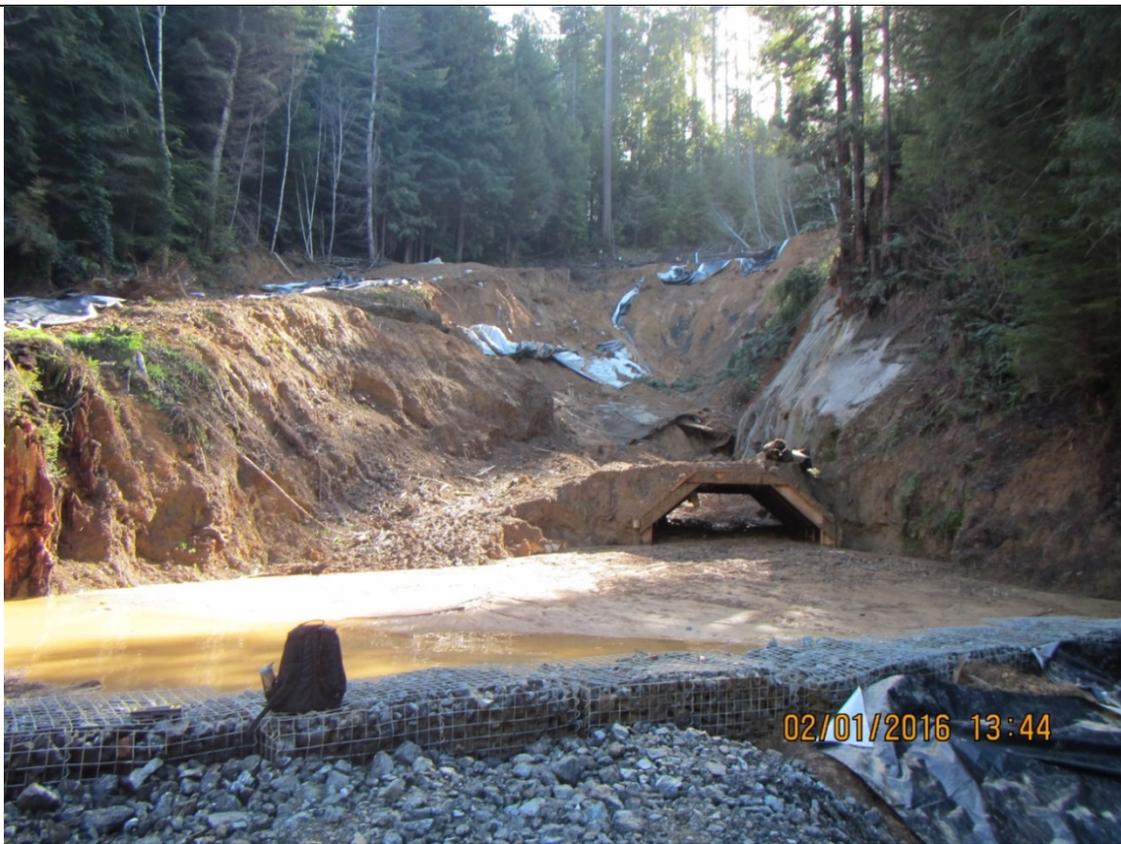
The Portal Trap basin area is composed of the voided space from the portal/tunnel collapse, 2 sides composed of gabions and crushed rock, and 2 sides consisting of slopes within the Collapse Area. The trap contains a mix of solid sediment and sediment-laden water. Skunk Train staff said that the major source of sediments in this trap are the collapse area slopes above it. The trap was full to a height within 2 feet of the top of the lowest gabions. Mr. Pinoli said that the lowest gabions are stacked 3 to 4 high. Each gabion is 3 feet tall, making the estimated depth of the trap 9-12 feet.

Photo 7 – View of the Portal Trap, looking south toward the Collapse Area slopes and the tunnel. Photo by Bryan Elder.

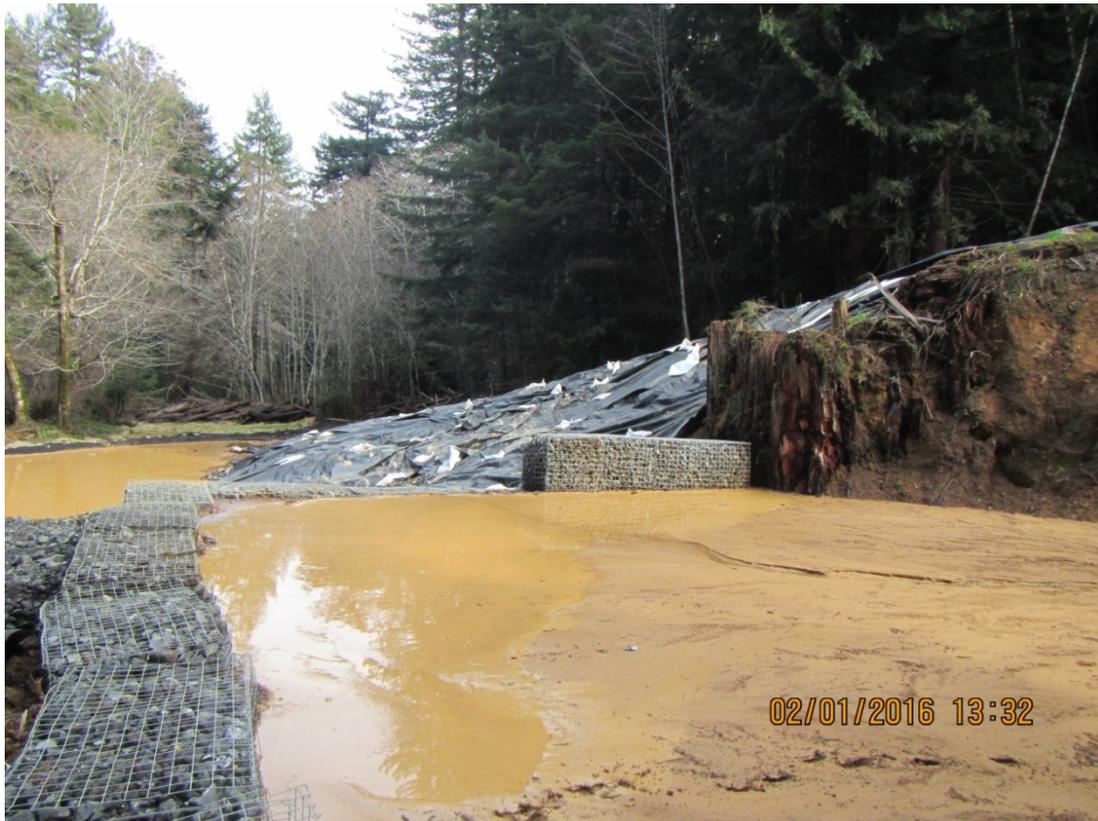
Photo 8 – Sediment and water within the Portal Trap, looking northeast toward the East Trap, at left. Photo by Bryan Elder.

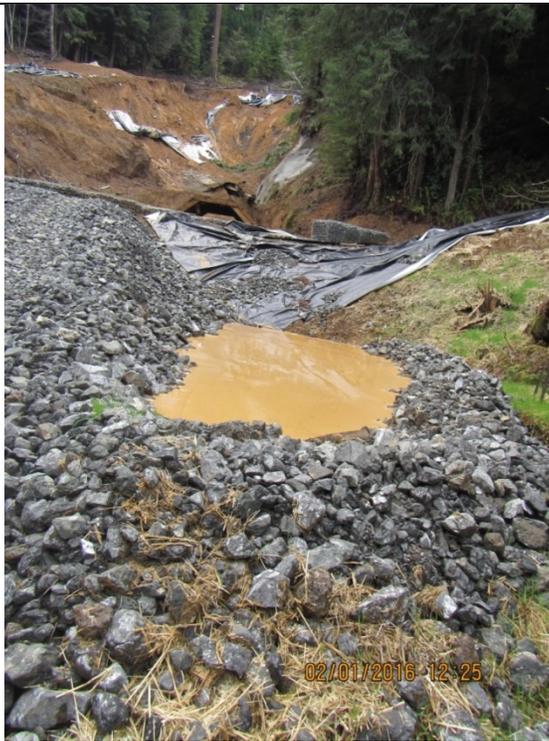
Photo 9 – West Trap, looking toward the portal and collapse area.

The west sediment trap is downslope and below the portal sediment trap. Although not visible, Mr. Pinoli said that the trap is underlain with filter fabric. Crushed rock is placed along the sides. The trap contained sediment and sediment laden water.

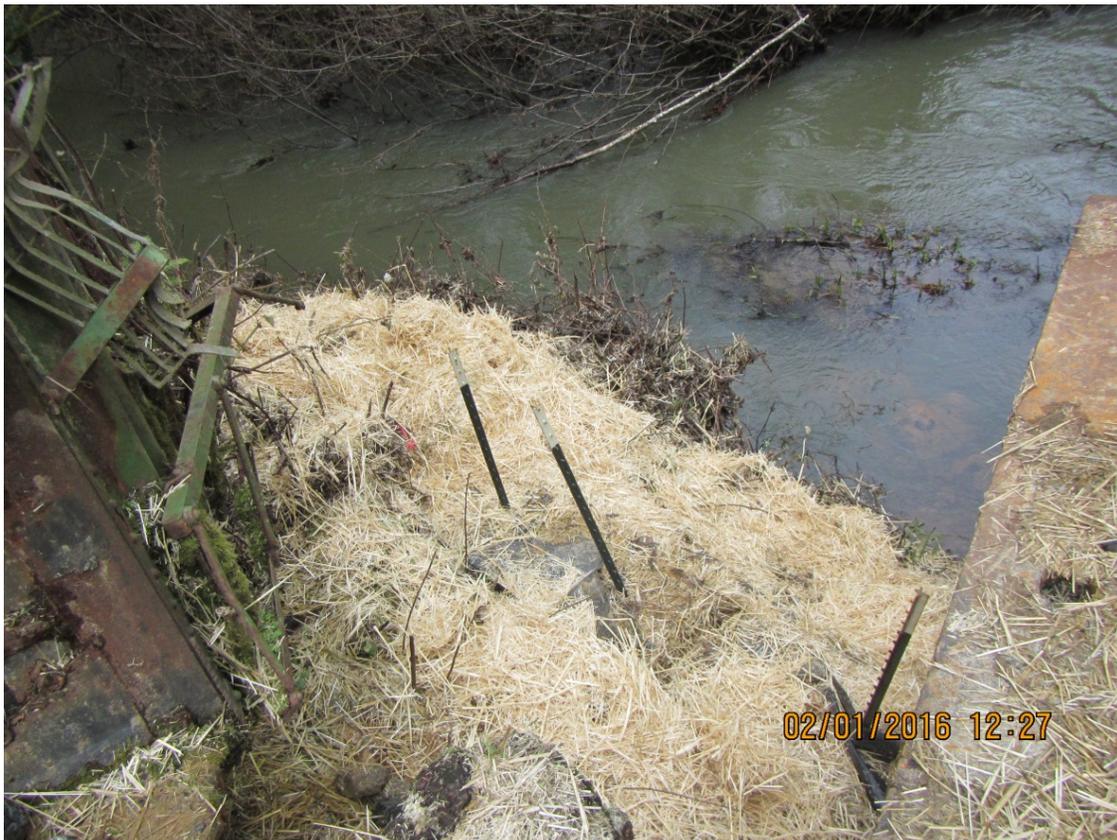
Discharge points for the traps are via indirect dewatering through the trap liner at basin edges. Water seeping from the traps has saturated adjacent soils that lie between the traps and south bank of Pudding Creek (see Photo 12 and 10). Saturated soils in this area were covered with hay, and a straw bale barrier is installed between the East Sediment Trap and the south bank of Pudding Creek.

Photo 10 – South bank of Pudding Creek below the West Trap, at the rail bridge. Straw applied along the bank was observed floating in the creek below (see Photos 4 and 5). Straw in this area was saturated. Ms. Barber said that straw was applied as ground cover and as a sediment filter for discharges that are de-watering from the sediment basins. A discharge point to Pudding Creek is shown in Photo 5, under the rail bridge.

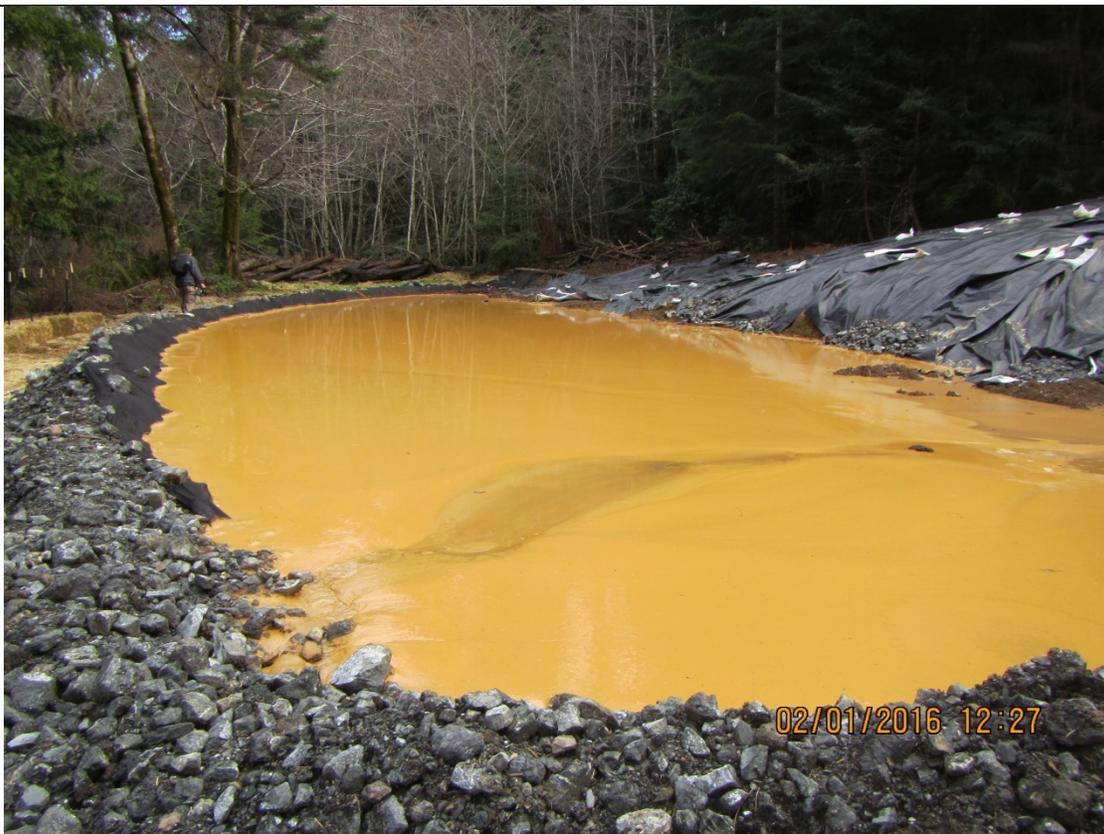
Photo 11 - East Trap, also composed of filter fabric and crushed rock. To the right of the photo is the beginning of the slopes of the Collapse Area. This portion of the slope is covered with plastic sheeting held in place by sandbags.

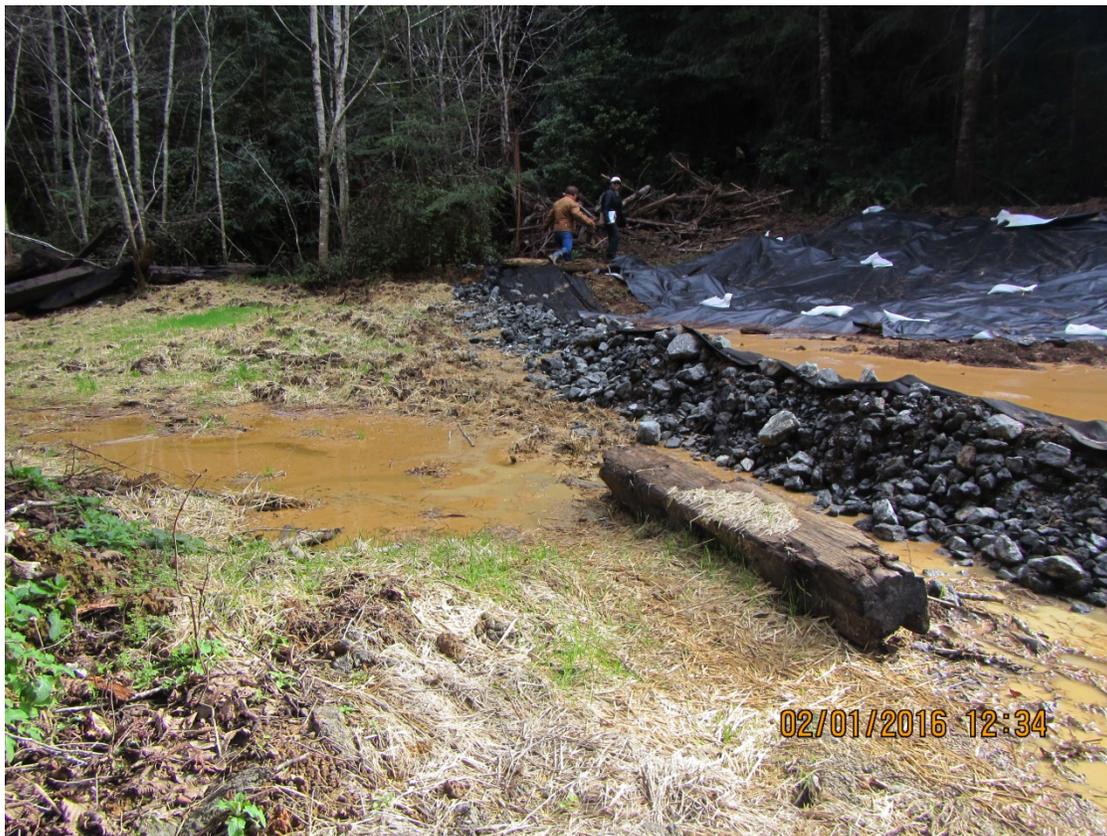
Photo 12 – Ground adjacent to the east sediment trap (to the left of Photo 11). Pudding Creek is out of view, to the left of this photo location. Ms. Barber said that liquid and sediments dewater from the east sediment trap onto the ground north of the trap. Surface flows of water appeared to travel north, toward Pudding Creek. Straw is applied sporadically on the ground adjacent to the trap.

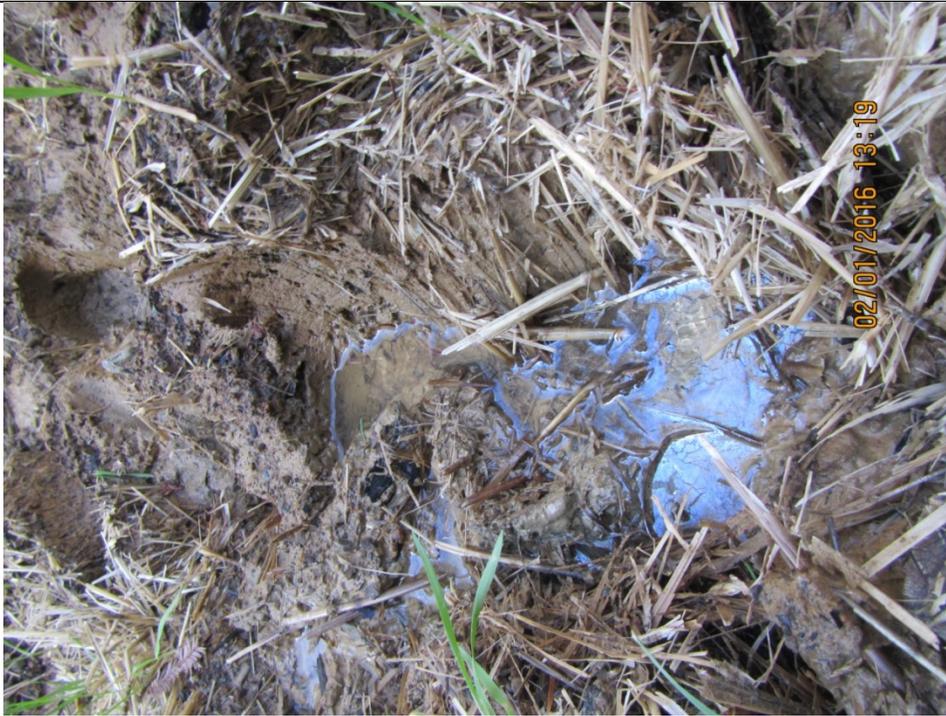
-Surface sheen on pooled water throughout the site should be evaluated for potential pollutants.

Photo 13 – Example close up of surface sheen in pooled water adjacent to the east sediment trap. The source of the sheen was unknown to Skunk Train staff. Surface sheen on pooled water was seen at several other locations throughout the site.

-Surface sheen on pooled water throughout the site (example in Photo 13) should be evaluated for potential pollutants. Skunk Train staff was unaware of potential sources of pollution that could cause this sheen. Further evaluation is required to ensure that the sheen is not the result of oil or grease or other pollutants that may contaminate soil or discharge to Pudding Creek.

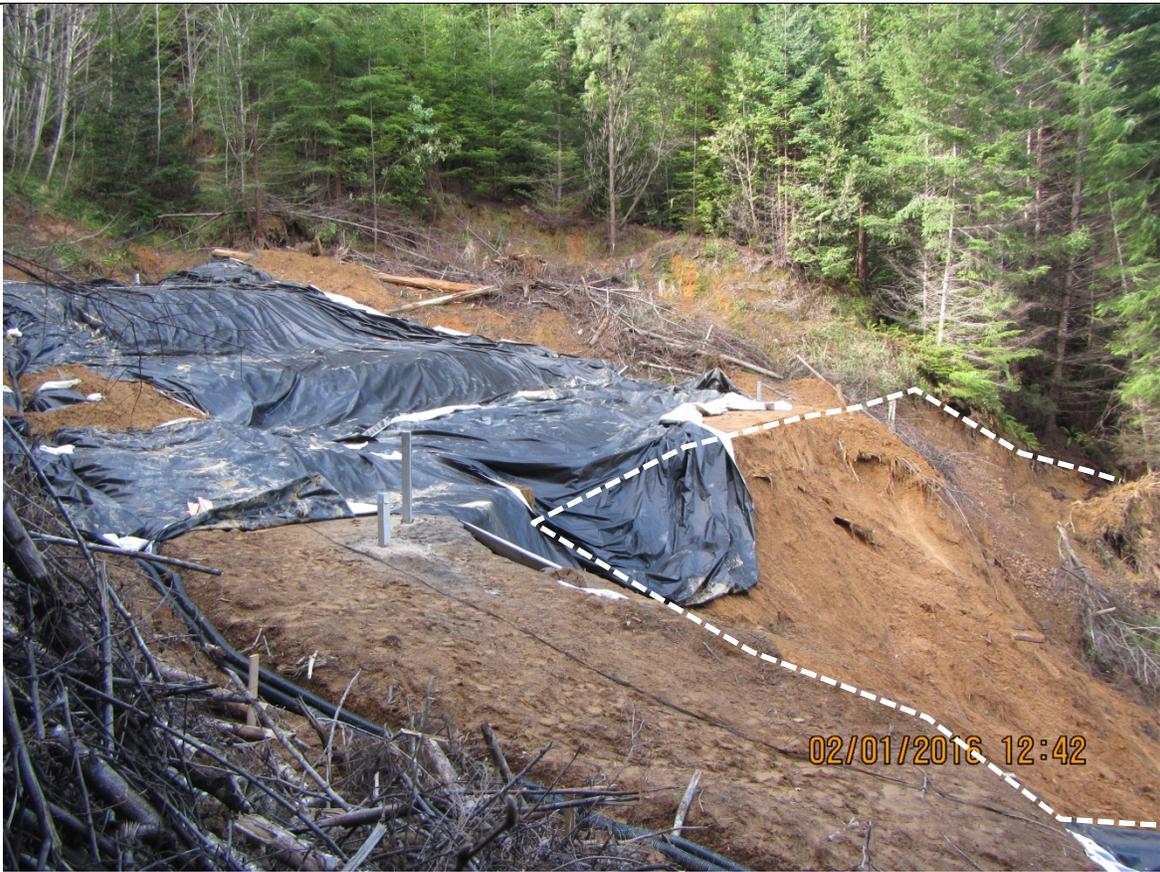
Application of plastic sheeting on slopes in the Collapse Area did not meet the implementation specifications as stated in the erosion control plan. Plastic sheeting was not keyed in at the top of slopes, edges were not embedded 6" into soil, sandbag and weight placement was not at regular intervals and was often more than 10 feet apart, and overlap between sheeting seams was irregular.

Due to the above issues with plastic sheeting implementation and maintenance, the BMP was not an effective form of erosion control for this area. I employed spot checks under sheeting that was not keyed in or embedded and saw indications of surface erosion, and gaps that would allow surface runoff to flow under sheeting and cause additional surface erosion underneath the plastic. Partial application of plastic sheeting on slopes in the Collapse Area has the potential to concentrate runoff, increase its velocity, and funnel it into the downslope portions that are not covered by sheeting, which are the most heavily eroded and steepest portions of the Collapse Area (seen in Photos 14 and 15).

Photo 14 – Upper portion of the Collapse Area. Plastic sheeting is incompletely applied, and not to implementation specifications. The area outlined in white is the steepest portion of the Collapse Area, and also where plastic sheeting is not applied due to safety concerns. In the foreground is a trench with plastic drainage pipe. According to Ms. Barber, the drainage pipe and trench are used to manage storm water run-on and ground water flows. The discharge point for the drainage pipe is shown in Photo 16.

- Plastic sheeting applied to Collapse Area slopes as erosion control is not installed to specification and requires maintenance, reducing effectiveness. Plastic sheeting is not keyed in at the top of slopes, edges were not embedded 6" into soil, plastic coverage of the slope was partial, and weight placement and sheeting overlap is irregular. Due to these issues, surface erosion was noted under plastic sheeting at the Collapse Area, and the BMP may increase surface erosion when high velocity concentrated runoff from plastic sheeting is directed onto adjacent, downslope, uncovered soil in the Collapse Area.

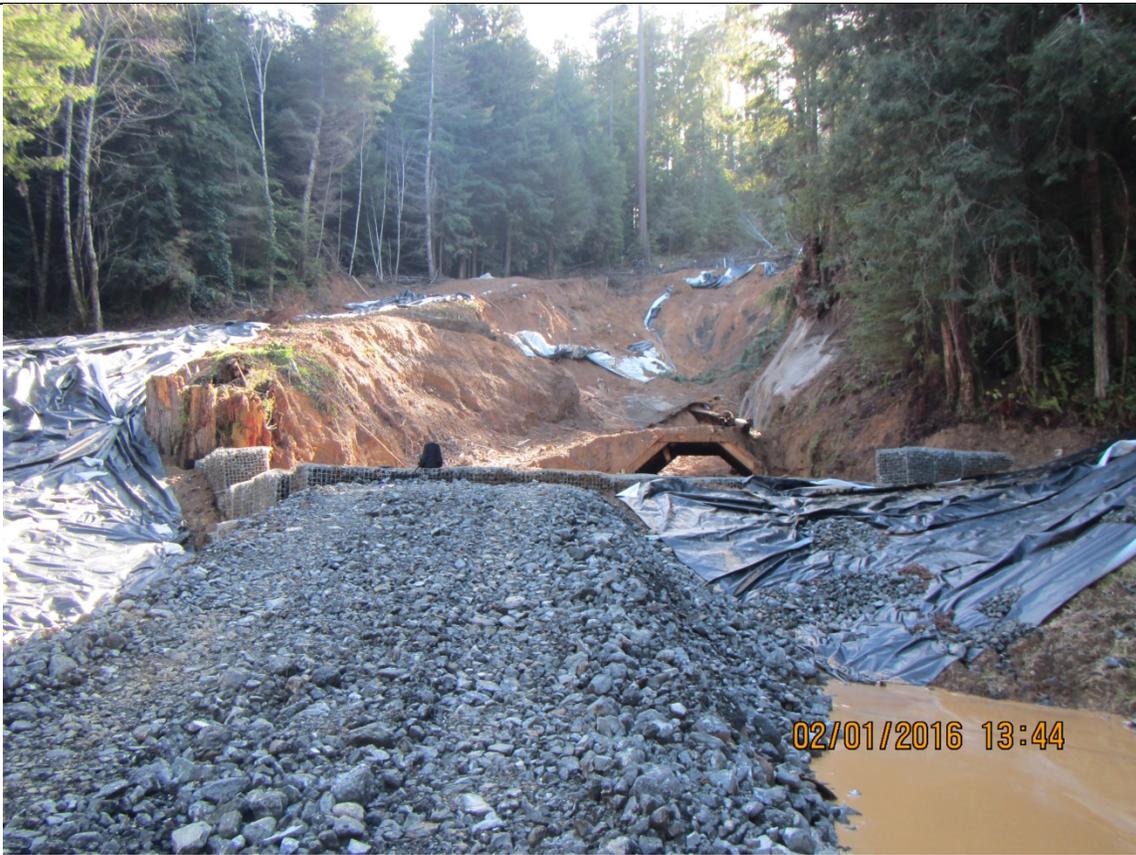
Photo 15 – Lower portion of the Collapse Area. At the left, the lower portion of the slope is covered with plastic sheeting. At the center, the steepest and most eroded portion of the collapse area is uncovered by plastic sheeting, or contains plastic sheeting that is not maintained. Photo by Bryan Elder.

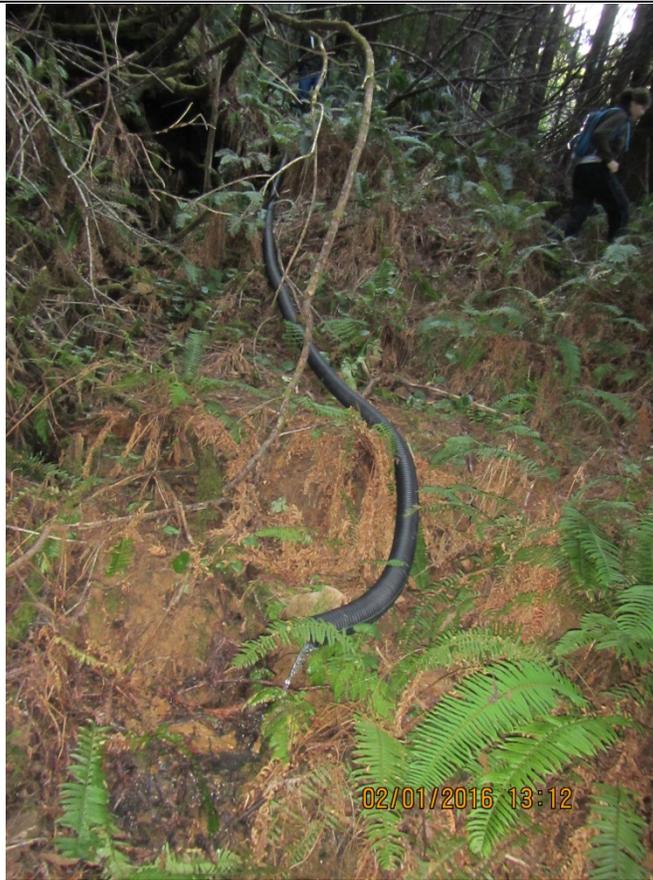
Photo 16 – Discharge point for plastic drainage pipe (seen in Photo 14) used to manage storm water run-on and ground water flows from the upper portion of the Collapse Area. It was flowing water at the time of the inspection. The discharge point is in the woods east and downslope of the upper portion of the Collapse Area.

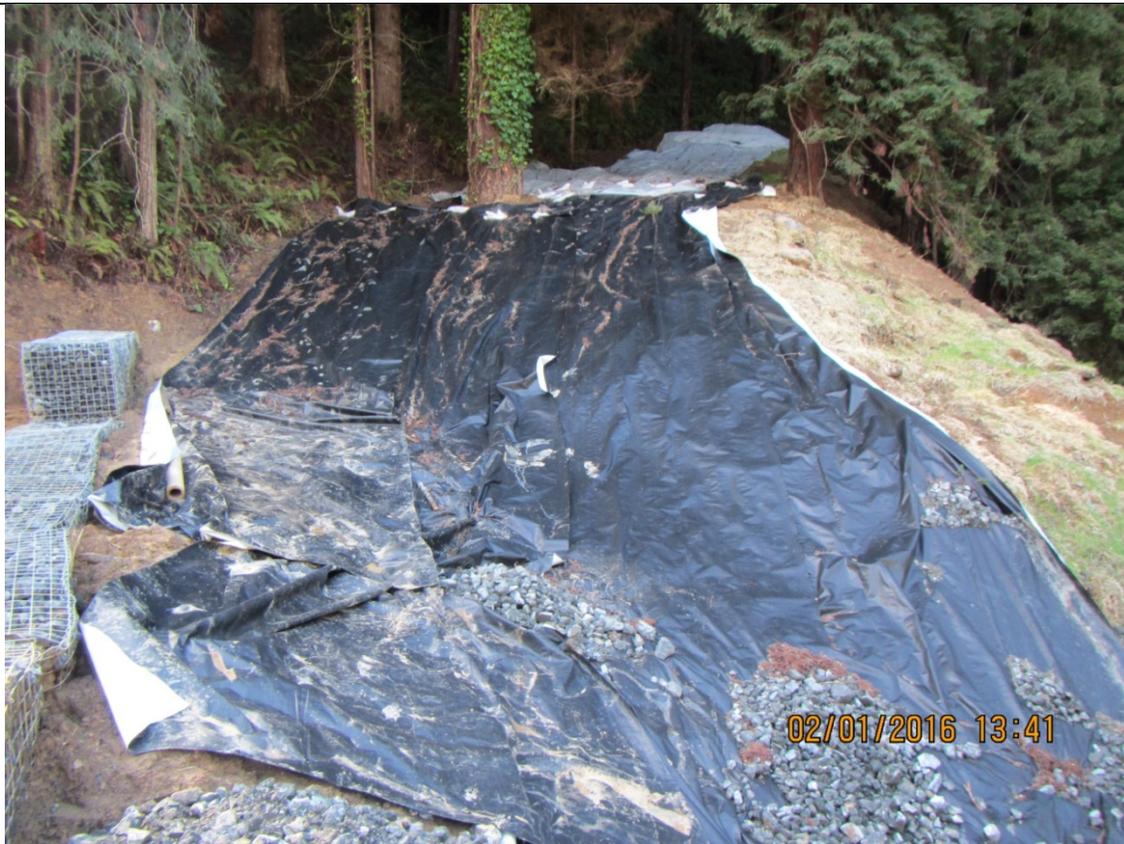
Photo 17 – Portal Spoils, seen from an area adjacent to the tunnel and West Trap. Plastic sheeting is applied to the east slope and held in place with sandbags and rocks. The north slope (which faces Pudding Creek, and seen in Photo 18) does not have erosion controls applied to the slope face. Photo by Bryan Elder.

Similar to plastic sheeting applied in the Collapse Area, the sheeting on the Portal Spoils did not meet the implementation specifications of the BMP as stated in the erosion control plan. Plastic sheeting was not keyed in at the top of slopes, edges were not embedded 6” into soil, sandbag and weight placement was often more than 10 feet apart, and overlap between sheeting seams was irregular.

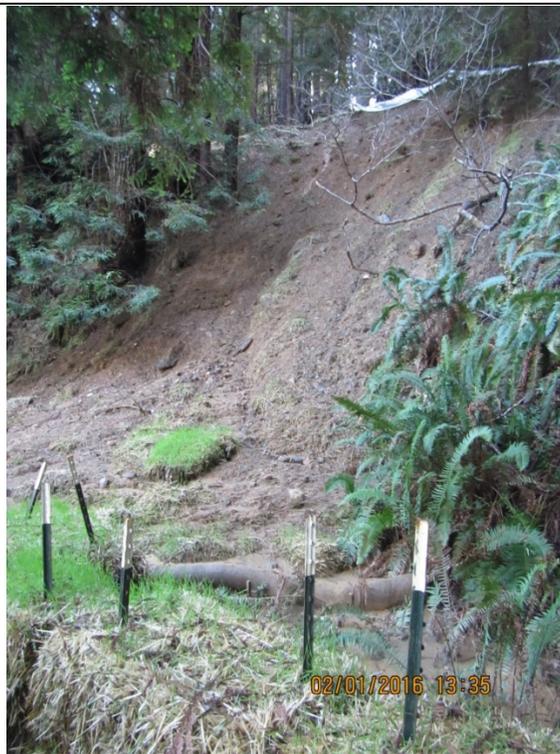
Photo 18 – The north slope of the Portal Spoils, which faces Pudding Creek (out of frame, to the left of the photo). The slope face does not have erosion controls. Fiber rolls and a straw bale barrier are applied as sediment control at the toe. Plastic sheeting visible at the top of the photo is at the top of the east slope.

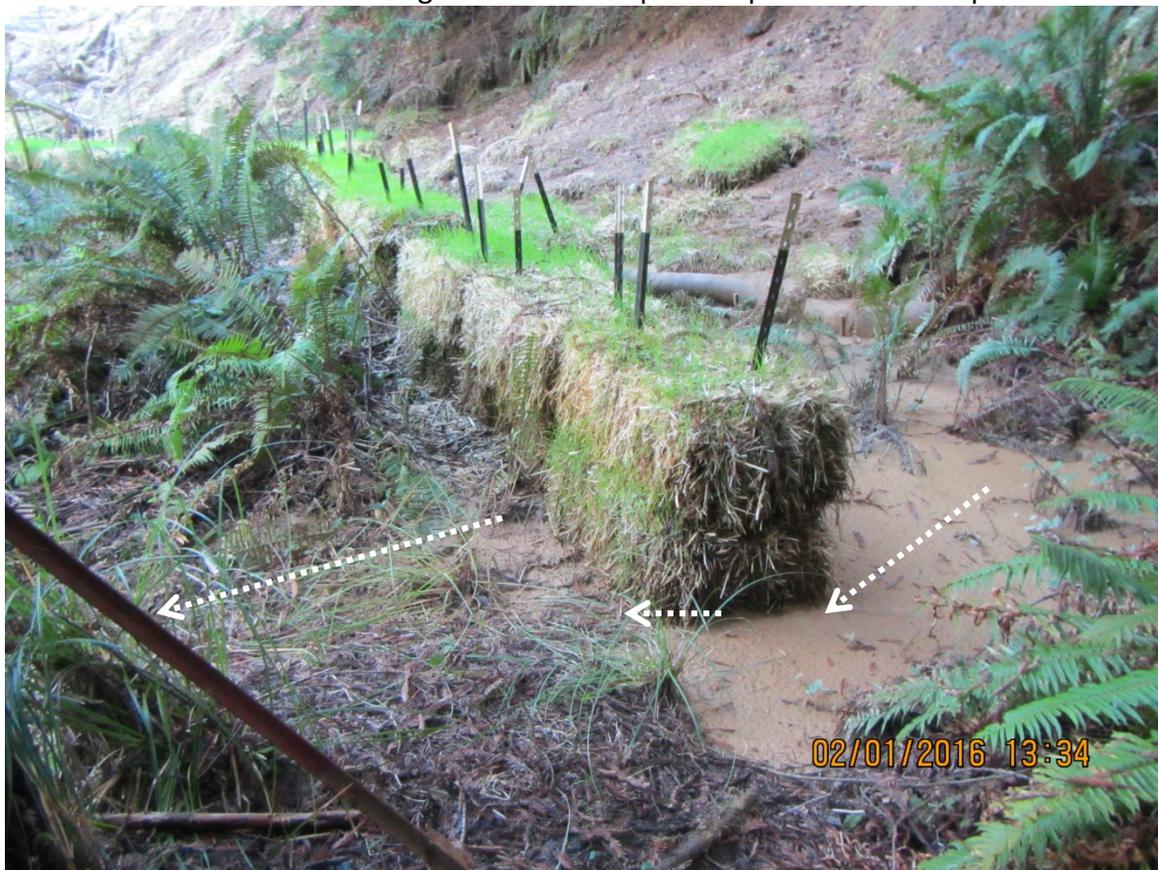
Photo 19 – Toe of the north slope of the Portal Spoils stockpile, and the point furthest west that sediment controls are applied to the slope toe. Sediment deposits on the ground are evidence of previous flows passing fiber rolls, and moving through and around the straw bale barrier, down the bank of the south bank of Pudding Creek (out of frame of the photo, to the left). Arrows indicate areas of sediment deposits and evidence of movement direction of previous sediment flows.

The straw bale barriers, fiber rolls, and silt fence applied along the northern slope toe of the Portal Spoils are currently not effective at controlling sediment flows coming off the north slope. The current condition of no erosion controls on the slope face, combined with evidence of damaged, unmaintained, or improperly implemented sediment controls (shown in Photos 18-20), has resulted in one or more previous discharges of sediment to Pudding Creek, evidenced by light colored sediment deposits seen in Photos 20-21, and deposits of sediment past BMP sediment barriers seen in Photo 19.

Sediment deposits were observed beyond the applied perimeter sediment controls (seen in Photos 19) and on the banks of Pudding Creek indicating a previous discharge of sediment (Photos 20-21). Erosion and sediment controls in this area are currently under maintained and insufficient at preventing discharges of sediment to Pudding Creek.

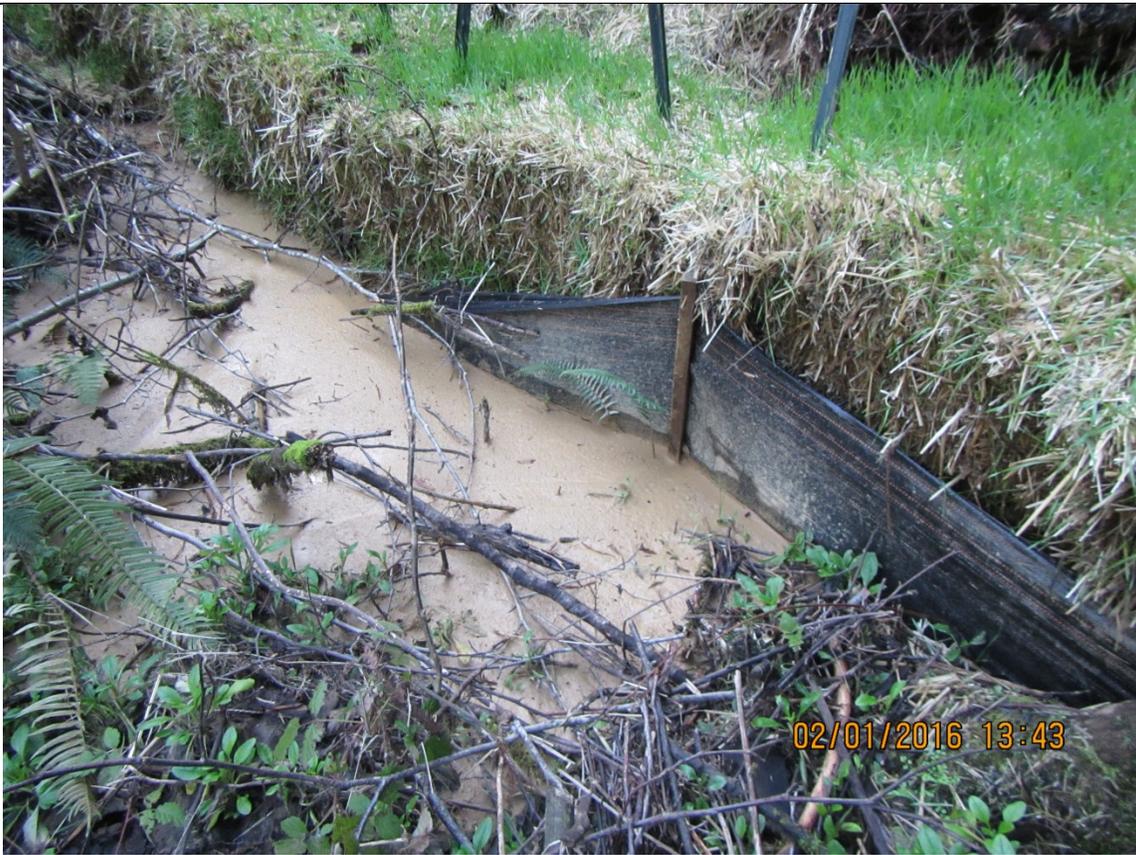
Photo 20 – Close up of silt fence at a straw bale barrier (part of the longer straw bale barrier seen in Photo 19). Fine sediment here has passed through the straw barrier and silt fence. Pudding Creek is to the left of this photo.

-Sediment best management practices at the Portal and North Spoils soil stockpile perimeters are inadequate to control sediment flows. At the Portal Spoils area, inspection of the straw bale barrier and silt fence (seen in Photos 19-20) showed that sediment is moving through or beyond these BMPs. At the North Spoils area, silt

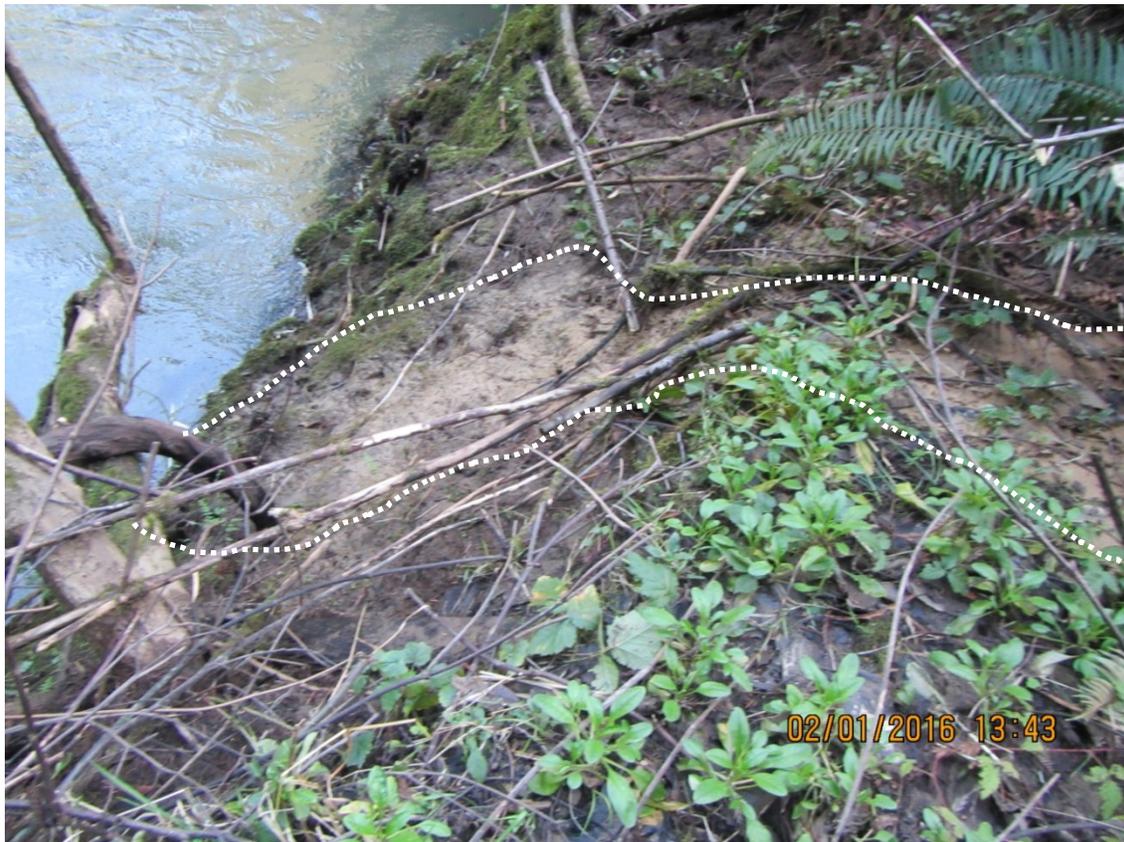
Photo 21 – Bank of Pudding Creek, to the left of Photo 20. Outlined in white is the approximate location of light color sediment deposits that have passed the straw bale barrier and silt fence shown in Photo 20. Sediment deposits on the banks to the water line indicate a previous discharge of sediment.

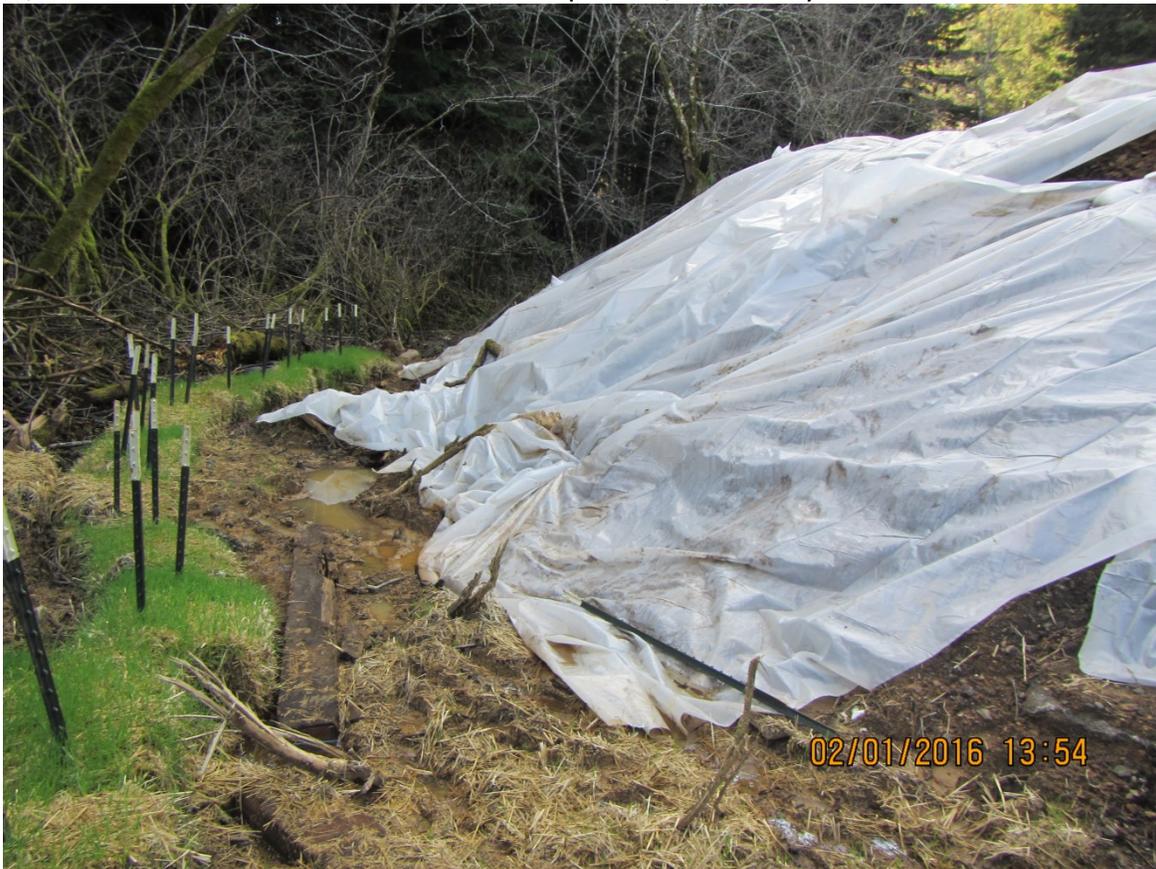
Photo 22 – Southeast edge of the North Spoils pile, to the left of this photo (out of frame) is the rail bridge and Pudding Creek. Plastic sheeting is applied over the pile, and a hay bale barrier is employed as sediment control at the spoils pile edge, which is also the top of the north bank of Pudding Creek.
