State Water Resources Control Board – Office of Enforcement Inspection Report

Inspection Date & Time:	02/01/2016 11:47am –3:11 pm	Inspected By:	<i>State Water Resources Control Board, Office of Enforcement:</i> Dylan Seidner Sr. Environmental Scientist & Bryan Elder Water Resource Control Engineer see Additional Attendees , below
SMARTS WDID:	1 23CN602948	Report By:	Dylan Seidner
Owner/Operator:	Sierra Northern Railway, 341 Industrial Way, Woodland, CA 95776 Mendocino Railway – Skunk Train, Foot of Laurel St., Fort Bragg		
Site Type:	Railway construction - tunnel cave-in repair		
Site Name:	Skunk Train, Tunnel 1 West Portal		
Site Address:	Approximately 39°26'49.55"N, 123°45'46.10"W (Pudding Creek bridge)		
Site Contact:	Robert Pinoli, Vice President, Skunk Train rjp@mcn.org ; 707.964.6371		
Site Staff Present for Inspection:	Robert Pinoli, Vice President, Skunk Train Kennan Beard III, President and CEO, Sierra Northern Railway kbeard@sierrarailroad.com ; 530.666.9646 ext. 101 Teri Jo Barber, Storm Water Consultant, Ridge to River Environmental Services teriijo@ridgetoriver.com ; 707.357.0857 Josh Bumpus, Manager, Maintenance of Way, Sierra Northern Railway jbumpus@sierrarailroad.

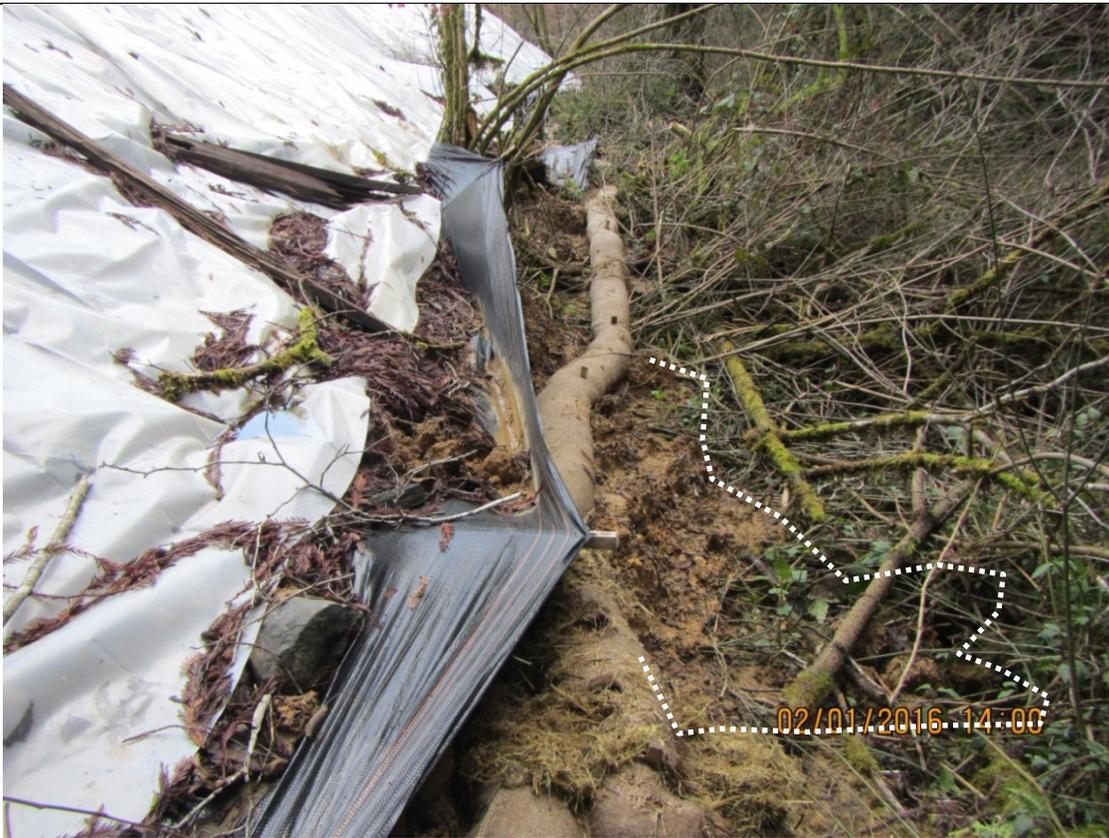
Photo 23 – Southwest side of the North Spoils. The dashed area highlights sediment that has travelled beyond the silt fence and fiber roll at the pile’s edge. Both the silt fence and fiber roll show signs of incorrect installation per specifications in the site’s erosion control plan, and are in need of maintenance or replacement (see Photo 24-25). Pudding Creek is to the right of the riparian vegetation in the photo.

fence and fiber rolls along the west side of the pile (following the banks of Pudding Creek) were installed incorrectly per specifications of the site's erosion control plan, or required maintenance or replacement (Photos 23 – 25). Sediment from the North Spoils pile was observed migrating under or through gaps in perimeter control, toward the north bank of Pudding Creek.

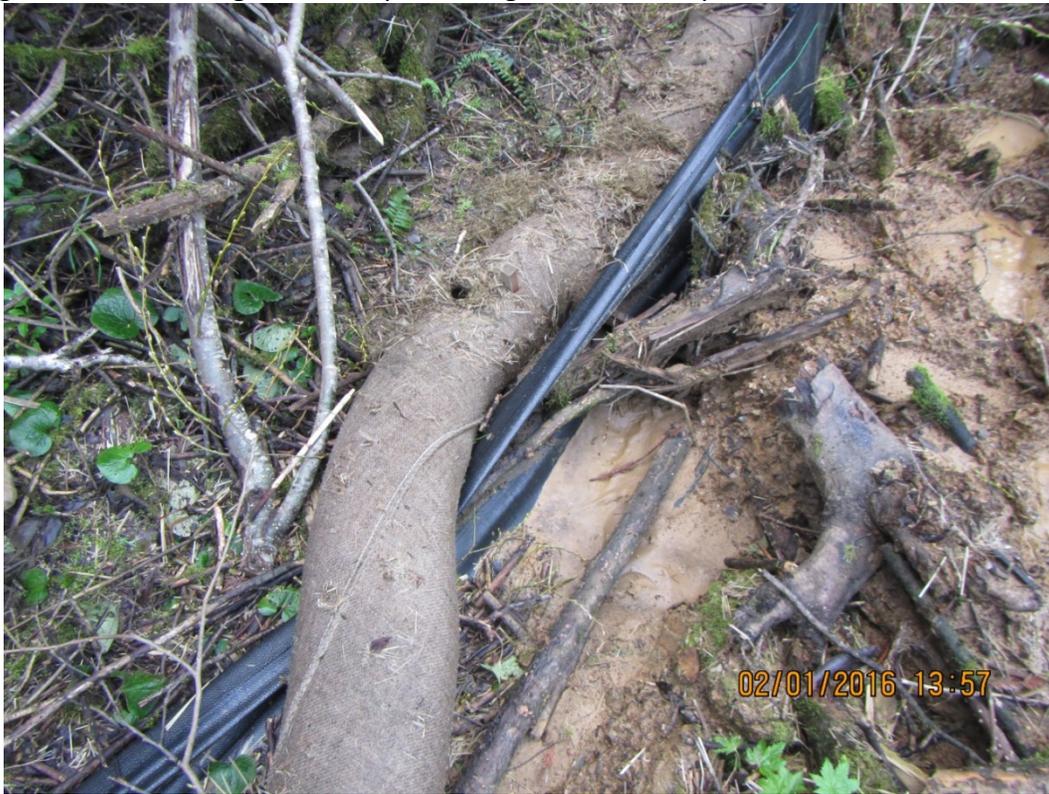
Photo 24 – Close-up of sediment controls along the southwest side of the North Spoils. The stockpile is on the right; riparian vegetation along Pudding Creek is to the left. The fiber roll shown requires replacement, and is missing stakes. The fiber roll is incorrectly installed overlapping a silt fence, rendering the fence and roll ineffective.

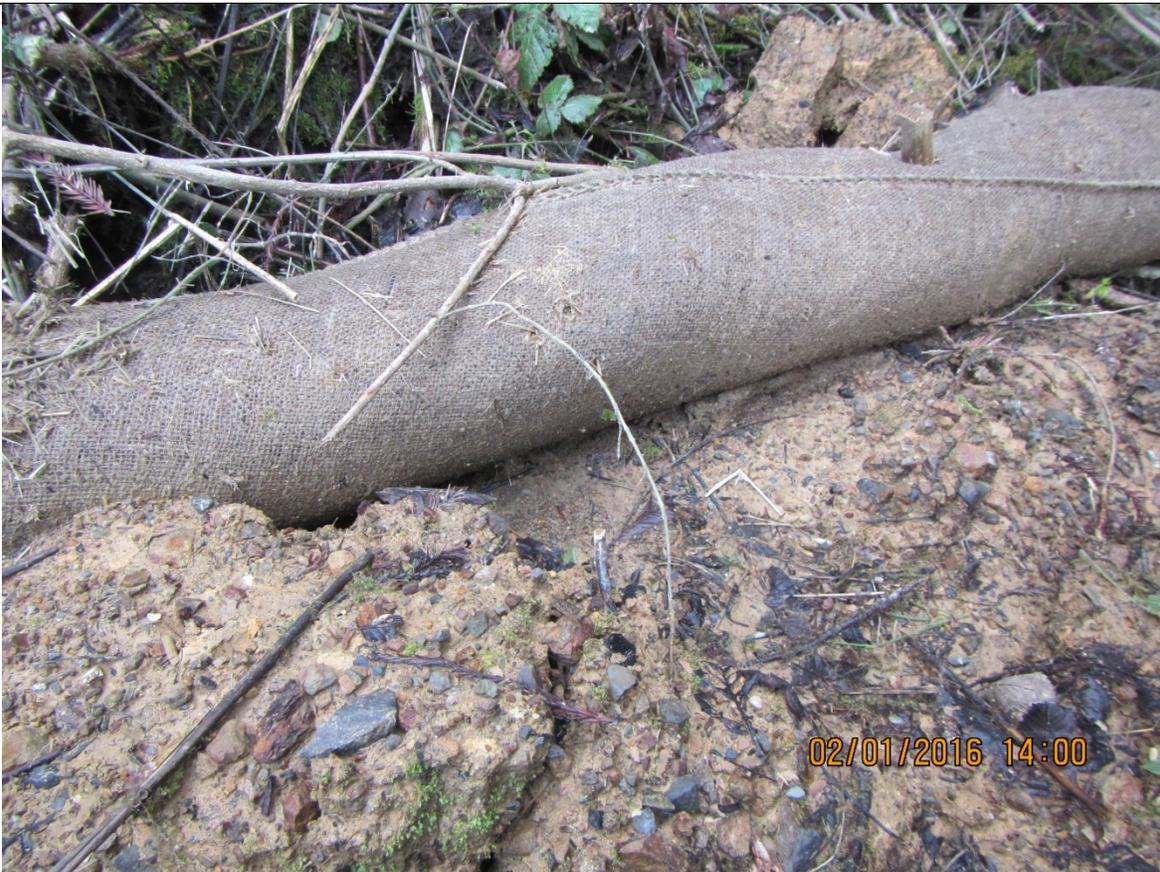
Photo 25 - Close-up of sediment controls along the southwest side of the North Spoils. The fiber roll shown here was not installed flush against the soil surface, and has allowed sediment to migrate under the fiber roll toward riparian vegetation along the banks of Pudding Creek.
