Subject: **NOTICE OF VIOLATION and required corrective actions for failure to protect stormwater at industrial facility**

Facility: E Poly Star
Attn: Steven Choi
2085 Burrough Ave
San Leandro CA 94577
WDID No.: 2 01I022621

Storm Water Industrial General Permit Inspection Report

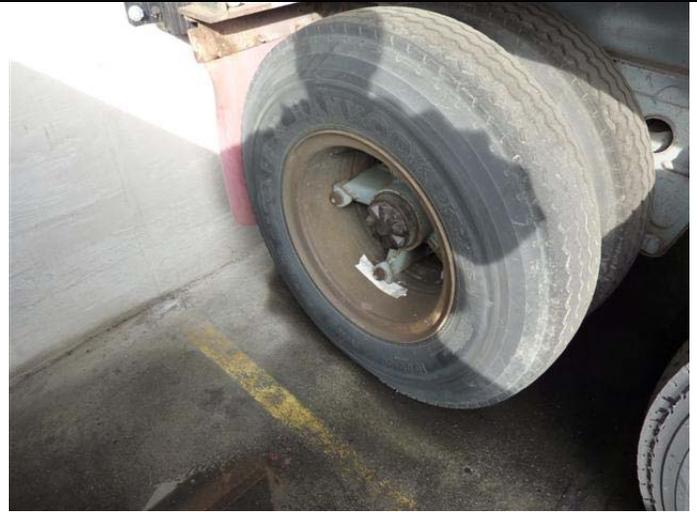
Photo 2. Truck trailer storage container spill cleaned up.

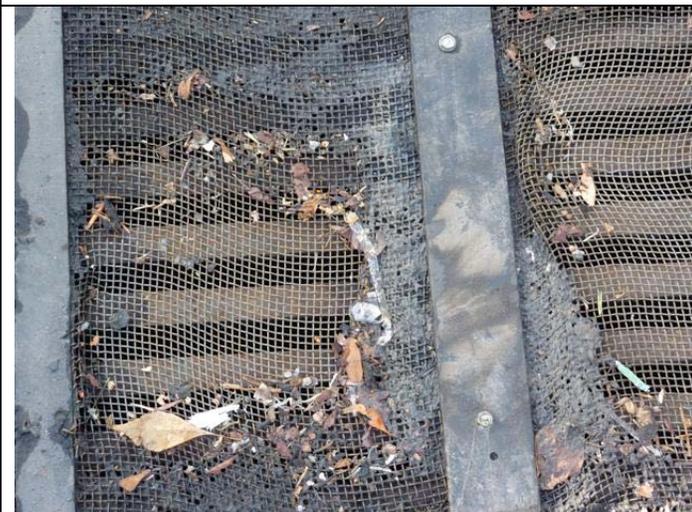
Photo 3. Screened storm drain in front parking area, plastic pellets are visible on the ground and on the screen.

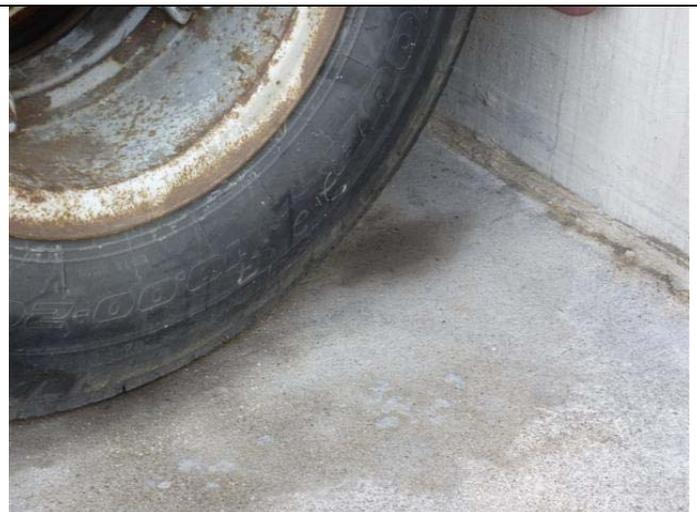
Photo 4. Truck trailer storage container spill cleaned up.

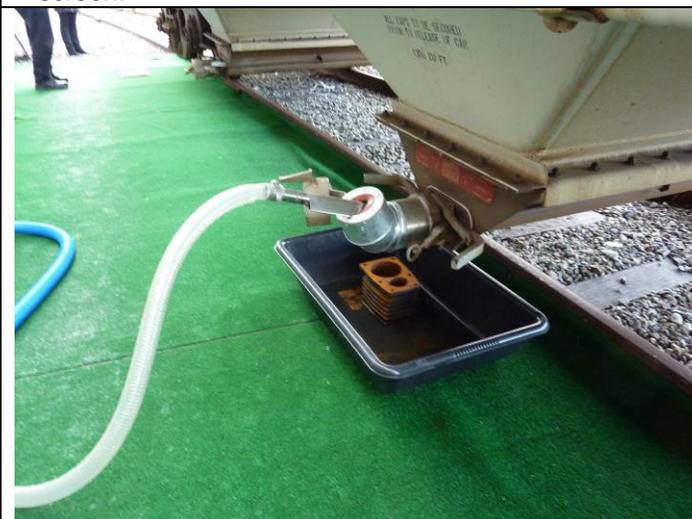
The site is much cleaner than it was but several areas of residual pellets or possible new spills remain at the rail siding (see photo 8). Out door areas are generally well maintained but the rail car unloading process is not well controlled and the possibility remains for additional pellet spills (see photos 5, 6 and 7). To meet the requirements of BCT/BAT the rail car unloading process needs to be improved with better equipment; tighter management controls and/or better site clean up. Stephen Choi was not on site and we were shown the facility by Judy Sun. She did not know about the facility inspection records and could not make them available during the inspection. The inspection records were provided by email on the evening of Dec. 15th. The records are complete but indicate the rail siding is clean and cars properly connected when they are not.

Photo 5 Rail car connection as E Poly Star presented in the Storm Water Pollution Prevention Plan and one connection was this way during the inspection

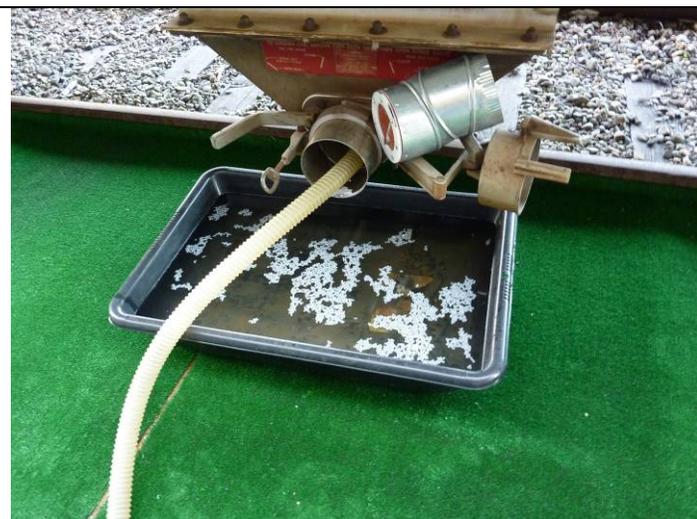
Photo 6 Rail car connection during the inspection

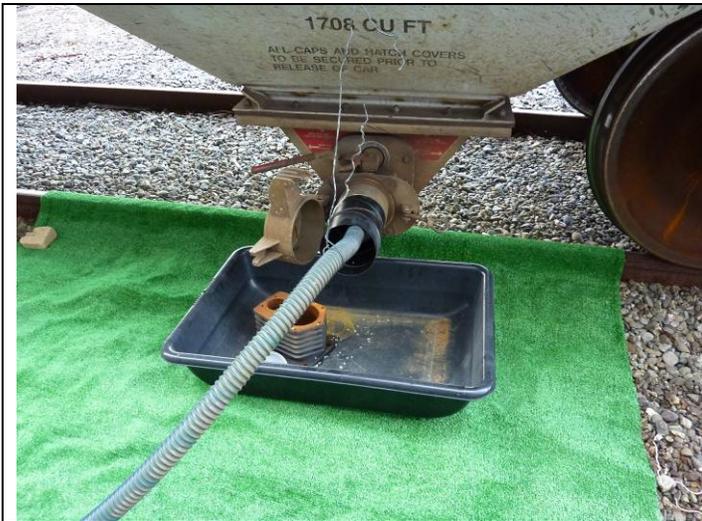
Photo 7 Another rail car connection improperly done on day of inspection

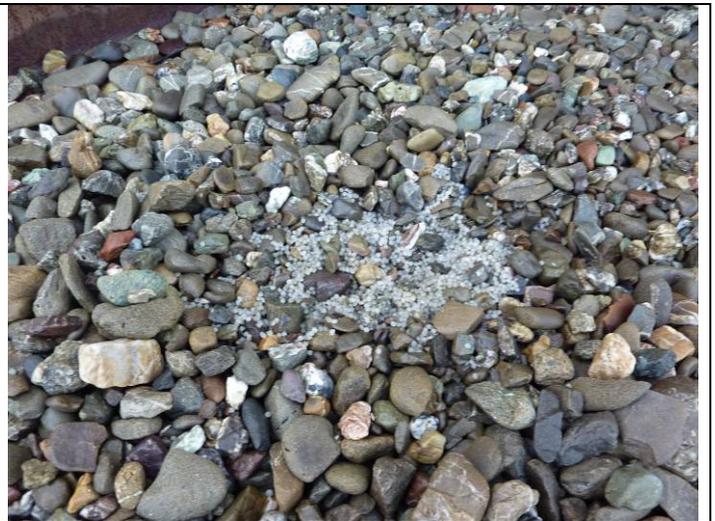
Photo 8 Pellets in railroad ballast one of several piles of pellets
