**SEWAGE COLLECTION SYSTEM INSPECTION FORM
(EPA Reg 9; form revised September 23, 2010)**

Inspection Date: **October 28, 2010**

Utility Name: City of Avalon Wastewater Treatment Plant		
Address: 123 Pebbly Beach Road Avalon, CA 90704		
Contact Person: Charlie Wagner, Chief Administrative Officer, City of Avalon		
Phone: 310-510-0220	Cell:	Fax:
Email:

PHOTOGRAPHS TAKEN DURING INSPECTION OF CITY OF AVALON, CALIFORNIA

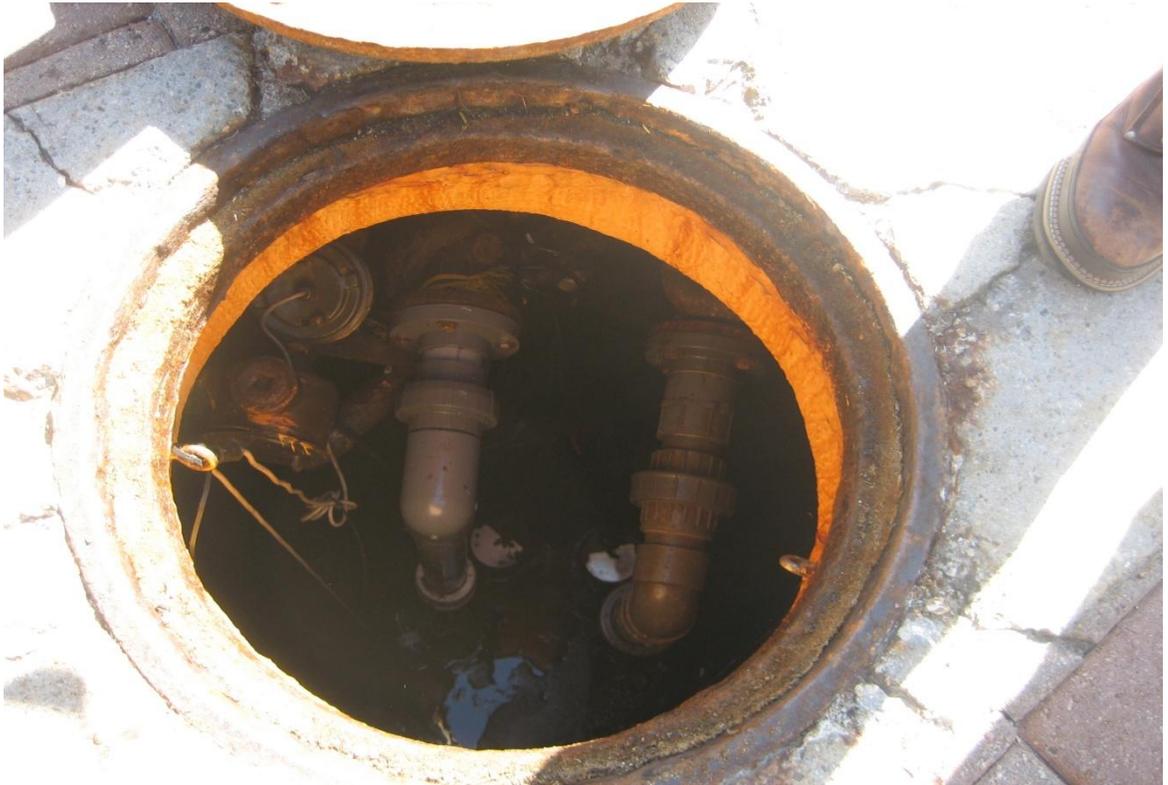
Figure 1: IMG_3259. Pump station for the low-flow diversion station at “Busy Bee” location. The City told the inspection team that the sewer system uses the low-flow diversion system to capture sewer system spills, which can then be pumped back to the WWTP. The system is a separate sewer system but is, in effect, operated similarly to a combined system.

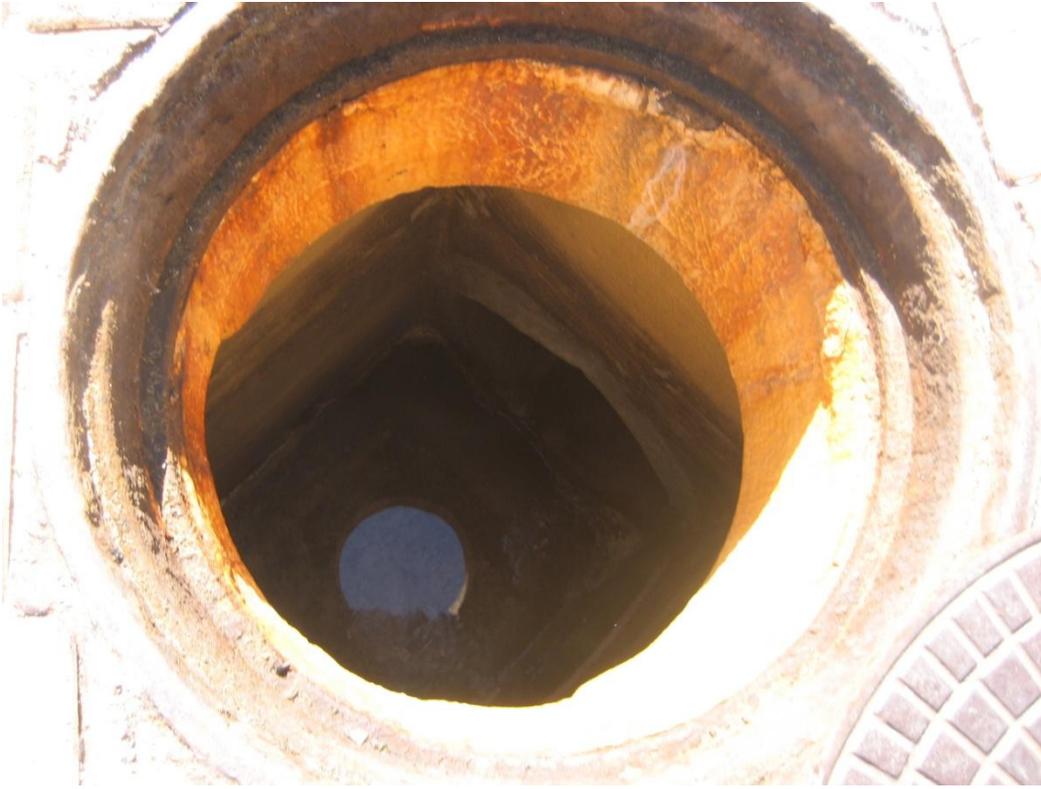
Figure 2: IMG_3260. Low-flow diversion system.

During the interview, City of Avalon representatives told the inspection team that spills in Avalon's downtown area flowed via the storm drain system into the storm water low-flow diversion system at Crescent Ave. near Metropole Ave. and then pumped to the treatment plant. However, the City staff also said that the diversion system was such that runoff went directly to the ocean after about an hour of heavy rainfall. Although the City did state to inspectors that such downtown SSOs were "usually due to pipe failure", the number of such spills was not stated, and no such spills have been reported to CIWQS. All spills from the sewage collection system are required to be reported to CIWQS, regardless the spill is pumped from the low-flow diversion system to the treatment plant. *Recommendation:* The City is required to report all SSOs, including spills that may occur on private property but are due to blockages in a city-owned pipe, as required by the State's Monitoring and Reporting Program No. 2006-0003-DWQ. The City should provide EPA with an explanation of the reasons any SSOs were not reported to CIWQS. The City should report all missing spill data to CIWQS, as appropriate.

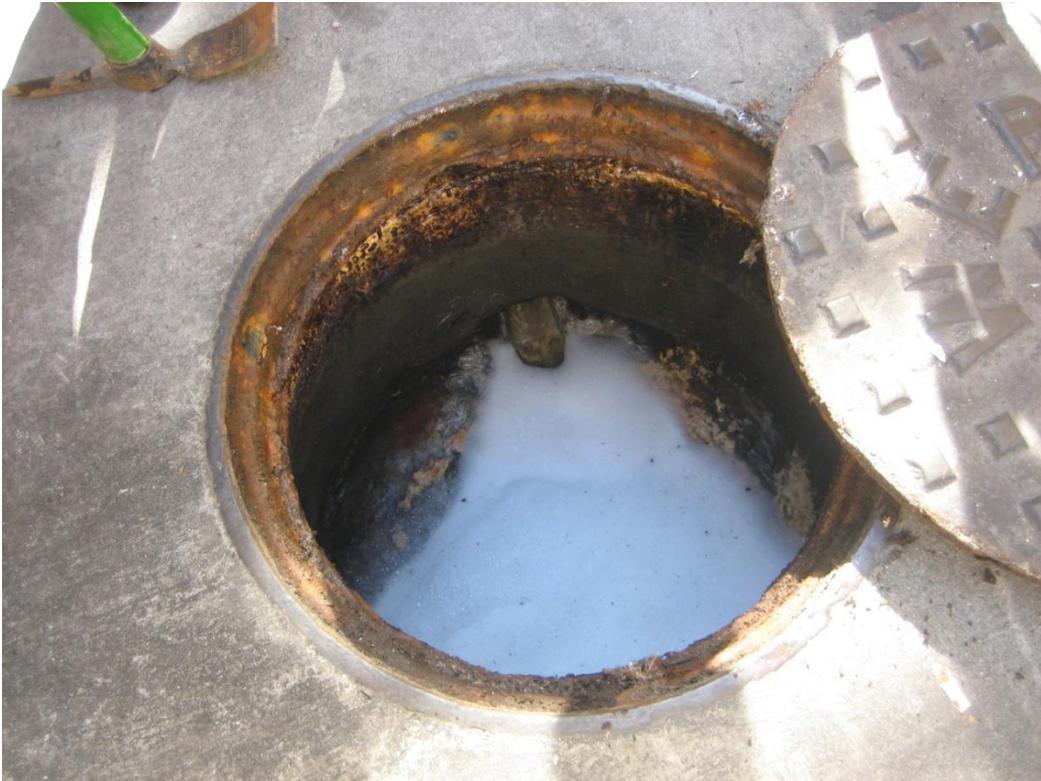
Figure 3: IMG_3261. Manhole located in the alley behind the El Galleon restaurant. Small amount of grease is visible, lots of soap suds.

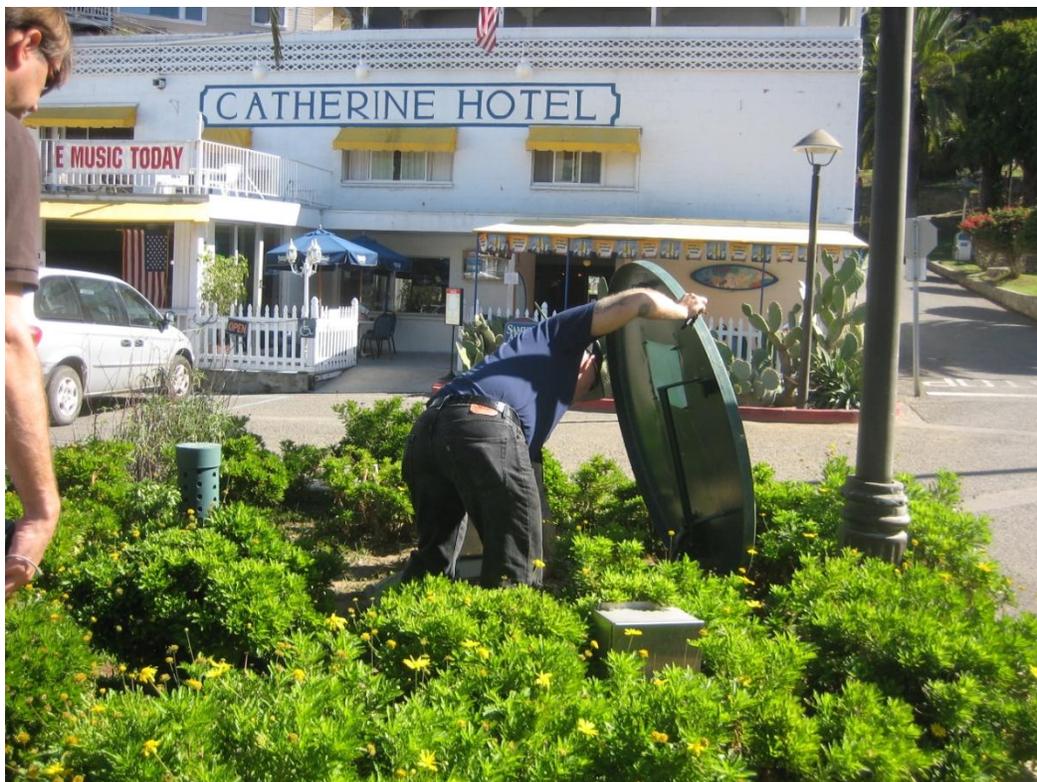
Figure 4: IMG_3262. Mike Jones of United Water opening the cover at the Catherine lift station.

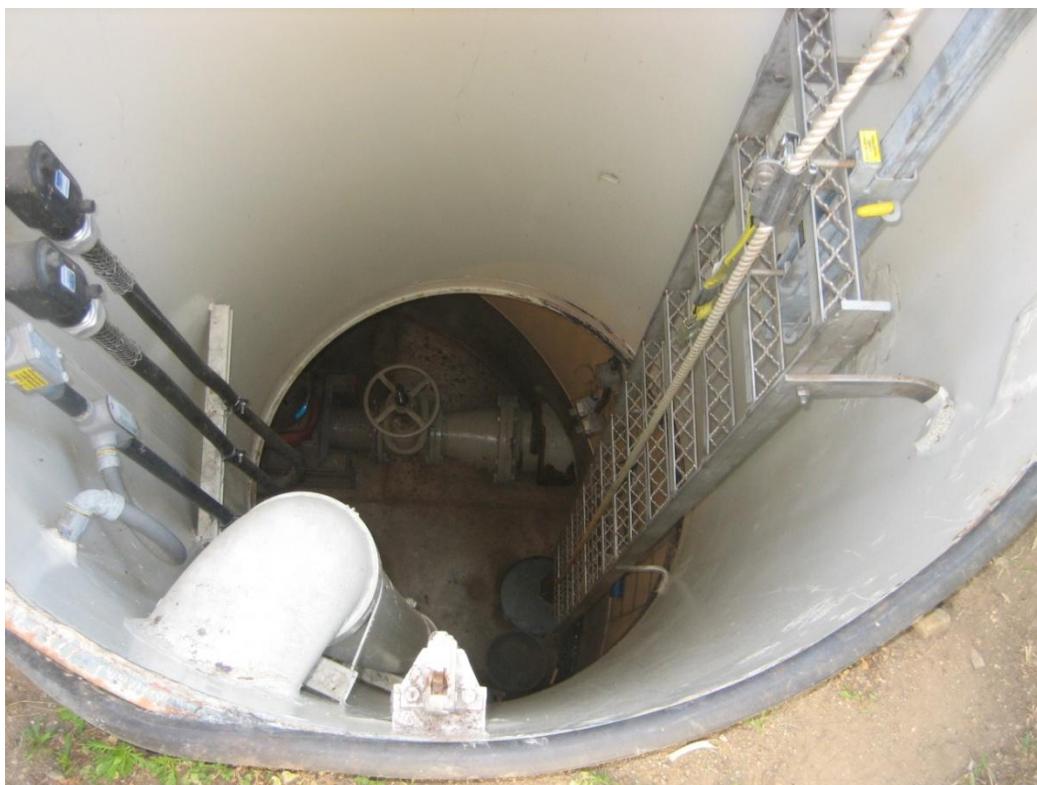
Figure 5: IMG_3263. Catherine lift station.

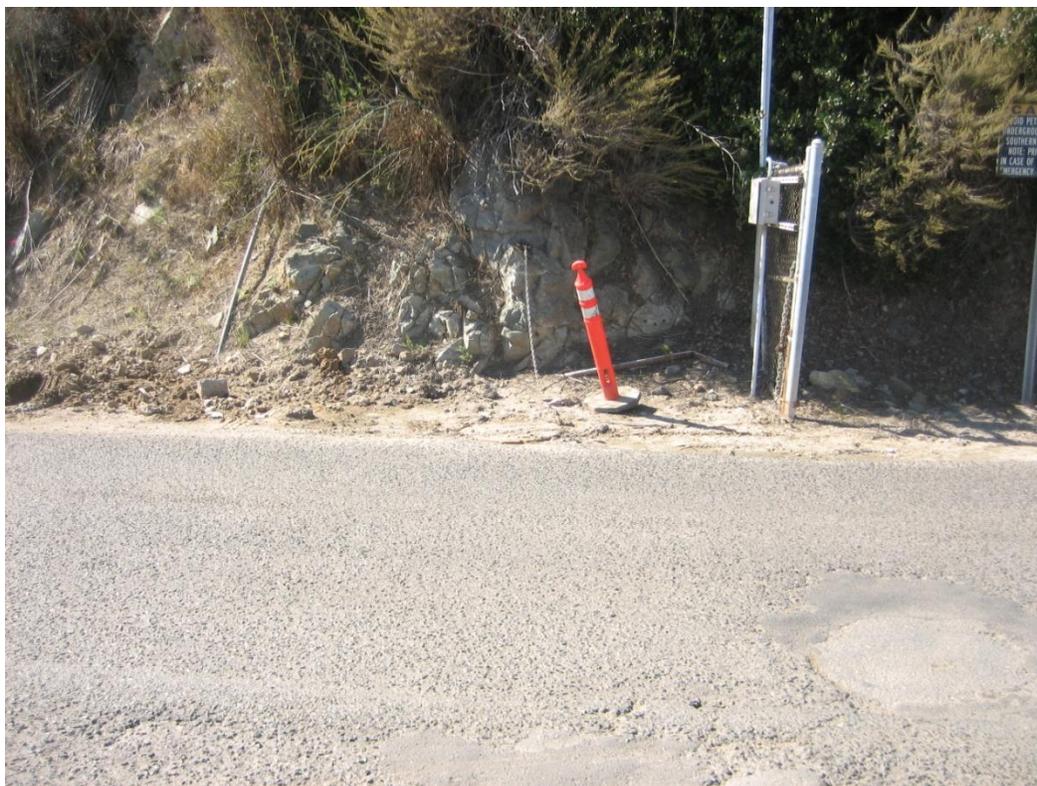
Figure 6: IMG_3264. Low point manhole between Catherine & Pebbly Beach lift stations.

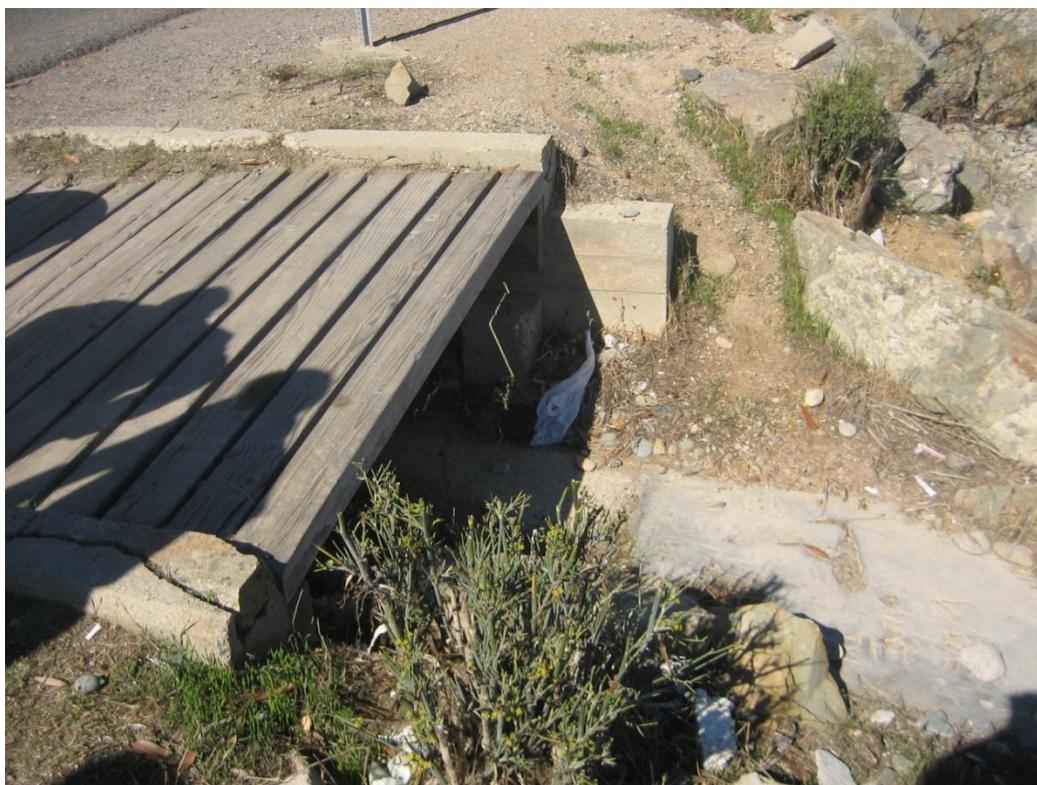
Figure 7: IMG_3265. Outlet to beach from the low point manhole pictured in IMG_3264.

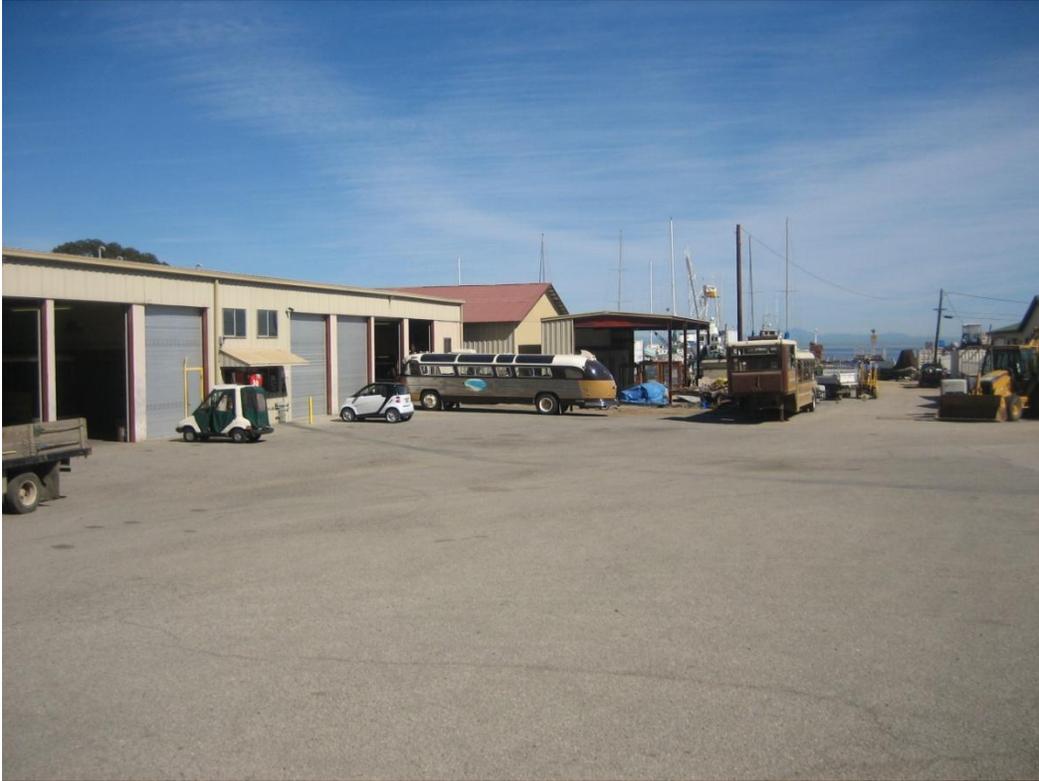
Figure 8: IMG_3266. Site of spill at Pebbly Beach lift station.

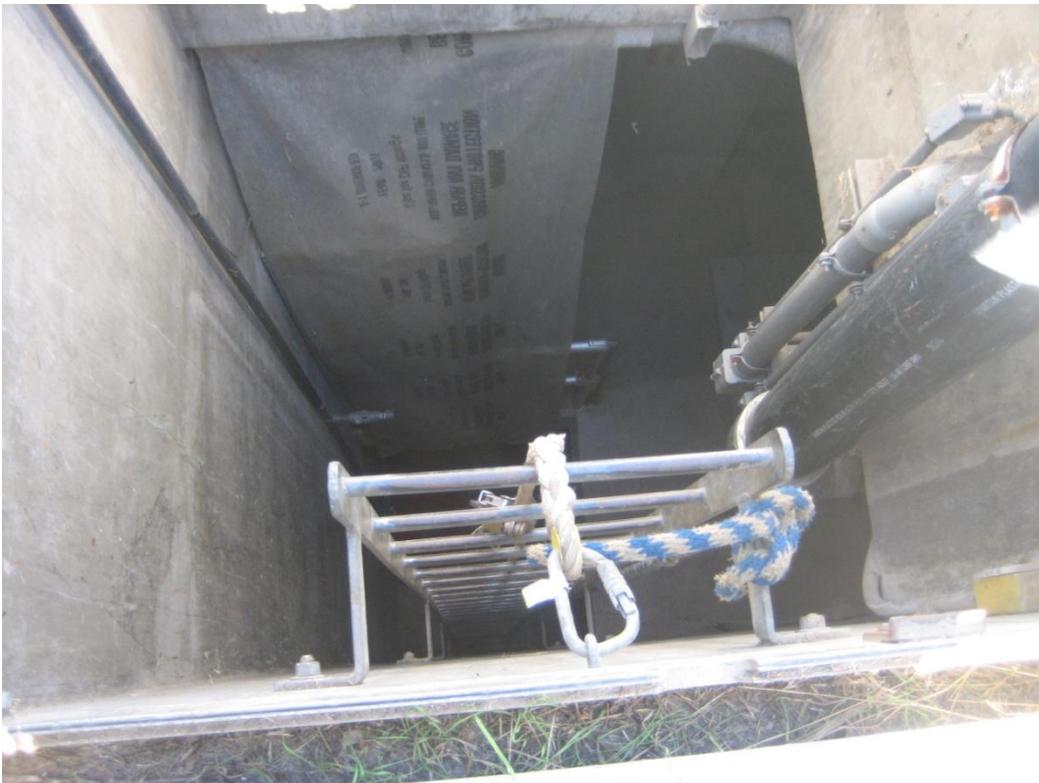
Figure 9: IMG_3267. Pebbly Beach lift station.

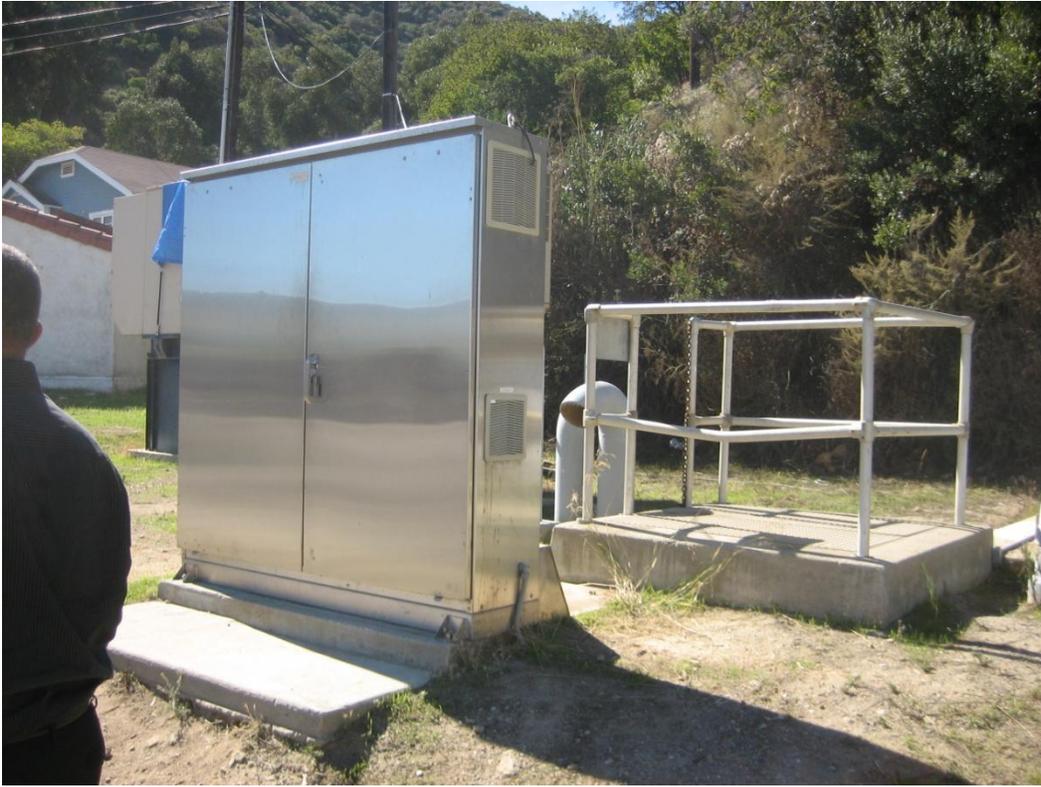
Figure 10: IMG_3268. Control panel and wet well area at Pebbly Beach lift station.

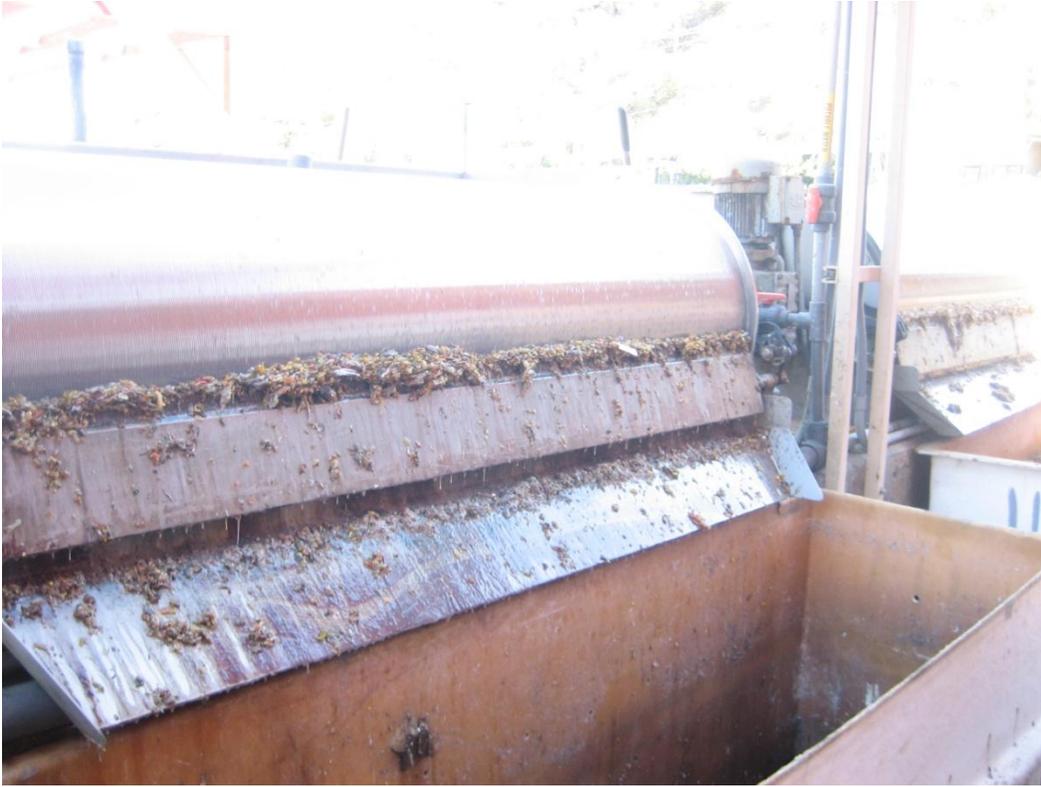
Figure 11: IMG_3269. Rotoscreens at wastewater treatment plant, site of an in-plant spill.

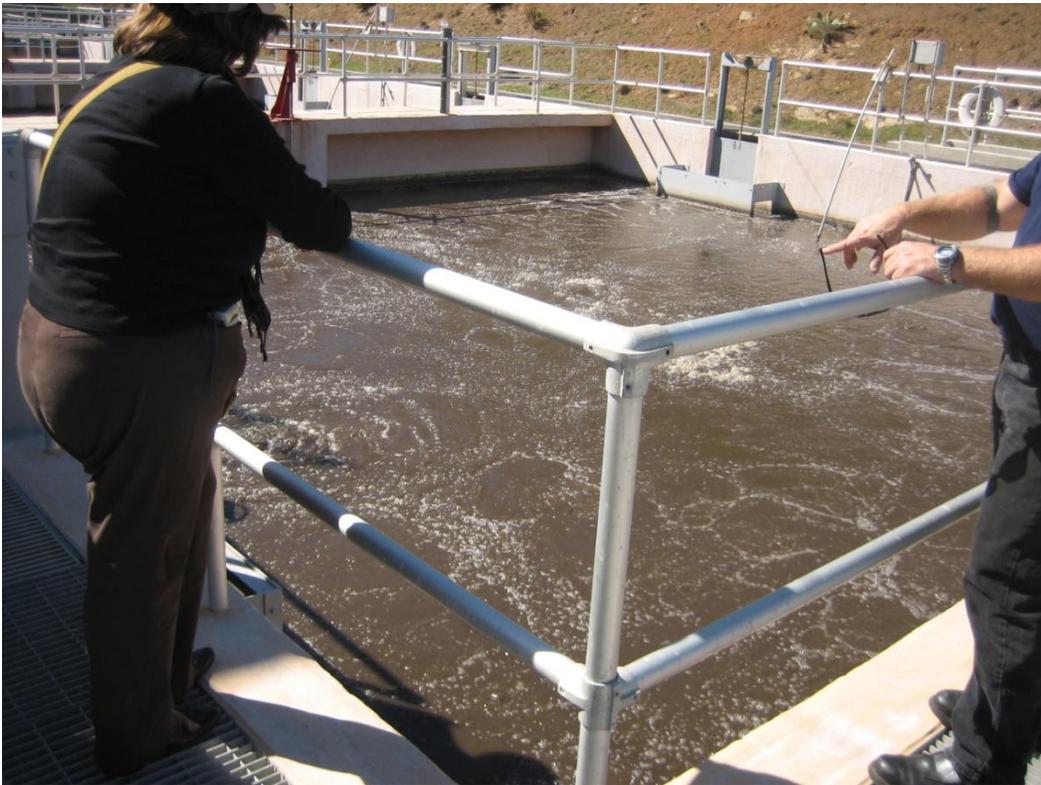
Figure 12: IMG_3270. Aeration basins.

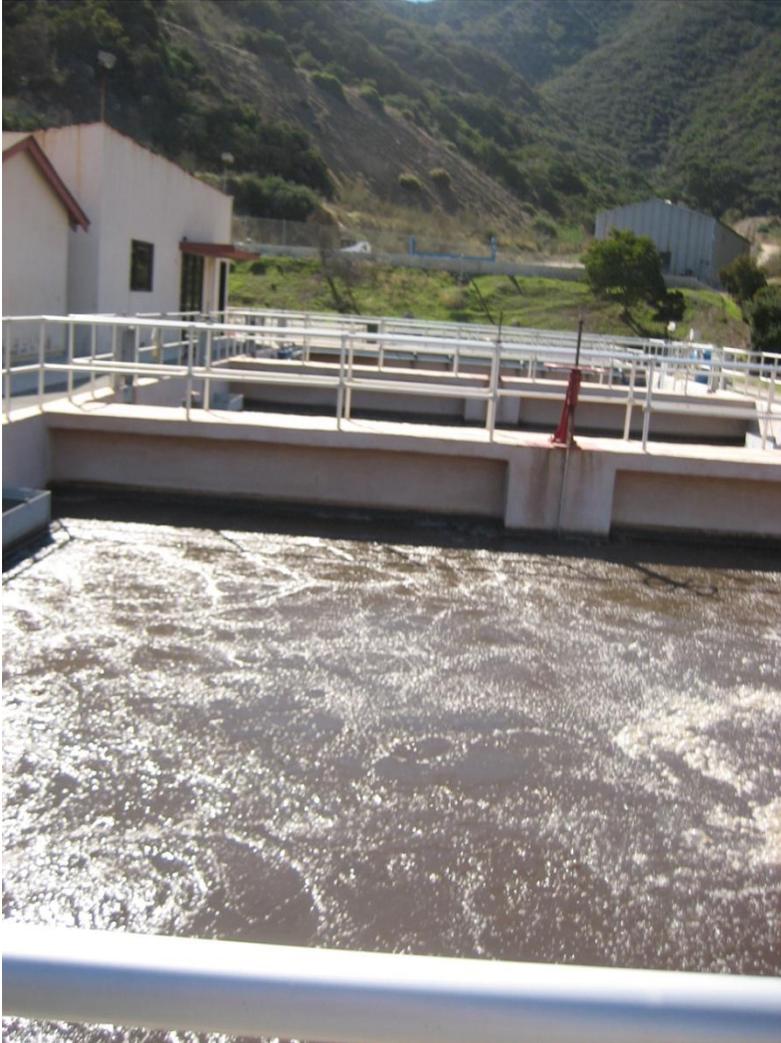
Figure 13: IMG_3271. Aeration basins. Original image has been rotated 90° clockwise.

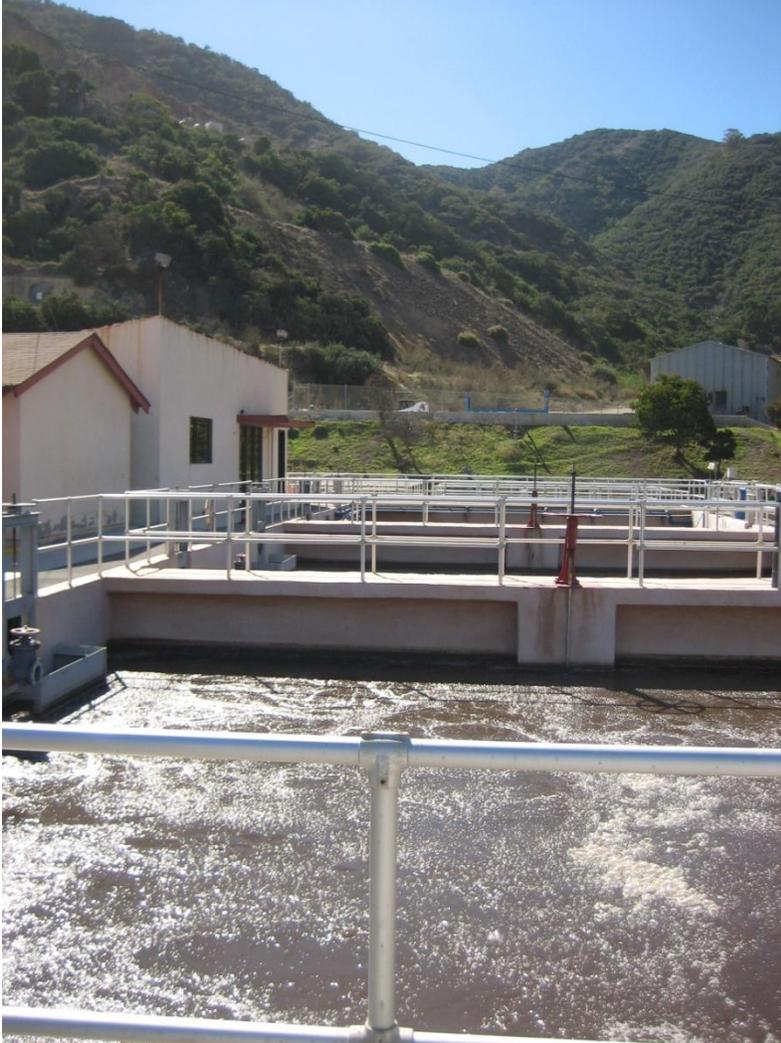
Figure 14: IMG_3272. Aeration basins. Original image has been rotated 90° clockwise.

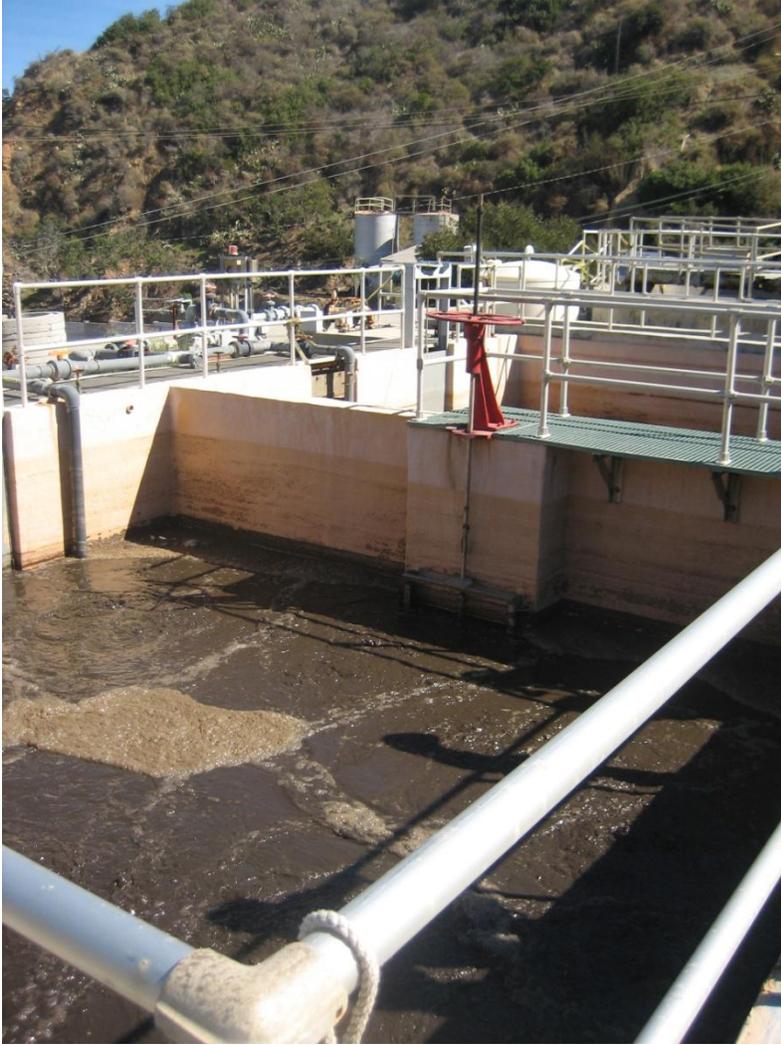
Figure 15: IMG_3273. Digesters. Original image has been rotated 90° clockwise.

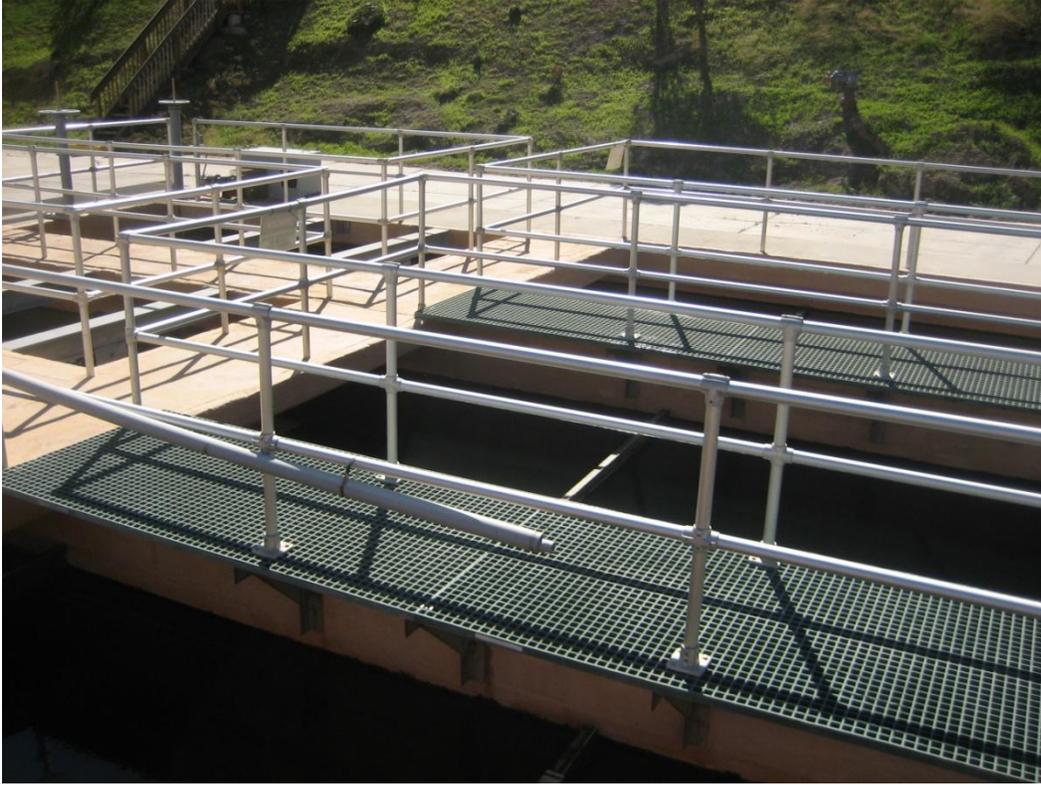
Figure 16: IMG_3274. Clarifiers.

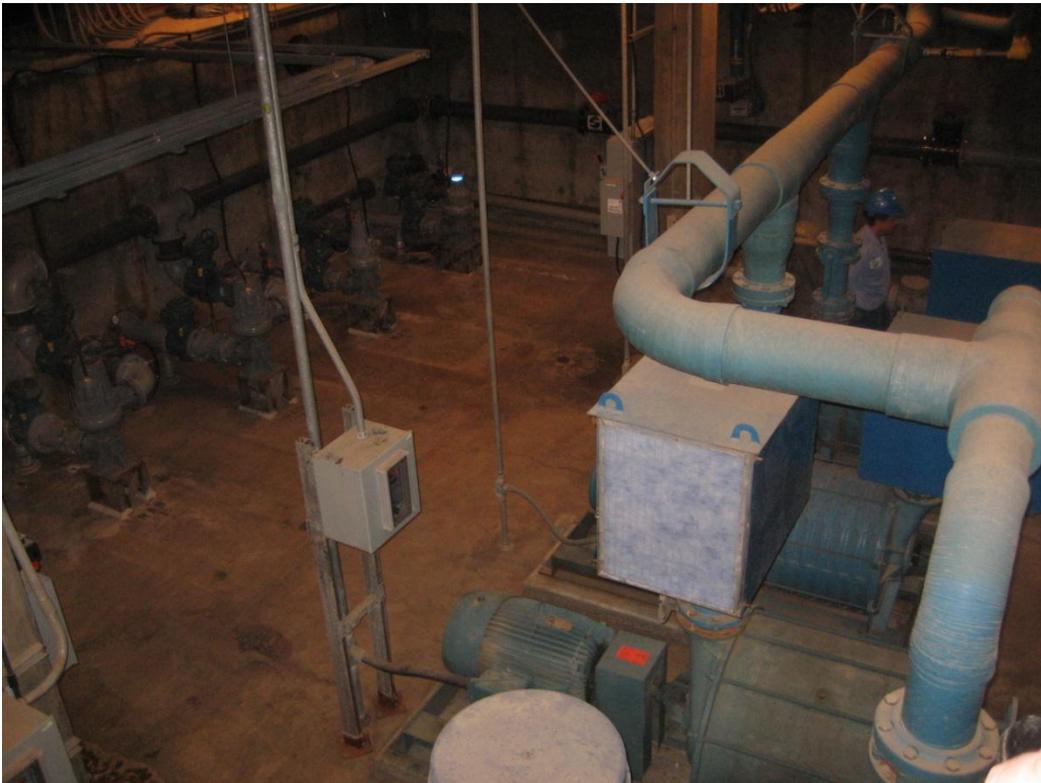
Figure 17: IMG_3275. Pumps and blowers.
