TRANSMITTAL OF INSPECTION REPORT FOR RED INK MAID AND BIG SEAM MINING CLAIMS, PLACER COUNTY

INSPECTION REPORT

DISCHARGER: Richard Sykora, Red Ink Maid and Big Seam Mining Claims

LOCATION & COUNTY: 6 miles east of Foresthill on Mosquito Ridge Road, Placer County,

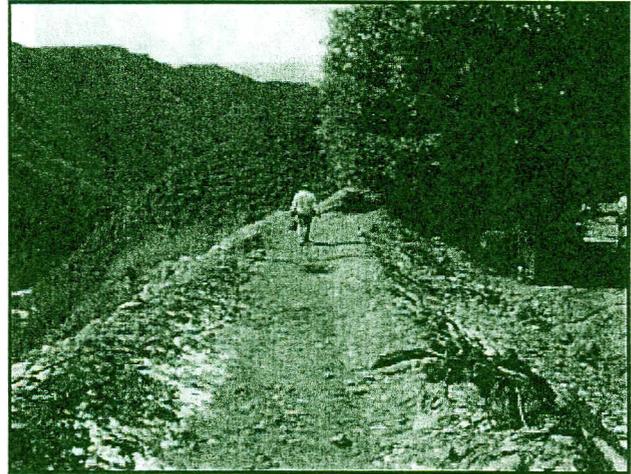
Representatives of the agencies divided into several smaller groups and inspected waste dumps #1 through #4 (photos 4-9). Upon inspection, it was clear that waste dumps #1 through #4 had not been fully reclaimed by 30 October 2009 as is required by Order No. R5-2007-0181 (Discharge Specification B.6.). No apparent reclamation measures such as hydroseeding or hydromulching that establish self-sustaining plant cover to control erosion,

Photo 4. Looking west at the berm of waste dump #2.
Middle Fork of the American River visible on left.

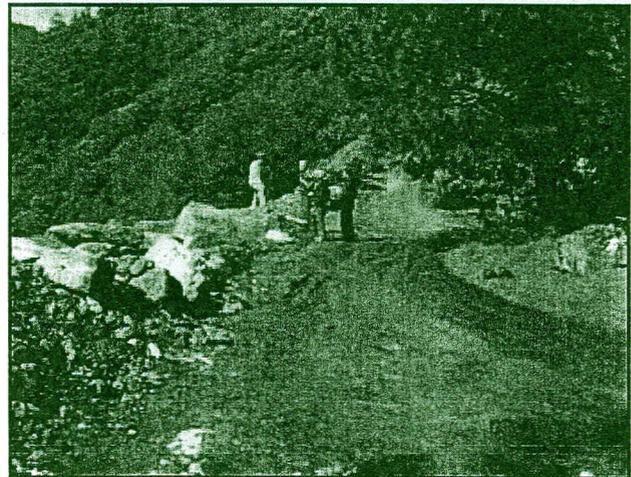
Photo 5. Portal area looking towards waste dump #1.

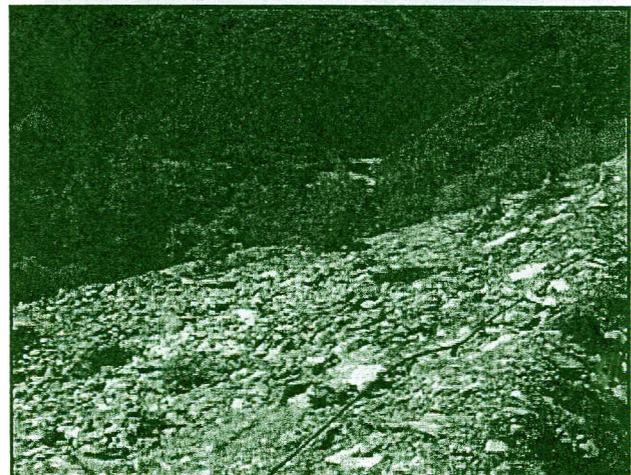
Mr. Gius of OMR summarized his observations from the inspection. Mr. Gius noted that he observed weak material and slippage near the toe of waste dumps #2 and #3 and that he had concerns about the placement method for waste dump #5. Mr. Gius indicated that he would be providing a written summary of his observations and findings.

Photo 6. Waste dump #3, looking west.

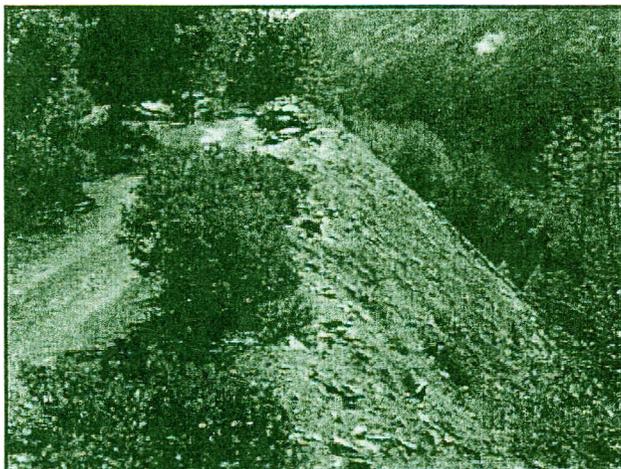
Photo 7. Looking east at waste dump #1.

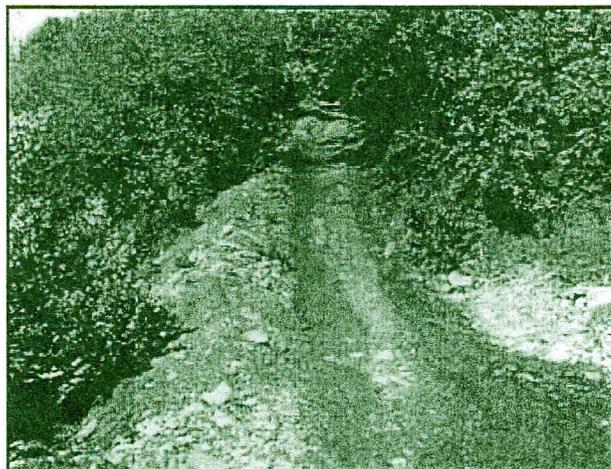
Upon finishing the inspection of waste dumps #1 through #4, representatives from OMR, the USFS, and staff proceeded to waste dump #5 (photo 10). Neither Mr. Sykora nor Mr. Rel of Placer County chose to accompany the group during the inspection of waste dump #5.

Photo 10. Looking west at the access road to waste dump #5.

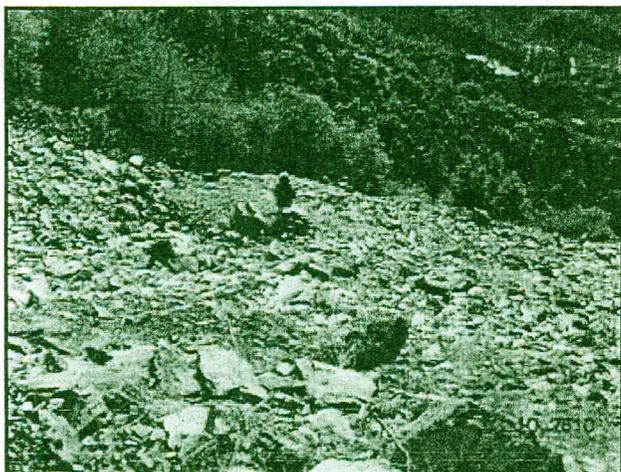
Photo 8. Looking east at waste dump #4.

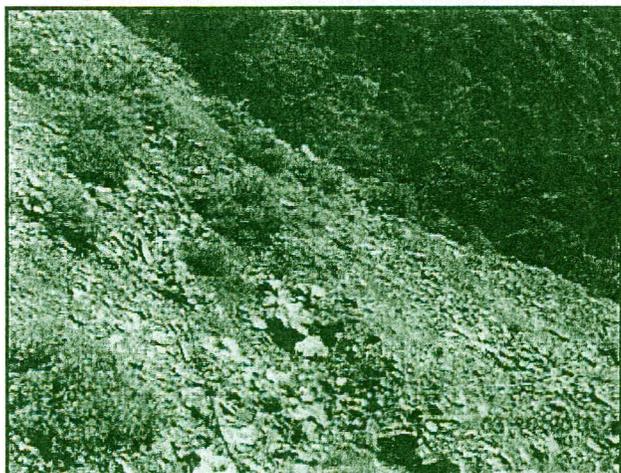
Photo 9. Looking at slump failure on waste dump #4.

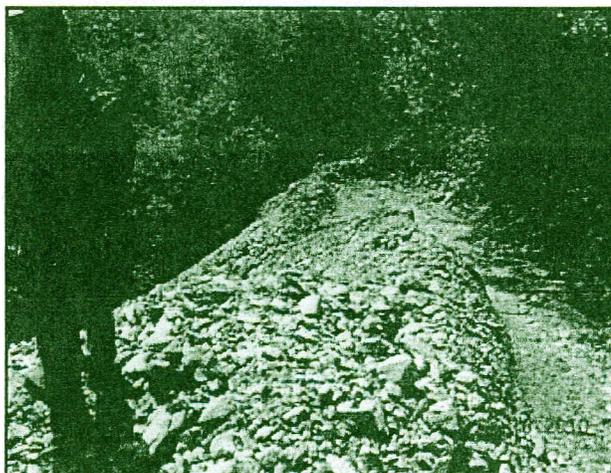
A significant quantity of mining waste had been discharged to waste dump #5 since our 30 July 2009 site visit (photo 11). It was evident that the mining waste was being discharged by end dumping method alone (photos 12-16) and no effort was being made to construct the waste dump in the manner prescribed in Findings 27 and 28 of Order No. R5-2007-0181

Photo 12. Waste dump #5 showing end dumped mining waste.

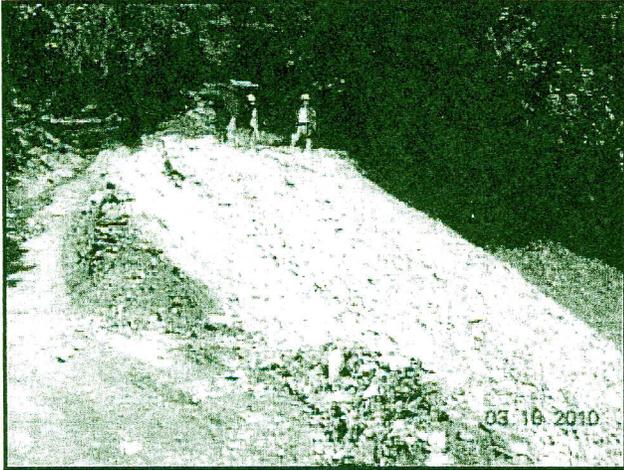
Photo 13. Waste dump #5 showing end dumped mining waste.

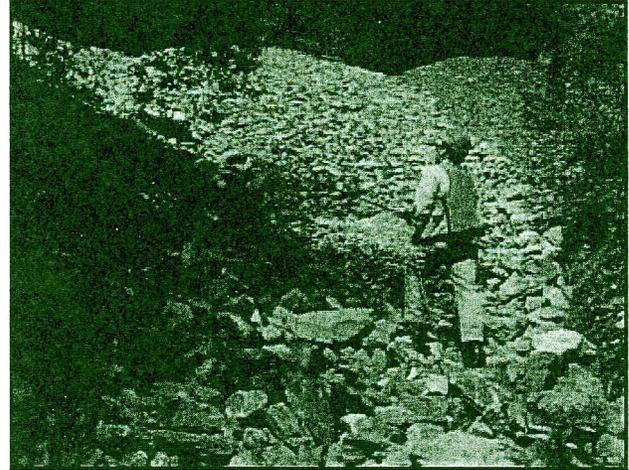
Photo 16. Showing natural segregation of end dumped materials.

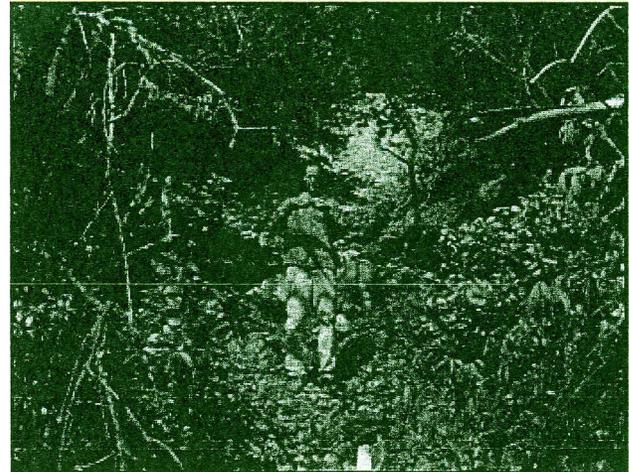
We next inspected the area below the toe of waste dump #5 (photo 17). Only one of the two debris or sediment barriers recommended by the Dischargers consultant (Holdrege & Kull, 12 March 2007) has been constructed. It did not appear that the debris or sediment barrier had been recently maintained or would be effective in reducing any potential debris or sediment discharged or eroded from waste dump #5 (photos 18-22). Approximately, 40 feet below the debris or sediment barrier, the topography becomes much steeper than the 33% slope that forms the base of waste dump #5.

Photo 17. Looking up from the debris barrier to waste dump #5.

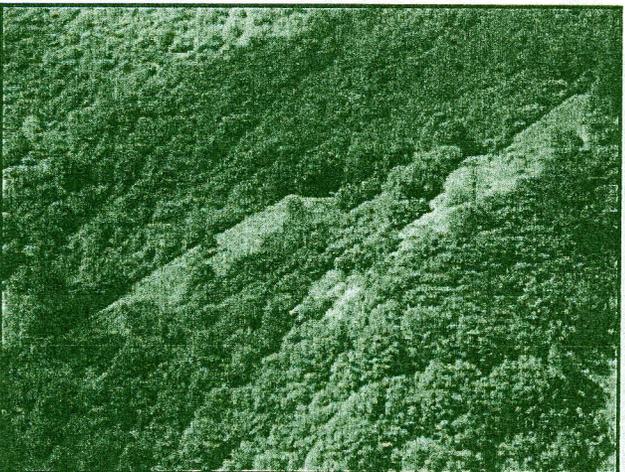
Photo 21. Photo taken from Mosquito Ridge Road overlook 1 mile east of mine site. Photo shows slope failures at the toes of waste dump #2 and #4.
