**CENTRAL VALLEY REGIONAL WATER QUALITY CONTROL BOARD**

**RECORD OF COMMUNICATION**

Emerald Bay Houseboats  
4801 Feather River Blvd., #16  
Oroville, Butte County  
Owner William Hill

SUBJECT: Conduct Non-filer ISWP inspection

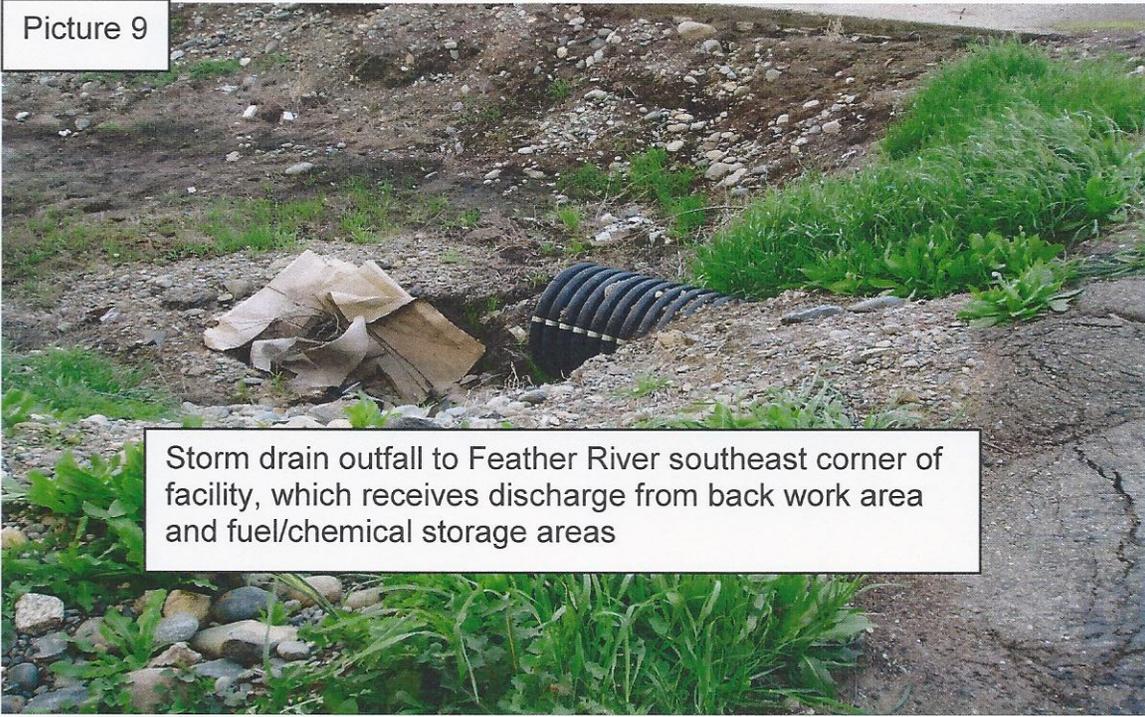
Picture 9

Storm drain outfall to Feather River southeast corner of facility, which receives discharge from back work area and fuel/chemical storage areas

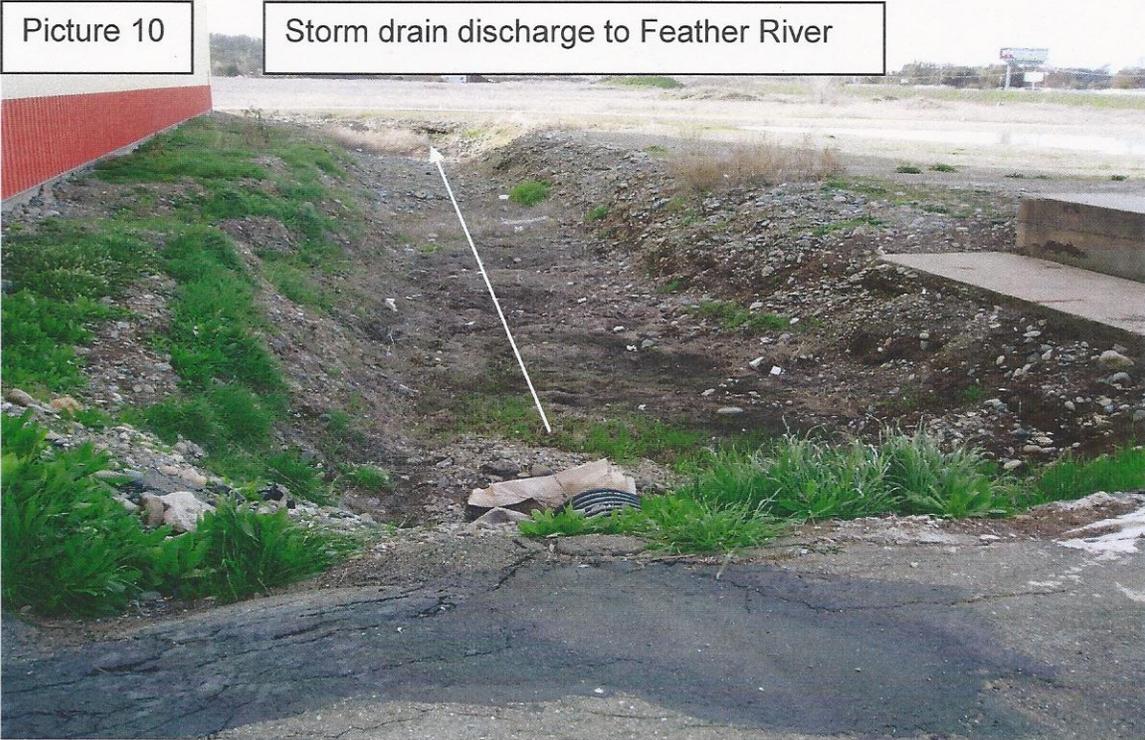
Picture 10

Storm drain discharge to Feather River

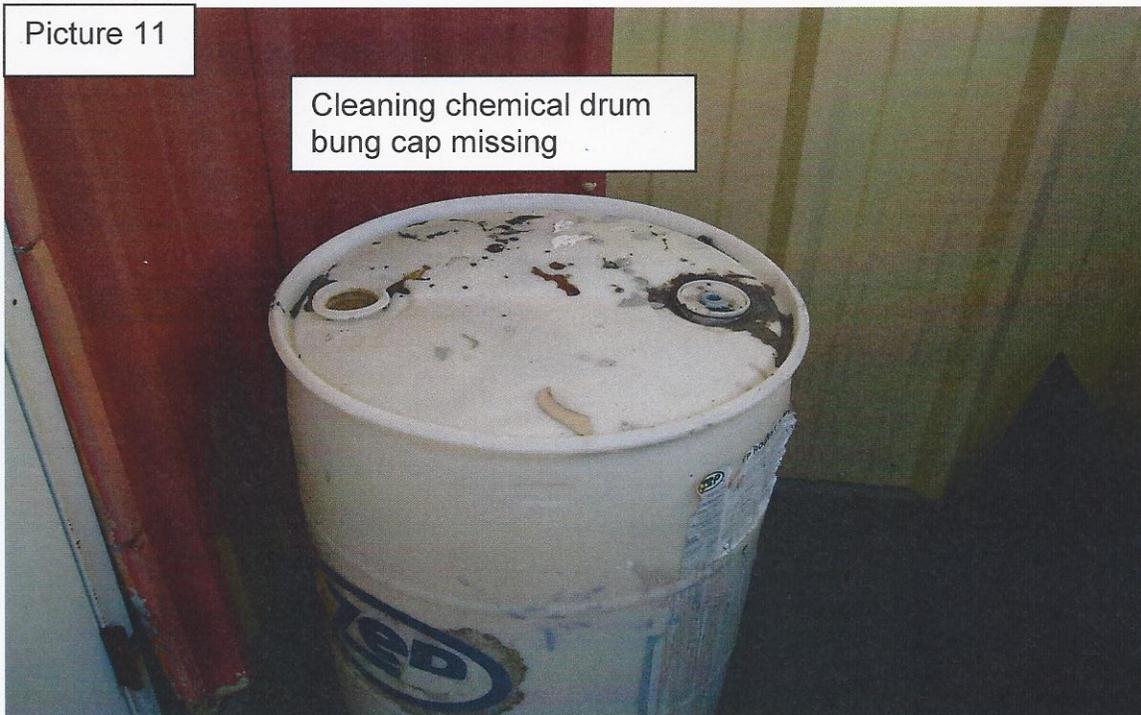
Picture 11

Cleaning chemical drum  
bung cap missing

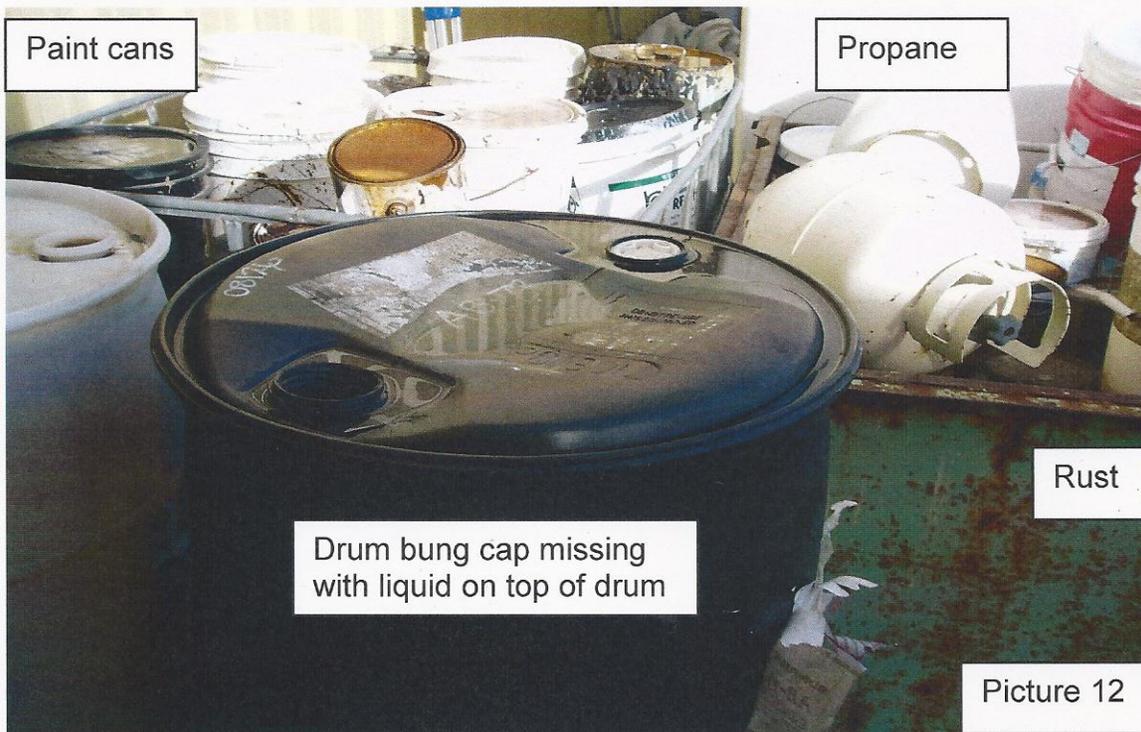
Picture 12

Paint cans

Propane

Rust

Drum bung cap missing  
with liquid on top of drum

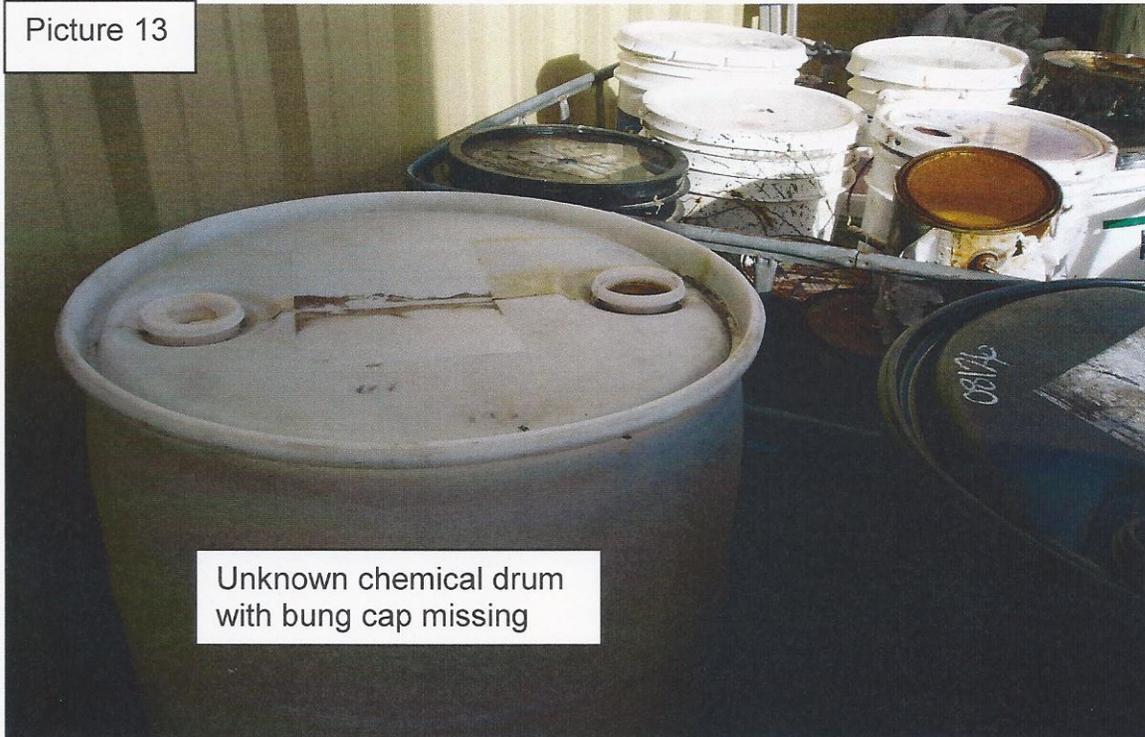
Picture 13

Unknown chemical drum  
with bung cap missing

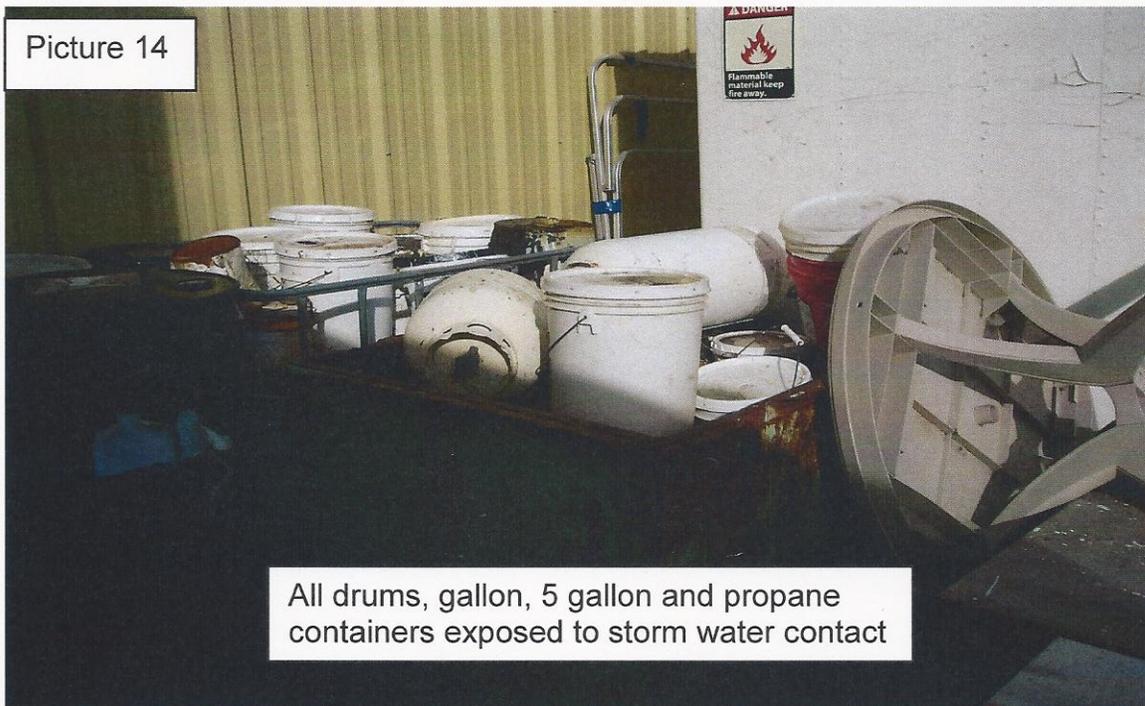
Picture 14

All drums, gallon, 5 gallon and propane  
containers exposed to storm water contact

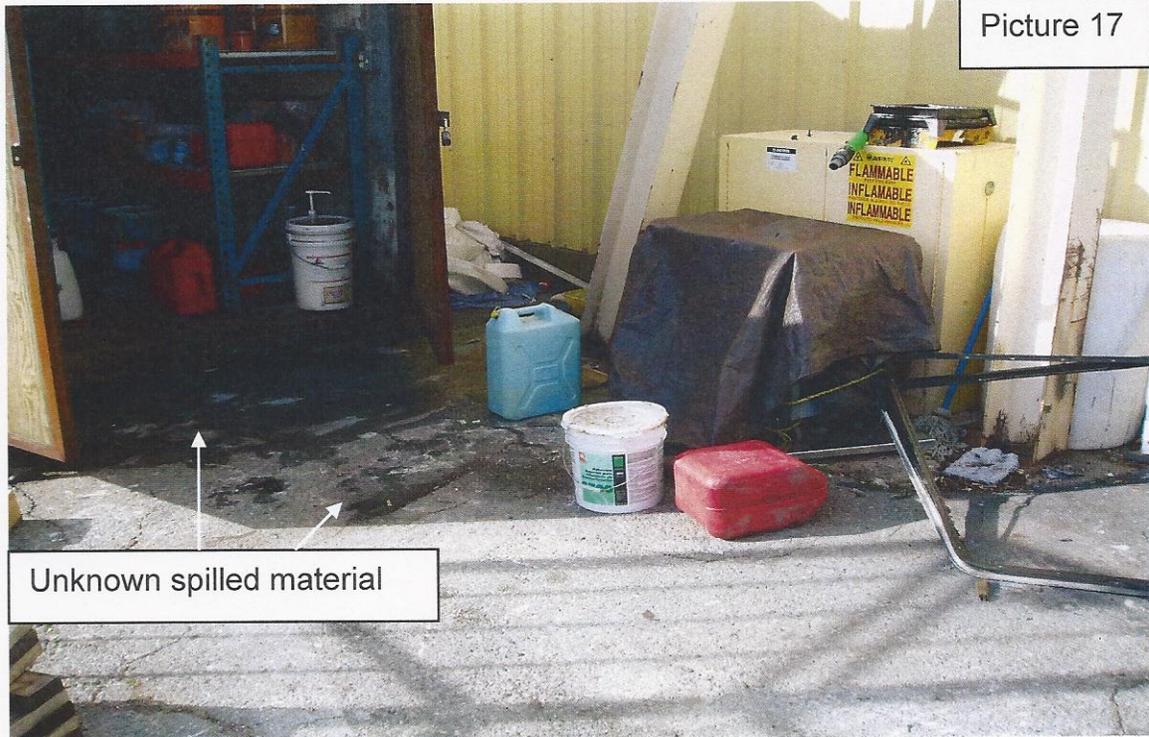
Picture 17

Unknown spilled material

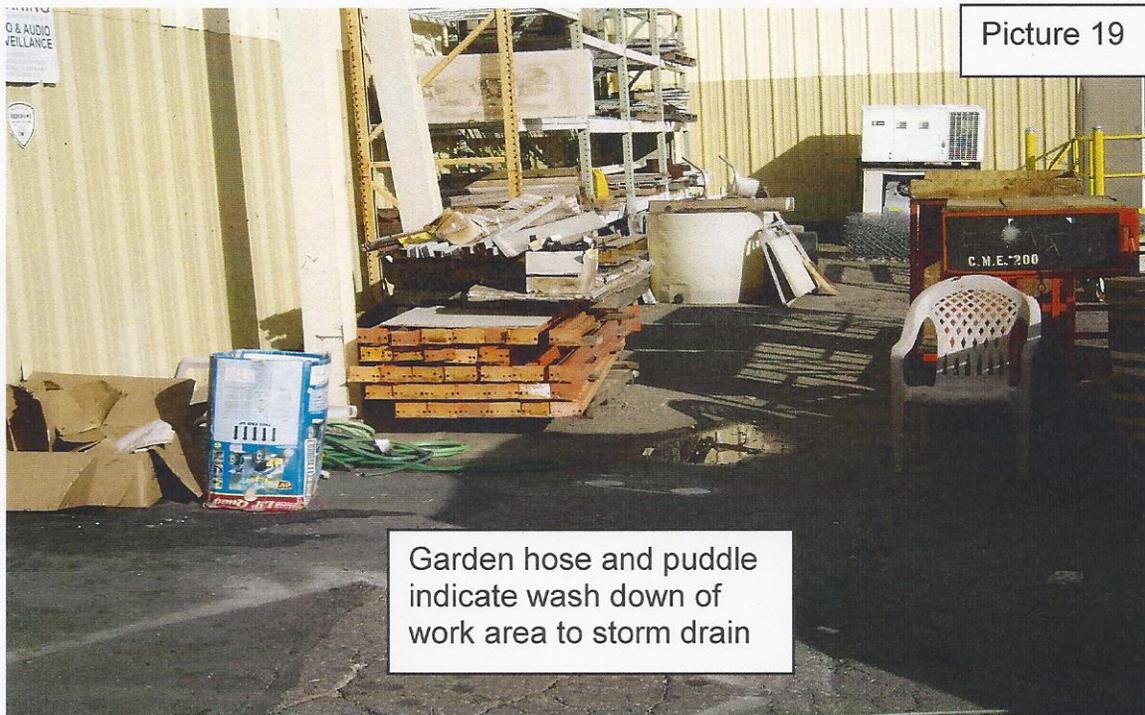
Picture 19

Garden hose and puddle indicate wash down of work area to storm drain

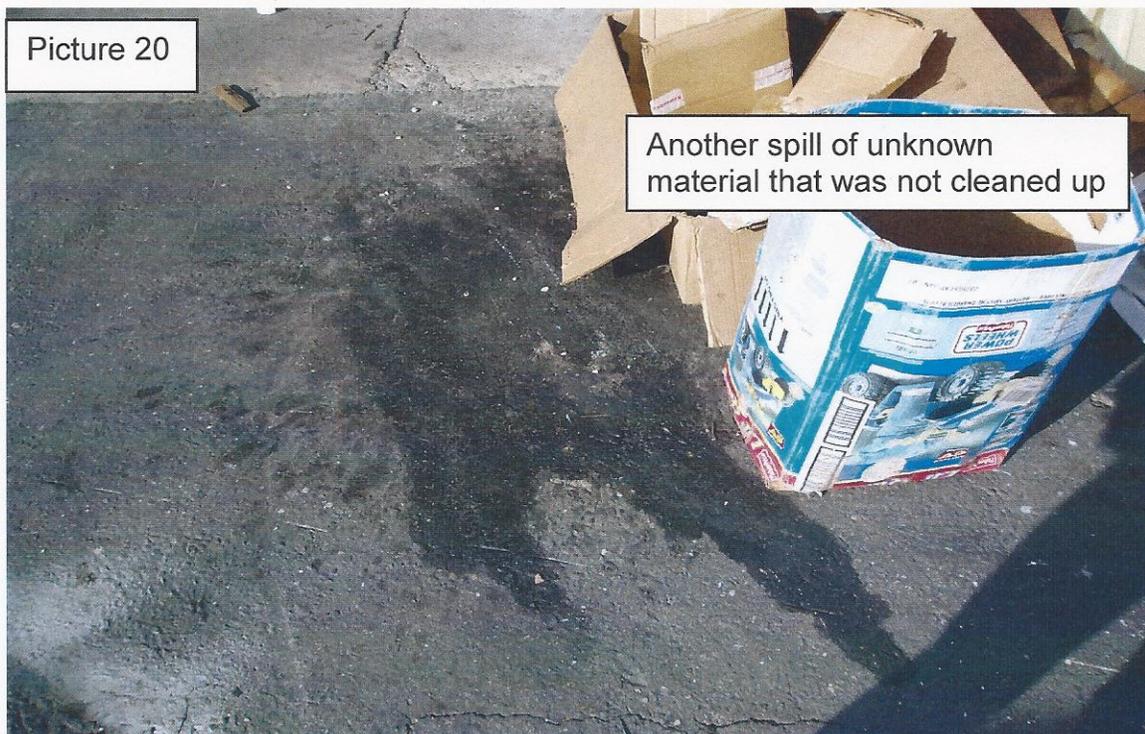
Picture 20

Another spill of unknown material that was not cleaned up

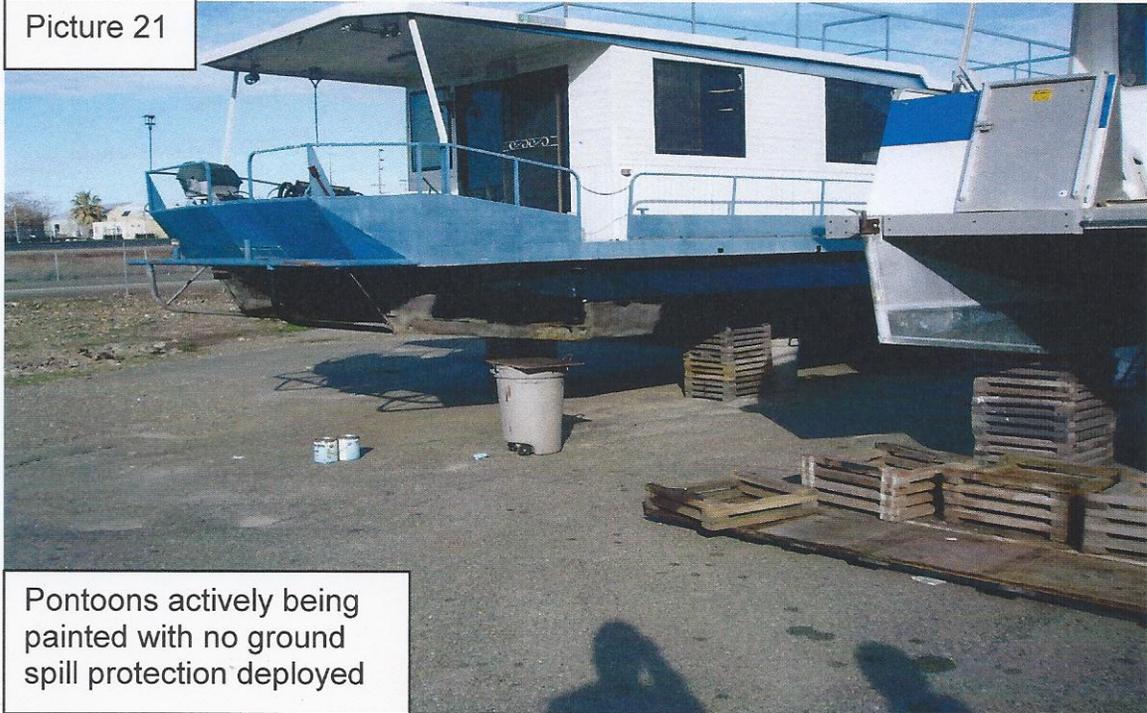
Picture 21

Pontoons actively being painted with no ground spill protection deployed

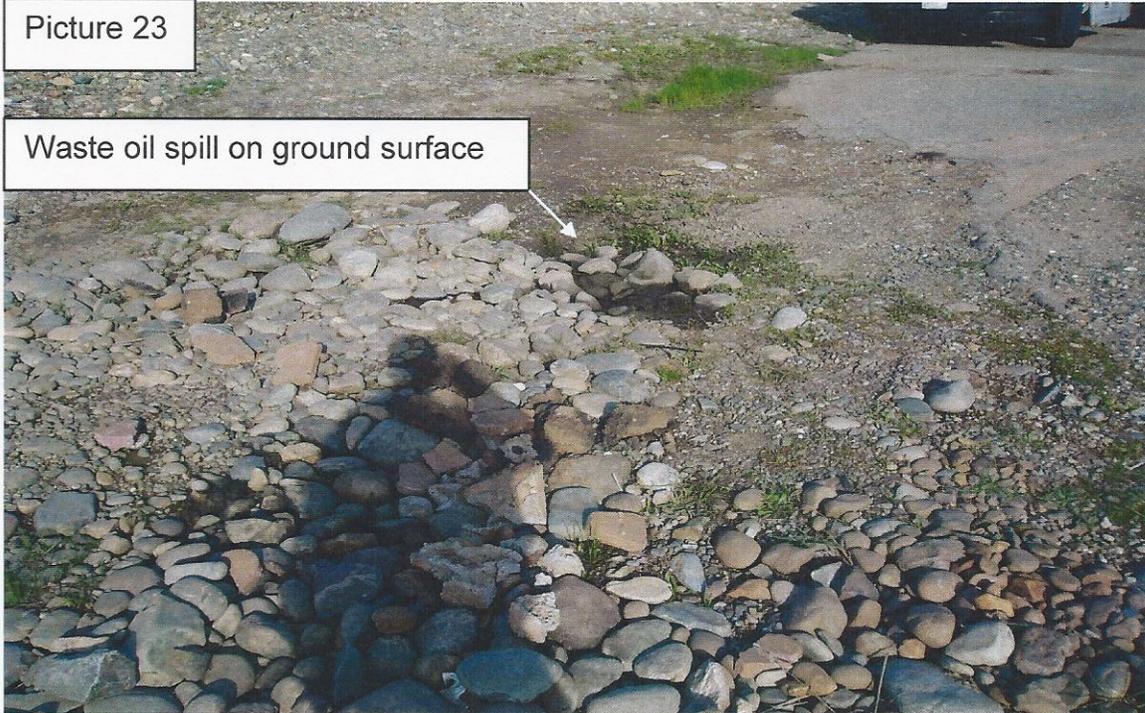
Picture 23

Waste oil spill on ground surface

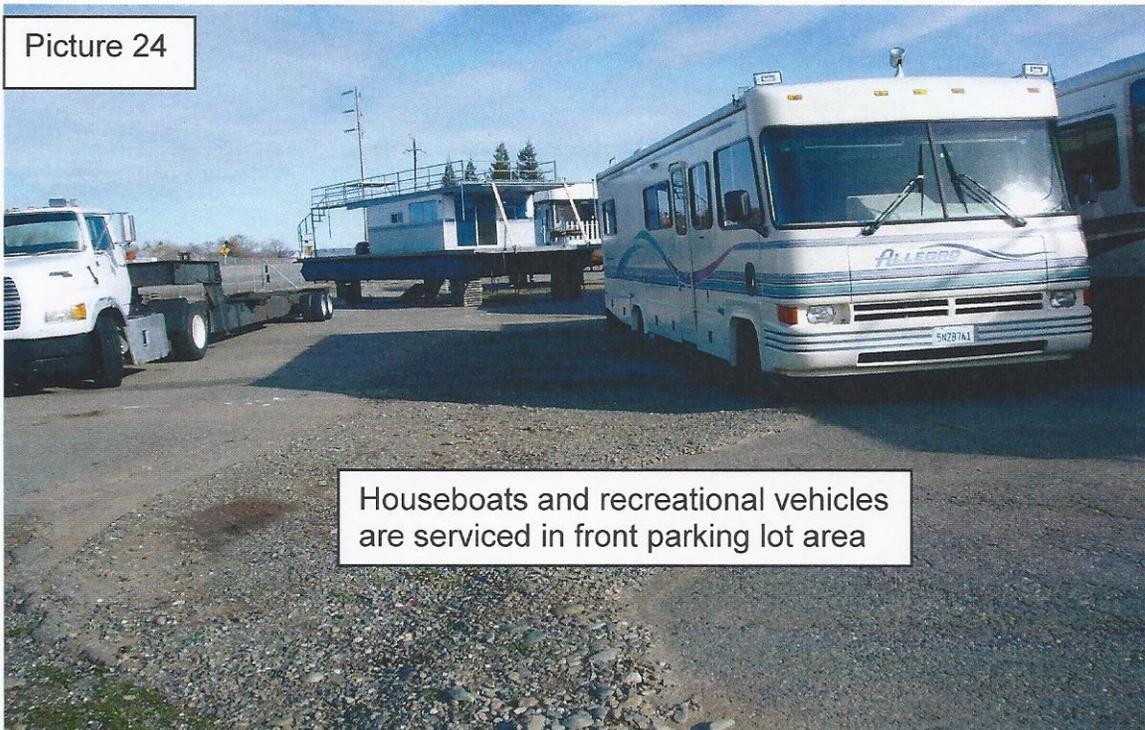
Picture 24

Houseboats and recreational vehicles  
are serviced in front parking lot area
