Re: Transmittal Letter for Subgrade Sampling Results and Report of Remedial
Actions, Compost High-Flow and Low-Flow Ponds, Recology Hay Road, Solano
County, California

**RE: SUBGRADE SAMPLING RESULTS, COMPOST AREA POND, RECOLOGY HAY ROAD,
SOLANO COUNTY, CALIFORNIA**

This report summarizes the remedial actions completed, repairs made to the liner systems, and the associated testing that was performed.

**FIGURE 2
COMPOST AREA PONDS REPAIR PLAN
RECOLOGY HAY ROAD**

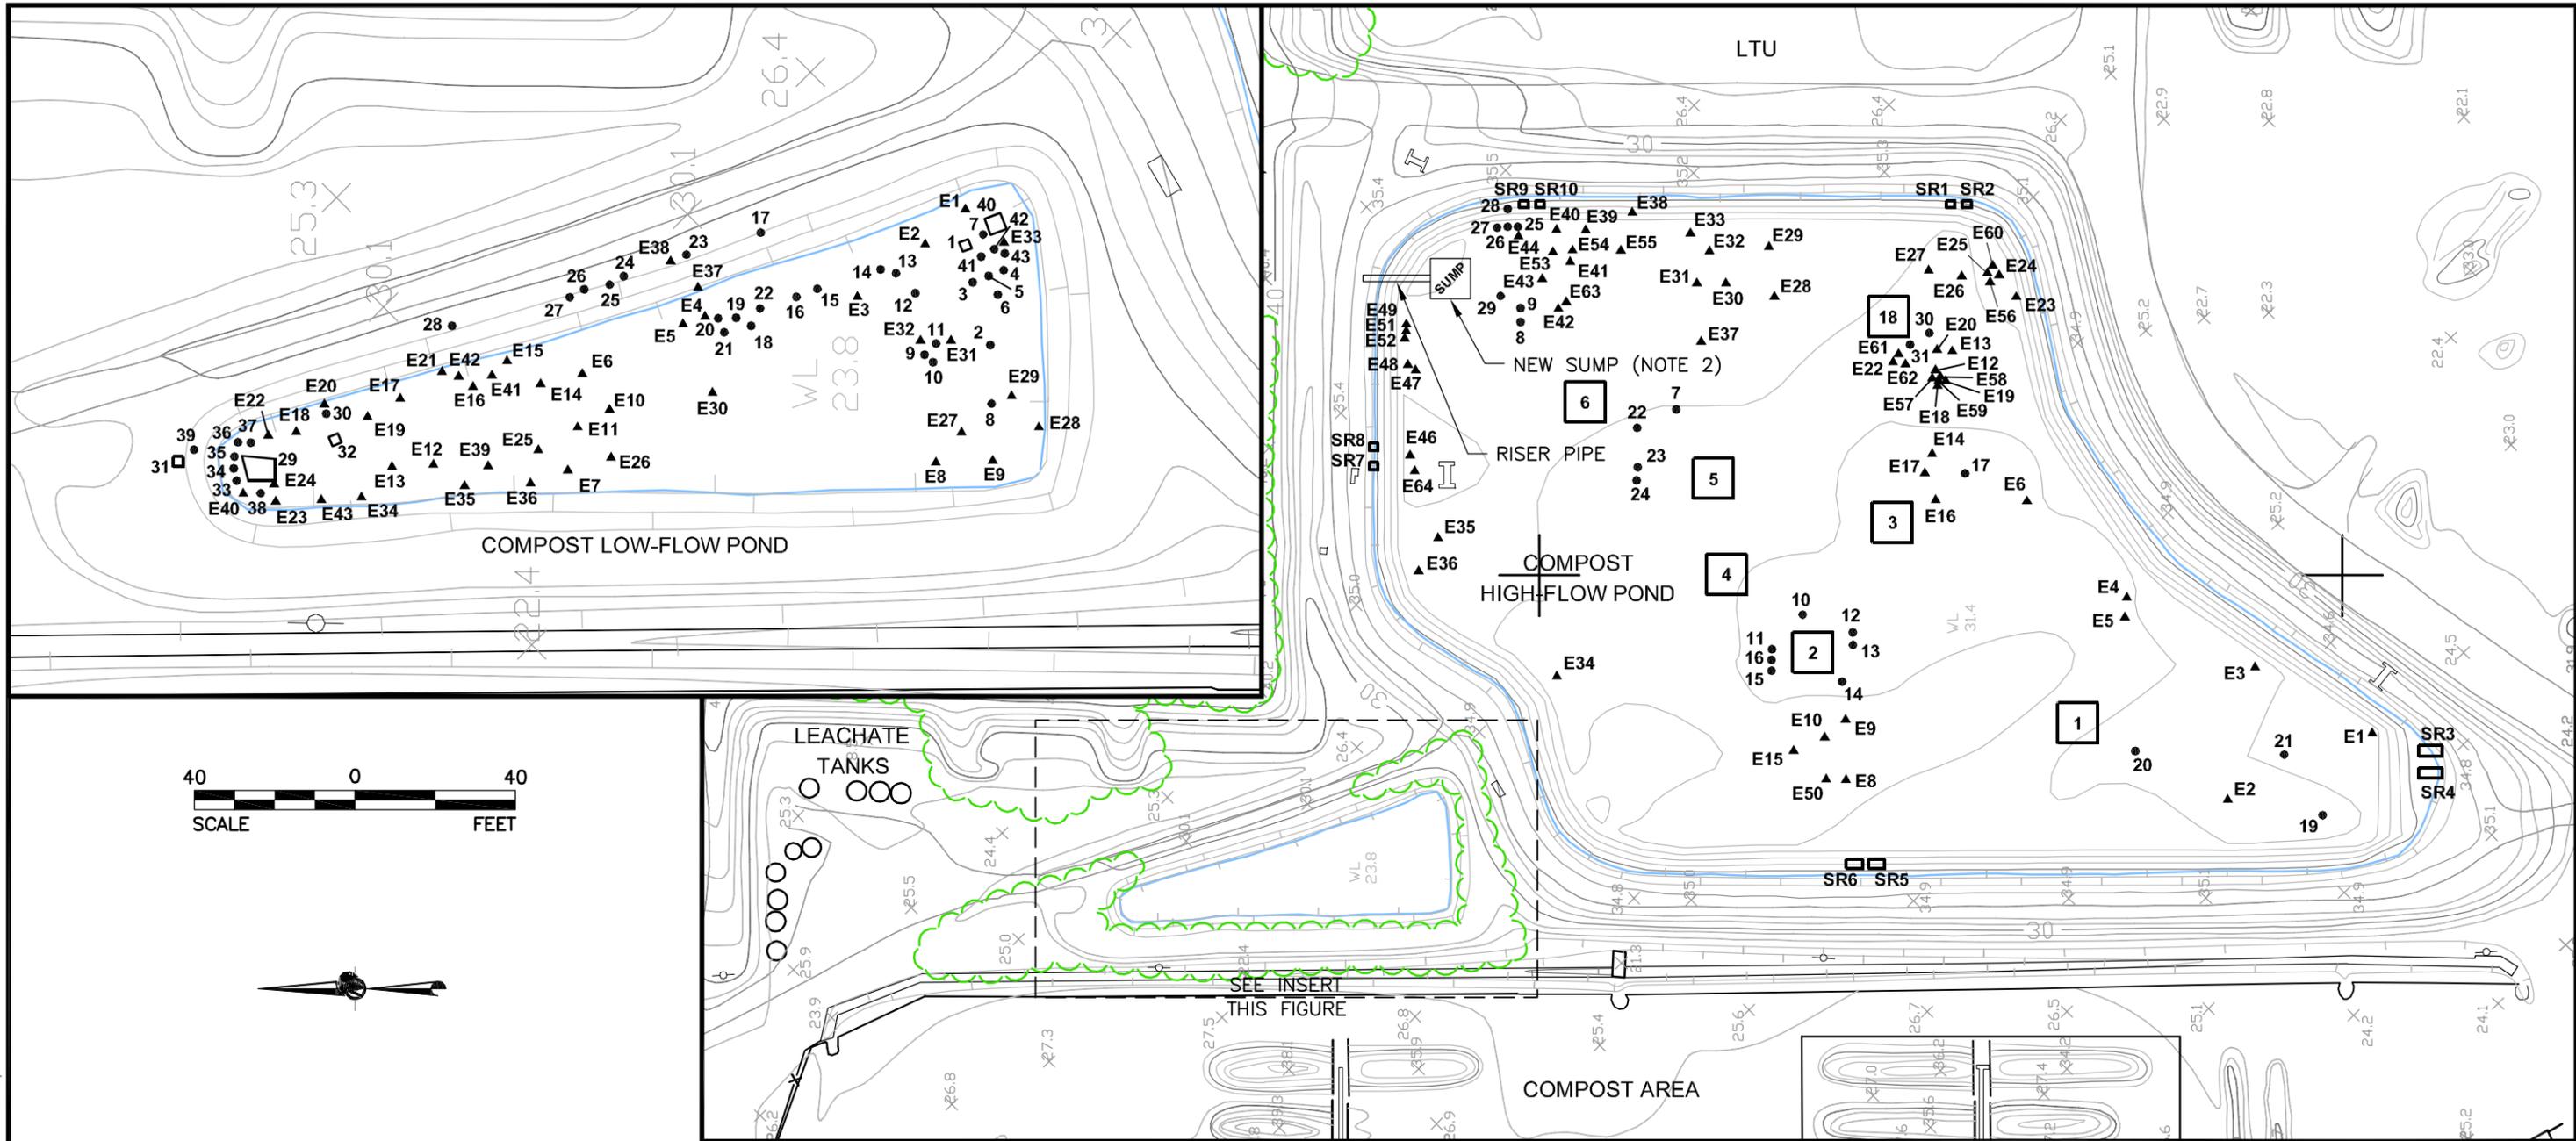
The initial geoelectric leak survey detected a large number of holes in each pond. A total of 64 holes were detected in the larger High-Flow Pond, and 43 holes were detected in the smaller Low-Flow Pond. The initial sediment removal was performed using metal shovels, which is attributed to have caused the majority of these defects and is presumably why the WDRs require a geoelectric leak survey any time that sediment is removed from the pond. During the latter portion of the repair effort, RHR staff switched to plastic snow shovels to reduce the geomembrane damage caused by the sediment removal. As indicated above, the geoelectric leak survey was repeated after all detected holes were repaired.

Geomembrane repair locations are shown in Figure 2. Photographs documenting key components and activities of the construction process were taken on a regular basis. Selected photographs are included in Attachment 1. Daily field monitoring reports were prepared throughout the construction to document the

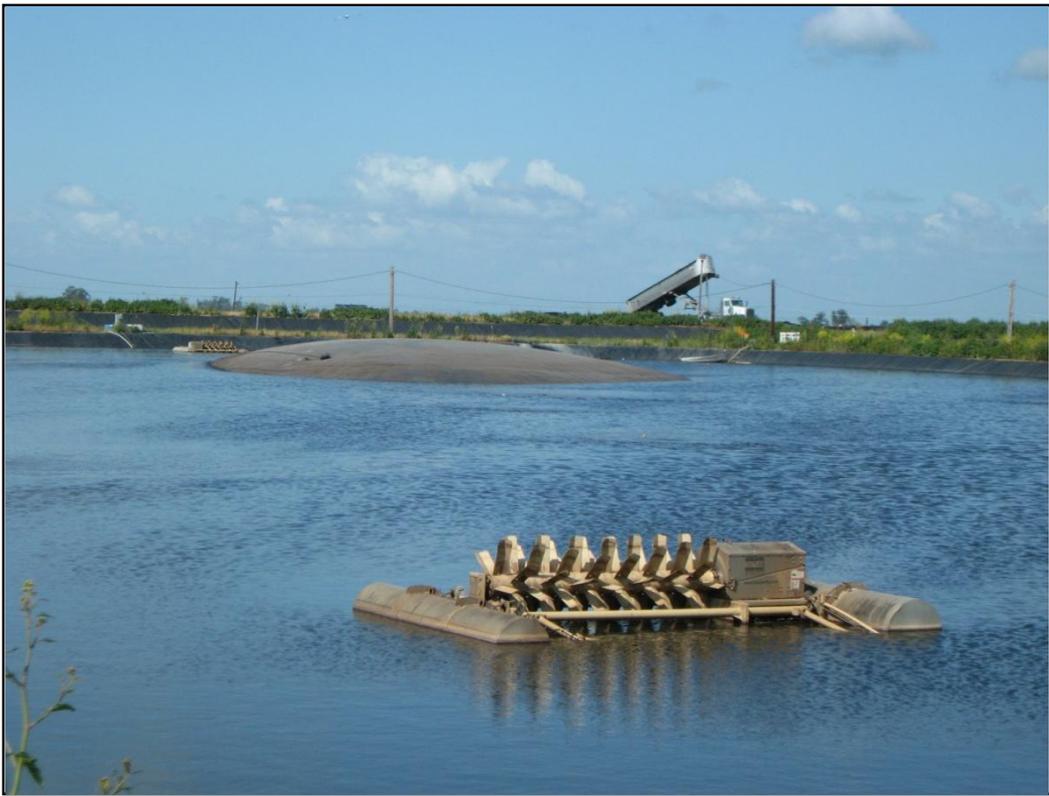
Earlier this year, RHR personnel noted that a gas bubble had formed under the base of the liner in the Compost High-Flow Pond. On April 14, 2010, Golder observed the bubble to measure approximately 200 feet in length by 100 feet in width above the water surface. At that time, Golder personnel also observed a hole below the water level which appeared to be at least one to two inches in diameter along the northeastern side-slope geomembrane liner. Additionally, during a site visit on August 12, 2010, Golder noted that the pond liner contained several holes that appeared to be associated with the anchor penetrations for the pond aerators. The boot seals were observed to be torn at locations along the

Photo 1: High-flow compost pond bubble with aerator in foreground.

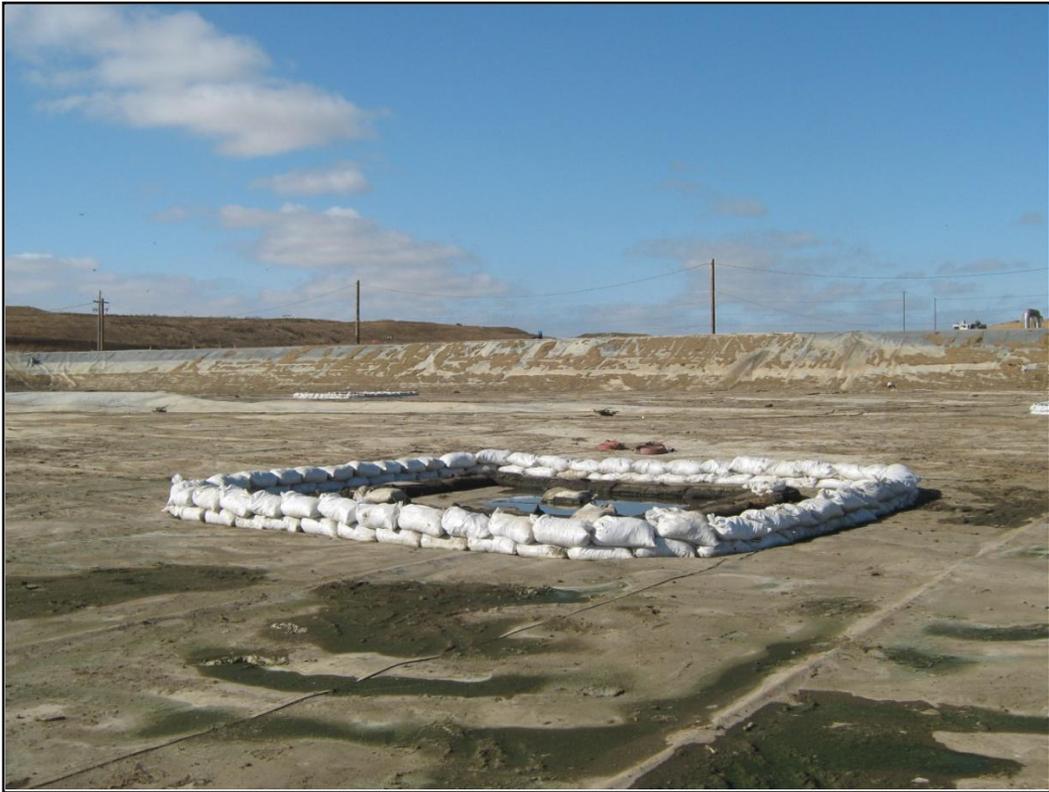
Photo 2: Subgrade sample location.

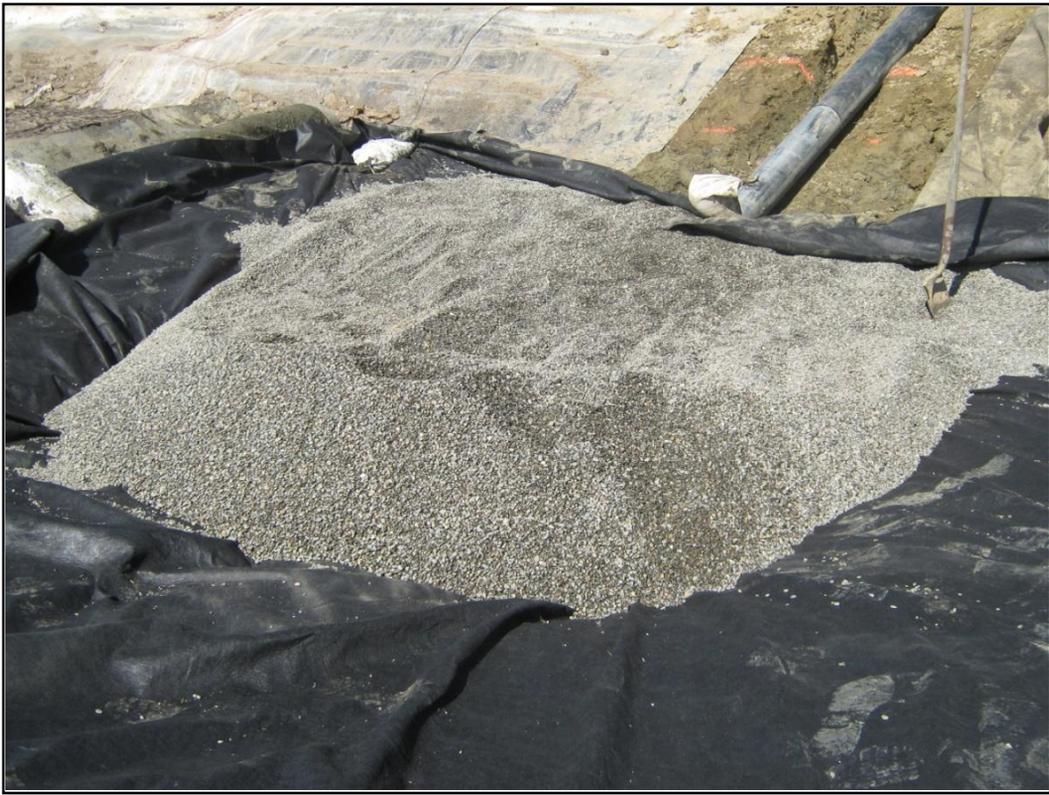
Photo 3: 25-foot by 25-foot sump installed in northeast corner.

- A sump was installed in the northeast corner of the Compost High-Flow Pond to provide a control to remove water under the liner if leakage were to re-occur.

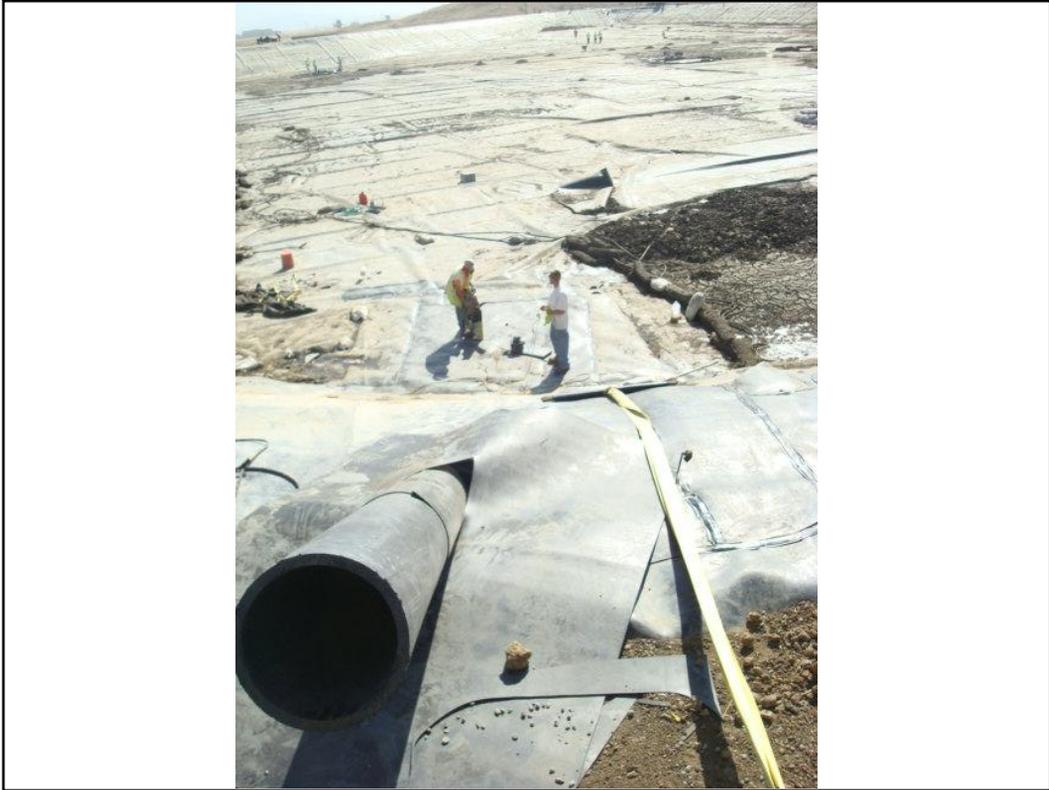
Photo 4: Sump riser pipe.

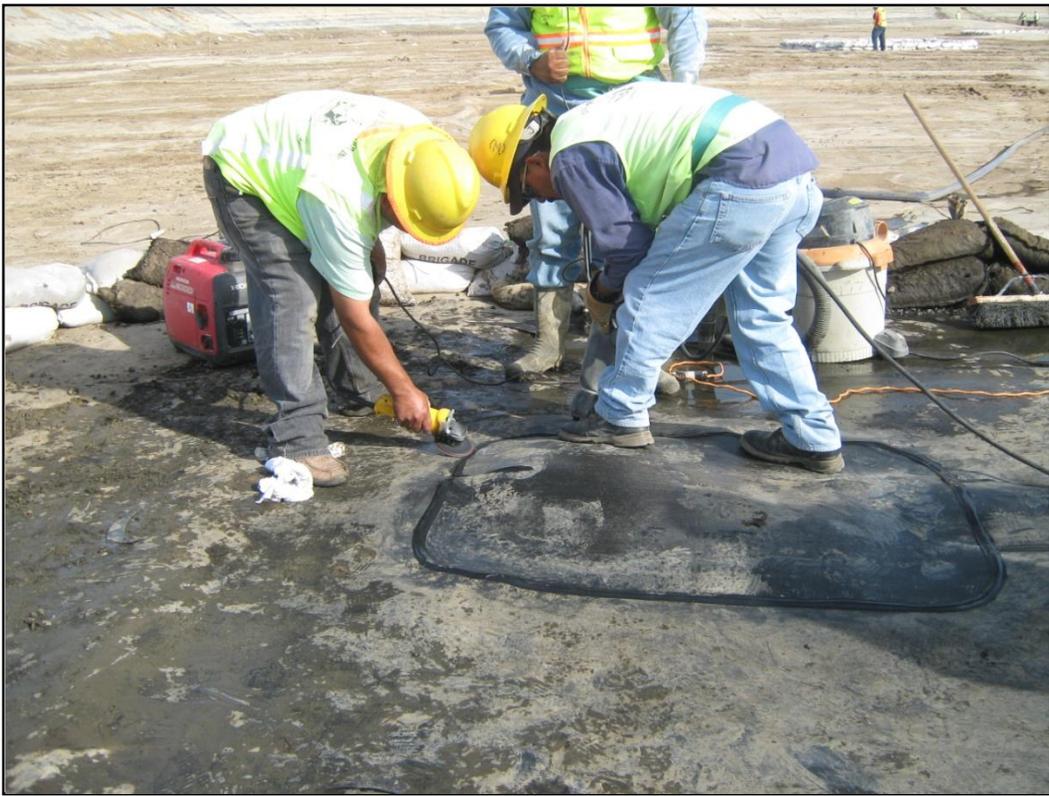
Photo 5: Extrusion welding geomembrane patch.

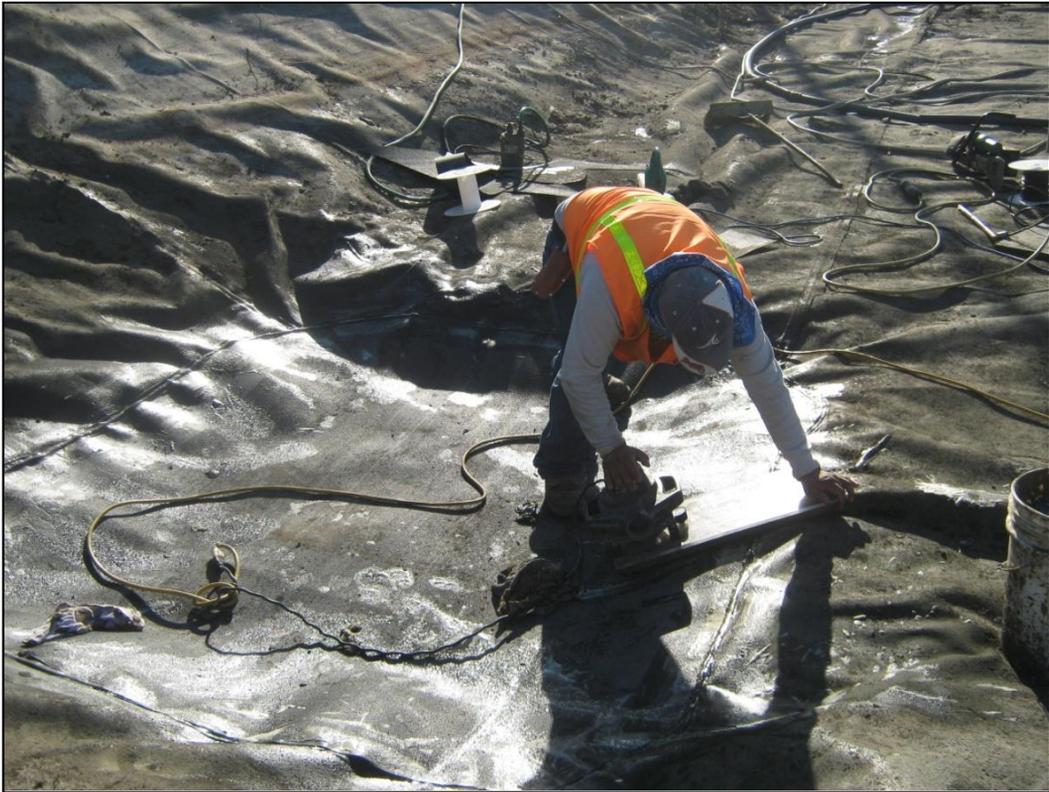
Photo 6: Vacuum testing geomembrane patch.

- All seams/patches were non-destructively tested. Extrusion welds conducted on the geomembrane were tested using the vacuum test method.
- Following completion of the repairs, a geoelectric leak survey was completed to verify all liner holes were repaired. The geoelectric leak survey was completed in accordance with the water puddle method (ASTM D7002). All detected holes were repaired and the geoelectric leak survey was repeated to confirm that no holes remained.

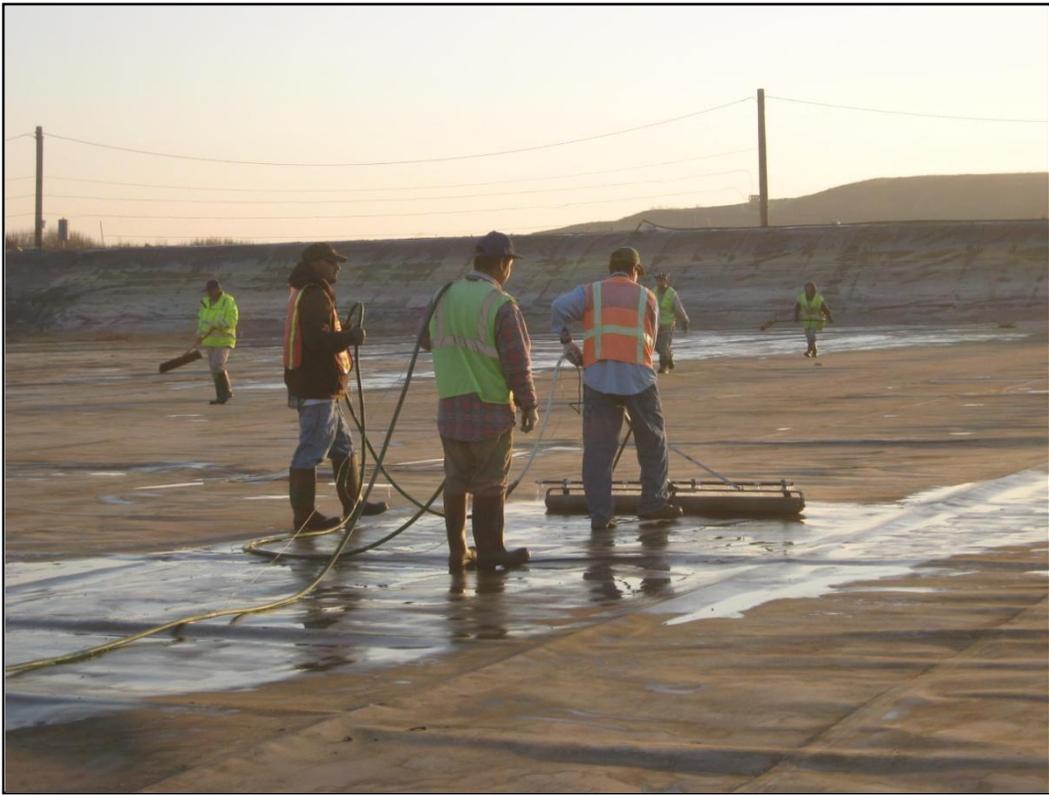
Photo 7: Geoelectric leak location survey using Water Puddle method on floor.

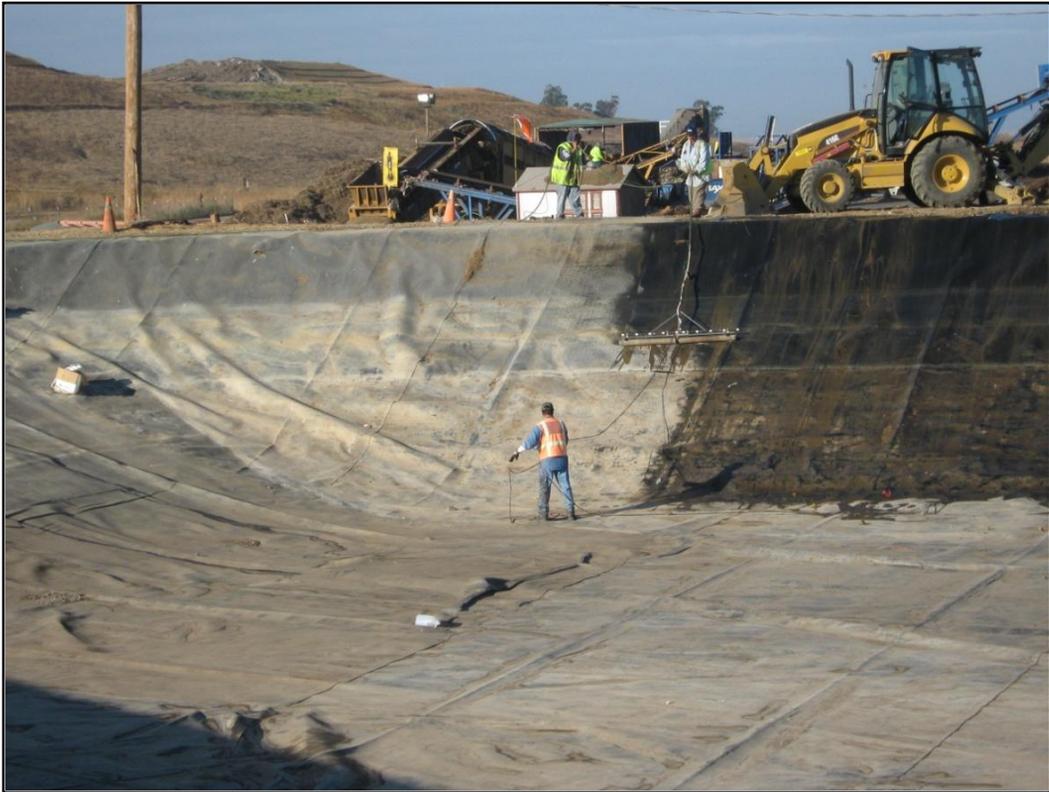
Photo 8: Geoelectric leak location survey using Water Puddle method on slopes.
