NOTICE OF VIOLATION: WET WEATHER SITE INSPECTION REPORT #2, RECOLOGY YUBA SUTTER LANDFILL, YUBA COUNTY

INSPECTION REPORT

INSPECTION DATE: 11 December 2014

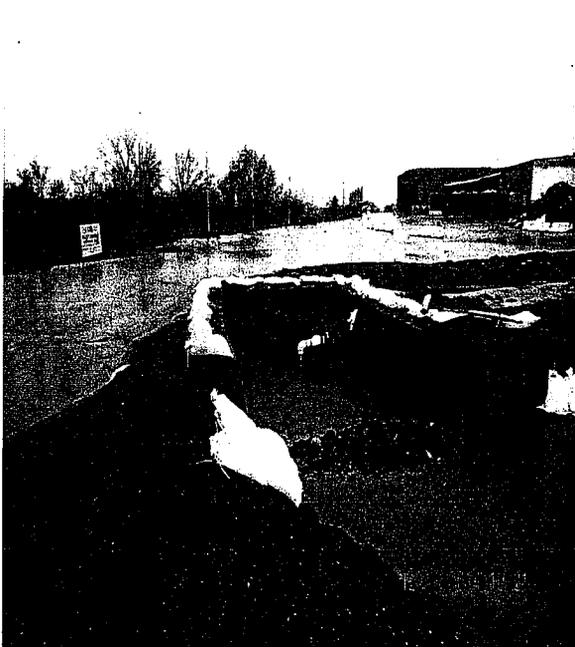
Photo 1: Southeast sump rebuilt following 3 December 2014 rain event. Note increased capacity but drainage from compost area still overwhelming pumping capability.

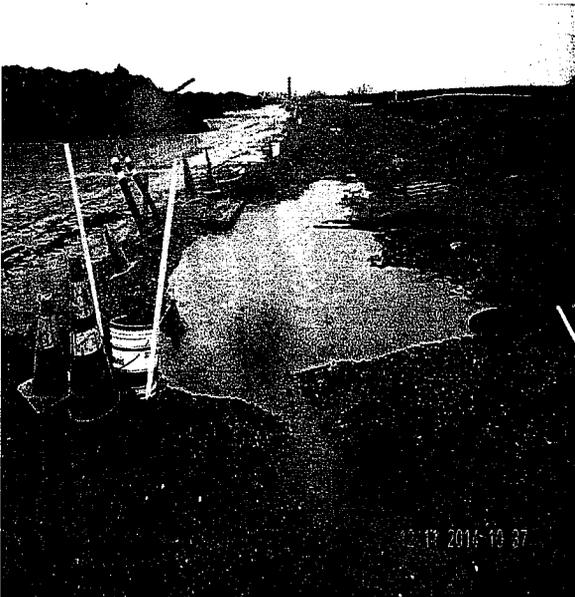
Photo 3: Southwest drain inlet for LF-2. Note turbid runoff redirected from compost area that had been bermed off. Filter of drain became clogged and overwhelmed with runoff.

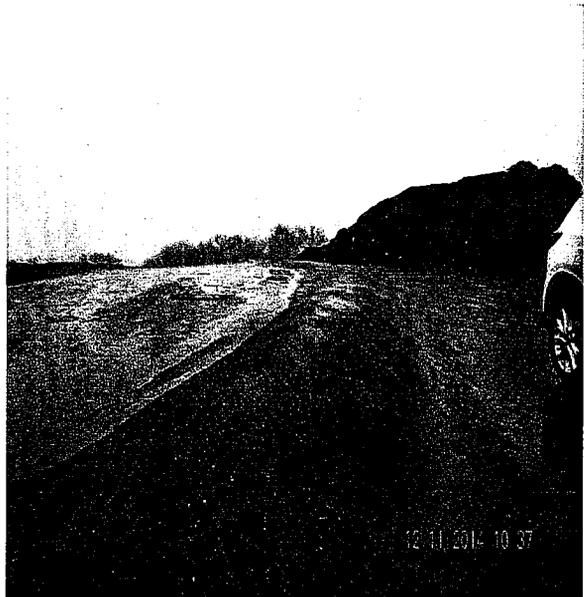
Photo 4: Looking southeast across green waste processing area with newly constructed berm to separate clean storm water from leachate generated at compost area. Clean storm water directed to drain inlet shown in Photo 3.

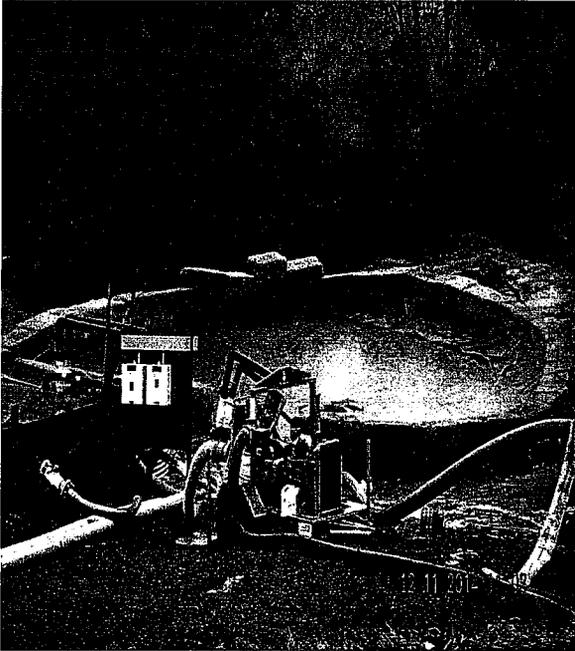
Photo 5: Visqueen pond erected by Discharger to capture leachate overflow from directly discharging to Hog Farm. This is not a permitted pond or an area allowed to accept this discharge.

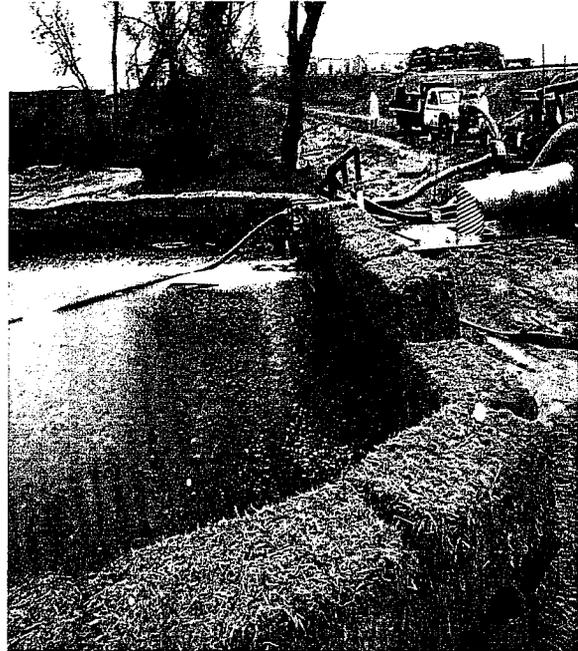
Consequently, another illegal discharge occurred. Staff observations concluded the Discharger did not have the pumping capability to move the volume of leachate generated during this storm. Excess volume of leachate could not be pumped at a high enough rate to prevent discharge to the hog farm. As shown in the Photo Log, the Discharger erected a temporary unpermitted basin to capture the leachate. In this instance, capacity in the northern sumps was the immediate compliance violation.

Photo 6: Discharge of leachate from compost area to visqueen pond. This occurred on 11 December 2014. This is second illegal discharge observed by staff.

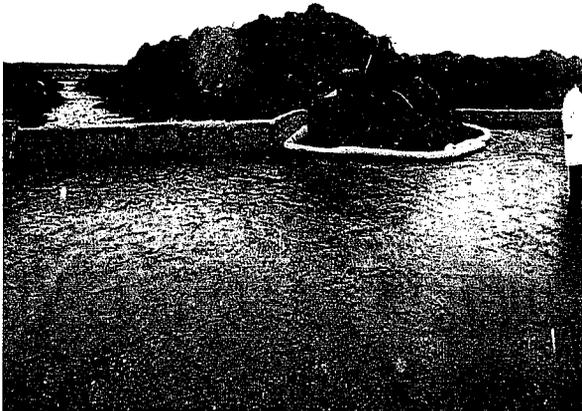
Photo 7: Compost Area upgrades include using straw waddles and hay bales to reduce velocity of precipitation and the transportation of fine sediment that could clog the drain system.
