CALIFORNIA REGIONAL WATER QUALITY CONTROL BOARD
CENTRAL VALLEY REGION

ADMINISTRATIVE CIVIL LIABILITY COMPLAINT R5-2015-0520
IN THE MATTER OF

CHRISTOPHER CORDES, EDDIE AXNER CONSTRUCTION, INC., AND EDDIE AXNER

ASSESSOR PARCEL 041-300-035-000
SHASTA COUNTY

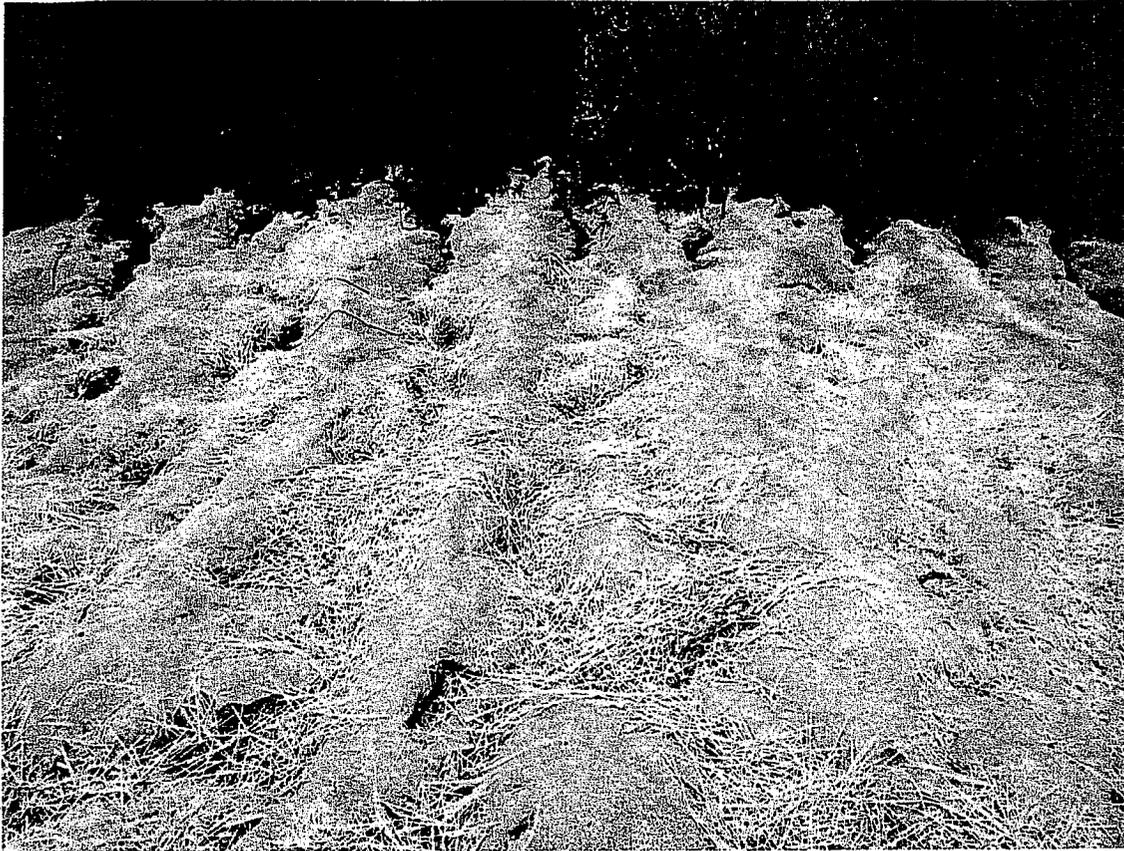
Photograph #1. West fill/side slope of lower terrace with straw mulch ineffectively protecting fill material from erosion.

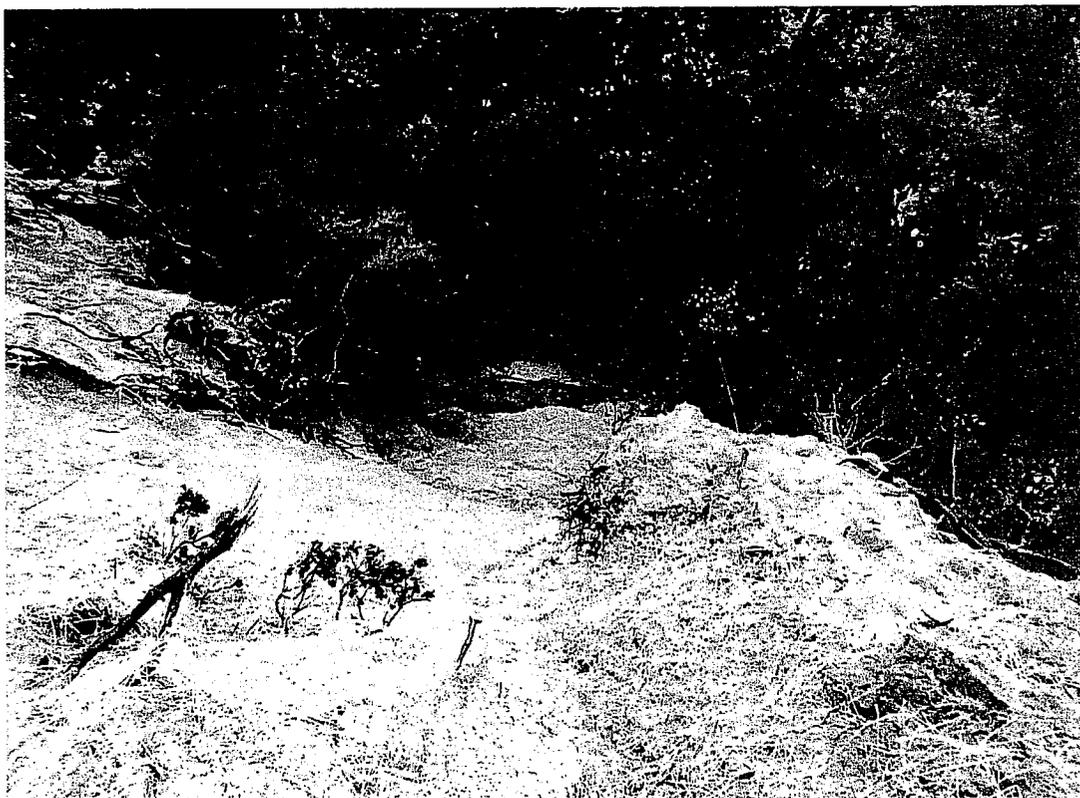
Photograph #2. Area where road and fill material from the New Road has discharged to an un-named tributary of North Fork Cottonwood Creek.

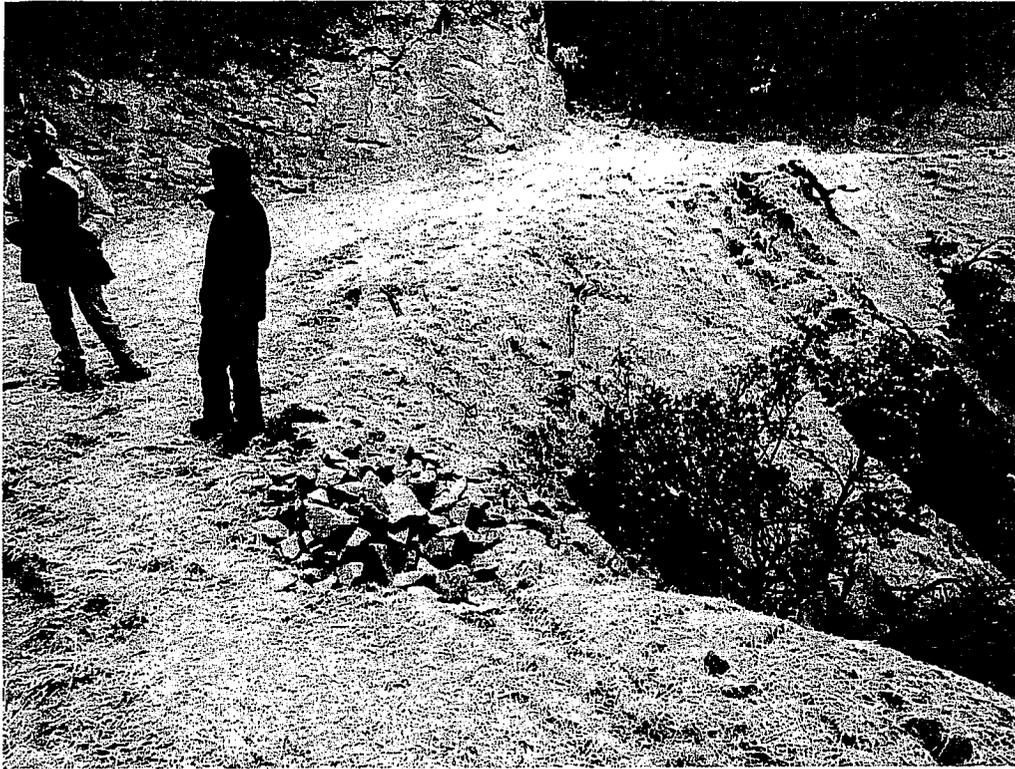
Photograph #3. Way Point 1 - Riprap in deep erosional scar on downstream side of watercourse crossing.

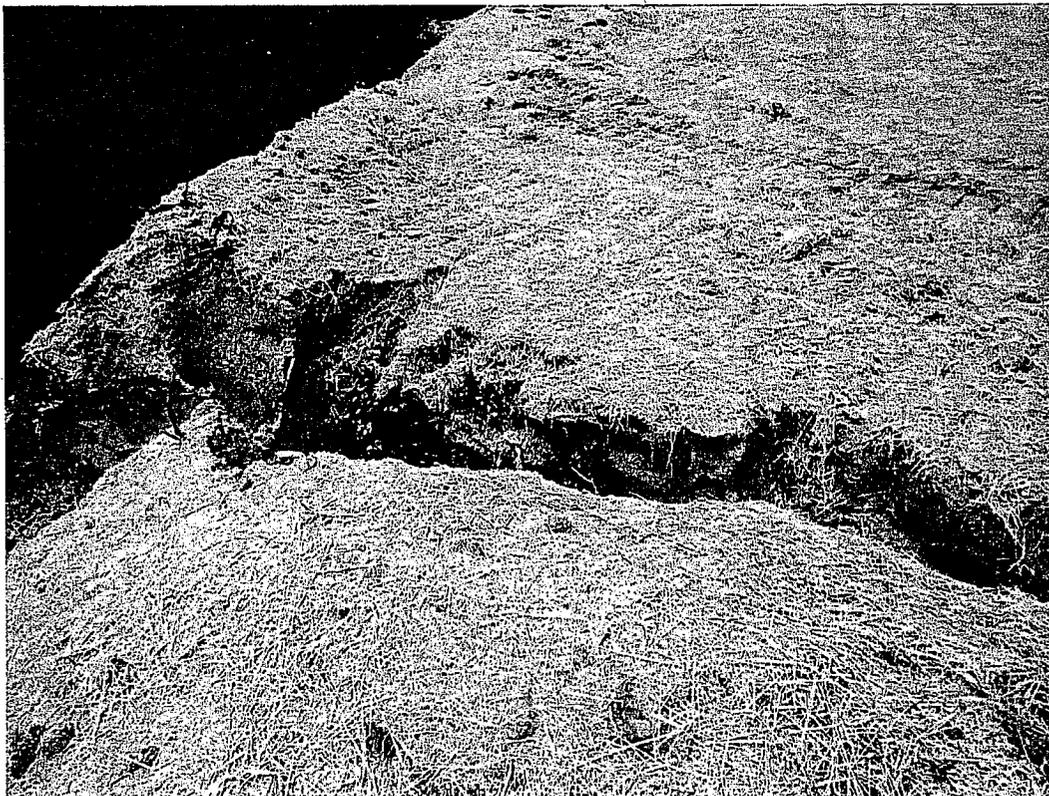
Photograph #4. Stormwater discharge location on New Road approximately 100 yards south of Way Point 2.

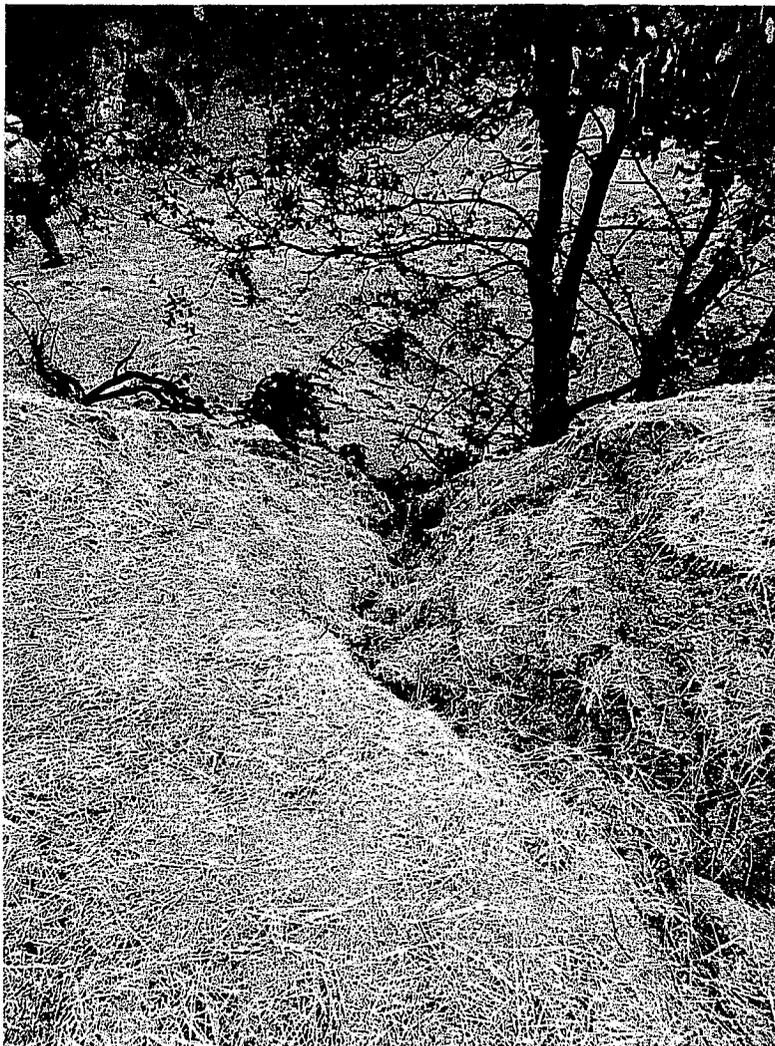
During the 19 November 2014 inspection, Staff found a second un-culverted, non-armored watercourse crossing on the newly constructed section of road. This crossing was constructed by placing more than 4,680 cubic feet of native rock and soil into a streambed and banks of an unnamed tributary of North Fork Cottonwood Creek (Attachment B - 19 November 2014 Baker Ridge Inspection Report, Appendix A, Way Point 2). Staff found and documented evidence that fill material from this watercourse crossing had discharged to the unnamed tributary of North Fork Cottonwood Creek below the crossing (Attachment B - 19 November 2014 Baker Ridge Inspection Report, Appendix B, Photograph #5).

Photograph #5. Way Point 2 – Fill and road material from New Road/watercourse crossing within watercourse on downstream side of watercourse crossing.

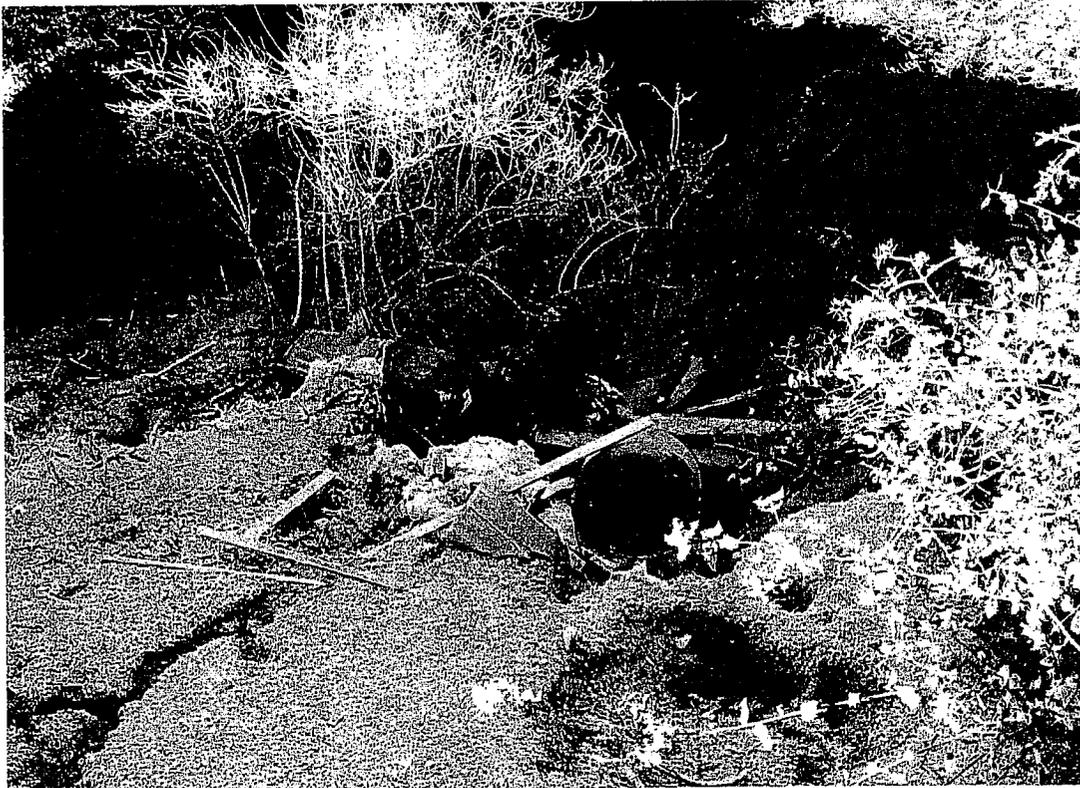
Photograph #2. Way Point 101 – Tires and metal incorporated into fill material, now exposed by erosion.

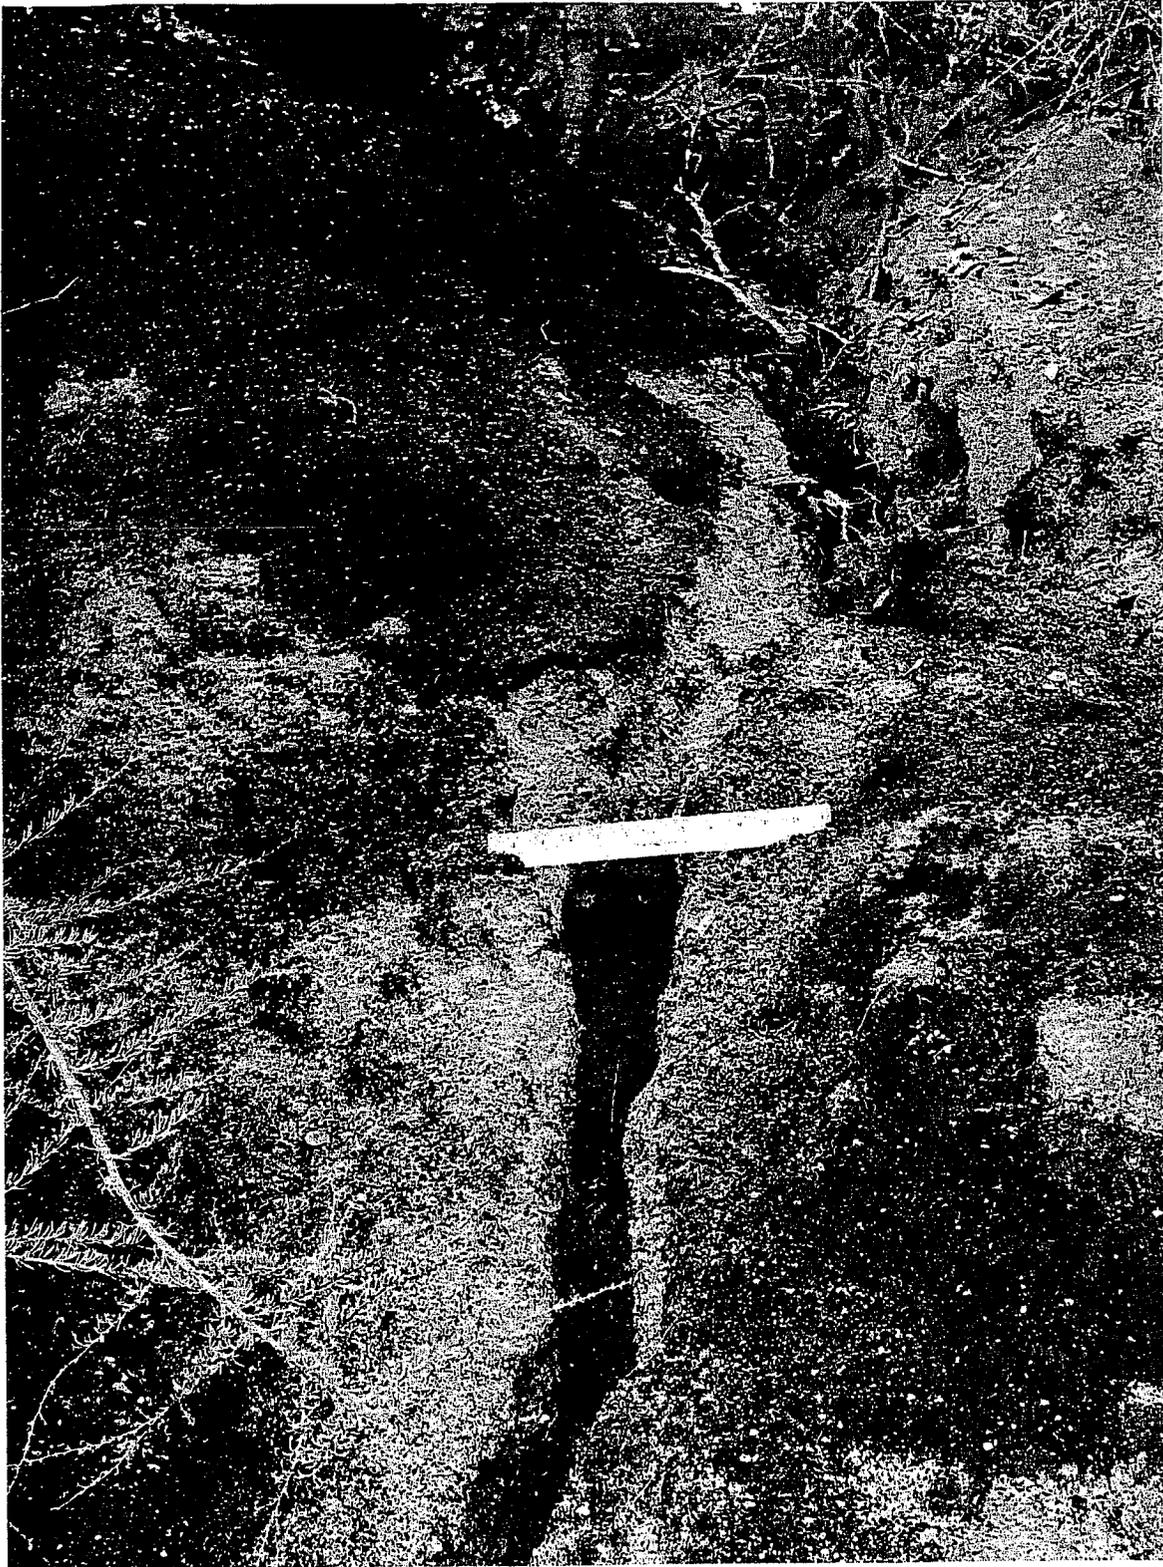
Photograph #3. Rill through dumped potting soil on fill/side slope of lower terrace leading directly to watercourse.

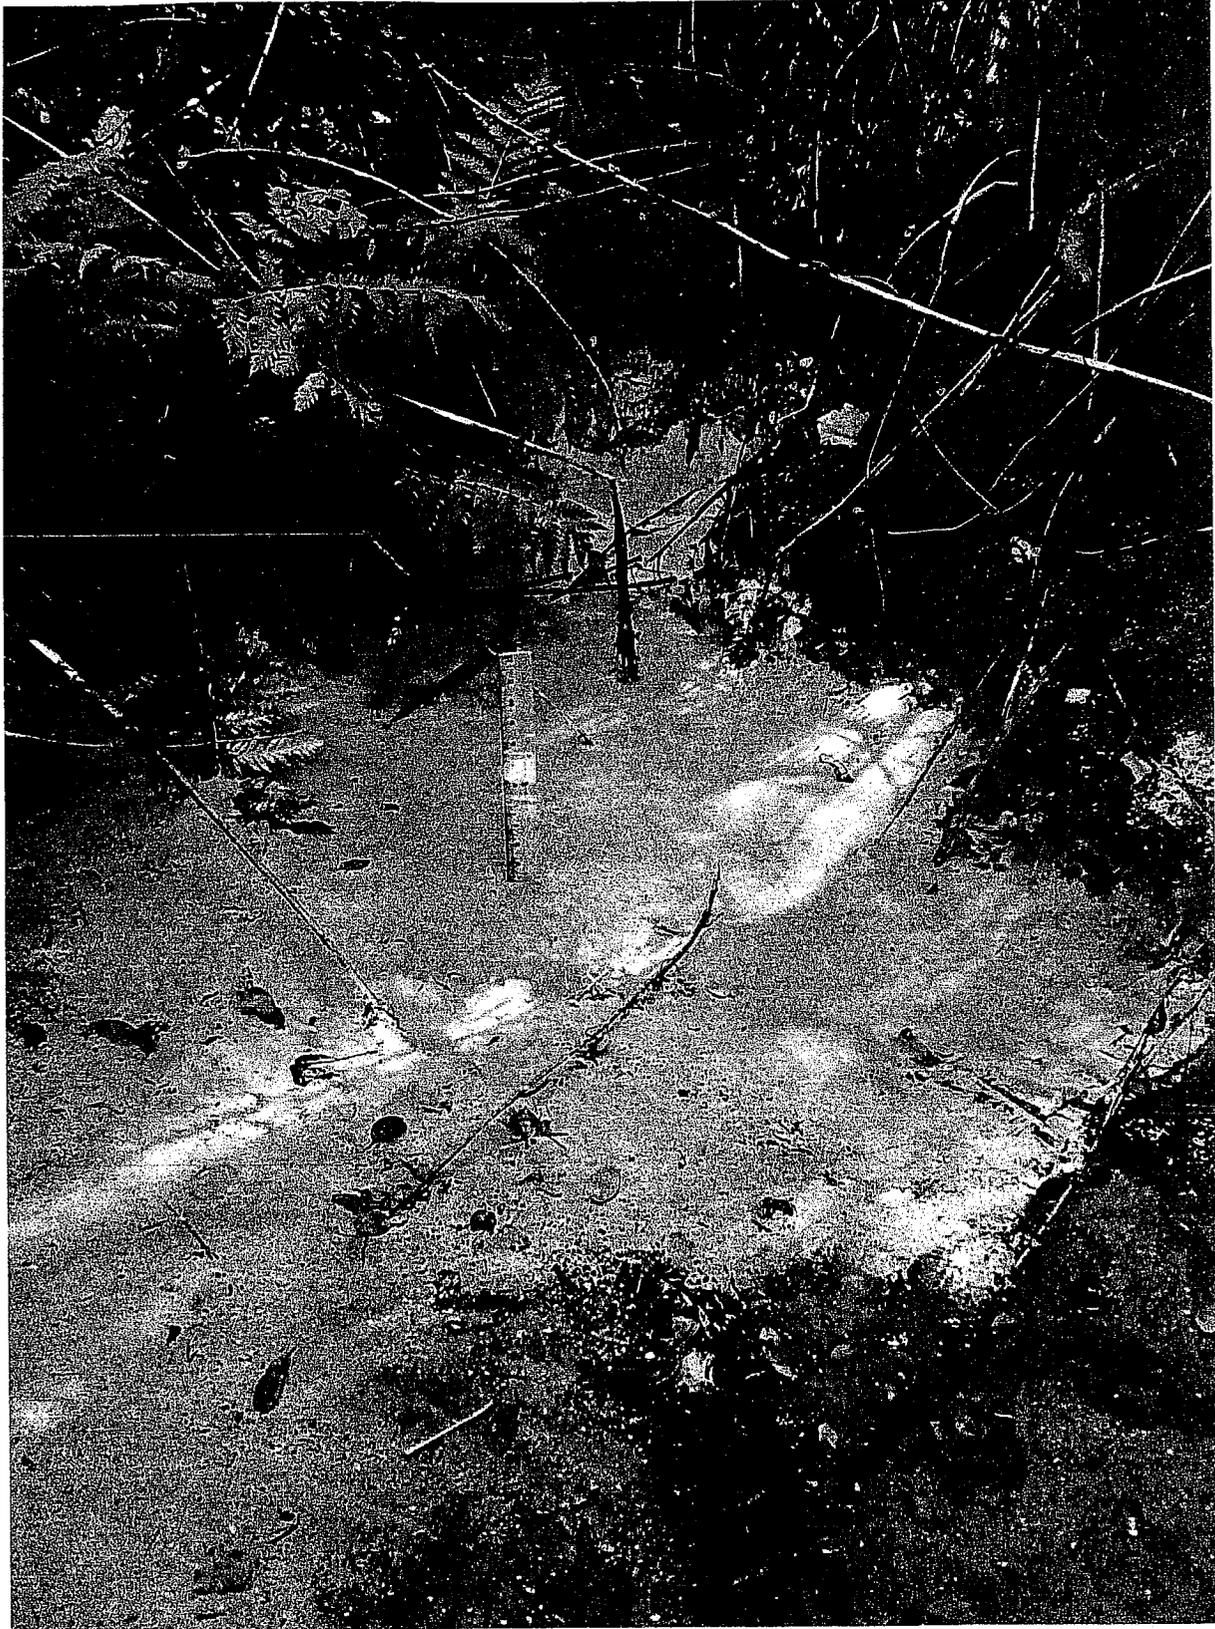
Photograph #5. Way Point 104 – Area where very fine sediments (Silts & Clays) have accumulated along one side of the watercourse.

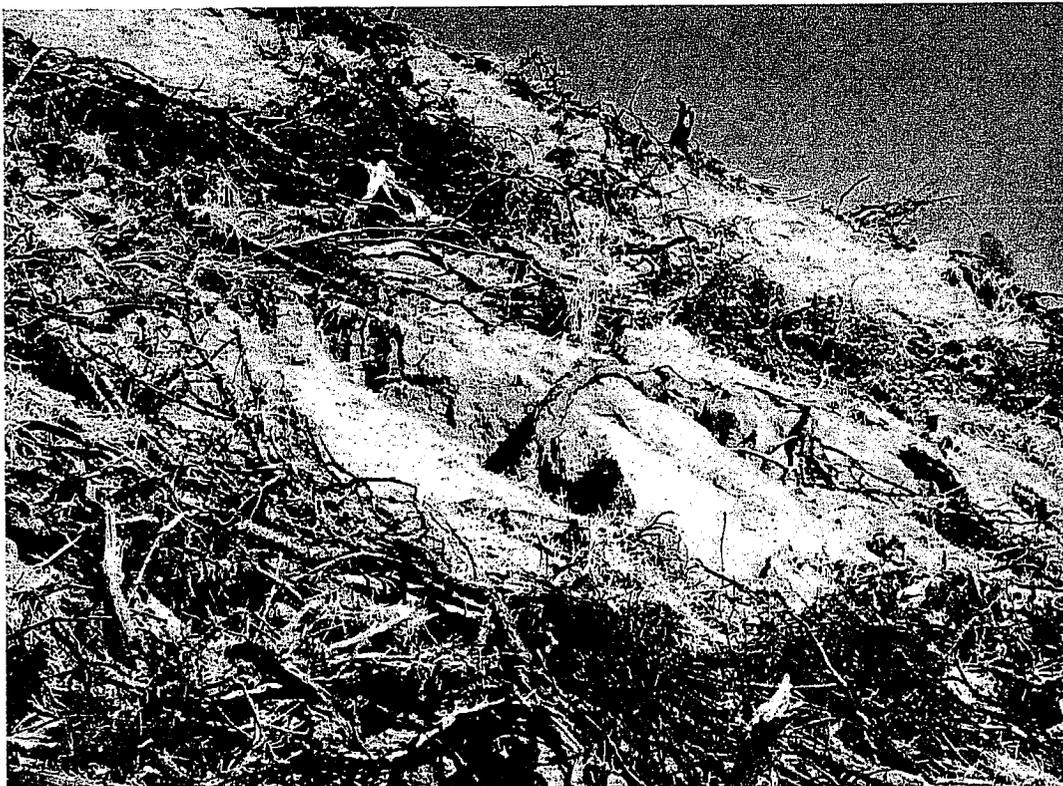
Photograph #8, Way Point 110 – Slash used in a failed attempt to protect steep (+55%) fill/side slopes from erosion.

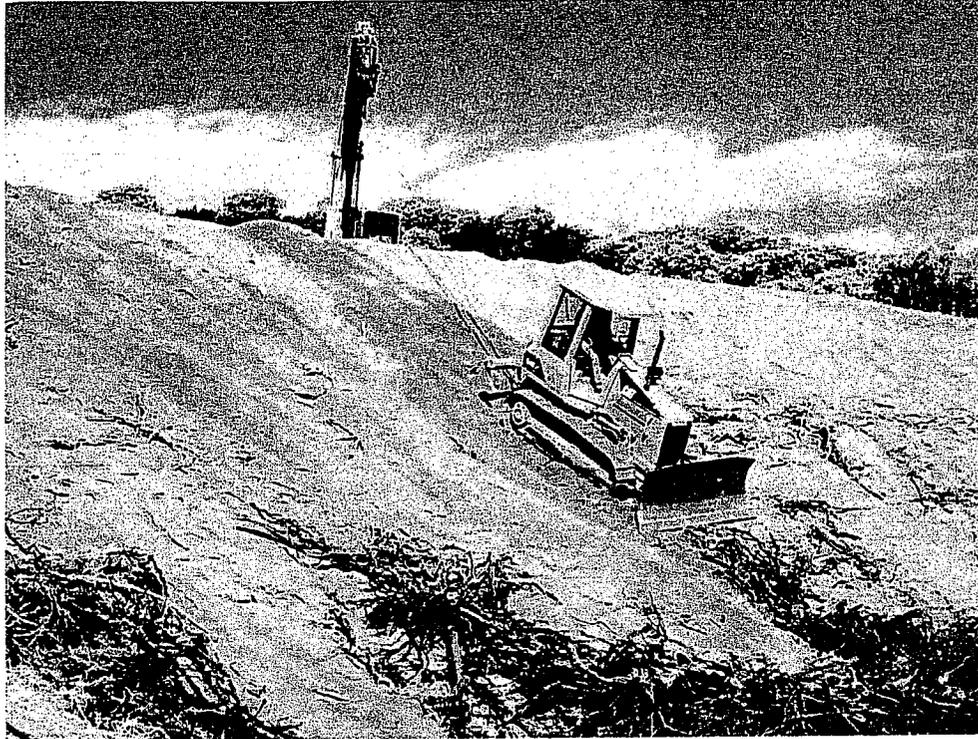
Photograph #9, Way Point 112 – Heavy equipment being operated on steep (+55%) fill/side slopes

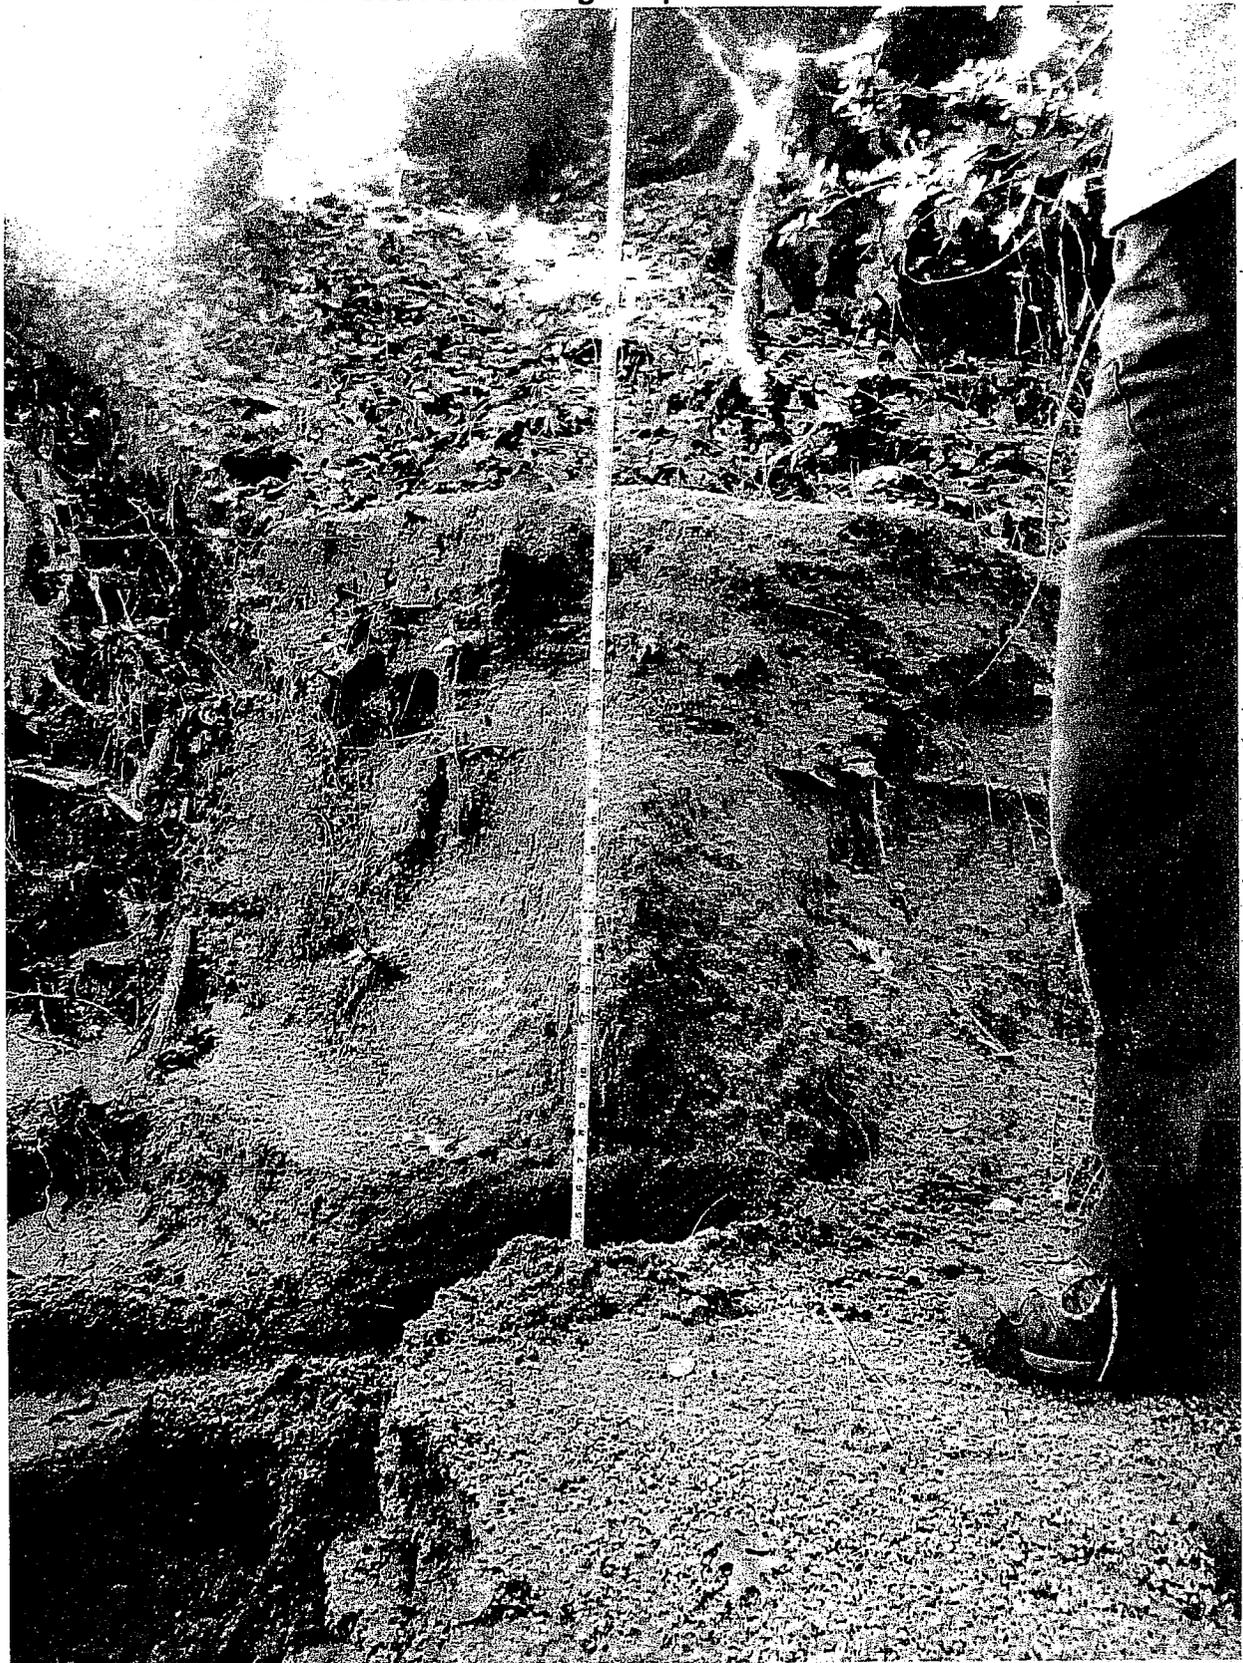
The second storm water runoff discharge location noted by Staff during the 28 October 2014 inspection was on the upstream side of the watercourse crossing located at the entrance to the Site (See Attachment C - 28 October 2014 Baker Ridge Inspection Report, Appendix A, Way Point 118). Storm water runoff from the Access Road, which is approximately 1000 feet long, 12-16 feet wide, and has a surface area of approximately 14,000 square feet, flows via an inside ditch to the before mentioned discharge location on the upstream side of the watercourse crossing, where it discharges to an unnamed tributary of North Fork Cottonwood Creek. At the time of the inspection, the crossing's 24-inch culvert was more than 50 percent plugged and staff found and documented areas along the banks of the watercourse where sediment from the road had discharged to the watercourse and a layer of sediment within the watercourse, 34 inches thick, directly below the storm water discharge point (Attachment C - 28 October 2014 Baker Ridge Inspection Report, Appendix B, Photograph #14).

Photograph #14. Way Point 118 – Sediment from road surface stacked as high as 34" along banks of watercourse.

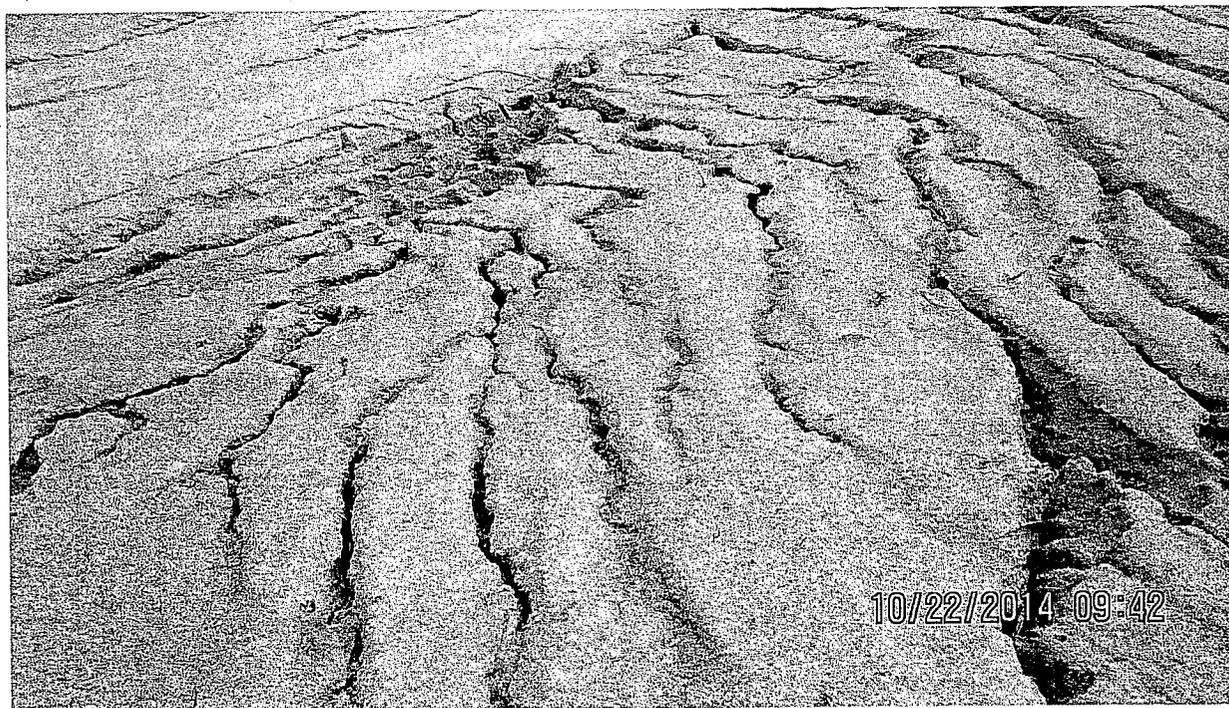
Photo 1: Photo shows deep rills developing in road material from the recent rain events showing high potential for future erosion.

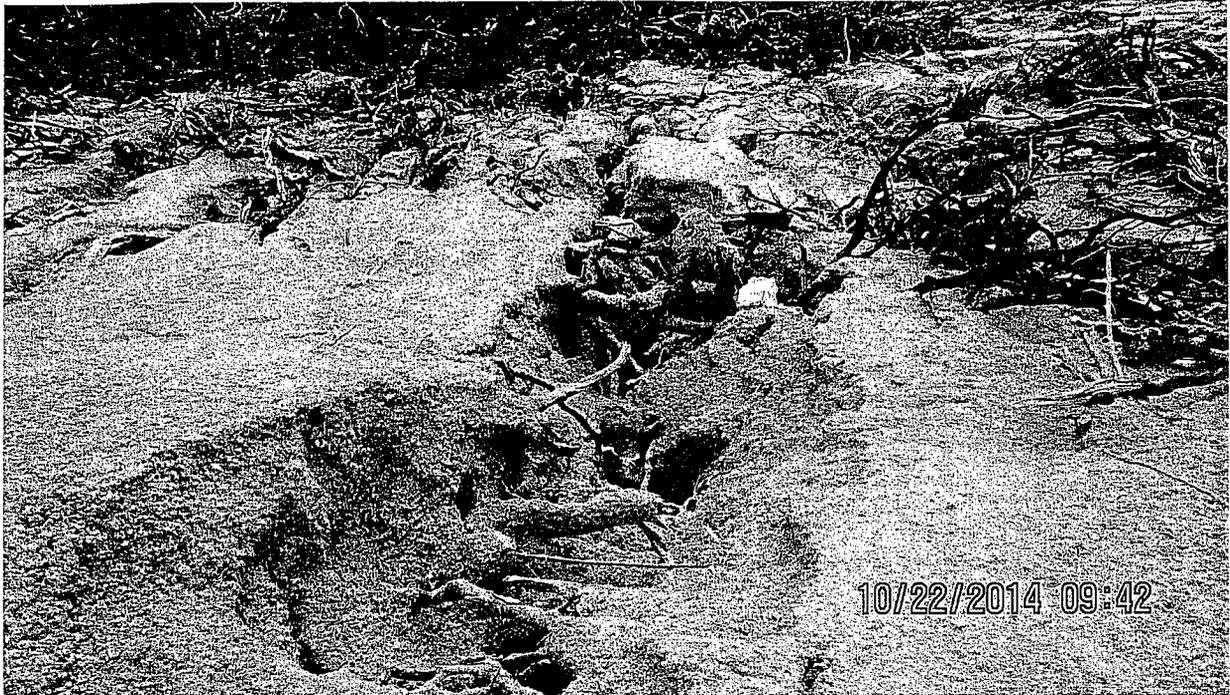
Photo 2: Photo shows erosion features running through Manzanita slash. This slash was used as an erosion control, and is not effective.

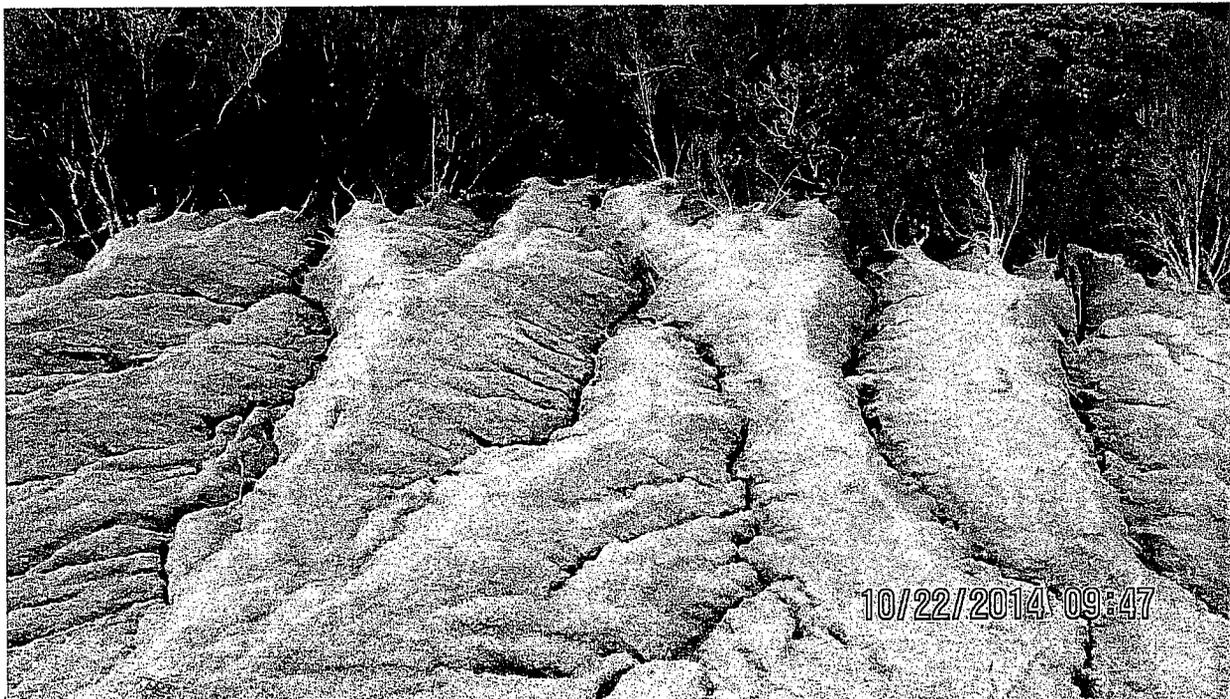
Photo 3: Photo shows erosion features from the recent rain activity on the side casting from the grading.

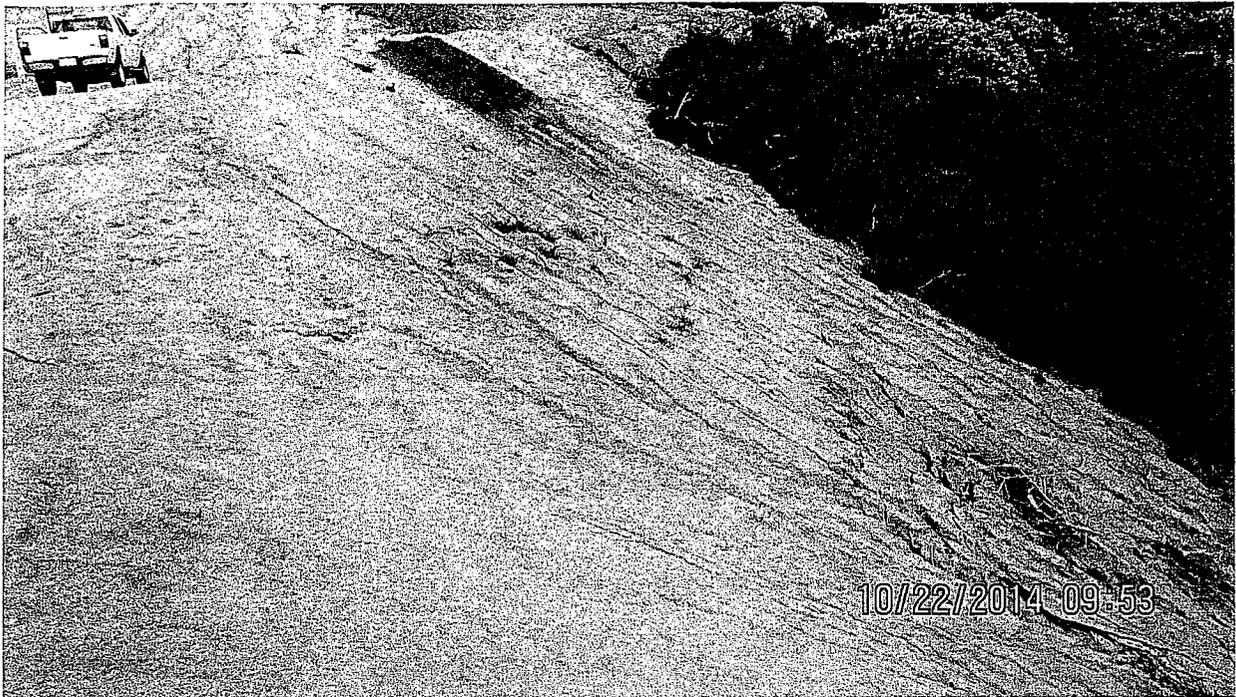
Photo 4: Photo shows the steep slopes of the side casting from grading, and erosional features from the recent rain storm.

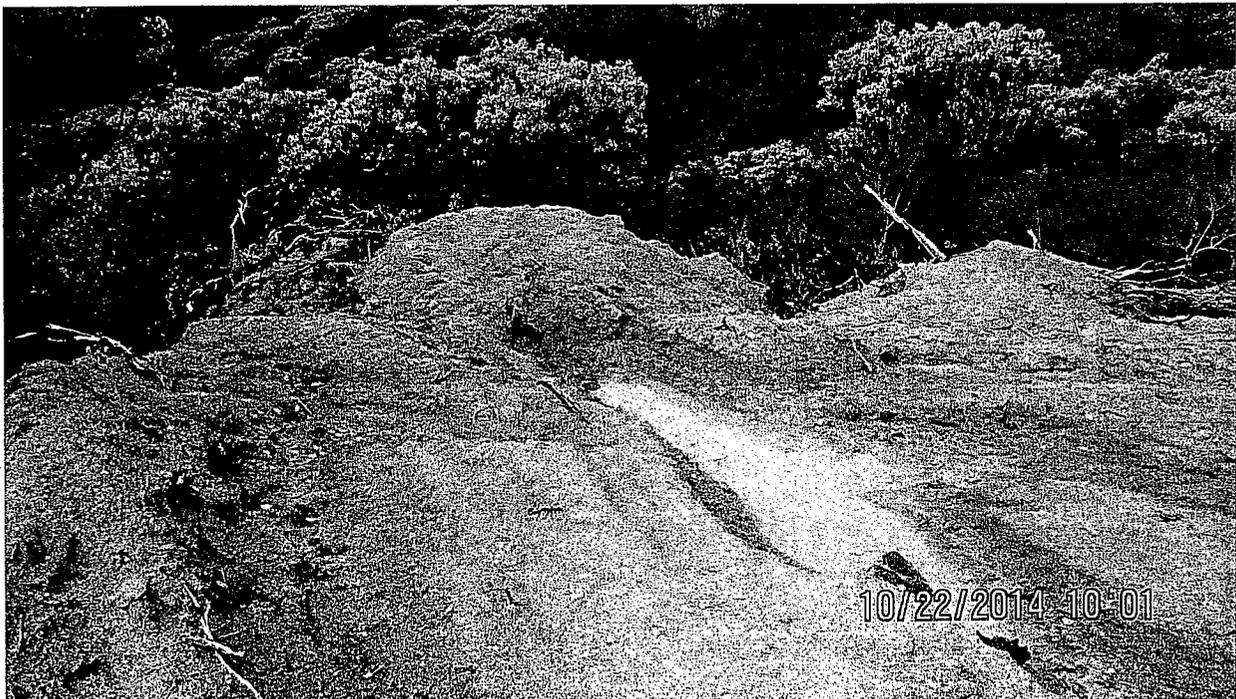
Photo 5: Photo shows ponding of water in the graded material.

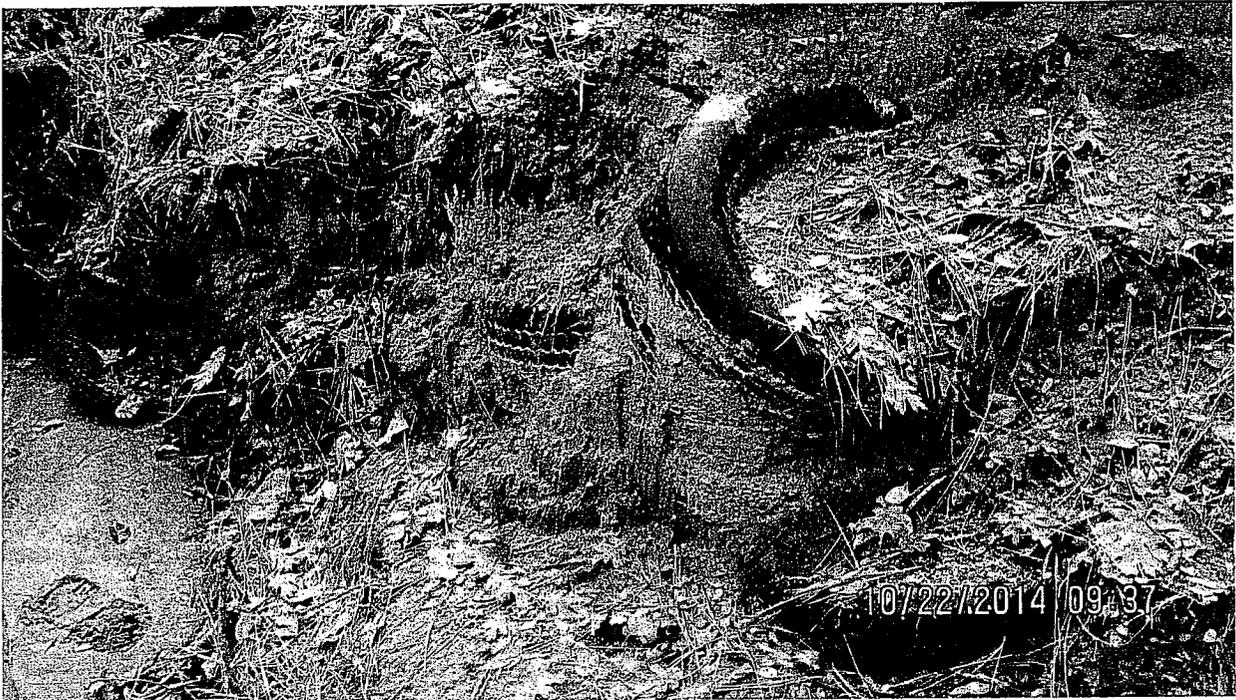
Photo 8: Photo shows the large quantity of abandoned tires embedded in poorly designed watercourse crossing structure.

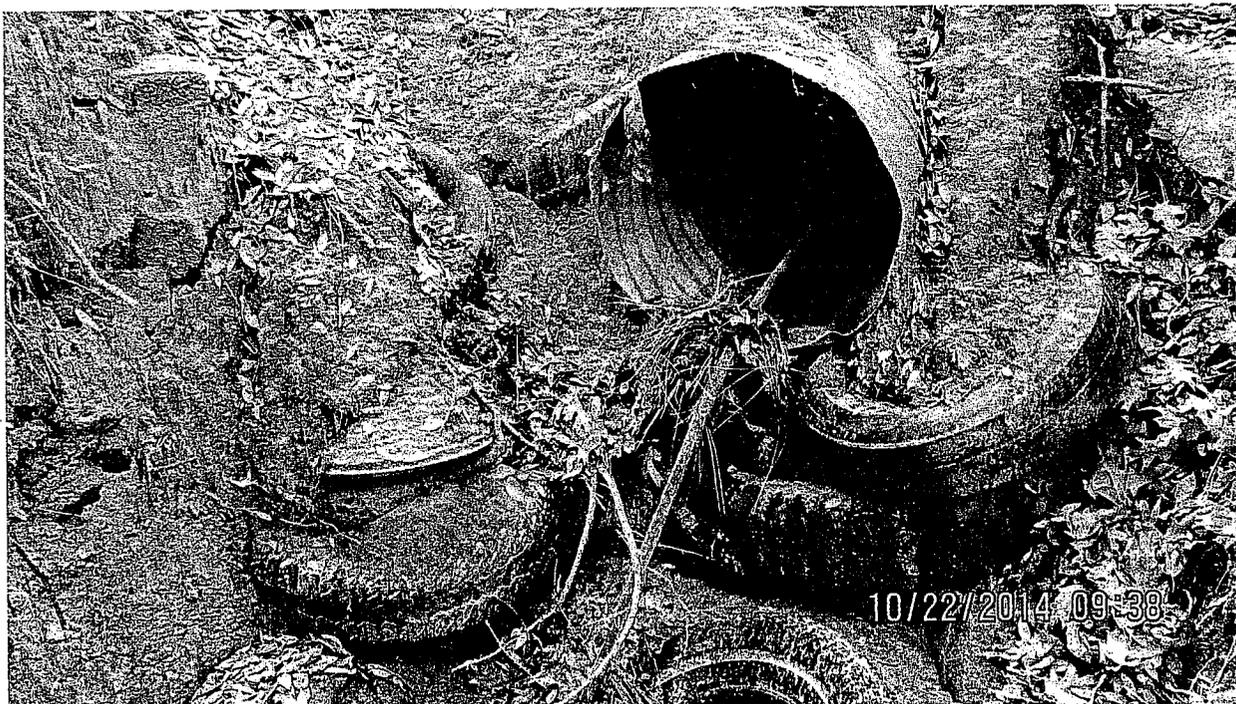
Photo 9: Photo shows abandoned tires and an improperly installed culvert. Culvert placement should be parallel to grade and terminate on a level surface without a cascading discharge.
