CENTRAL VALLEY REGIONAL WATER QUALITY CONTROL BOARD

INSPECTION REPORT

LOCATION & COUNTY: Berry Street Mall (Aka Finger's) Landfill

INSPECTION DATE: 24 October 2013

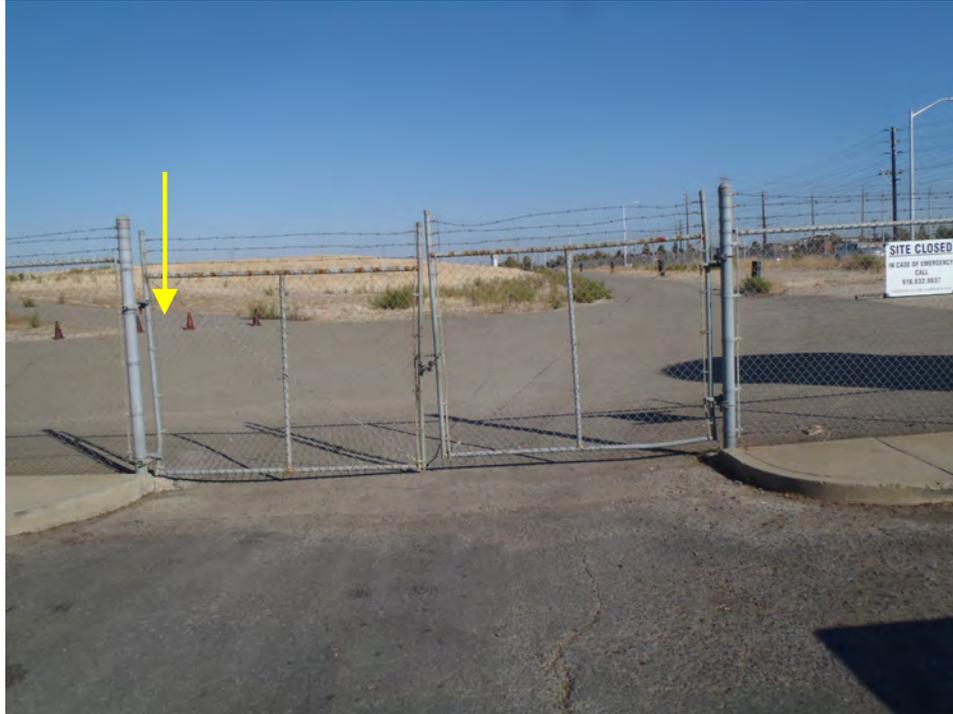
Figure 1

The purpose of this Site visit was to confirm observations made by Placer County, the Local Enforcement Agency (LEA), regarding the parking of vehicles atop the cover. While the front gate to the WMU was locked (Figure 1) during this visit, vehicle track marks and cones set in place to deter people from driving up to the crest of the WMU can be seen in Figures 2 and 3. Additionally, as seen in Figure 4, deep vehicle tracks are also visible along the southeastern perimeter of the landfill cover.

Looking north along the eastern Site boundary at the facility's front gate. The yellow arrow points to cones placed to keep cars from driving up the WMU when the gate is open. Galleria Blvd is located just to the right/east of this photograph.

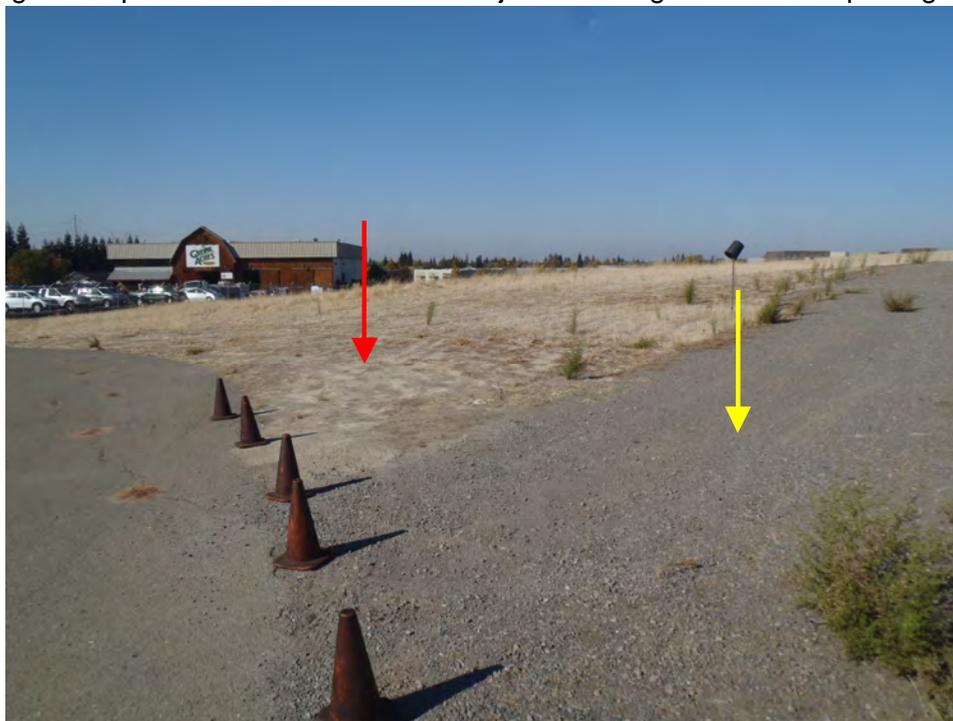
Figure 2

Looking southwest across the southeastern base of the WMU. The cones are the same as those seen in Figure 1, the yellow arrow points to the gravel road that leads to the top of the WMU, and the red arrow points to an area with obvious vehicle tracks on the WMU. The Green Acres commercial building can be seen in the background.

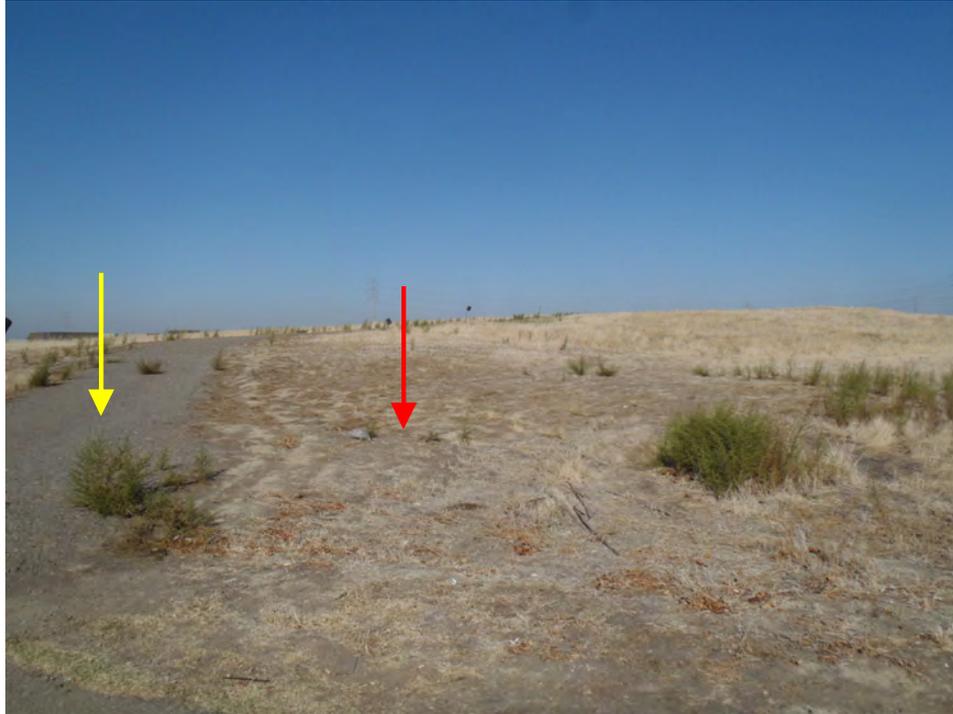
Figure 3

Standing in the same location as Figure 2, but looking northwest at the WMU. The yellow arrow points to the gravel road that leads to the top of the WMU, and the red arrow points to another area with obvious vehicle tracks atop the WMU.

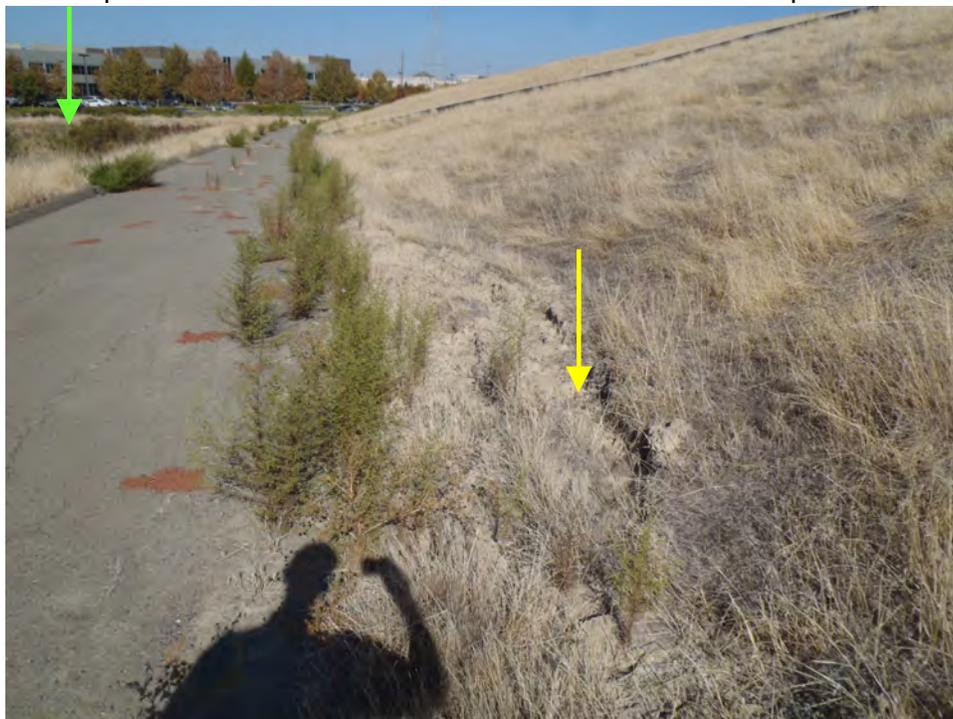
Figure 4

Looking northwest along the southwestern side of the WMU. The yellow arrow points to vehicle tracks along the toe of the WMU. The green arrow points to the Site's storm water sedimentation basin.

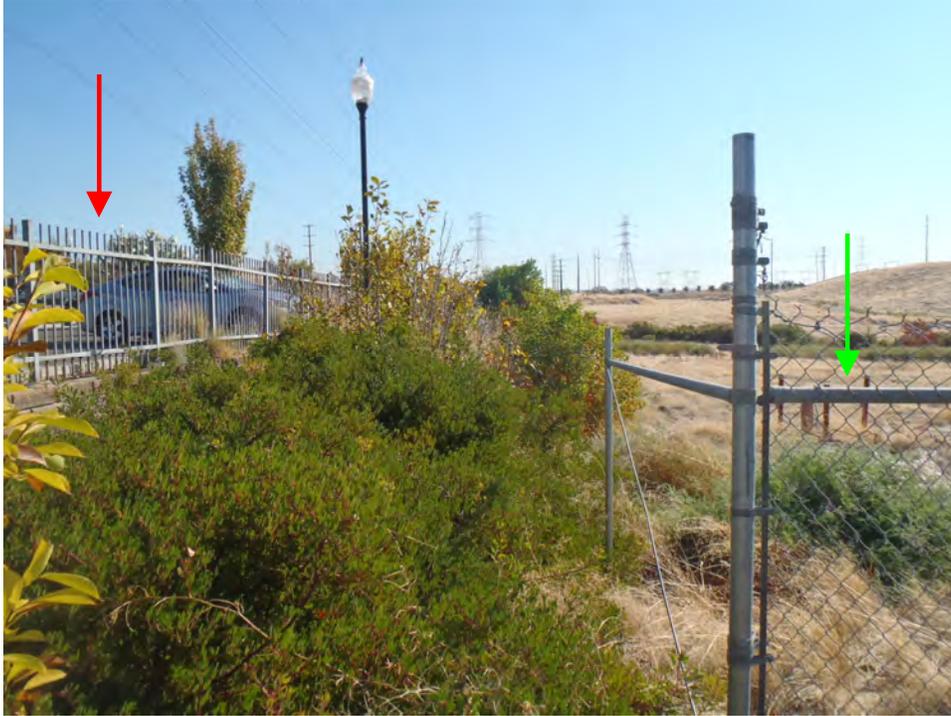
Figure 5

While fencing surrounds most of the Site, a large gap in the fenced perimeter is present at the northwestern corner of the Site, Figure 5. Additionally, as can also be seen in Figure 5, while the original fence surrounding the Site was topped with three rows of barbed wire, the rows of barbed wire have been removed from the northern and western fences.

Standing at the northwestern Site boundary looking east along the northern fence line (red arrow). An obvious gap exists between the northern fence line (red arrow), and the western fence line (green arrow).

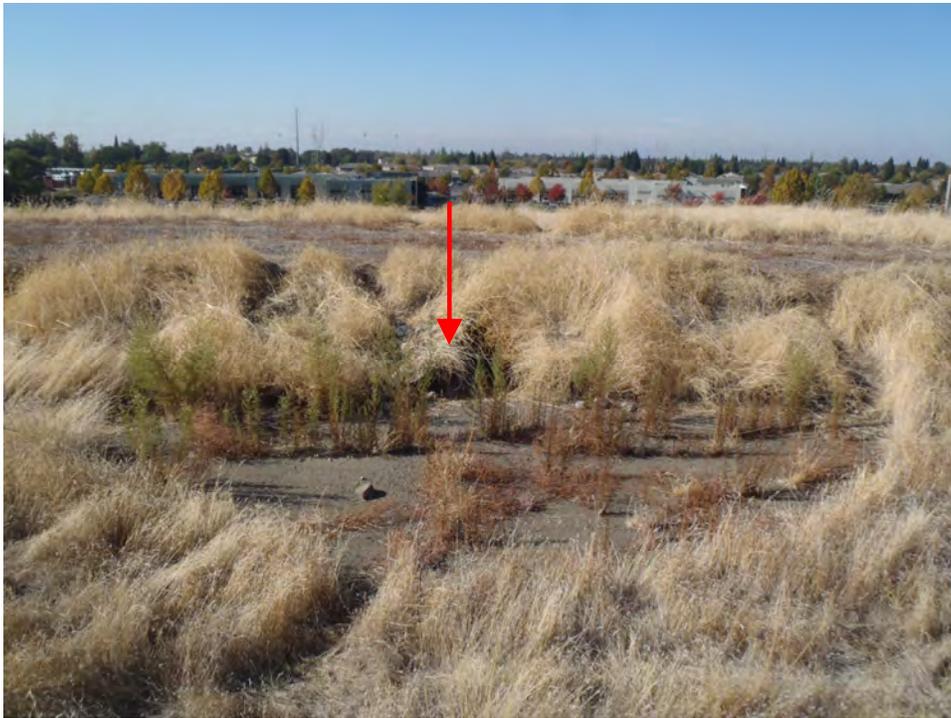
Figure 6

The Site's perimeter road, V-ditches and down drains are all in need of maintenance. Weeds surround the entry points to the two storm water down drains atop the WMU (Figures 6 and 7), weeds as high as three feet are present on the perimeter road, the V-ditches are choked with weeds, and sections of the perimeter road are crumbling (Figures 8 through 12).

Looking southwest at the entry to the southwestern storm water down drain, red arrow.

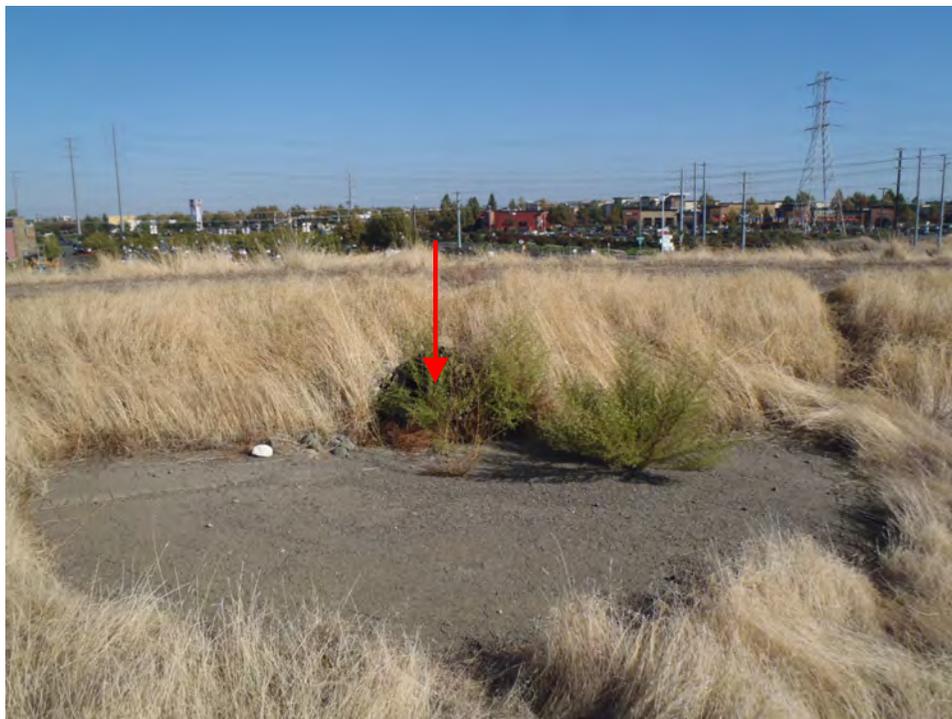
Figure 7

Looking northeast at the entry to the northern storm water down drain, red arrow.

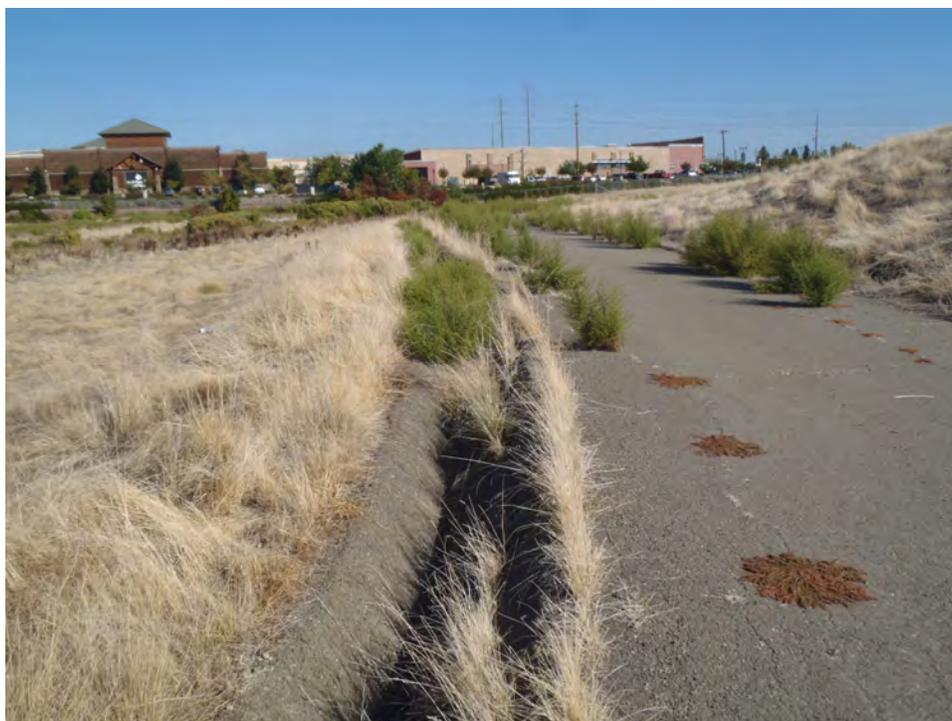
Figure 8

Looking northeast along the northwestern perimeter of the WMU.

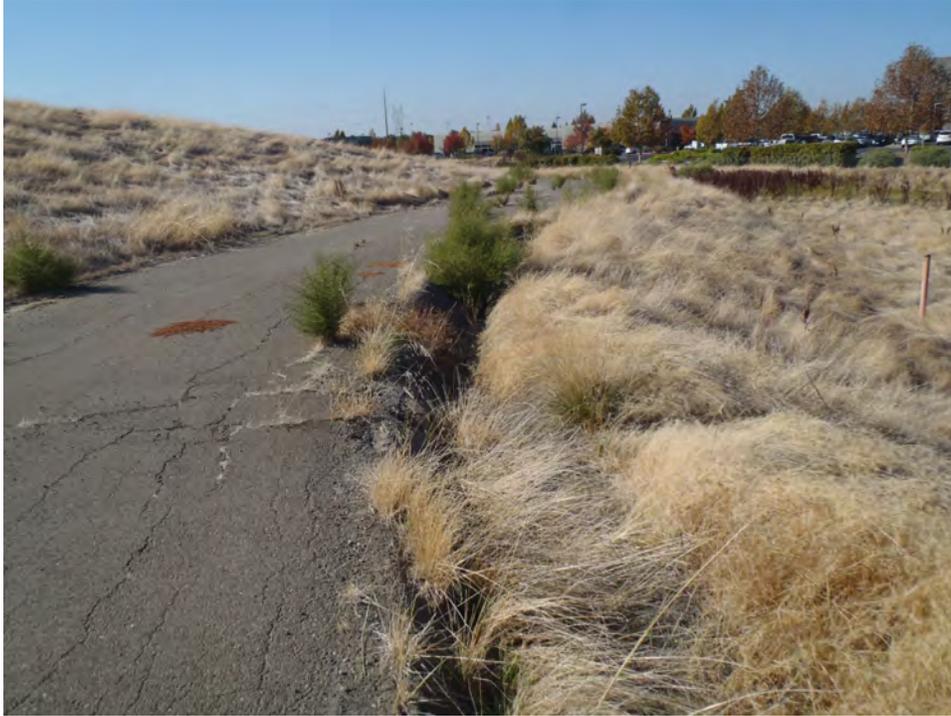
Figure 9

Looking southwest along the northwestern perimeter of the WMU. Well GW-2 is located just to the right/west of this photo.

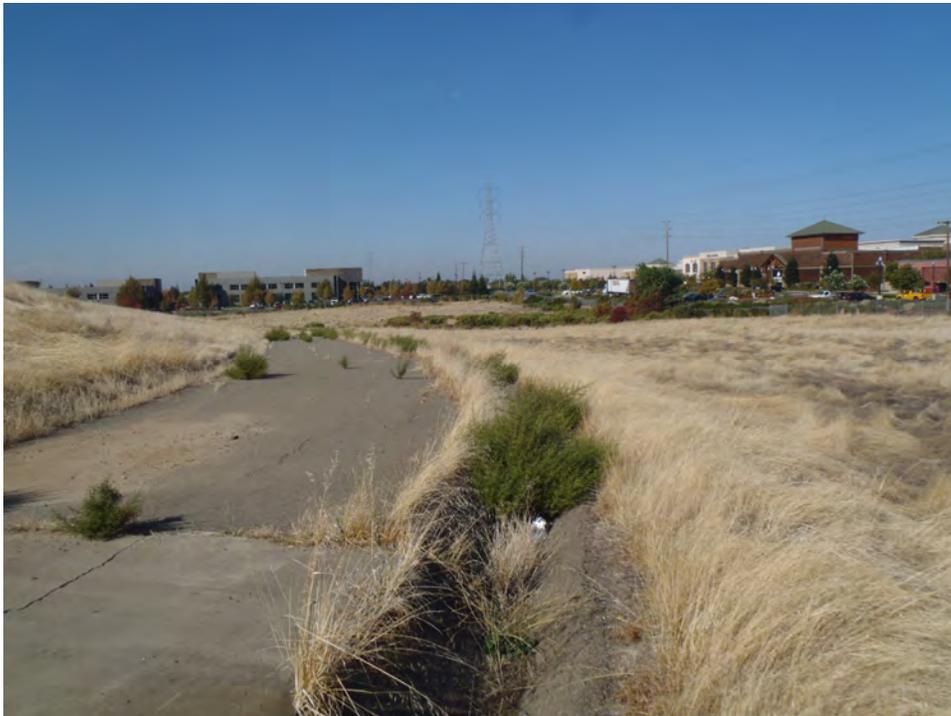
Figure 10

Looking west along the northern perimeter of the WMU.

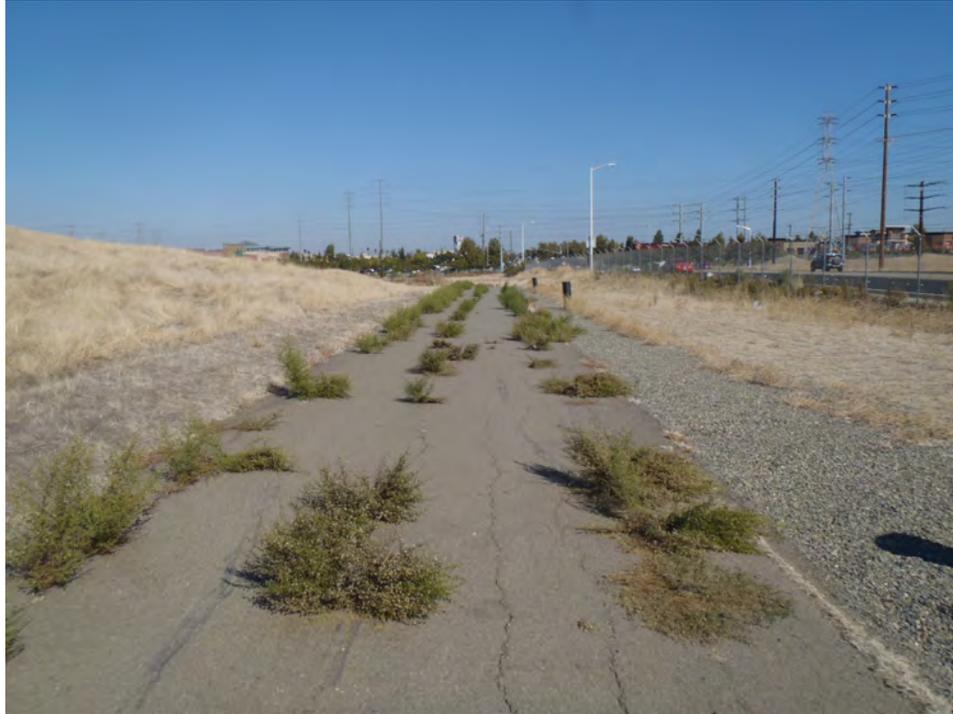
Figure 11

Looking north along the eastern perimeter of the WMU. Gallery Blvd is located just to the right/east of this photograph.

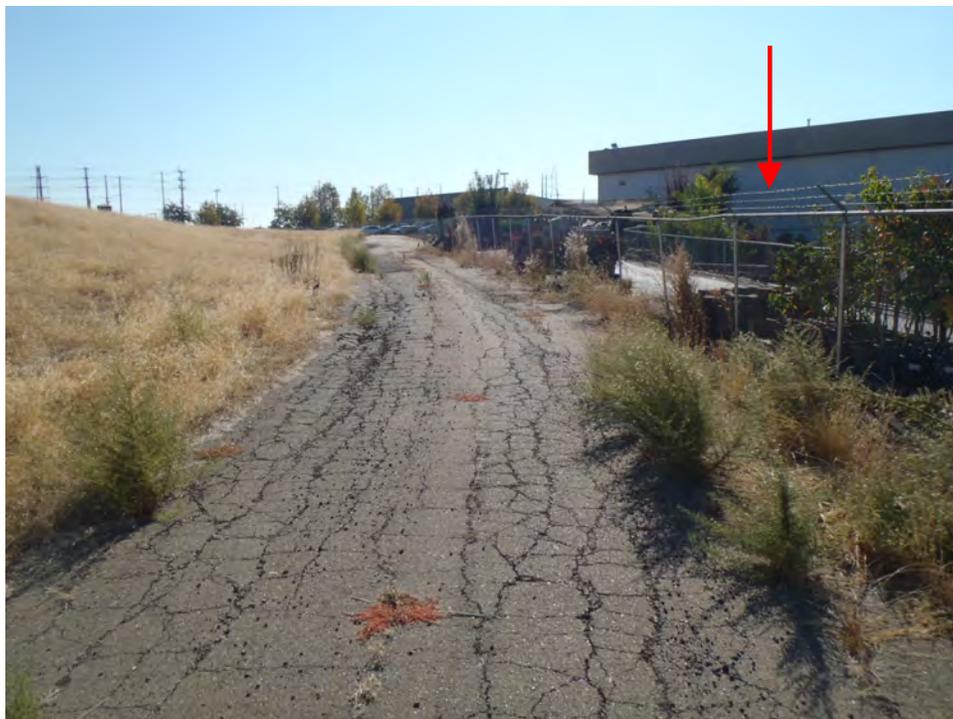
Figure 12

Looking southeast along the southwestern boundary of the WMU, the red arrow points to the Green Acres commercial building.

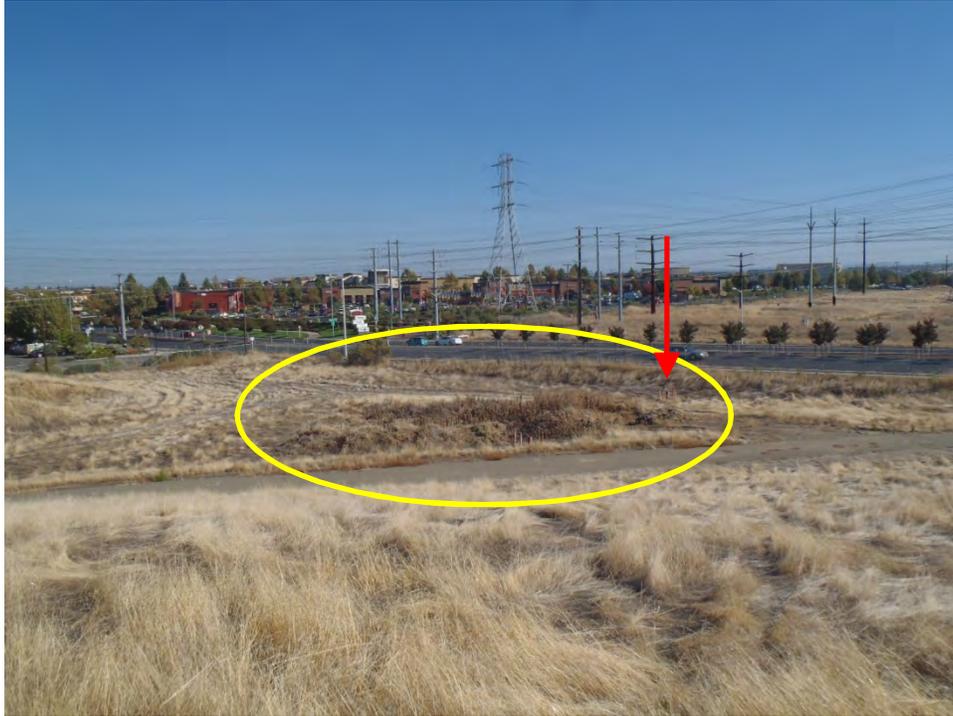
Figure 13

A pile of unauthorized waste consisting mostly of what appears to be foreign soil with PVC piping and corrugated drainage pipe, along with dead sod, has been dumped in the northeast corner of the Site, just beyond the WMU near GW-1 (Figures 13 through 15). Additionally, concrete fence posts (Figures 16, 17, and 18), a piece of discarded fence and a wood pallet were also found dumped onsite just outside of the covered MWU.

Standing atop the WMU looking northeast at the unauthorized waste pile, located within the yellow oval. The red arrow points to GW-1.

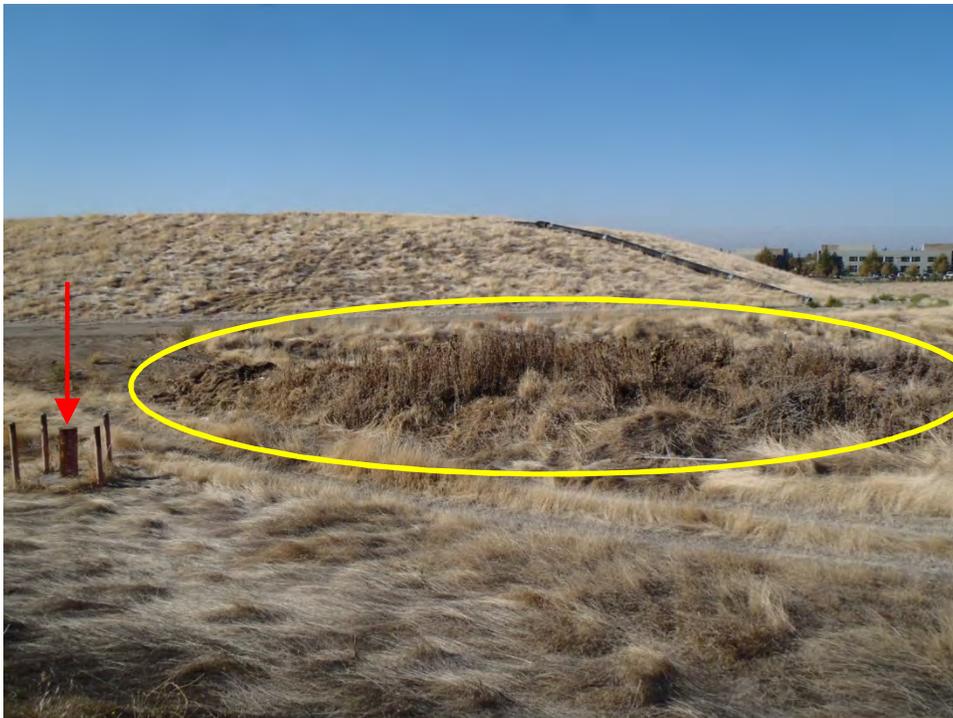
Figure 14

Looking southwest at the unauthorized waste pile (yellow oval). The WMU can be seen in the background, and the red arrow points to GW-1.

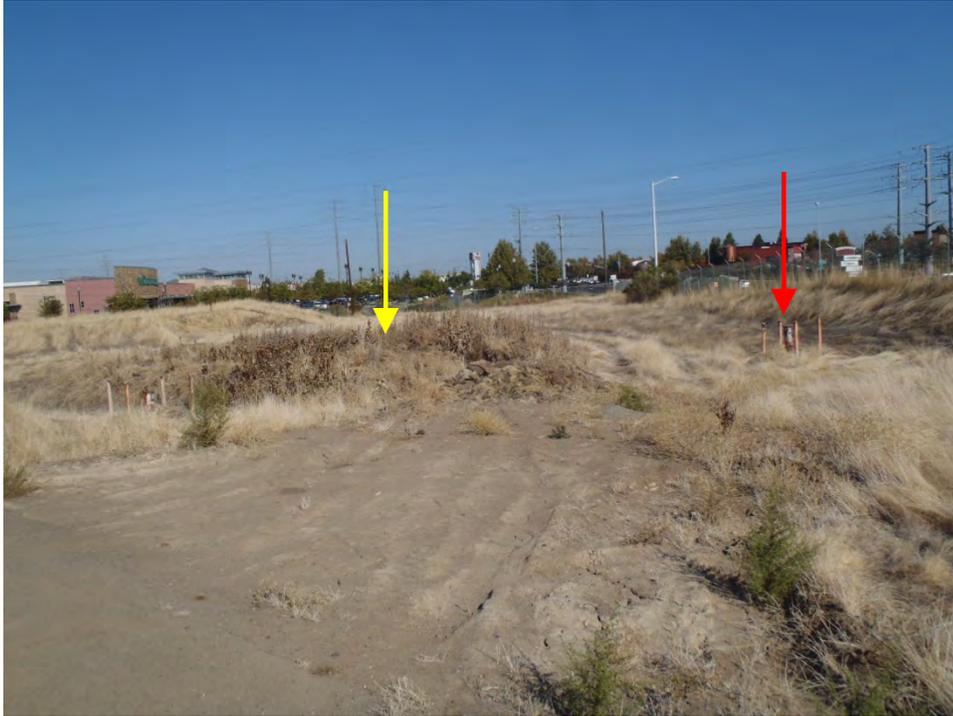
Figure 15

Standing on the WMU perimeter road looking north at the unauthorized waste pile, yellow arrow. The red arrow points to GW-1.

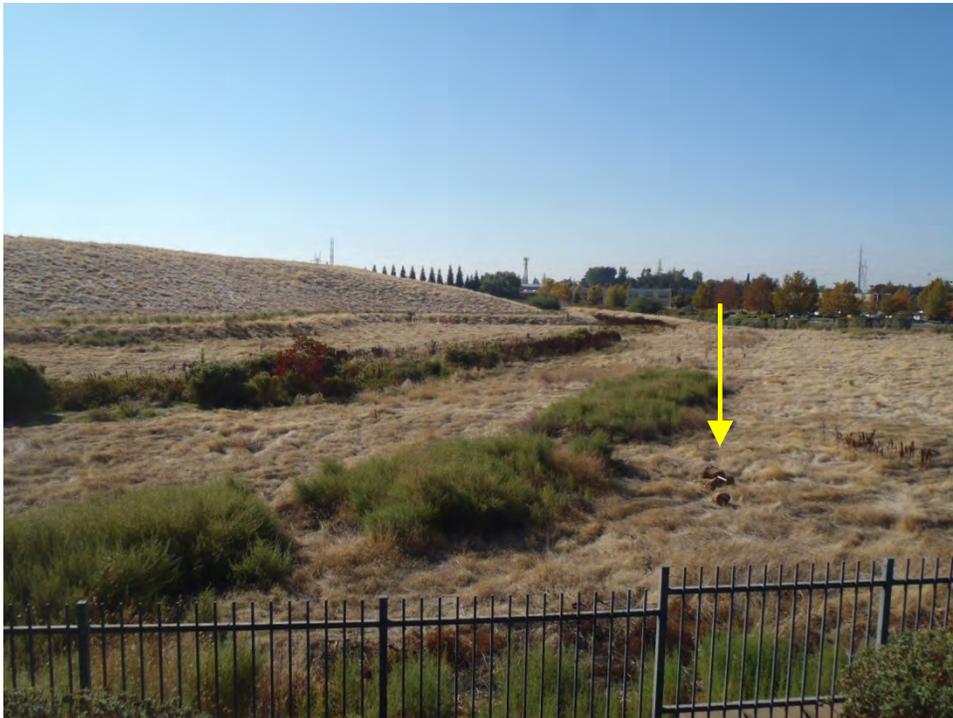
Figure 16

Standing just north of the northern fenced boundary of the Site looking southwest. The yellow arrow points to discarded former fence post blocks.

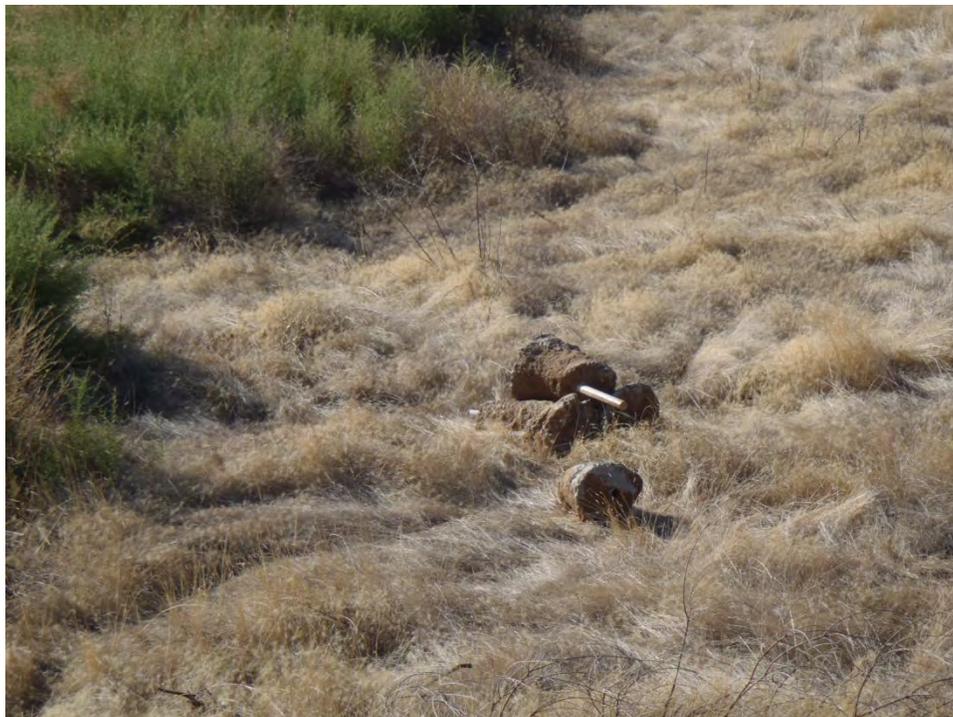
Figure 17

A close up of the former fence post bocks seen in Figure 16.

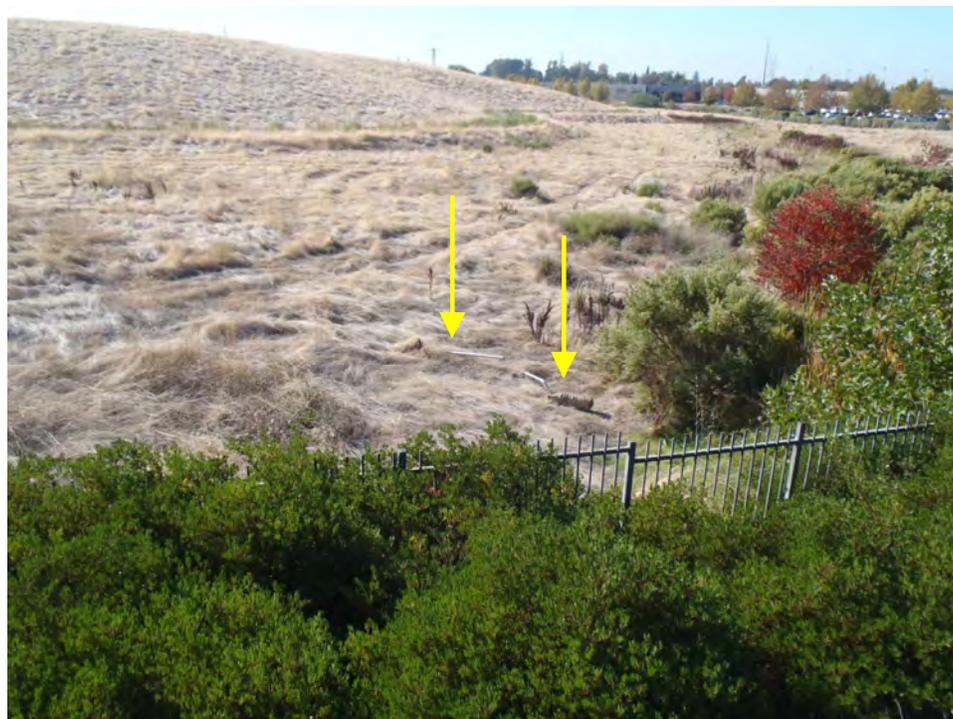
Figure 18

Standing just north of the northern fenced boundary of the Site looking southwest. The yellow arrows point to two other discarded former fence post bocks.

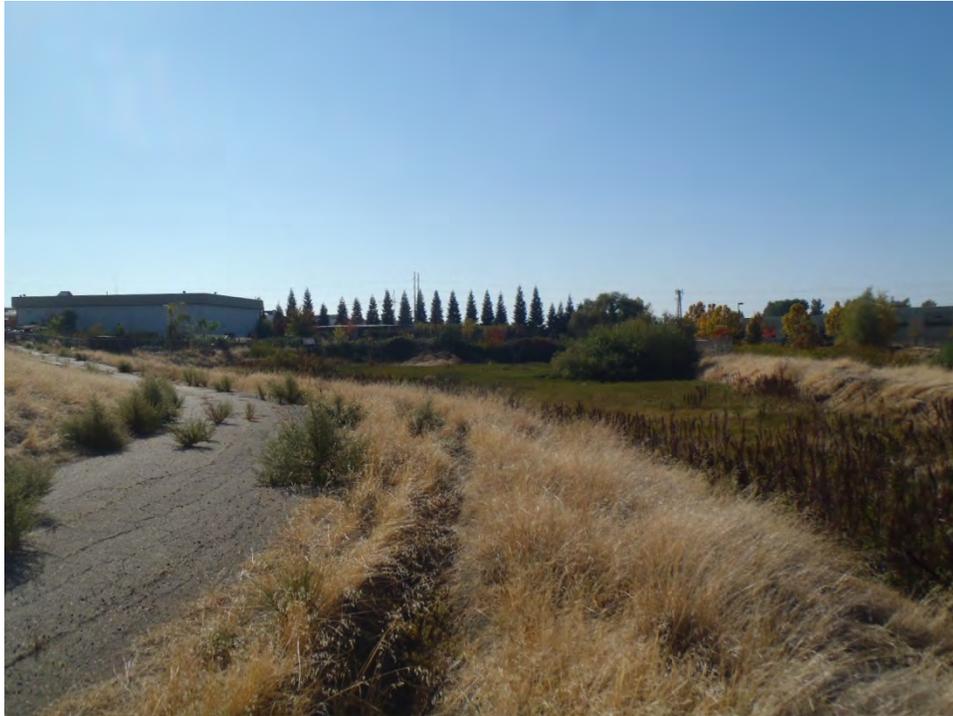
Figure 19

Near the beginning of the storm water sedimentation basin (Figure 19), along the western side of the WMU, there is a large poly tank with a lid atop it (Figure 20). According to historical reports this poly tank is a manhole for the Site's leachate collection system.

Standing along the western boundary of the WMU looking south at the storm water sedimentation basin. The poly tank as shown in Figure 20 below is located just to the right/west of this photograph.

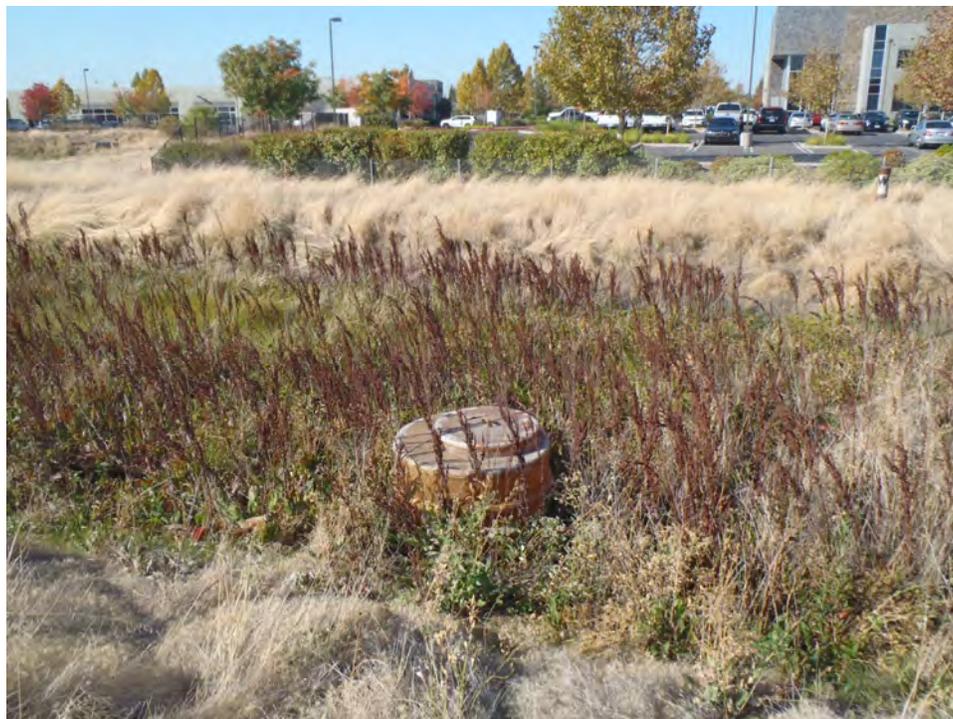
Figure 20

Standing in the same location as Figure 19, but looking west at the poly tank, which according to historical reports is a manhole for the Site's leachate collocation system.
