Cleanup and Abatement Order R5-2016-XXXX

NOTICE OF VIOLATION

UNLAWFUL DISCHARGE OF WASTE TO EAST FORK STILLWATER CREEK, SHASTA COUNTY ASSESSOR PARCEL 306-250-004-000, REDDING, SHASTA COUNTY

INSPECTION REPORT

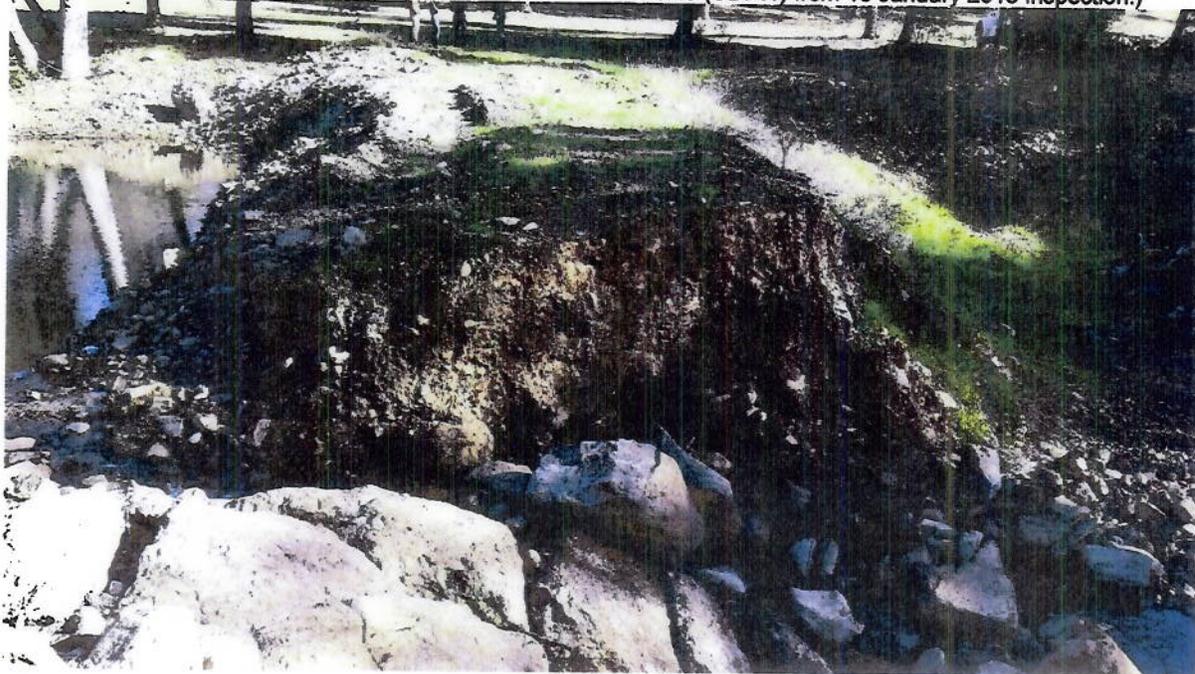
Improper engineering and inadequate erosion control measures were evidenced by the failure of the Dam Structure on the western end nearest the natural stream channel (Photos 1, 4-6) where approximately 23 linear feet of embankment was breached discharging rock, earthen material, cement, and asphalt downstream. Waypoint 014 marks the western end of the existing Dam Structure, Waypoint 015 marks the eastern end, and Waypoint 016 identifies the base of the dam (Figures 2 & 3). Staff collected measurements of the Dam Structure including: its entire length before failure as well as the existing length, several cross sections, and slope gradients along the Dam Structure to approximate fill volume and volume of discharged fill from the failure. Staff's calculations estimate the total Dam Structure volume (prior to failure) to have been approximately 21,186 cubic feet; the remaining Dam Structure volume was estimated at 15,095 cubic feet; and approximately 6,091 cubic feet of materials used to construct the dam

Photo 1: Failed dam embankment discharging rock and sediment to East Fork Stillwater Creek.
(Photo provided by California Department of Fish and Wildlife (CDFW) from 13 January 2015 inspection.)

- Cleanup of discharged debris, rock, and sediment associated with past dam failure; and
- Either:
 - (a) removal of the dam and restoration of the low-flow channel to pre-dam conditions; or
 - (b) stamped engineered plans for reinstallation of the dam including acquisition of the appropriate water rights from the State Water Resources Control Board's Division of Water Rights.

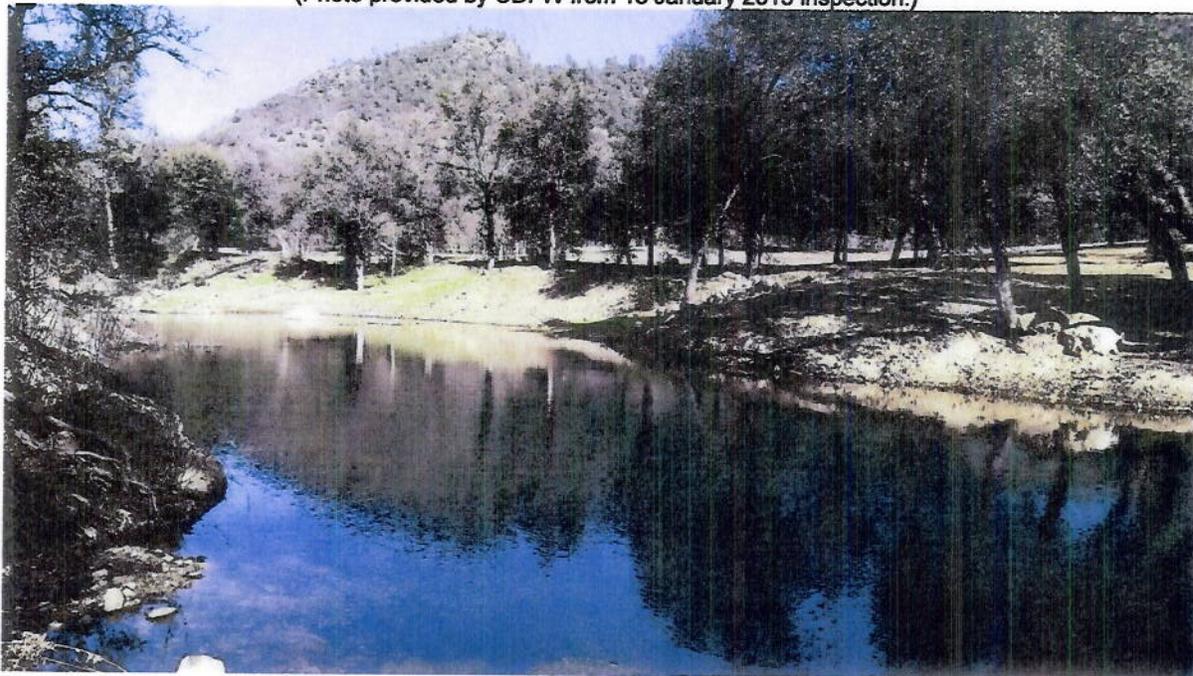
Photo 2: Reservoir on East Fork Stillwater Creek.
(Photo provided by CDFW from 13 January 2015 inspection.)

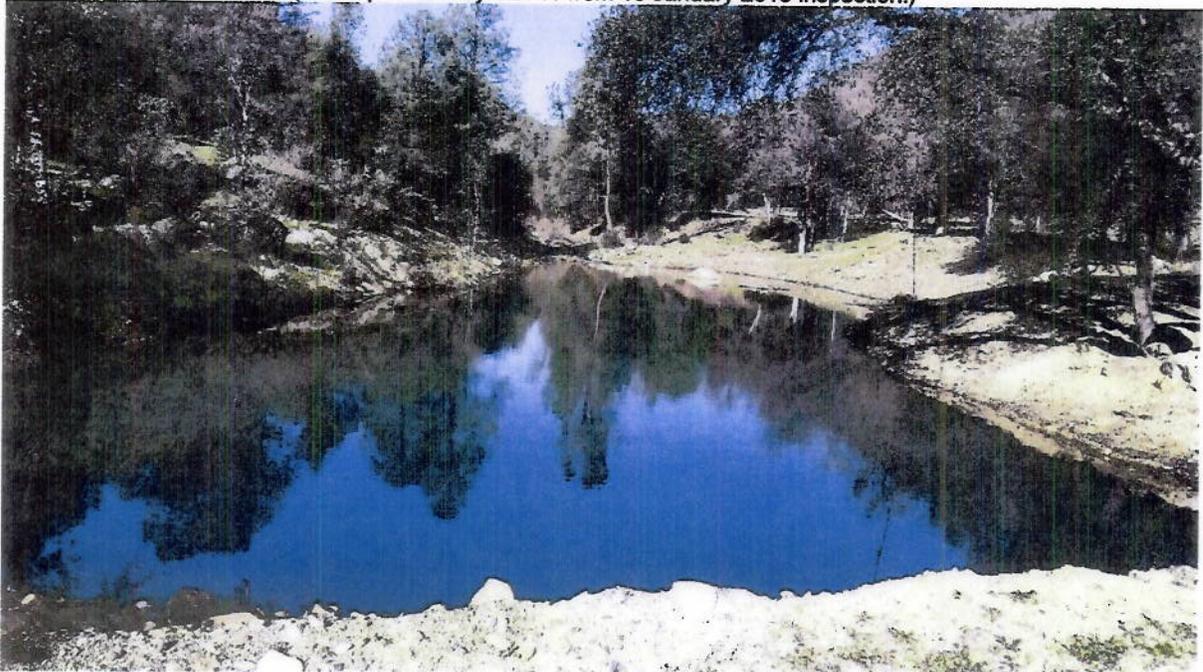
**Photo 3: Reservoir on East Fork Stillwater Creek.
(Photo provided by CDFW from 13 January 2015 inspection.)**

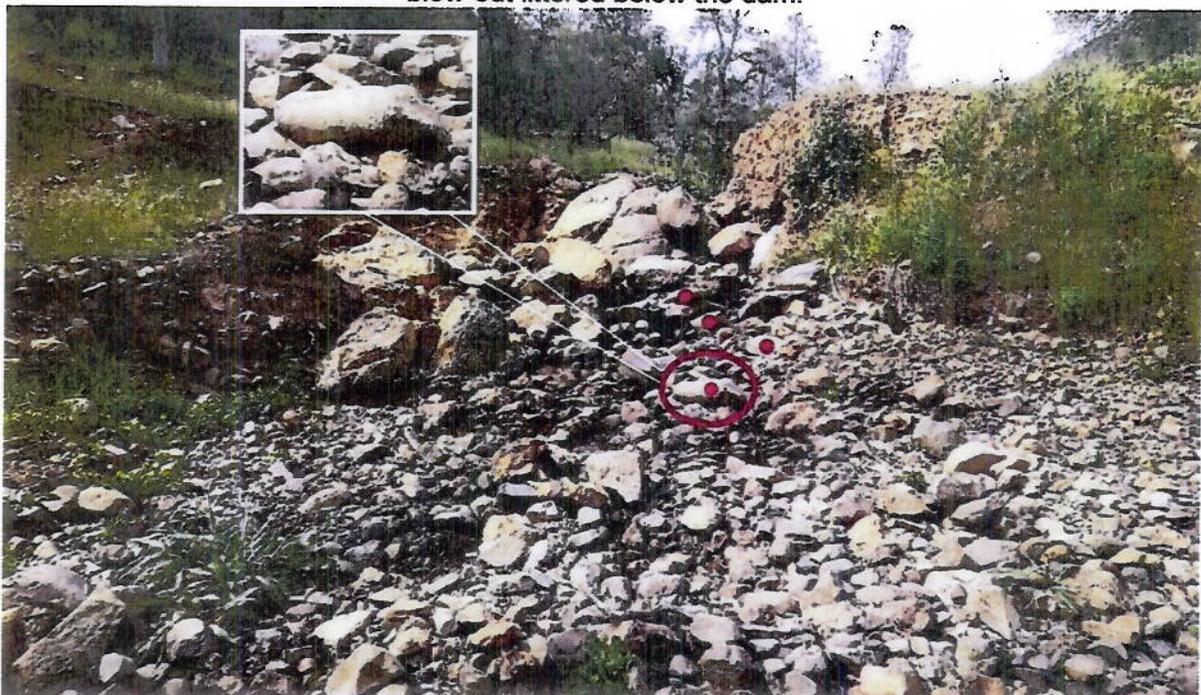
Photo 4: Breached/failed Dam Structure showing deposition of rock and fill materials in East Fork Stillwater Creek. Several solidified bags of cement can be seen with other debris from the blow-out littered below the dam.

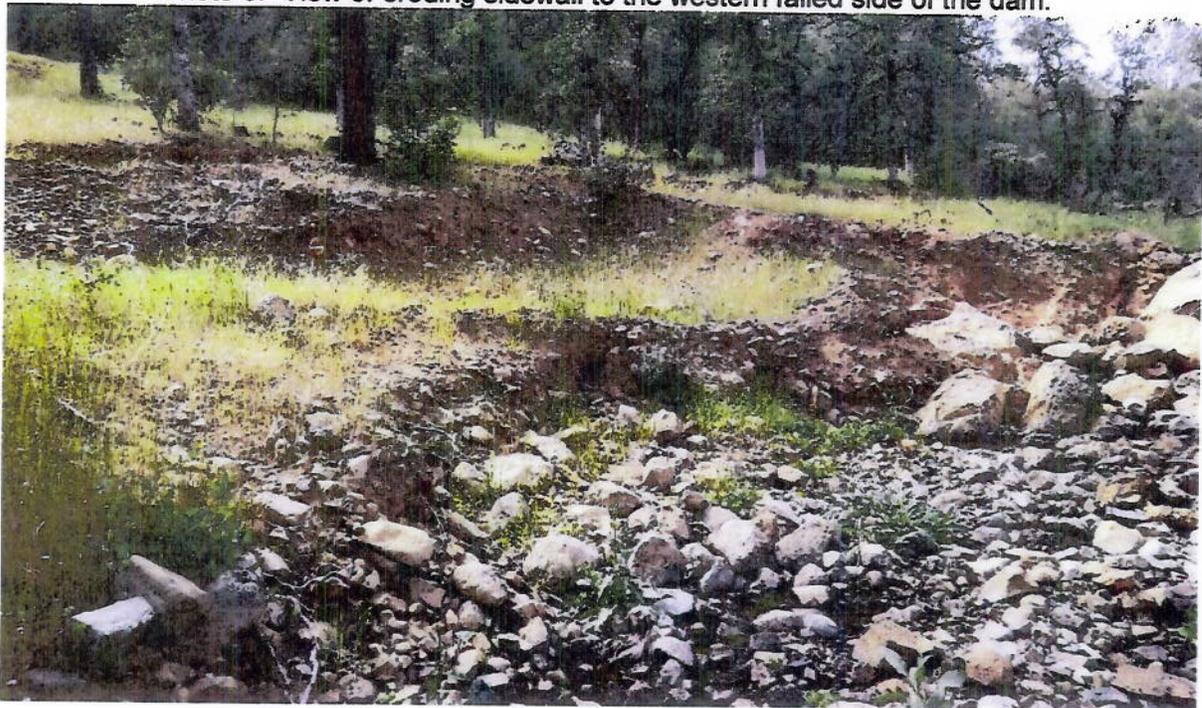
Staff collected a soil sample from the western sidewall of the Dam Structure at Waypoint 014. The sample was classified by Central Valley Water Board Engineering Geologist Kevin Pfeiffer using the Visual Classification of Soils - Unified Soil Classification System, ASTM Standard D 2488-00, Standard Practice for Description and Identification of Soils (Visual-Manual Procedure). The soil sample is interpreted to be the native soil present in the area and is physically described as follows:

Photo 5: View of eroding sidewall to the western failed side of the dam.

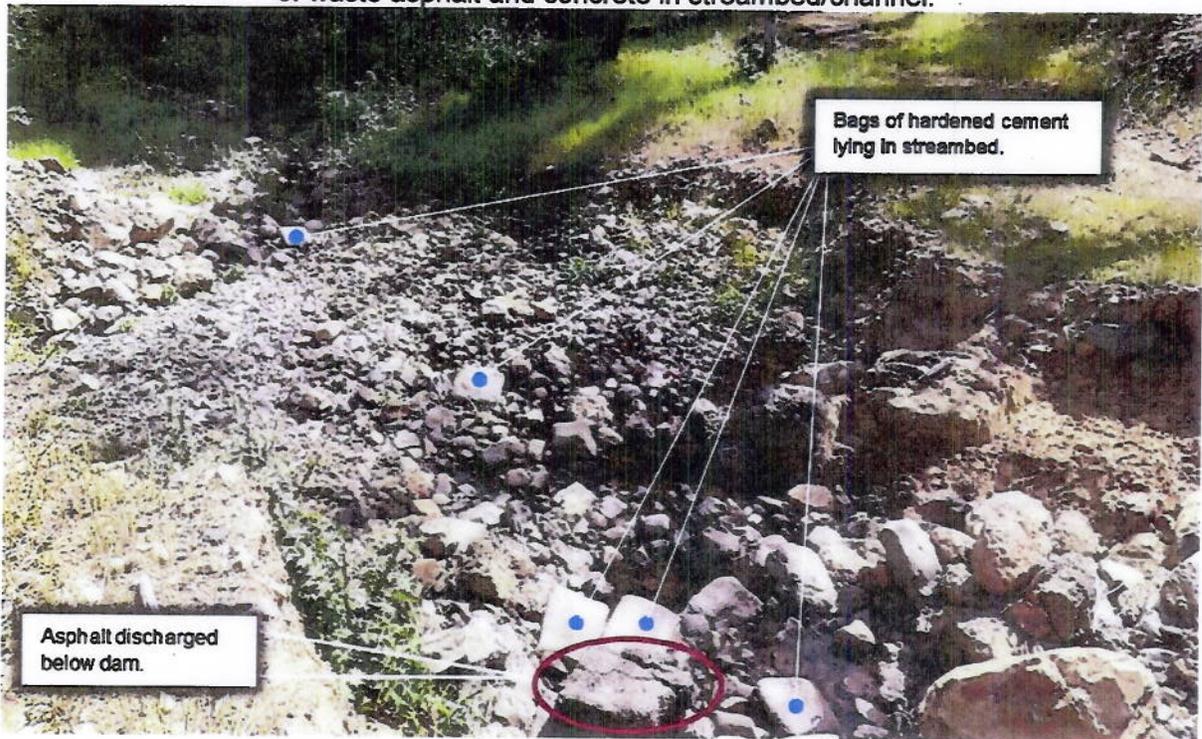
Photo 6: Looking downstream (South). View of discharge to lower stream and further evidence of waste asphalt and concrete in streambed/channel.

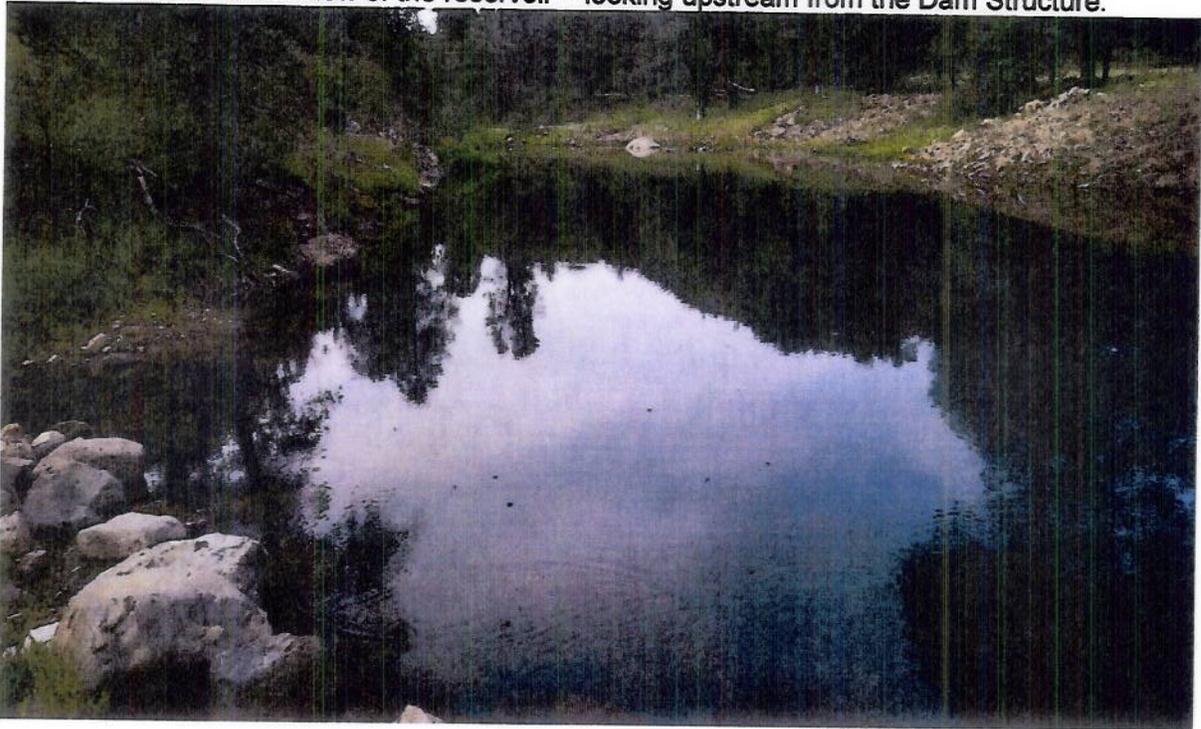
Photo 7: North view of the reservoir – looking upstream from the Dam Structure.

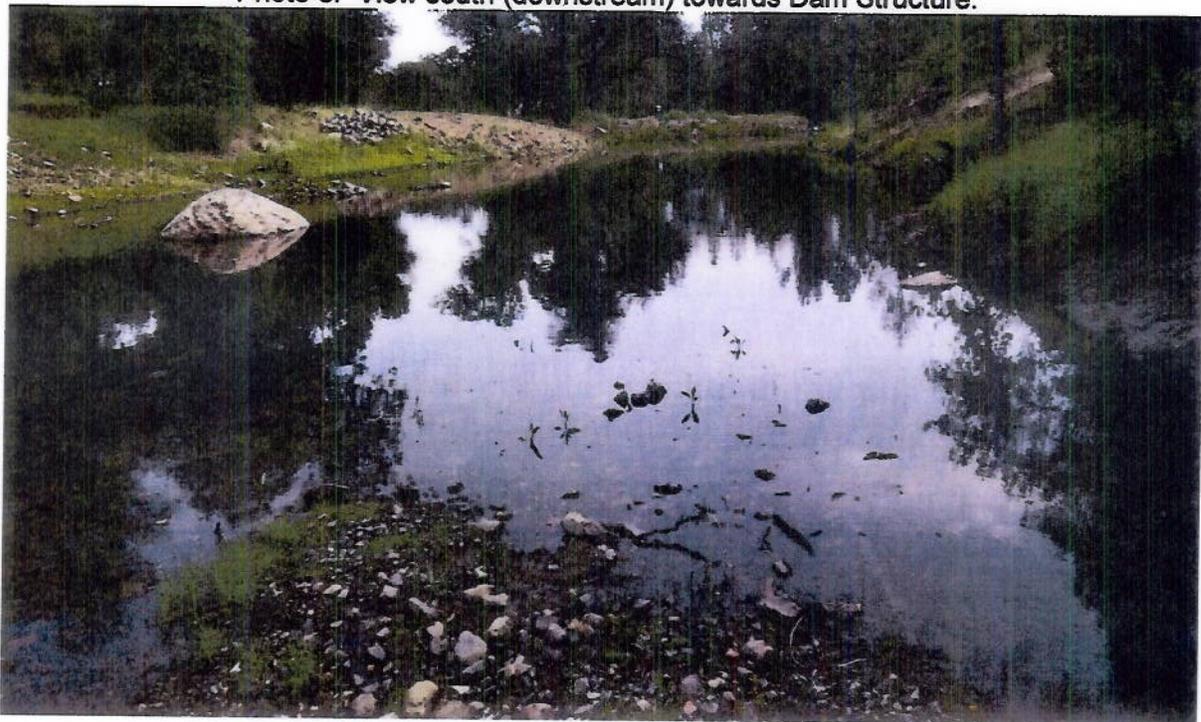
Photo 8: View south (downstream) towards Dam Structure.

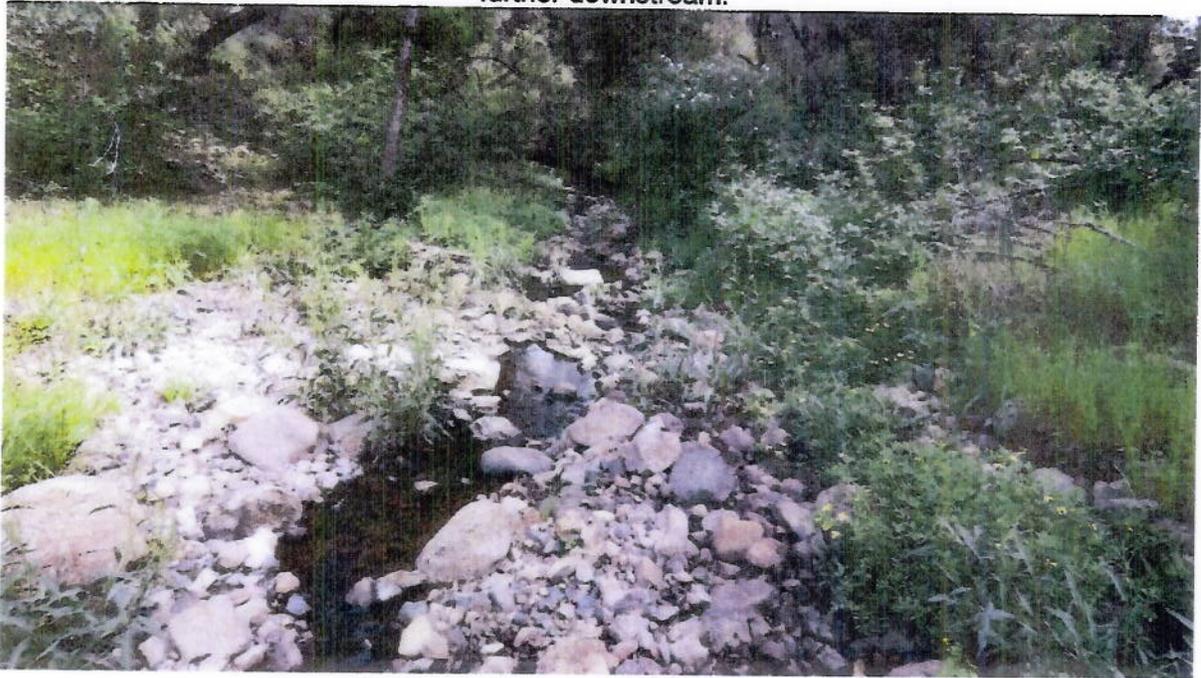
Staff inspected East Fork Stillwater Creek downstream of the Dam Structure to assess the extent of sediment and rock transport from the failure, and to assess effects downstream from the Dam Structure and Reservoir. Staff noted discharged debris including cobbles and boulders, along with scattered concrete and asphalt. Staff also identified several aquatic insects present in surface water downstream of the Dam Structure. Along with the tadpole species noted in the Reservoir, the presence of aquatic insects identifies this reach as a Class II watercourse supporting invertebrate aquatic species (Photos 9-13). Staff marked Waypoint 017, approximately 185 feet downstream from the failure of the Dam Structure, as identifying the extent of cobble deposition in the streambed; however sands and fines, as seen in the soil sample collected from the Dam Structure, have likely traveled further downstream.

Photo 9: Downstream from Dam Structure looking south. Deposition of cobbles and boulders; fines and sands, like those found in the soil sample from the Dam Structure, have likely traveled further downstream.

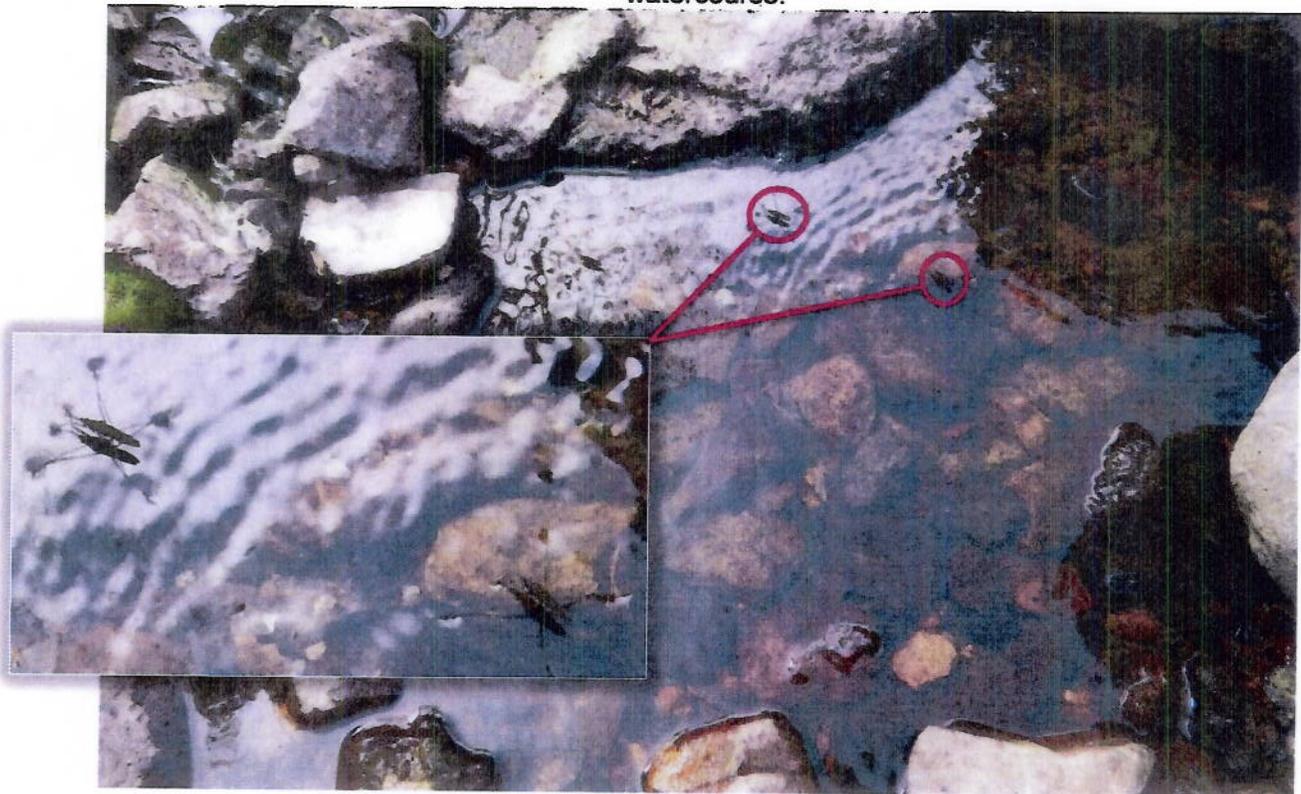
Photo 10: Downstream. Note: aquatic insects present (water striders) indicating a Class II watercourse.

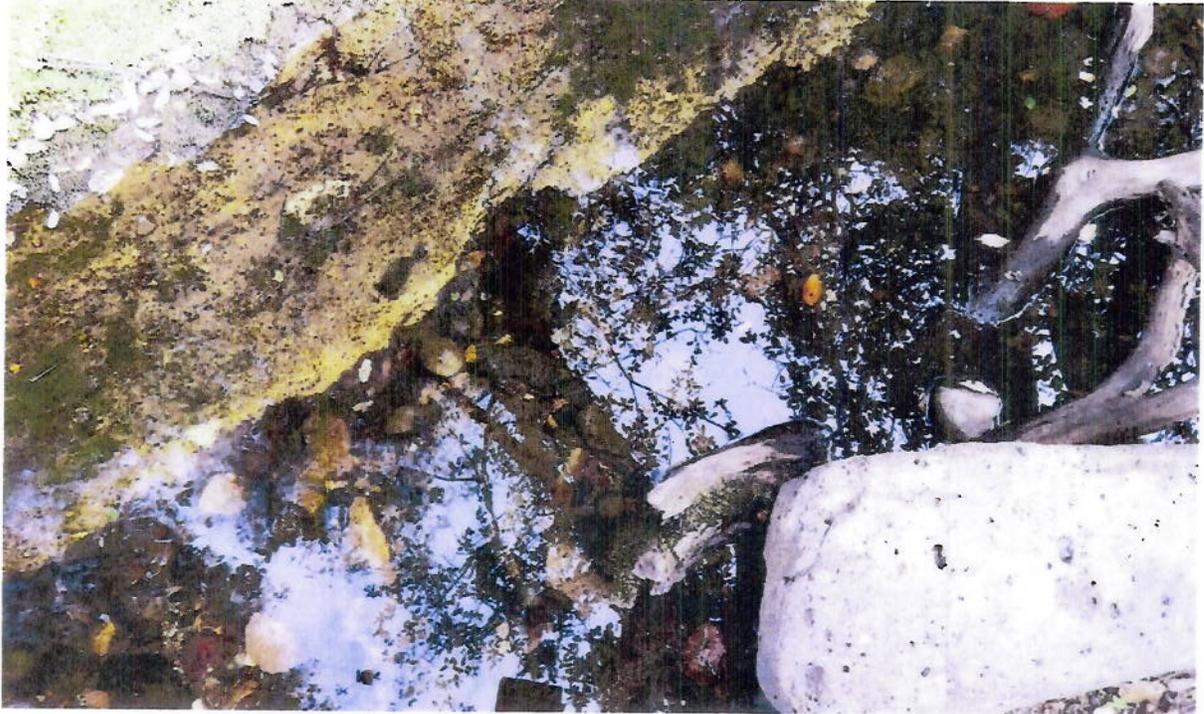
Photo 11: Cobbles and gravel deposited along bedrock in the streambed.

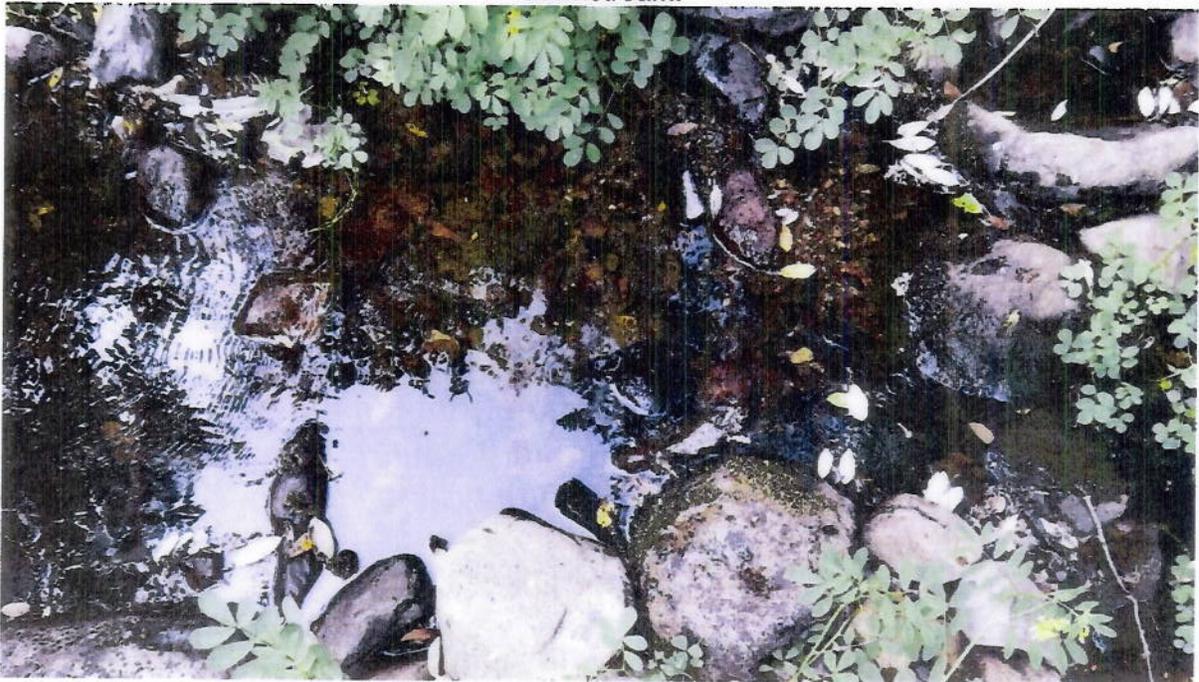
Photo 12: Additional depositions downstream. More sands and fine gravels are evident further downstream.

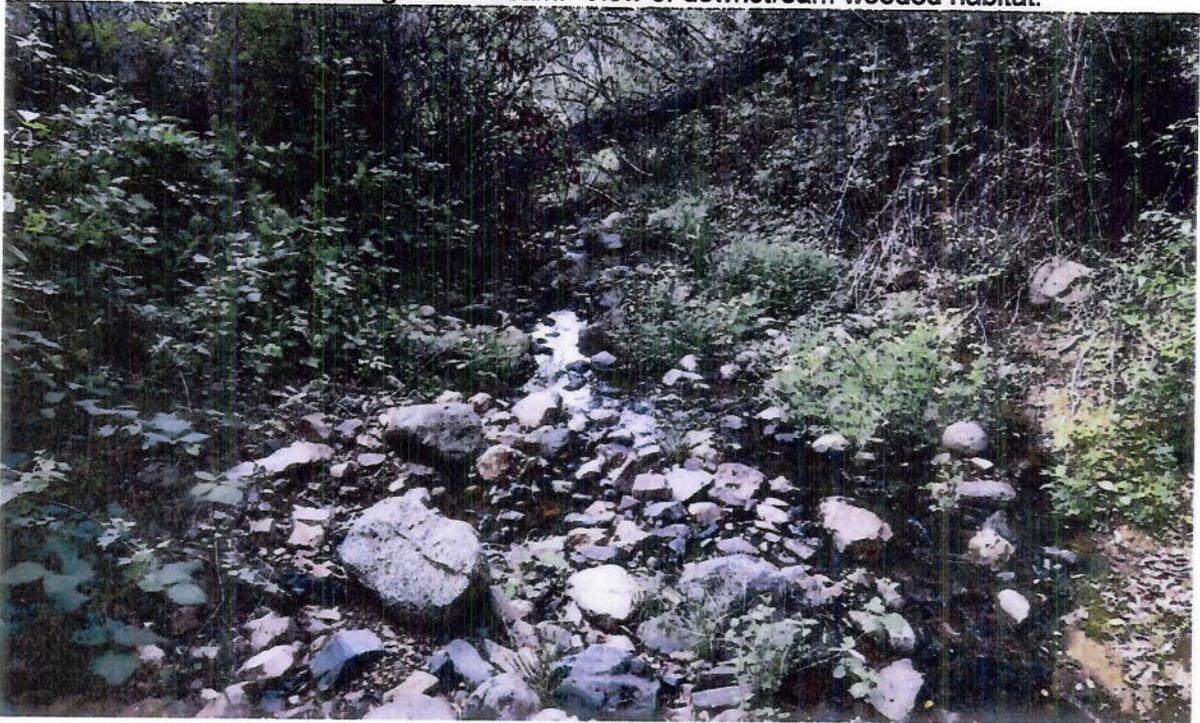
Photo 13: Looking downstream. View of downstream wooded habitat.

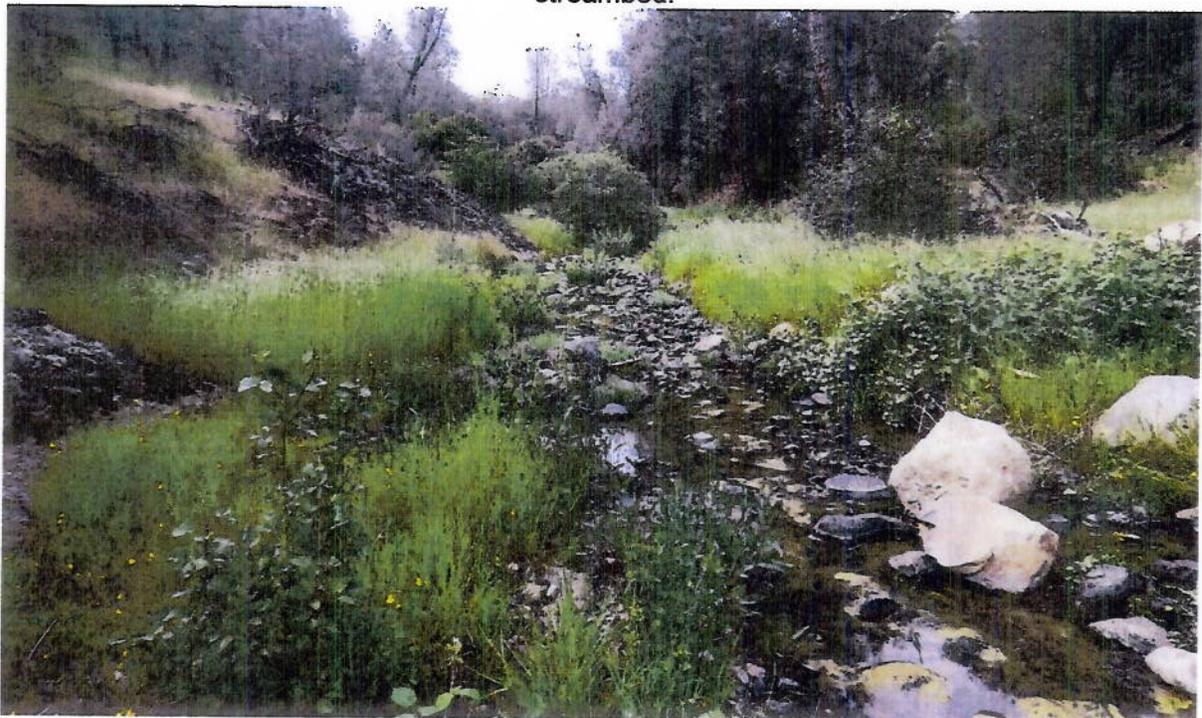
Photo 14: East Fork Stillwater Creek upstream from the Reservoir. Low flow channel with some cobbles and boulders. Note presence of filamentous algae on cobbles within the streambed.

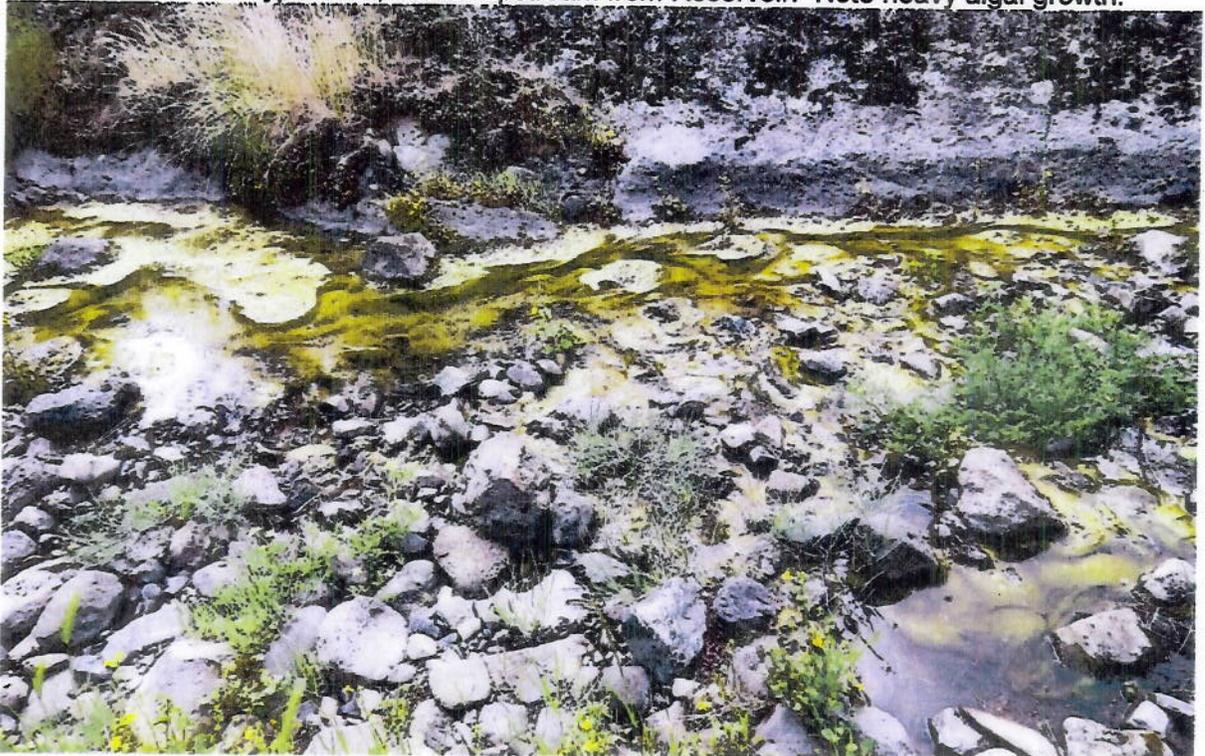
Photo 15: Waypoint 18; further upstream from Reservoir. Note heavy algal growth.

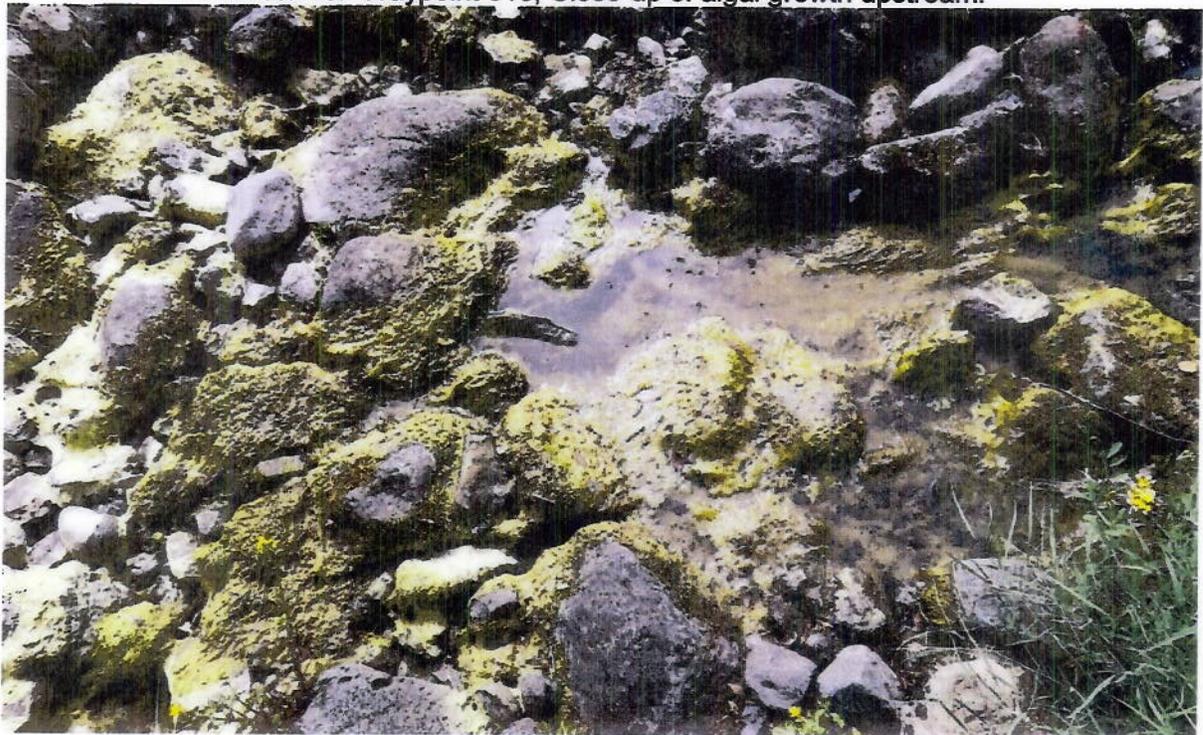
Photo 16: Waypoint 018; Close-up of algal growth upstream.

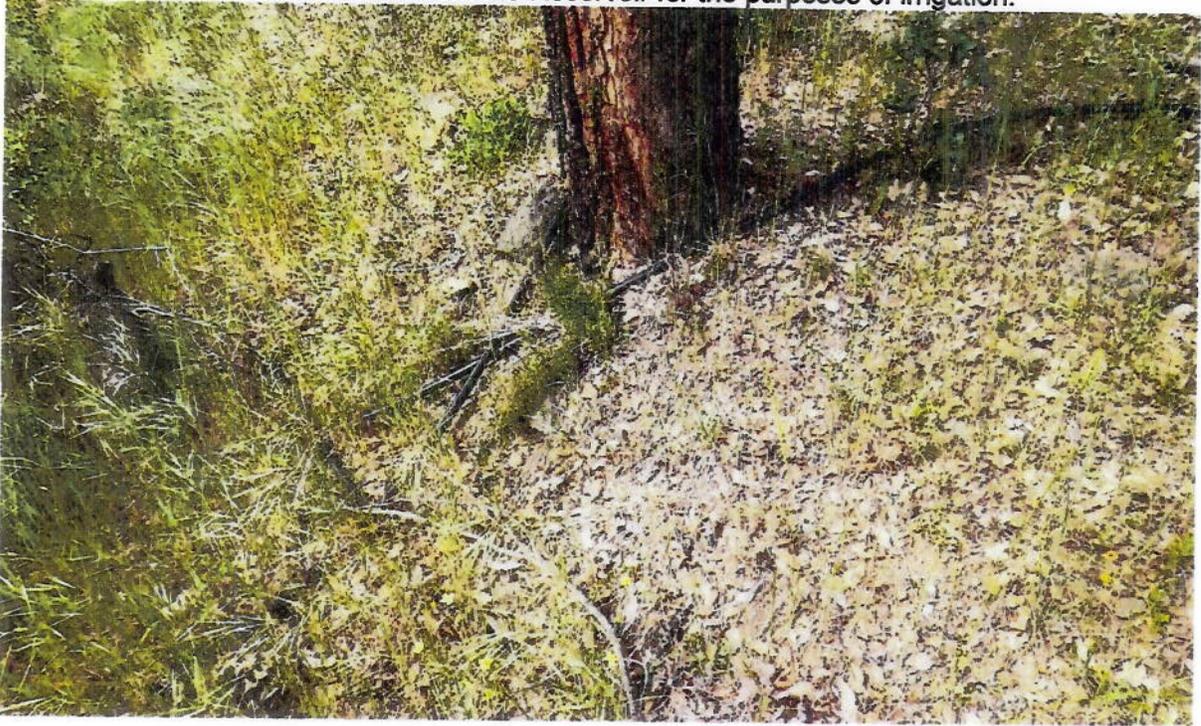
Photo 17: Upstream from Reservoir; Waypoint 021. Black irrigation piping indicating water may have been drawn from the Reservoir for the purposes of irrigation.

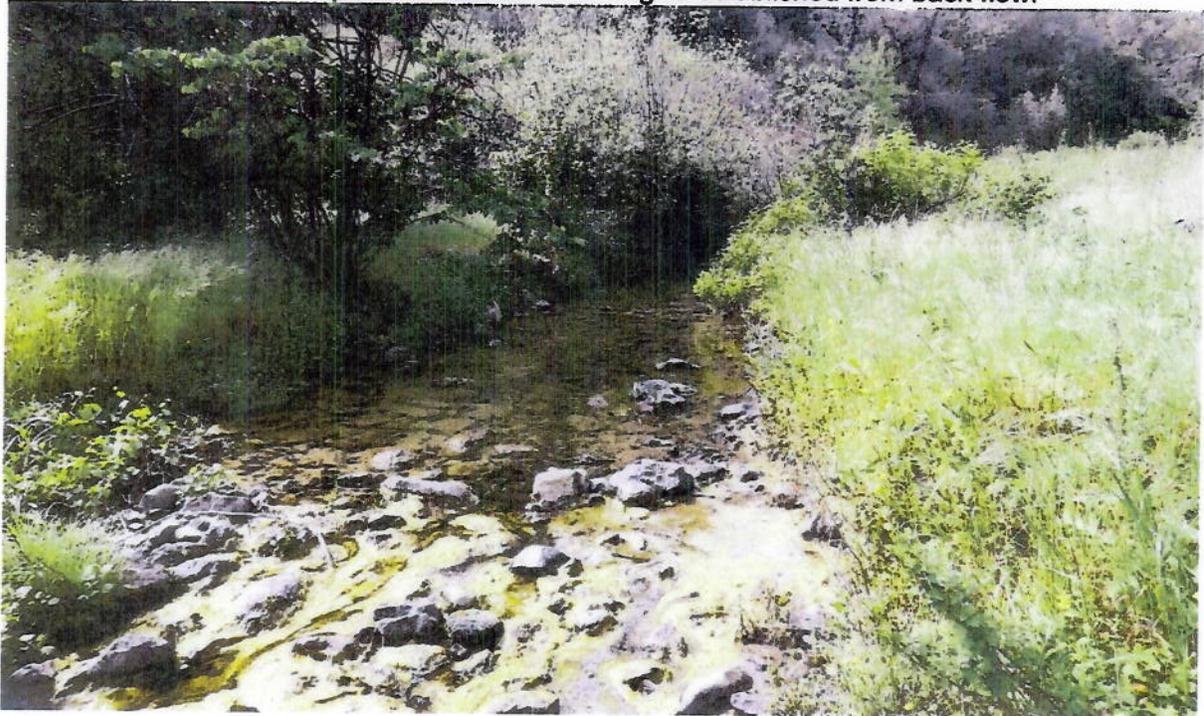
Photo 18: Upstream habitat becoming re-established from back-flow.

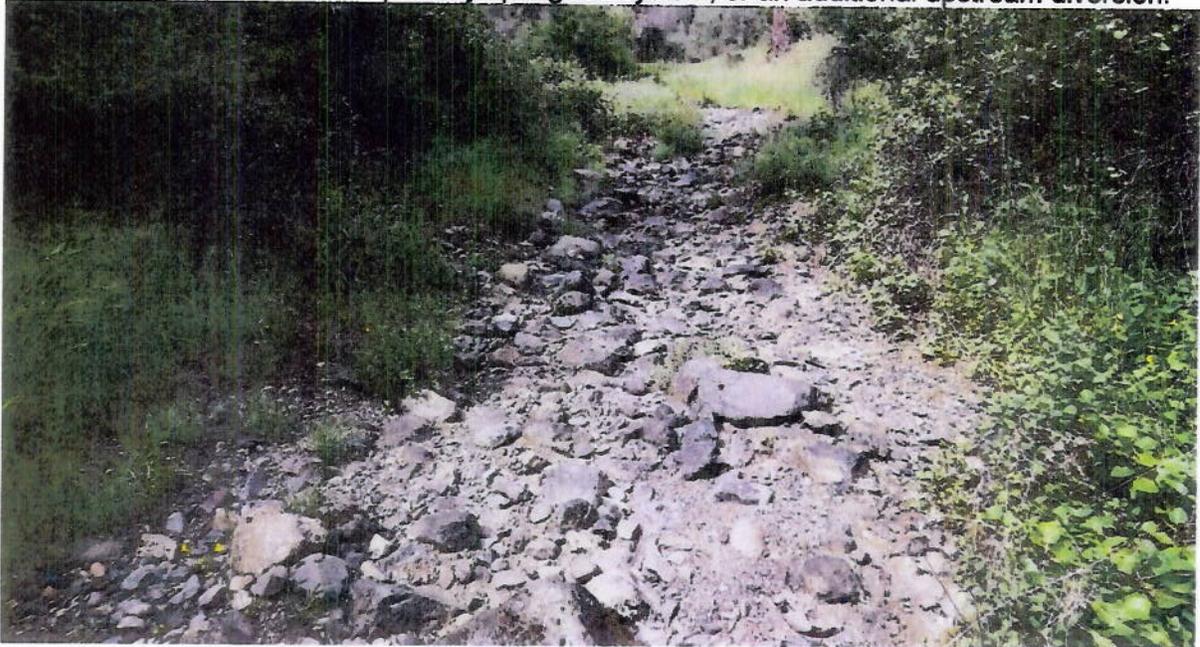
Photo 21: Waypoint 019; dry streambed upstream from Reservoir near property line. Dried bed indicates the potential for a partially spring-fed system, or an additional upstream diversion.

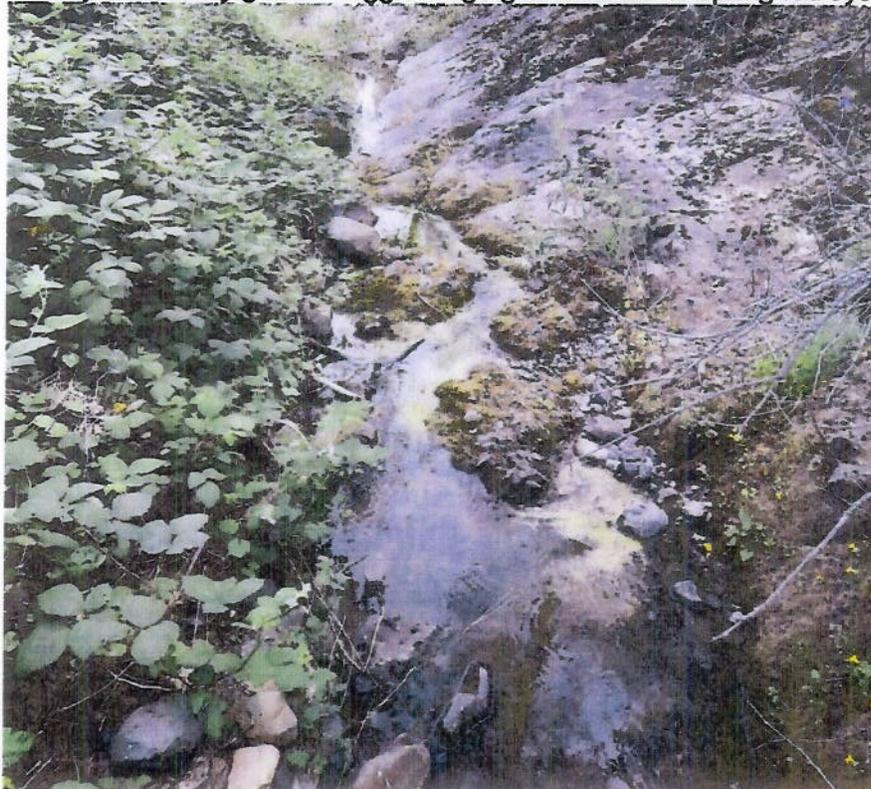
Photo 22: Waypoint 020; immediately downstream from dried streambed. Presence of bedrock and heavy blackberry growth suggest high groundwater or spring fed system.

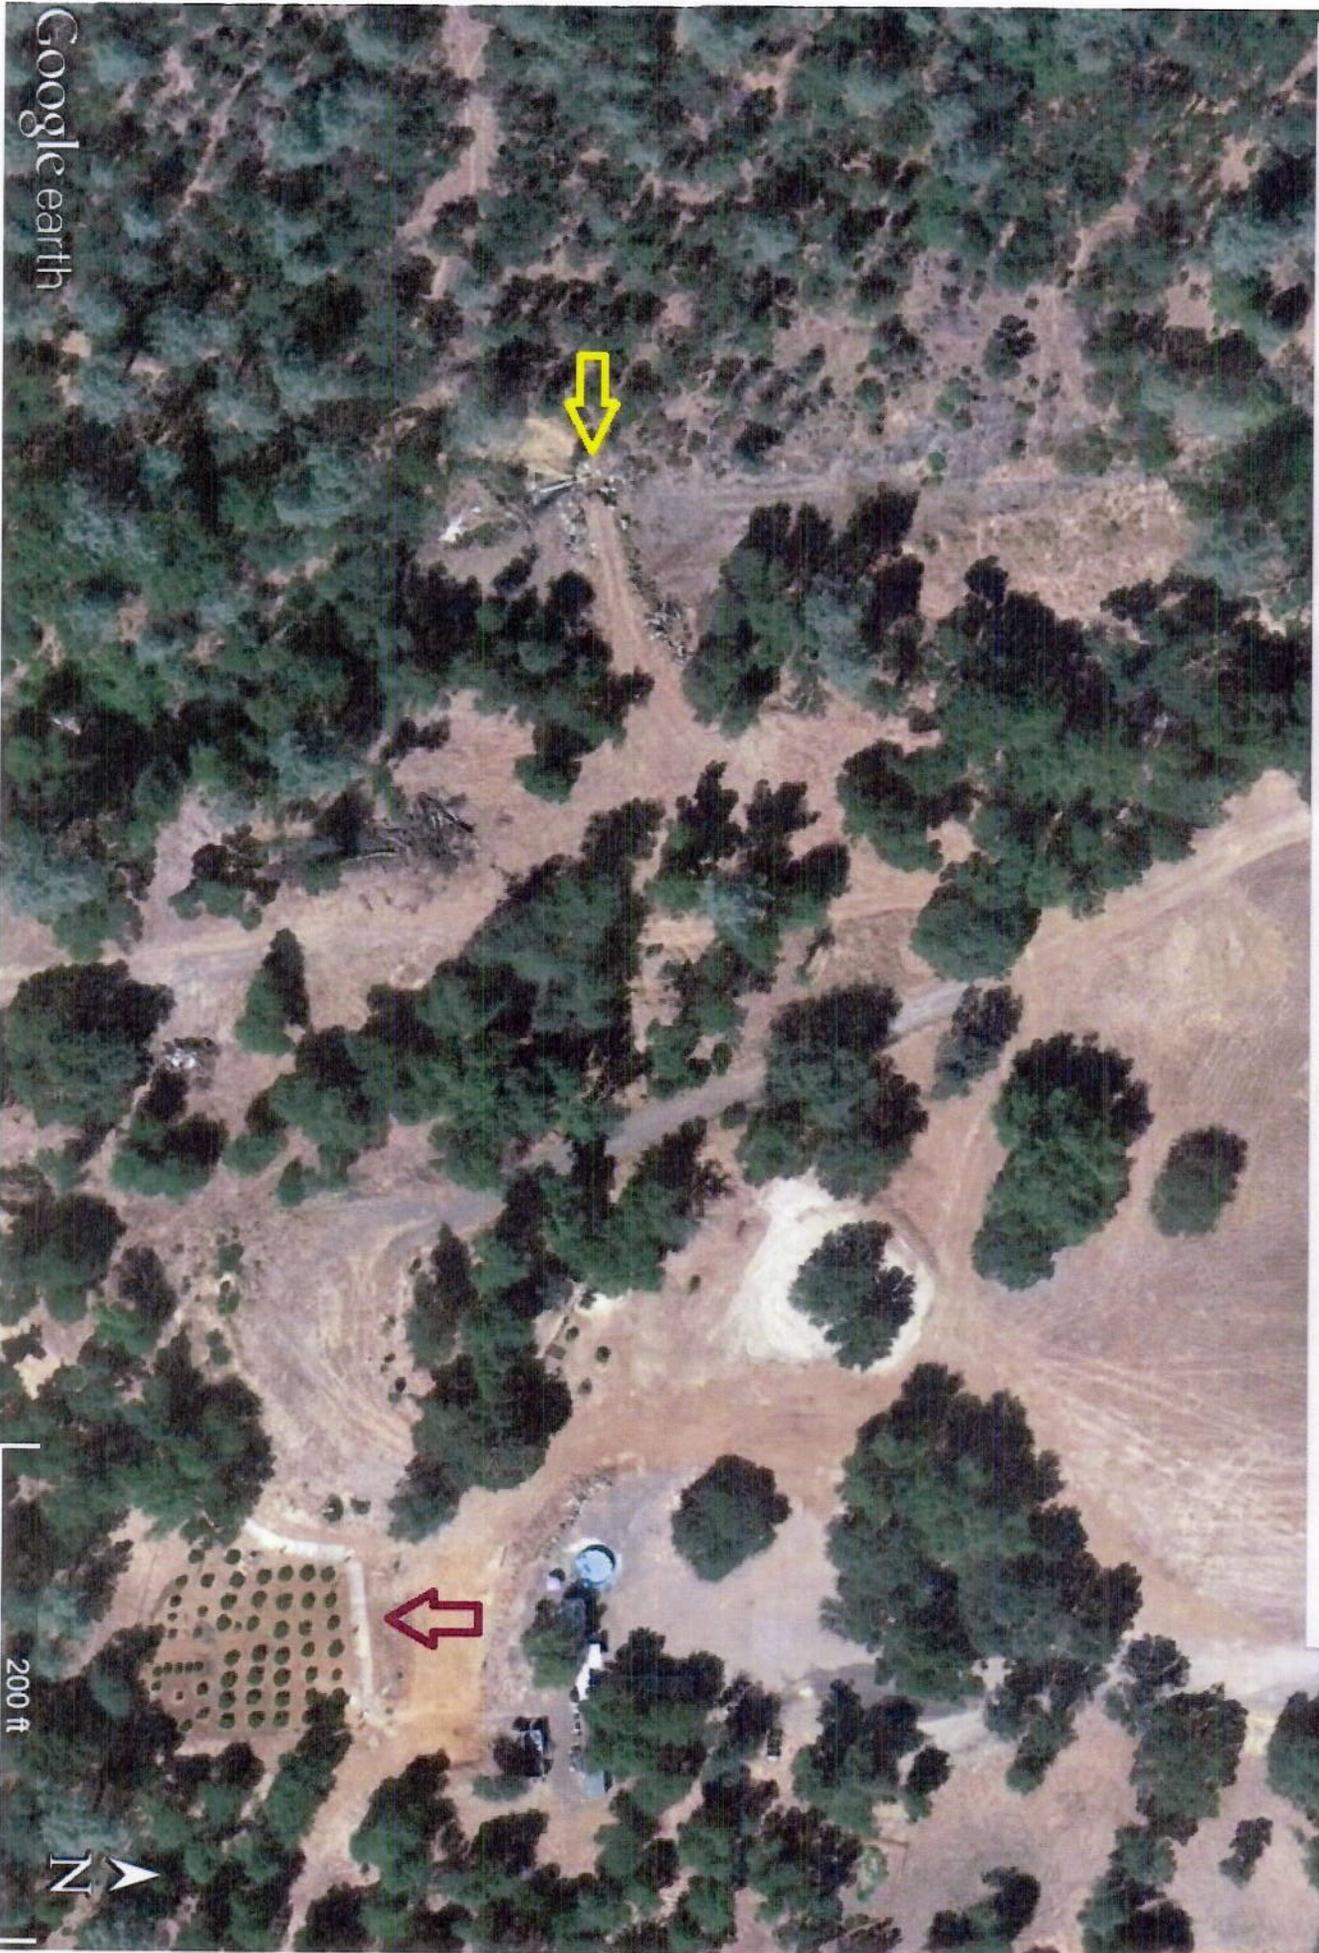
2010

Shasta County APN: 306-250-004-000; Dam Structure (yellow arrow) visible from satellite imagery and tree clearing with potential "grow" site (red arrow) visible to the south east.
