Cleanup and Abatement Order R5-2016-XXXX

NOTICE OF VIOLATION

UNLAWFUL DISCHARGE OF WASTE TO EAST FORK STILLWATER CREEK, SHASTA COUNTY ASSESSOR PARCEL 306-250-004-000, REDDING, SHASTA COUNTY

INSPECTION REPORT

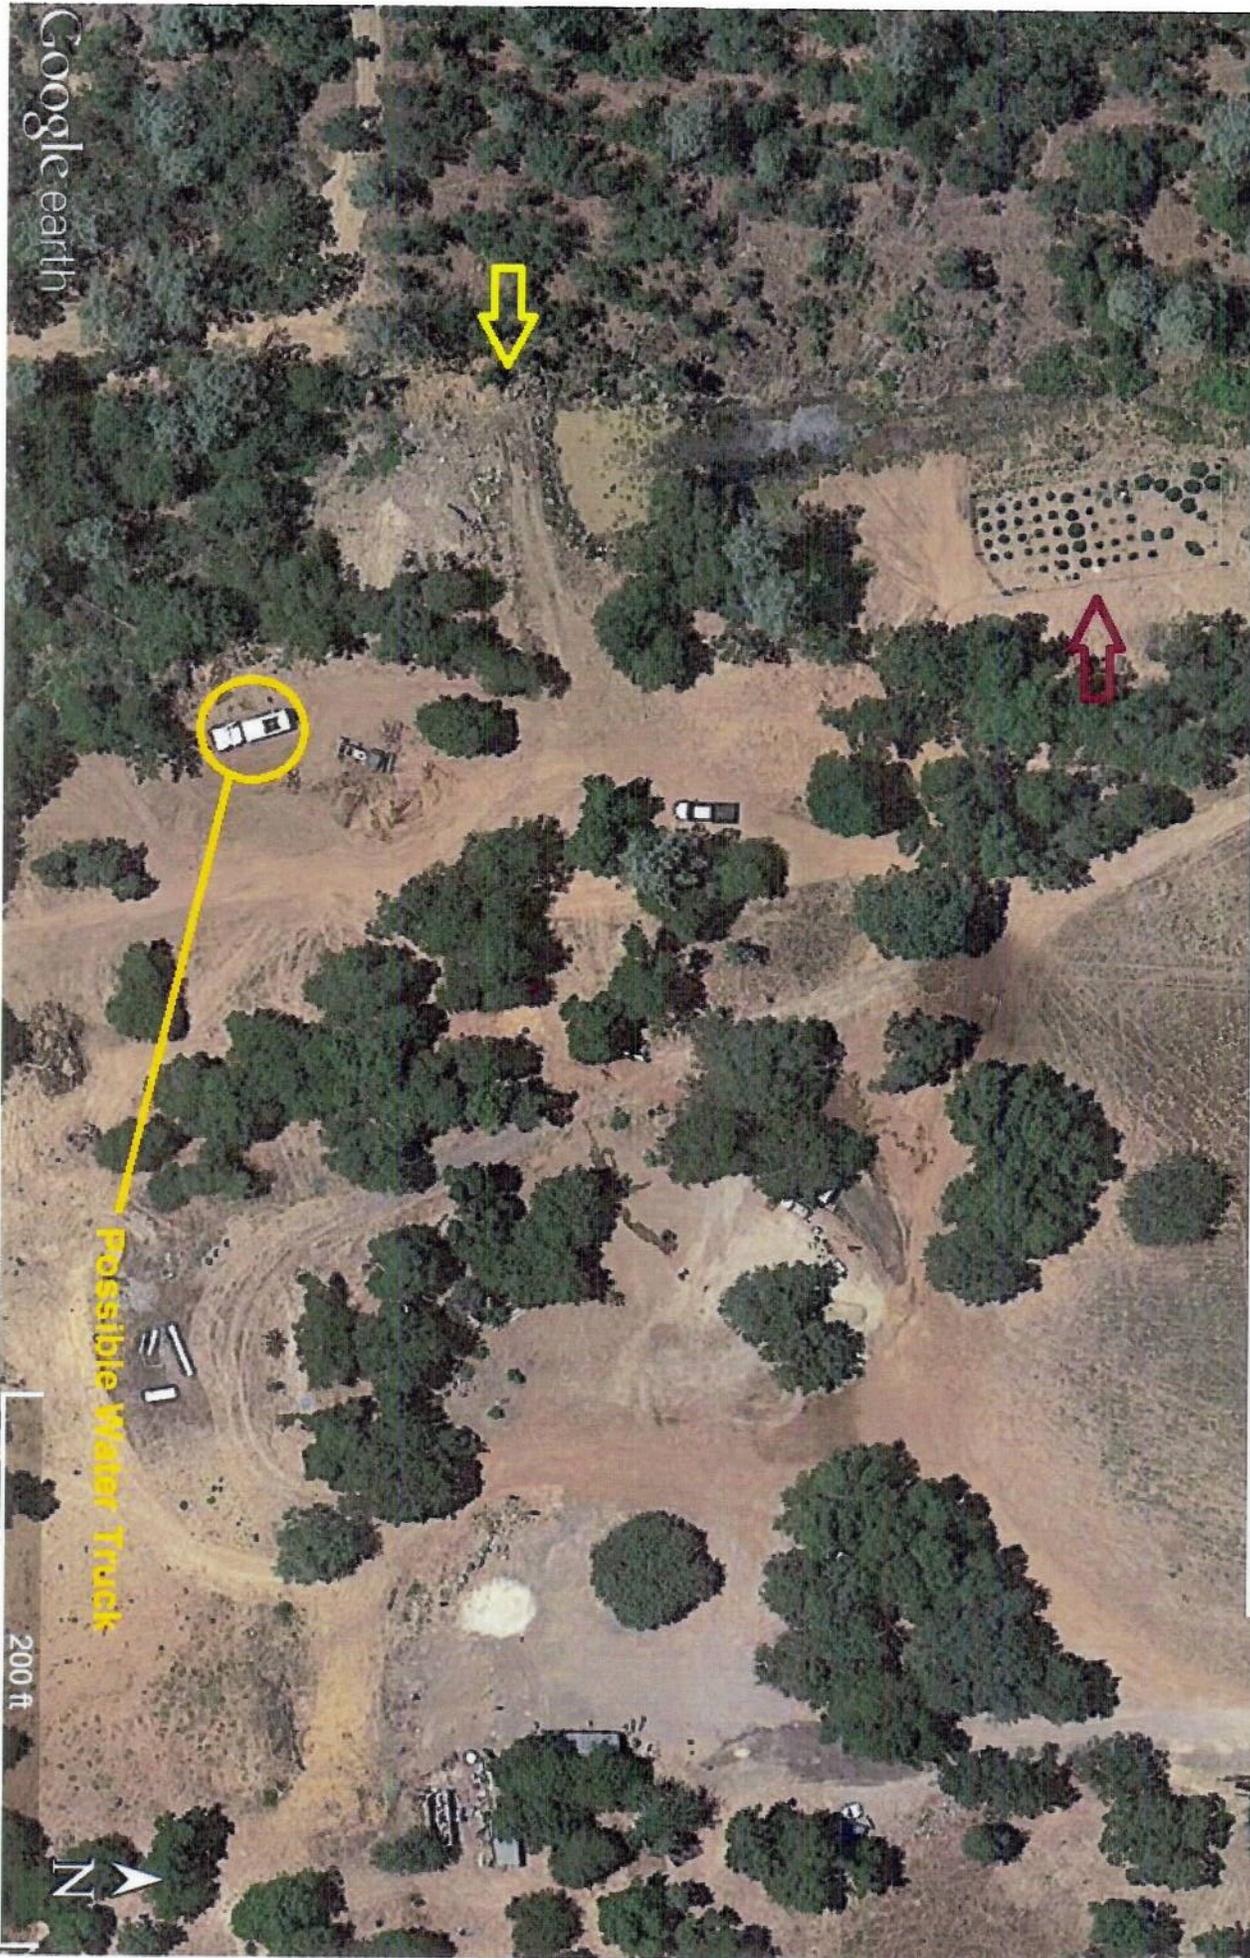
2011

Shasta County APN: 306-250-004-000: "Intact" Dam Structure (yellow arrow) visible from satellite imagery and potential "grow" site (red arrow) visible in the widened streambed to the east of the natural channel. Additional clearing/grading visible to the south east of the dam. What appears to be a water truck is also visible to the south east within the newly cleared area. Google Earth Imagery Date: 7-28-2011.

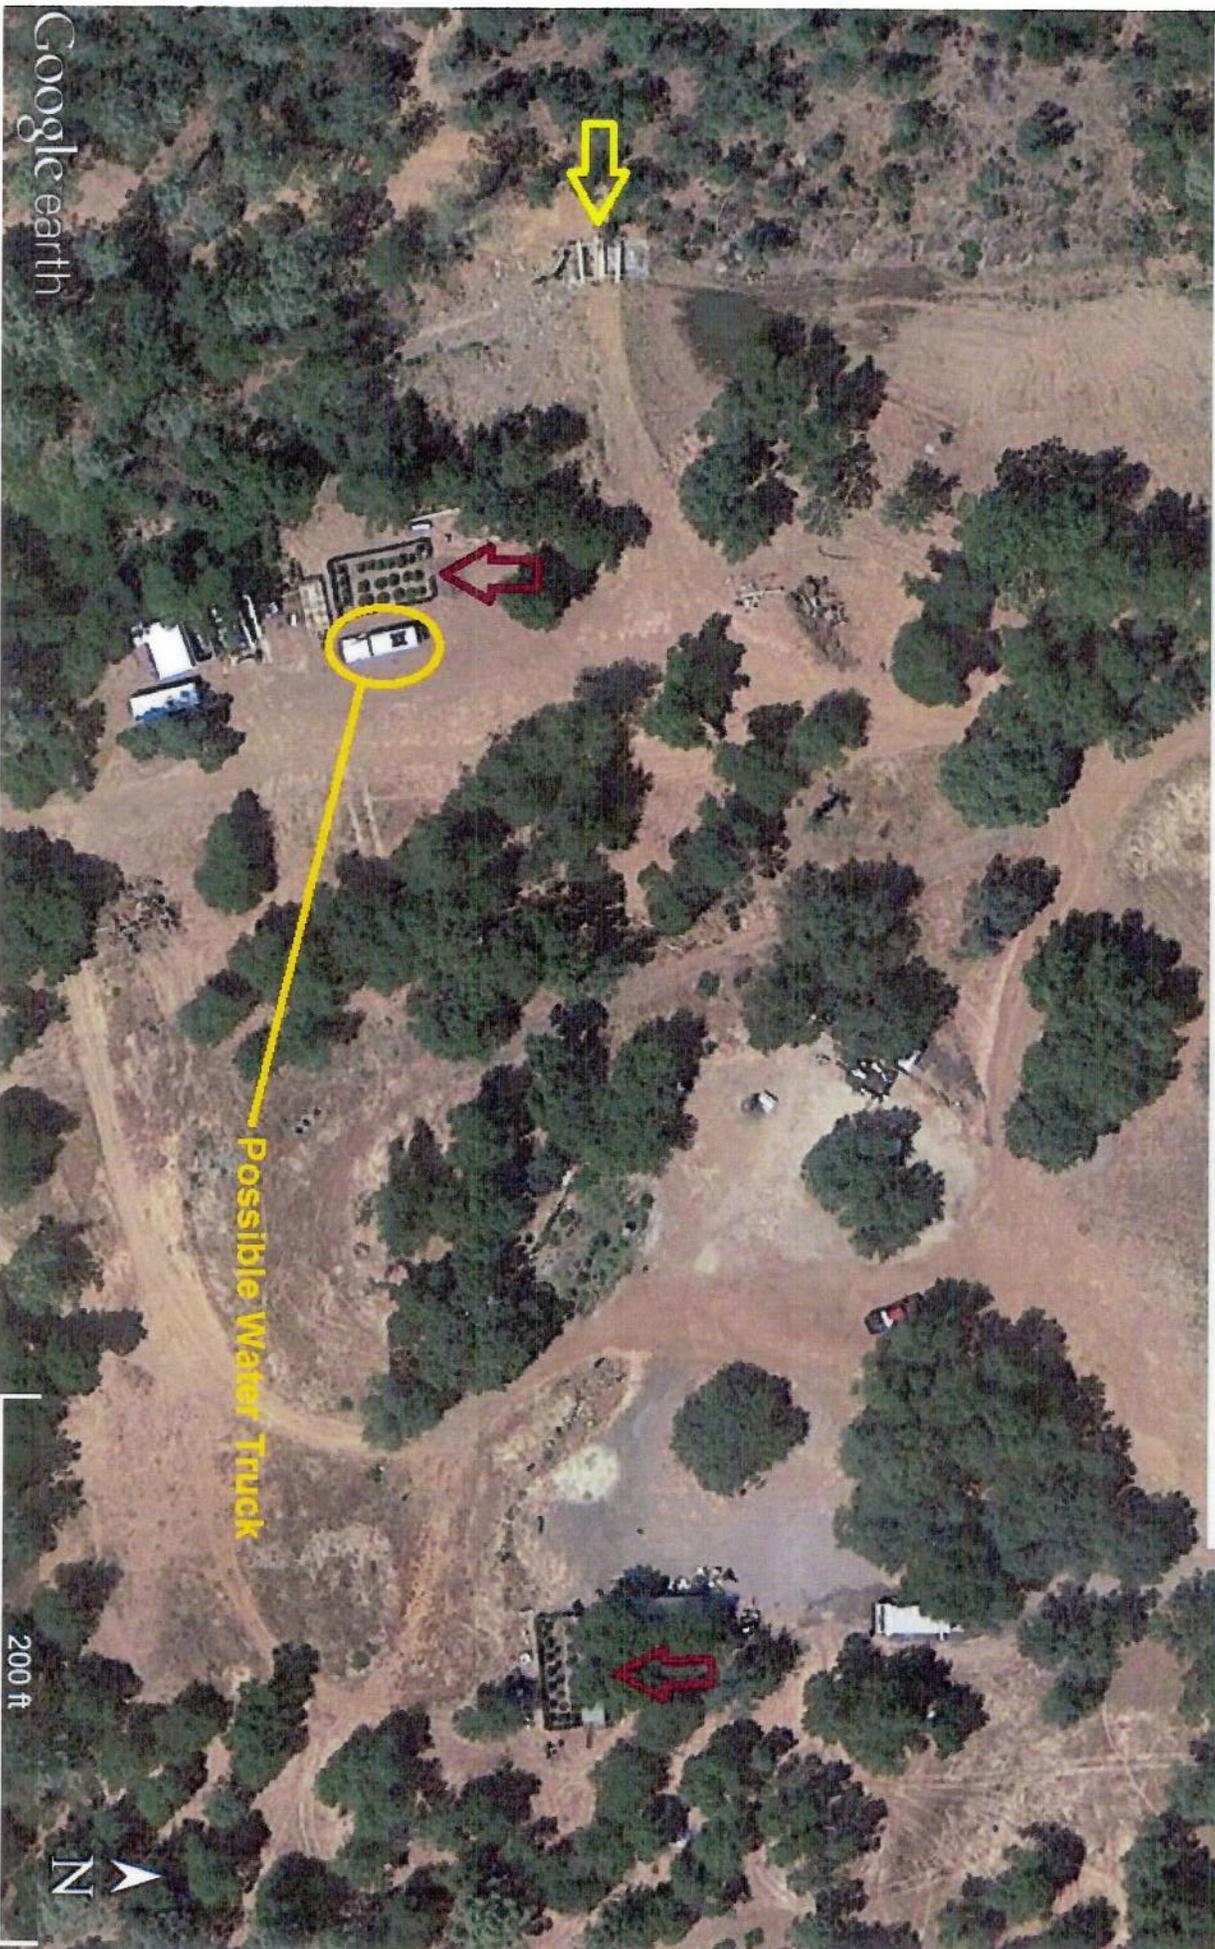
2012

Shasta County APN: 306-250-004-000: "Failed" Dam Structure (yellow arrow) with supports visible from satellite imagery and tree clearing with potential marijuana "grow" sites (red arrows) visible in two smaller plots on the property to the east and south of the Dam Structure. What appears to be a water truck is parked adjacent to the "grow" site to the south of the Dam Structure.
Google Earth Imagery Date: 7-09-2012.

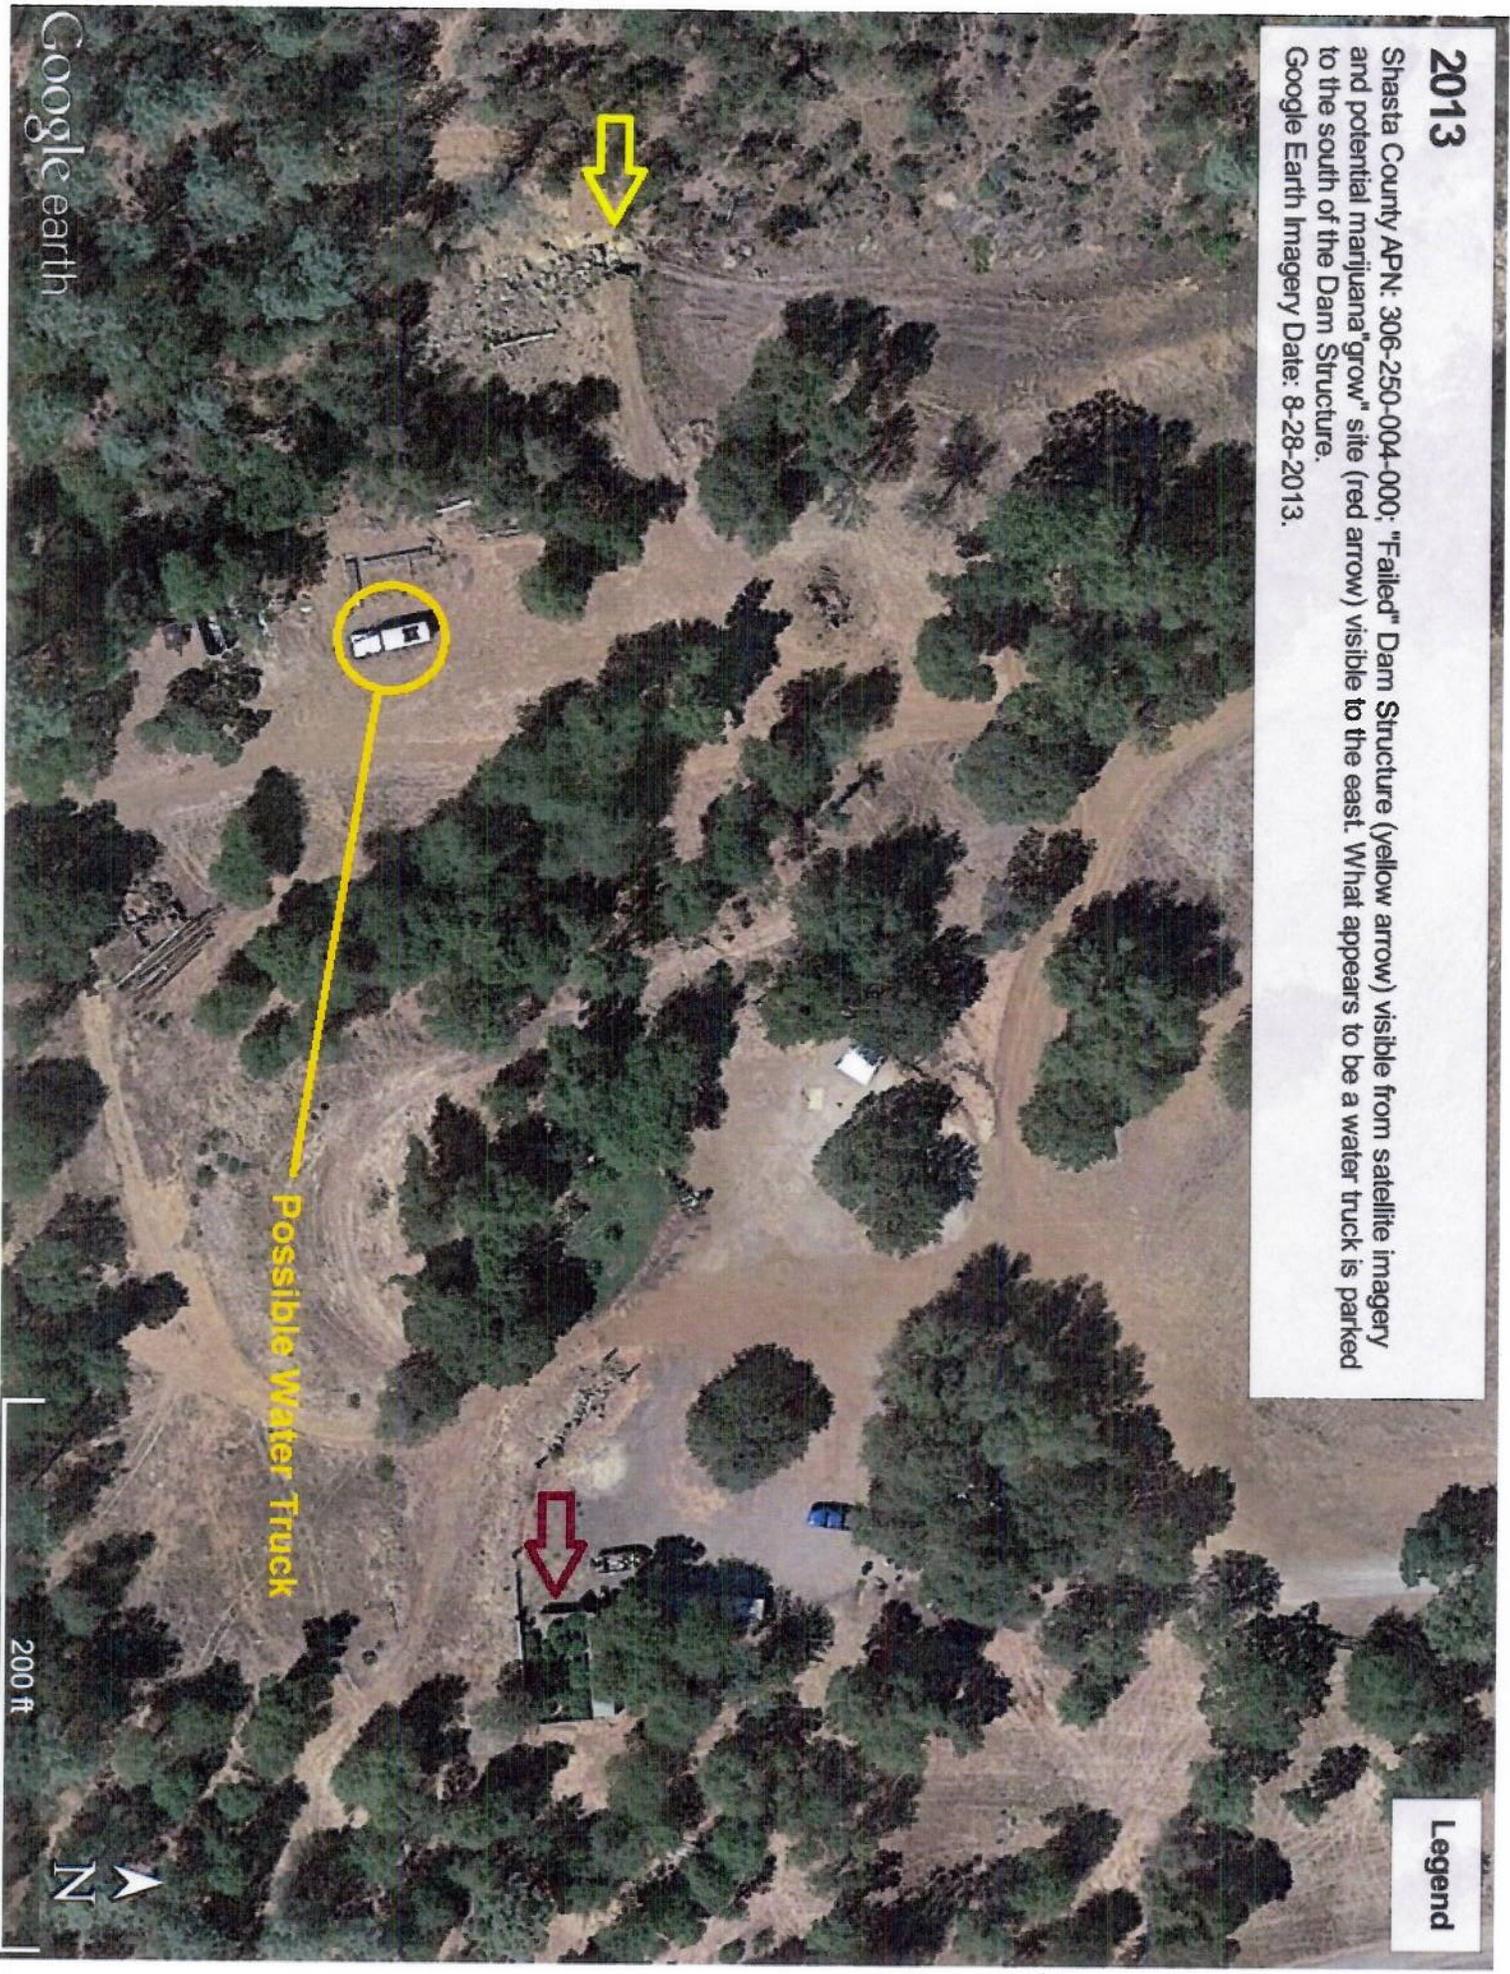
2013

Shasta County APN: 306-250-004-000: "Failed" Dam Structure (yellow arrow) visible from satellite imagery and potential marijuana "grow" site (red arrow) visible to the east. What appears to be a water truck is parked to the south of the Dam Structure.
Google Earth Imagery Date: 8-28-2013.

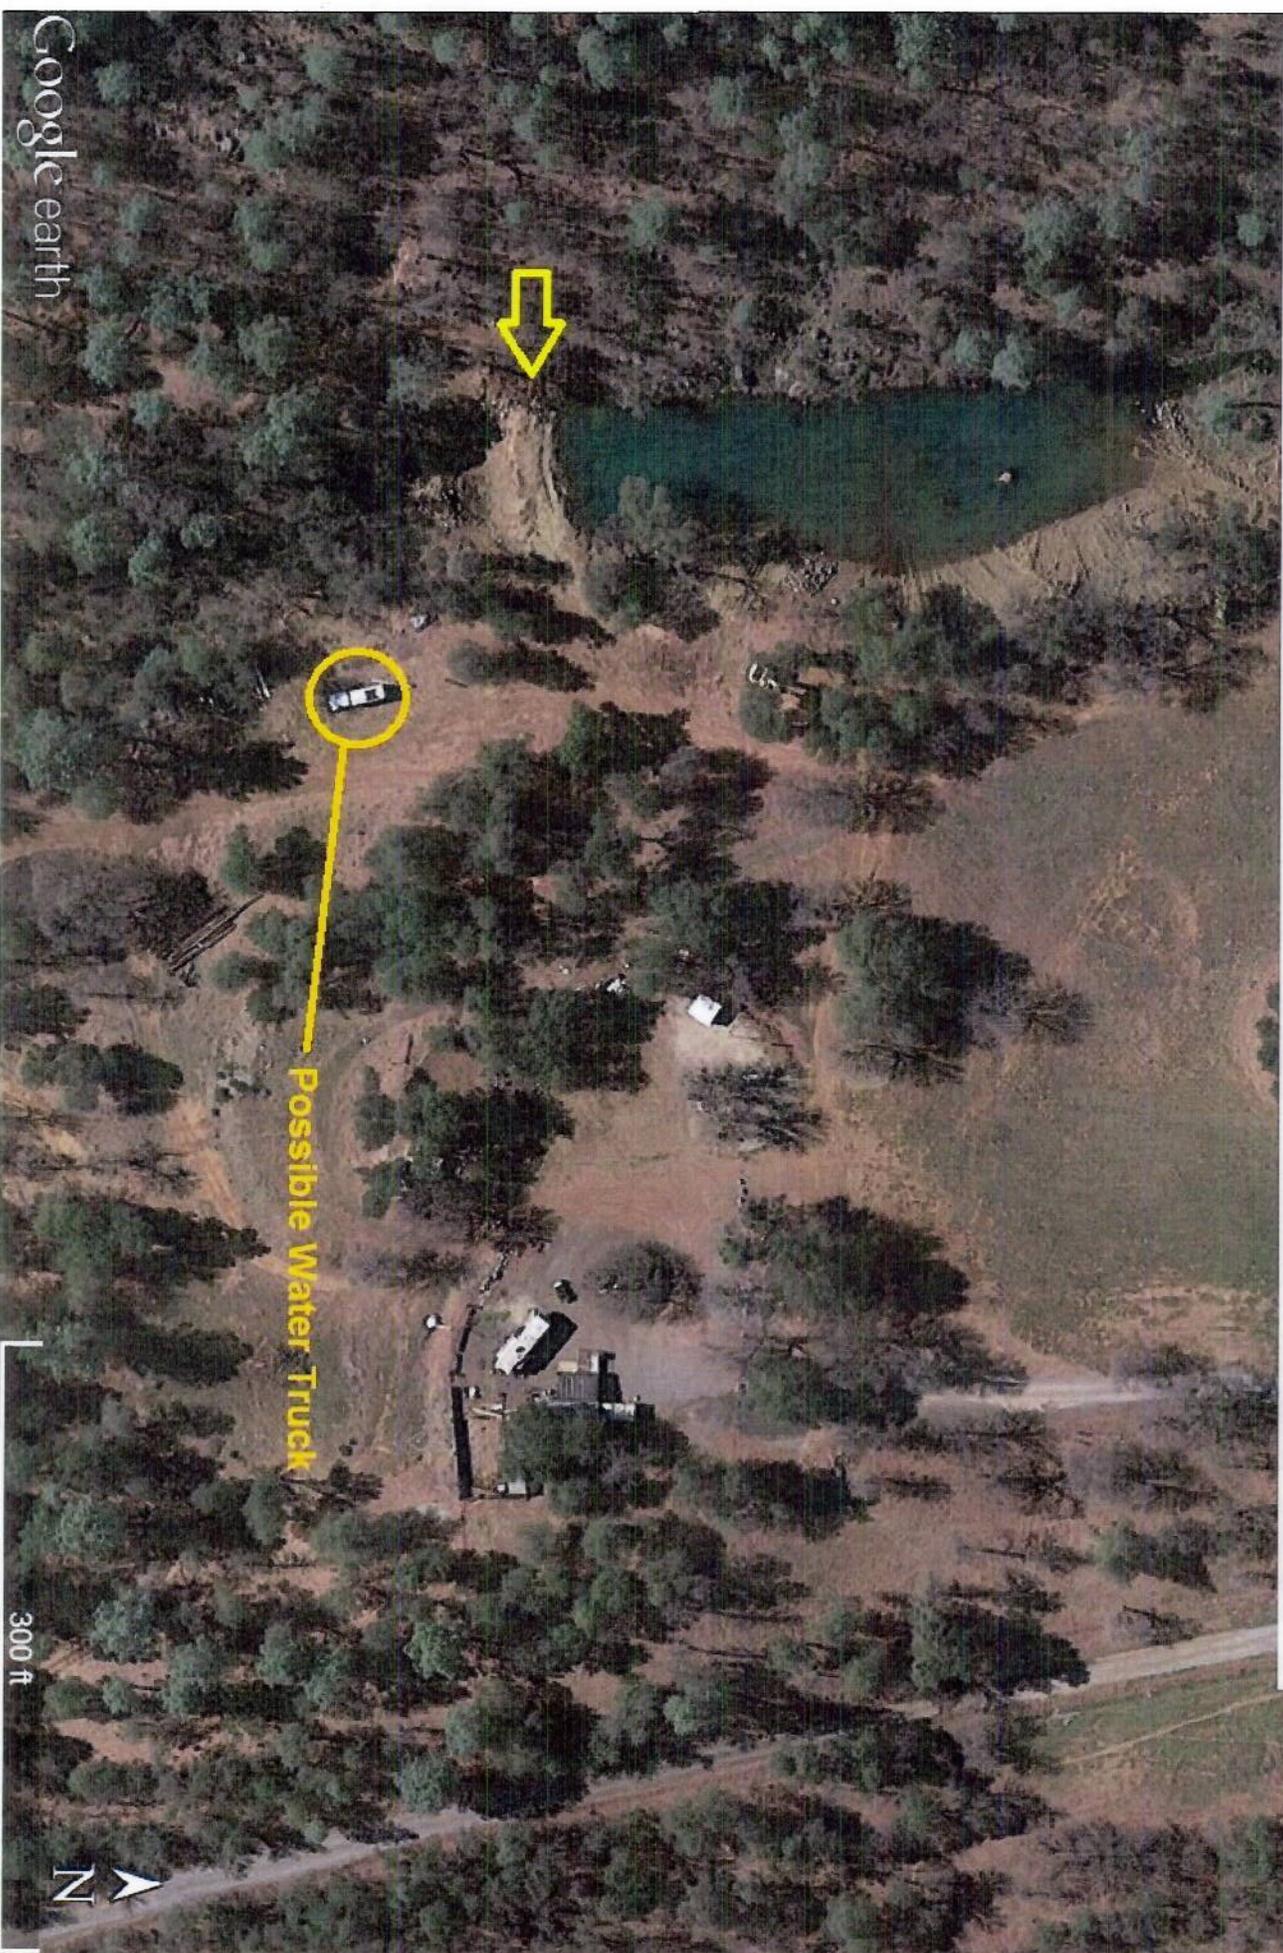
2014

Shasta County APN: 306-250-004-000; "Repaired" Dam Structure (yellow arrow) and impounded water visible from satellite imagery. What appears to be a water truck is parked to the south of the Dam Structure. Google Earth Imagery Date: 2-22-2014.
