Description and Photo-Documentation of Field Work Activities – Westside Monitoring Station Maintenance

Report 4.1.1

December, 2013

Ecological Engineering Research Program
School of Engineering & Computer Sciences
University of the Pacific
3601 Pacific Avenue
Chambers Technology Center
Stockton, CA 95211

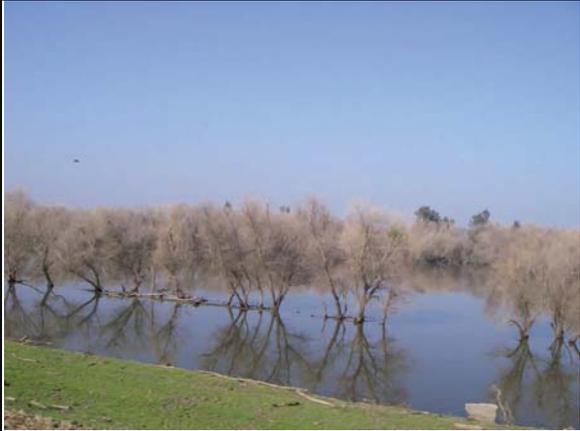
Ramona Lake Drain
Ramona lake is flooded.

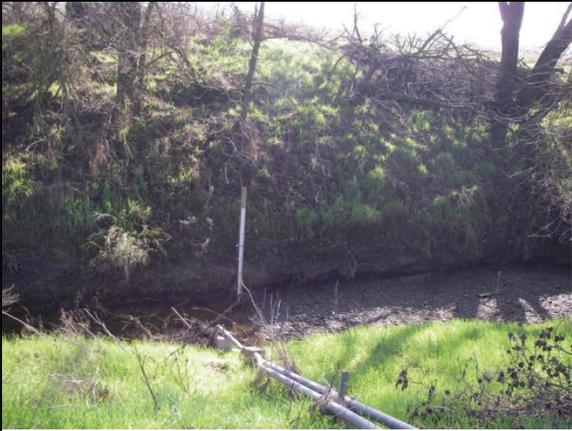
Del Puerto Creek
Del Puerto Creek is dry.

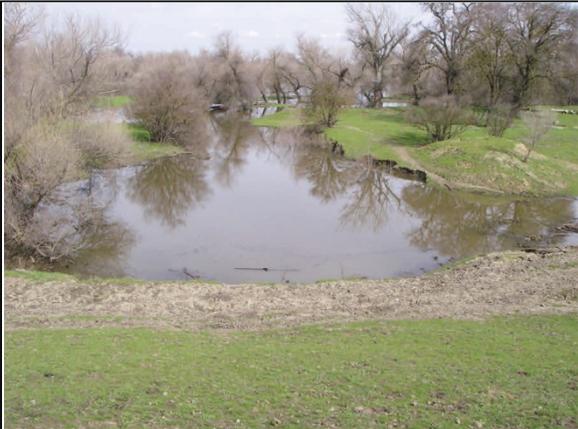
Ramona Lake Drain
The water level at Ramona Lake is unusually high.

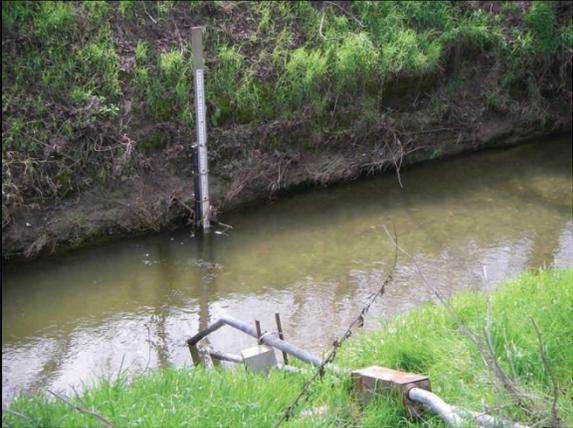
Del Puerto Creek
Backflow conditions exist at Del Puerto Creek.

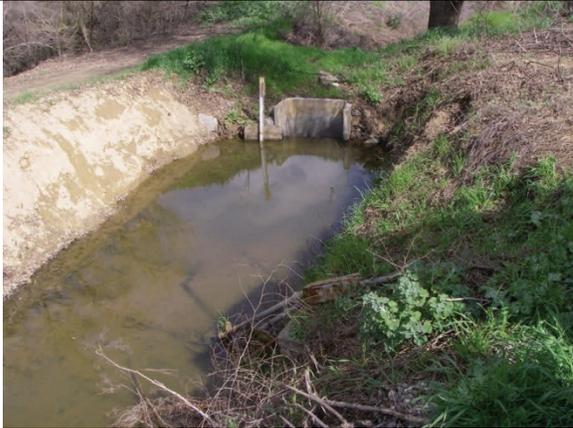
Westley Wasteway
The conductivity sensor is out of the water at Westley Wasteway.

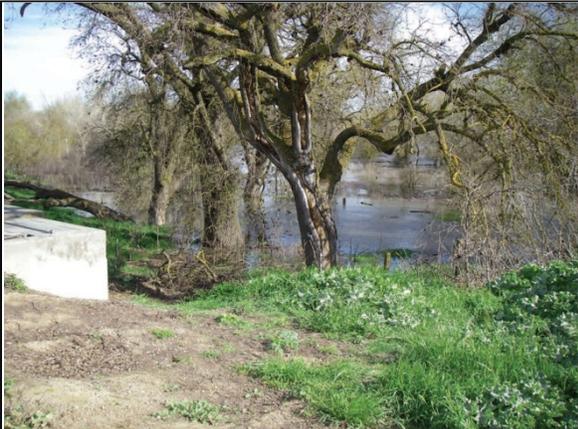
Spanish Grant Drain
Marshall and Spanish Grant drains are flooded.

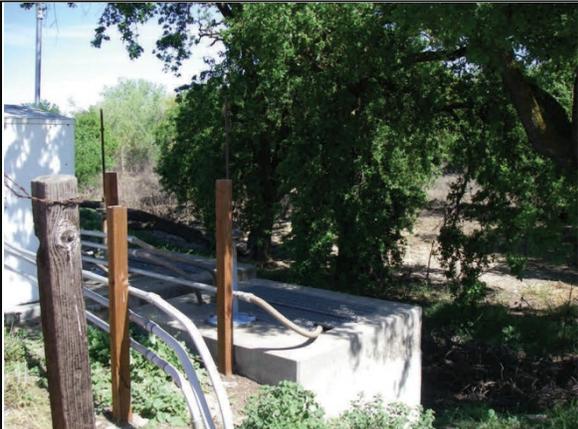
Spanish Grant Drain
The field behind Spanish Grant Drain which was flooded last month is now dry. A weir board had been removed from the drain.

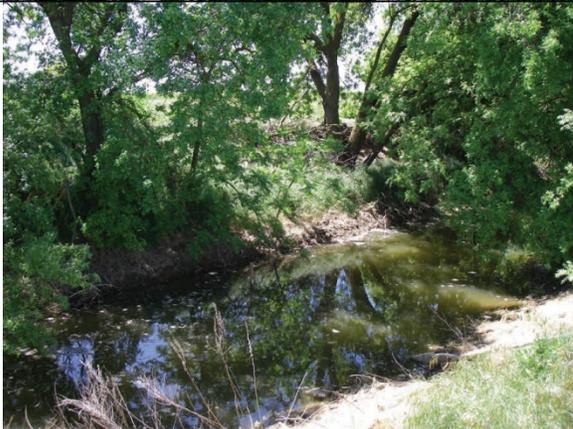
Del Puerto Creek
Backflow conditions exist at Del Puerto Creek.

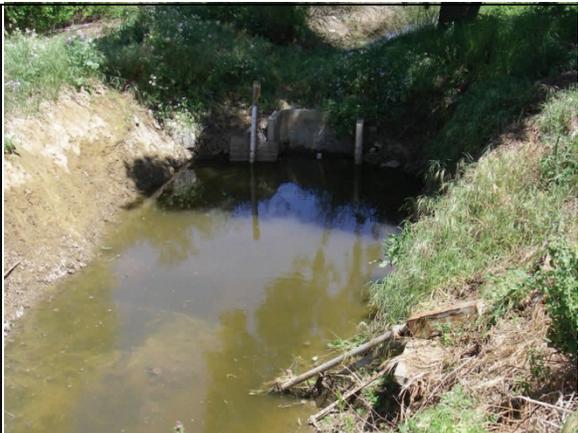
Westley Wasteway
The conductivity sensor was replaced at Westley Wasteway.

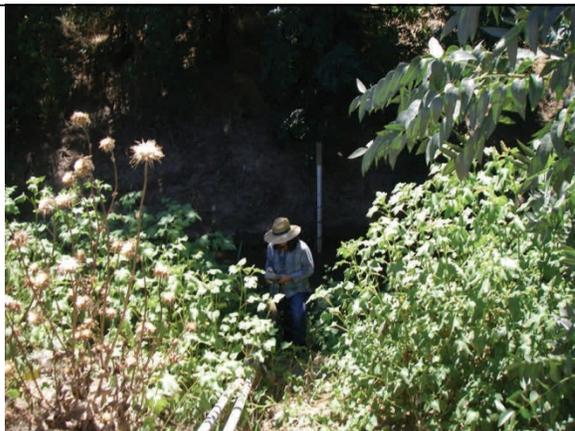
Del Puerto Creek is becoming over grown with vegetation.

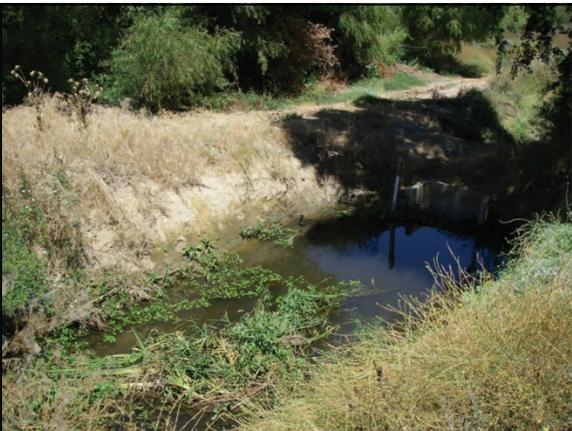
Westley Wasteway is frequently a collection point for dumped wastes such as wood, rocks, plant matter, and trash. The field team frequently removes this debris from around the weir boards and the sonde. On September 18, 2012 it was found that a large amount of broken concrete was dumped into the canal, effectively burying the sonde and altering the path of flow in the waterway. This issue has yet to be resolved and will require use of heavy equipment.

The debris at Westley Wasteway significantly reduced the flow of water.

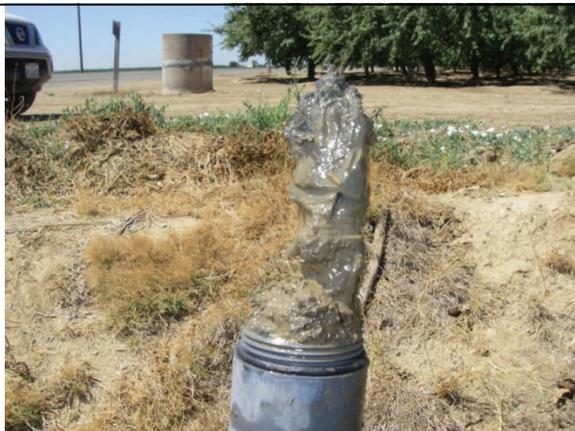
Ingram Creek

The sonde at Ingram was found to be packed in mud.

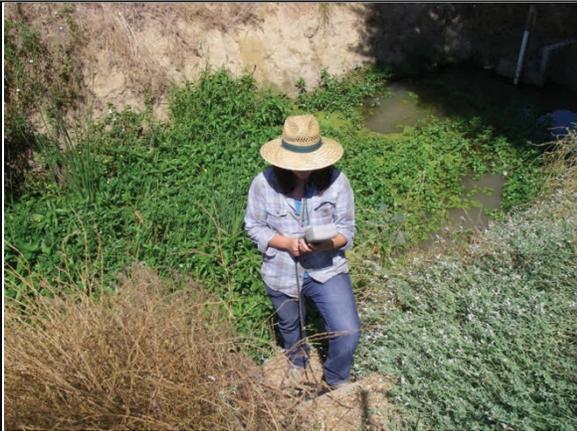
Westley Wasteway

Plant life in Westley is filling in the wasteway.

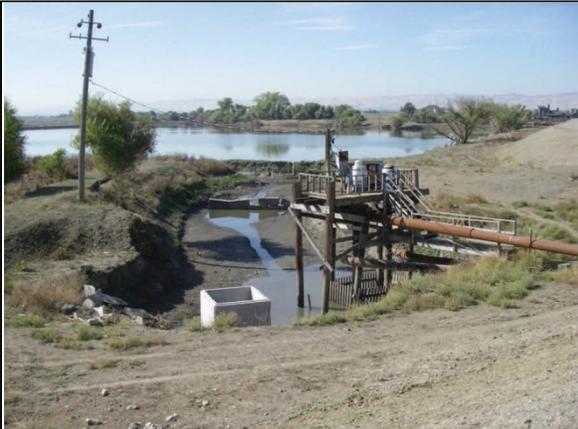
Ramona Lake Drain
The water level at Ramona Lake is unusually low.

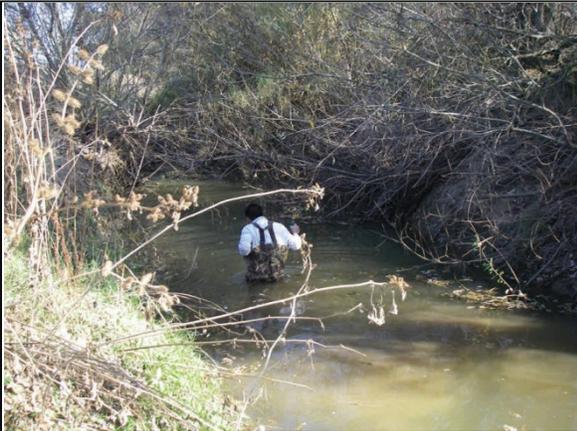
A dam formed downstream of the Del Puerto Creek flow station, creating backflow conditions and preventing the establishment of an accurate relationship between stage and flow. In addition, the creek bed is shifting and frequently covers the sonde in sediment which could affect accuracy of water quality measurements. This is in spite of the fact that the field team frequently digs the creek bed out around the sonde.

Mike investigates the cause of the backflow conditions at Del Puerto Creek.

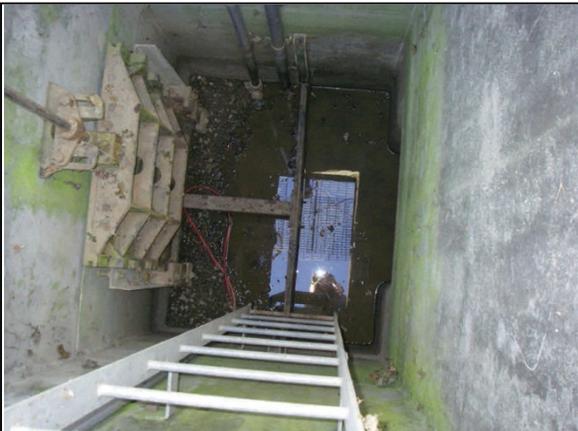
Moran Drain
There is no flow at Moran Drain.

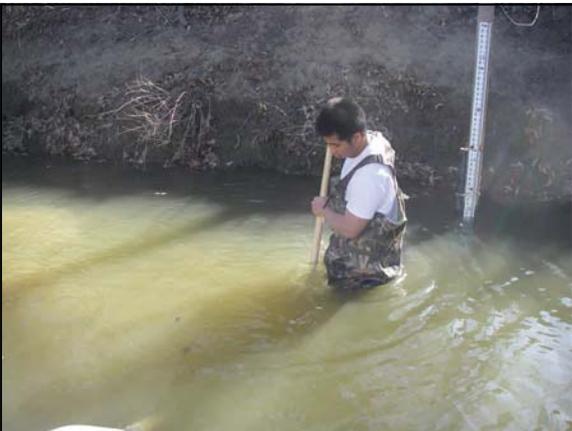
Del Puerto Creek
The rising creek bed at Del Puerto has risen to the level of the sonde. Mike digs out around it to ensure accurate measurements.

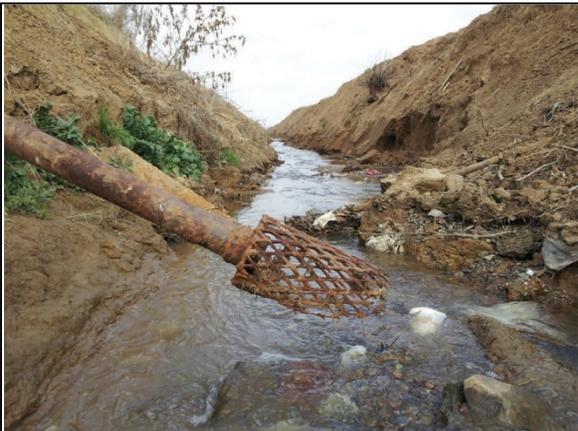
Dredging at Ingram Creek has caused severe erosion of the channel and the water level has fallen below the reach of the sonde. On July 19, 2012 when it was realized that the water level would never return to previous levels, the sonde was removed in order to preserve the sensors as well as prevent theft or vandalism. The sonde will be moved to a new location under the bridge next to the stage sensor in the spring of 2013.

Due to dredging, the water level has fallen below the sonde.

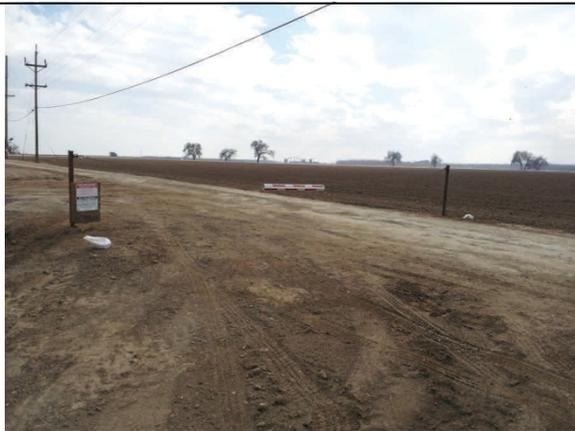
A steel cable was installed preventing truck access to the Del Puerto Creek station.

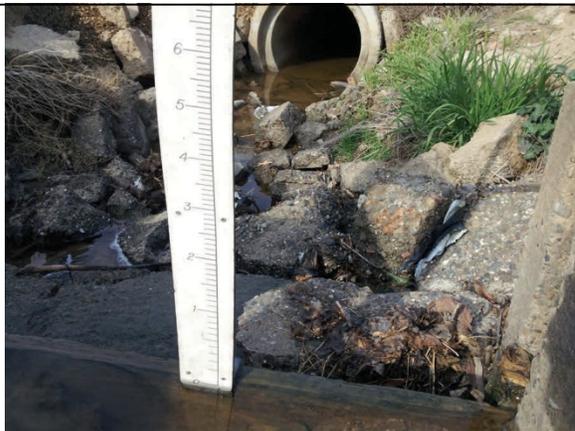
Hospital Creek

Due to low flow, it is impossible to make a measurement with a weir stick at Hospital Creek.

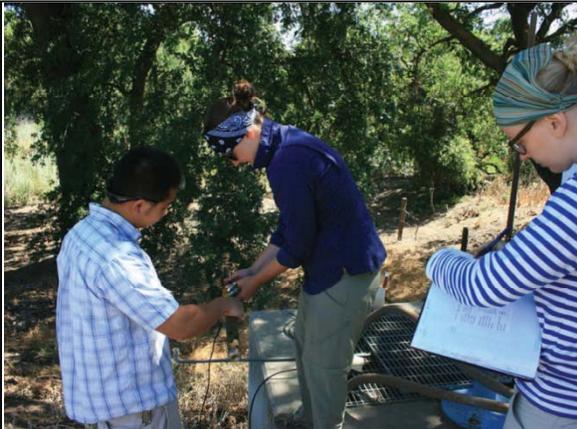
Marshall Road Drain

determined that the cable was defective and it was shipped to the manufacture for repair. A replacement cable was installed on July 24, 2012 and logging capabilities were restored. On October 30, 2012, the sonde was found to be reading negative values for temperature and SpC. The sonde was brought back to the EERP lab and it was determined that the sonde must be sent to the manufacturer for repair. EERP is currently waiting to receive the repaired sonde from the manufacturer. On December 11, 2012, the logger would not turn on. The battery was brought back to EERP lab for recharging and was reinstalled on January 10, 2013.

The team runs diagnostics after it is discovered that no measurements have been logged at Marshall Road Drain. The logger is removed and brought back to the lab.

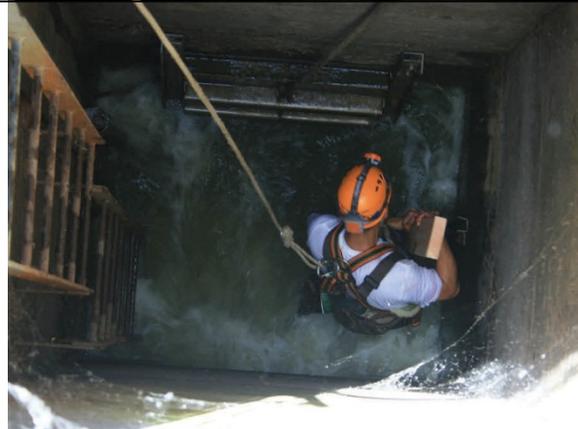
Ramona Lake Drain

On August 9, 2011, it was discovered that one of the weir boards had broken off and that water was leaking through gaps in the remaining boards. After several attempts to re-situate the existing boards, they were replaced with entirely new boards by EERP on June 19, 2012. Frequent movement of the boards by local land owners makes it particularly challenging to maintain a flow to discharge relationship.

Mike goes into the drain to replace a broken weir board.

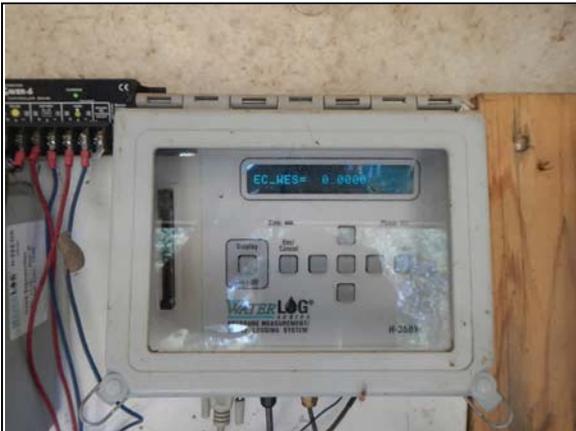
No specific conductance measurements were available until the sensor was replaced on April 27, 2011. Due to wet dirt roads, the site was inaccessible on March 30, 2011. On July 24, 2012, it was discovered that the sonde at Westley would not take measurements. The field team switched the sonde with the one that was removed from Ingram and water quality measurements resumed. On September 18, 2012 it was discovered that the logger was not logging. The logger was removed and brought back to the lab for diagnostics. The logger is currently with the manufacturer undergoing repairs.

The sonde at Westley Wasteway isn't taking SpC readings. It is removed and taken back to the lab for diagnostics.

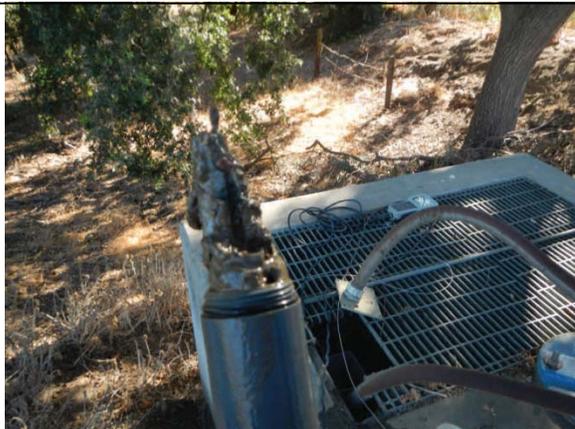
The sonde at Marshall Road Drain is packed in mud and worms.

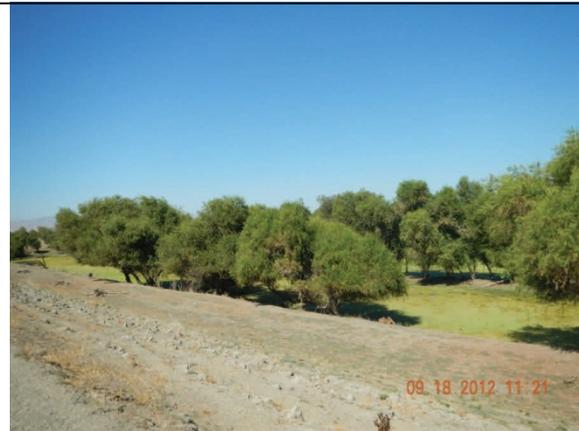
Ramona Lake Drain

The water around Ramona Lake is covered in duckweed.

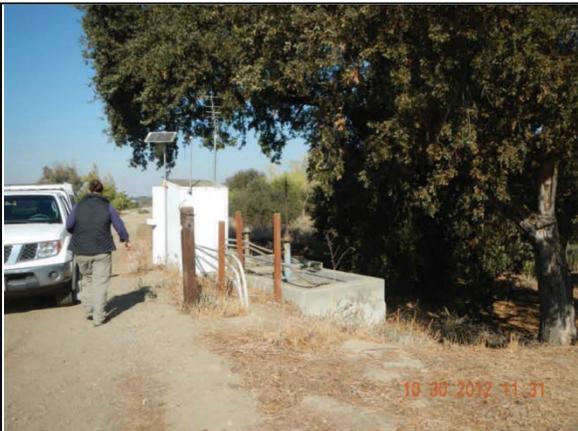
Marshall Road Drain

The sonde is removed and brought back to the lab after it was found to be taking negative SpC and temperature measurements.

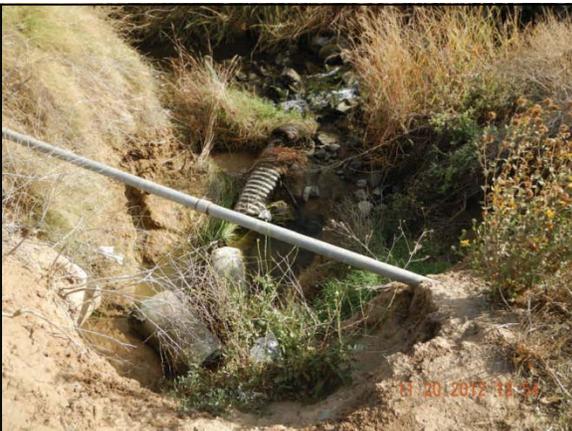
The area around a drain pipe at Ingram Creek is eroding away. You can see the sonde pipe which used to be buried.

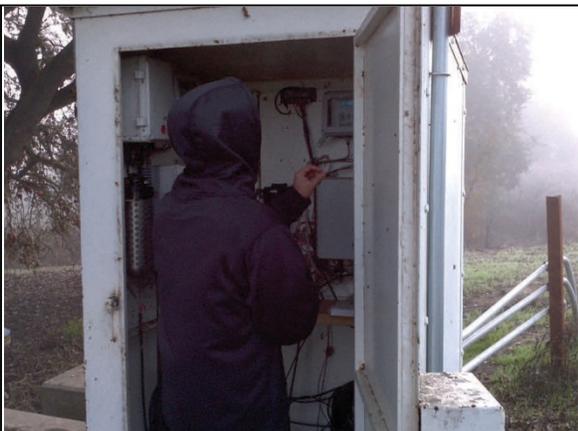
Marshall Road Drain

It appears the battery is dead at Marshall, Moran, and Spanish Grant drains. The battery is removed and brought back to the lab for recharging.

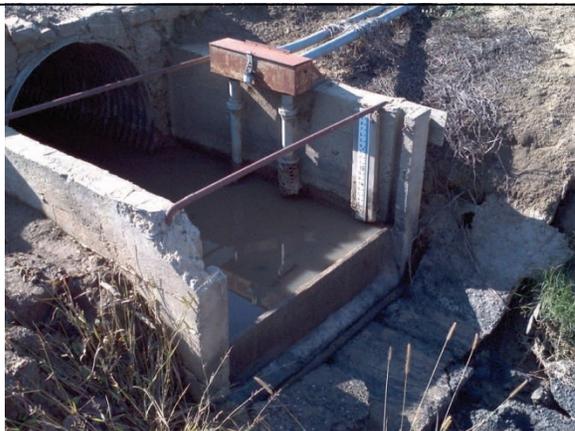
There is too little flow at Hospital Creek to take a stage or weir measurement.
