## TECHNICAL MEMORANDUM

# System-wide Evaluation to Identify Restoration Opportunities

**San Bernardino County  
Flood Control District**

January 2011

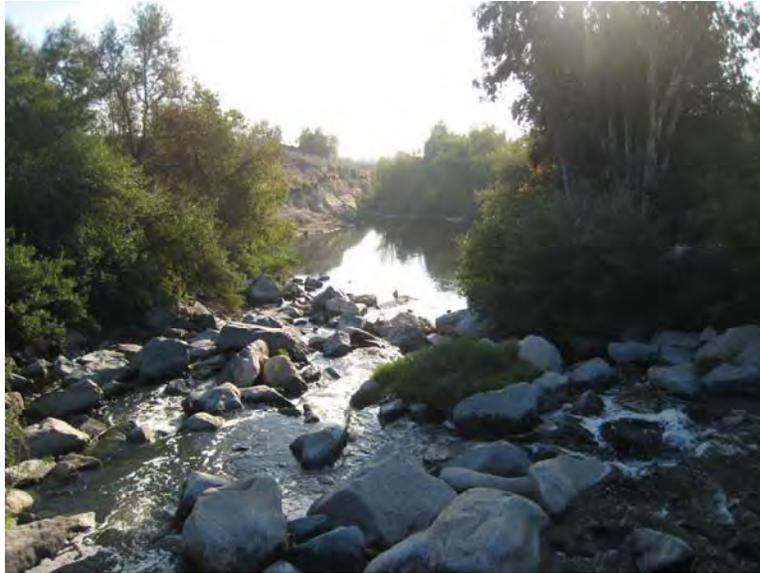
**Figure 2: Site No. 1 Upstream View**

**Site No. 1: Cucamonga Channel Restoration Site** is located near the Chino Corona Road crossing in the City of Chino, CA. This section of the channel is classified as non- Engineered, Hardened, and Maintained (EHM) with significant degradation and stretches from an upstream EHM channel to Prado Damhere. There is ample space to widen and restore the natural channel.

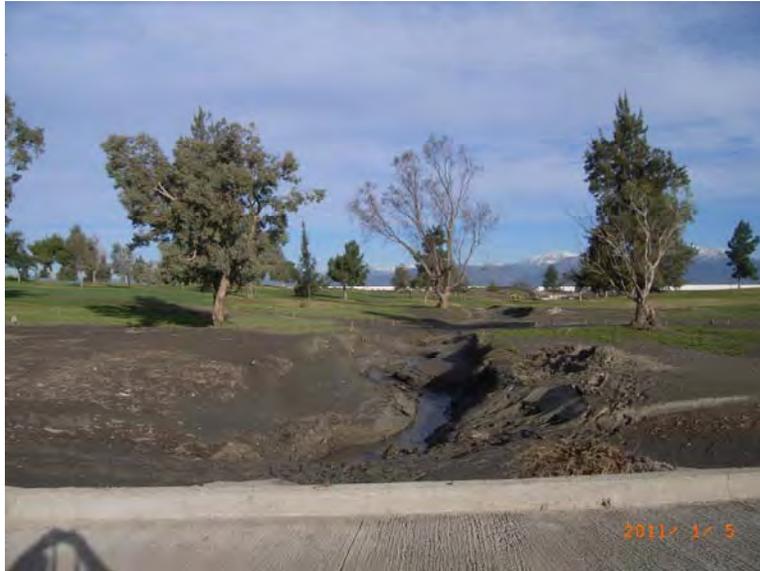
**Figure 4: Site No. 2 Upstream View**

**Site No. 2: Cypress Channel Restoration Site** is located within the El Prado Golf Course along Pine Avenue in the City of Chino. This section of the channel is classified as non-EHM and varies in size and shape throughout the site. Generally, the channel is a natural earthen trapezoidal channel with turf as the bank protection. There is significant degradation and erosion, and aesthetically, restoration would be very beneficial. This site is owned by the U.S. Army Corps of Engineers.

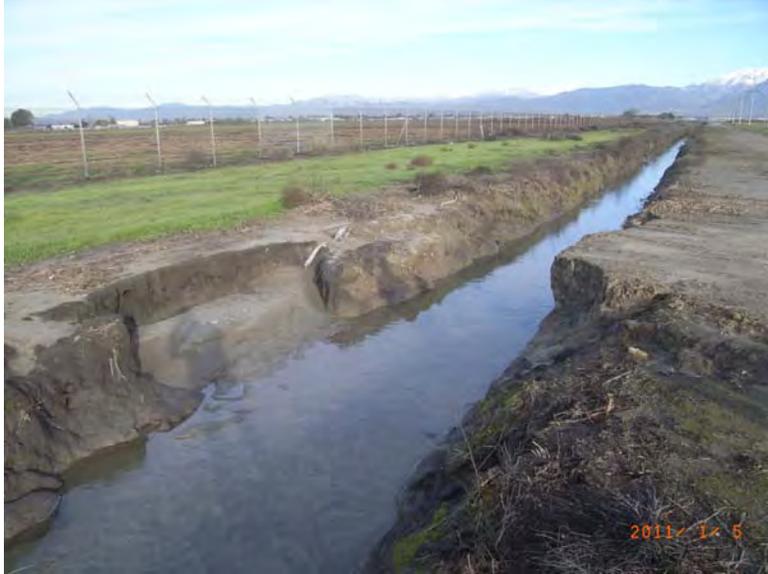
**Figure 6: Site No. 3 Upstream View**

**Site No. 3: Magnolia Channel Restoration Site** is located between Edison Avenue and Kimball Avenue in the City of Chino, CA. The channel has not been classified but is an earthen trapezoidal channel with a bottom width of approximately 5 feet. The bank protection is in poor condition, and there are signs of bank and toe erosion. There is some potential for widening the channel to the west.

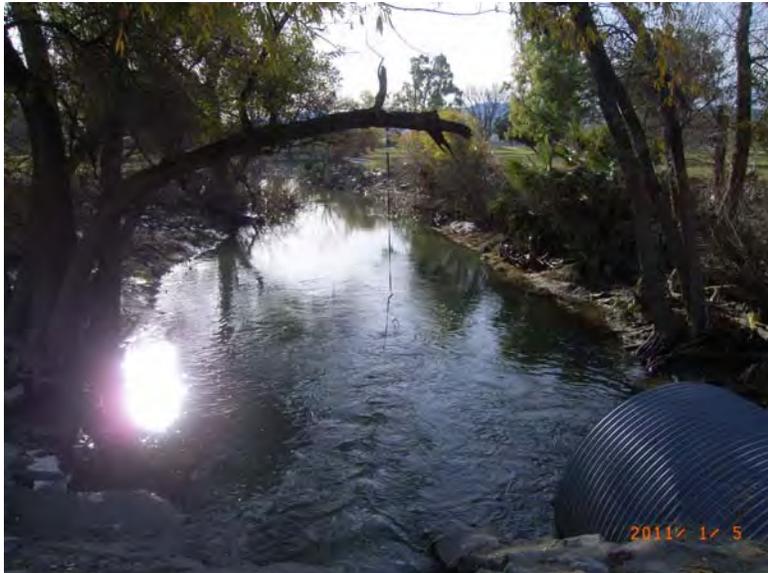
**Figure 8: Site No. 4 Downstream View**

**Site No. 4: San Antonio Channel Restoration Site** is located within the El Prado Golf Course along Pine Avenue in the City of Chino, CA. This section of the channel is classified as non-EHM and is a trapezoidal channel with riprap bank protection. There is some toe erosion, but the majority of the channel is stabilized. Restoration would most likely only consist of a general cleanup of the channel and vegetation stabilization, but there is sufficient room for widening the channel.

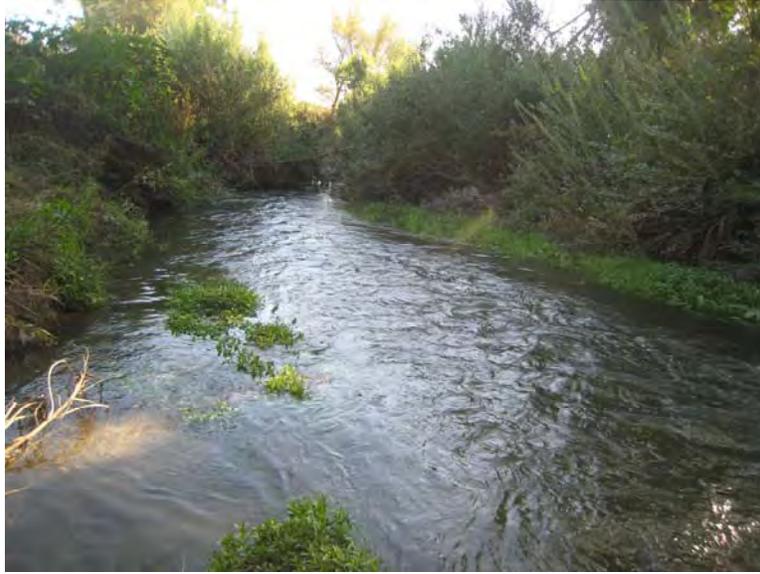
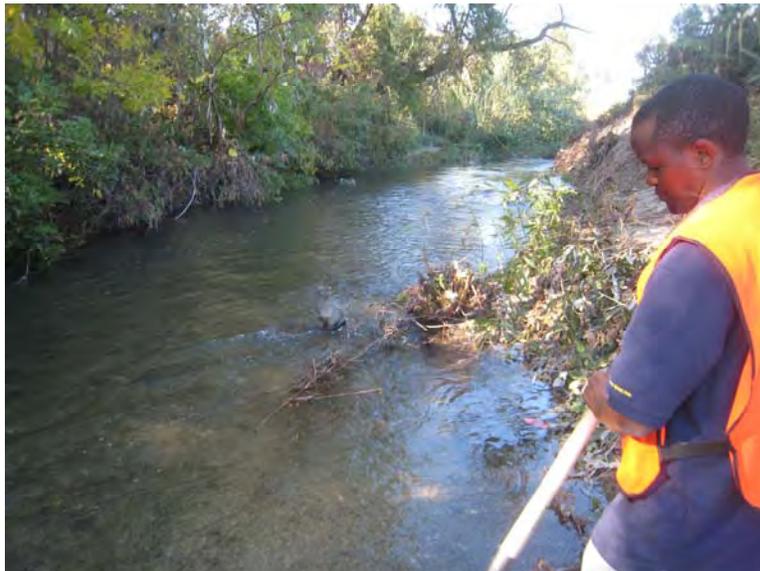
**Site No. 5: San Antonio Channel Restoration Site** is located adjacent to El Prado Road and between Central Avenue and the wastewater plant in the City of Chino. This section of the channel is classified as non-EHM and is a natural channel. There is heavy vegetation along the banks, but significant degradation has occurred to the invert of the channel. There is sufficient room to widen the channel.

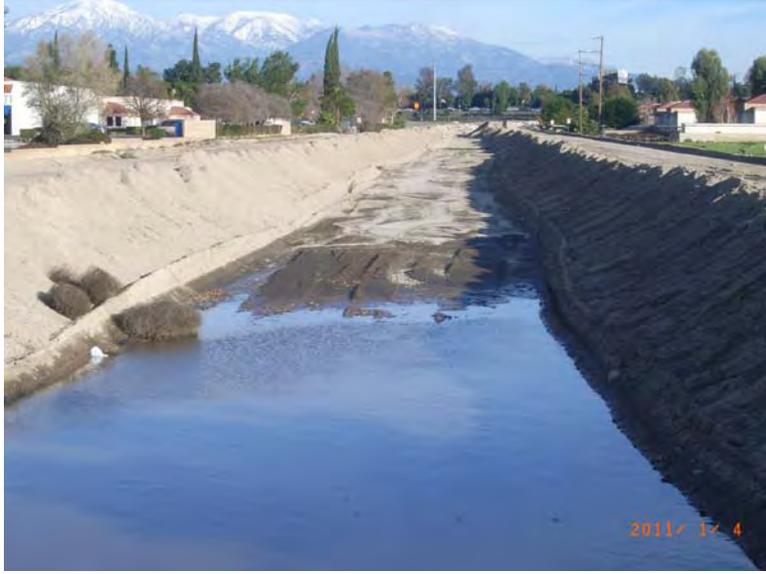
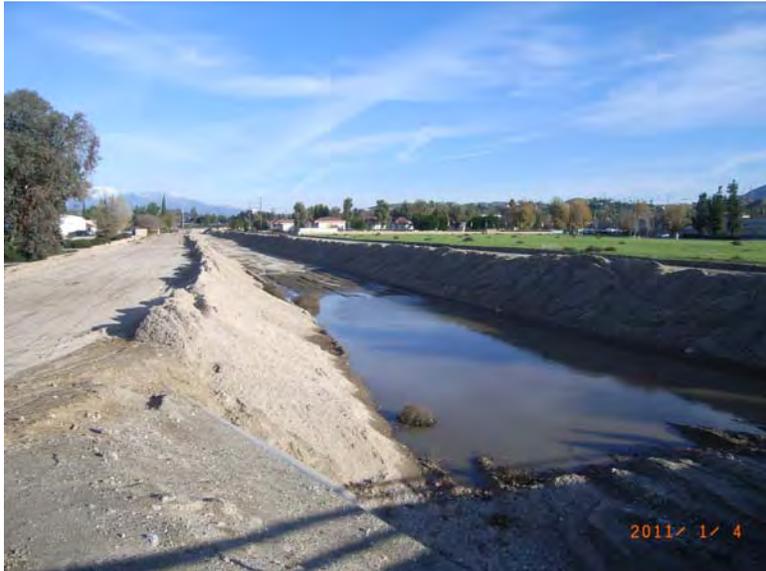
**Site No. 6: Reche Canyon Channel Restoration Site** is located between Interstate 215 and the Santa Ana River in the City of Colton. This section of the channel is classified as EHM and is an earthen trapezoidal channel. The channel had recently been maintained at the time of the site visit, but there were signs that toe and bank erosion had occurred. The access roads would need to be modified to widen the channel.

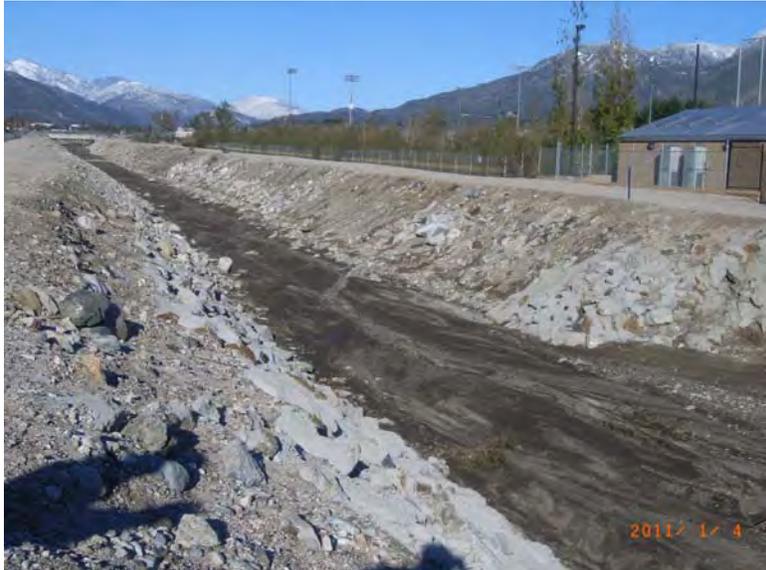
**Figure 14: Site No. 7 Upstream View**

**Site No. 7: Cable Creek Restoration Site** is located between N. Little League Drive and Palm Avenue in the City of San Bernardino. This stretch of Cable Creek is classified as an EHM channel and has riprap-lined banks. The channel invert is showing signs of aggradation, most likely due to the downstream drop structures. There is ample room for widening the channel.

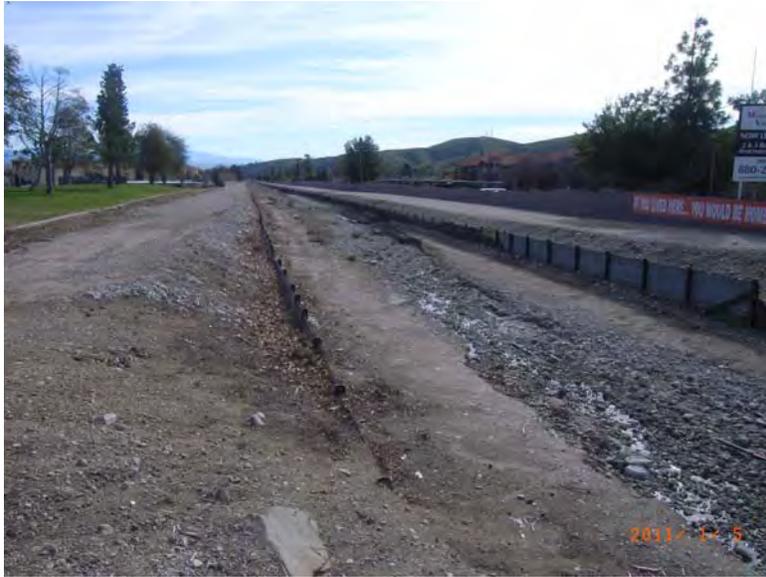
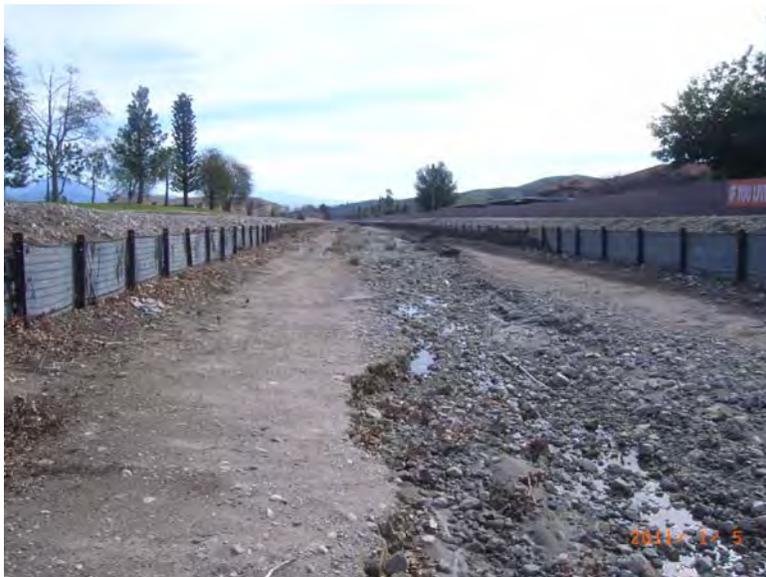
**Site No. 8: Devil Creek Channel Restoration Site** is located between University Parkway and Western Avenue in the City of San Bernardino. This section of the channel is classified as EHM and the bank protection consists of corrugated metal piles, which are in poor condition. The channel shows signs of minor toe erosion and invert degradation. Stretches of the channel have sufficient room for widening, but the majority of the channel would require modification to the access roads.

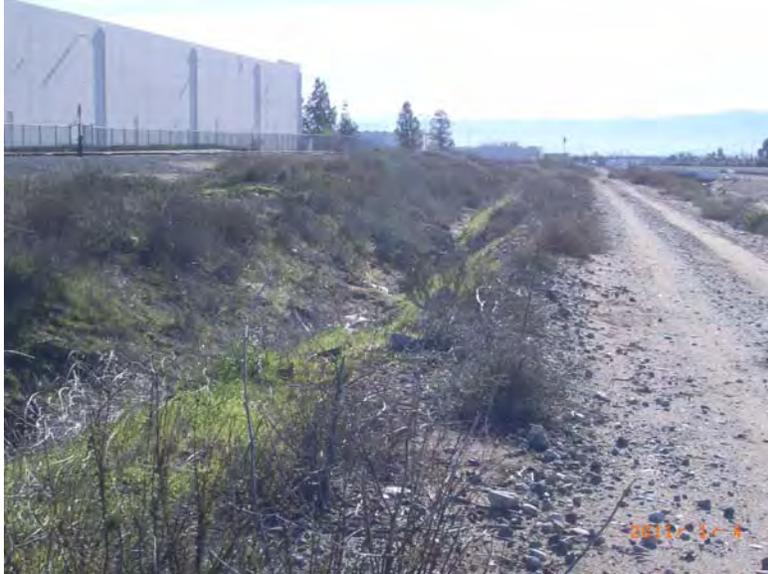
**Figure 18: Site No. 9 Downstream View**

**Site No. 9: Ono Storm Drain Restoration Site** is located adjacent to Cajon Boulevard and the railroad tracks in the City of San Bernardino. This section of the channel is classified as EHM and is a small, vegetated trapezoidal channel. There are signs of toe erosion and invert degradation, but neither is significant. This site will likely require additional right-of-way from the adjacent owner in order to widen the channel.

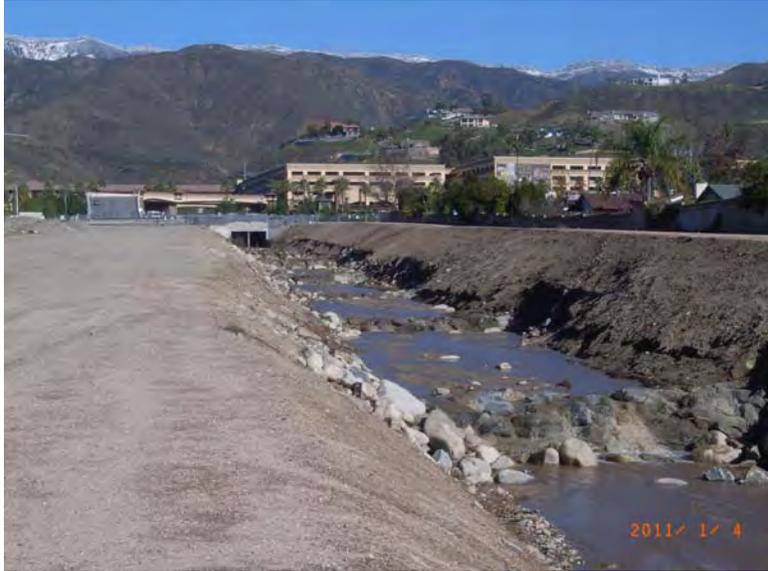
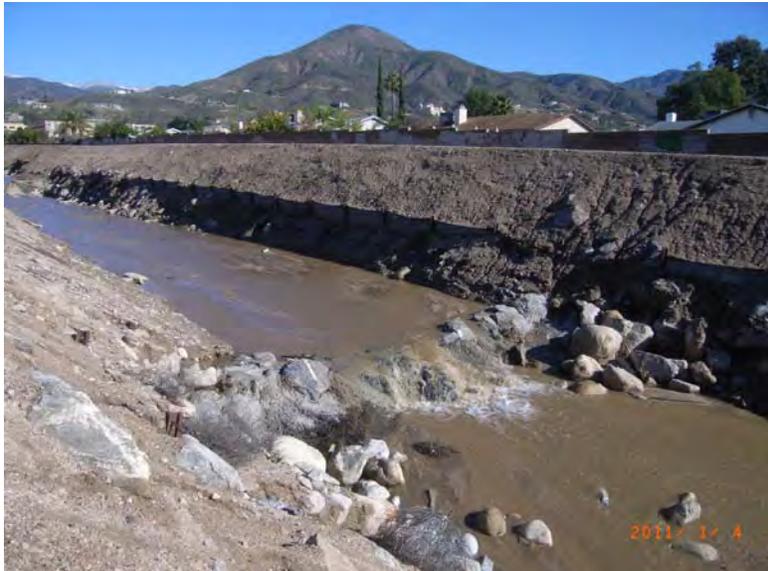
**Site No. 10: Sand Creek Restoration Site** is located between Lynwood Drive and Patton Basin in the City of Highland. This section of the channel is classified as EHM and is a trapezoidal shaped channel with corrugated metal piles protecting the banks. The channel also has drop structures every 100-200 feet along the invert. Downstream is a large drop structure into Patton Basin. There is some bank and toe erosion, but the invert appears stabilized. There is sufficient room to widen the channel. Restoration could be aesthetically beneficial, because the San Manuel Indian Bingo and Casino has a direct line of sight to the channel.

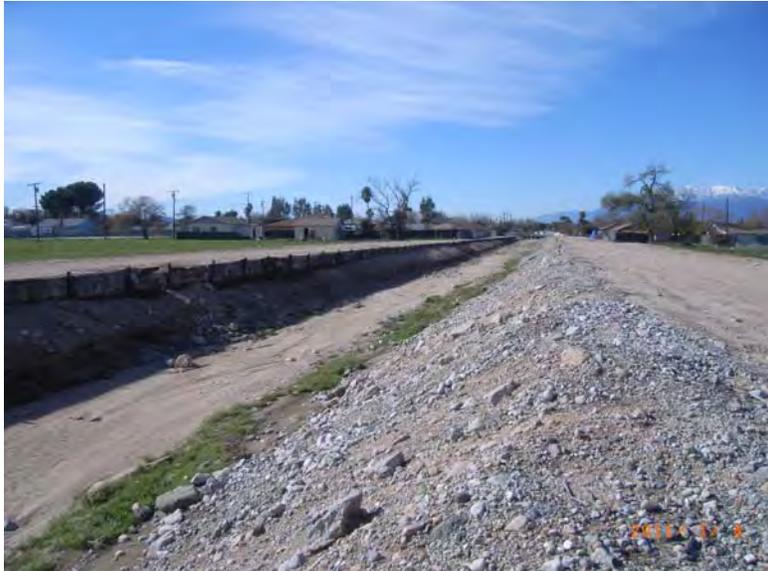
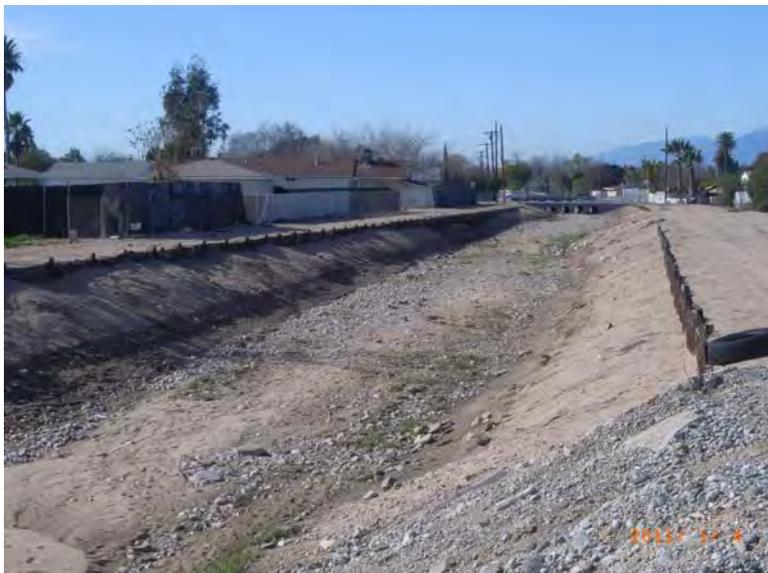
**Site No. 11: City Creek Restoration Site** is located between 3<sup>rd</sup> Street and Twin Creek Channel in the City of San Bernardino. This section of the channel is classified as EHM, with the banks being protected by corrugated metal piles and some river rock along the invert. The corrugated metal piles are starting to fail, and there are signs of toe and bank erosion. For approximately 1000 feet downstream of 3<sup>rd</sup> Street, there is plenty of space for widening the channel, but over the majority of the restoration site, the access roads would have to be modified to accommodate the wider channel.

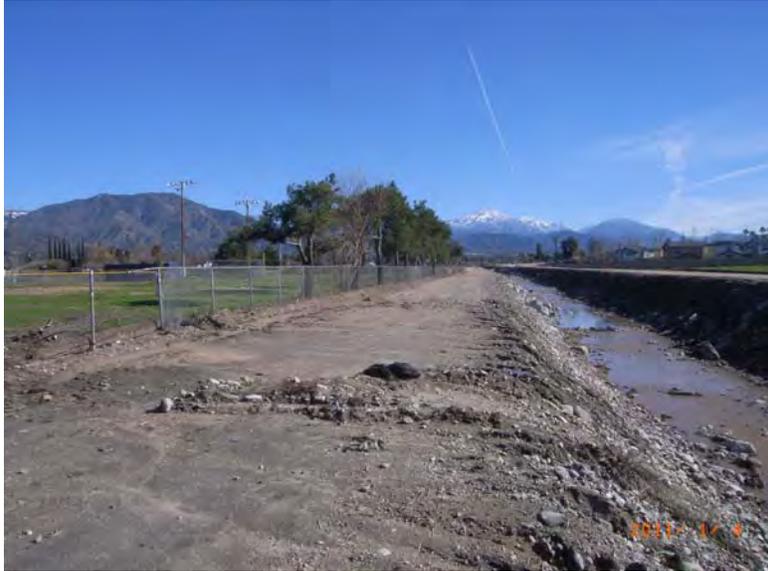
**Figure 24: Site No. 12 Upstream View**

**Site No. 12: Upper Warm Creek Restoration Site** is located adjacent to Baseline Road, between the confluence with Sand Creek and Sterling Avenue in the City of San Bernardino. This section of the channel is classified as EHM and is an earthen trapezoidal channel with river rock along the invert. The channel is fairly stabilized, but it does show signs of bank erosion. The majority of the site has room to widen the channel with Belcher Park, undeveloped land, and San Gorgonio Senior High School to the north, but portions of the channel would require modifications to the access road.

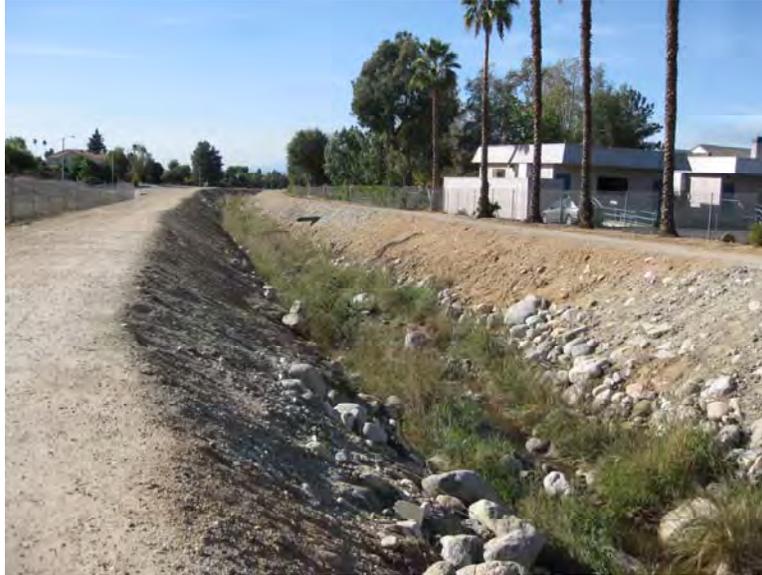
**Figure 26: Site No. 13 Upstream View**

**Site No. 13: Zanja Creek Restoration Site** is located adjacent to Laramie Avenue and Herrington Drive, and between Wabash Avenue and Lincoln Street in the City of Redlands. This section of the channel is classified as EHM and is an earthen trapezoidal channel. There are non-EHM sections of channel up- and downstream of the site. There is very little invert degradation, and the banks appear stable. Modification of the access roads would be required if the channel were widened.

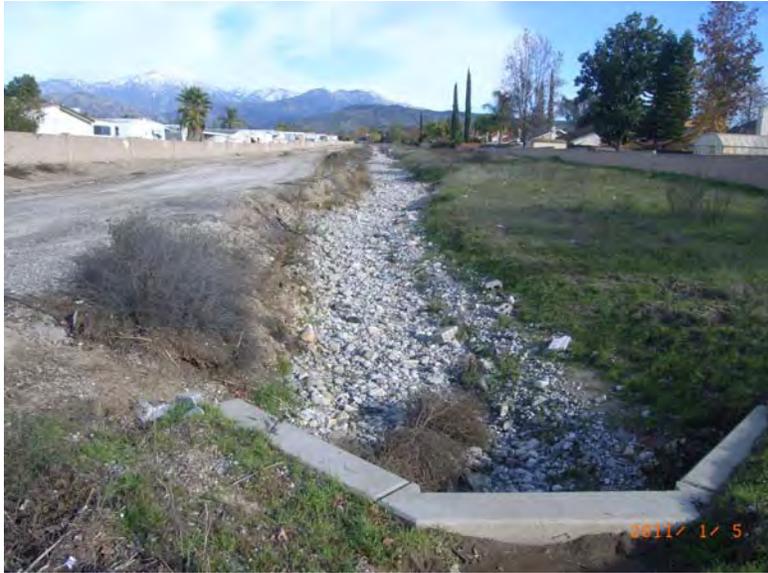
**Figure 27: Site No. 14 Upstream View**

**Site No. 14: Zanja Creek Restoration Site** is an unnamed channel tributary to Zanja Creek and conveys water from the north. The site is located between Wabash Avenue and Sylvan Boulevard in the City of Redlands. This section of the channel is classified as EHM and is an earthen channel with river rock along the invert. The channel invert appears stable, but there is bank and toe erosion. There is sufficient room to widen the channel to the north where railroad tracks have been removed.

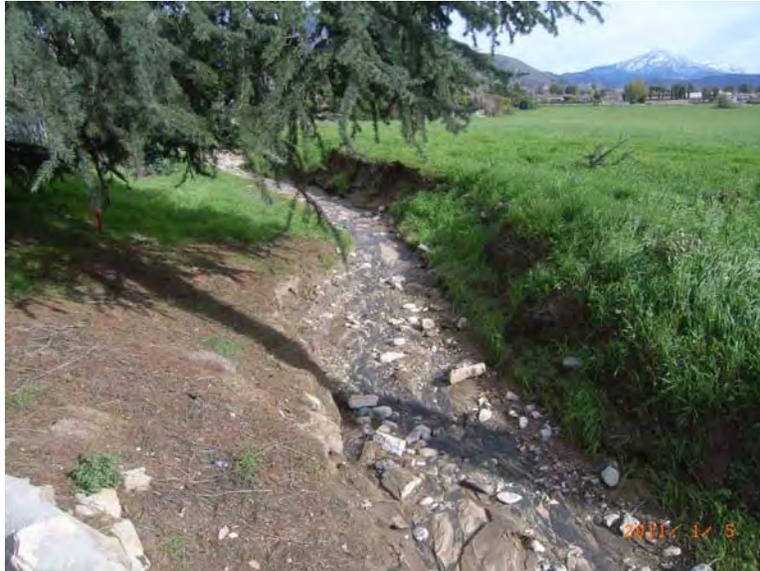
**Figure 29: Site No. 15 Upstream View**

**Site No. 15: Baldrige Channel Restoration Site** is located at the North Orange Street crossing in the City of San Bernardino. Two sections of the channel were assessed: the downstream EHM channel that conveys water through the upstream non-EHM (Figure 1) and the jail (Figure 2). The downstream section is a trapezoidal earthen channel with a riprap-lined invert for low flow. There is plenty of room to lower the side slopes. Upstream of North Orange Street is approximately 250 feet of non-EHM channel. The channel is showing signs of toe and bank erosion due to the poor condition of the bank protection and has room to the east for widening.

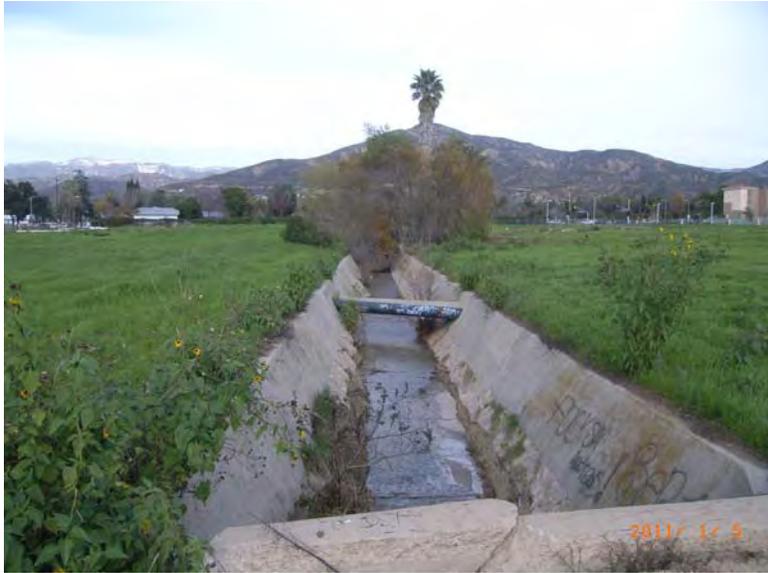
**Figure 31: Site No. 16 Upstream View**

**Site No. 16: Baldrige Channel Restoration Site** is located between E. Highland Avenue and Highway 210 in the City of San Bernardino. (Figure 31). This section of the channel is classified as EHM due to the concrete lining. The majority of the channel is in fair condition, but a portion has failed and allowed a large scour channel to manifest to the west of the concrete channel. (Figure 32) The scour channel is approximately 15 feet deep. There is ample room to widen the channel.

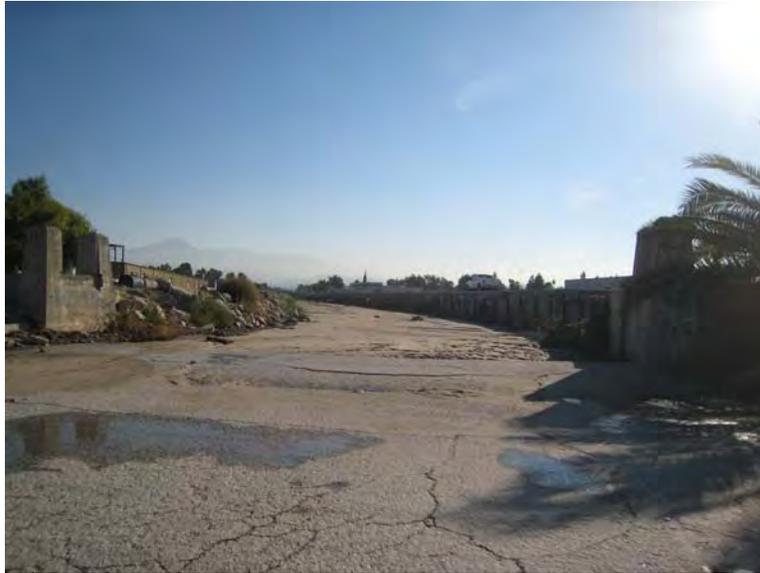
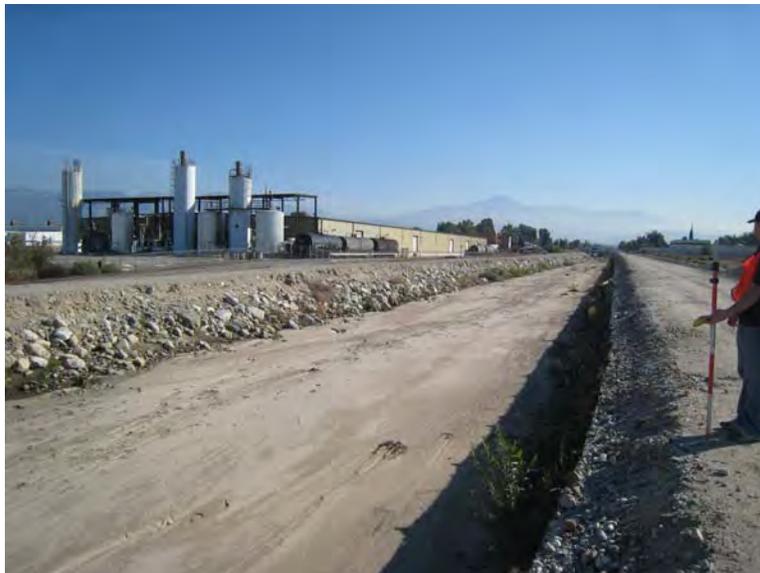
**Site No. 17: Mission Channel Restoration Site** is located at Tippecanoe Avenue crossing and extends west for approximately 1550 feet in the City of San Bernardino. This section of the channel is classified as EHM with corrugated metal piles on the southern bank and river rock on the northern bank. The corrugated metal piles are deteriorating and there is bank erosion. The channel invert shows signs of aggradation due to the downstream drop structure. There is room to widen the channel to the south. The stretch of channel upstream of Tippecanoe Avenue is in the same condition, but it has significantly less room to expand.

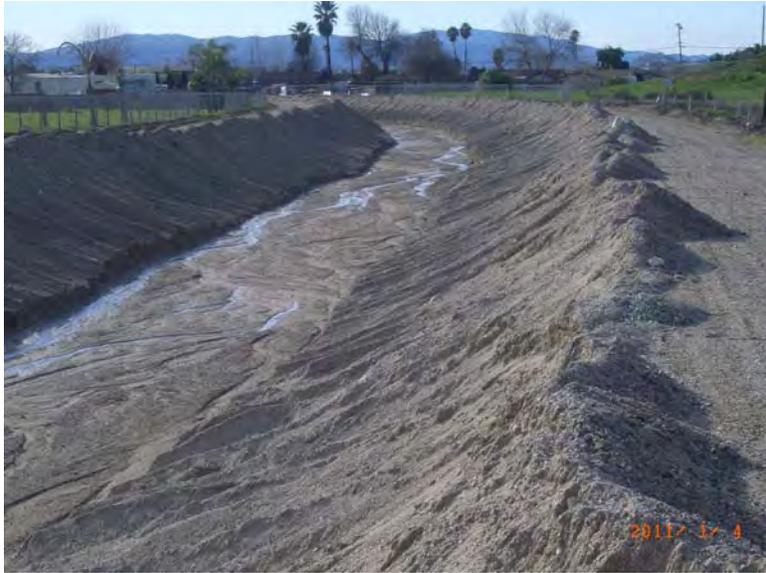
**Figure 37: Site No. 18 Downstream View**

**Site No. 18: Wildwood Creek Restoration Site** is between Interstate 10 and 1300 feet east of Bryant Street in the City of Yucaipa. This section of the channel is classified as EHM and is a trapezoidal earthen channel. The channel had recently been maintained at the time of the site visit but there were signs that toe and bank erosion had occurred. Upstream of 6<sup>th</sup> Place, sections of the channel have grouted rip rap bank protection that is in good condition. The majority of the site has sufficient room to widen the channel.

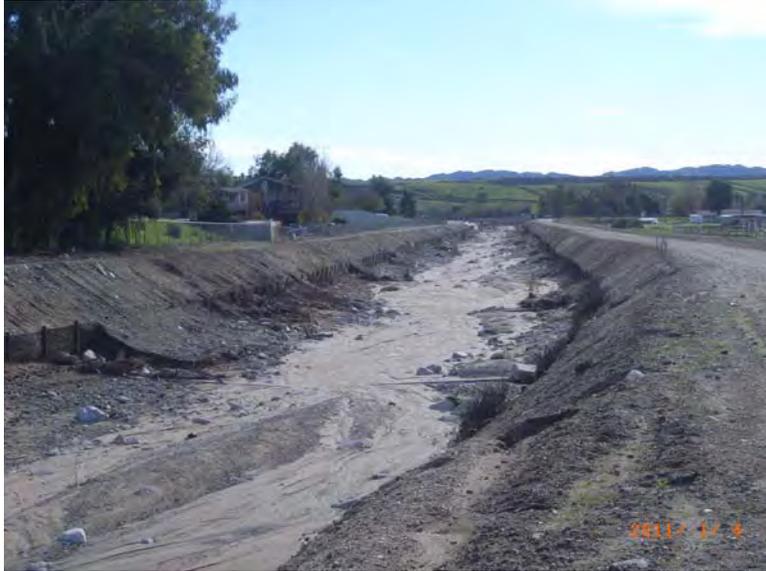
**Figure 39: Site No. 19 Downstream View**

**Site No. 19: Wilson Creek Restoration Site** is located between 10<sup>th</sup> Street and Avenue E in the City of Yucaipa. This section of channel is classified as EHM and is an earthen, trapezoidal shaped earthen channel with corrugated metal piles protecting the banks. The corrugated metal piles are deteriorating, but significant erosion has not occurred to the toe or bank of the channel. The channel appears to be stabilized due to the drop structures located every 50 feet along the invert. The majority of the site has sufficient room to widen, but most areas seem to be privately owned and, in some stretches, the access roads would require modification.

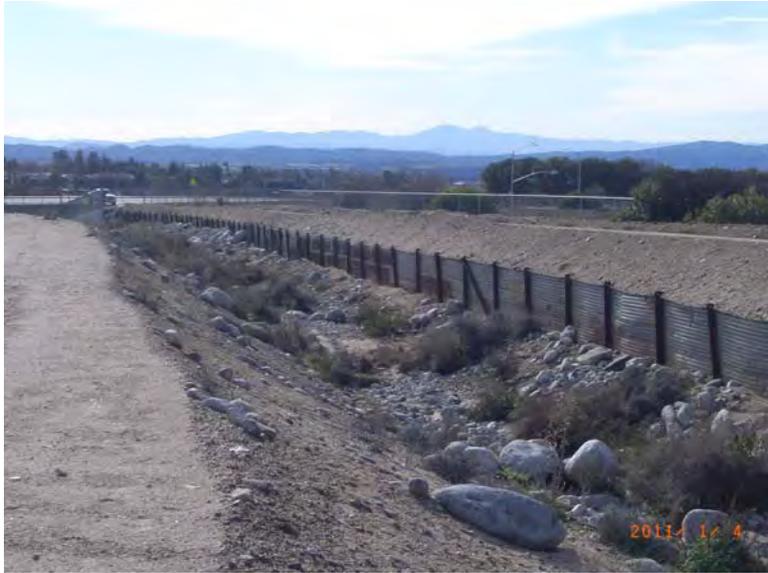
**Figure 41: Site No. 20 Downstream View**

**Site No. 20: Wilson Creek Restoration Site** is located between Bryant Street and Oak Glen Road in the City of Yucaipa. This section of the channel is classified as EHM and is an earthen trapezoidal shaped channel with corrugated metal piles protecting the west bank and river rock protecting the invert and east bank. This site has non-EHM sections of channel up- and downstream. The channel shows signs of bank erosion and invert degradation. There is sufficient room to widen the channel to the east.
