Appendix 2C – URS 2000 Seismic Report

FINAL REPORT

PROGRAM RESEARCH, ASSESSMENT AND PLAN OF APPROACH SEISMIC ANALYSIS PROGRAM BIG CANYON RESERVOIR NEWPORT BEACH, CALIFORNIA

December 2000

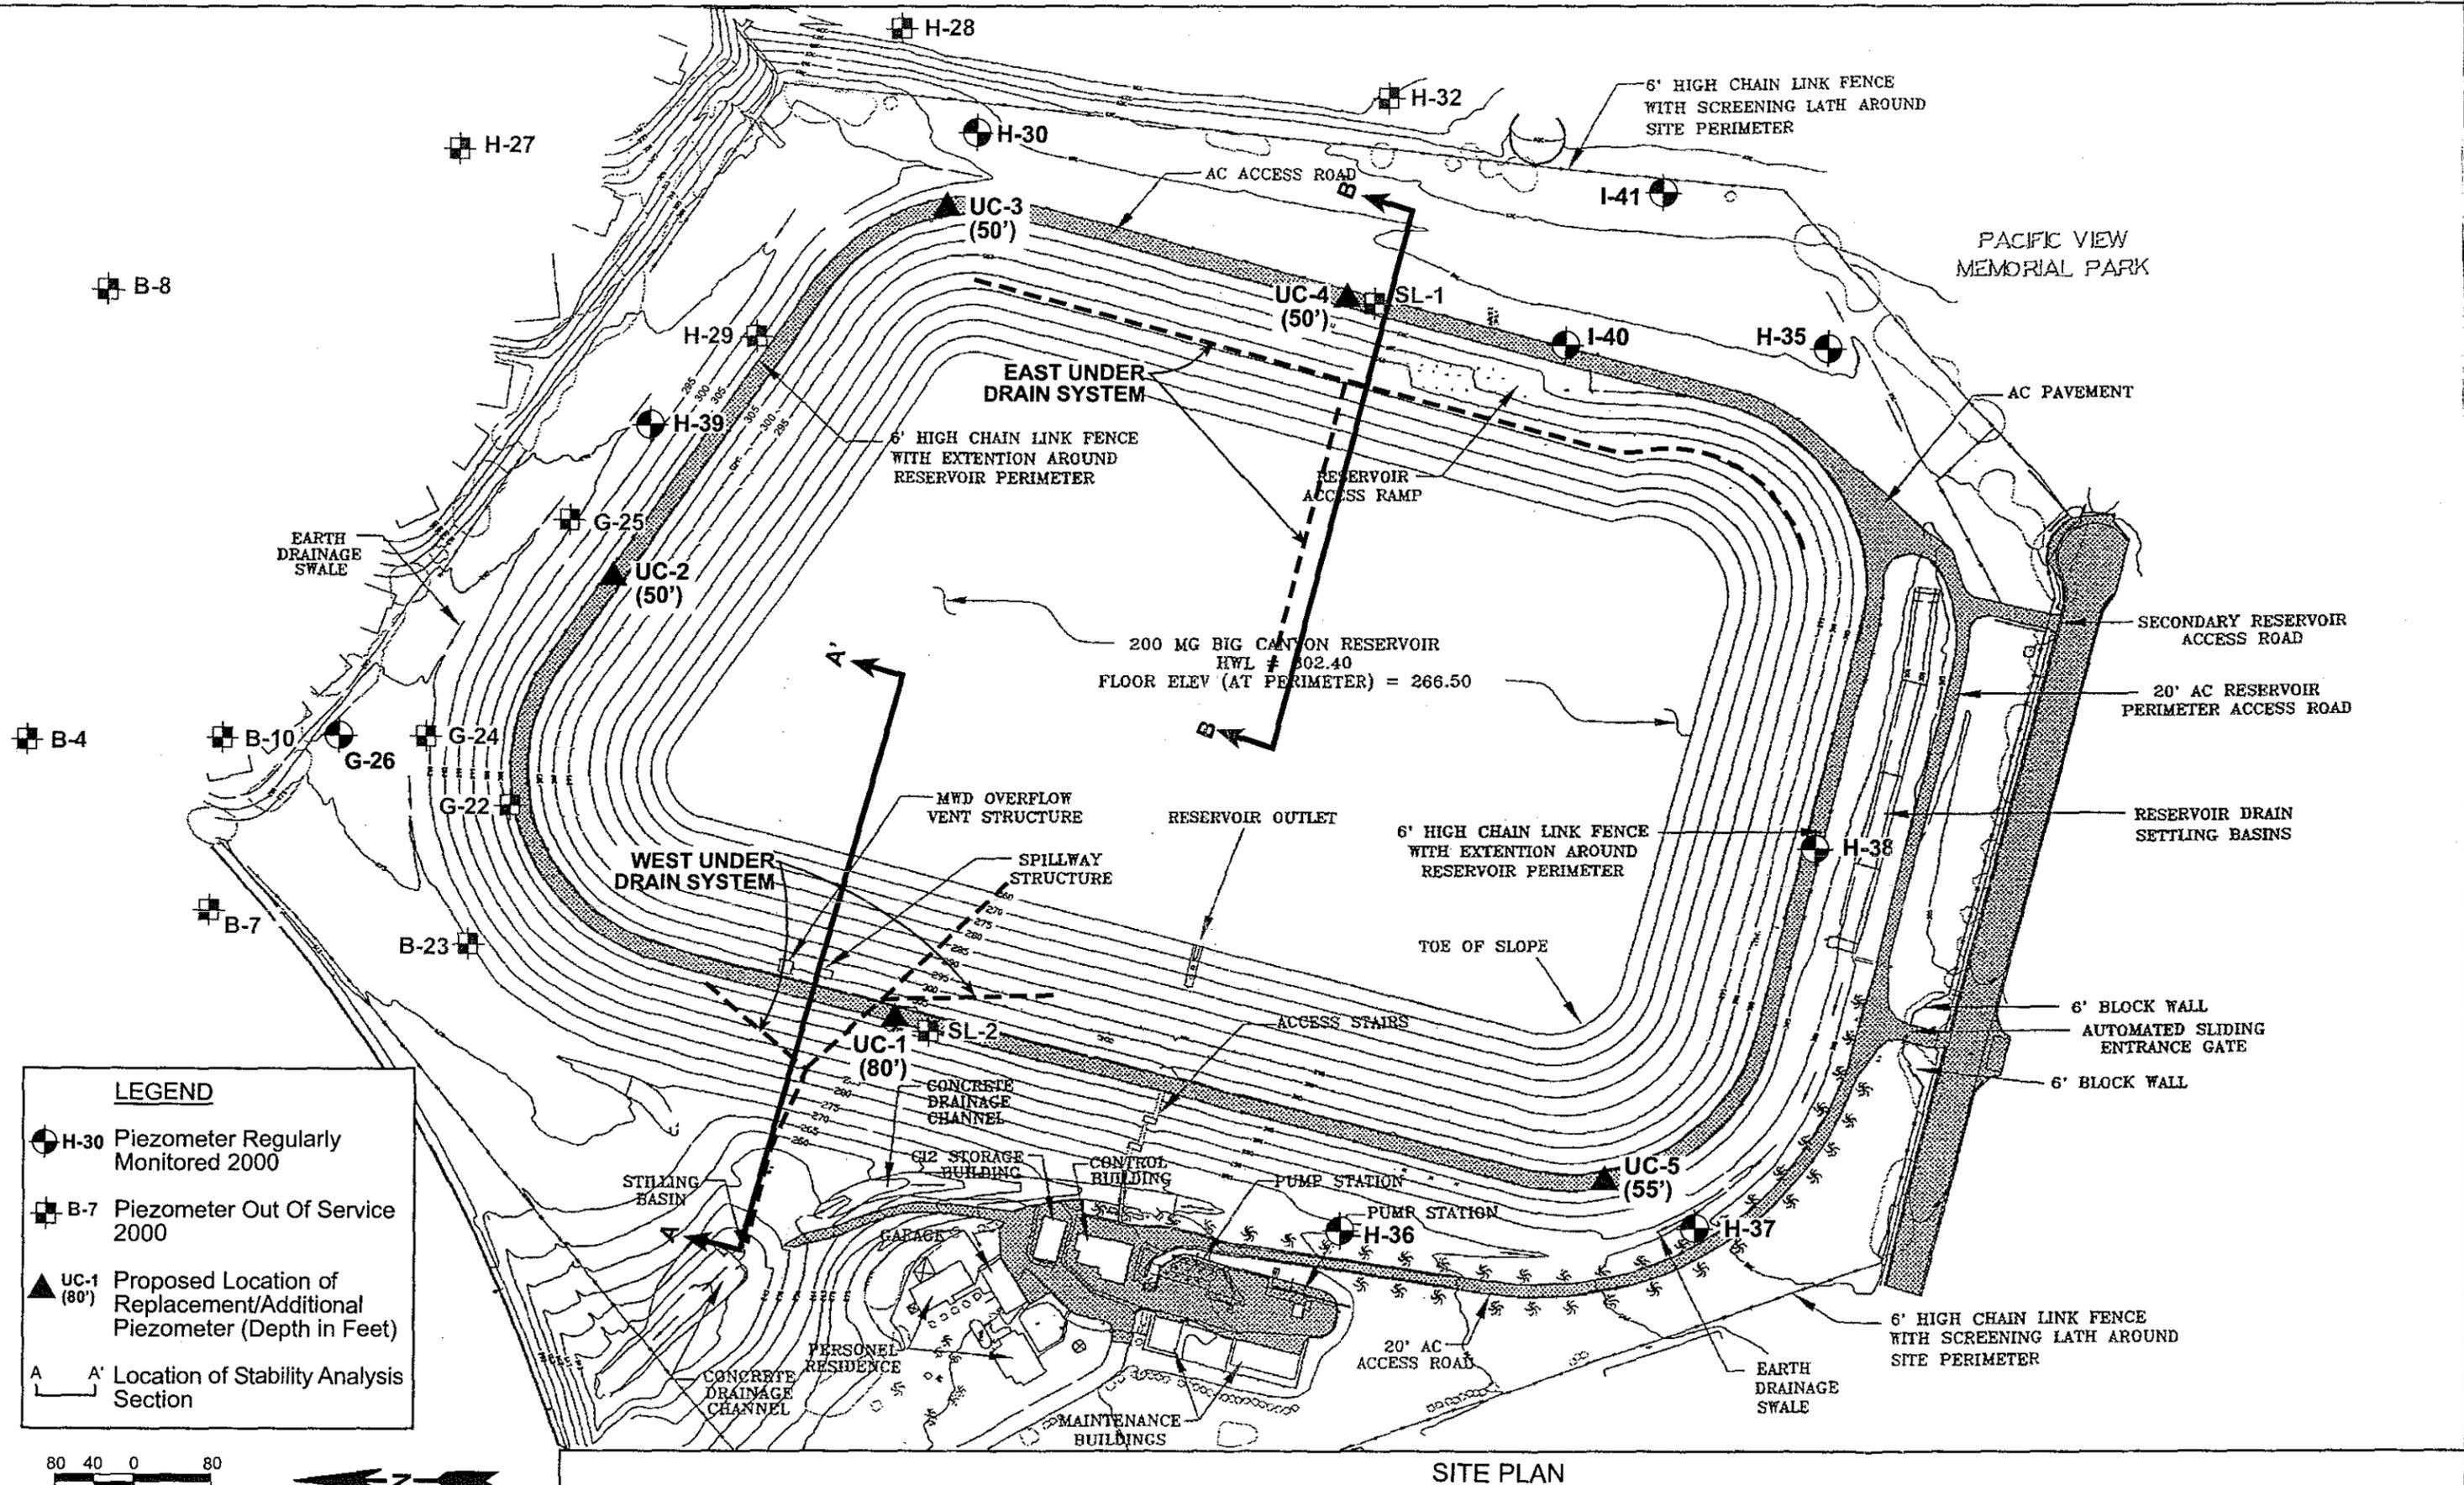
Project No.: 5700012020.01	Date: SEPTEMBER 2000	Project: BIG CANYON RESERVOIR	FIGURE 1
----------------------------	----------------------	-------------------------------	----------

Instrumentation for the reservoir consists of open standpipe piezometers installed within the embankment and in the surrounding area as well as flow measurements from the two underdrain systems. A summary of the piezometers that have been installed at the site is provided in Table 2, with an annotation whether they are installed in the embankment or the reservoir area. As summarized in Table 2, of the 23 piezometers installed at the site, nine are currently (September 2000) monitored monthly. Of these nine, one is in the embankment fill, four are in the east reservoir wall, and four are in the reservoir area. The remaining 14 piezometers are considered "out of service" due to either being decommissioned during subsequent development, or being clogged or damaged such that readings are not considered reliable. The locations of all of the piezometers are shown on Figure 1.

⁽³⁾ It is also recommended that 3 additional piezometers be added at the locations shown on Figure 1. The additional piezometers would be monitored on a 3 month schedule.

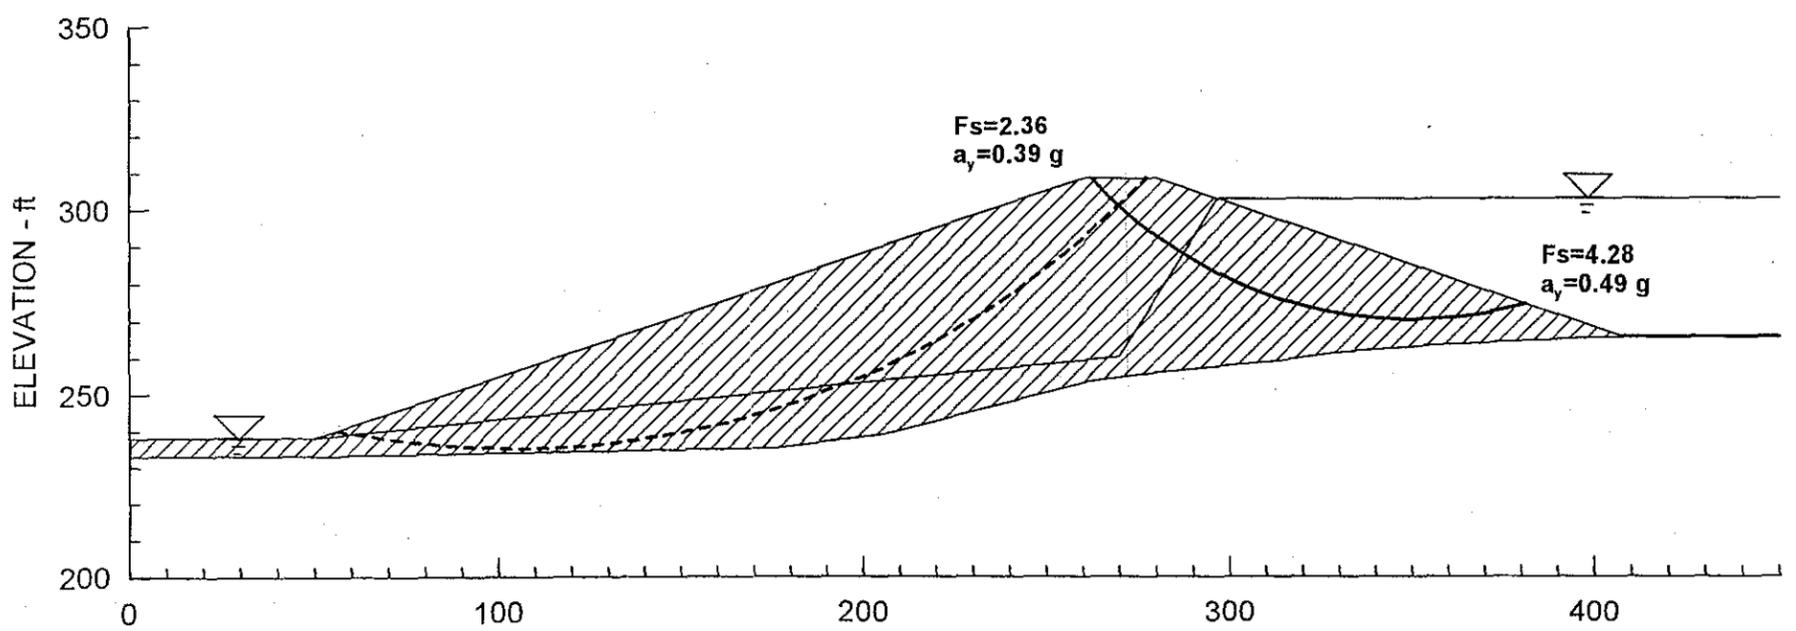
Project No. 5700012020.01	Date: SEPT 2000	Project: BIG CANYON RESERVOIR	CROSS SECTION A-A CRITICAL SURFACE AND FACTOR OF SAFETY STATIC SLOPE STABILITY ANALYSIS	Fig. 4
URS

Based on the results of the preliminary analyses, presented in Table 4, the minimum acceptable factors of safety are satisfied. However, the results of the preliminary seismic deformation estimate indicate deformations on the order of 1.5 percent of the embankment height. This exceeds the one percent deformation criteria, yet the deformation of less than 12 inches is significantly less than half of the 5.6 feet of available freeboard. It is concluded that the preliminary analyses indicate that the seismic performance of the embankment is adequate for the assumed material and load conditions.
