## **Attachment 10**

This attachment includes photos from several construction sites inspected on April 9-10, 2014. Sites include private development, capital improvement projects (CIPs), including two linear undergrounding projects (LUPs).

Photos from Audit Field Days  
Location: Bankers Hill (LUP Job 945)

Date: April 9, 2014

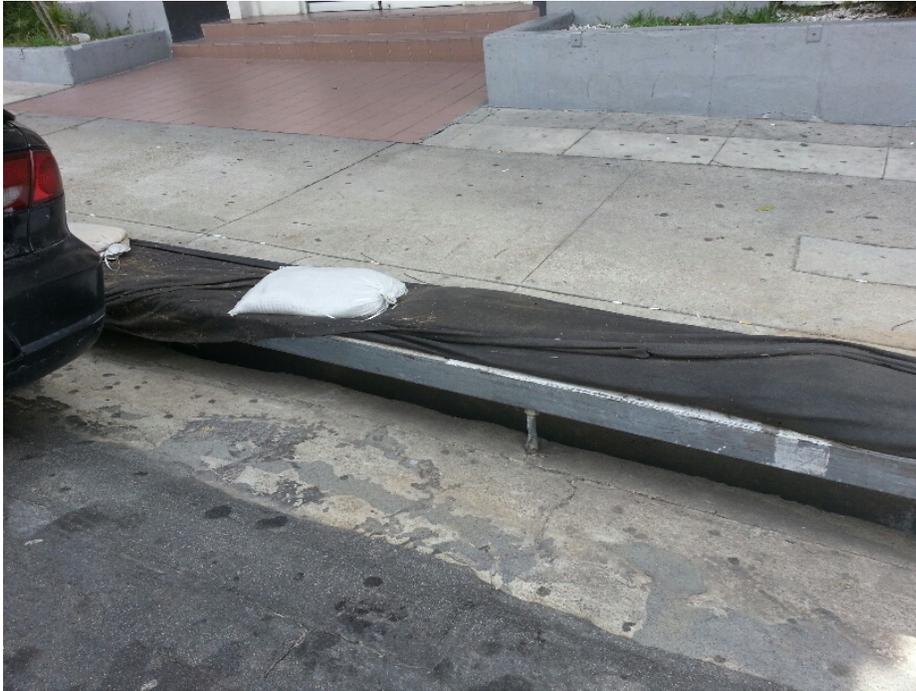
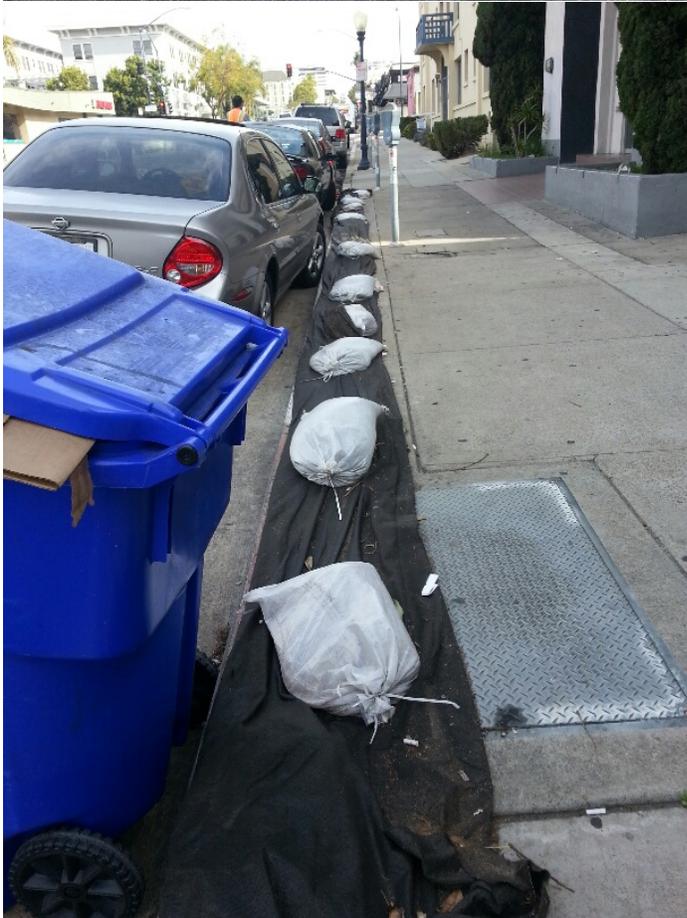
Inadequate Storm Drain  
Inlet Protection

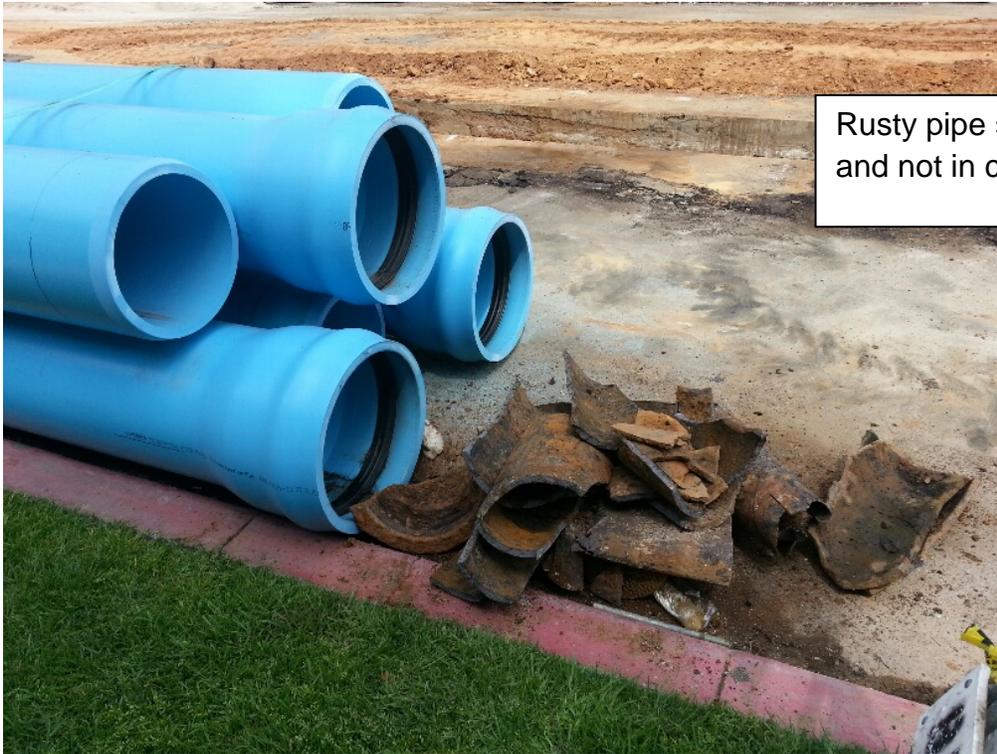
Rusty pipe should be contained and not in contact with ground.

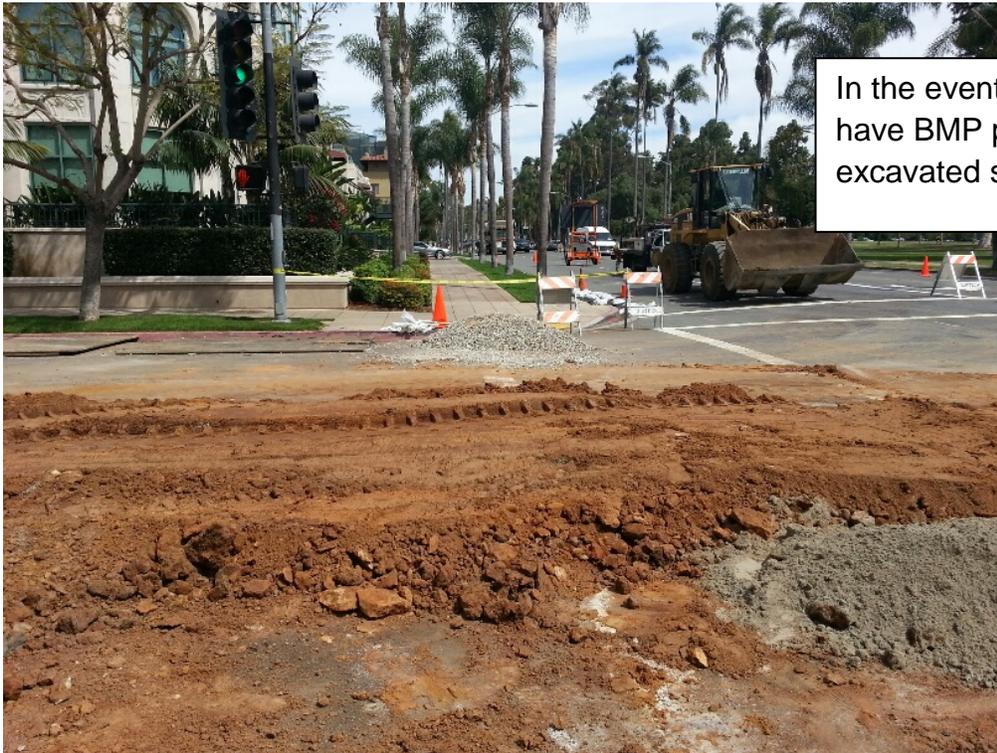
In the event of rain, City must have BMP plan for the excavated soil.

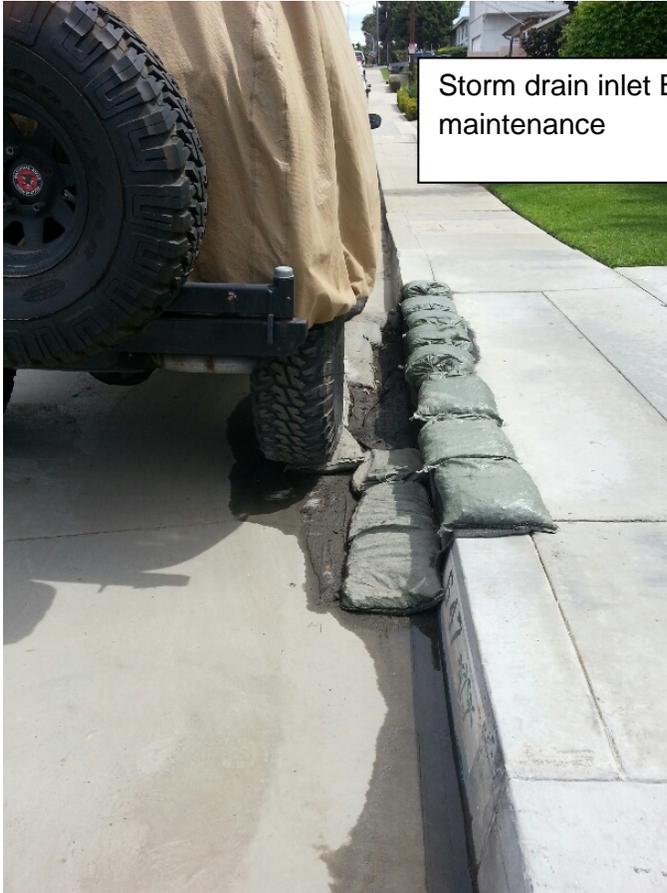
Storm drain inlet BMPs need maintenance

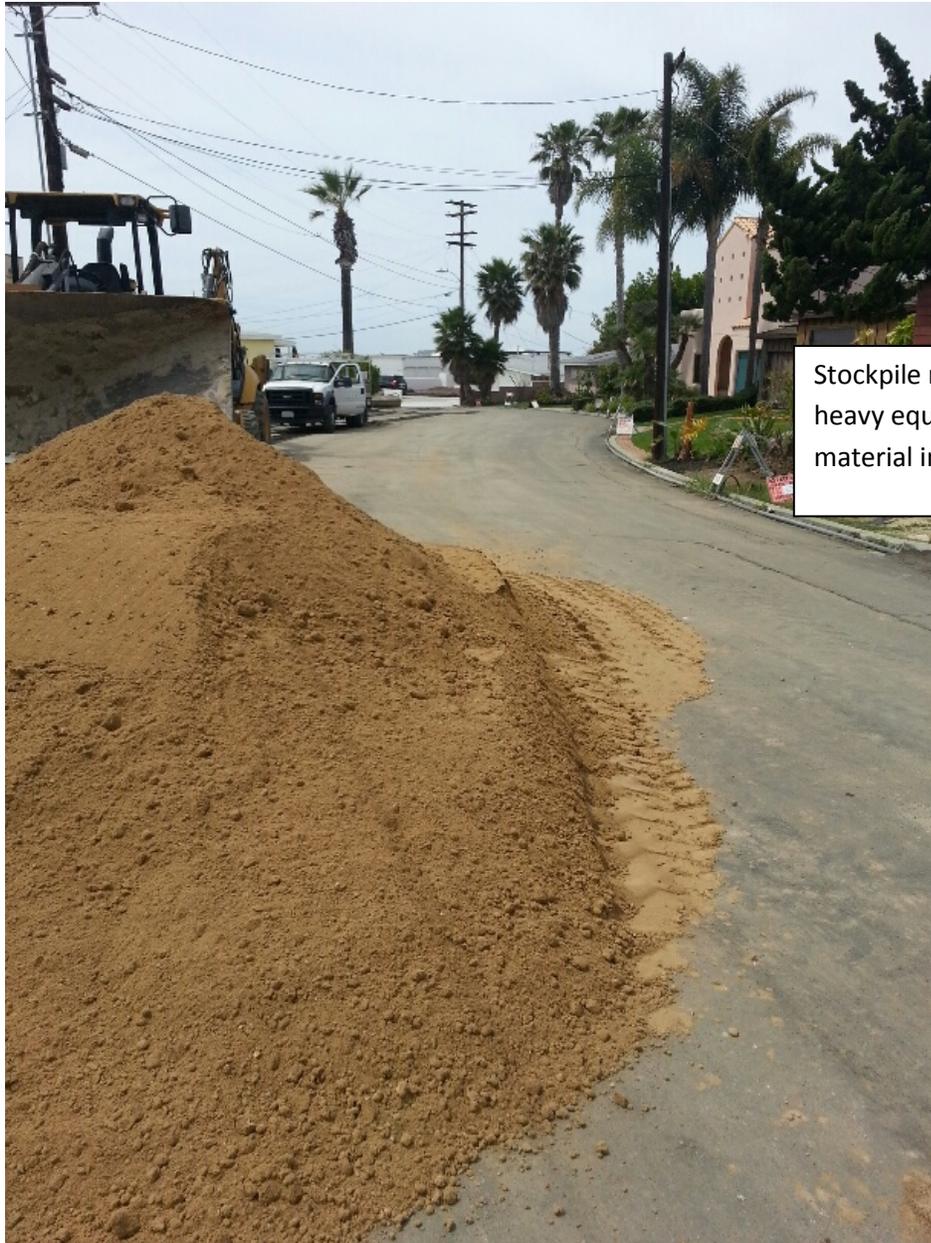
Stockpile not properly contained and heavy equipment can disperse material into the street and offsite.
