**CALIFORNIA REGIONAL WATER QUALITY CONTROL BOARD - SAN DIEGO REGION
WATERSHED PROTECTION PROGRAM**

FACILITY INSPECTION REPORT

FACILITY: Torrey Hills Unit 19 **INSPECTION DATE/TIME:** 09/20/2013; 1000

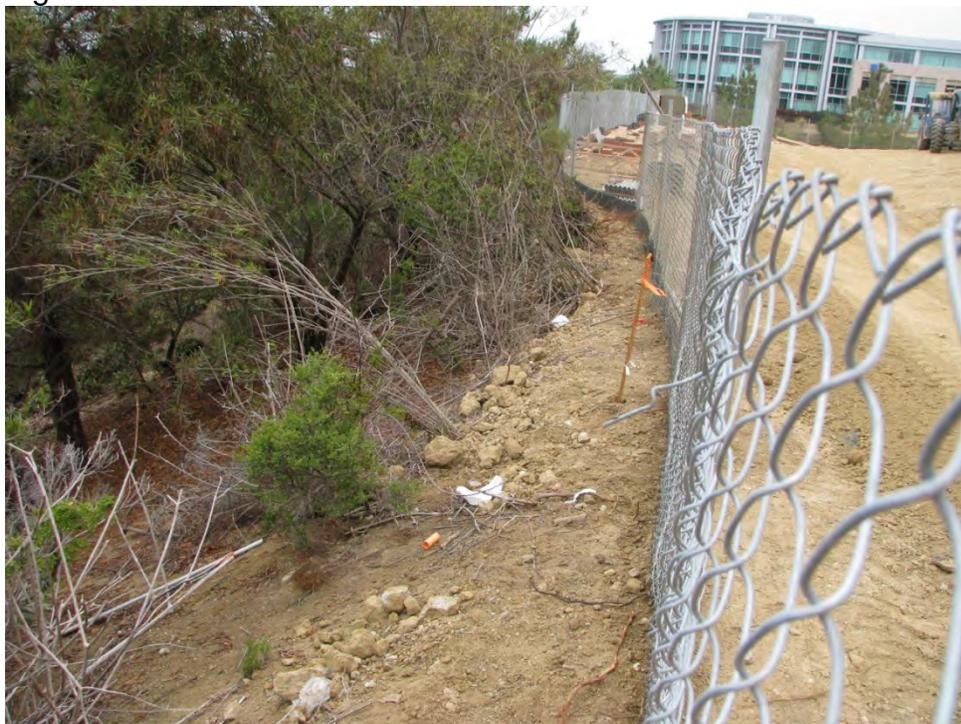
5. The site generally slopes towards the westerly direction. The perimeter controls along the west side were inadequate for containing the sediment within the construction site (Figures 10-12). There was evidence of a sediment discharge from the site and onto the adjacent downstream property (Figure 12).

Figure 12. Sediment discharge outside site boundary

3. The west side perimeter lacks adequate sediment controls to prevent sediment from leaving the site.
4. Sediment stockpiles should not be located near the edge of a steep slope.
