**Subject: Notice of Violation No. R9-2013-0148, Torrey Hill Unit 19,
NPDES Order No. 2009-0009-DWQ**

NOTICE OF VIOLATION
No. R9-2013-0148

FACILITY INSPECTION REPORT

FACILITY: Torrey Hills Unit 19 **INSPECTION DATE/TIME:** 09/20/2013: 1000

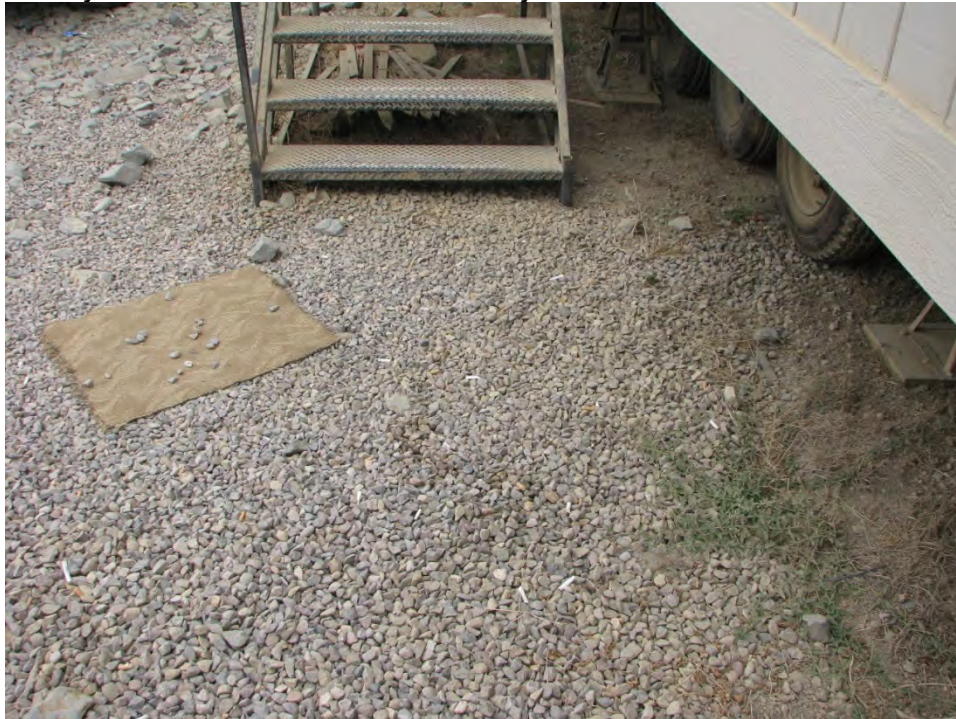
1. The site was littered with cigarette butts, trash, and debris throughout. Mr. Do was unaware of any specific dedicated trash area (See Figures 1-7).

Figure 1. Trailer entrance; cigarette butts

1. Overall the site lacks adequate housekeeping. The site requires an improved method for dealing with trash and construction debris.
2. The site requires erosion control and adequate sediment control BMPs. All slopes require improved soil stabilization such as hydroseed, bonded fiber matrix, or erosion control blankets.

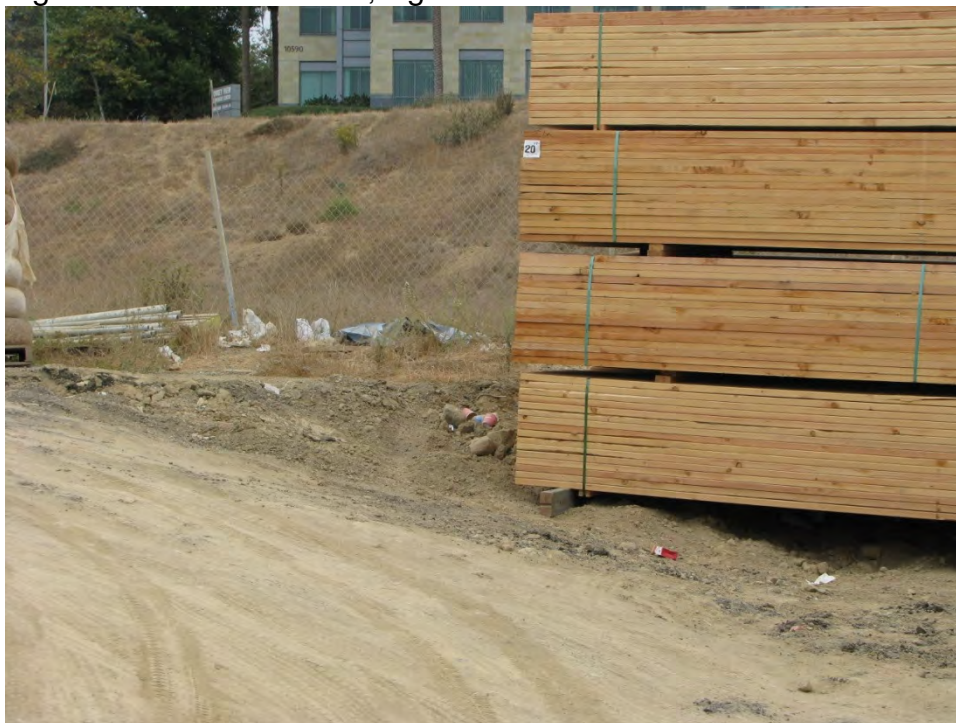
Figure 2. Near south entrance; trash area

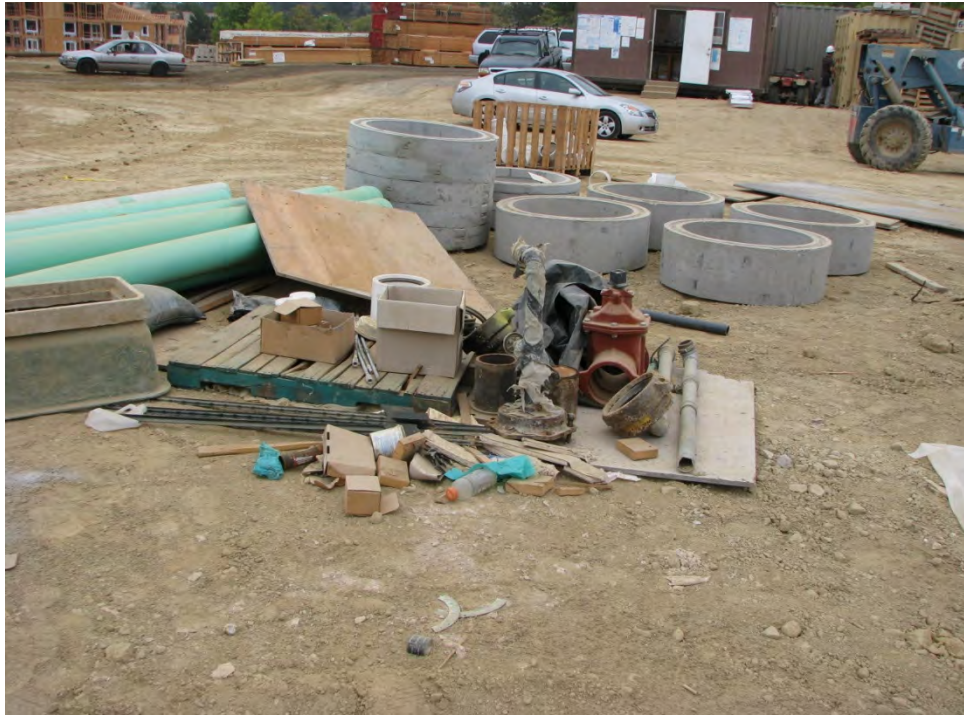
Figure 3. Site interior; construction debris

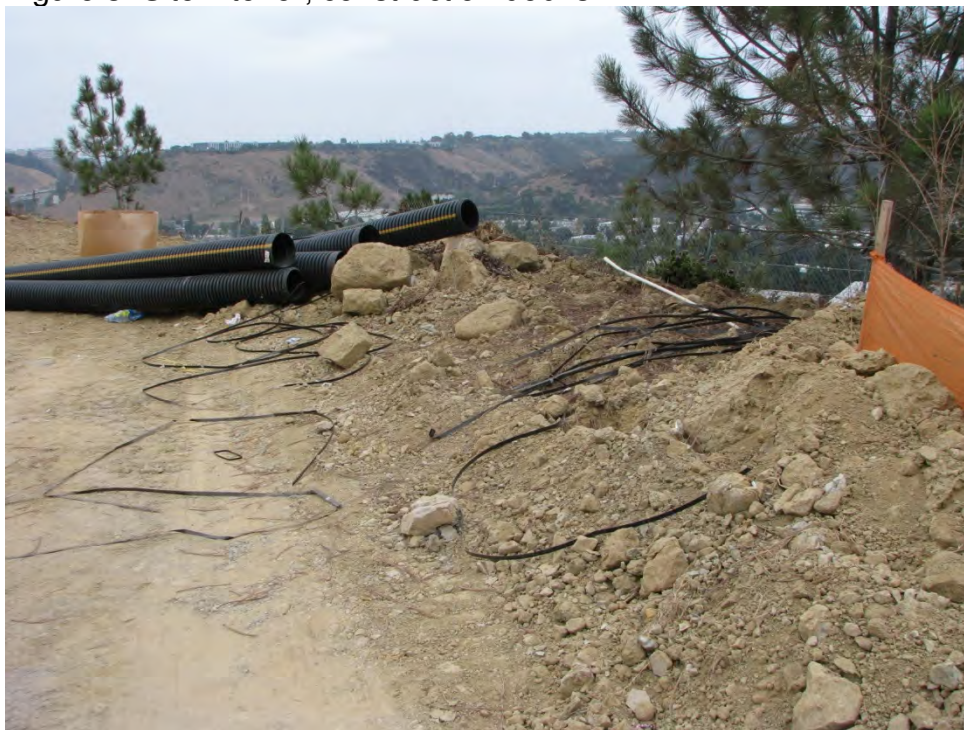
Figure 4. South west side; construction debris

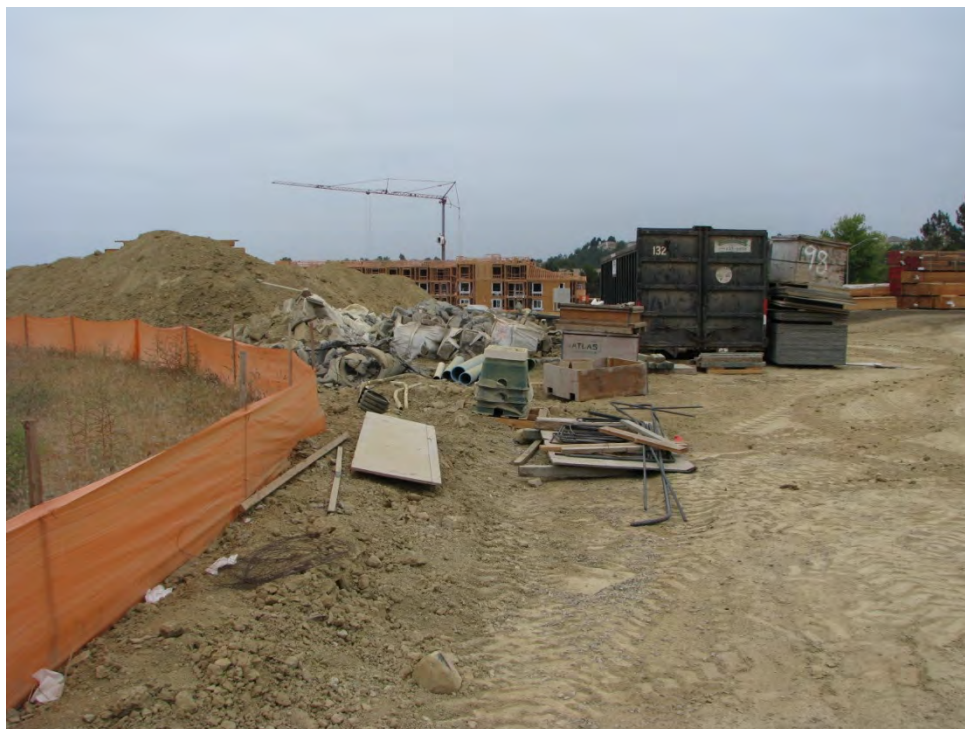
Figure 5. Site interior; construction debris

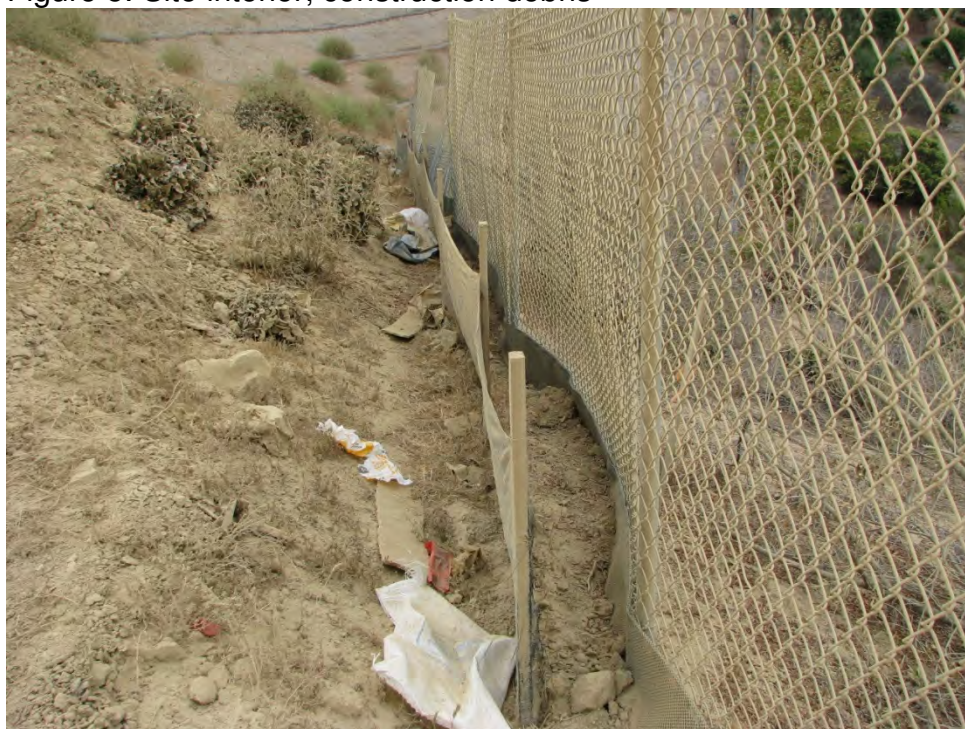
Figure 6. West perimeter; trash

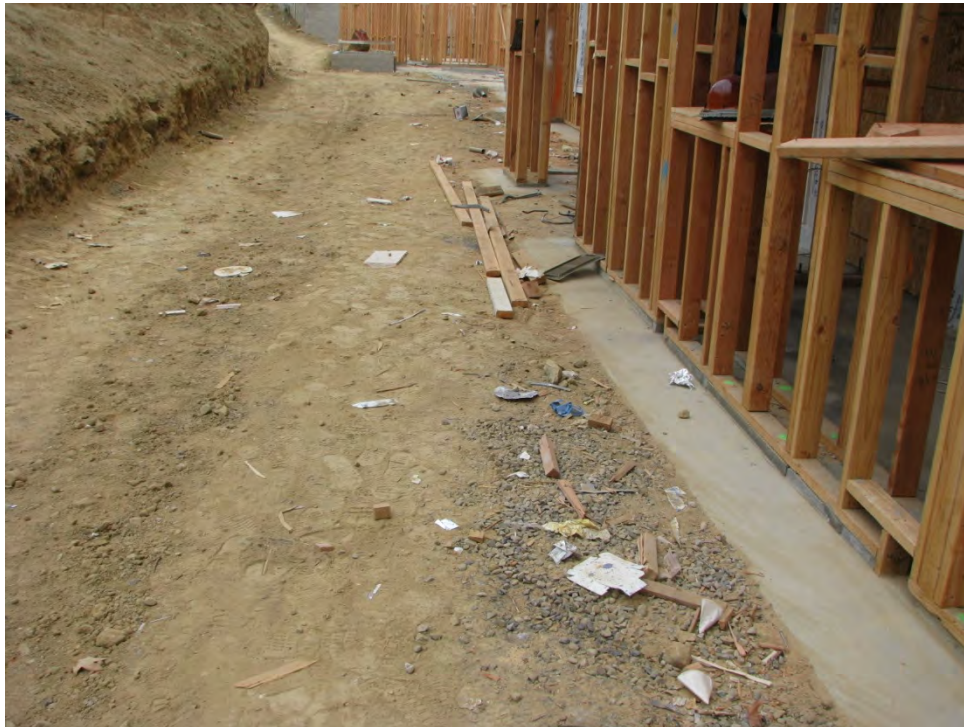
Figure 7. Site interior; trash

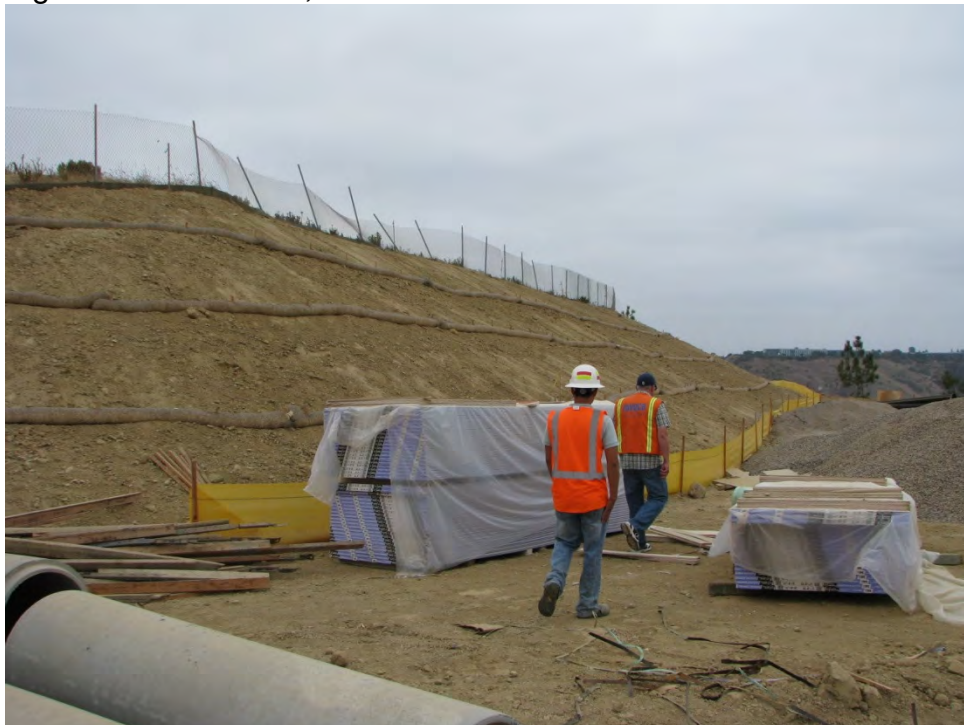
- b. **Observation:** During the September 20, 2013 inspection, San Diego Water Board inspectors observed finished slopes with no visible erosion control BMPs.

2. The site had inadequate erosion control and sediment control BMPs throughout the site.
3. The steep slopes on the east side of the site had fiber rolls and a silt fence at the toe of the slope. However, there was no erosion control. The slopes were bare and require erosion control BMPs because they are at risk for mobilization during a heavy rain (Figure 8).

Figure 8. Slope east side; bare soil

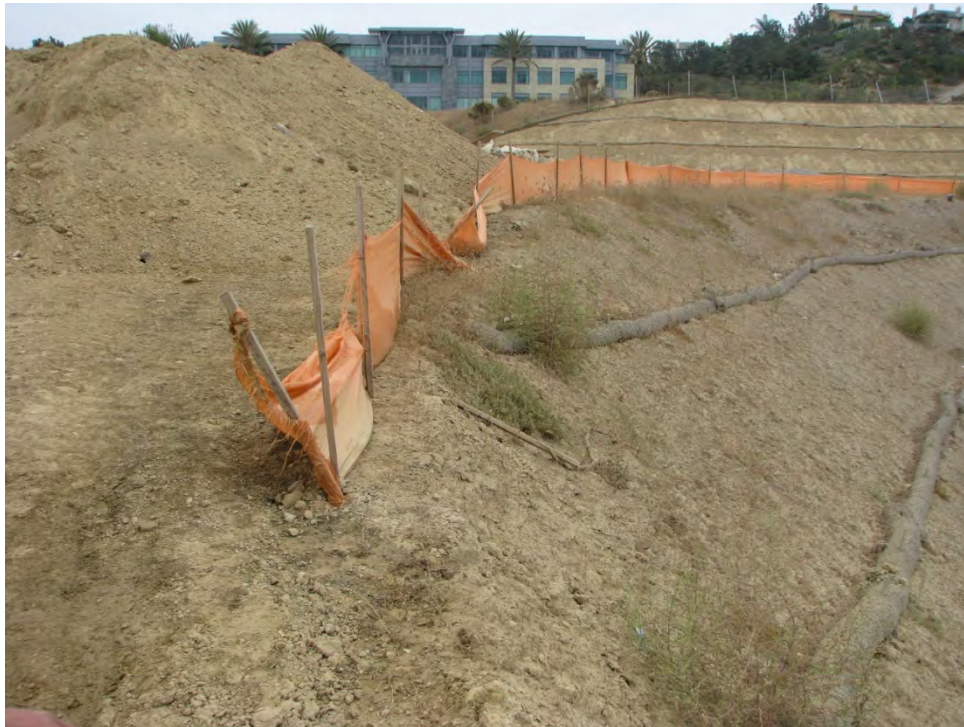
4. There is a stockpile located next to a steep slope. The silt fence between the stockpile and slope is in need of repair (Figures 9). Mr. Do was unaware of when the adjacent/downstream slope had been last sprayed with hydroseed.

Figure 9. Sediment stockpile with broken silt fence

3. The west side perimeter lacks adequate sediment controls to prevent sediment from leaving the site.
4. Sediment stockpiles should not be located near the edge of a steep slope.

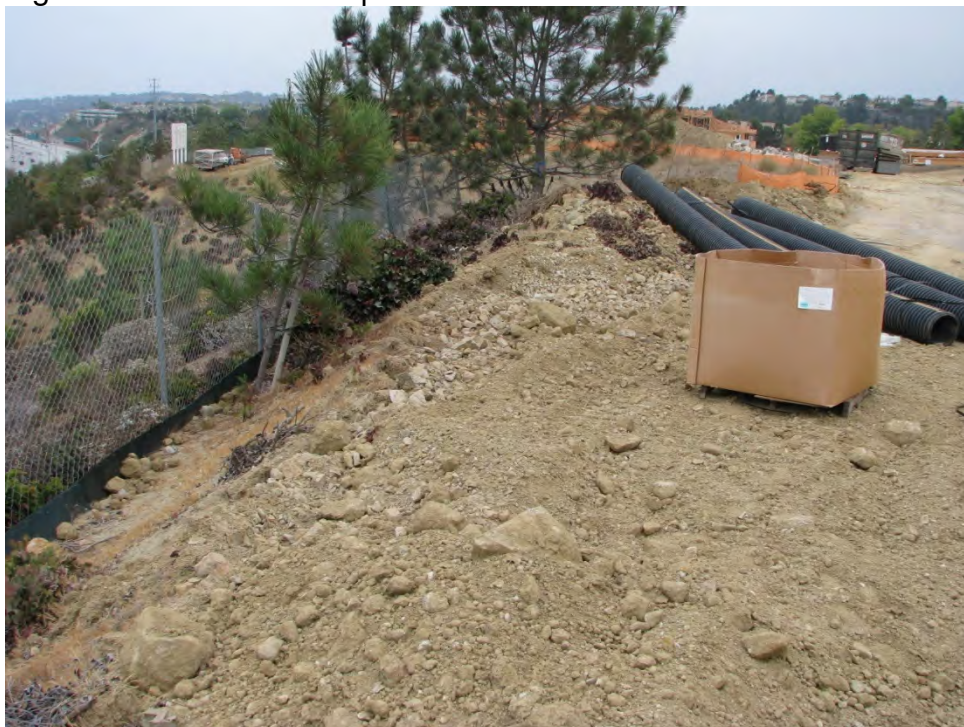
5. The site generally slopes towards the westerly direction. The perimeter controls along the west side were inadequate for containing the sediment within the construction site (Figures 10-12). There was evidence of a sediment discharge from the site and onto the adjacent downstream property (Figure 12).

Figure 10. Perimeter south west side

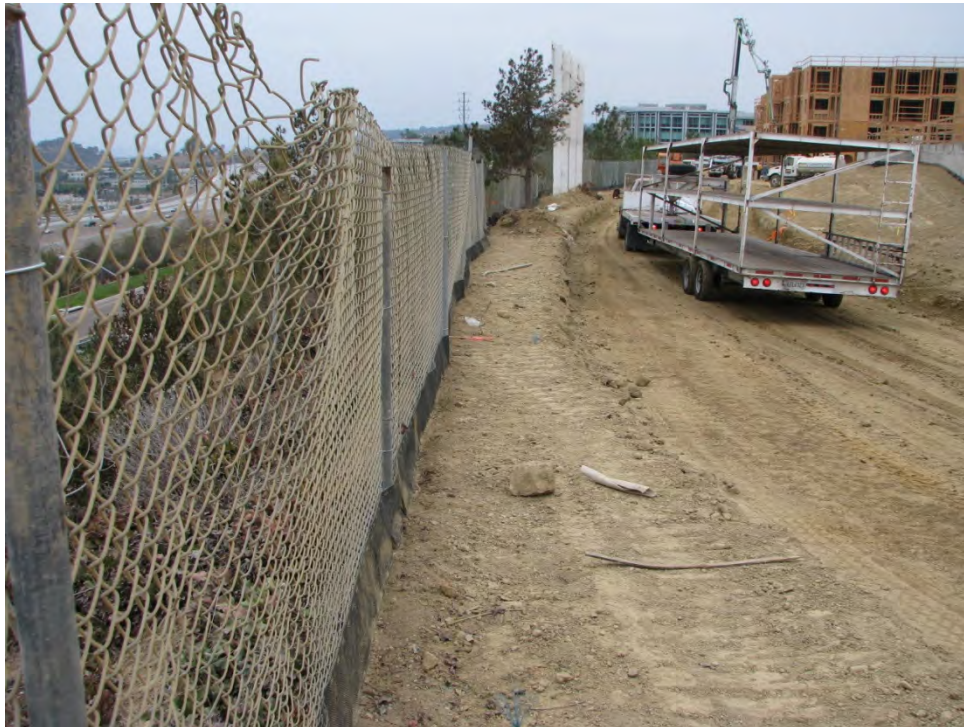
Figure 11. Perimeter west side

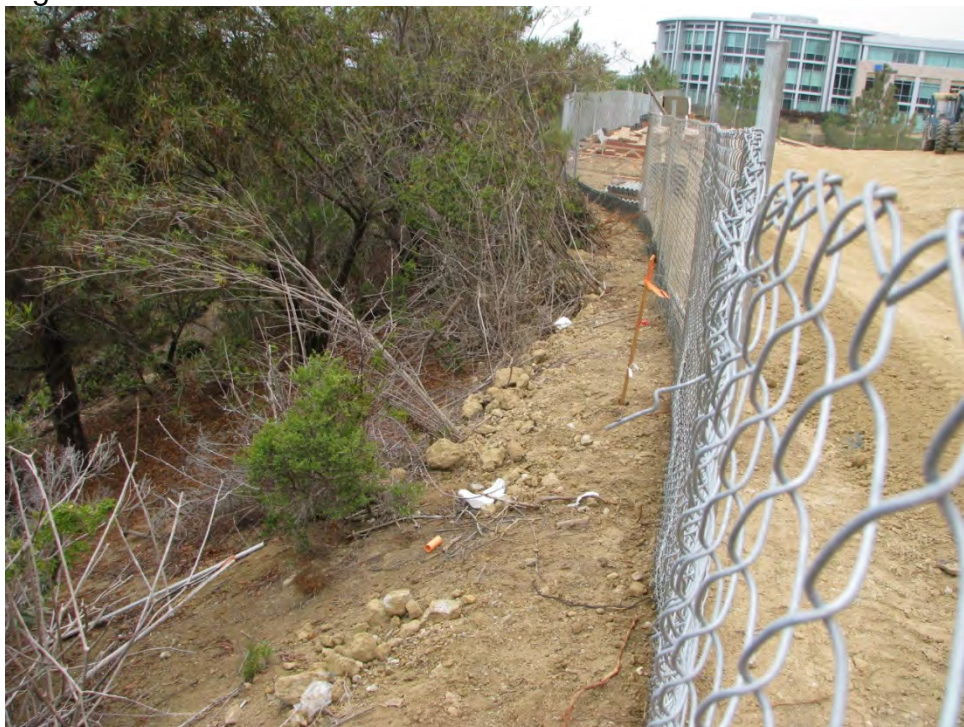
- a. Pursuant to Provision III A. of Order No. 2009-0009-DWQ:** Dischargers shall not violate any discharge prohibitions contained in applicable Basin Plans or statewide water quality control plans.
- b. Pursuant to Provision III B. of Order No. 2009-0009-DWQ:** All discharges are prohibited except for the storm water and non-storm water discharges specifically authorized by this General Permit or another NPDES permit.
- c. Observation:** During the September 20, 2013 inspection, San Diego Water Board inspectors observed discharges of sediment and trash beyond the project boundaries and onto the adjacent downstream property. See attached Facility Inspection Report, Figure 12.

Figure 12. Sediment discharge outside site boundary

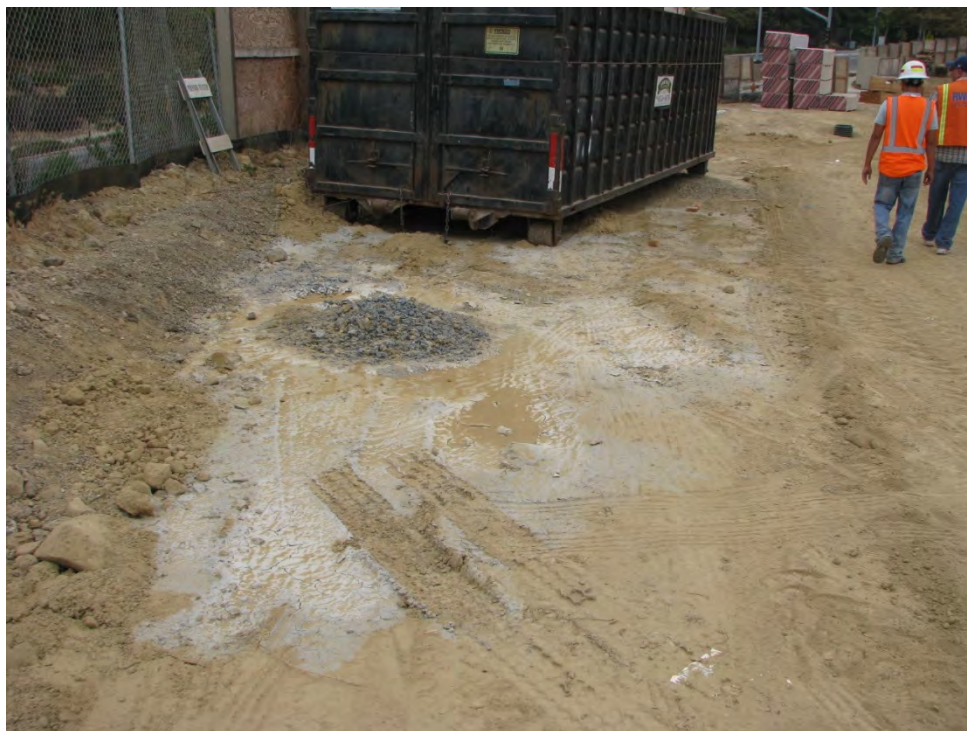
- a. Pursuant to Provision B.2.i of Attachment D to Order No. 2009-0009-DWQ:** Risk Level 2 dischargers shall implement good housekeeping measures for waste management, which, at a minimum, shall consist of the following: Ensure the containment of concrete washout areas and other washout areas that may contain additional pollutants so there is no discharge into the underlying soil and onto the surrounding areas.
- b. Observation:** During the September 20, 2013 inspection, San Diego Water Board inspectors found two areas within the construction site that had been used as concrete washouts. Neither site was contained, and as a result, waste material was allowed to come into contact with the underlying soil.

6. Two areas of the site were used as concrete wash-out areas, with no containment in either area (Figures 13-14).
7. Gravel and shaker plates at entrances/exits are ineffective at retaining sediment onsite. Sediment can be seen in the street (Figures 15-17).

Figure 13. Concrete washout with no containment

5. A designated concrete washout area for the site must be established and used. Concrete must not be allowed to come into contact with bare ground.
6. Site entrance/exit BMPs are inadequate and require maintenance.

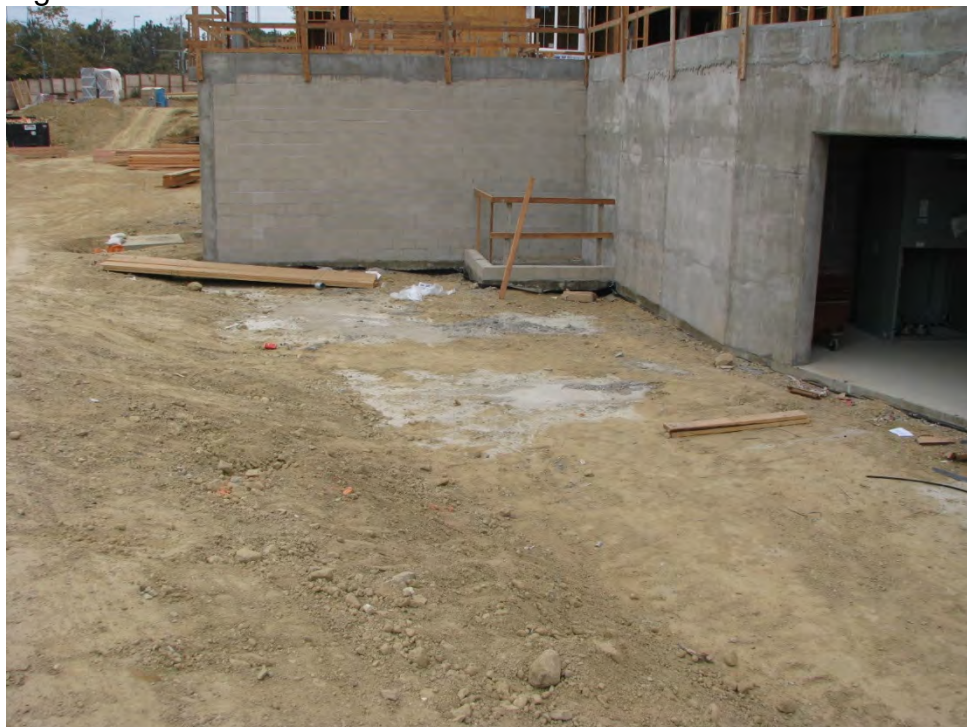
Figure 14. Concrete washout with no containment

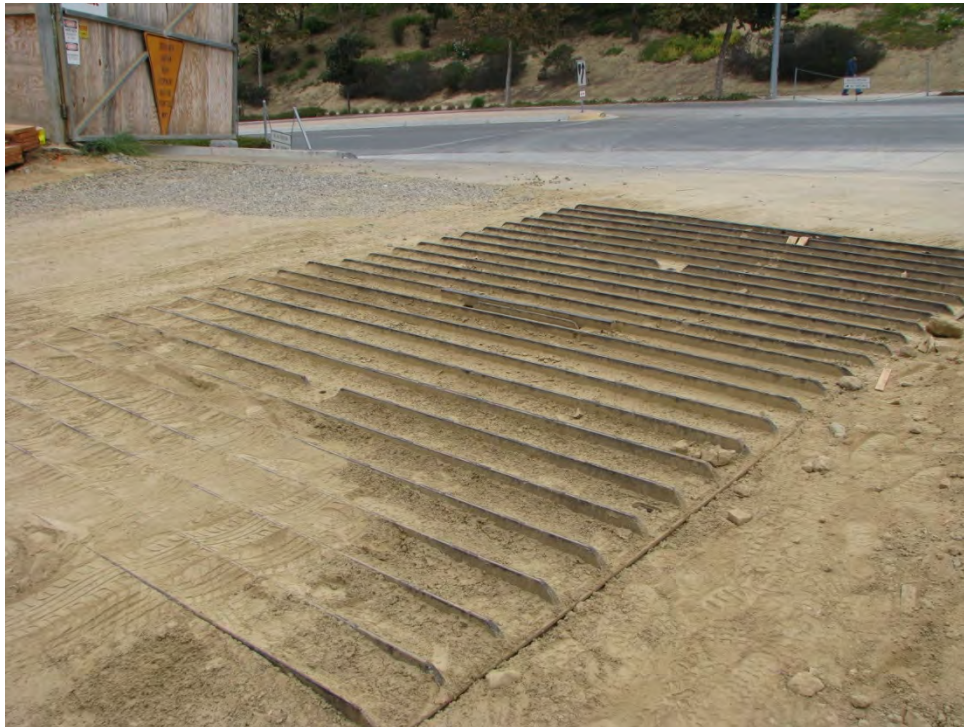
Figure 15. Shaker plates north entrance

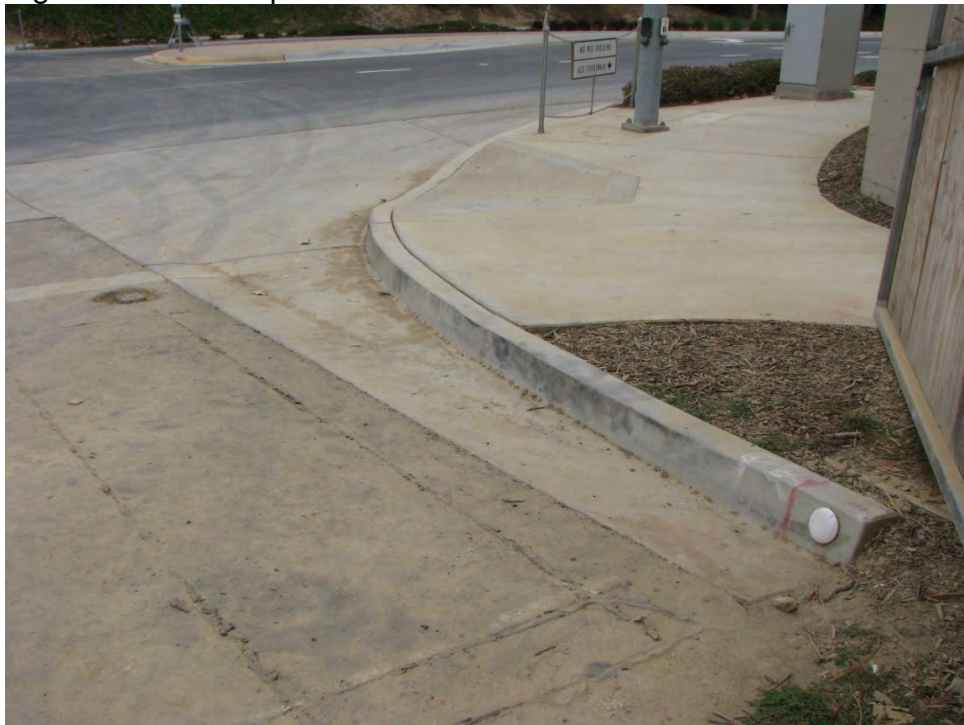
Figure 16. Public street outside construction site

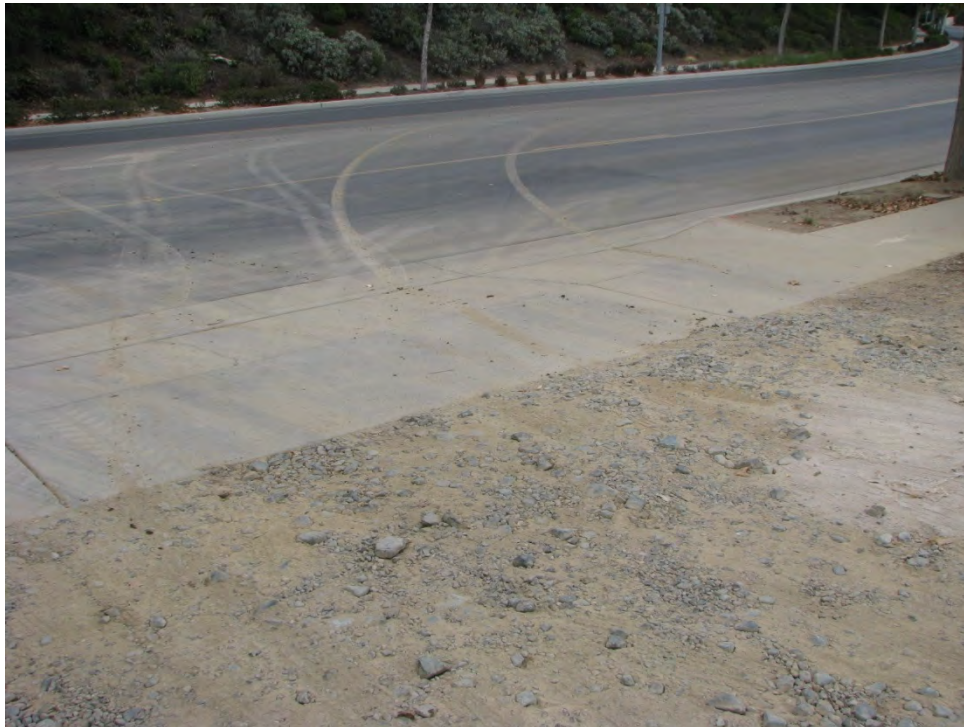
Figure 17. Gravel at south entrance

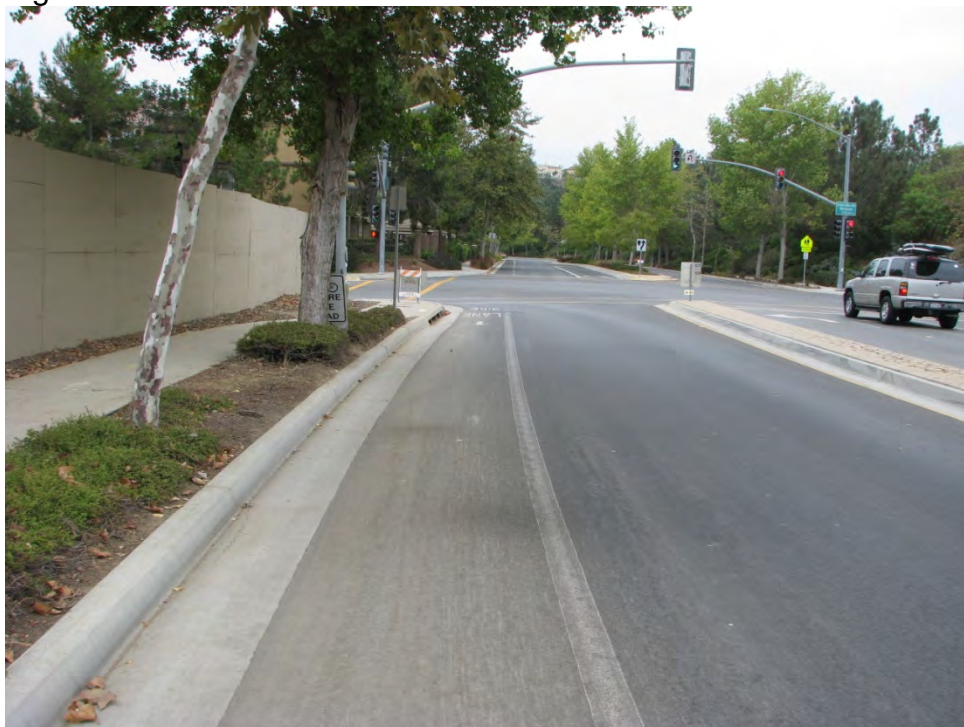
8. The storm drain inlet downstream of the site (on the street) has no protection (Figure 18).
9. Live storm drains within the site are covered by material used for silt fence, which is permeable. Drains are surrounded by sediment on all sides (Figures 19-20).

Figure 18. Nearest storm drain downstream; no inlet protection

7. Public storm drain inlets downstream of the site must be protected with BMPs.
8. Storm drain inlets within the construction site require improved BMPs to prevent sediment from entering.

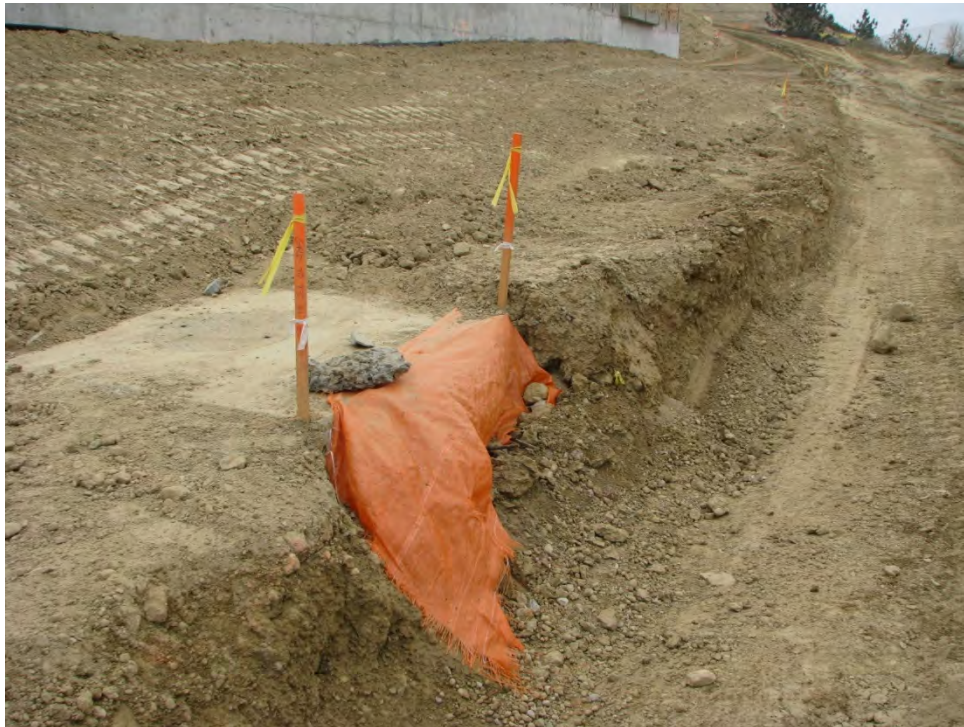
Figure 19. Live storm drain covered with permeable fabric

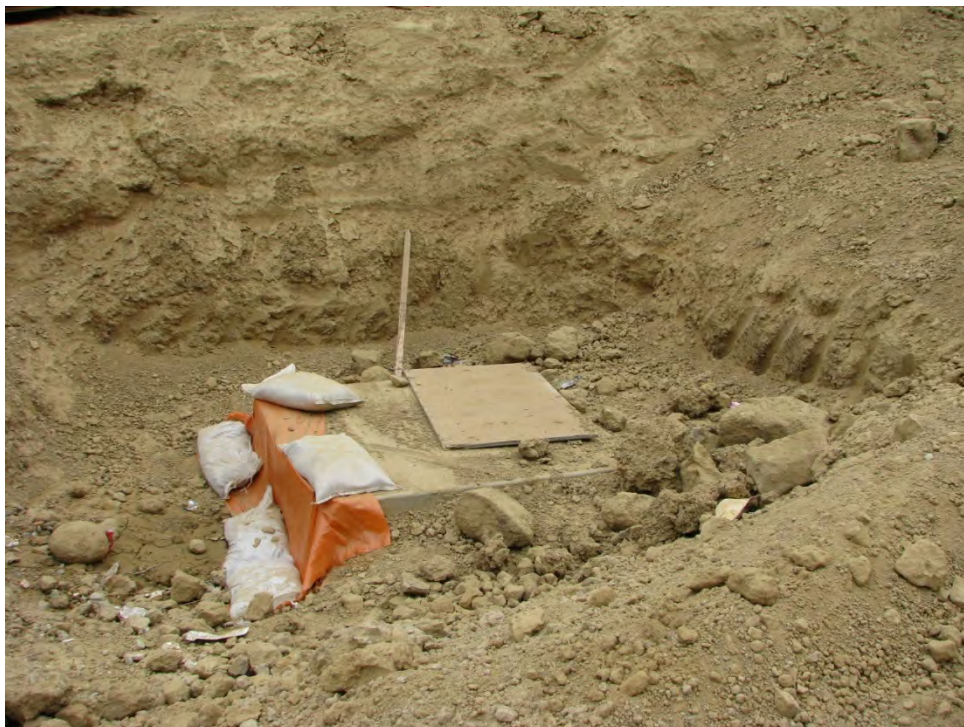
Figure 20. Live storm drain covered with permeable fabric
