Subject: Notice of Violation No. R9-2014-0149, La Jolla Del Rey Phase 2 Construction Project, Order No. 2009-0009-DWQ, NPDES Permit No. CAS000002, Construction General Permit

**NOTICE OF VIOLATION
No. R9-2014-0149**

La Jolla Del Rey Phase 2 Construction Project
PIN No. SM-827215:wchiu

Facility: La Jolla del Rey Phase 2
Inspection Date: 12/4/2014

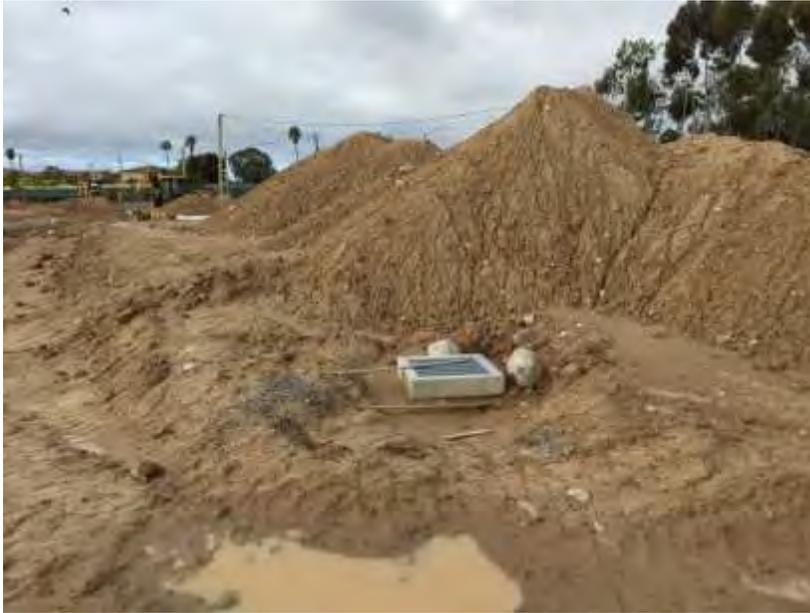
protection, resulting in erosion and sediment transport. See attached December 4, 2014 Facility Inspection Report Photo 1.

2. Construction waste stockpile observed without adequate cover or containment (See Photo 1). Evidence of erosion and sediment transport from the stockpile observed during the inspection. All construction sites are required to contain and securely protect stockpiled waste material from wind and rain at all times unless actively being used.

Photo 1 shows soil stockpile without adequate cover or containment next to a storm drain inlet. Evidence of erosion and sediment transport along that base of the stockpile.

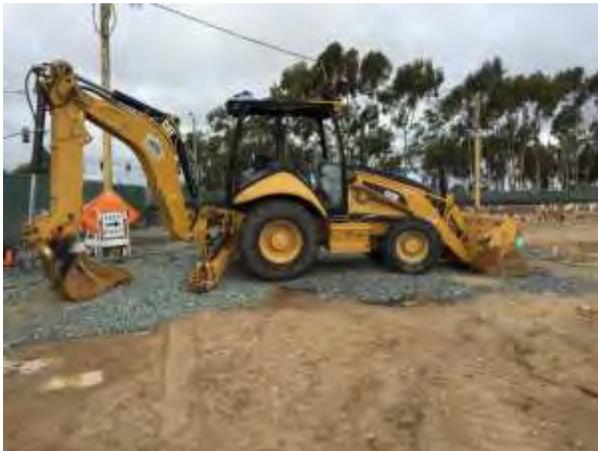
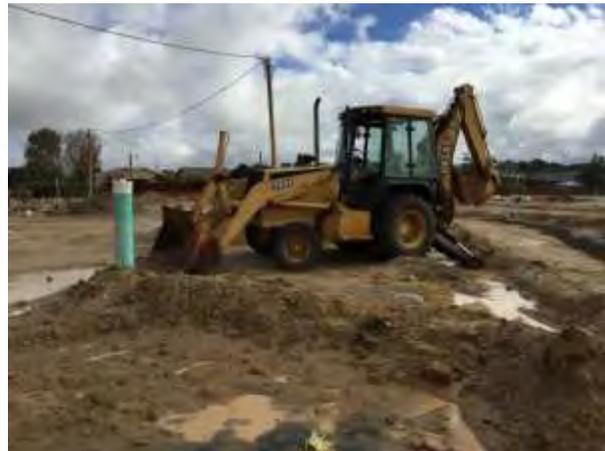
- a. **Pursuant to Provision IX and Section B.3.a of Attachment C of State Water Board Order No. 2009-0009-DWQ:** Risk Level 1 dischargers are required to prevent oil, grease, or fuel to leak in to the ground, storm drains or surface waters.
- b. **Pursuant to Provision IX and Section B.3.b of Attachment C of State Water Board Order No. 2009-0009-DWQ:** Risk Level 1 dischargers are required to place all equipment or vehicles, which are to be fueled, maintained and stored in a designated area fitted with appropriate BMPs.
- c. **Observation:** During the December 4, 2014 inspection, the San Diego Water Board inspector several construction vehicles stored without appropriate BMPs to prevent oil, grease or fuel to leak in to the ground, storm drains or surface waters. See attached December 4, 2014 Facility Inspection Report Photos 2 and 3.

3. Construction equipment and vehicles observed without appropriate BMPs (e.g. drip pans) to prevent oil, grease, or fuel to leak in to the ground, storm drains, or surface waters (See Photos 2 and 3). All construction sites are required to prevent oil, grease or fuel to leak in to the ground, storm drains, or surface waters, and to place all equipment and vehicles, which are to be fueled, maintained and stored in a designated area fitted with appropriate BMPs.

Photos 2 and 3 show construction equipment and vehicles without appropriate BMPs (e.g. drip pans) to prevent oil, grease, or fuel to leak in to the ground, storm drains, or surface waters.

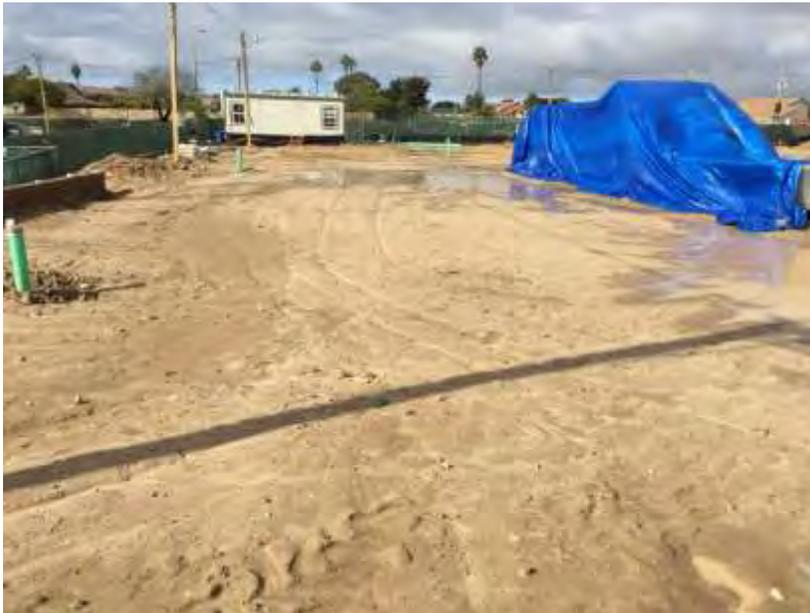
4. Several areas were observed to be inactive, or could be scheduled to be inactive, without effective soil cover to control potential erosion. In particular, two completed building pads and a slope (See Photos 4 and 5), which had not been disturbed for at least a month according to Mr. Underwood, lacked any effective soil cover for erosion control. The lack of erosion controls in these areas contributed to unauthorized sediment discharges from the site (See Photos 5 and 6). All construction sites are required to provide effective soil cover for inactive areas (i.e. areas that have been disturbed and not scheduled to be re-disturbed for at least 14 days) and all finished slopes, open space, utility backfill, and completed lots.

6. Lack of effective runoff controls observed within and around the site which contributed to sediment discharges from the site (See Photos 4 and 9). All construction sites are required to effectively manage run-on, all runoff within the site and all runoff that discharges off the site.

Photo 4 shows completed building pads without any erosion controls or runoff controls and evidence of erosion and sediment transport. .

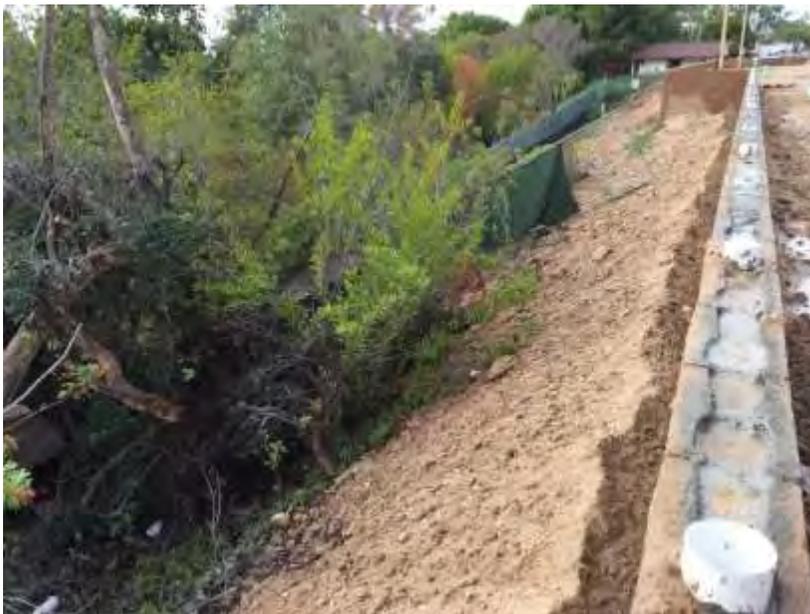
Photo 5 shows slope adjacent to completed building pad without any erosion controls.

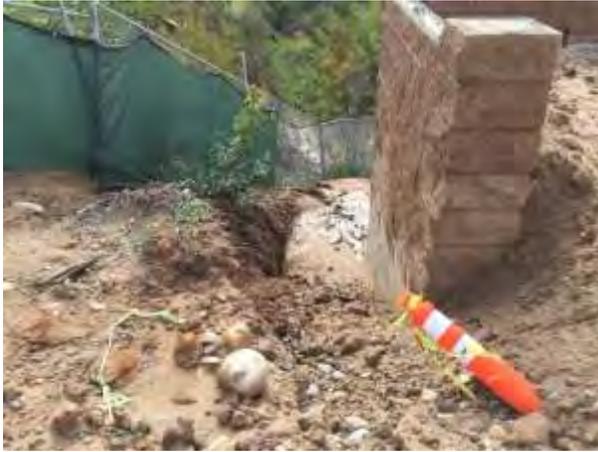
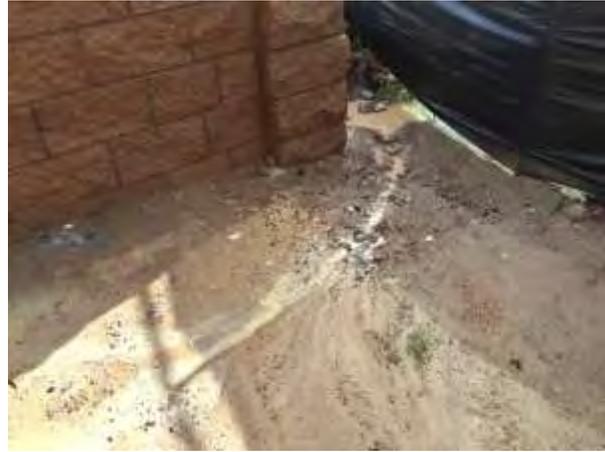
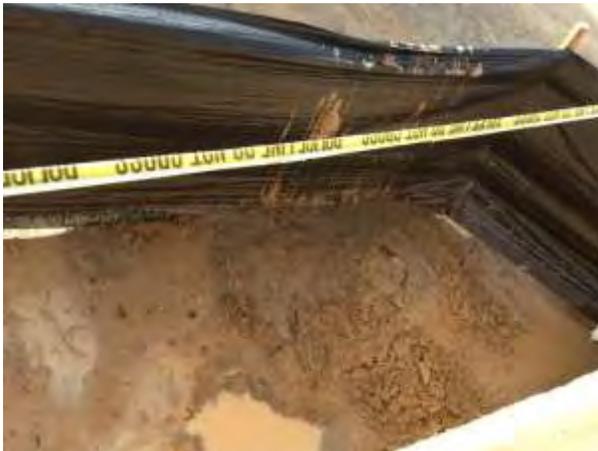
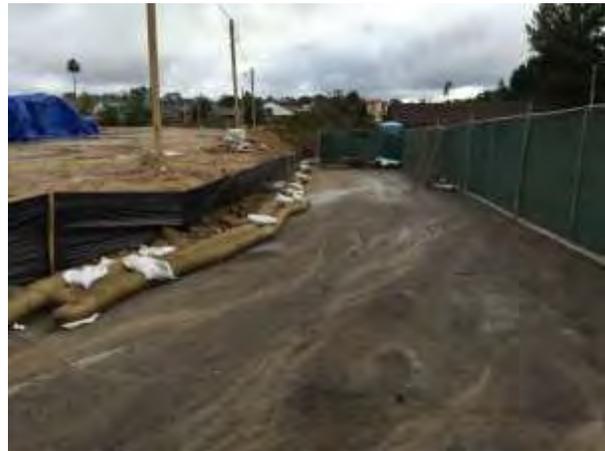
Legally Responsible Person (LRP) enrolled under the Construction General Permit (CGP) for the site. On December 4, 2014, the San Diego Water Board inspector observed evidence of sediment discharged from the site due to inadequate and ineffective implementation of best management practices (BMPs), constituting an unauthorized discharge of sediment from the site. See attached December 4, 2014 Facility Inspection Report Photos 8, 10, and 11.

from the site. See attached December 4, 2014 Facility Inspection Report Photos 6 and 9.

5. Lack of effective perimeter sediment controls observed in several locations of the site which resulted in unauthorized sediment discharges from the site (See Photos 6 through 9). All construction sites are required to establish and maintain effective perimeter controls and stabilize all construction entrances and exits to sufficiently control erosion and sediment discharges from the site.

Photos 6 through 9 show inadequate implementation of perimeter sediment controls to prevent discharges of sediment from the site. Photo 6 shows evidence of erosion and sediment transport from completed building pads that contributed to an offsite discharge of sediment, with accumulation of sediment in a v-ditch outside of the site boundaries due to lack of perimeter controls at the base of the slope. Photos 7 and 8 shows evidence of erosion and sediment transport from the site that contributed to an offsite discharge of sediment and sediment-laden storm water due to inadequately installed perimeter controls. Photo 9 shows evidence of sediment transport through the site with lack of runoff controls and perimeter controls along the chain-link fence to prevent sediment discharges from the site.
