NOTICE OF VIOLATION
No. R9-2014-0145

Northwest Village Creek Construction Project
PIN No. SM-828254:wchiu

FACILITY INSPECTION REPORT

FACILITY: Northwest Village Creek (Walgreens) **INSPECTION DATE/TIME:** 12/4/2014; 11:30 am

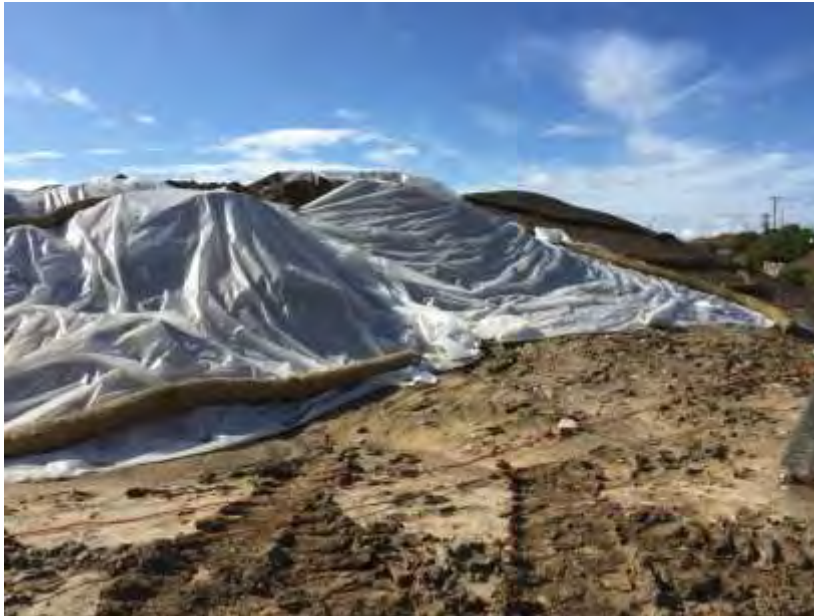
- c. Observation:** During the December 4, 2014 inspection, the San Diego Water Board inspector observed soil stockpiles that appeared to be inactive, or could be scheduled to be inactive without adequate cover, berm, containment or protection, resulting in erosion and sediment transport. See attached December 4, 2014 Facility Inspection Report Photos 1 and 4 through 8.

Photo 1 show soil stockpile without adequate cover or containment. Evidence of erosion and sediment transport along that base of the stockpile. Photo taken by San Diego Water Board inspector on December 4, 2014.

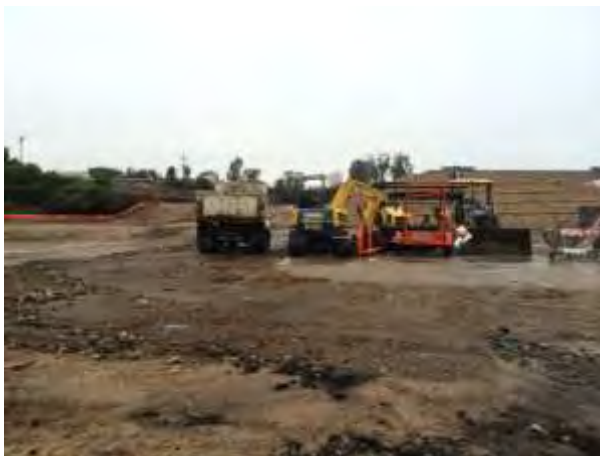
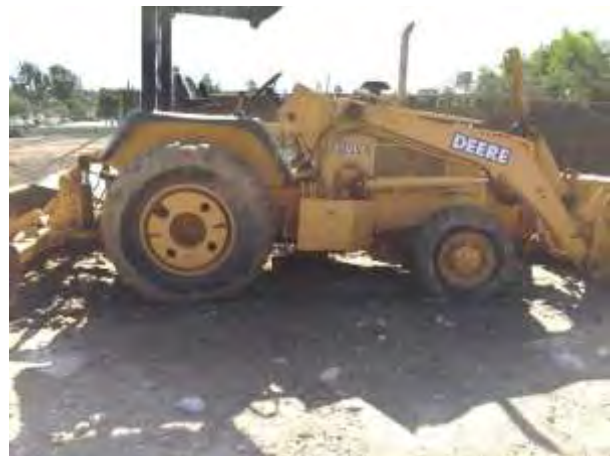
- a. Pursuant to Provision IX and Section B.3.a of Attachment C of State Water Board Order No. 2009-0009-DWQ:** Risk Level 1 dischargers are required to prevent oil, grease, or fuel to leak in to the ground, storm drains or surface waters.
- b. Pursuant to Provision IX and Section B.3.b of Attachment C of State Water Board Order No. 2009-0009-DWQ:** Risk Level 1 dischargers are required to place all equipment or vehicles, which are to be fueled, maintained and stored in a designated area fitted with appropriate BMPs.
- c. Observation:** During the December 4, 2014 inspection, the San Diego Water Board inspector several construction equipment and vehicles stored without appropriate BMPs to prevent oil, grease or fuel to leak in to the ground, storm drains or surface waters. See attached December 4, 2014 Facility Inspection Report Photos 2 and 3.

3. Several construction equipment and vehicles observed without appropriate BMPs (e.g. drip pans) to prevent oil, grease, or fuel to leak in to the ground, storm drains, or surface waters (See Photos 2-3). All construction sites are required to prevent oil, grease or fuel to leak in to the ground, storm drains, or surface waters, and to place all equipment and vehicles, which are to be fueled, maintained and stored in a designated area fitted with appropriate BMPs.
4. Several areas were observed to be inactive, or could be scheduled to be inactive, without effective soil cover to control potential erosion. All construction sites are required to provide effective soil cover for inactive (i.e. areas that have been disturbed and not scheduled to be re-disturbed for at least 14 days) areas and all finished slopes, open space, utility backfill, and completed lots.

Photos 2 and 3 show construction equipment and vehicles without appropriate BMPs (e.g. drip pans) to prevent oil, grease, or fuel to leak in to the ground, storm drains, or surface waters. Photo 2 provided by concerned citizen, taken in the morning on December 3, 2014. The same vehicles were observed by the San Diego Water Board inspector on December 4, 2014, also without appropriate BMPs. Photo 3 taken by the San Diego Water Board inspector on December 4, 2014.

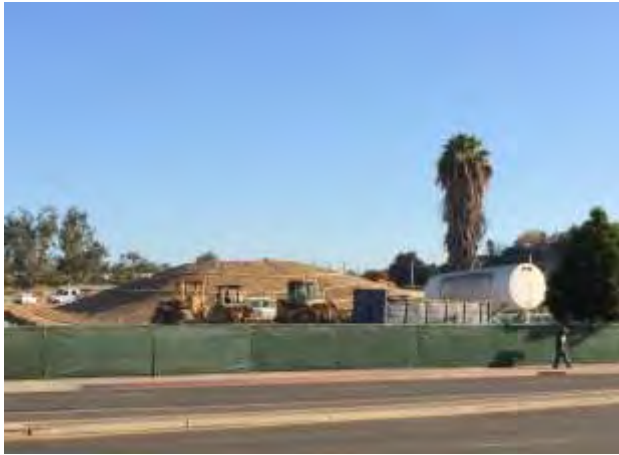
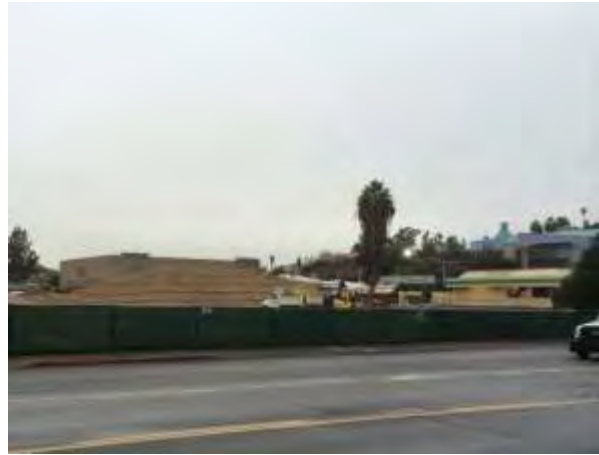
prevent erosion. In particular, a large topographic feature (claimed to be a stockpile by the site superintendent) documented by a concerned citizen from as early as September 30, 2014 to the date of the inspection (December 4, 2014), lacked any effective soil cover for erosion control. Evidence of erosion and sediment transport due to lack of erosion control measures were observed throughout the site during the inspection. See attached December 4, 2014 Facility Inspection Report Photos 4 through 8.

In particular, a large topographic feature (claimed to be a stockpile by Mr. Dipalma) documented by a concerned citizen from as early as September 30, 2014 to the date of the inspection (December 4, 2014), lacked any effective soil cover for erosion control. Evidence of erosion and sediment transport due to lack or erosion control measures were observed throughout the site during the inspection (See Photos 4 through 8).

Photos 4 and 5 show the large topographic feature without any erosion controls. Linear sediment controls can be observed. Photo 4 provided by concerned citizen, taken in the morning on September 30, 2014. Photo 5 provided by concerned citizen, taken in the morning on December 3, 2014. Approximate size and shape of the topographic feature has not changed.

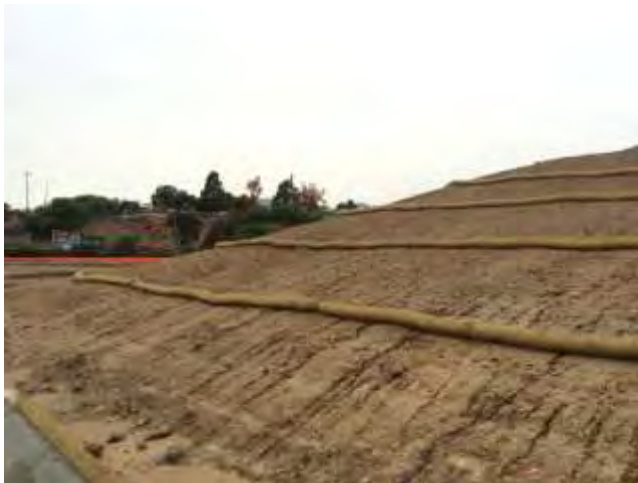
Photo 6 shows the evidence of erosion and sediment transported to the base of the slope. Photo 6 also shows the linear sediment controls were not properly installed, as the fiber rolls are not overlapped and properly trench into the slope. Photo 6 provided by concerned citizen, taken in the morning on December 3, 2014.

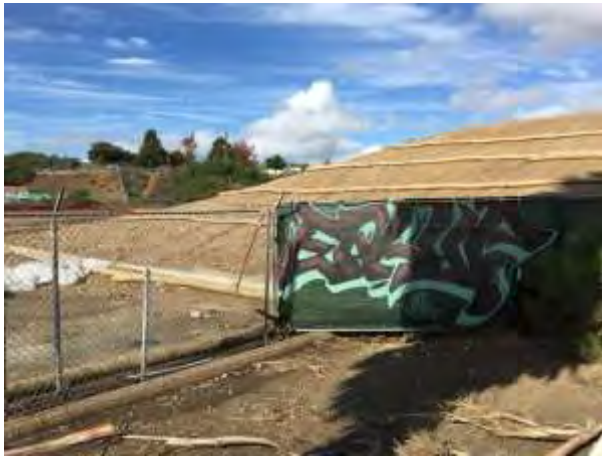
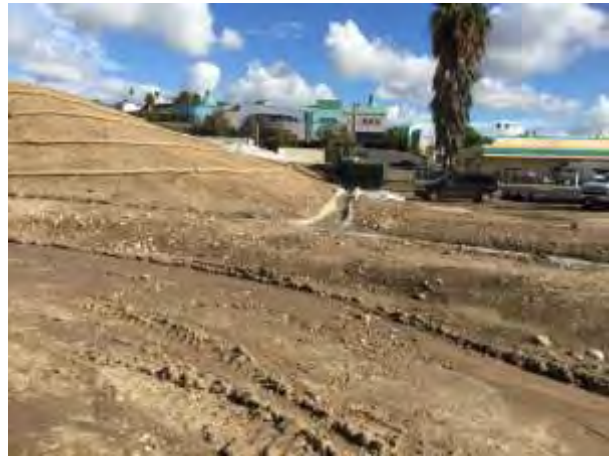
Photos 7 and 8 show evidence of erosion, in the form of rills on the slope. Photo 7 also shows evidence that erosion has resulted in sediment transport to v-ditch at base of the topographic feature, which drains to a post-construction BMP basin. Photos 6 and 7 taken by San Diego Water Board inspector on December 4, 2014.

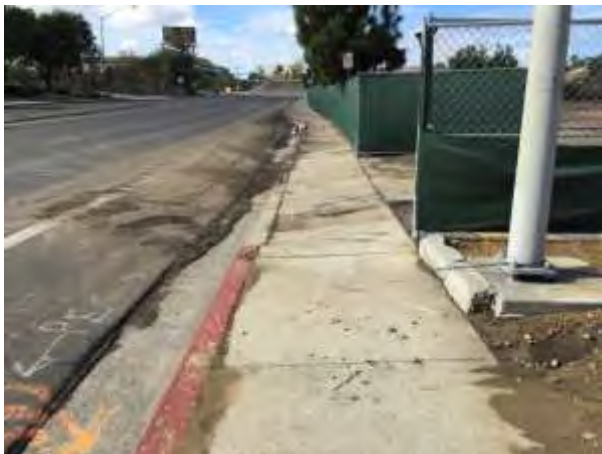
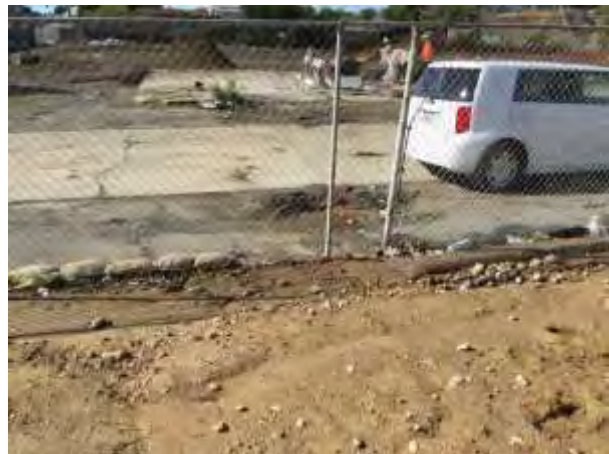
5. Lack of effective perimeter sediment controls observed in several locations of the site (See Photos 9 through 11). One construction entrance/exit was not adequately controlled which resulted in sediment discharges from the site. All construction sites are required to establish and maintain effective perimeter controls and stabilize all construction entrances and exits to sufficiently control erosion and sediment discharges from the site.

6. Lack of effective run-on controls observed which resulted in sediment discharges to the site, and contributed to sediment discharges from the site (See Photo 10). All construction sites are required to effectively manage run-on, all runoff within the site and all runoff that discharges off the site. Run-on from off site must be directed away from all disturbed areas or collectively be in compliance with the effluent limitations of the CGP.

Photos 9 and 10 show factors that contributed to uncontrolled sediment discharges from the site. Photo 9 shows lack of perimeter sediment controls or tracking controls at an entrance/exit to the site. Significant offsite tracking of sediment can be seen in Photo 9. Photo 10 shows a missing section of the perimeter controls allowing offsite sediment to run-on to the site, which contributed to the sediment discharges from the site shown in Photo 9. Photos 9 and 10 taken by the San Diego Water Board inspector on December 4, 2014.

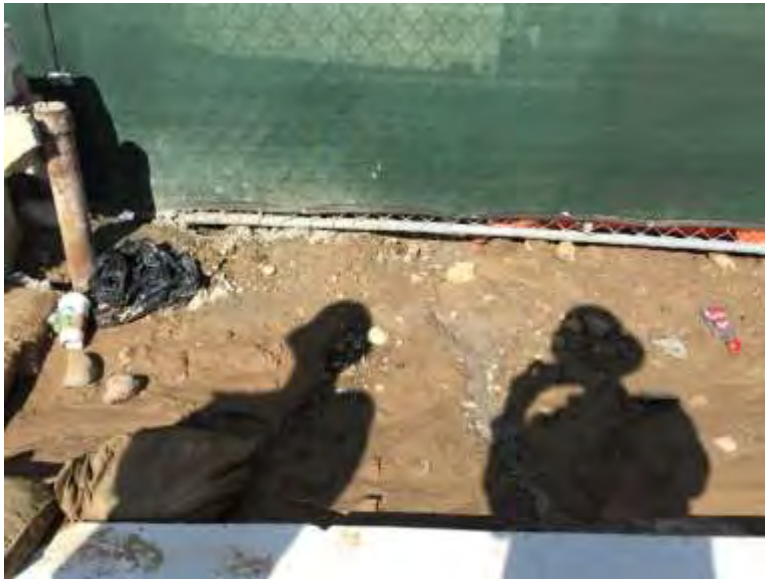
Photo 11 shows an additional location where perimeter sediment controls were not established, resulting in a discharge of sediment from the site. Photo 11 taken by the San Diego Water Board inspector on December 4, 2014.

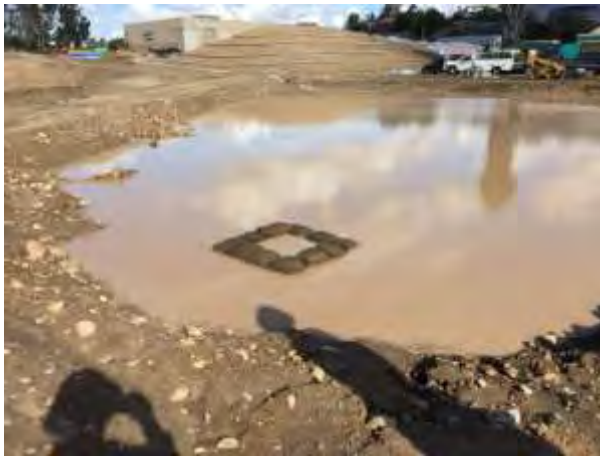
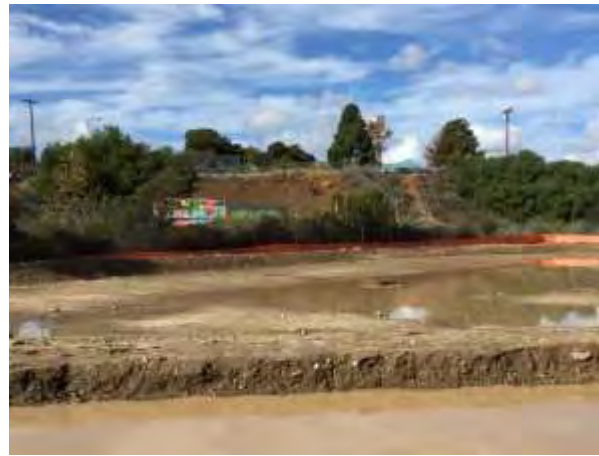
The unauthorized discharge originated from the two basins that appeared to be constructed to be post-construction BMPs, and were not appropriately modified to be sediment traps (or sediment basins) during the construction phase as the outlets (or storm drain inlets) are located on the bottom of the basins without any

risers or spillways (See Photos 12 and 13). In addition, erosion controls were not implemented to reduce the potential for sediment to be transported to the sediment traps (or sediment basins). The outlets from the post-construction BMPs are connected to a six-inch pipe outfall that discharges directly to Chollas Creek (See Photos 14 through 16).

Photos 12 and 13 show the post-construction BMP basin that were inappropriately used and/or designed for the construction phase. Photo 12 shows the eastern basin, which collects runoff from the topograph feature seen in the background. Photo 13 shows the western basin. In both photos, the outlets (or storm drain inlets) can be seen surrounded by gravel bags. According to the superintendent, the outlets are covered with filter fabric. Photos 12 and 13 taken by the San Diego Water Board inspector on December 4, 2014.

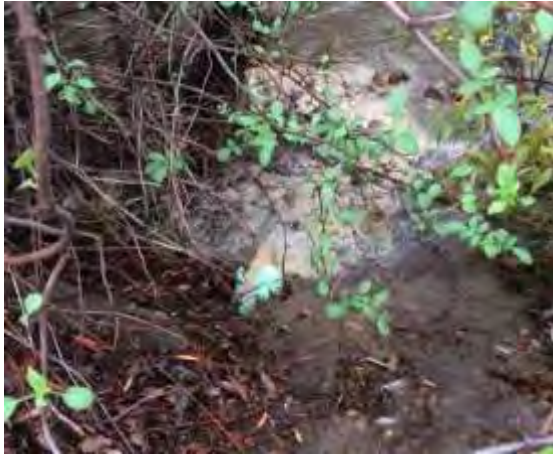
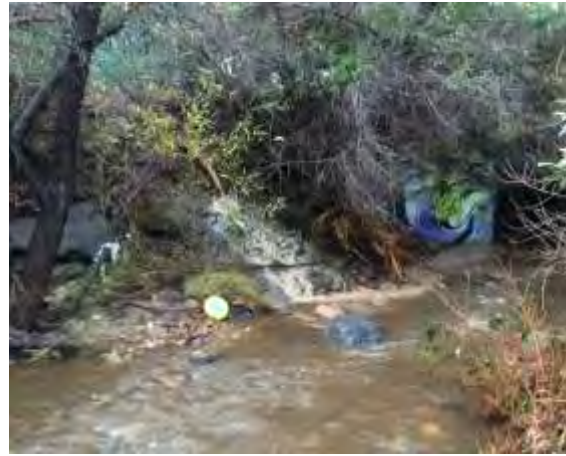
Photos 14 and 15 show the 6-inch pipe outfall connected to the post-construction BMP basins on the site discharging sediment-laden storm water directly to Chollas Creek. Photo 15 also shows a plume of sediment-laden storm water traveling downstream in Chollas Creek. Photos 14 and 15 provided by concerned citizen, taken in the morning on December 4, 2014.

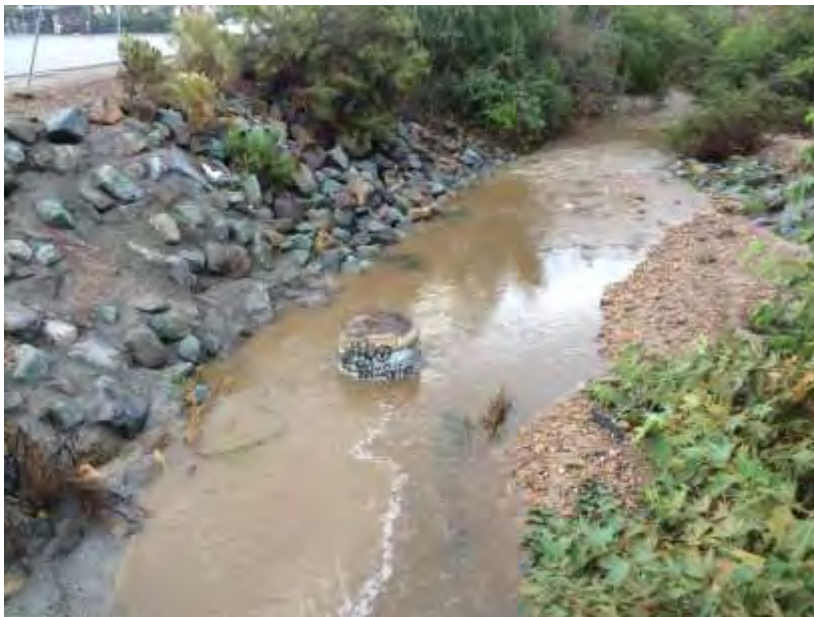
Photo 16 shows plume of sediment-laden storm water downstream from discharge point shown in Photos 14 and 15. Photo 16 provided by concerned citizen, taken in the morning on December 4, 2014.
