**CALIFORNIA REGIONAL WATER QUALITY CONTROL BOARD - SAN DIEGO REGION  
WATERSHED PROTECTION PROGRAM**

**FACILITY INSPECTION REPORT**

**FACILITY:** Mission Gorge Apartments  
**WDID/FILE NO.:** 937C369143

**INSPECTION DATE/TIME:** 12/12/2014; 9:00 am

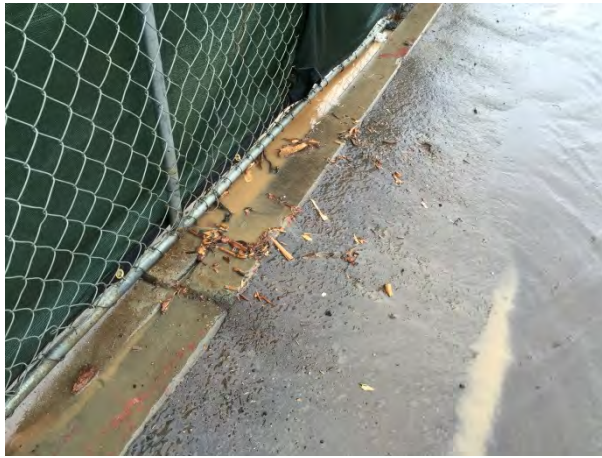
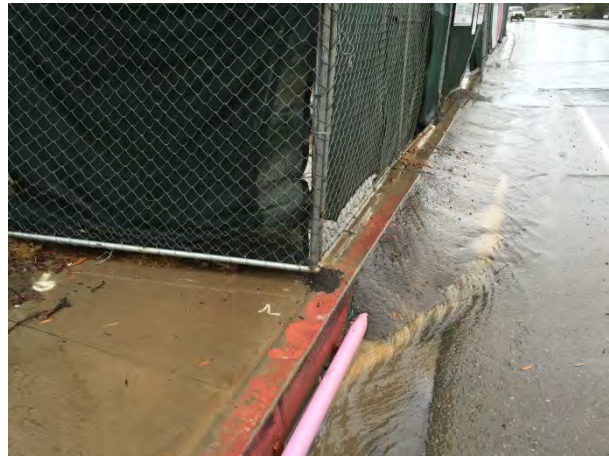
During a December 12, 2014 storm event, Ms. Ghoram observed a discharge of sediment-laden storm water from the site to the City of San Diego municipal separate storm sewer system (MS4) on Mission Gorge Road (See Photos 1 and 2). Wayne Chiu of the San Diego Water Board performed a follow up inspection of the Mission Gorge Apartments construction site for compliance with the requirements CGP to determine whether the discharge of sediment-laden storm water from the site was an authorized.. According to the Storm Water Multiple Application & Report Tracking System (SMARTS), the site is a Risk Level 1 construction site, disturbing over 10 acres, and owned being developed by KNR Mission Gorge LLC.

**Photos 1 and 2** show discharges of sediment-laden storm water runoff from the site to the City of San Diego MS4 drainage system on Mission Gorge Road.

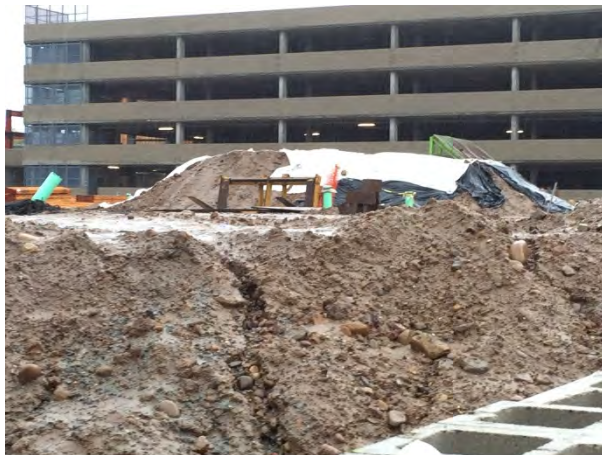
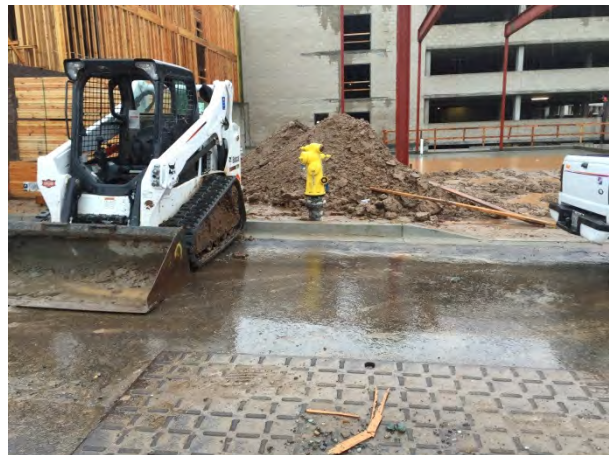
1. Several stockpiles observed without adequate cover and containment (See Photos 3 and 4). Evidence of erosion and sediment transport from the stockpile observed during the inspection. All construction sites are required to contain and securely protect stockpiled waste material from wind and rain at all times unless actively being used.

1. There is evidence that the site failed to implement good site management “housekeeping” BMPs for soil stockpiles before the storm event (See Finding 1).

**Photos 3 and 4** show soil stockpiles without adequate cover and containment during December 11 and 12, 2014 storm event. Evidence of erosion and sediment transport along that base of the stockpile.

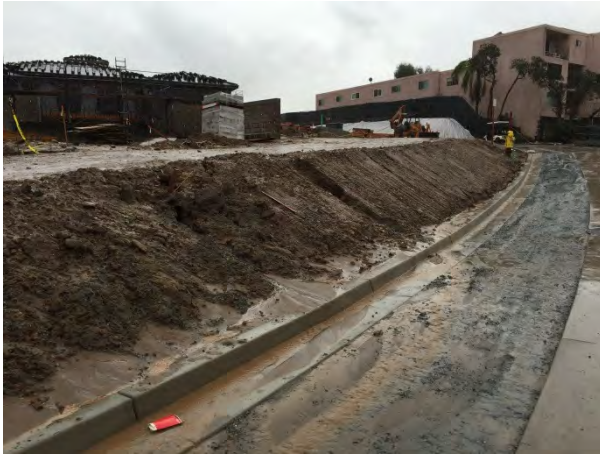
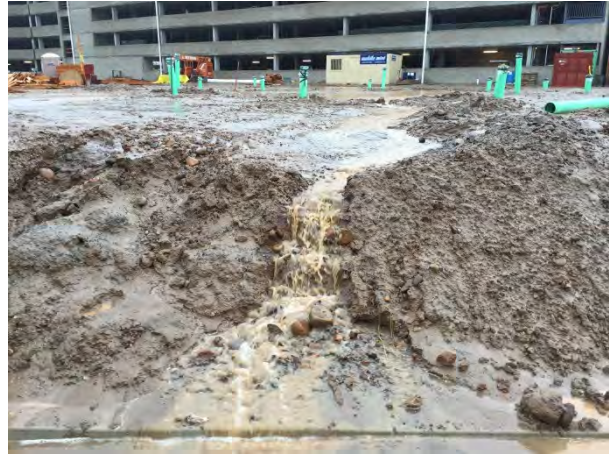
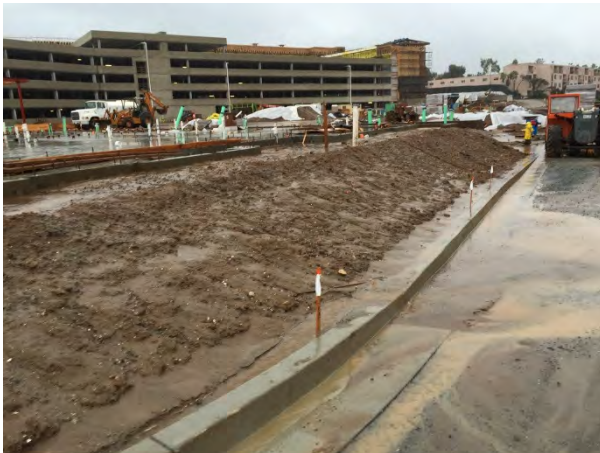
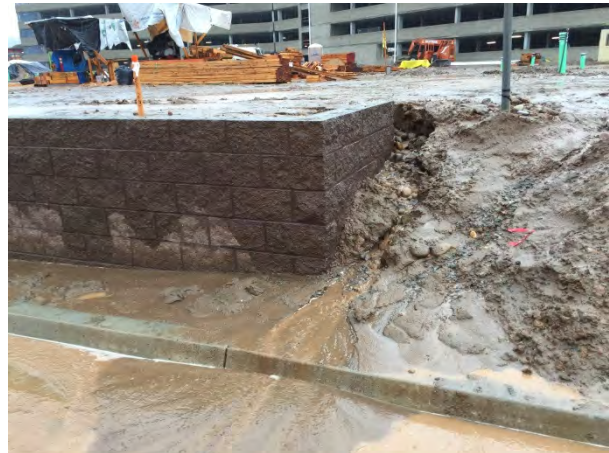
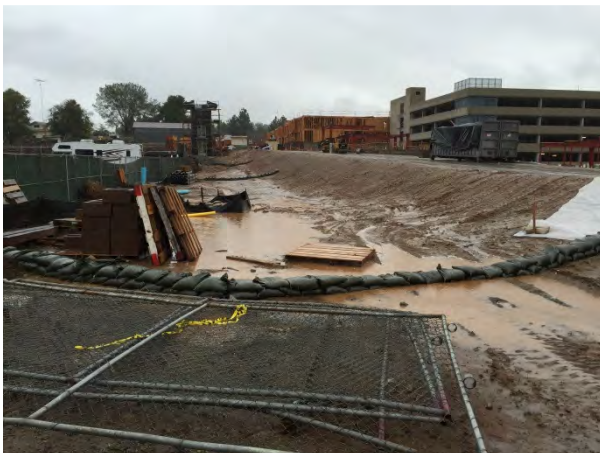
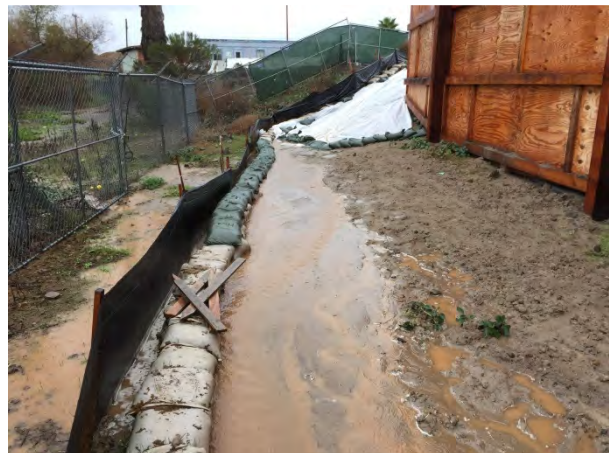
2. Several areas were observed to be inactive, or could be scheduled to be inactive, without effective soil cover to control potential erosion. Several inactive slopes (See Photos 5 through 10) lacked any effective soil cover for erosion control. The lack of erosion controls in these areas contributed to unauthorized sediment discharges from the site (See Photos 11 through 15). All construction sites are required to provide effective soil cover for inactive areas (i.e. areas that have been disturbed and not scheduled to be re-disturbed for at least 14 days) and all finished slopes, open space, utility backfill, and completed lots.

3. Lack of effective runoff controls observed within and around the site which contributed to discharges of sediment-laden storm water runoff from the site (See Photos 5 through 10). The lack of runoff controls within the site contributed to unauthorized sediment discharges from the site (See Photos 11 through 15). All

**Photos 5 through 10** show several slopes and areas that have been inactive for at least 14 days lacking erosion control measures to prevent erosion. Photos also show lack of runoff controls within the site to limit the transport of sediment through the site.

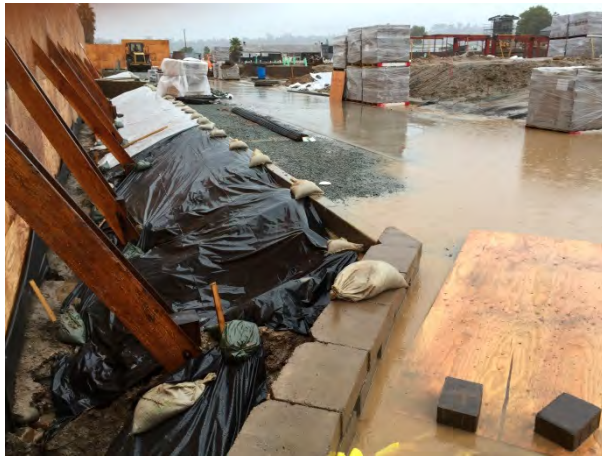
**Photos 11 through 15** show pathway to unauthorized discharges of sediment and sediment-laden storm water runoff from the site to the San Diego River. Photo 11 shows area where runoff in Photos 5 through 8 collect. Photo 12 shows where runoff from Photo 11 flow down slope. Photo 13 shows where flow from Photo 12 emerges. Photo 14 shows where flow from Photo 13 and Photos 9 and 10 converge and discharge from location in perimeter controls (i.e. gravel bags) that appears to have been moved to allow flow off site. Photo 15 shows sediment-laden storm water runoff flowing off site to the San Diego River due to inadequate implementation of erosion controls, runoff controls within the site, and perimeter sediment controls.

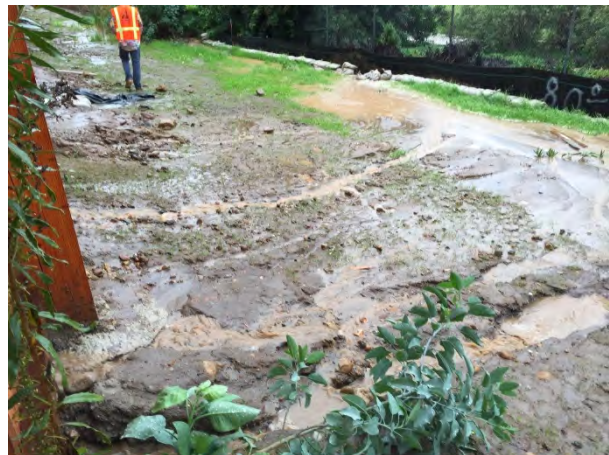
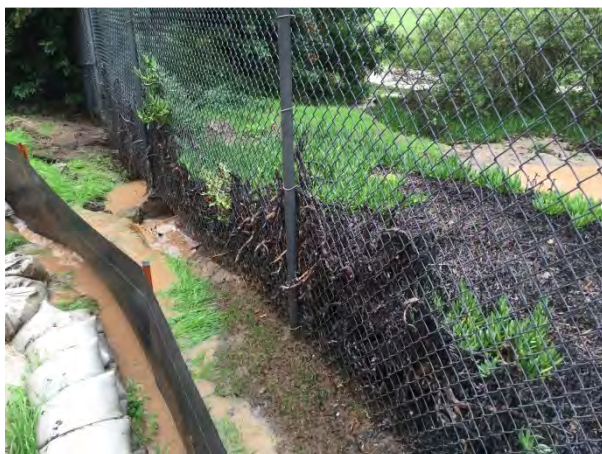
4. Lack of effective perimeter sediment controls observed which resulted in unauthorized sediment discharges from the site (See Photos 14 and 15). All construction sites are required to establish and maintain effective perimeter controls and stabilize all construction entrances and exits to sufficiently control erosion and sediment discharges from the site.
