NOTICE OF VIOLATION
No. R9-2014-0154

Mission Gorge Apartments Construction Project
PIN No. SM-826367:wchiu

FACILITY INSPECTION REPORT

FACILITY: Mission Gorge Apartments
WDID/FILE NO.: 937C369143

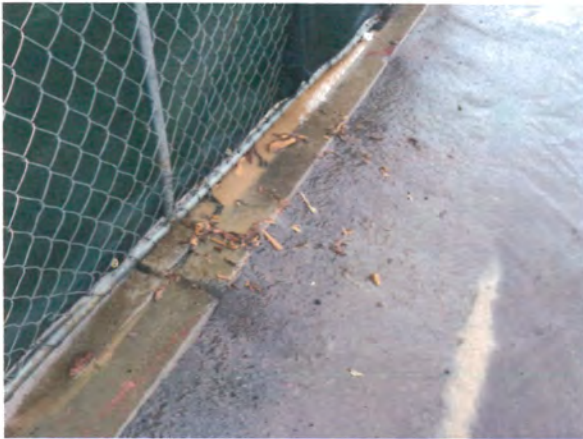
Photo 1

During a December 12, 2014 storm event, Ms. Ghoram observed a discharge of sediment-laden storm water from the site to the City of San Diego municipal separate storm sewer system (MS4) on Mission Gorge Road (See Photos 1 and 2). Wayne Chiu of the San Diego Water Board performed a follow up inspection of the Mission Gorge Apartments construction site for compliance with the requirements CGP to determine whether the discharge of sediment-laden storm water from the site was an authorized.. According to the Storm Water Multiple Application & Report Tracking System (SMARTS), the site is a Risk Level 1 construction site, disturbing over 10 acres, and owned being developed by KNR Mission Gorge LLC.

Photos 1 and 2 show discharges of sediment-laden storm water runoff from the site to the City of San Diego MS4 drainage system on Mission Gorge Road.

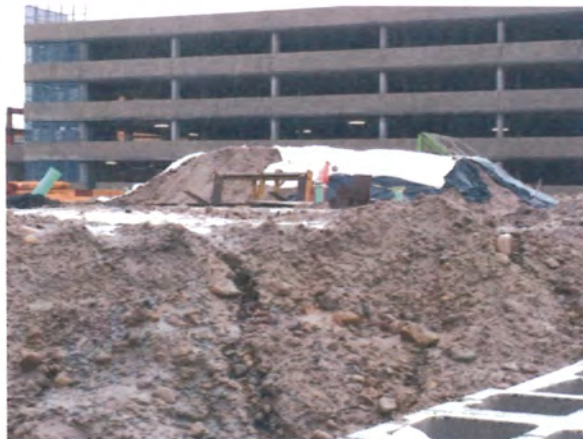
Photo 3

or protection, resulting in erosion and sediment transport. See attached December 12, 2014 Facility Inspection Report Photos 3 and 4.

1. Several stockpiles observed without adequate cover and containment (See Photos 3 and 4). Evidence of erosion and sediment transport from the stockpile observed during the inspection. All construction sites are required to contain and securely protect stockpiled waste material from wind and rain at all times unless actively being used.

Photos 3 and 4 show soil stockpiles without adequate cover and containment during December 11 and 12, 2014 storm event. Evidence of erosion and sediment transport along that base of the stockpile.

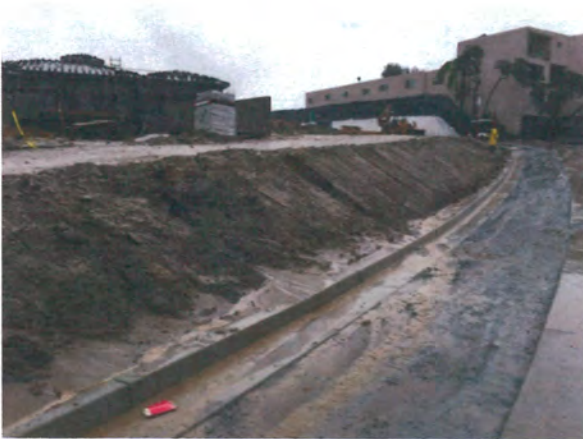
Photo 5

2. Several areas were observed to be inactive, or could be scheduled to be inactive, without effective soil cover to control potential erosion. Several inactive slopes (See Photos 5 through 10) lacked any effective soil cover for erosion control. The lack of erosion controls in these areas contributed to unauthorized sediment discharges from the site (See Photos 11 through 15). All construction sites are required to provide effective soil cover for inactive areas (i.e. areas that have been disturbed and not scheduled to be re-disturbed for at least 14 days) and all finished slopes, open space, utility backfill, and completed lots.

3. Lack of effective runoff controls observed within and around the site which contributed to discharges of sediment-laden storm water runoff from the site (See Photos 5 through 10). The lack of runoff controls within the site contributed to unauthorized sediment discharges from the site (See Photos 11 through 15). All

Photos 5 through 10 show several slopes and areas that have been inactive for at least 14 days lacking erosion control measures to prevent erosion. Photos also show lack of runoff controls within the site to limit the transport of sediment through the site.

Photos 11 through 15 show pathway to unauthorized discharges of sediment and sediment-laden storm water runoff from the site to the San Diego River. Photo 11 shows area where runoff in Photos 5 through 8 collect. Photo 12 shows where runoff from Photo 11 flow down slope. Photo 13 shows where flow from Photo 12 emerges. Photo 14 shows where flow from Photo 13 and Photos 9 and 10 converge and discharge from location in perimeter controls (i.e. gravel bags) that appears to have been moved to allow flow off site. Photo 15 shows sediment-laden storm water runoff flowing off site to the San Diego River due to inadequate implementation of erosion controls, runoff controls within the site, and perimeter sediment controls.

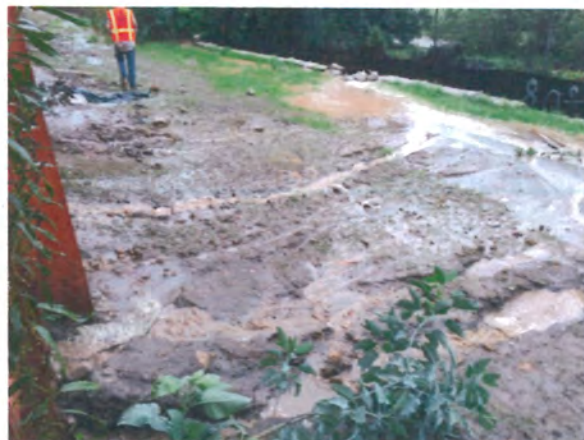
Photo 14

- a. Pursuant to Provision IX and Section E.1 of Attachment C of State Water Board Order No. 2009-0009-DWQ:** Risk Level 1 dischargers shall establish and maintain effective perimeter controls and stabilize all construction entrances and exits to sufficiently control erosion and sediment discharges from the site.
- b. Observation:** During the December 12, 2014 inspection, the San Diego Water Board inspector observed perimeter controls that were not adequately established or maintained to sufficiently control erosion and sediment discharges from the site. See attached December 12, 2014 Facility Inspection Report Photos 14 and 15.

4. Lack of effective perimeter sediment controls observed which resulted in unauthorized sediment discharges from the site (See Photos 14 and 15). All construction sites are required to establish and maintain effective perimeter controls and stabilize all construction entrances and exits to sufficiently control erosion and sediment discharges from the site.
