**Subject: Notice of Violation, City of San Diego Construction Oversight Program,  
NPDES Order No. R9-2007-0001**

**FACILITY INSPECTION REPORT**

**FACILITY:** Del Sur/Unit 14

**FACILITY:** Casa Mira View

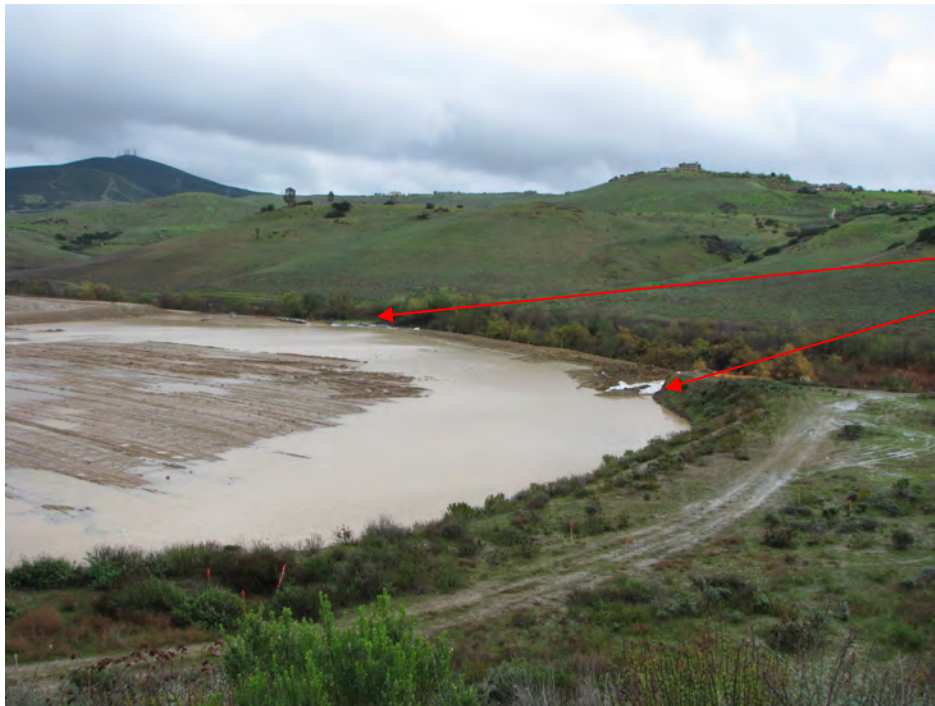
Figure 1. Construction site; looking south at Lusardi Creek

Sites of two recent breaches

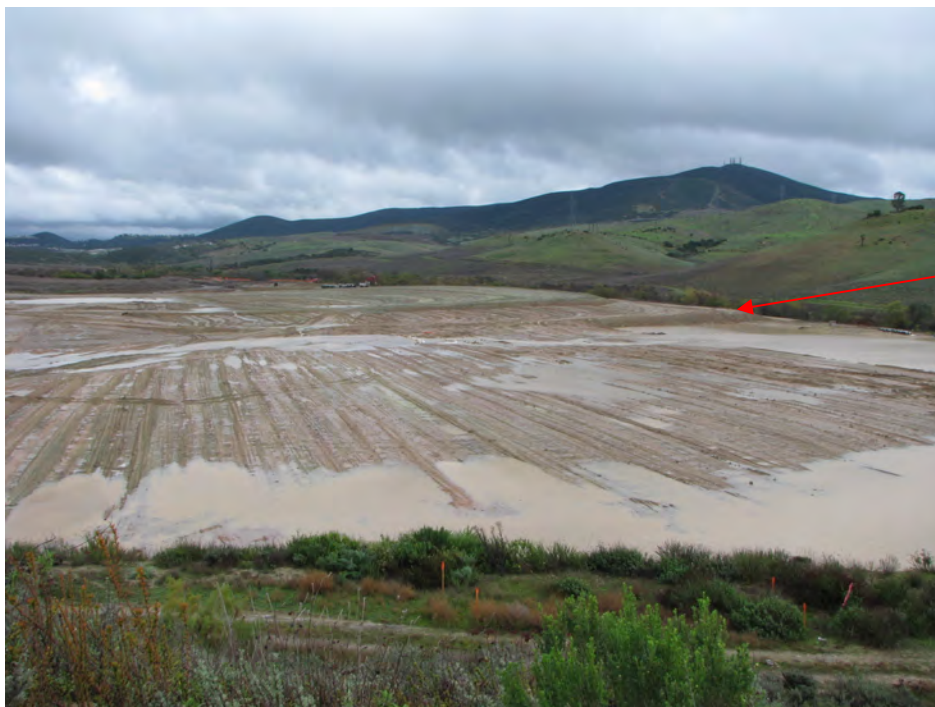
Figure 2. Construction site; looking east from Camino del Sur

Berm that will eventually used as permanent storm water detention feature

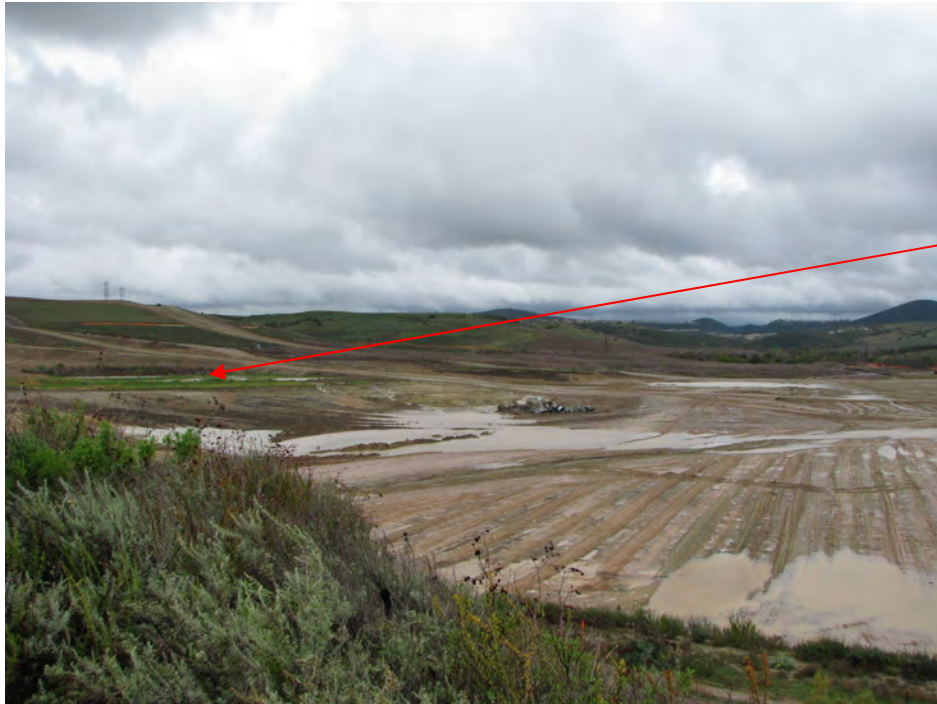
Figure 3. Construction site looking northeast

Storm water detention basin used to detain offsite run on from upstream development

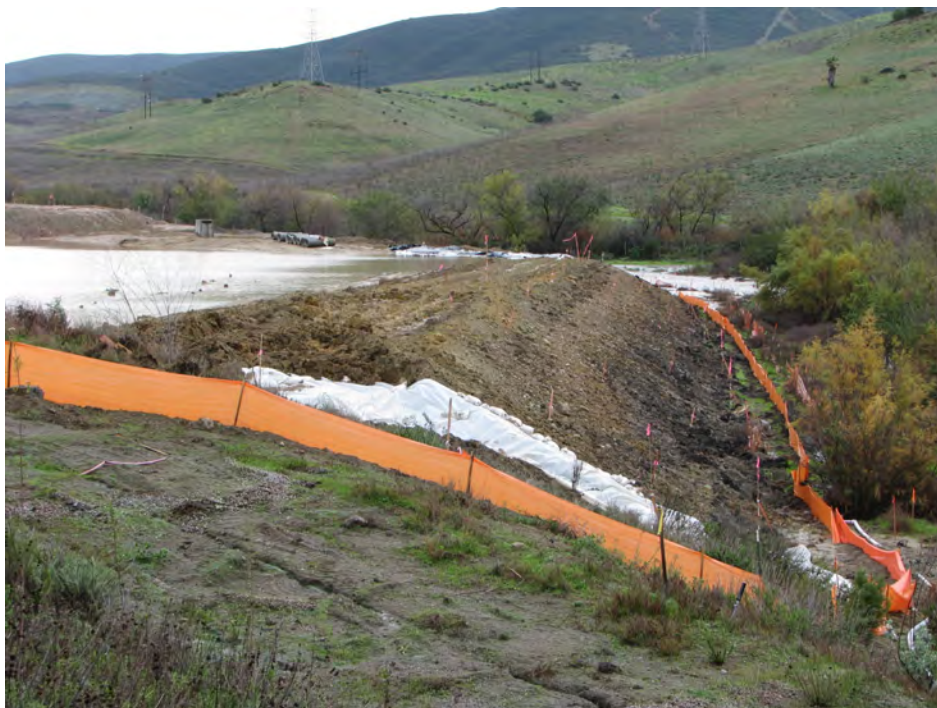
Figure 4. Berm used to detain storm water

4. The berm at the perimeter that was used to temporarily detain the storm water was overwhelmed by recent storms. Sediment-laden storm water breached the berm in at least two places and entered Lusardi Creek (Figures 4-9).

Note slopes have no erosion control

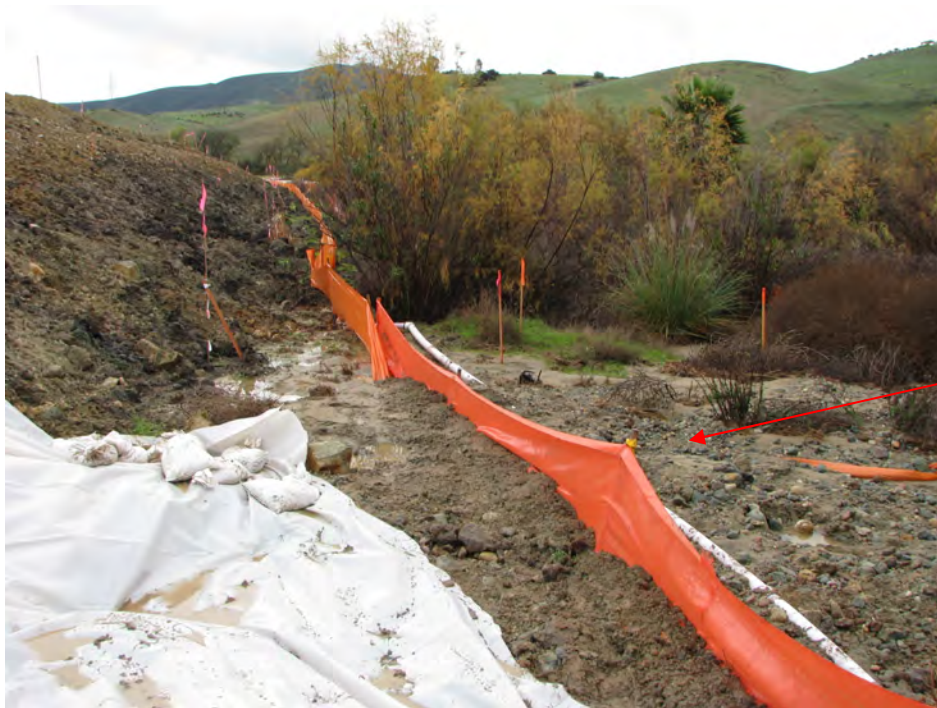
Figure 6. Foot of berm

Sediment from  
 construction site has  
 entered Lusardi Creek

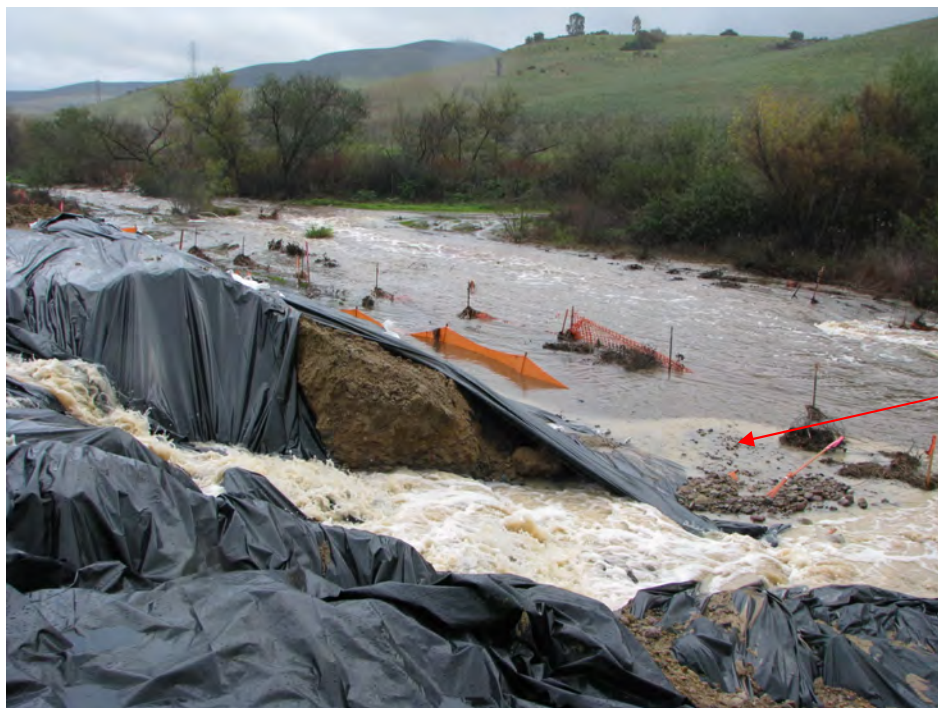
Note discoloration of  
 storm water from site  
 mixing with creek

Figure 8. Construction site discharge entering Lusardi Creek

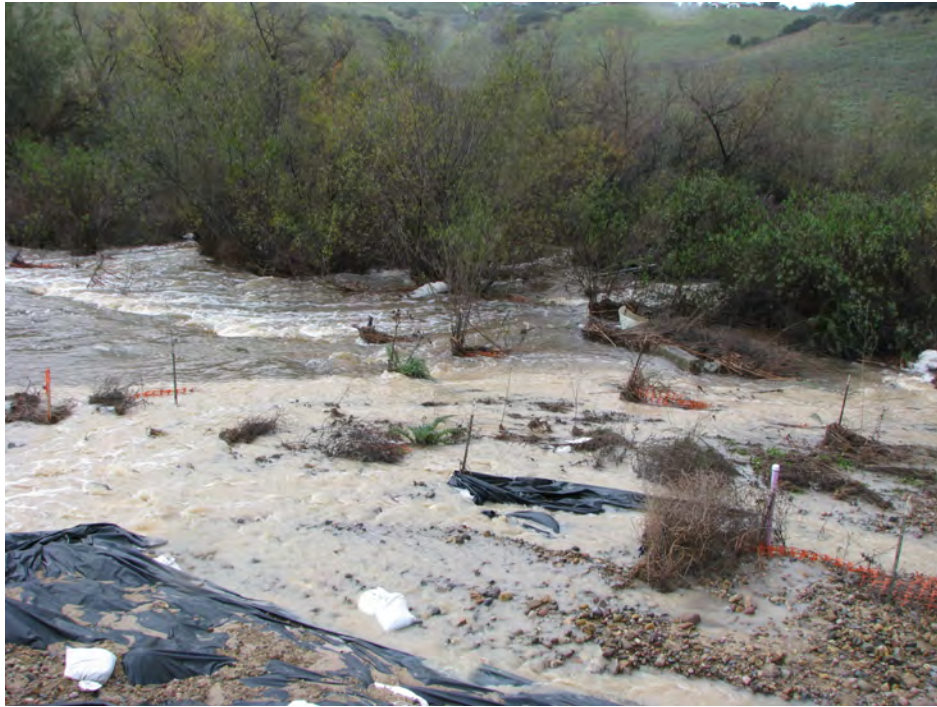
Note silt fences are underwater.

Figure 9. Construction site discharge entering Lusardi Creek

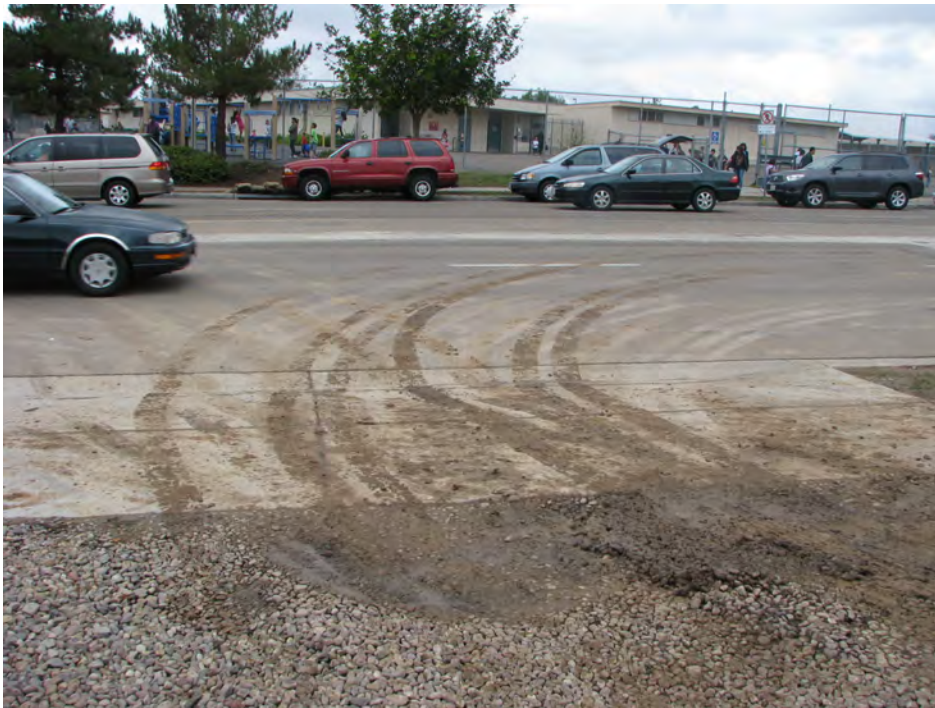
Note sediment on street.  
 Gravel BMP in poor  
 condition and in need of  
 maintenance.

Figure 1. Construction site entrance

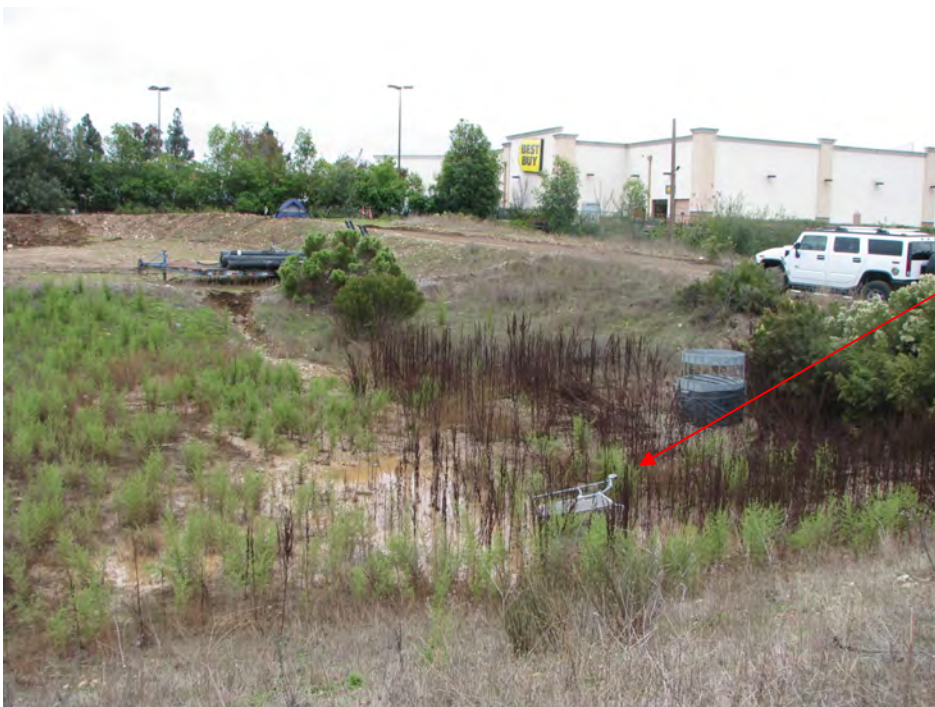
Shopping cart in desilting  
 basin should be  
 removed.

Figure 2. Desilting basin inside project boundaries

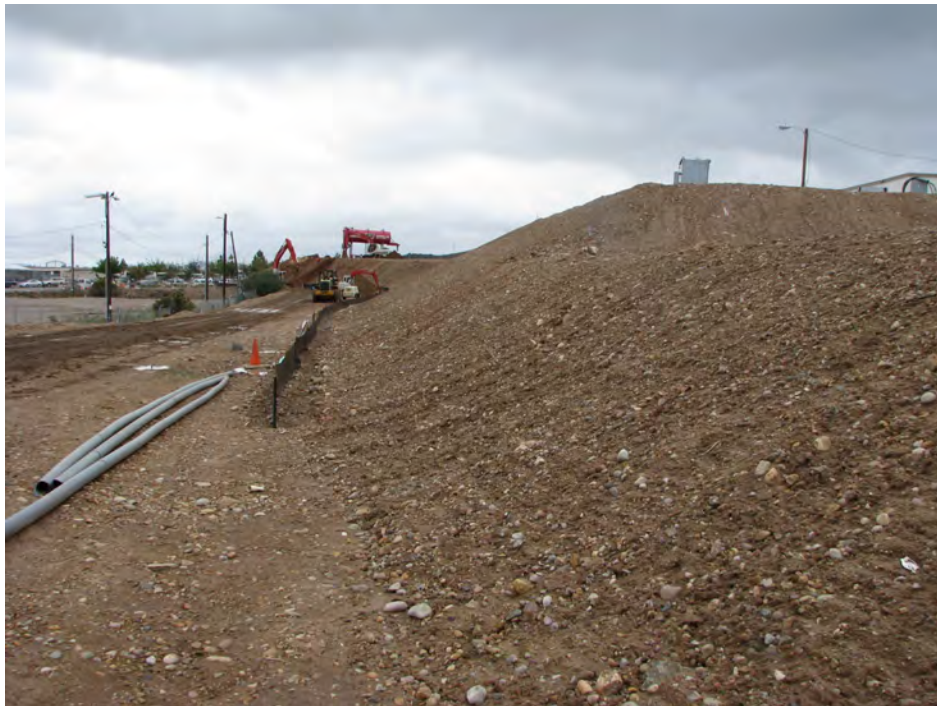
Erosion control measures must be applied to slopes.

Figure 3. Uncovered slope (inside property)

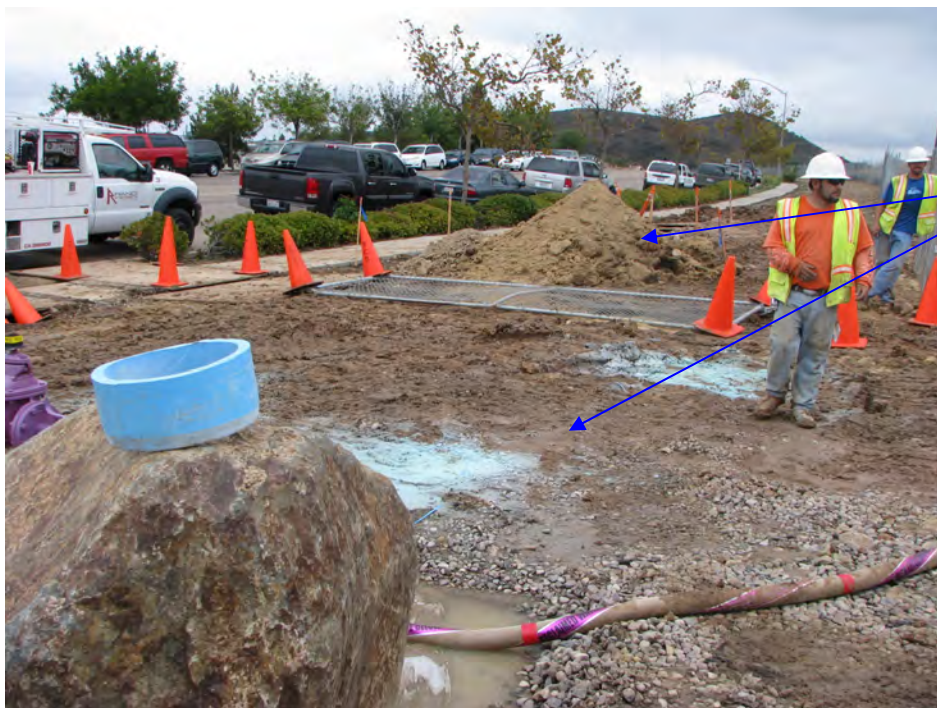
Figure 4. Project site at street level

Note uncovered stockpile and blue dust from pipe cutting

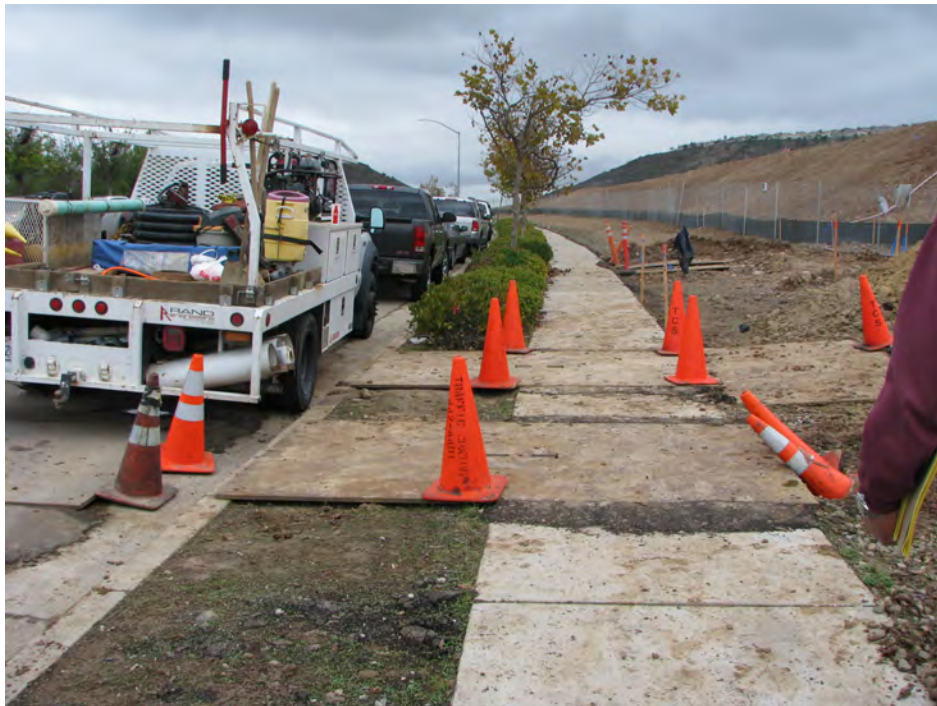
Figure 5. Sidewalk adjacent to project site

Project sediment is on sidewalk and street.

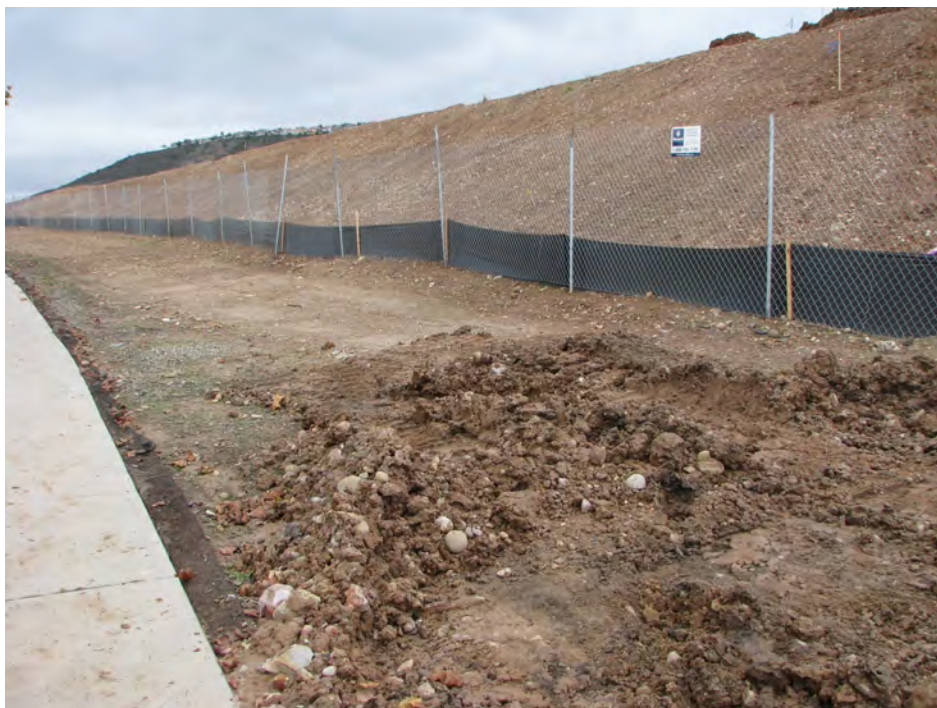
Figure 6. Slope and project material at perimeter

Slopes on West side (perimeter) of site have no erosion control BMPs. Also, disturbed sediment near sidewalk should be covered or removed.

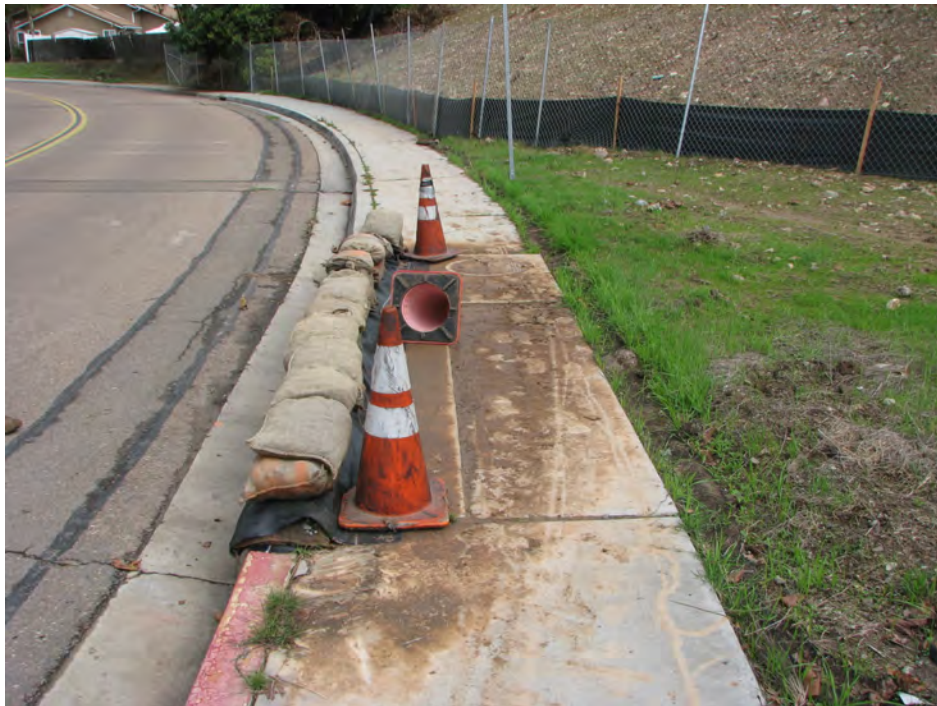
Figure 7. Storm drain inlet at North side of property

Area near storm drain inlet should be swept.

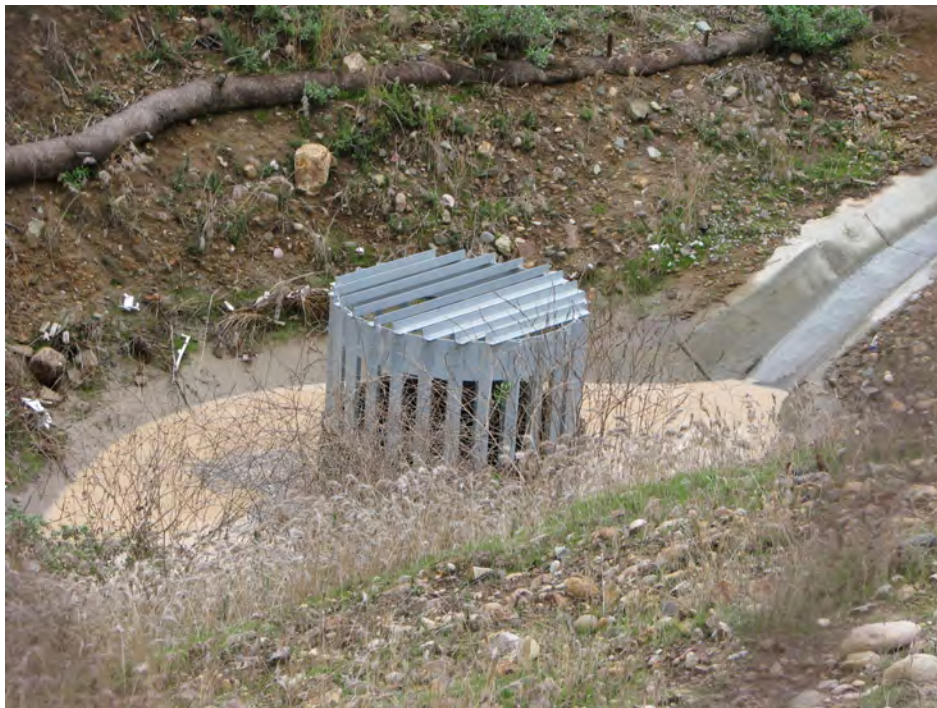
Figure 8. Storm drain on Caltrans right of way (East side project boundary)

Riser pipe is wrapped with filter fabric. Note turbid water surrounding pipe entering via concrete swale.

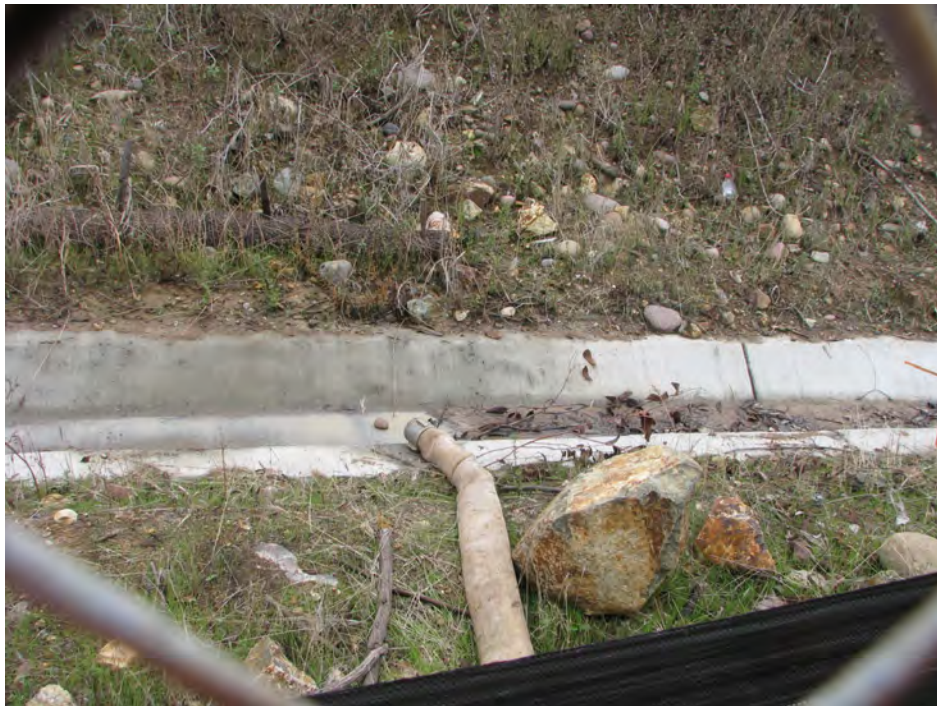
Figure 9. Outlet pipe of illegal discharge

Source of turbid water is illegal discharge from project site.

1. Prevent additional illegal pumping of sediment laden water into the storm drains. The illegal discharge observed during the inspection must be formally reported to the San Diego Water Board and Legally Responsible Person within 30 days (see SWPPP page 1-3).
2. Implement erosion control BMPs site-wide immediately.
3. Implement additional sediment control BMPs site-wide to prevent additional discharges of sediment. Site entrance/exit BMPs must be maintained.
4. Sediment from the construction site must be removed regularly from the public right-of-way and streets.
5. Temporary stockpiles should be covered during rain events.
6. Chemical residue should be removed and disposed of properly.

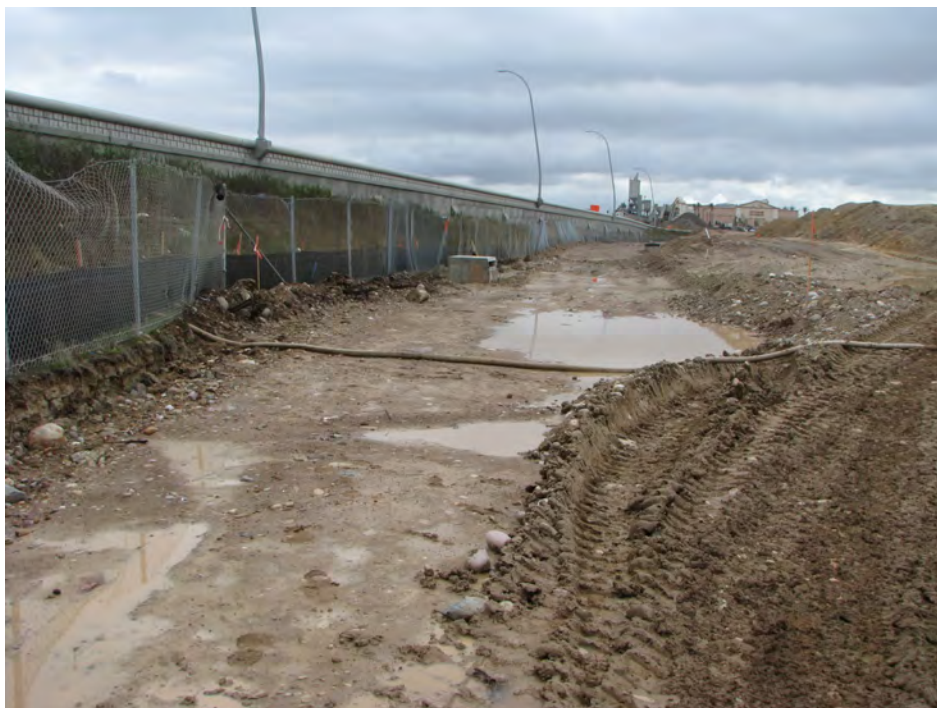
Figure 10. Pipe leading off property (from pump)

Pipe from project site was placed through chain link fence to concrete swale.

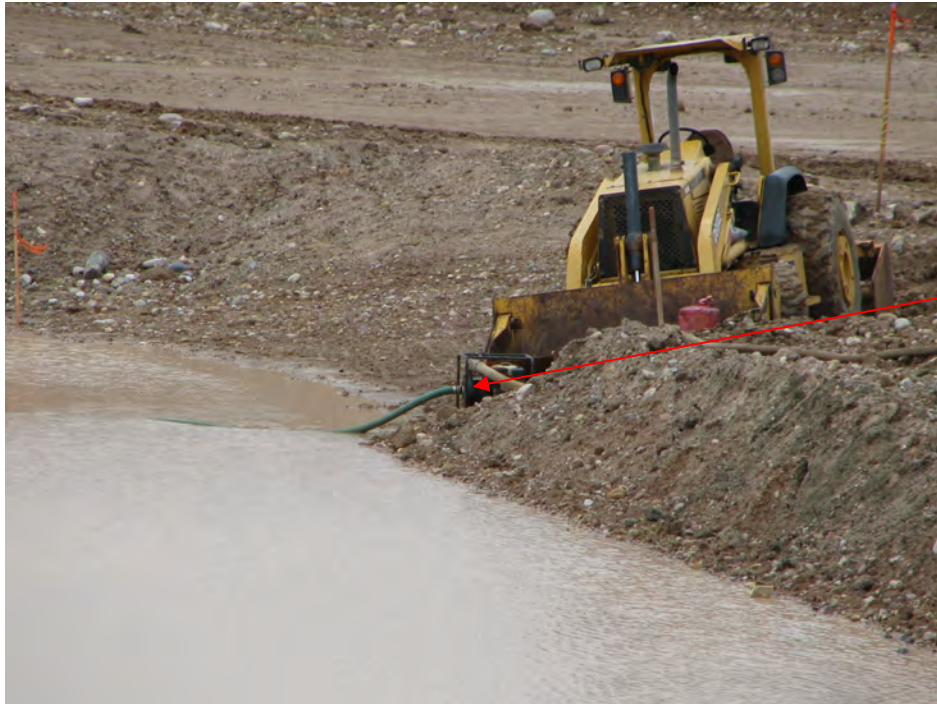
Figure 11. Pump intake

Pump intake line

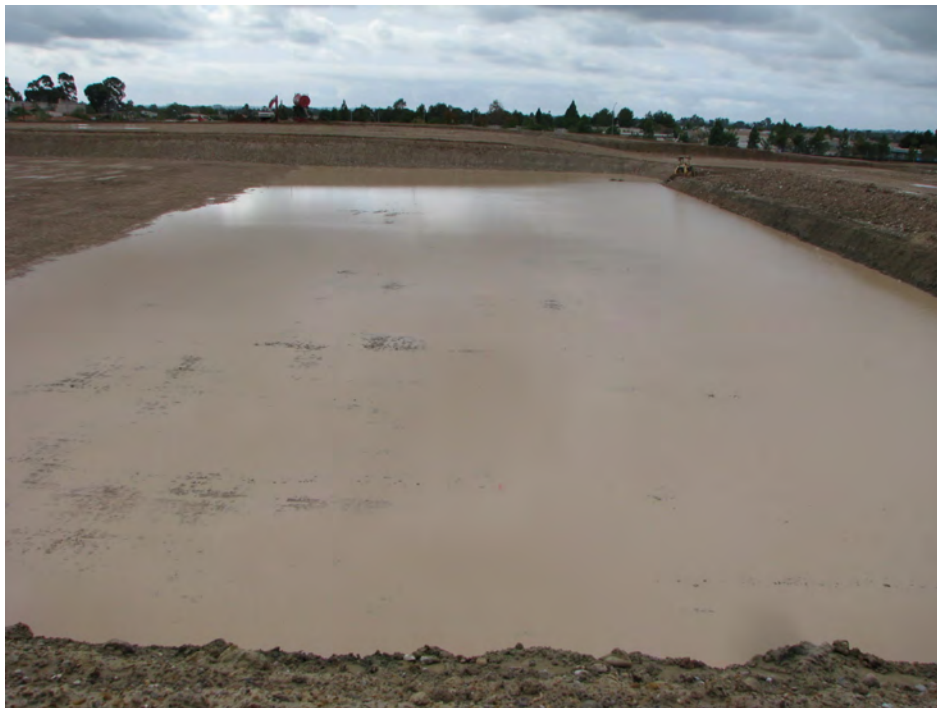
Figure 12. Dewatering area

Area of construction site  
being dewatered.
