**CALIFORNIA REGIONAL WATER QUALITY CONTROL BOARD - SAN DIEGO REGION
WATERSHED PROTECTION PROGRAM**

FACILITY INSPECTION REPORT

FACILITY: Hall Property Park, City of Encinitas Community Park **INSPECTION DATE/TIME:** 12/17/2012; 1300

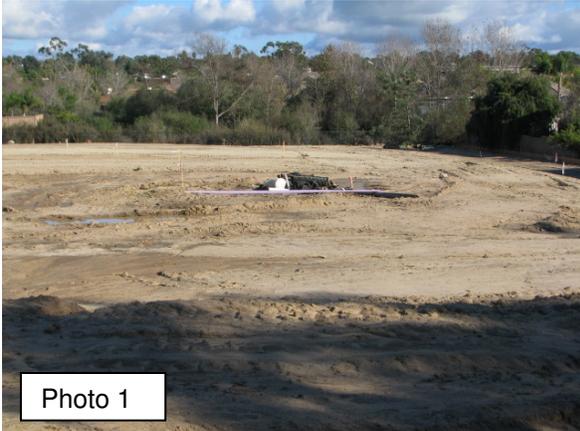
Photo 1

Finding 1: 43 acre site in rough grading stage, during the rainy season.

Photo 1: Looking south east over future *Dog Park* location. No erosion or sediment controls in place. Photo 2: Looking south towards Caretta Way. No erosion control and no sediment control in place on the site.

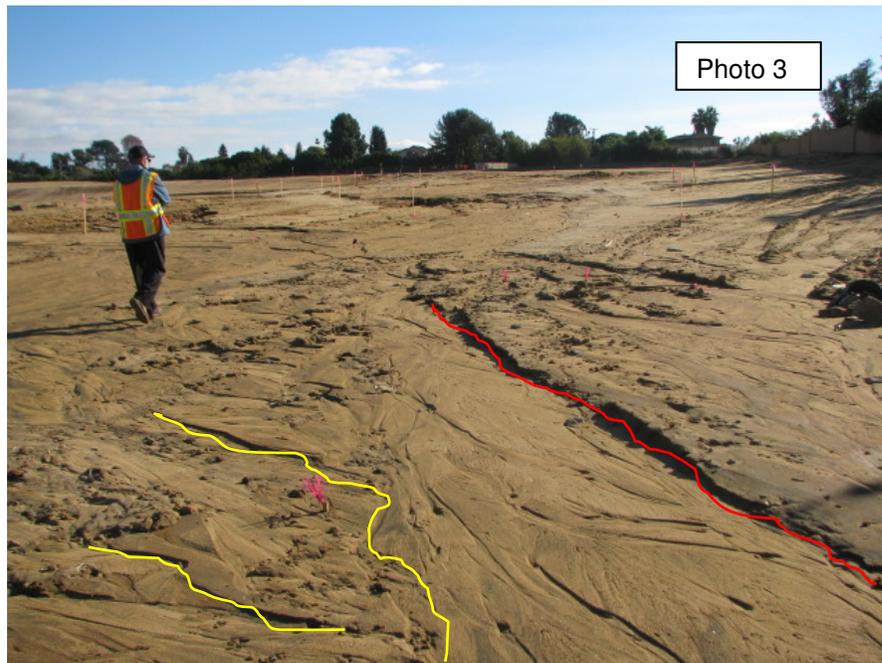
Photo 3

Finding 2: Erosion controls and sediment controls not in place at the site.

Photo 3: Looking uphill, over largest area of *Community Park* towards Caretta Way. Erosion and sediment controls not present on site. There are no check dams, erosion control blankets, or soil binders in place within the concentrated flow paths as specified in the SWPPP. Erosion evident by rills (a few shown in yellow) and channel incisions (a few shown in red) seen in soil on site.

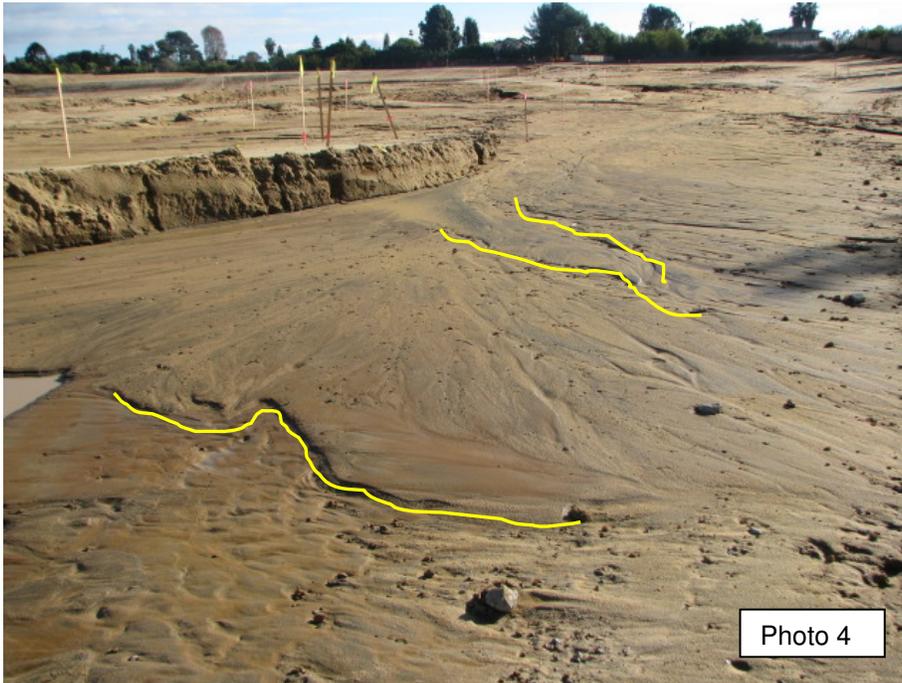
Photo 4

Photo 4: Erosion (rills shown by yellow lines) occurred due to lack of erosion and sediment control BMPs on site prior to the rainy season. There are no check dams, erosion control blankets, or soil binders in place within the concentrated flow paths as specified in the SWPPP.

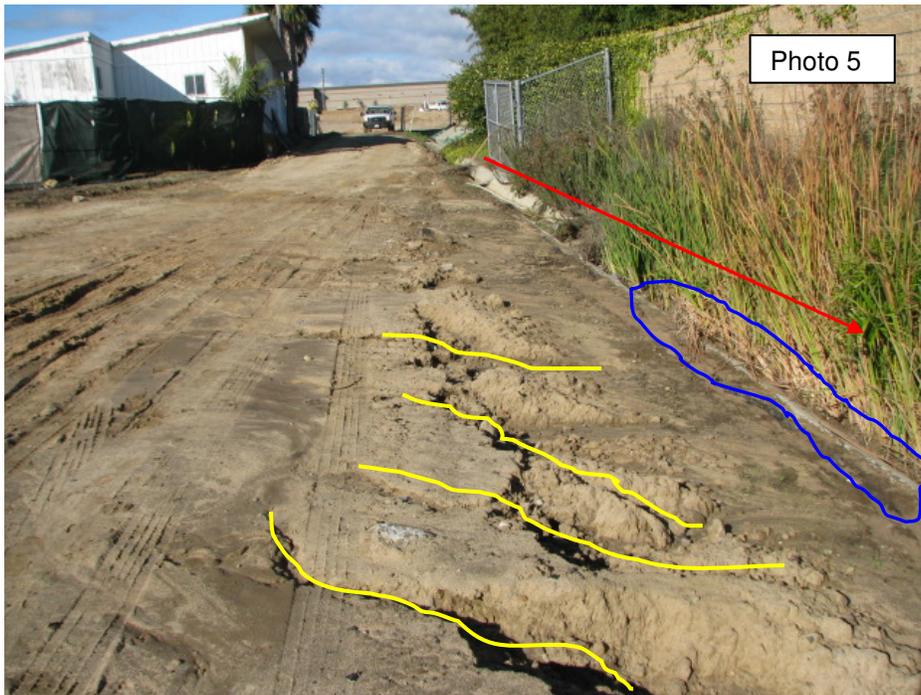
Photo 5

Drainage path leading to Rossini Creek (red arrow). Sediment discharge to drainage ditch evident by large erosion rills (yellow lines) and sediment within vegetation (blue outline).

Photo 5: Significant erosion occurred due to lack of erosion control and sediment control BMPs on site prior to the rain. There are no check dams, erosion control blankets, or soil binders in place within the concentrated flow paths as specified in the SWPPP. Sediment discharged from the site to the concrete ditch (at the right of the photo) that discharges to Rossini Creek.

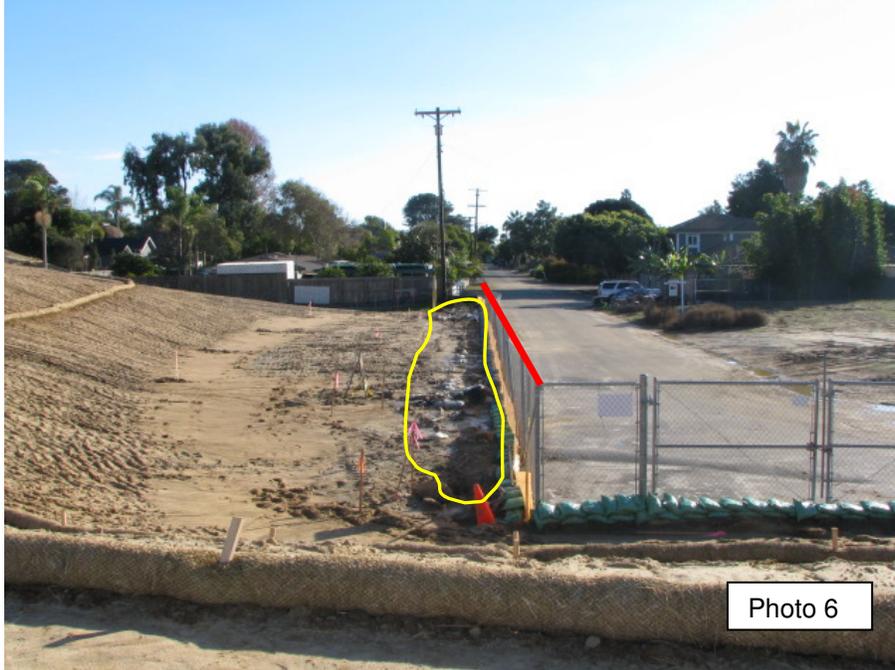
Photo 6

Finding 3: Erosion control BMPs (runoff control and soil stabilization) were not present on site. Sediment-laden storm water was discharged from the construction to Rossini Creek.

Photo 6: Soil binders were reportedly used in conjunction with “track-up/track-down” BMPs on the slope. These BMPs failed to secure soil and prevent erosion. This photo shows sedimentation at the base of the slope (outlined in yellow) along the fence line (shown in red).

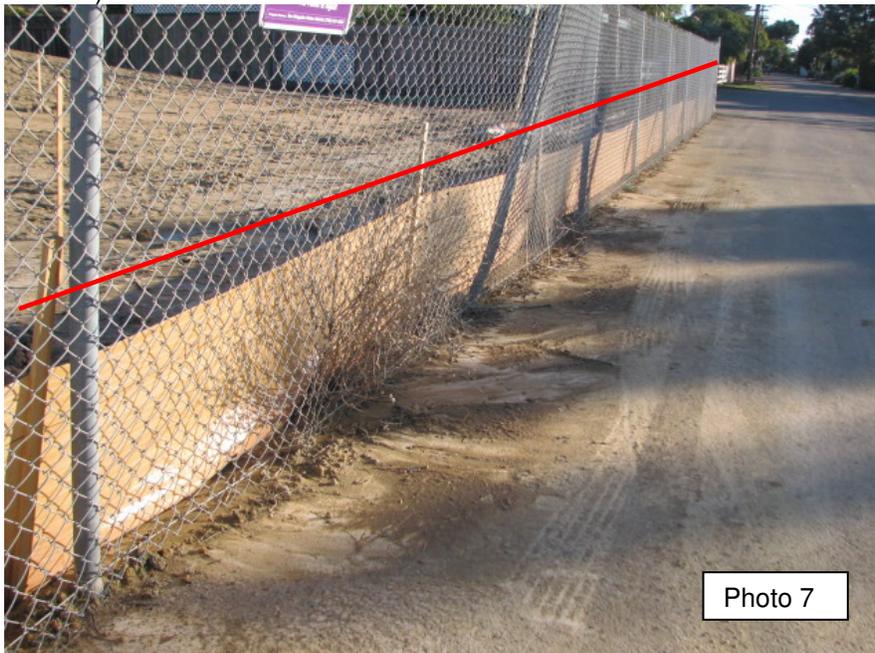
Photo 7

Photo 7: This is the same fence line (in red) shown in Photo 6. Soil binders and track-up/track-down BMPs failed to secure soil and prevent erosion. This photo shows sediment left the site and was discharged to Starlight Drive. This sediment still had not been cleaned up at the time of inspection. This silt fence looked new because of how clean it is. It is unknown if a silt fence was there prior to the rain event.

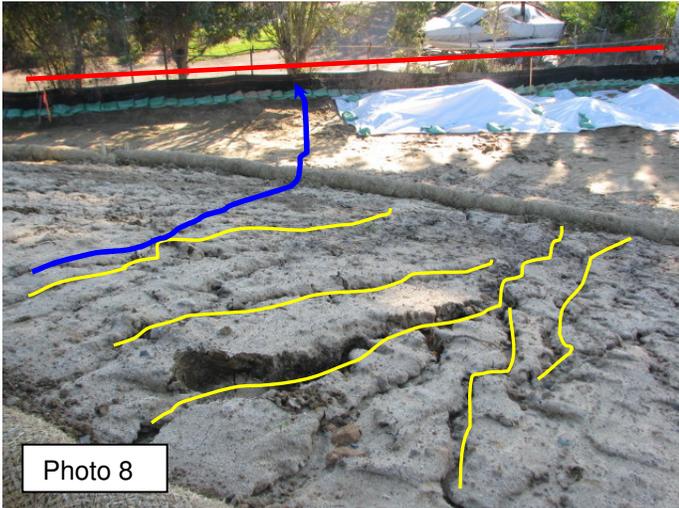
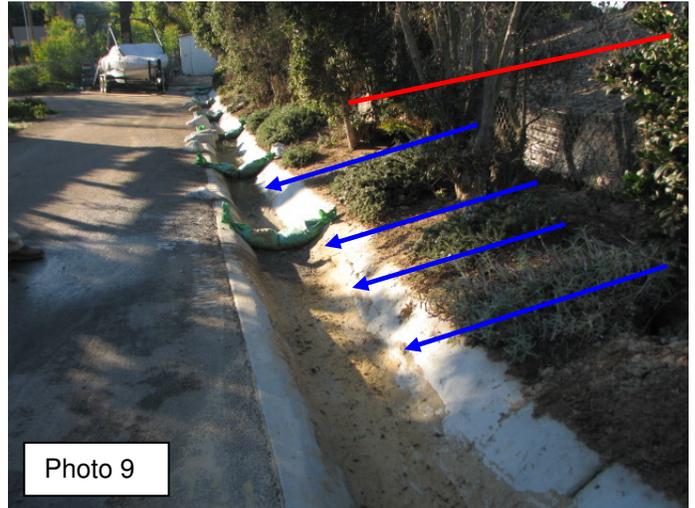
Photo 8 shows evidence of significant erosion rills (outlined in yellow). This slope was reportedly treated with soil binders and the track-up/track-down BMP. As seen in Photo 9, sediment discharged beyond the site fence (outlined in red). This is the same fence as seen in Photo 8. Sediment discharged from the site after the last rain event still seen in the drainage ditch in Photo 9. Sediment deposits can also be seen on the asphalt of Caretta Way in Photo 9. Flow and sediment left the site along a path shown by the blue lines.

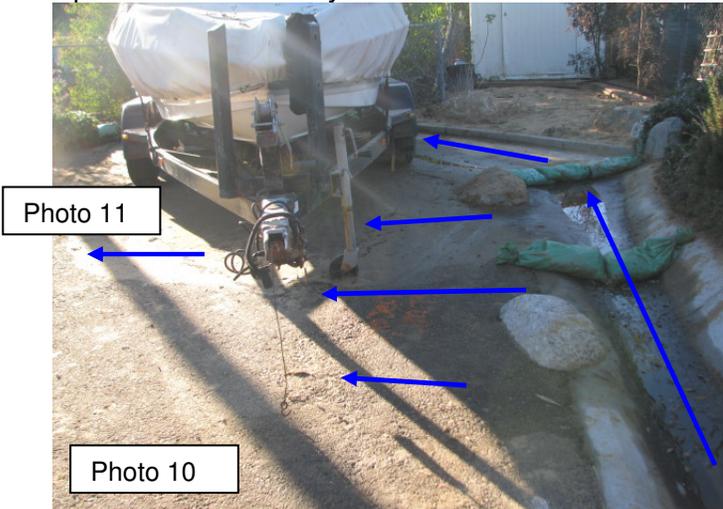
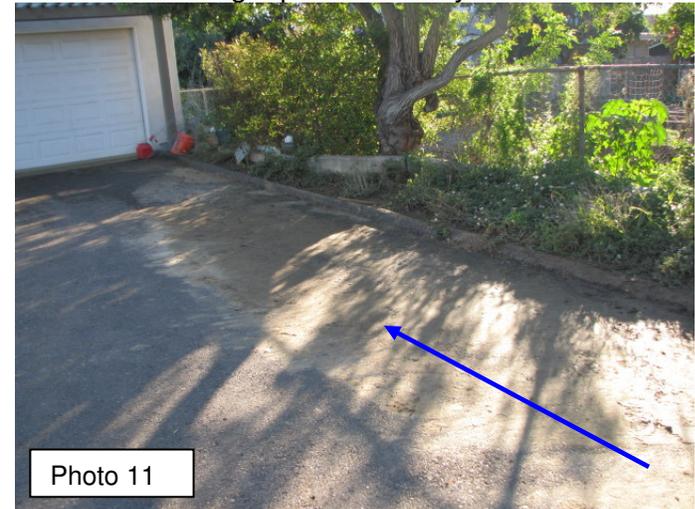
Flow and sediment from the site discharged past the fence line shown in Photo 8 and flowed the path shown by the blue line in Photo 9, 10 and 11. As seen in Photo 11 sediment discharged from the site travel quite a distance documenting the lack of erosion control BMPs on the construction site.

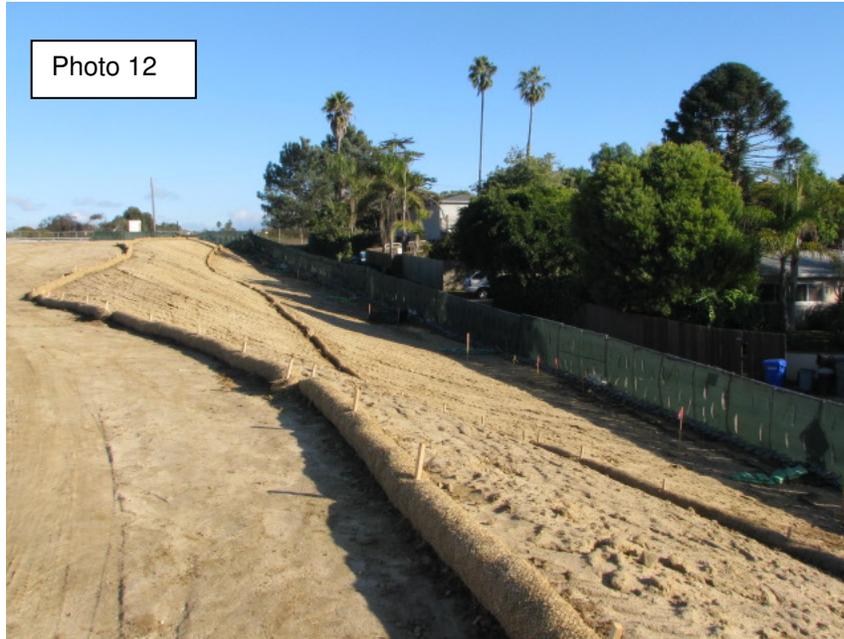
Finding 4: Sediment Control on slopes along Caretta Way.

Photo 12: Soil binder plus “track-up/track down” was reportedly used as a sediment control BMP on the slope shown in Photo 12. The fiber rolls in Photo 12 and the gravel bags at the fence line were placed after the rain event and before the inspection because they were free of any sediment and very clean.

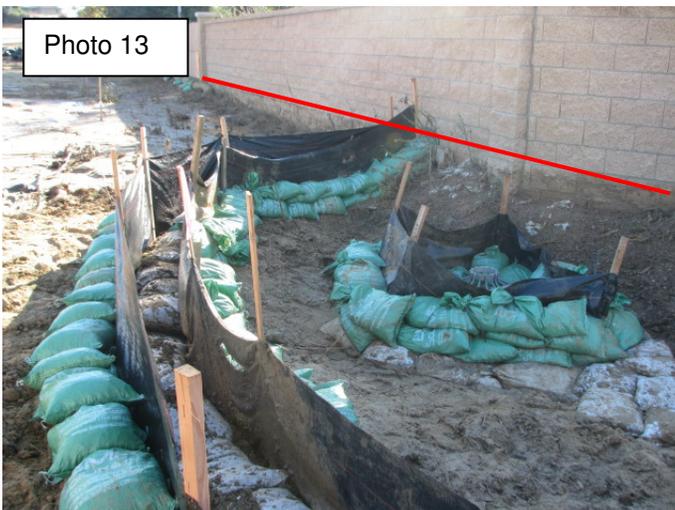
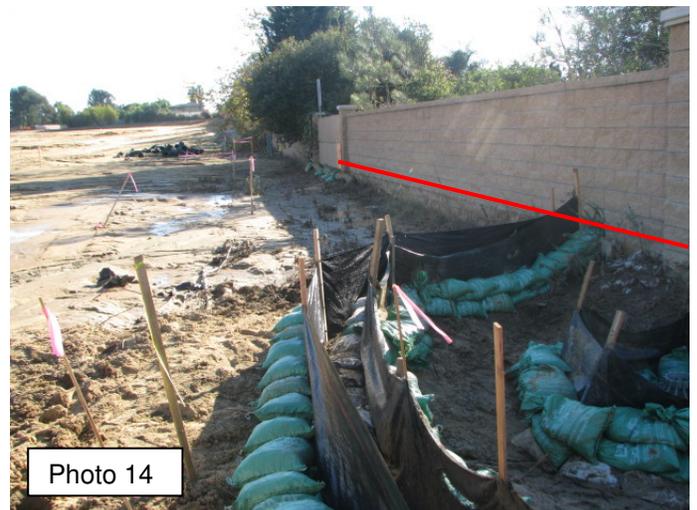
Photo 13 and 14 show new gravel bags (green bags) were placed after the rain event and prior to the inspection. The outer most silt fence was also placed after the rain event and prior to the inspection. The middle silt fence has sediment all over it indicating it was in place before the rain event. The outer most silt fence and stakes were clean. This area was inundated with sediment laden water as indicated by the sediment line on the brick wall (red line). The elevation of the red line is well above the storm drain inlet indicating a discharge of site sediment to the storm drain.

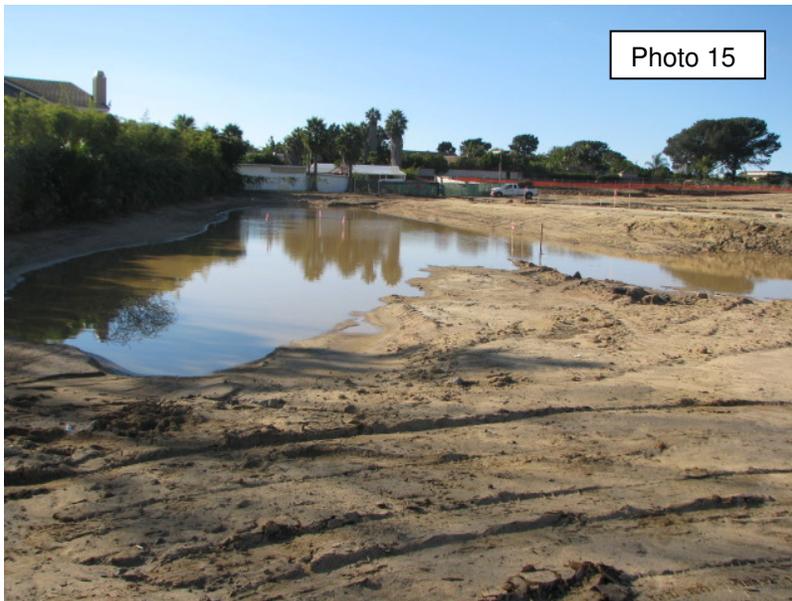
Finding 5: Storm water detention basins to control sediment were not present on site.

Photo 15 shows reported location where a sediment basin will be constructed.

2. Sediment control basins can be used provided they are designed with adequate capacity to capture and treat sediment-laden storm water generated from the site. Implementation of adequate erosion control BMPs, sediment control BMPs, and sediment basins are required to prior to the rainy season (October 1), as described in the SWPPP.
