California Regional Water Quality Control Board, San Diego Region

Subject: Areas of Concern and WDR Violations, Maxson Street Landfill, City of Oceanside, San Diego County, California

Landfill Inspection Report

Maxson Street Landfill
June 26, 2012 Inspection Pictures

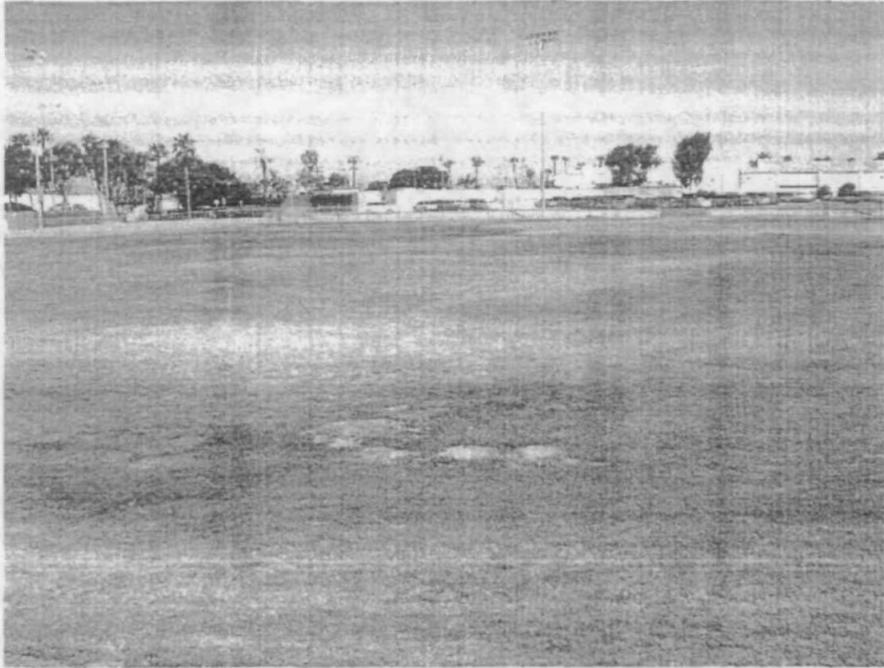
During the inspection, numerous rodent holes and mounds were observed in the landfill cover in the northeastern baseball field, overlying the Landfill; refer to attached landfill inspection report. These features may serve as preferential migration pathways for surface water that may adversely impact the landfill cover integrity. These conditions are areas of concern that warrant corrective action in a timely manner, but no later than October 31, 2012.

Rodent holes and mounds observed in the northeastern baseball field.

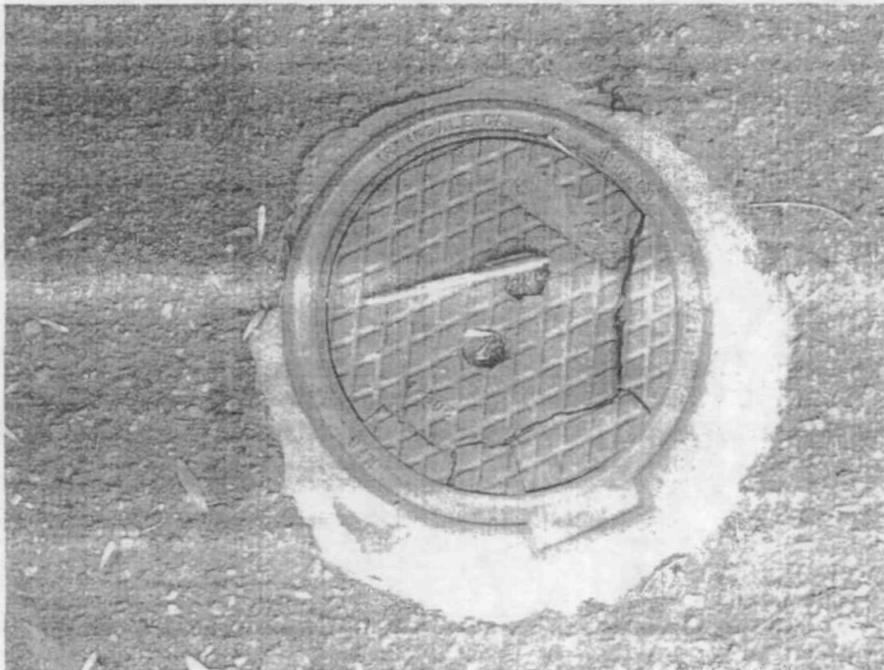
Cracked metal cover for security vault of MW-1.

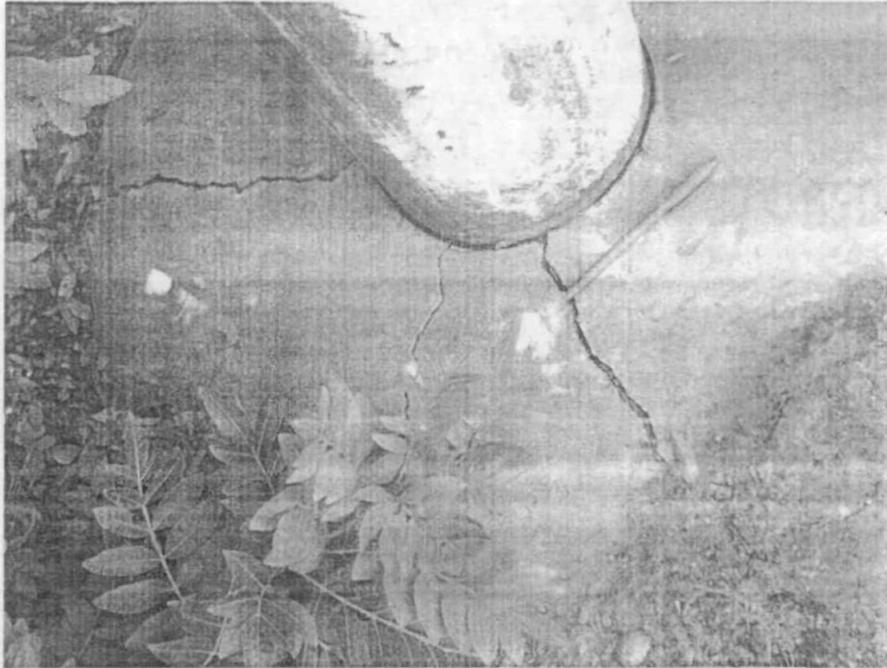
Cracked concrete surface seal of MW-2.

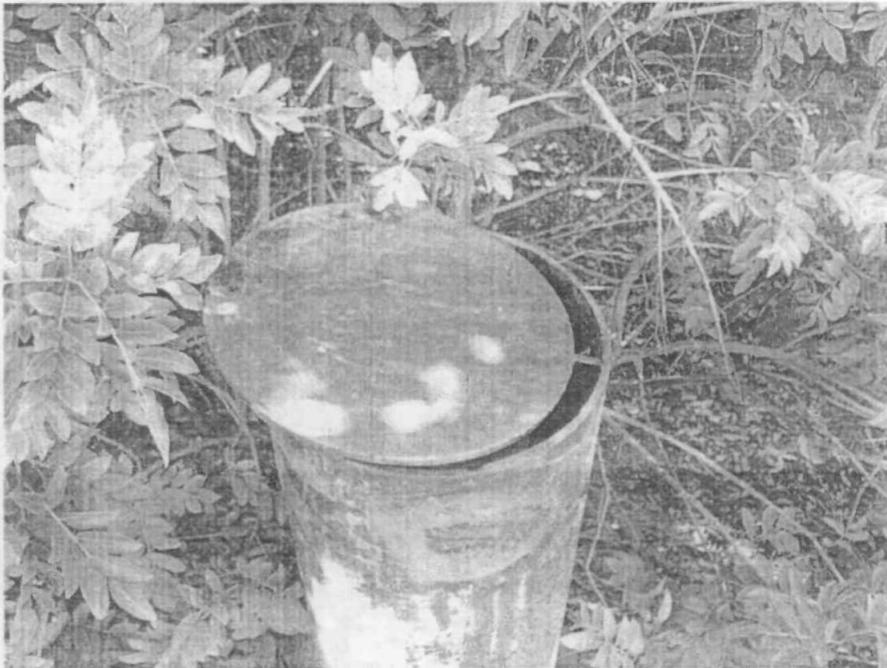
Unlocked protective steel well head cover of MW-2.
