From: [Ghoram, Whitney@Waterboards](mailto:Ghoram_Whitney@Waterboards)
To: chadh@ecconstructors.com
Cc: [Walsh, Laurie@Waterboards](mailto:Walsh_Laurie@Waterboards); [Ghoram, Whitney@Waterboards](mailto:Ghoram_Whitney@Waterboards)
Subject: Grossmont High School Increment 1 Construction: Post Inspection Required Corrective Actions
Date: Wednesday, February 24, 2016 12:07:09 PM
Attachments: [InspectionPics-GrossmontHS-Increment-1Construction.pdf](#)
Importance: High

Grossmont High School Increment 1 Construction
1100 Murray Drive, El Cajon 92020
WDID: 9 37C369958

Inspection Date: February 23, 2016
Inspector: Whitney Ghoram
San Diego Water Board

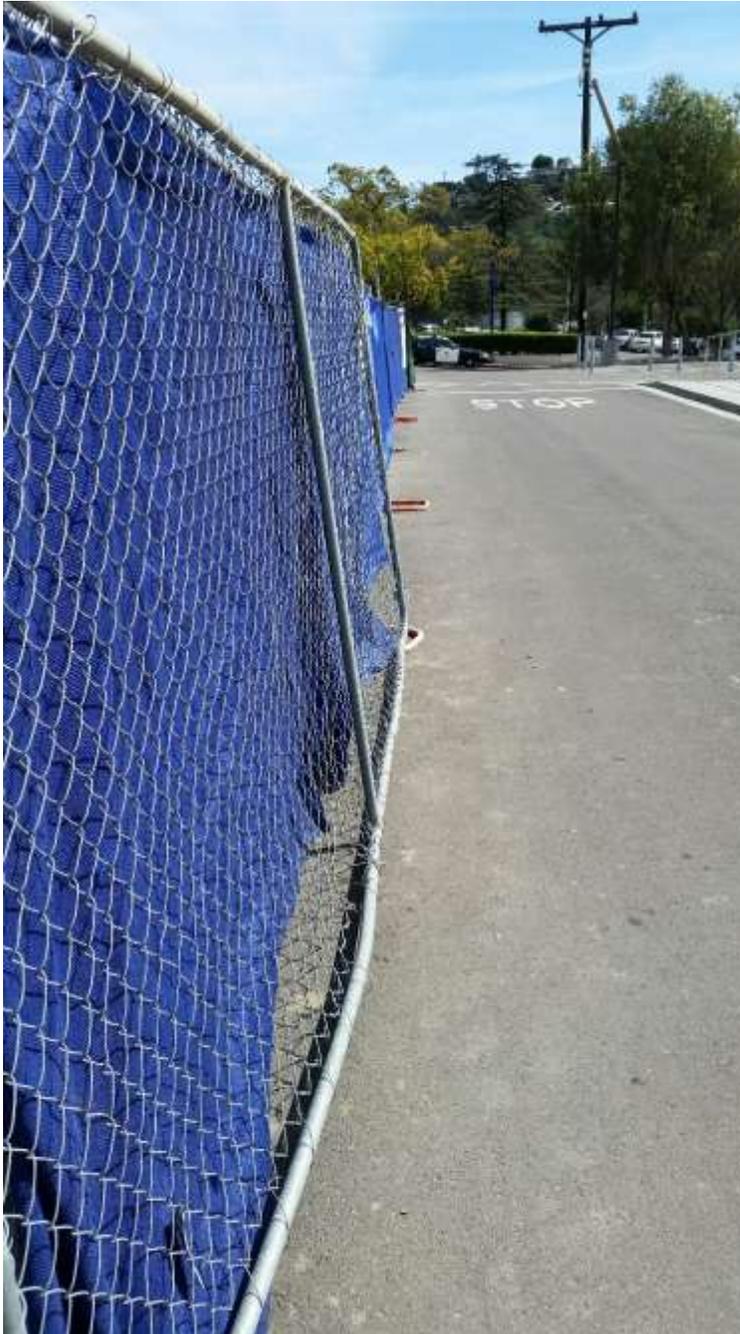
Lack of perimeter controls

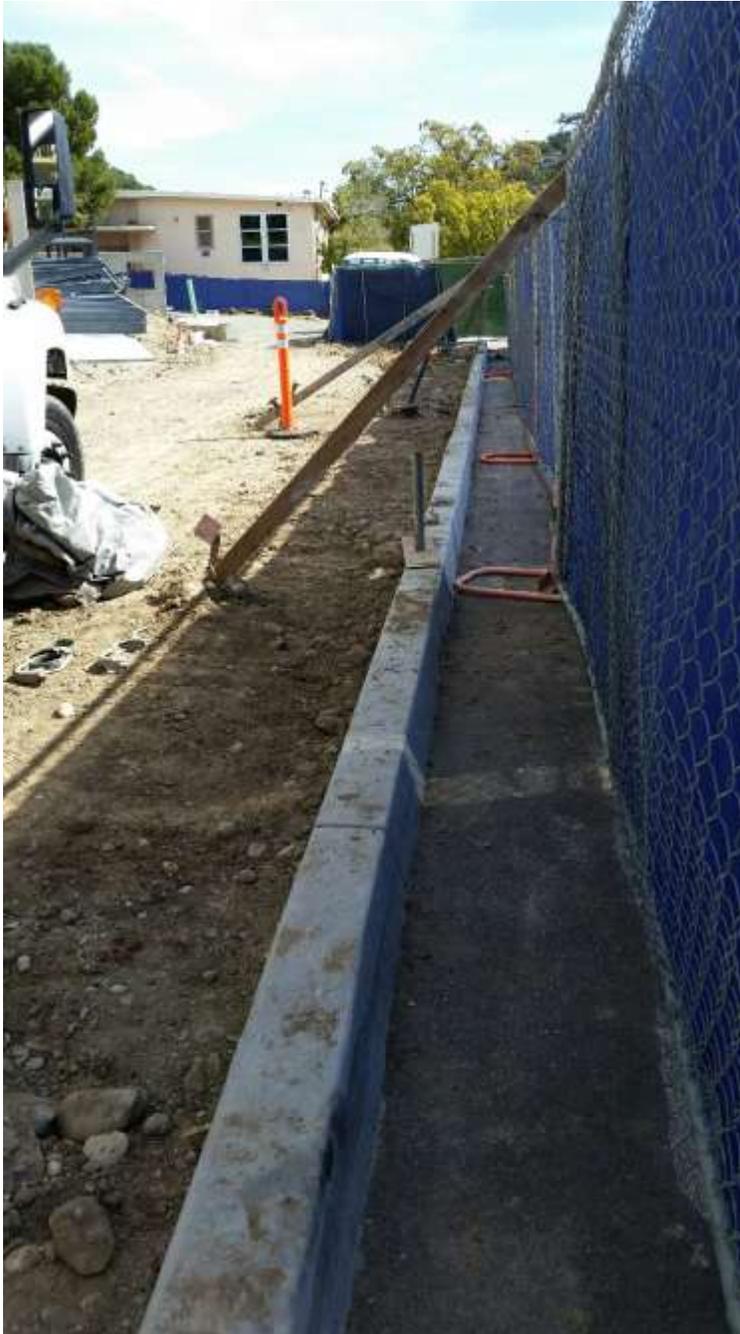
Lack of perimeter control BMPs,
Poor Housekeeping

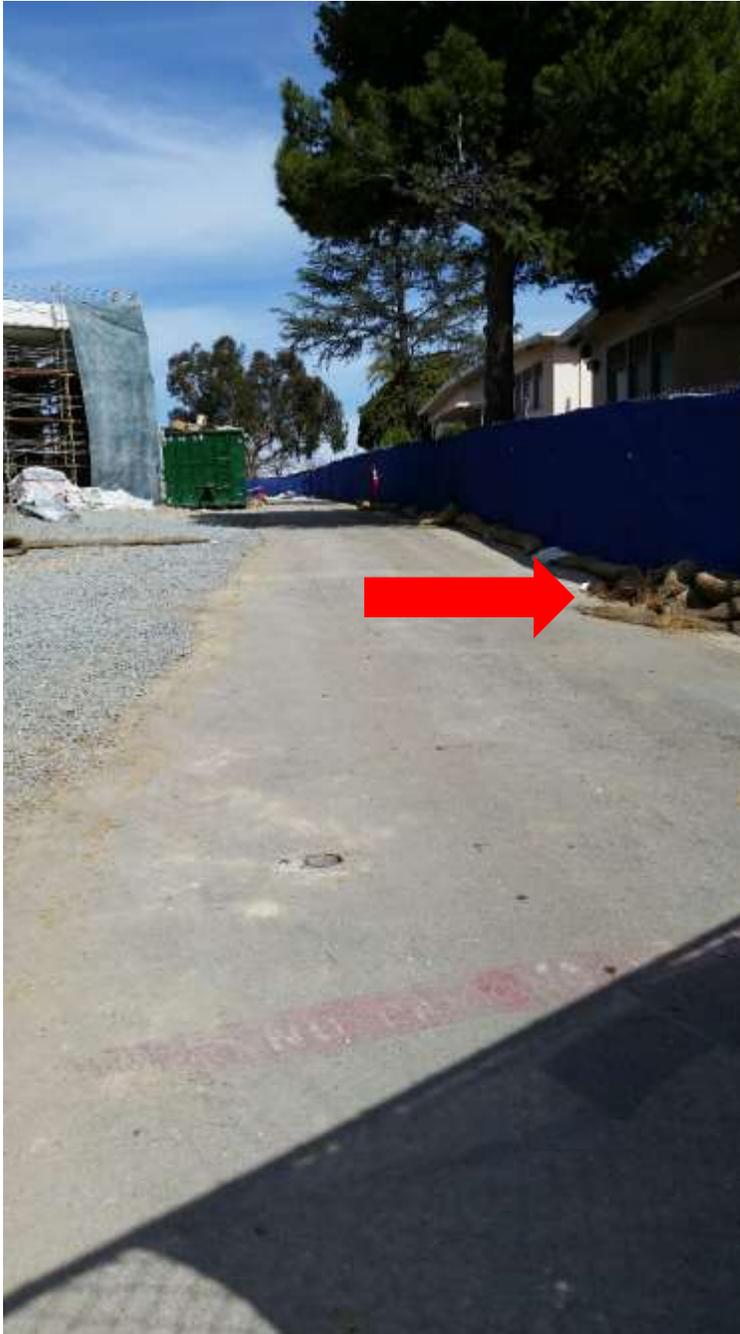
Deficient and lack of perimeter control BMPs.

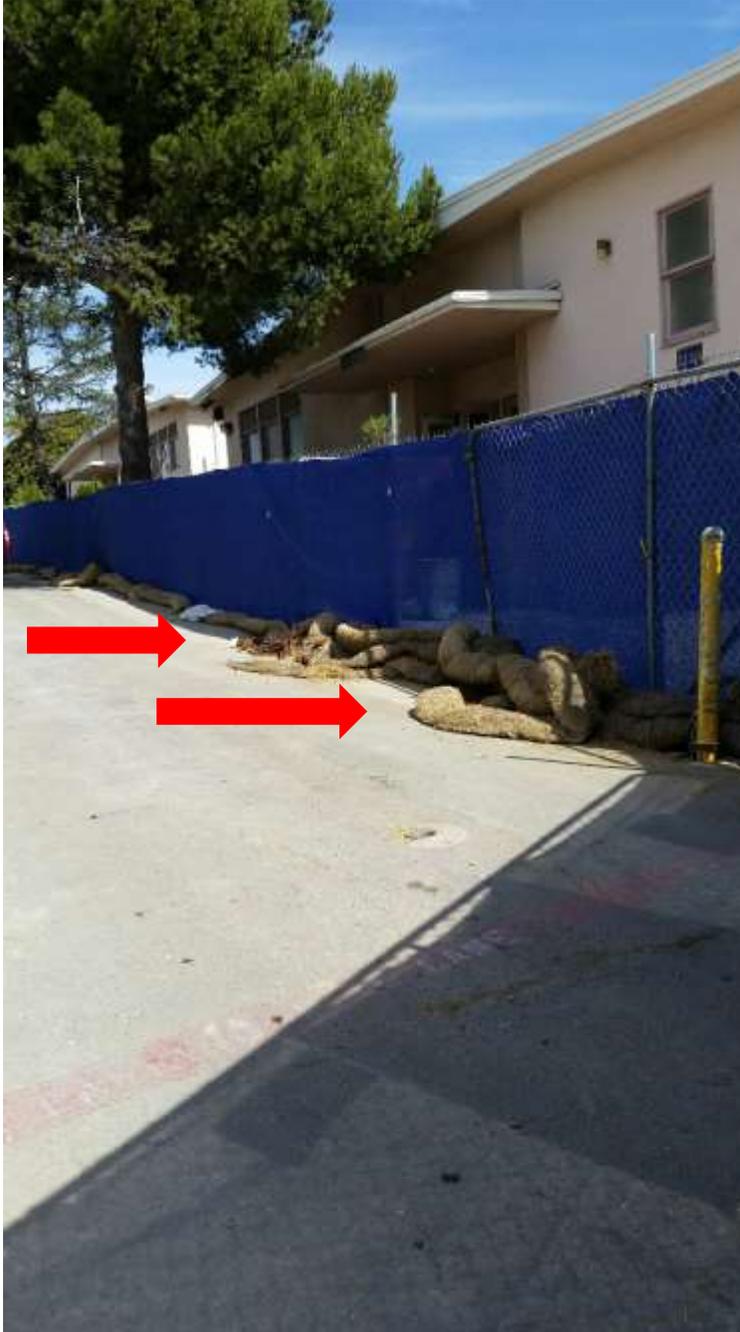
Grossly deficient perimeter control BMPs

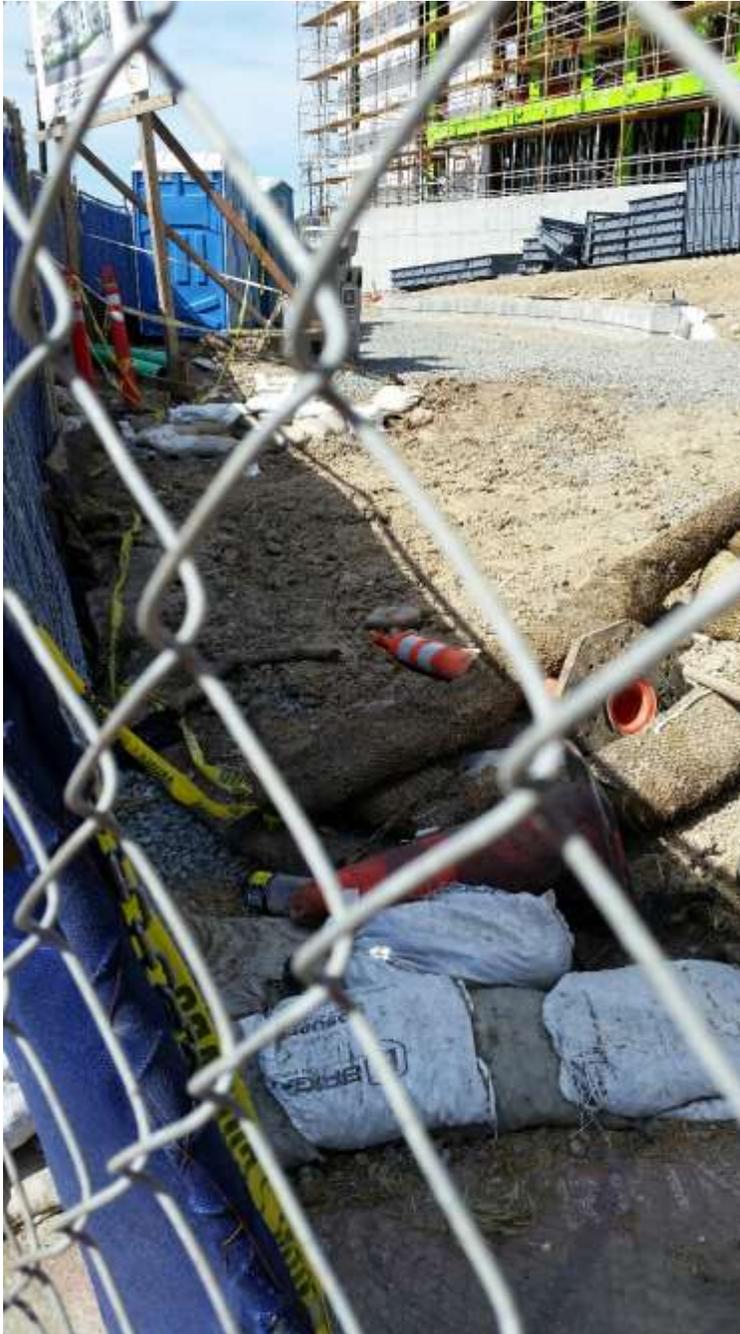
Poor housekeeping. Deficient
BMPs

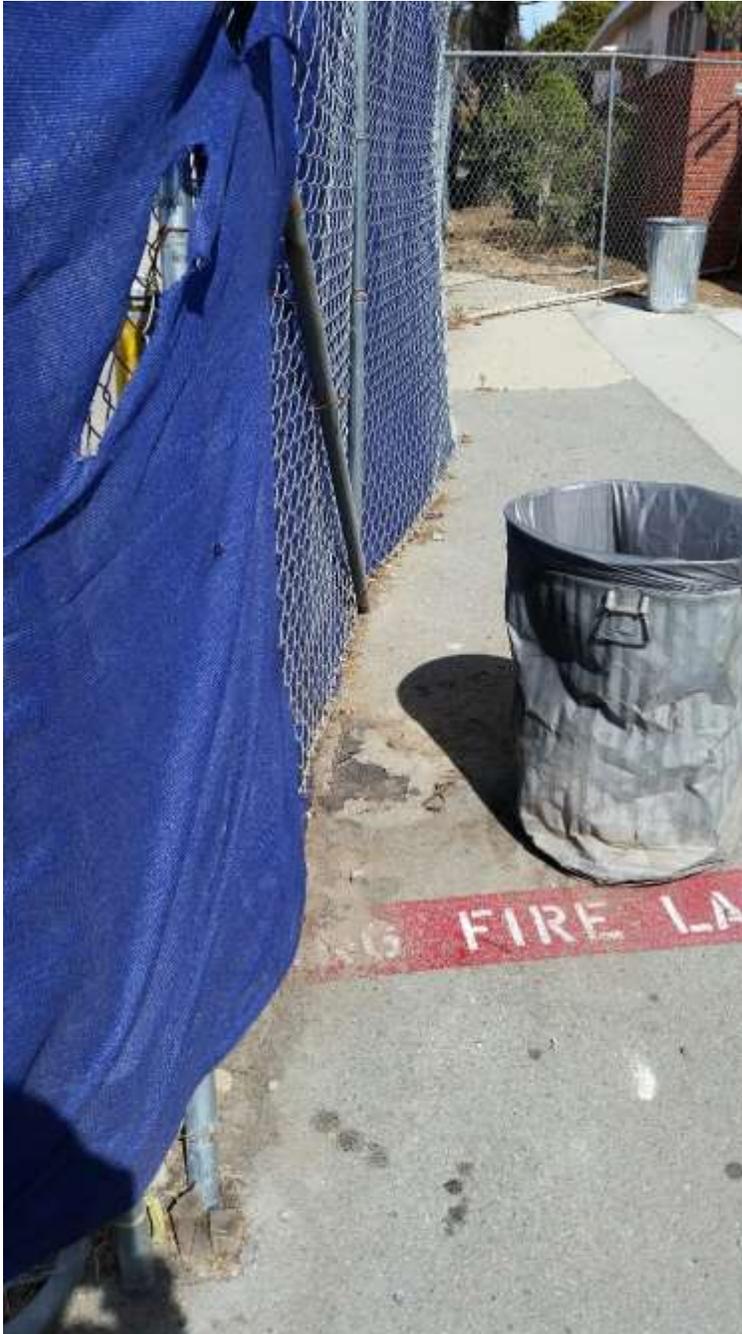
Lack of perimeter controls

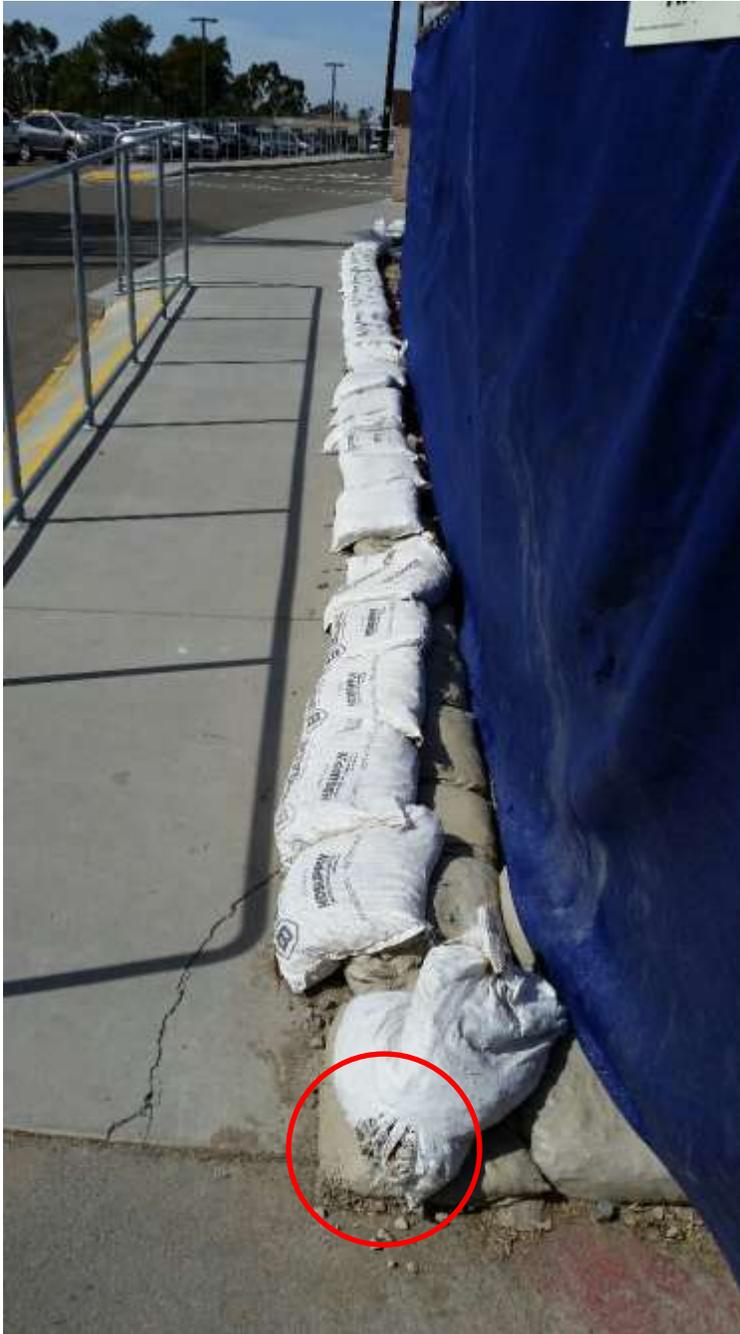
Broken gravel bag

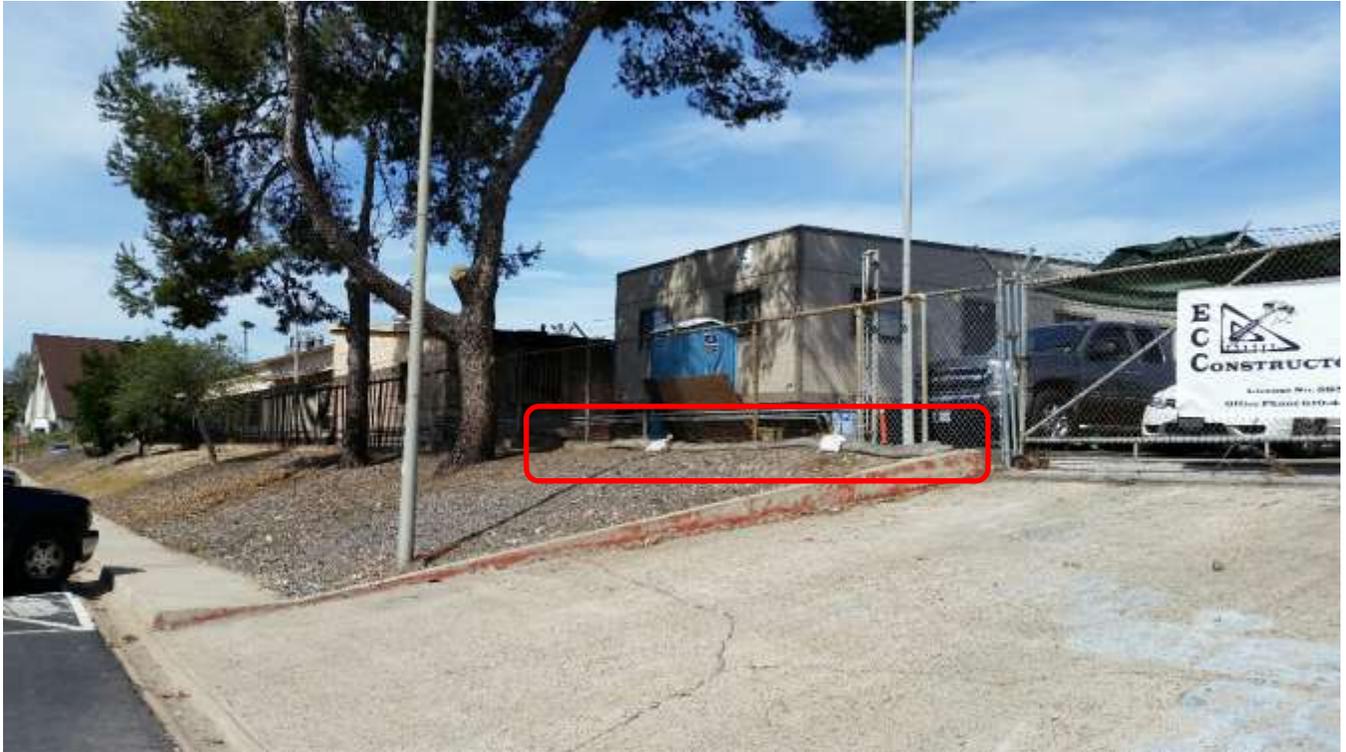
Deficient perimeter controls: Worn fiber rolls that are not staked into the ground at 4 foot intervals.

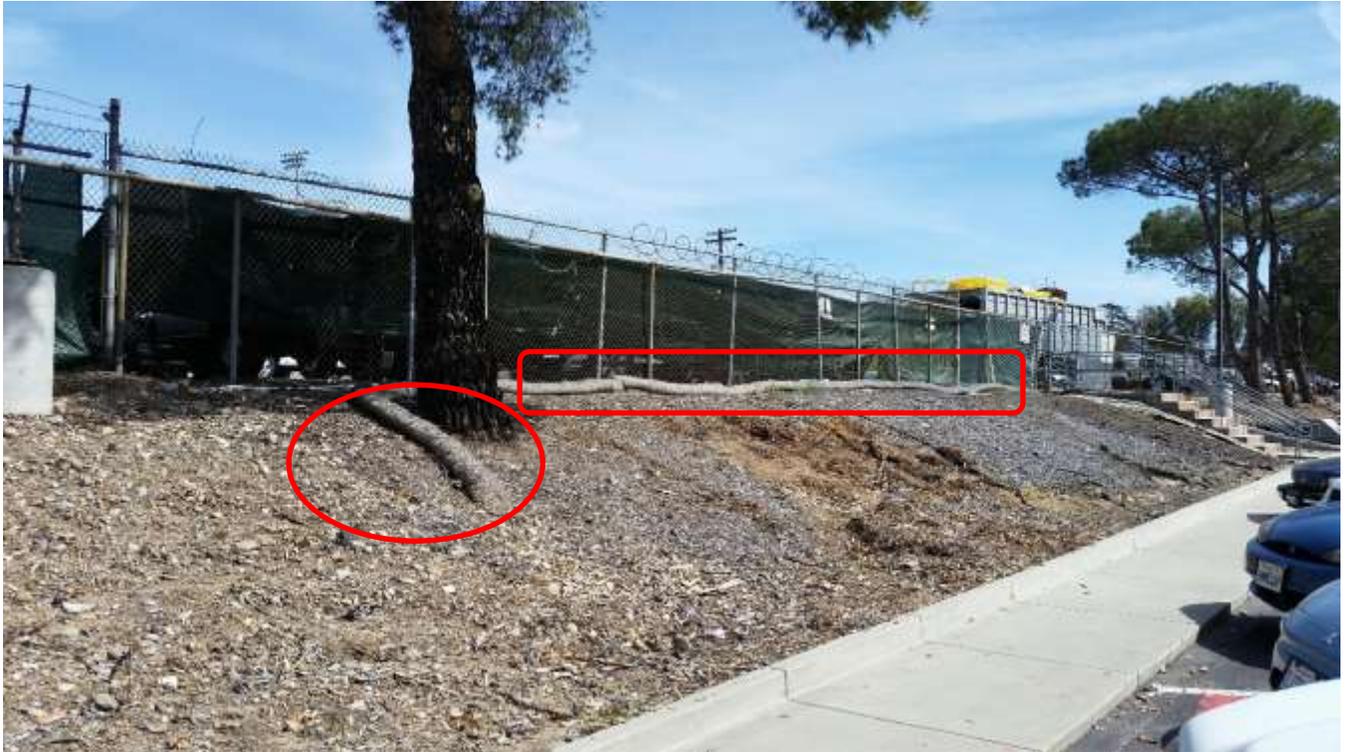
Deficient perimeter controls: Worn fiber rolls that are not staked into the ground at 4 foot intervals.

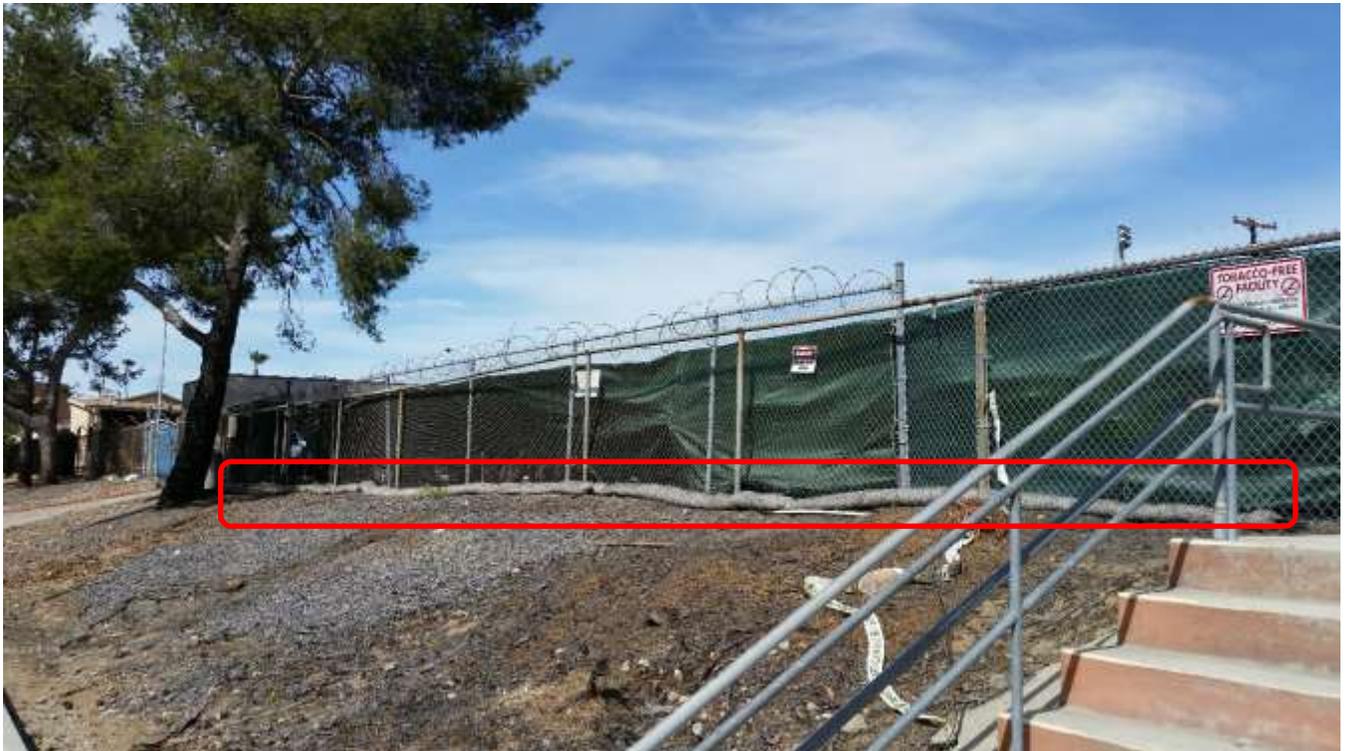
Deficient perimeter controls
and lack of perimeter controls.
Fiber rolls are not properly
installed, not staked into
ground.

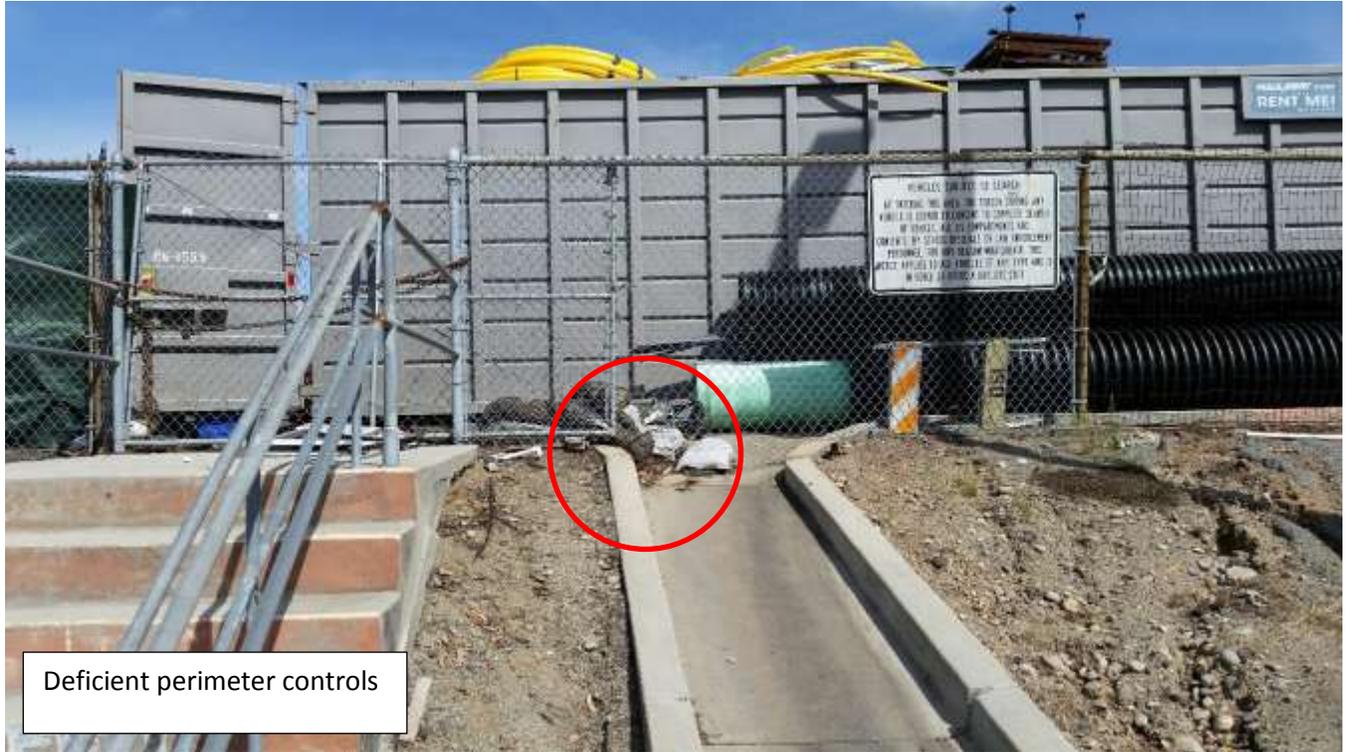
Deficient perimeter controls

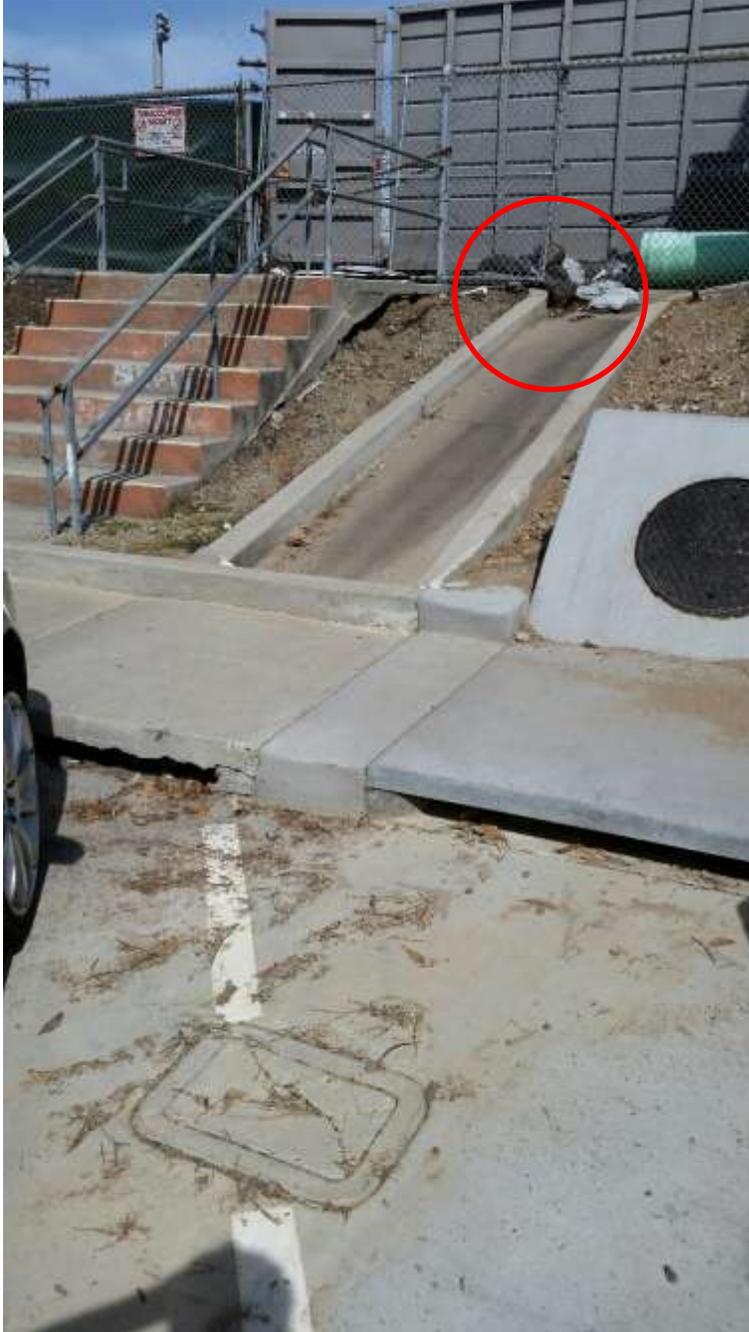
Deficient perimeter controls at discharge point to MS4 (storm drain inlets). Also, evidence of sediment discharge.
