Subject: Notice of Violation No. R9-2014-0154, Mission Gorge Apartments Construction Project, Order No. 2009-0009-DWQ, NPDES Permit No. CAS000002, Construction General Permit

NOTICE OF VIOLATION
No. R9-2014-0154

Mission Gorge Apartments Construction Project
PIN No. SM-826367:wchiu

FACILITY INSPECTION REPORT

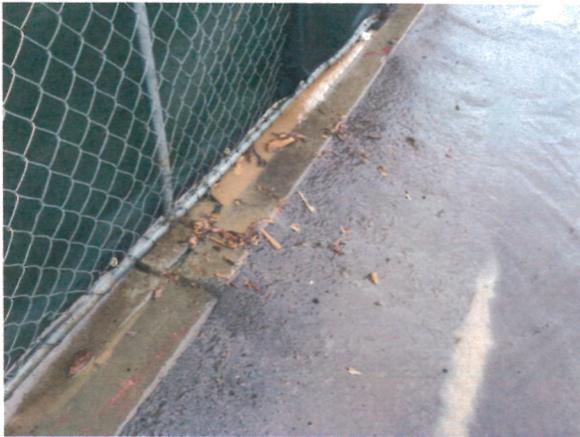
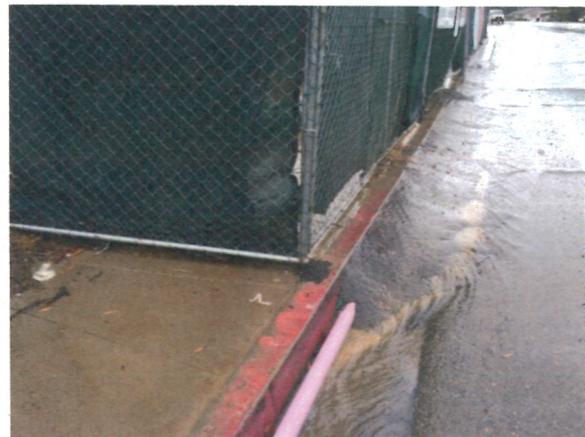
During a December 12, 2014 storm event, Ms. Ghoram observed a discharge of sediment-laden storm water from the site to the City of San Diego municipal separate storm sewer system (MS4) on Mission Gorge Road (See Photos 1 and 2). Wayne Chiu of the San Diego Water Board performed a follow up inspection of the Mission Gorge Apartments construction site for compliance with the requirements CGP to determine whether the discharge of sediment-laden storm water from the site was an authorized.. According to the Storm Water Multiple Application & Report Tracking System (SMARTS), the site is a Risk Level 1 construction site, disturbing over 10 acres, and owned being developed by KNR Mission Gorge LLC.

Photos 1 and 2 show discharges of sediment-laden storm water runoff from the site to the City of San Diego MS4 drainage system on Mission Gorge Road.

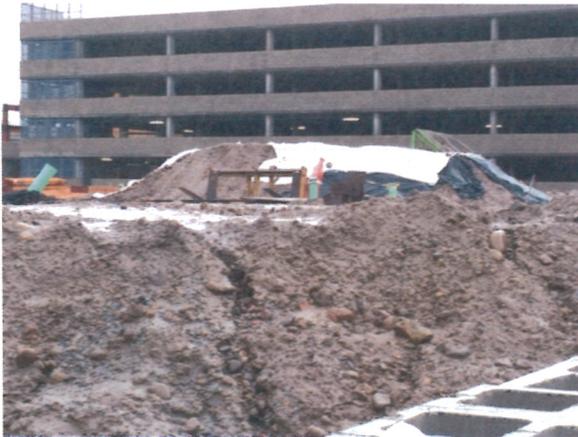
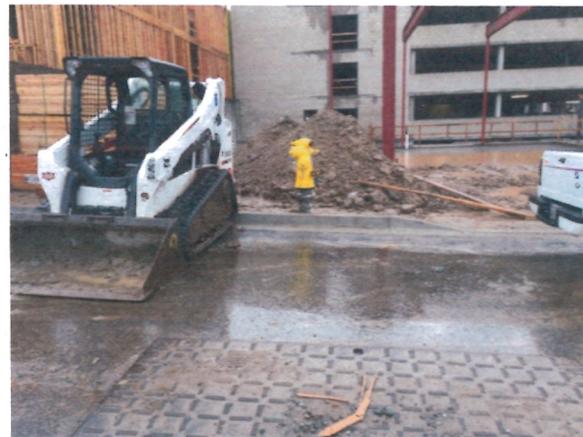
or protection, resulting in erosion and sediment transport. See attached December 12, 2014 Facility Inspection Report Photos 3 and 4.

1. Several stockpiles observed without adequate cover and containment (See Photos 3 and 4). Evidence of erosion and sediment transport from the stockpile observed during the inspection. All construction sites are required to contain and securely protect stockpiled waste material from wind and rain at all times unless actively being used.

1. There is evidence that the site failed to implement good site management "housekeeping" BMPs for soil stockpiles before the storm event (See Finding 1).

Photos 3 and 4 show soil stockpiles without adequate cover and containment during December 11 and 12, 2014 storm event. Evidence of erosion and sediment transport along that base of the stockpile.

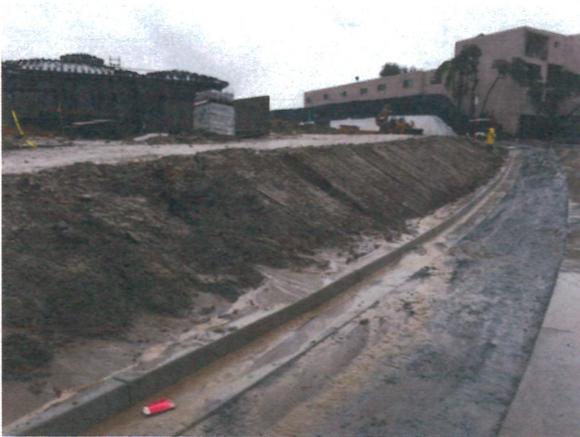
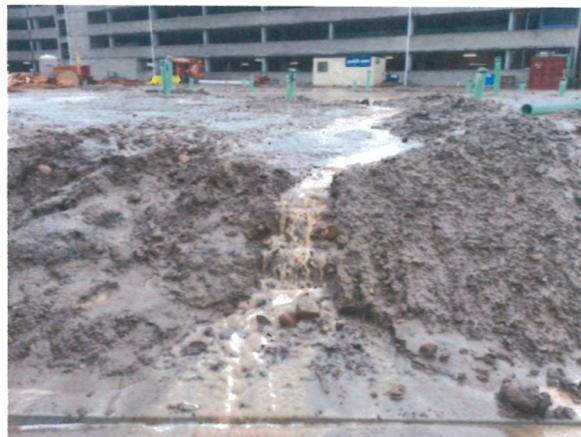
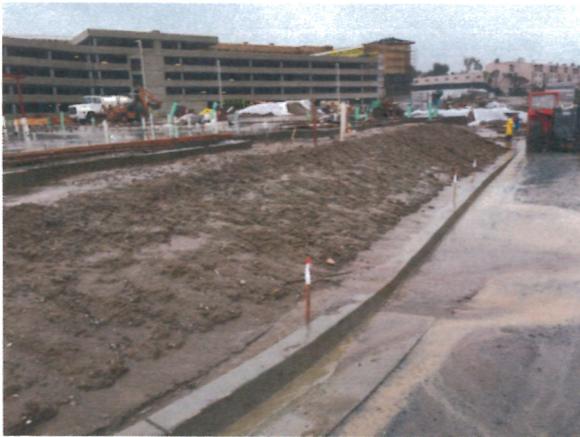
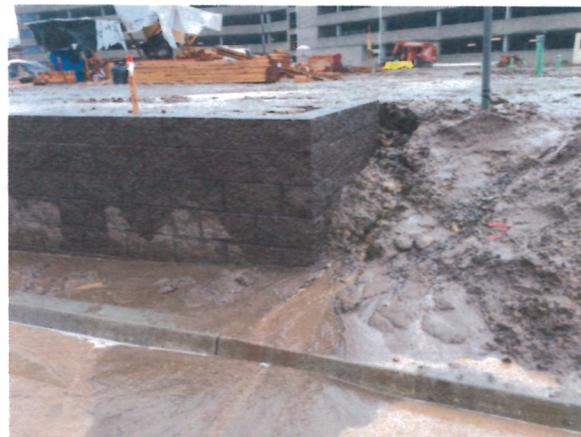
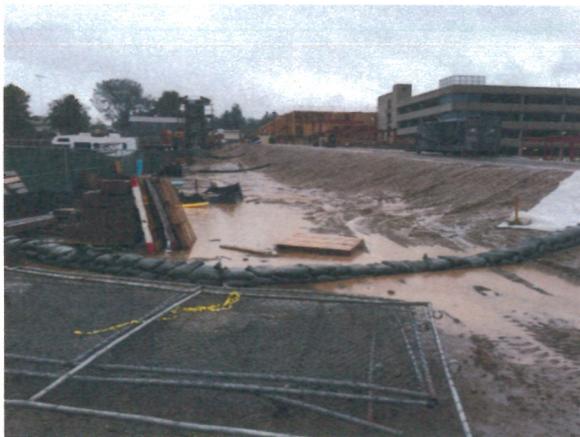
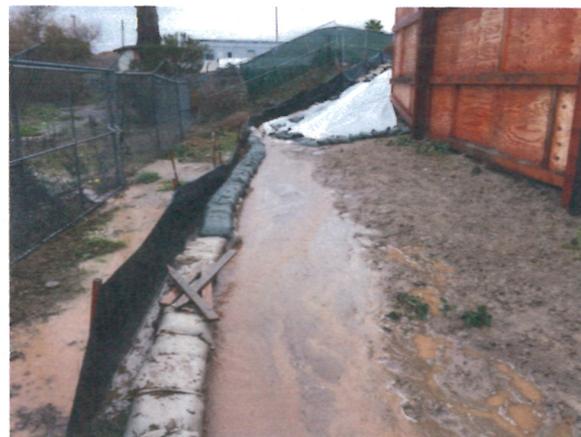
- a. Pursuant to Provision IX and Section D.2 of Attachment C of State Water Board Order No. 2009-0009-DWQ:** Risk Level 1 dischargers shall provide effective soil cover for inactive areas and all finished slopes, open space, utility backfill, and completed lots.
- b. Observation:** During the December 12, 2014 inspection, the San Diego Water Board inspector observed several completed areas and slopes on the site that appeared to be inactive, or could be scheduled to be inactive, without effective soil cover or other BMPs that could prevent erosion. Evidence of erosion and sediment transport due to lack or erosion control measures for inactive areas were observed throughout the site during the inspection. See attached December 12, 2014 Facility Inspection Report Photos 5 through 10.

2. Several areas were observed to be inactive, or could be scheduled to be inactive, without effective soil cover to control potential erosion. Several inactive slopes (See Photos 5 through 10) lacked any effective soil cover for erosion control. The lack of erosion controls in these areas contributed to unauthorized sediment discharges from the site (See Photos 11 through 15). All construction sites are required to provide effective soil cover for inactive areas (i.e. areas that have been disturbed and not scheduled to be re-disturbed for at least 14 days) and all finished slopes, open space, utility backfill, and completed lots.

3. Lack of effective runoff controls observed within and around the site which contributed to discharges of sediment-laden storm water runoff from the site (See Photos 5 through 10). The lack of runoff controls within the site contributed to unauthorized sediment discharges from the site (See Photos 11 through 15). All

2. There is evidence that the site failed to implement adequate erosion controls for several inactive areas and slopes before the storm event contributing to discharges of sediment-laden storm water runoff from the site (See Finding 3).

Photos 5 through 10 show several slopes and areas that have been inactive for at least 14 days lacking erosion control measures to prevent erosion. Photos also show lack of runoff controls within the site to limit the transport of sediment through the site.

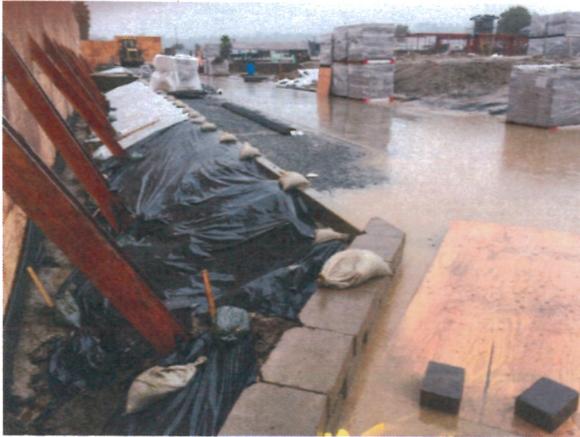
Photos 11 through 15 show pathway to unauthorized discharges of sediment and sediment-laden storm water runoff from the site to the San Diego River. Photo 11 shows area where runoff in Photos 5 through 8 collect. Photo 12 shows where runoff from Photo 11 flow down slope. Photo 13 shows where flow from Photo 12 emerges. Photo 14 shows where flow from Photo 13 and Photos 9 and 10 converge and discharge from location in perimeter controls (i.e. gravel bags) that appears to have been moved to allow flow off site. Photo 15 shows sediment-laden storm water runoff flowing off site to the San Diego River due to inadequate implementation of erosion controls, runoff controls within the site, and perimeter sediment controls.

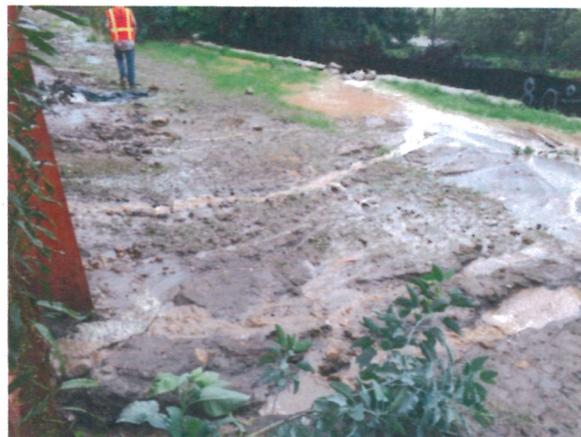
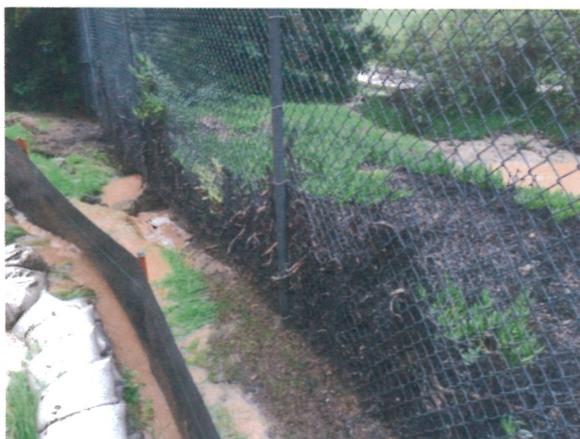
- a. Pursuant to Provision IX and Section E.1 of Attachment C of State Water Board Order No. 2009-0009-DWQ:** Risk Level 1 dischargers shall establish and maintain effective perimeter controls and stabilize all construction entrances and exits to sufficiently control erosion and sediment discharges from the site.
- b. Observation:** During the December 12, 2014 inspection, the San Diego Water Board inspector observed perimeter controls that were not adequately established or maintained to sufficiently control erosion and sediment discharges from the site. See attached December 12, 2014 Facility Inspection Report Photos 14 and 15.

4. Lack of effective perimeter sediment controls observed which resulted in unauthorized sediment discharges from the site (See Photos 14 and 15). All construction sites are required to establish and maintain effective perimeter controls and stabilize all construction entrances and exits to sufficiently control erosion and sediment discharges from the site.

3. There is evidence that the site failed to implement adequate perimeter sediment controls, as well as runoff controls within the site, which contributed to discharges of sediment-laden storm water runoff from the site (See Findings 6 and 7).
